Contract No. : DC/2007/06
River Improvement Works in Upper Lam Tsuen She
Shan River and Upper Tai Po River

ENVIRONMENTAL MONITORING AND AUDIT
MONTHLY EM&A REPORT of Upper Tai Po River for
November 2008

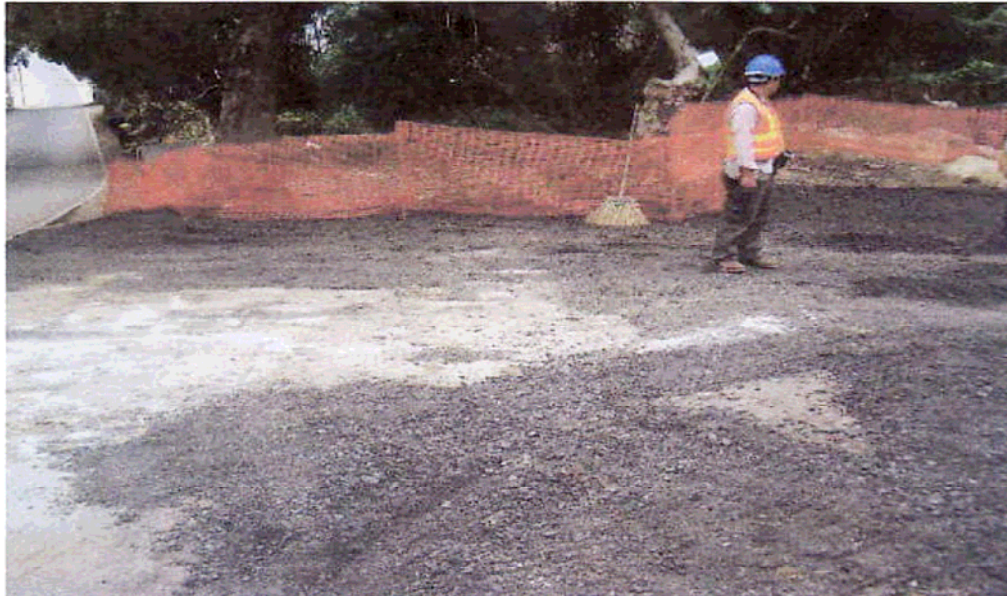
(Fig 1) Site entrance was paved with bituminous materials, photo taken on 3rd December 2008

<p><u>RECOMMENDATIONS</u></p> <ol style="list-style-type: none"> 1. Contractor was reminded if any earth materials are brought to the public access, action of cleaning up shall be taken immediately. 2. The bituminous materials should be well paved to minimize bringing the debris of bitumen, to the public access.

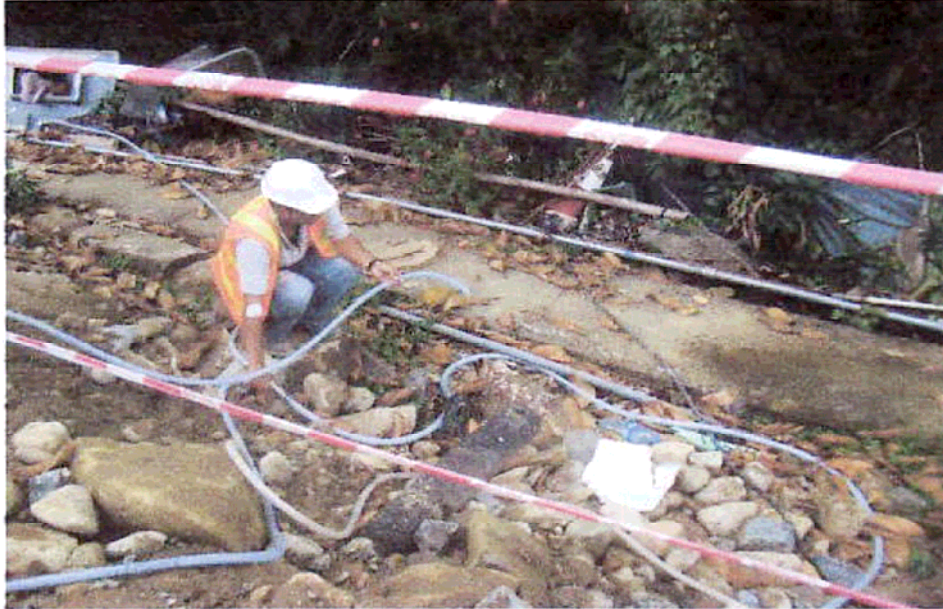
(Fig 2) High jet water sprayer was provided for washing vehicles, photo taken on 3rd December 2008

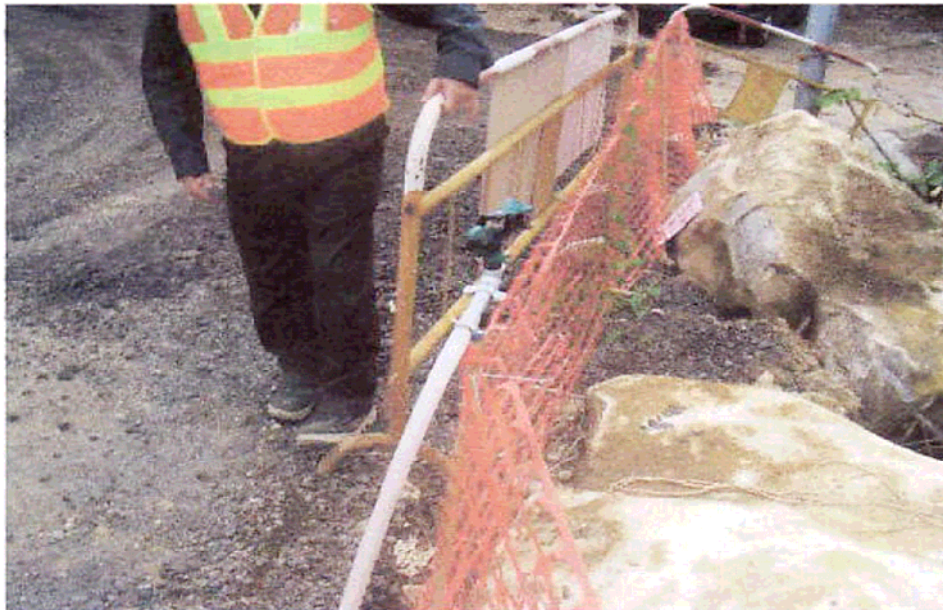
(Fig 3) Water sprinklers were installed for dust suppression, photo taken on 3rd December 2008
