Contract No. : DC/2007/06
River Improvement Works in Upper Lam Tsuen She
Shan River and Upper Tai Po River

ENVIRONMENTAL MONITORING AND AUDIT
MONTHLY EM&A REPORT of Upper Tai Po River for
December 2008

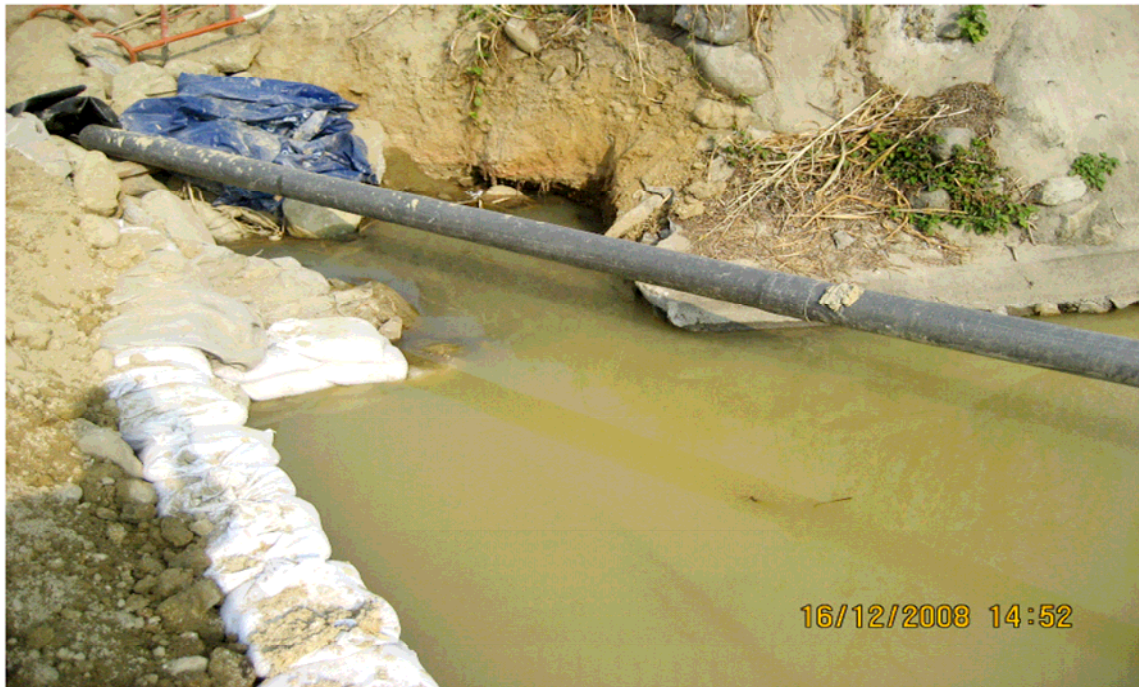
3. Findings from the investigation showed that several mal-practices caused turbid to the river water included:
 - Site water was directly discharged to the branch of LTR (ch.250~300 approximately) without proper treatment (Fig.1 & 2);

Fig.1 Site water was directly discharged to the branch of LTR (at ch.250~300)

1. Contractor should consider of using desilting tank instead of soak-away pond to effectively treat the site water before entering the river channels at ch.250-300 of LTR.
2. Haul road / works area beside of the river channels should be well enclosed by applying proper mitigation measures to prevent site runoff entering the river channels and cause water pollution.
3. Contractor should provide effective barrier bunds and weirs that meet the design stated in method statement proposed for runoff control before any kind of river-based works start.
4. With the provision in 3, contractor should by any proper means minimize disturbance of sediments wherever any works carried out in the river.
5. Contractor is reminded again to take serious notice on the complaint and always keep good environmental management at site.

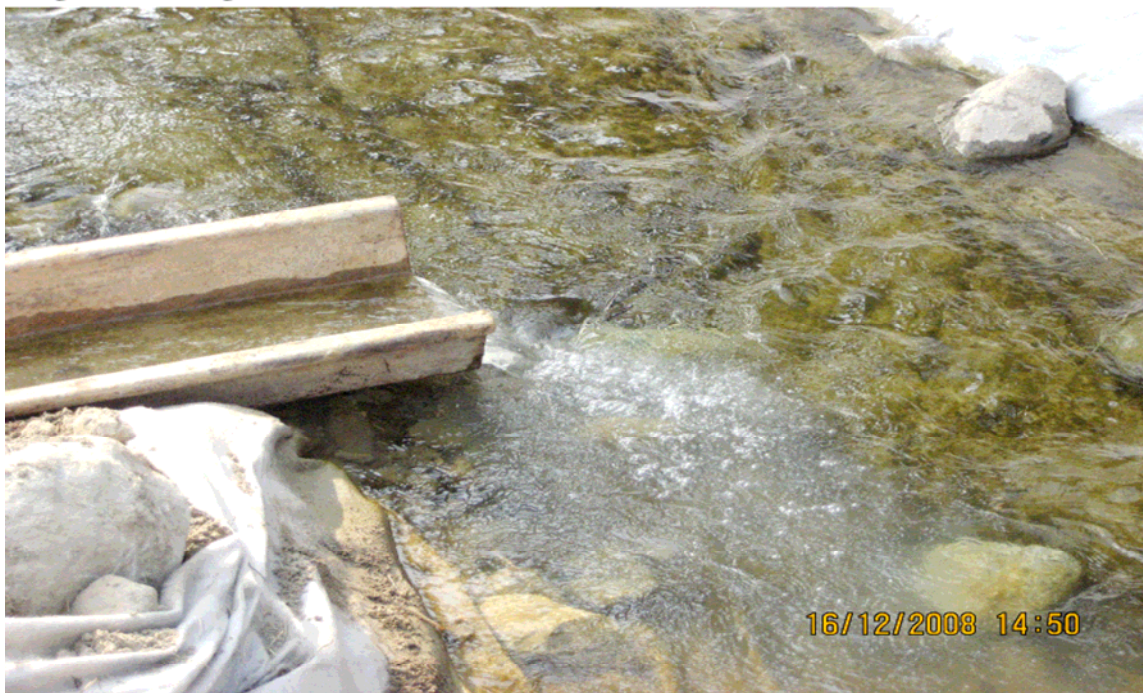
Fig.2 Discharge from the branch to the river channel of LTR (at ch.250~300)

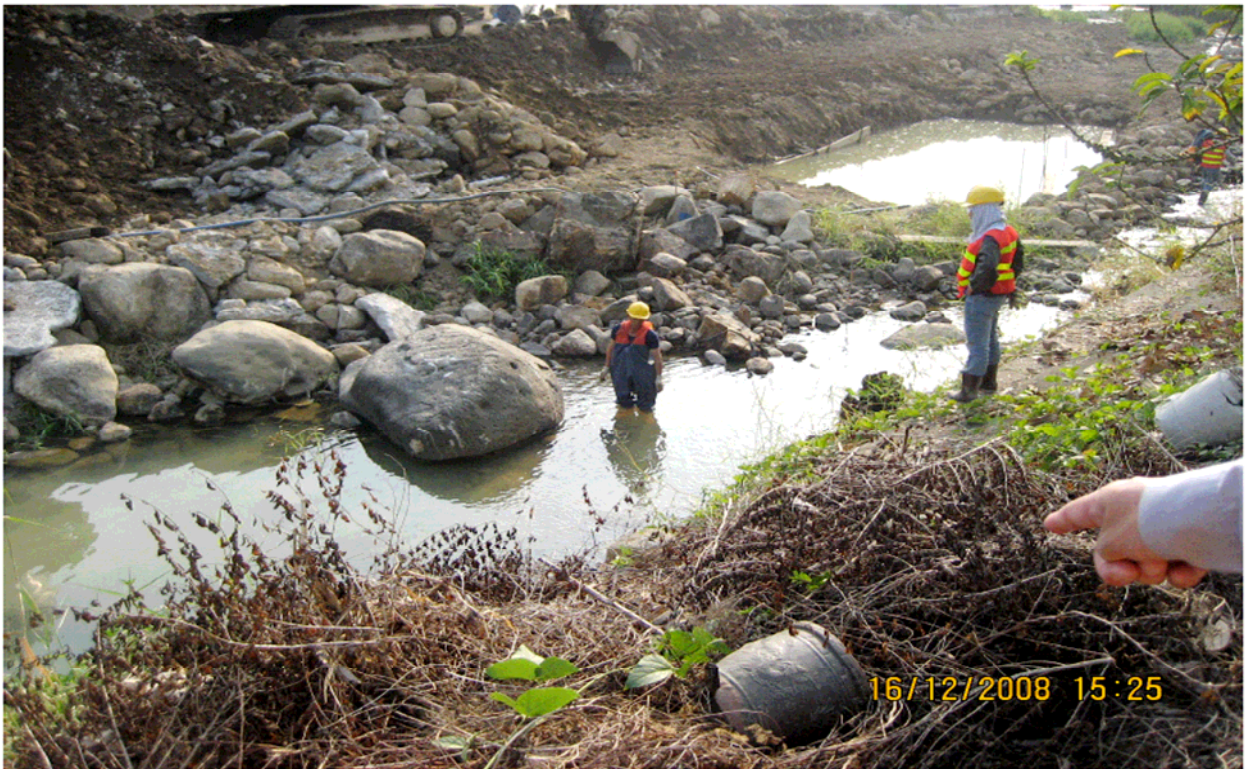
- Disturbance of sediments in diverted river channel, caused by the river-based activities at ch.750 (Fig.3);
 - Discharge from defective desilting facilities at LTR road B ch.950~1000 (Fig.4); and

Fig.3 Disturbed riverbed from works carried out by site staffs

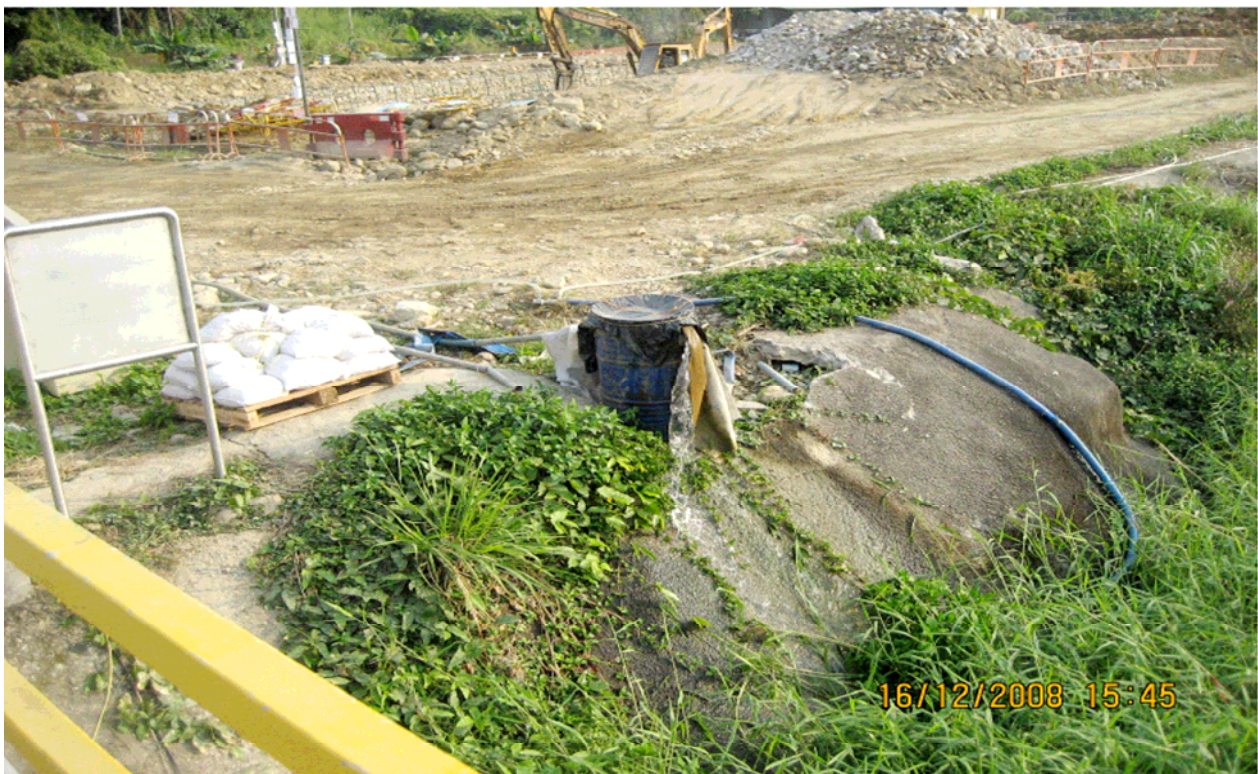
Fig.4 Defective desilting facilities found at LTR road B ch.950~1000

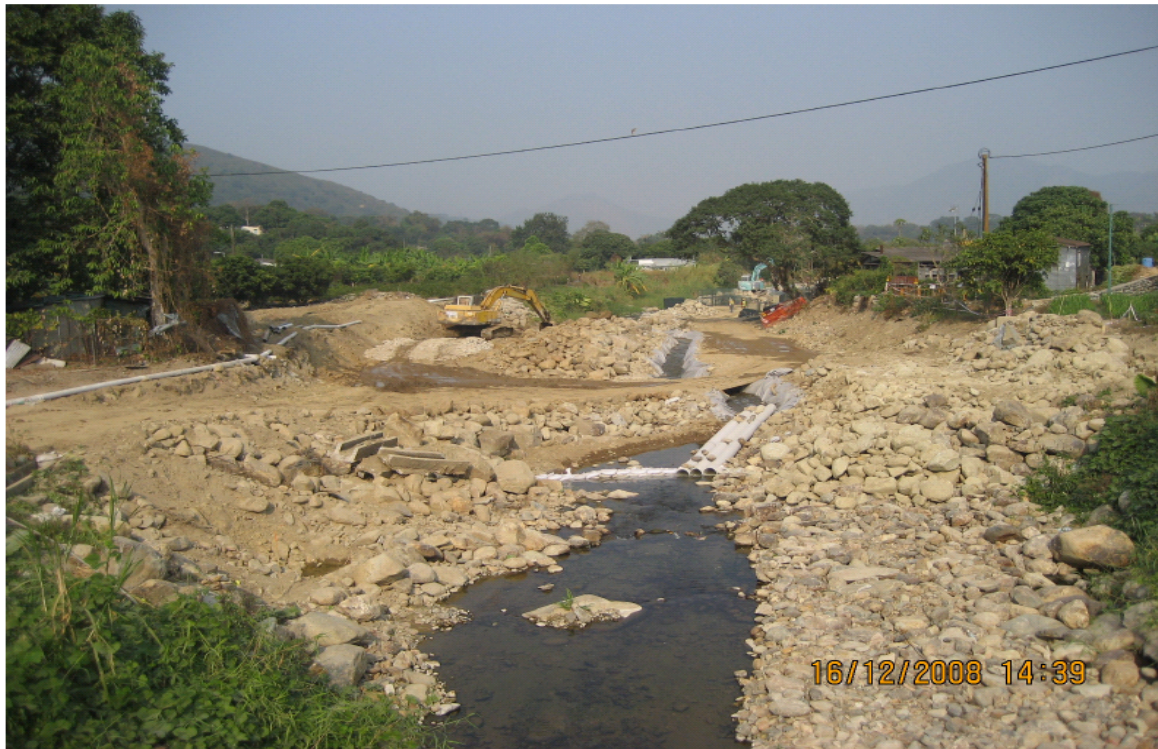
- Deficiency of Barrier Bunds installed along the river, which cannot effectively protect the river from runoff (Fig.5 & 6).
4. Contractor was urged to carry out necessary remedial actions to rectify the non-compliance as soon as possible.

Fig.5 Bunds without coverage of geo-textile at ch.0 of LTR

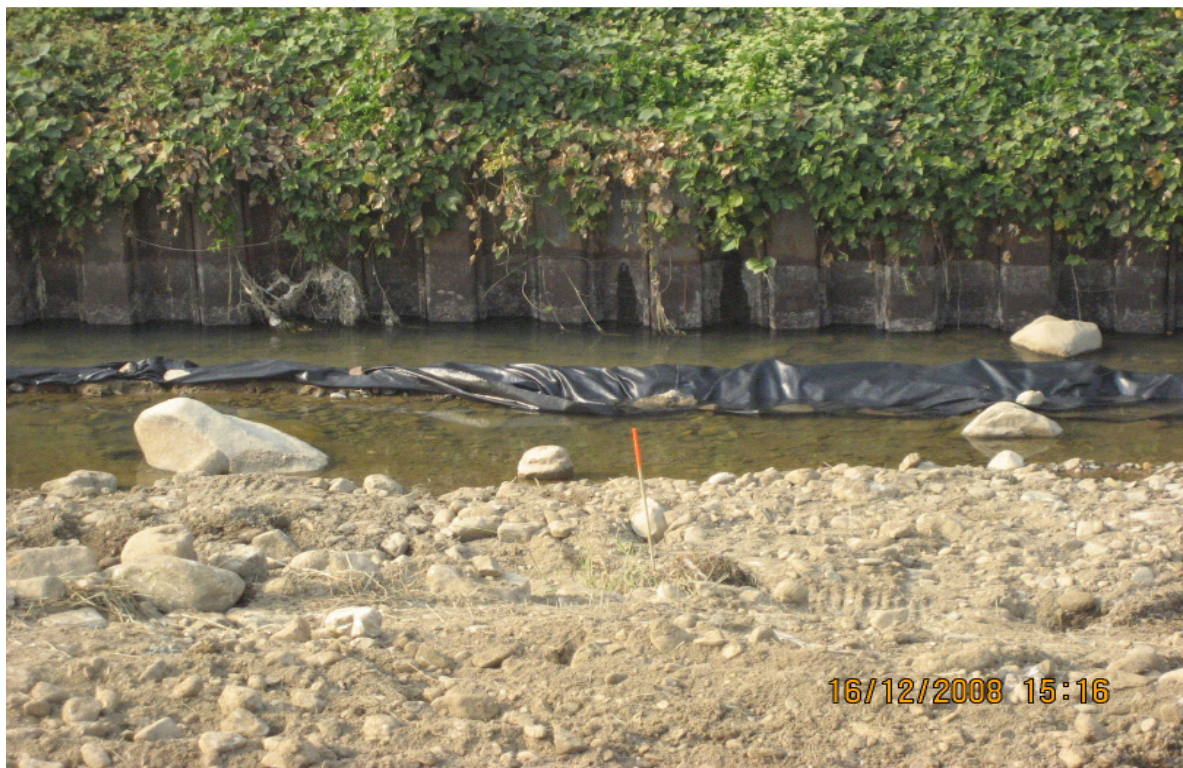
Fig.6 Insufficient height of barrier bunds at LTR

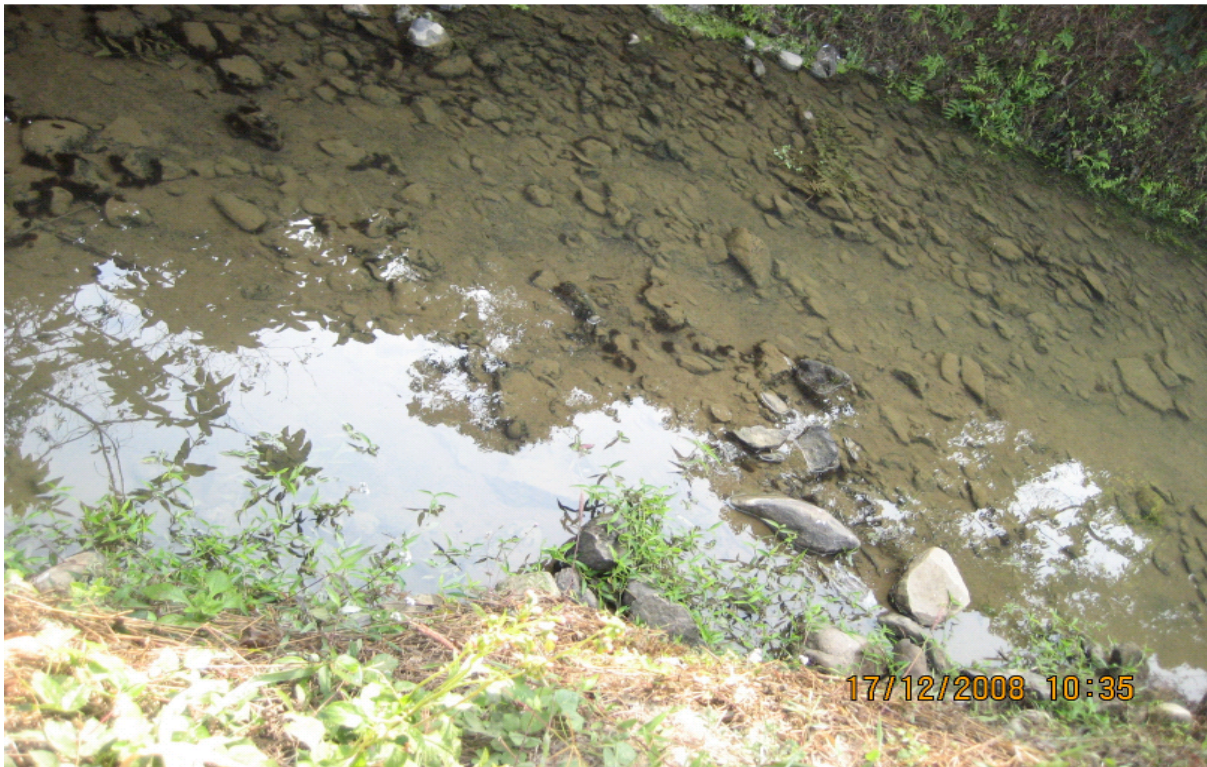
7. During the investigation, new sediments were observed accumulated at the river bed, of SSR ch.1500 approximately (Fig.7). Also turbid river water was observed at UTPR ch.100 (Fig.8).

Fig.7 new sediments were formed at the riverbed of SSR ch.1500 approximately

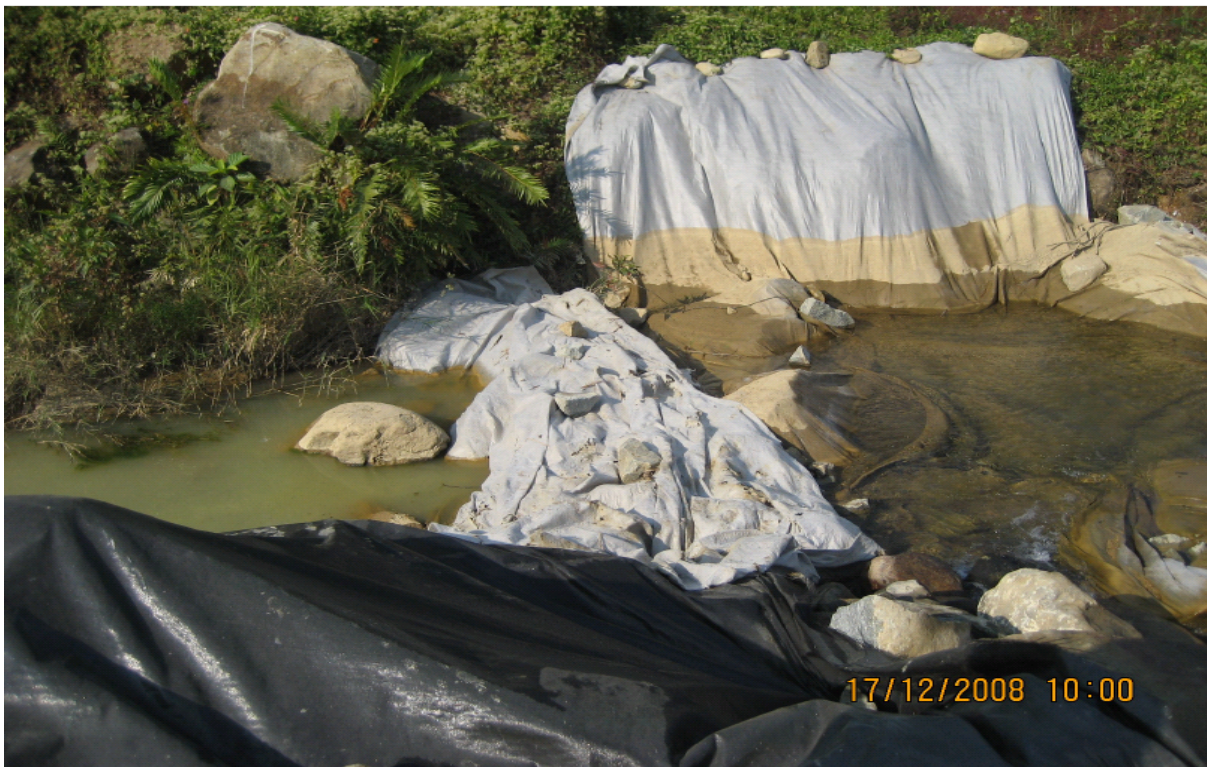
Fig.8 muddy water was being entered the river channel, located ch.100 of UTPR approximately
