**CEDD CONTRACT NO. CV/2012/05 –
BATHING BEACH AT LUNG MEI, TAI PO**

**POST-CONSTRUCTION MONITORING AND AUDIT
REPORT**

PREPARED FOR
WELCOME CONSTRUCTION CO., LTD.

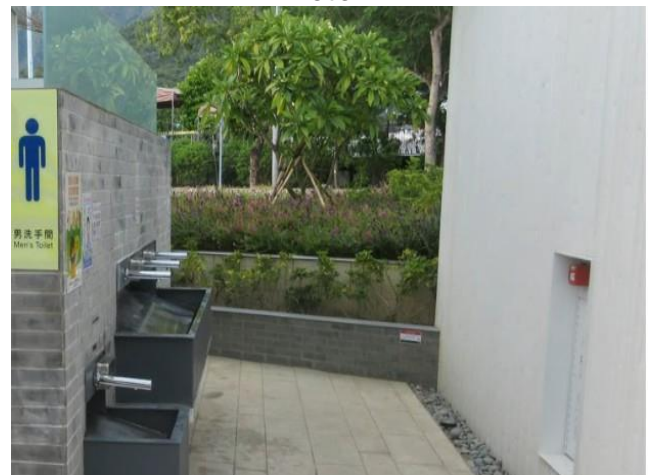
Photo L.

The plant near the male changing room (Planter P7) is *Schefflera arboricola* instead of *Rhapis excelsa* shown in the plan

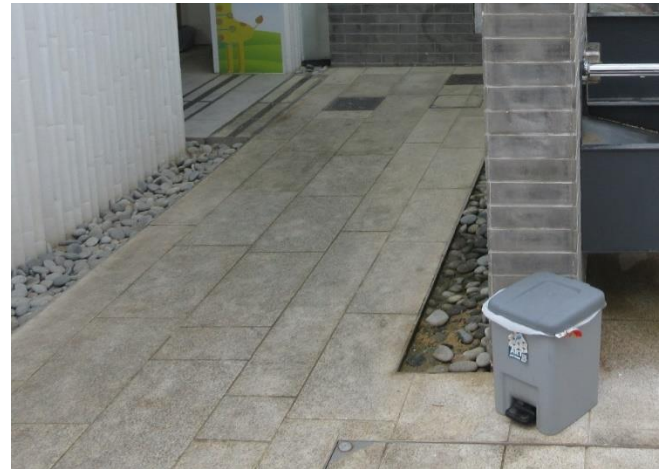
Photo M.

No plant in the planter outside the male (Planter P14) changing room

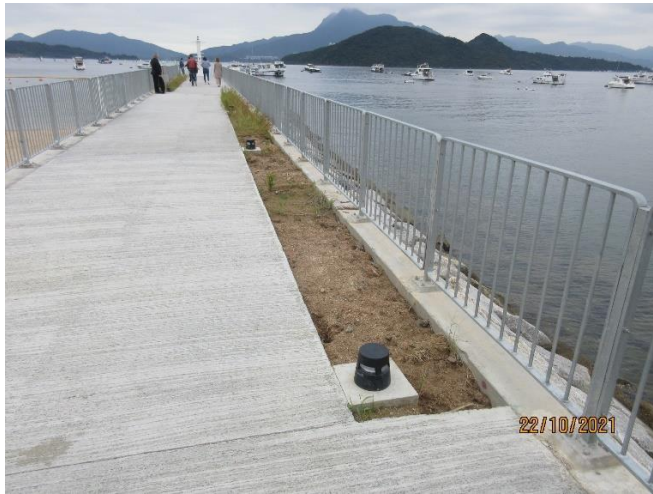
Photo N.

Some of the plants in the planters on the Western groyne were wilted and removed

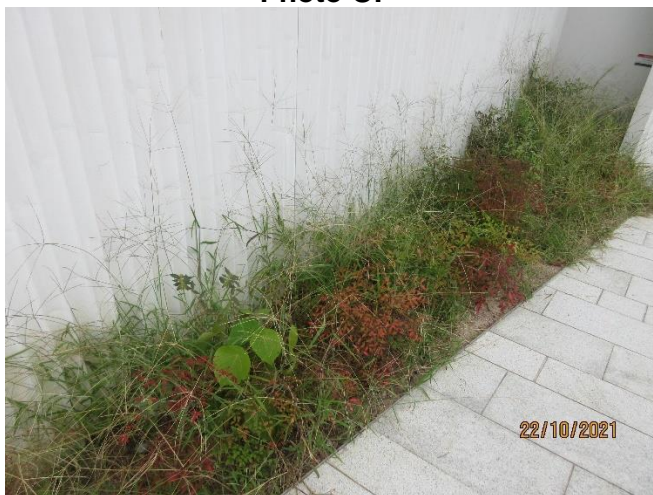
Photo O.

There are certain amounts of weeds in the planters "p3a" and "p4a"

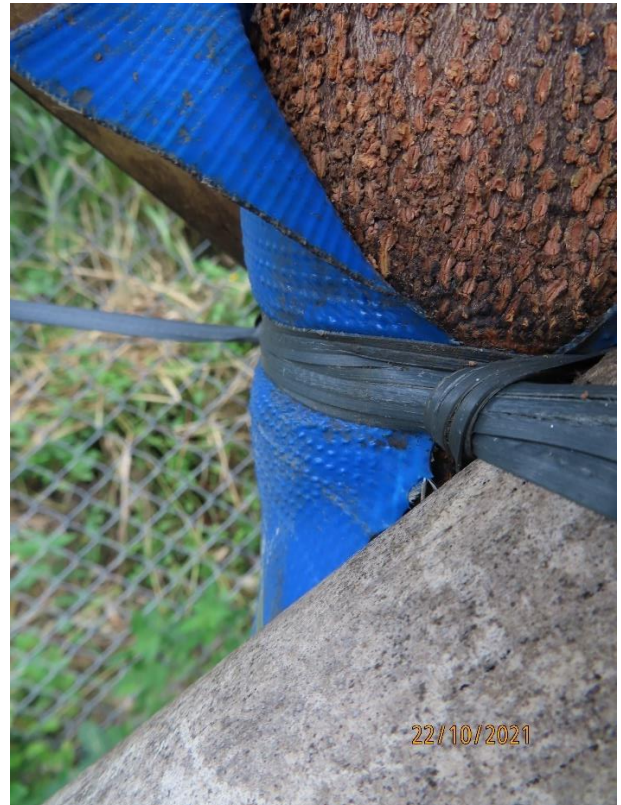
Some ties and stakes already girdled and affected the growth of the trees

The Contractor(s) is/are reminded to check the guying and staking of all retained/newly planted trees to prevent from damage of the trees by rubbing and girdling from ties and stakes.

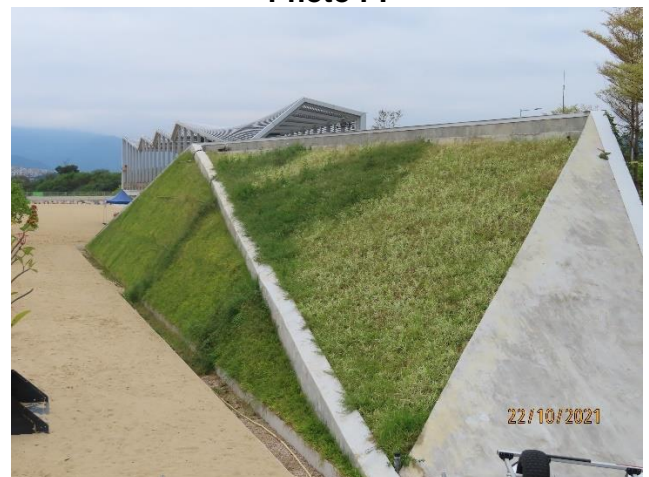
Photo P.

There are certain amounts of weeds in the planters "p6a" and "p6b"

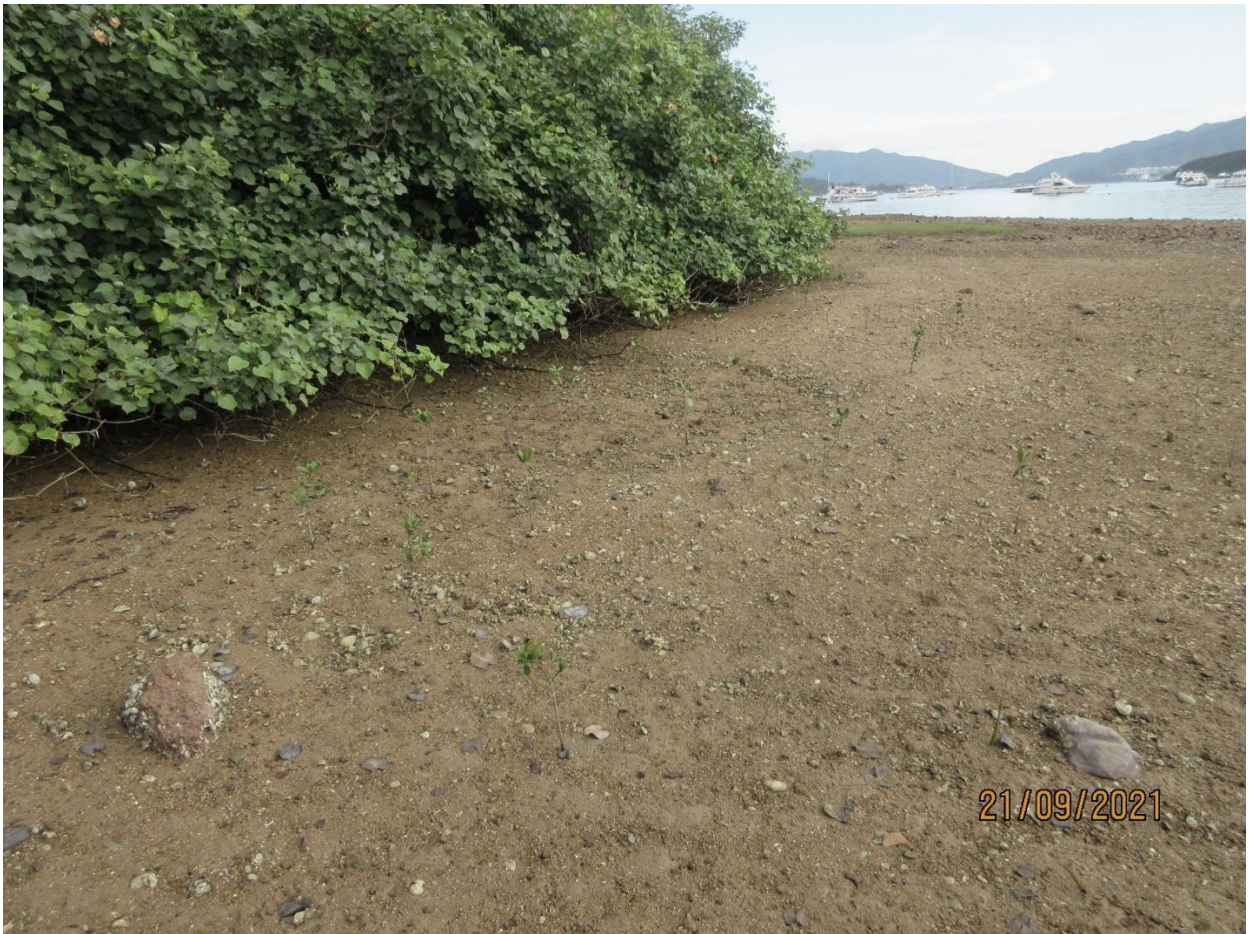
For location 1, Nearly half of the seedlings were alive, however, only a few of the seedlings on the most landward side have leaves (Photo 3.1). Many of the seedlings were in poor condition (no leaves but still alive (Photo 3.2)) and approximate half of the seedlings were dead (Photo 3.3).

Photo 3.1 A few of the seedlings on the most landward side have leaves

The contractor is recommended to replant the seedlings and review if the planting location should be moved to a more landward side to improve the survival rate.

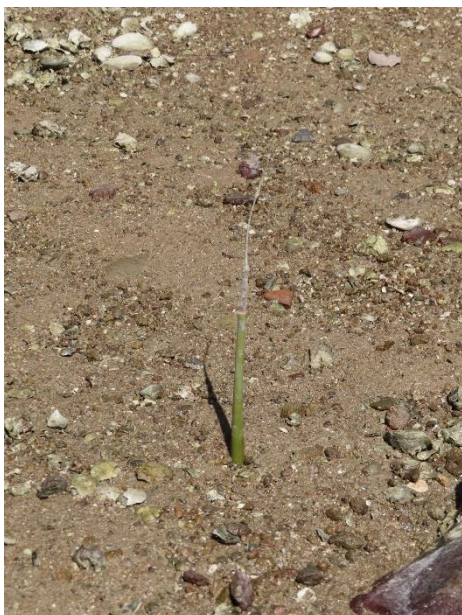
Photo 3.2 Seedling with poor condition (no leaves but still alive)

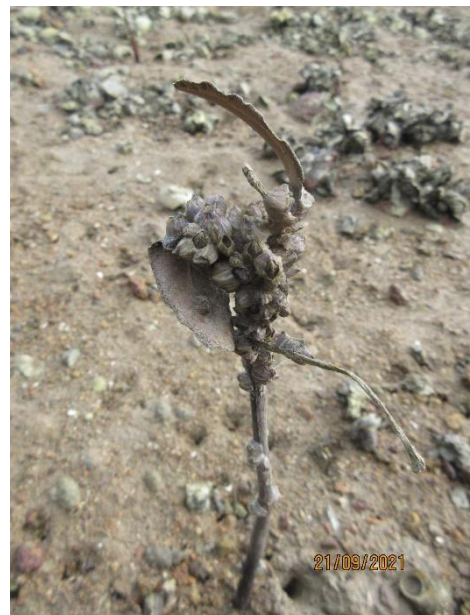
Photo 3.3 Dead Seedling

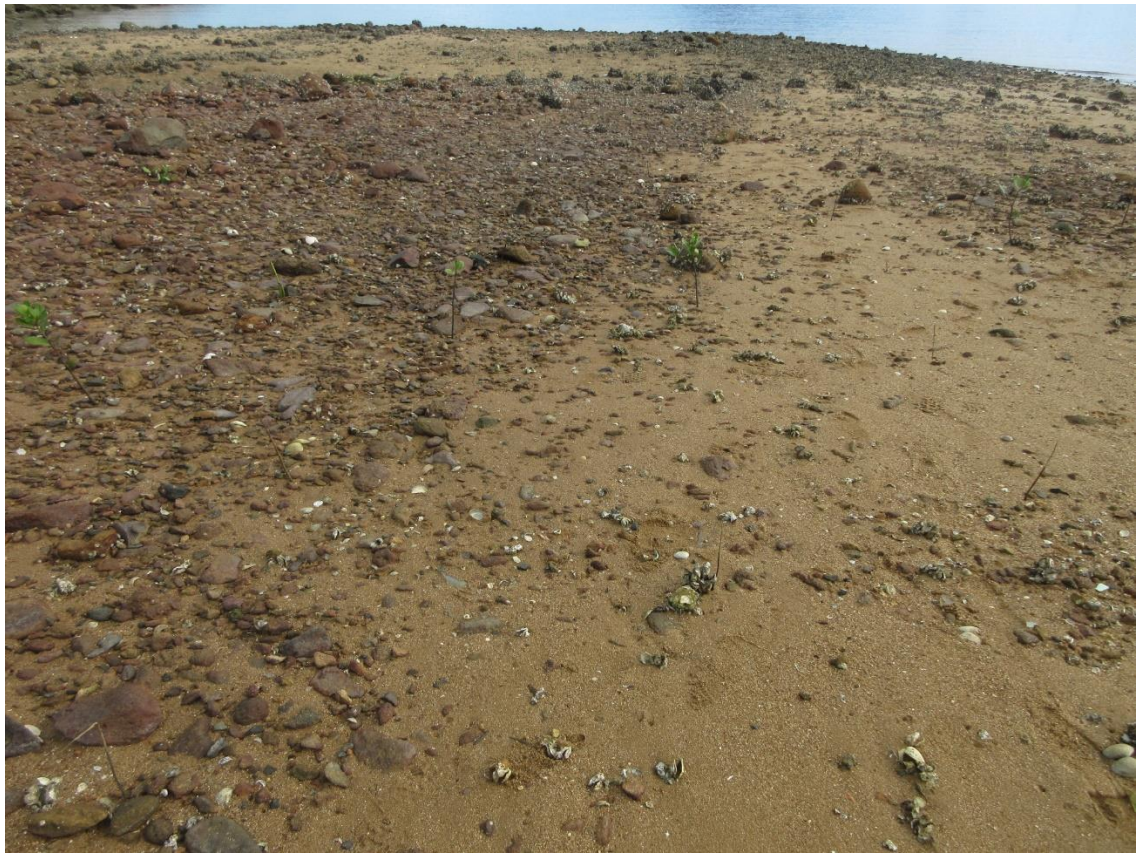
For location 2, A large amount of the seedlings were dead (Photo 3.4), few of the seedlings on the most landward side have leaves (Photo 3.5) and several seedlings are in poor condition (no leaves but still alive)

Photo 3.4 A large amount of the seedlings were dead and in poor condition

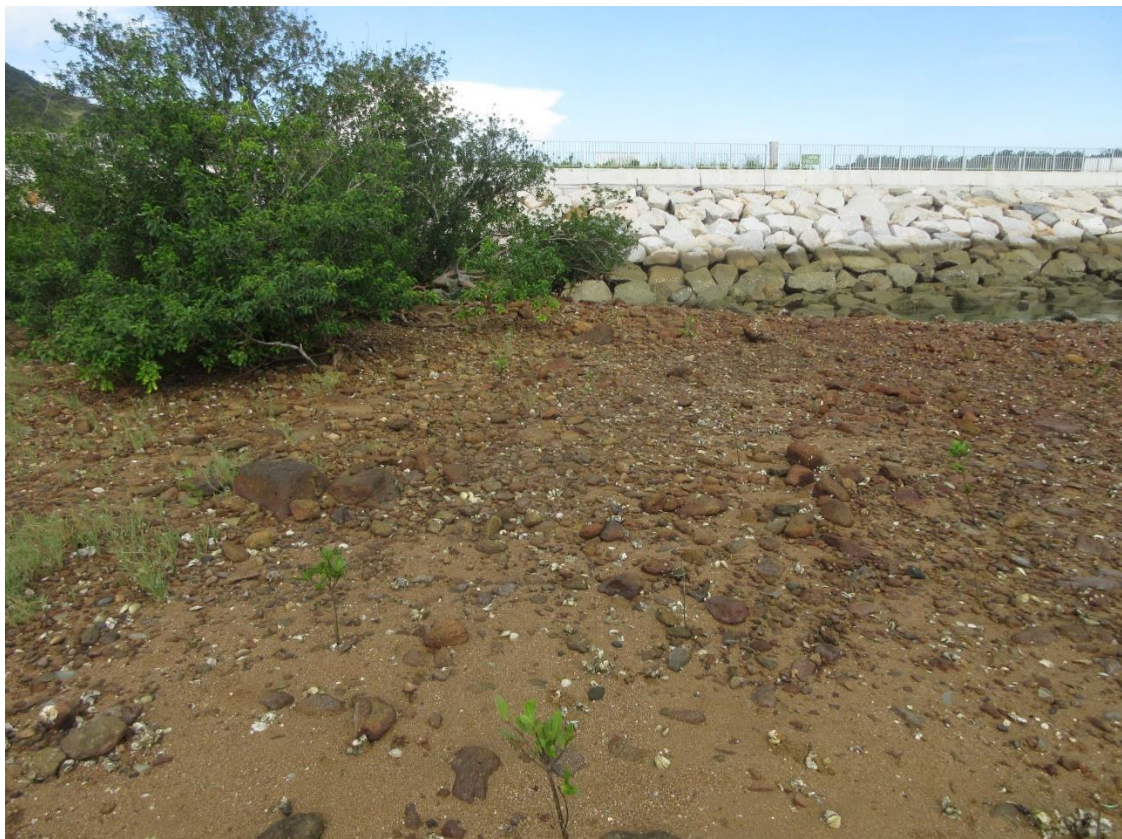
Photo 3.5 Few of the seedlings on the most landward side have leaves

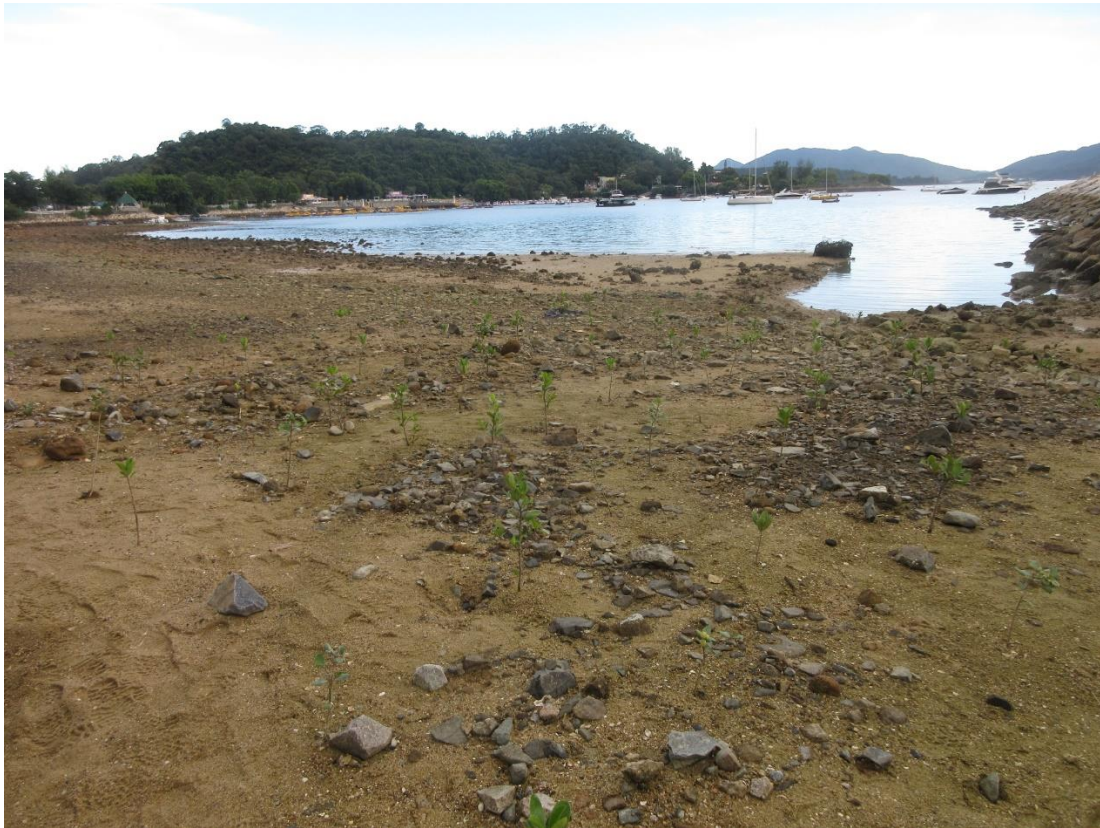
For location 3, most of the seedlings have leaves and are in good condition (Photo 3.6). A small portion of the seedlings at the seaward side was in poor condition (no leaves but still alive) and dead (Photo 3.7).

Photo 3.6 Seedling with good condition

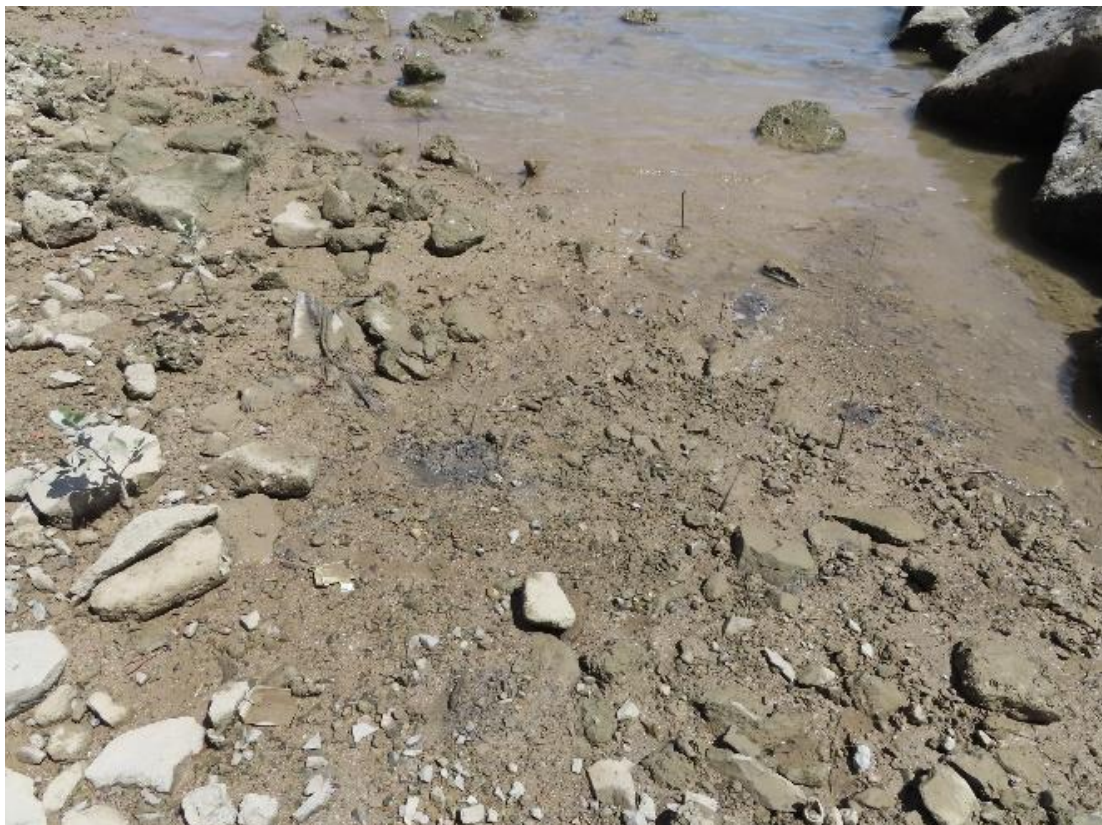
Photo 3.7 Dead and poor condition seedlings at the seaward side

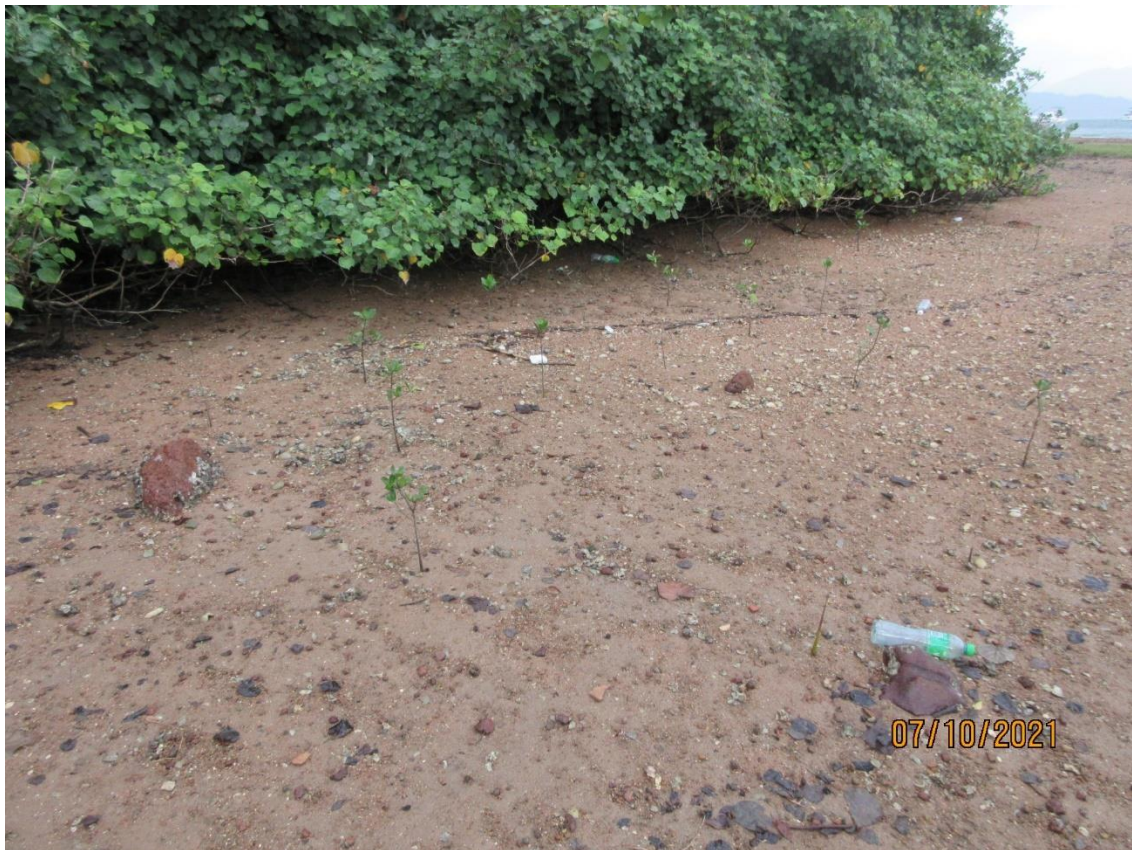
Photo 3.1 A few of the seedlings on the most landward side have leaves

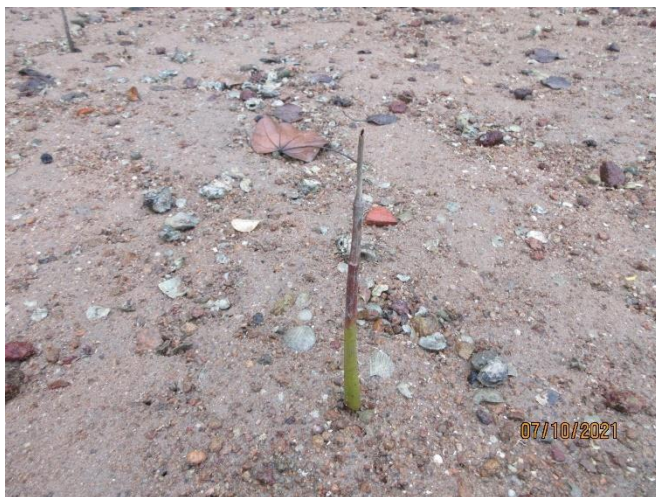
Photo 3.2 Seedling with poor condition (no leaves but still alive)

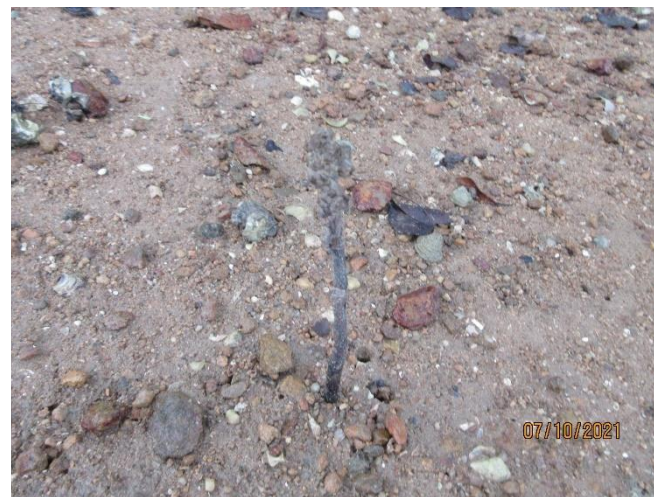
Photo 3.3 Dead Seedling

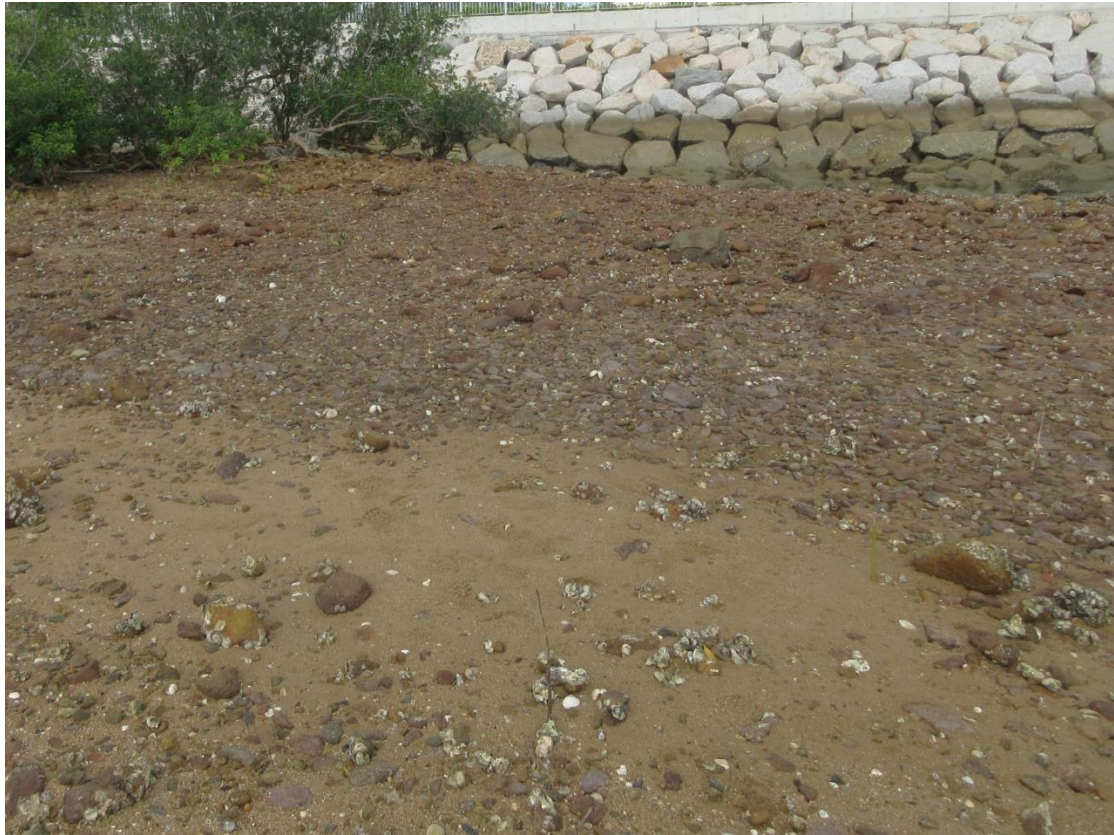
Photo 3.4 A large amount of the seedlings were dead and in poor condition

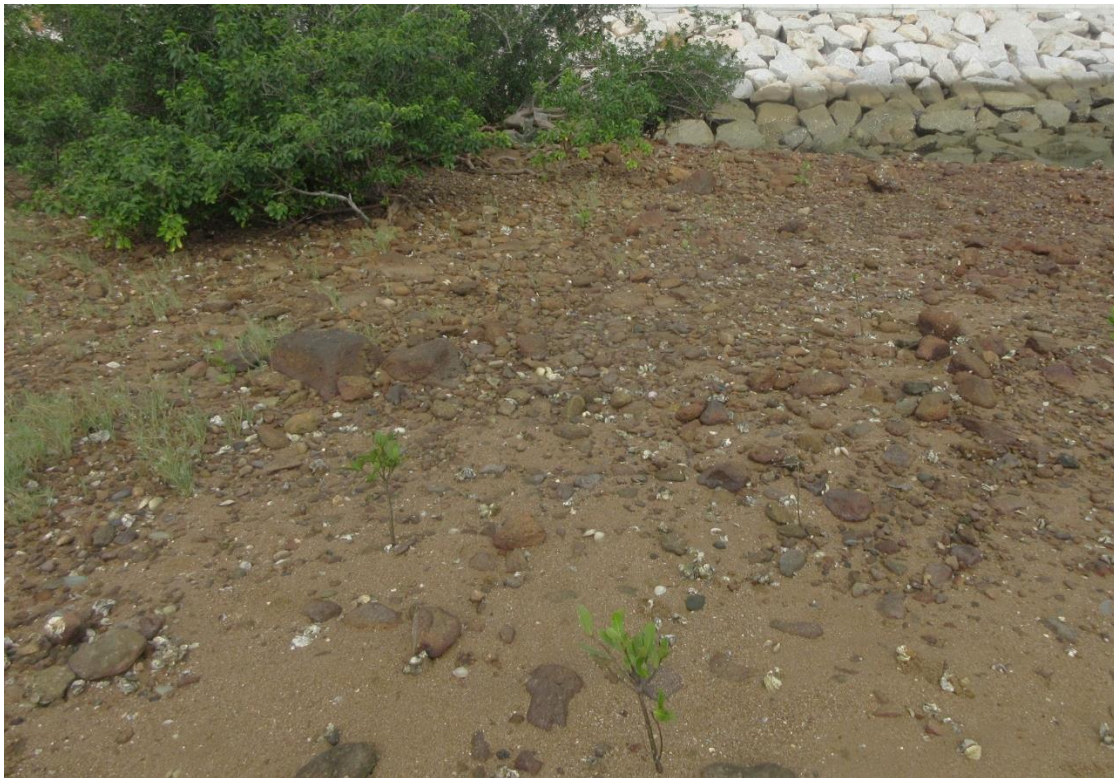
Photo 3.5 Few of the seedlings on the most landward side have leaves

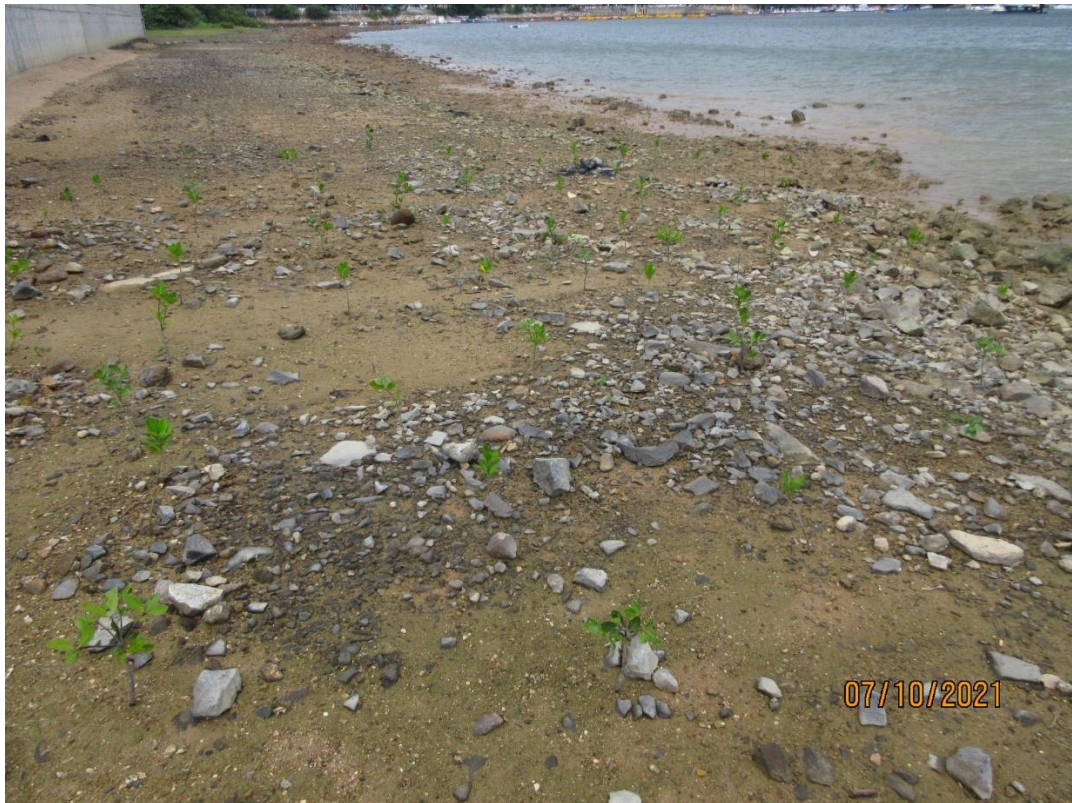
Photo 3.6 Seedling with good condition

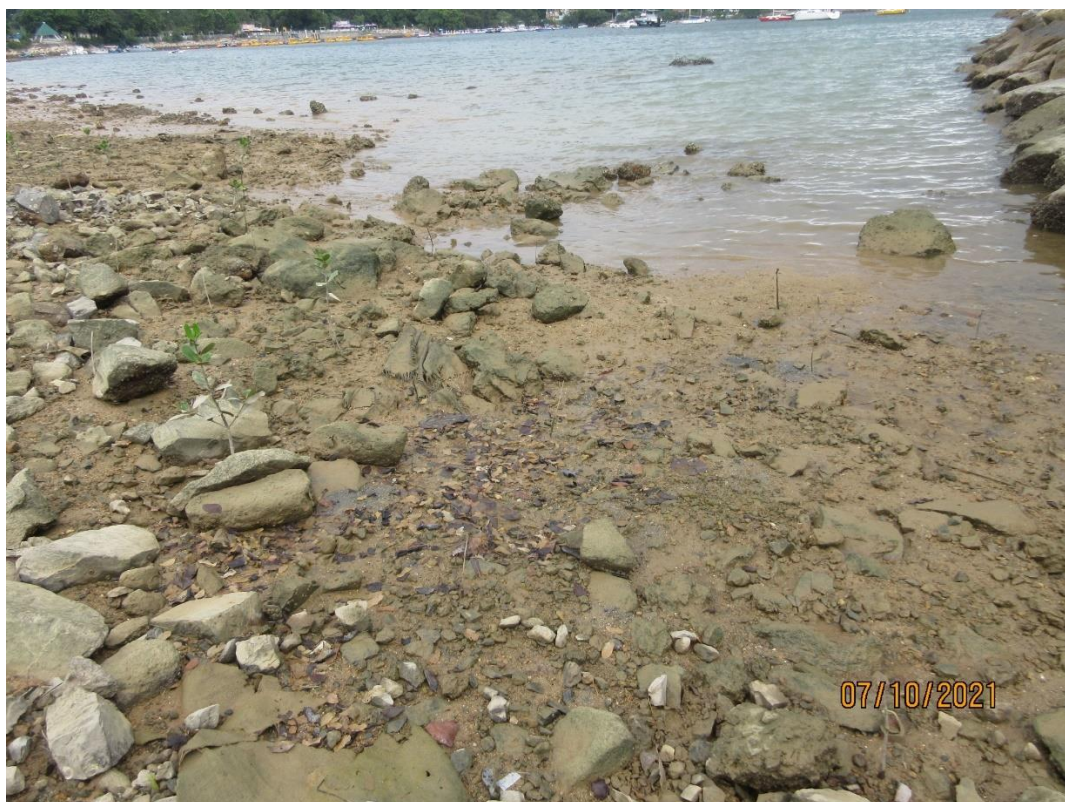
Photo 3.7 Dead and poor condition seedlings at the seaward side

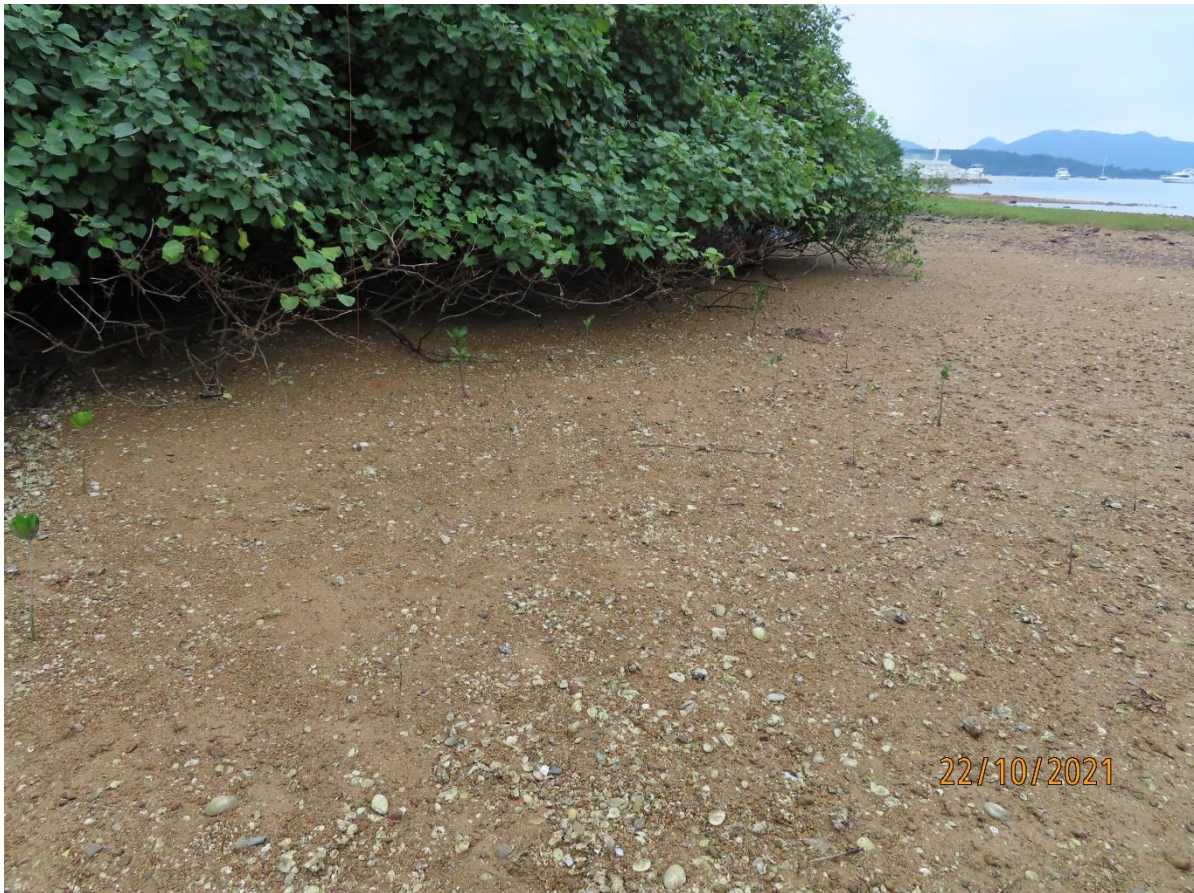
Photo 3.1 A few of the seedlings on the most landward side have leaves

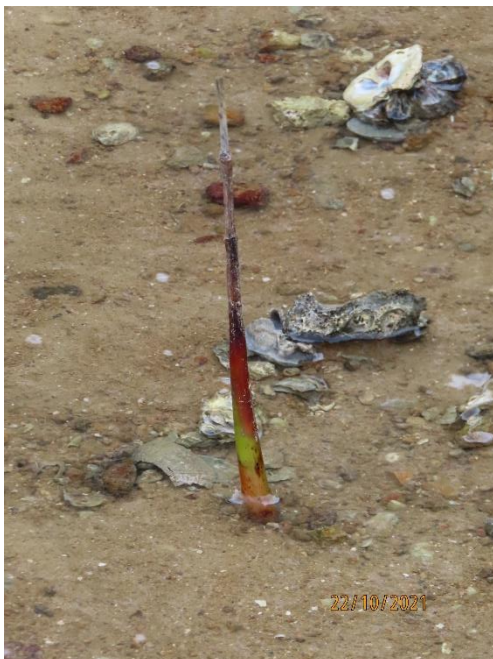
Photo 3.2 Seedling with poor condition (no leaves but still alive)

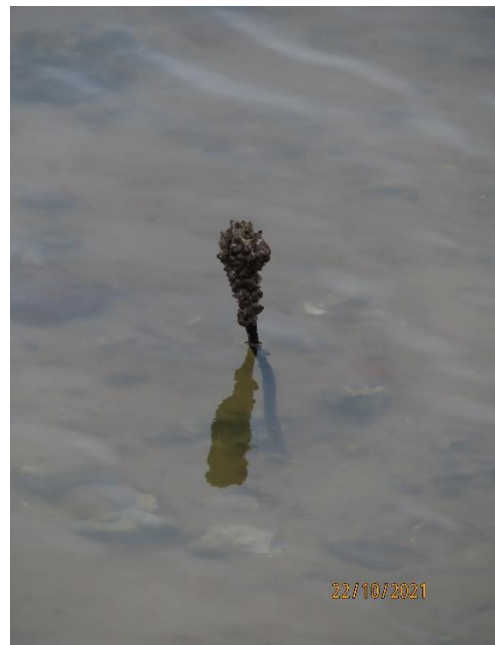
Photo 3.3 Dead Seedling

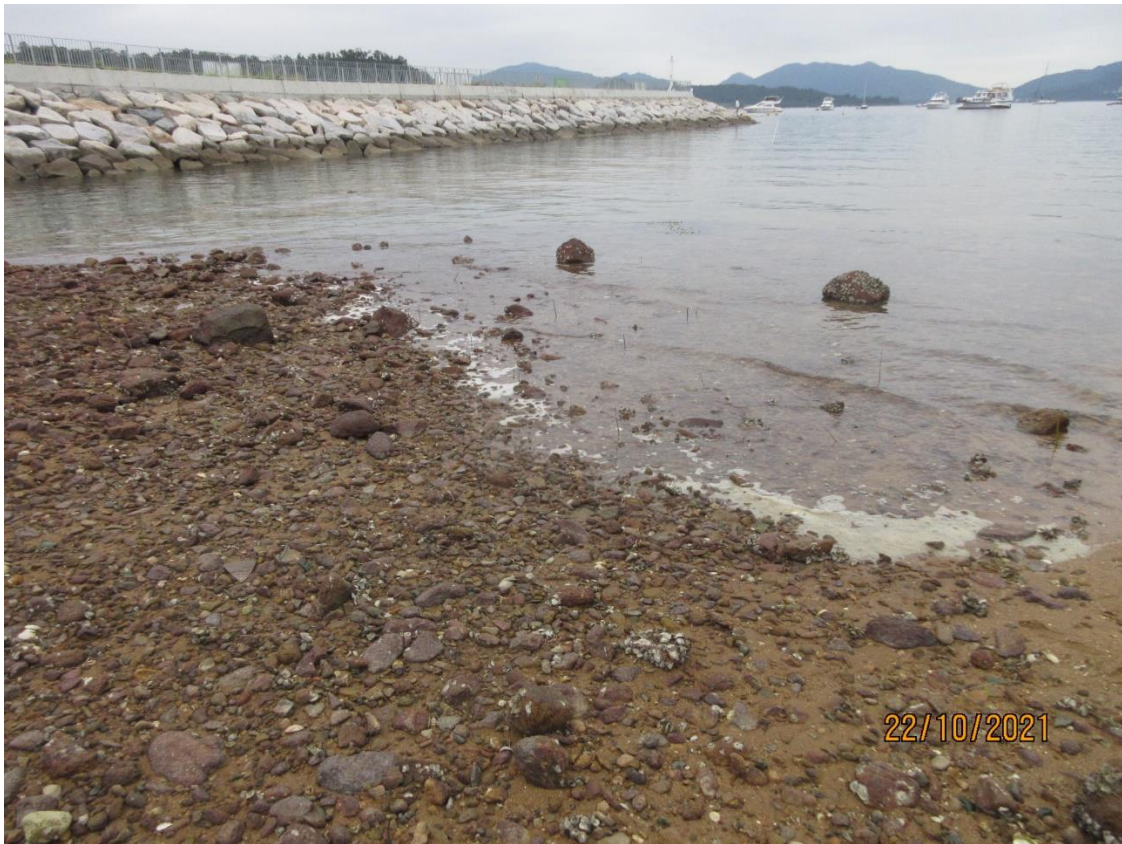
Photo 3.4 A large amount of the seedlings were dead and in poor condition

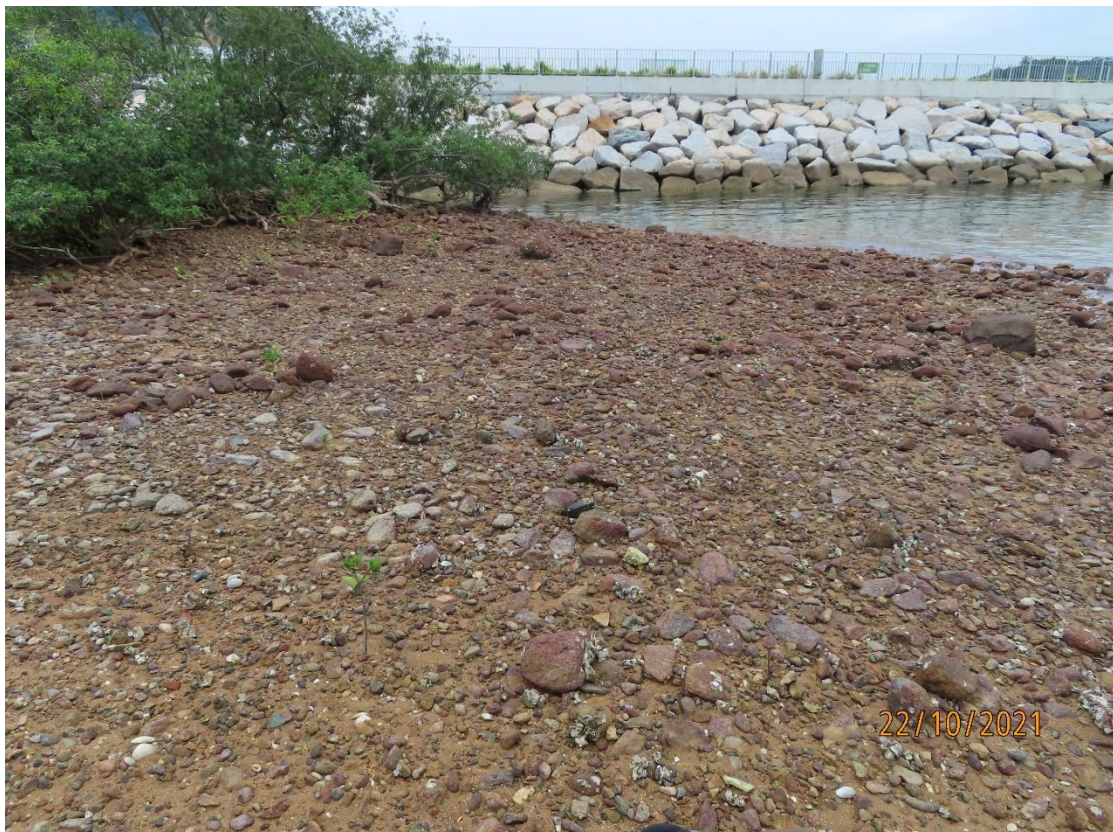
Photo 3.5 Few of the seedlings on the most landward side have leaves

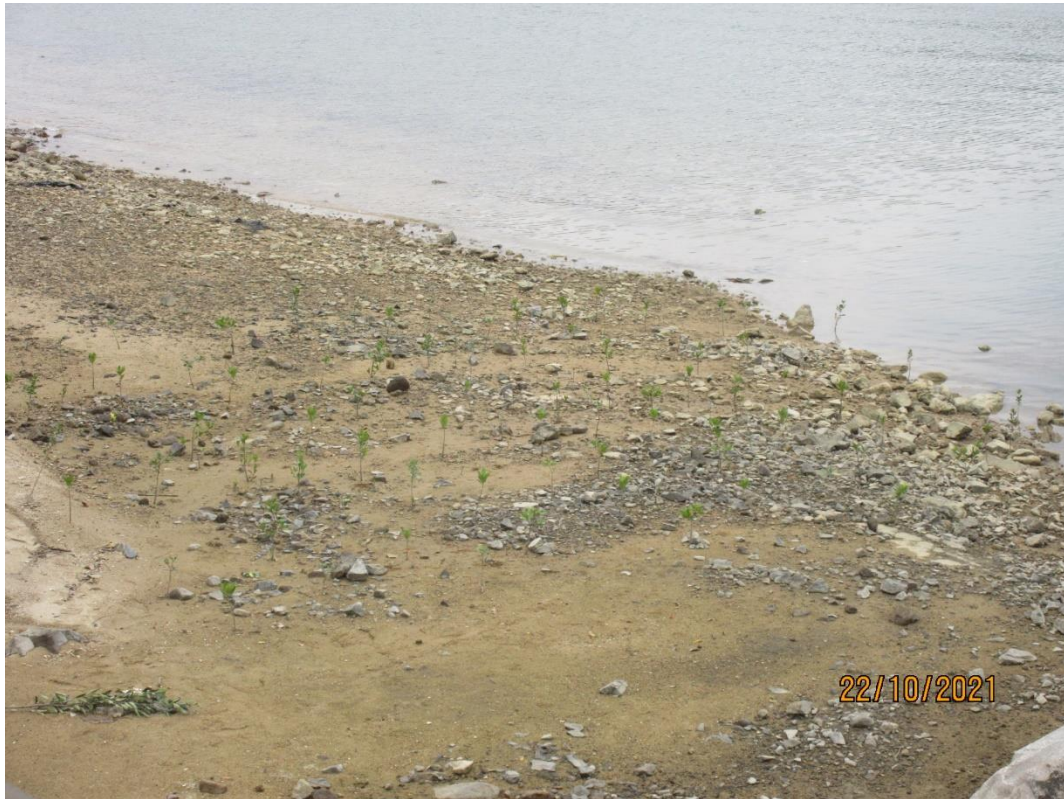
Photo 3.6 Seedling with good condition

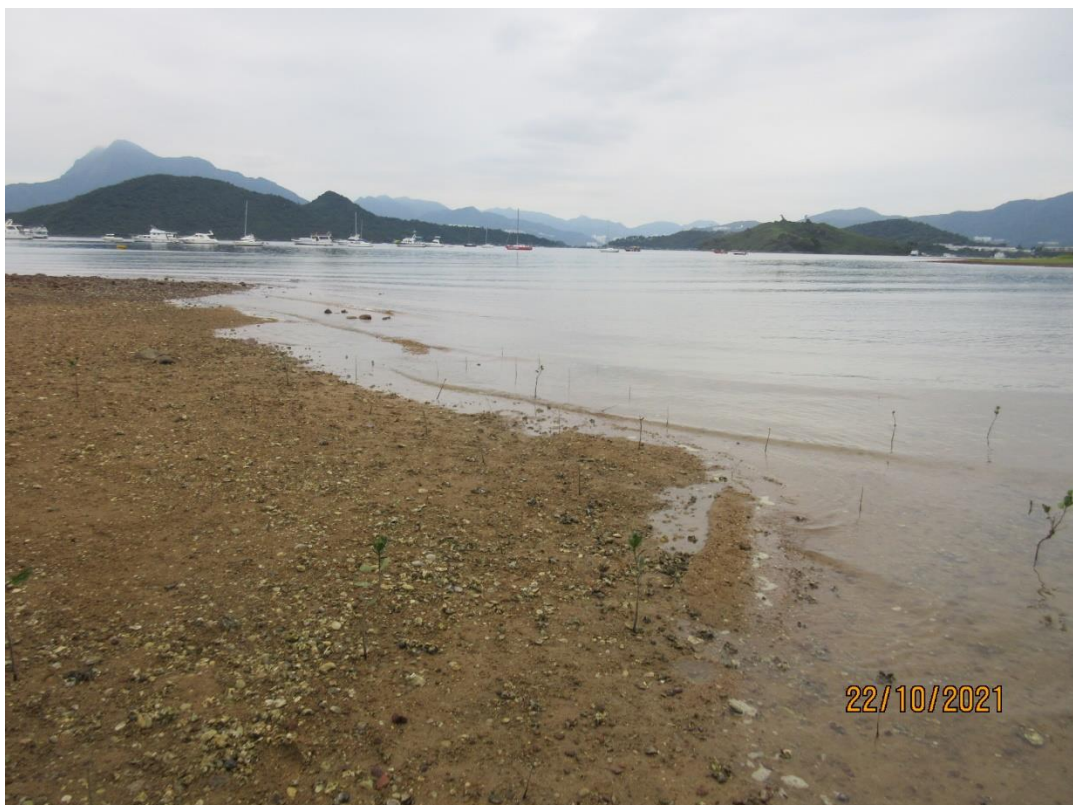
Photo 3.7 Dead and poor condition seedlings at the seaward side
