PROJECT No.: TCS/00874/16

**CEDD CONTRACT NO. CV/2012/05 –
BATHING BEACH AT LUNG MEI, TAI PO**

**POST-CONSTRUCTION MONITORING AND AUDIT
REPORT (NOVEMBER TO DECEMBER 2021)**

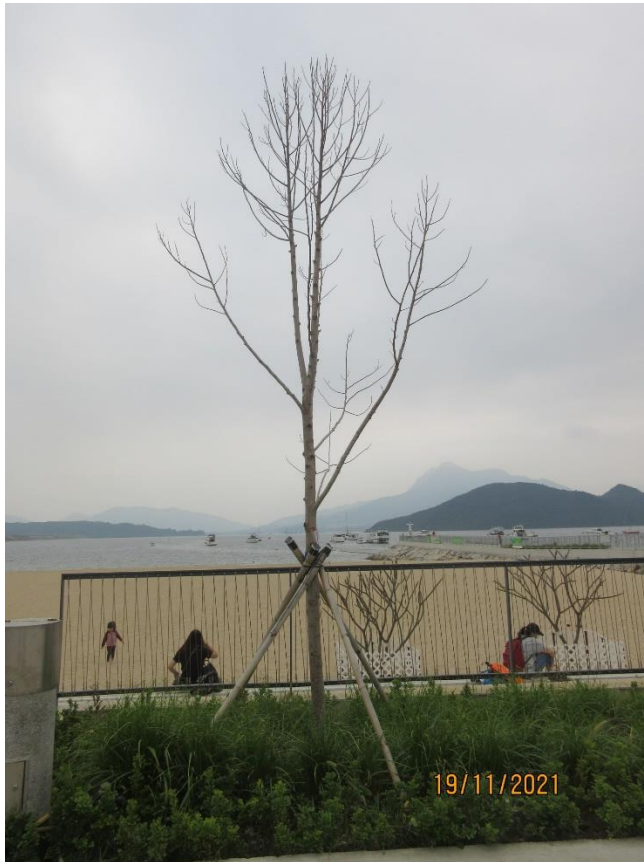
Photo I.

1. Two nos. of new trees (*Michelia x alba*) are found dead, contractor is required to replace the concerned trees. (Photo I)
2. There is no planting with bare soil in the planters outside the male (Planter P14) and female (Planter P3b) changing rooms. (Photo J and Photo K).

Dead *Michelia x alba*

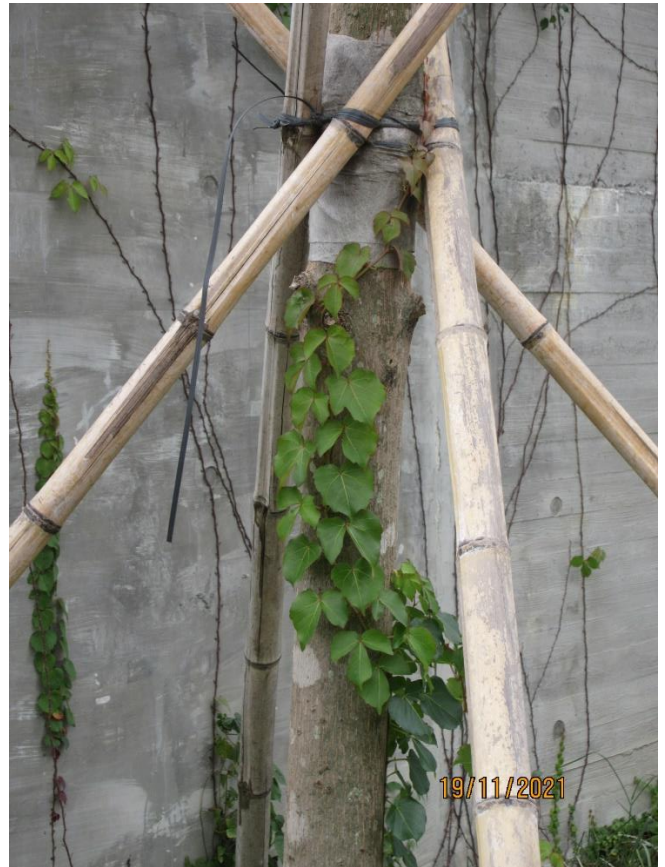
Photo N.

1. Two nos. of new trees (*Michelia x alba*) are found dead, contractor is required to replace the concerned trees. (Photo I)
2. There is no planting with bare soil in the planters outside the male (Planter P14) and female (Planter P3b) changing rooms. (Photo J and Photo K).
3. The contractor is required to plant *Schefflera arboricola* instead of *Rhapis excelsa* as shown on the plan for the planter (Planter P7) close to the male changing room. (Photo L)
4. *Bauhinia glauca* is required to plant as shown on plan but it was not found within the site. The Contractor is required to follow the approved plan and complete all planting including the planting of *Bauhinia glauca* before the next audit checking.
5. Some of the plants in the planters on the Western groyne were wilted and removed (Photo M)
6. Some ties and stakes already girdled and affected the growth of the trees (Photo N)

Some ties and stakes already girdled and affected the growth of the trees

1. Girdling by the ties and stakes was observed on some of the trees. Contractors are required to adjust the ties to prevent the damage of the tree
2. Contractors are reminded to update the planting plan in the drawings

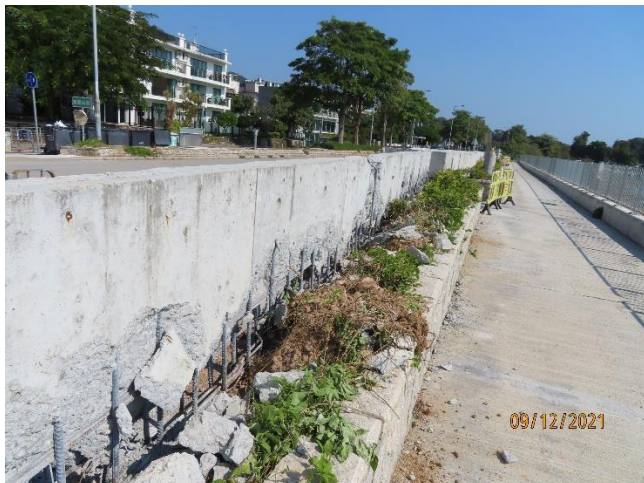
Photo O.

5. Some of the plants in the planters on the Western groyne were wilted and removed (Photo M)
6. Plants at the Eastern box culvert were damaged by the concrete debris from the construction works (Photo O and Photo P)

Plants at the Eastern box culvert were damaged by the concrete debris from the construction works

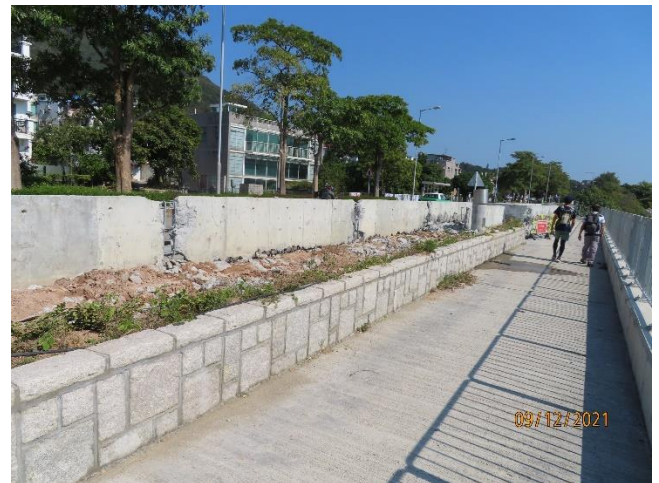
Photo P.

Plants at the Eastern box culvert were damaged by the concrete debris from the construction works

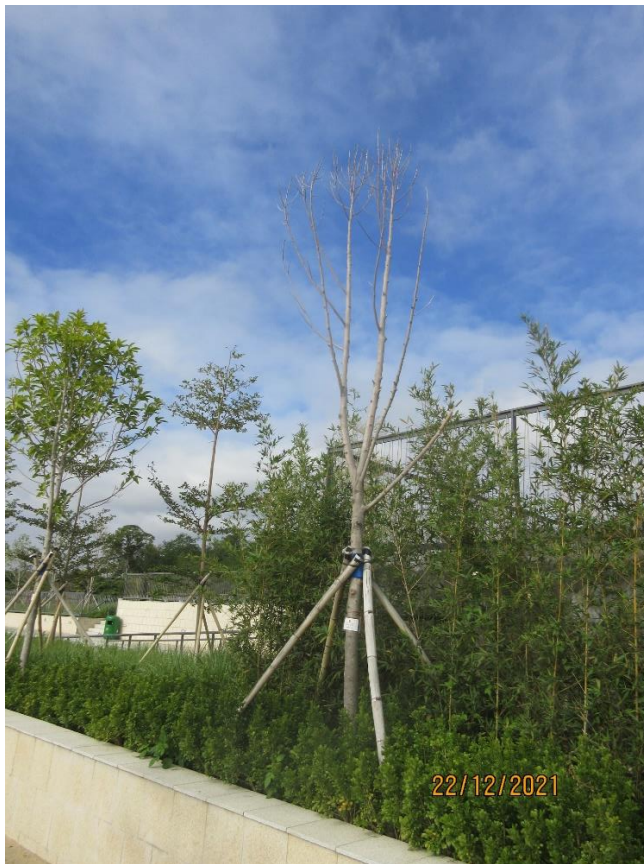
Photo I.

Dead *Michelia x alba*

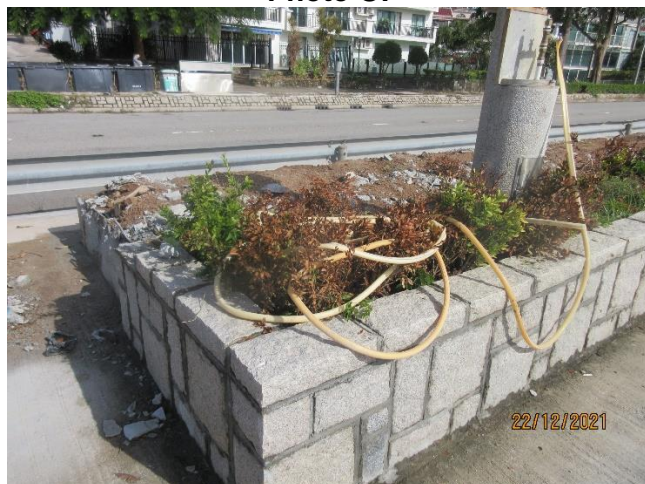
Photo O.

Plants at the Eastern box culvert were damaged by the concrete debris from the construction works

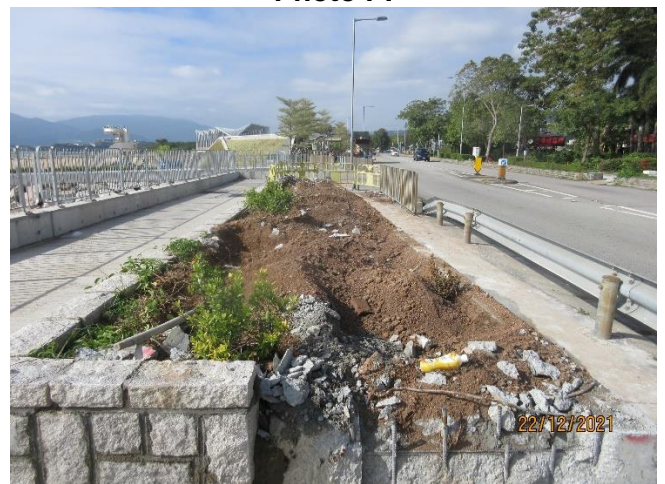
Photo P.

Plants at the Eastern box culvert were damaged by the concrete debris from the construction works

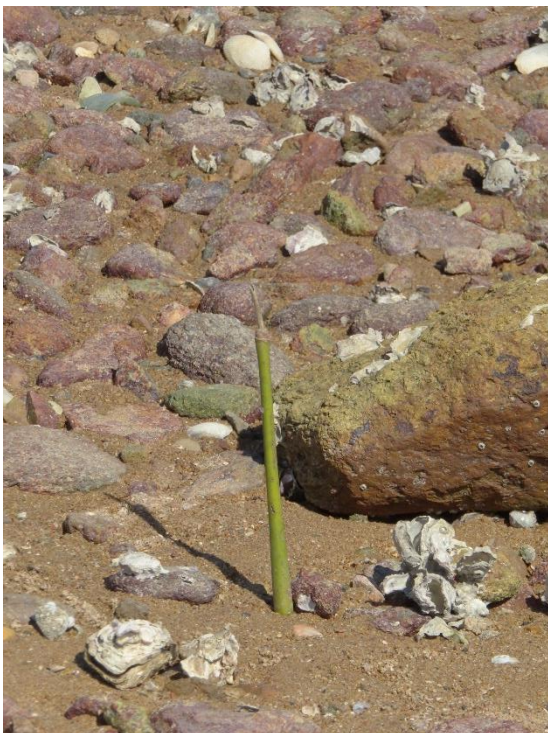
Photo 3.2 Seedling with poor condition (no leaves but still alive)

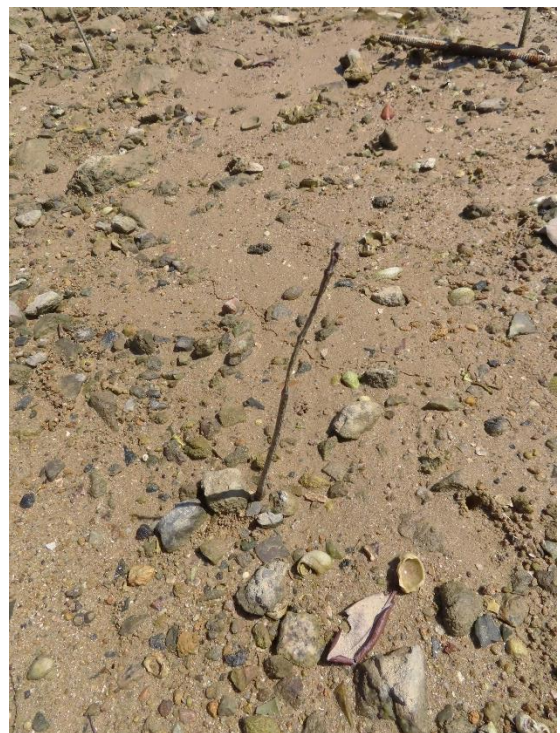
Photo 3.3 Dead Seedling

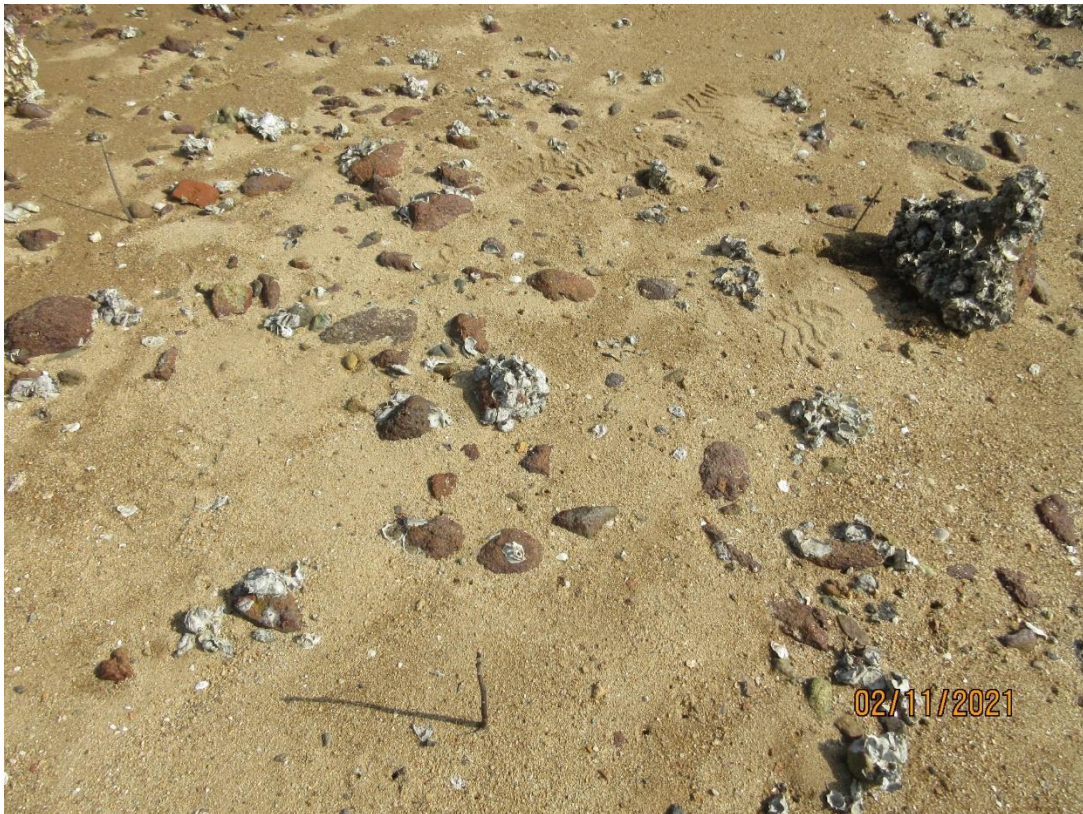
Photo 3.4 A large amount of the seedlings were dead and in poor condition, some of them with very short dead stem remain

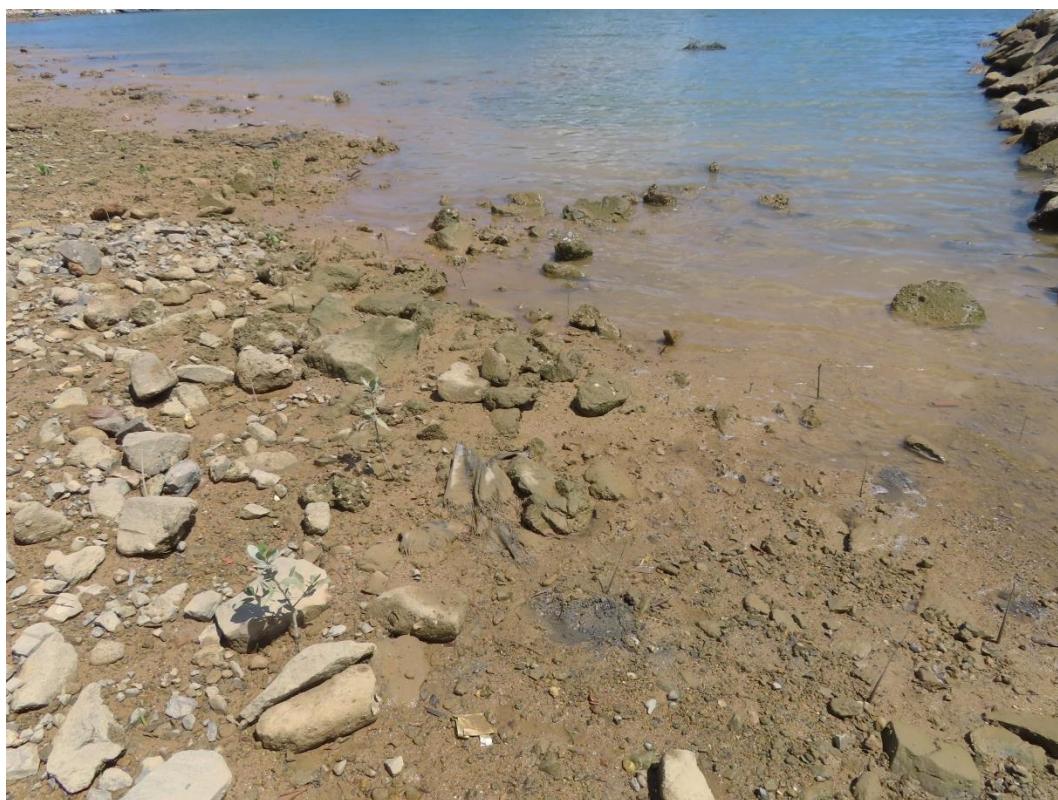
Photo 3.7 Dead and poor condition seedlings at the seaward side

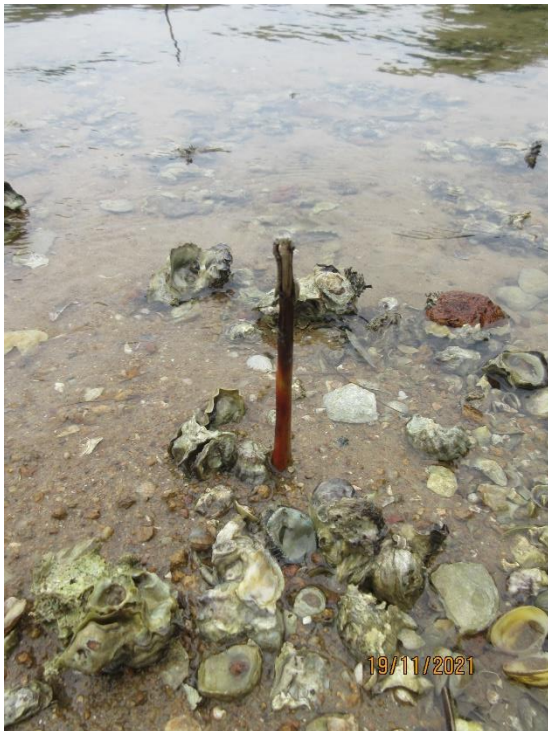
Photo 3.2 Seedling with poor condition (no leaves but still alive)

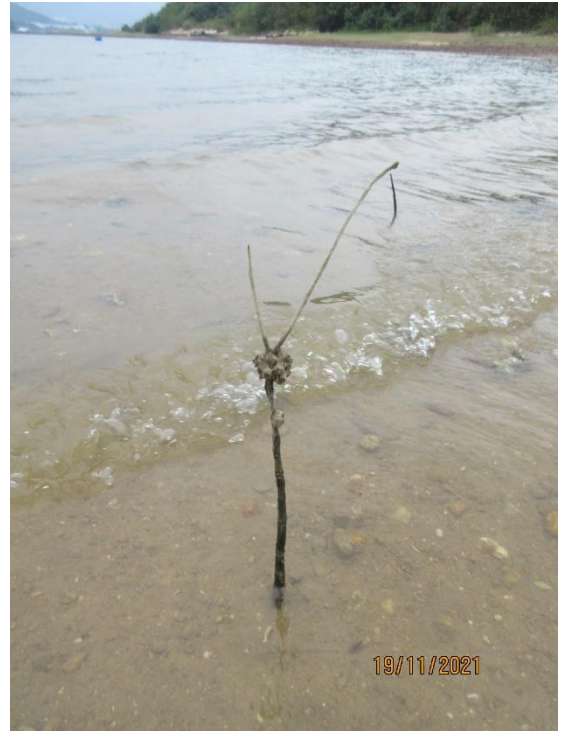
Photo 3.3 Dead Seedling

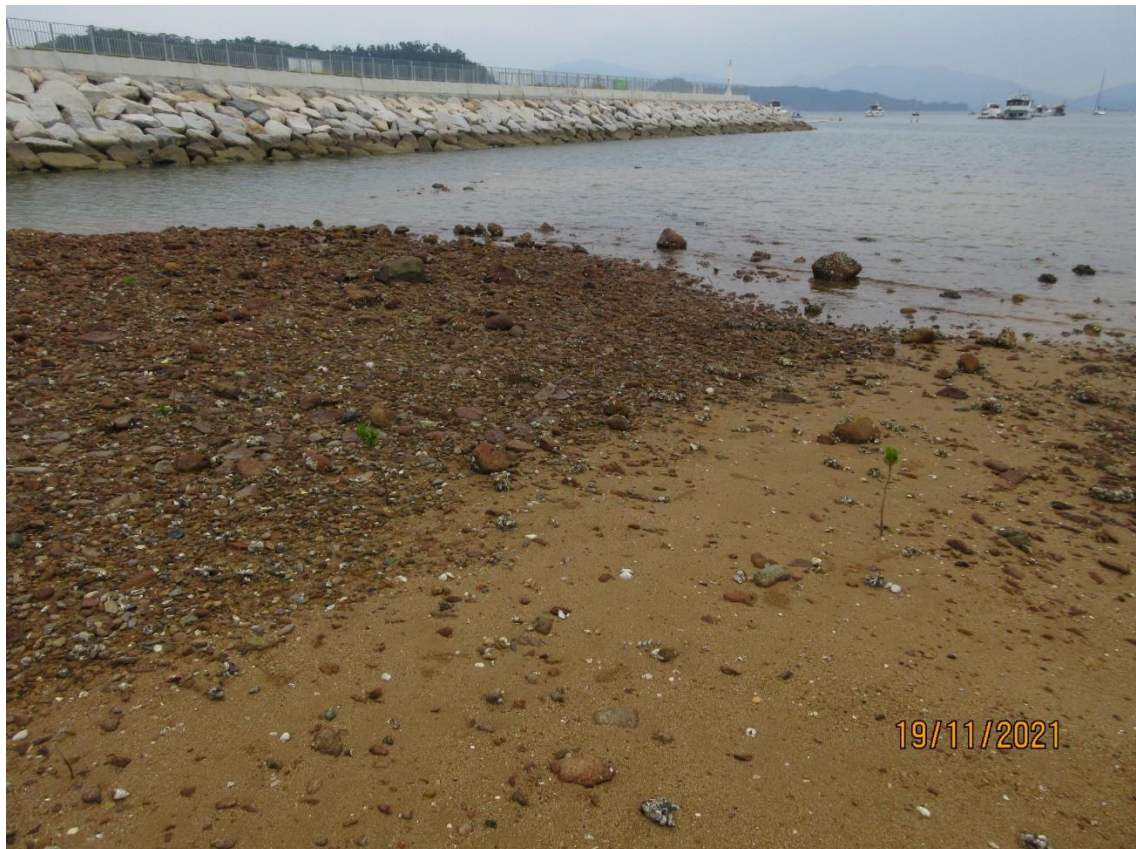
Photo 3.4 A large amount of the seedlings were dead and in poor condition, some of them with very short dead stem remain

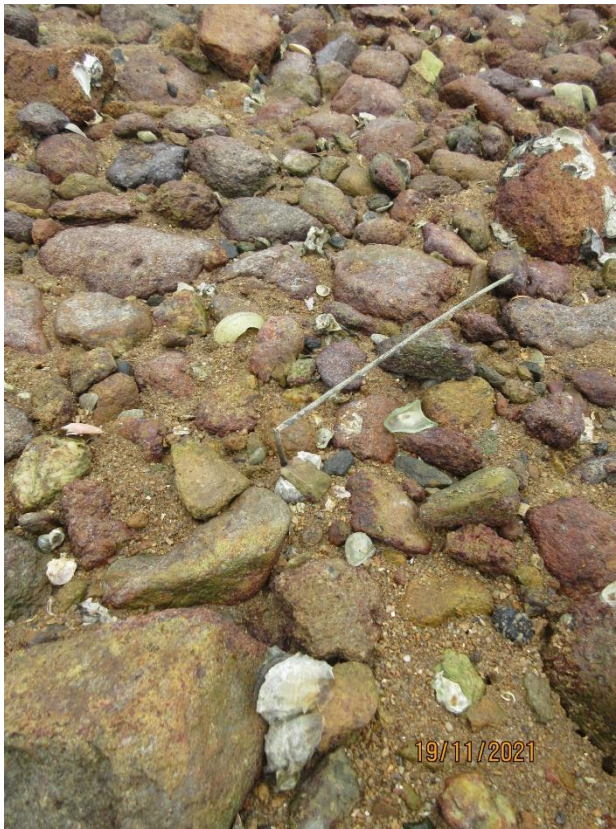
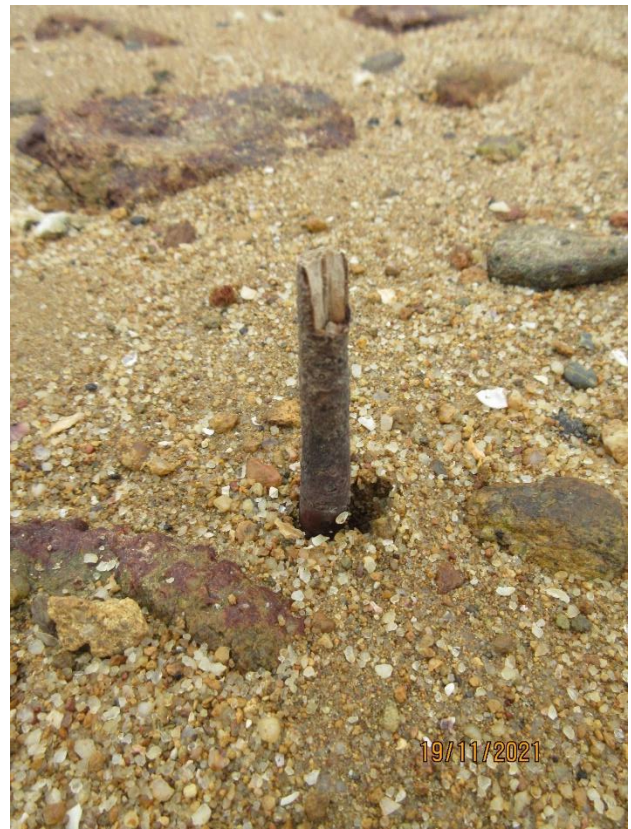
Photo 3.5a and 3.5b Dried and decay seedlings

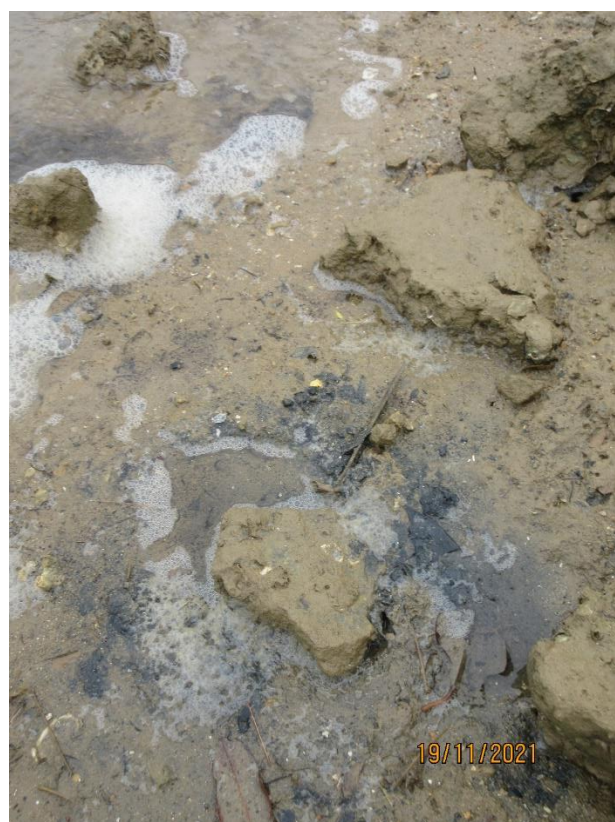
Photo 3.8 Dead and poor condition seedlings at the seaward side

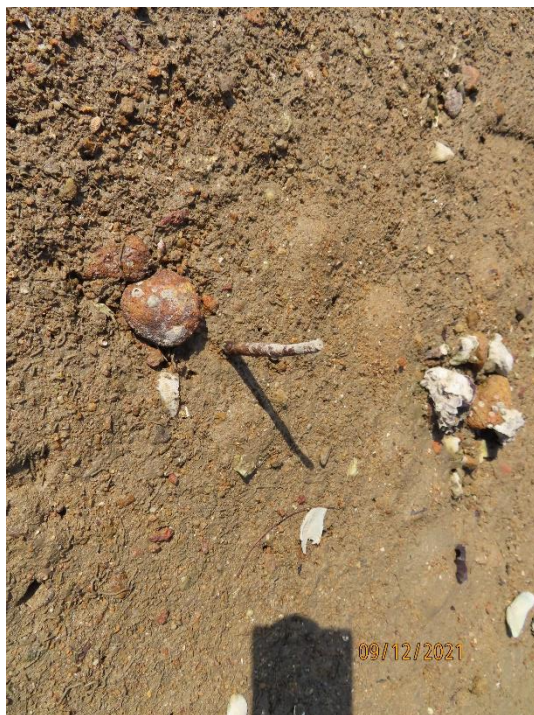
Photo 3.2 Seedling with the poor condition is kept declining (no leaves but still alive)

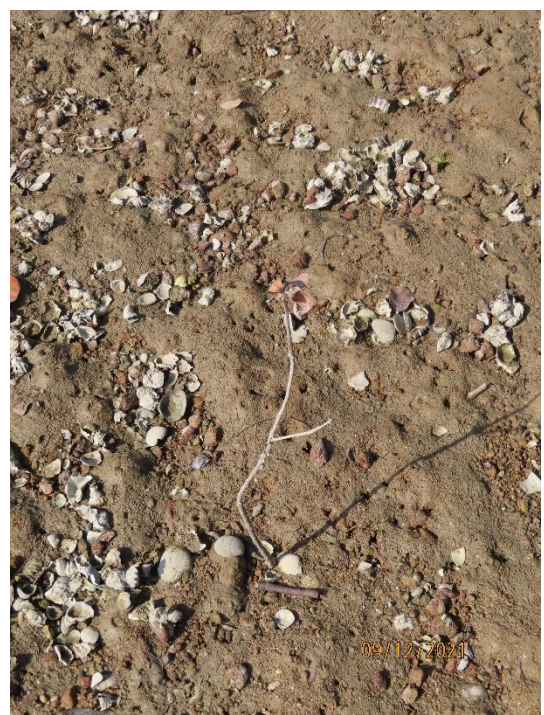
Photo 3.3 Dead Seedling

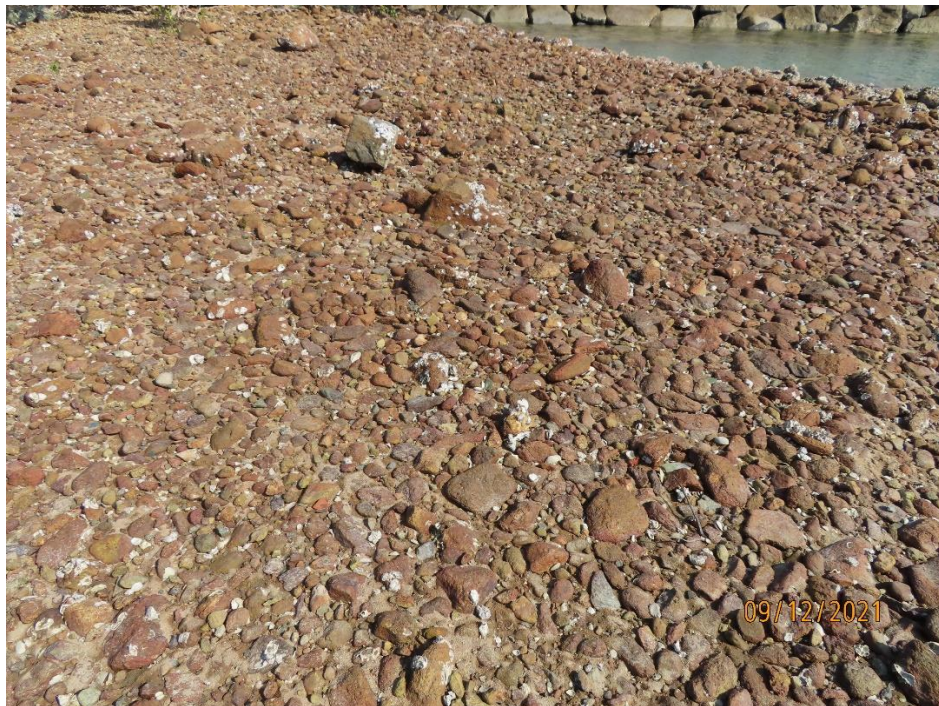
Photo 3.4 A large amount of the seedlings were dead and in poor condition, some of them with very short dead stem remain

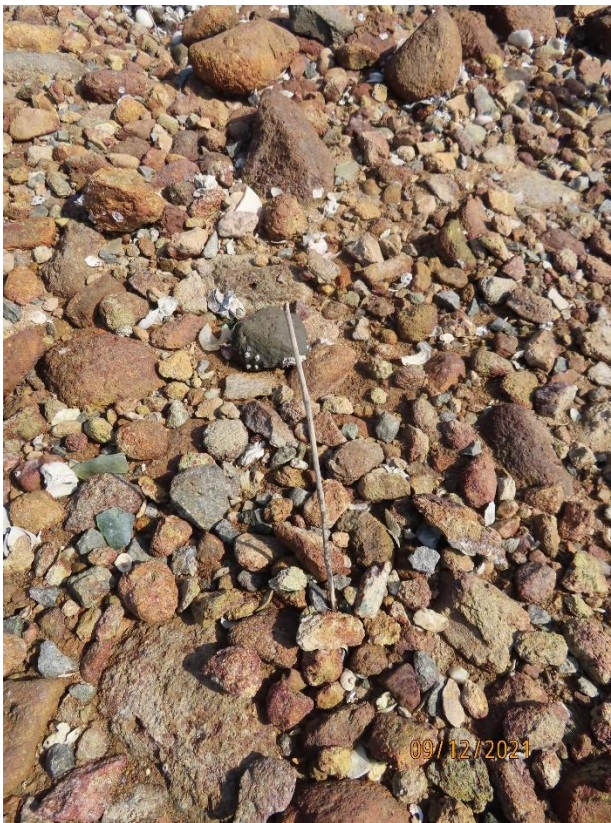
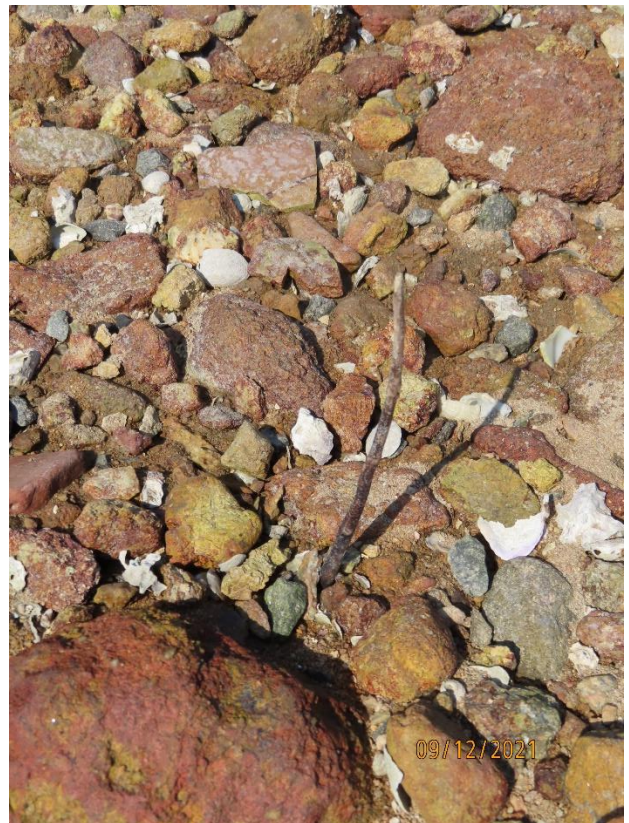
Photo 3.5a and 3.5b Dried and decay seedlings

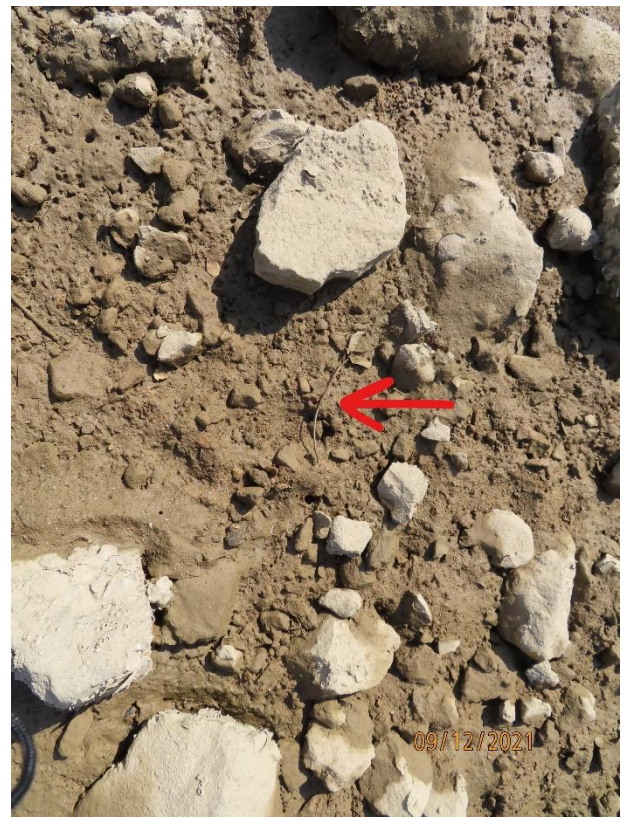
Photo 3.8 Dead and poor condition seedlings at the seaward side

Based on the observation from Sep to Dec, only the seedlings at the landward side thrive. The seedlings at the seaward side showed poor health and death even at location 3, which the general condition of the seedling is the best among those 3 locations. For the poor health seedlings, there is no sign to re-sprout and is expected to decline and be washed away by the tidal over time, which was observed in the recent inspections.

Since the mangrove distribution and survival is primarily determined by sea level and its fluctuations, other secondary factors are air temperature, salinity, ocean currents, storms, shore slope, and soil substrate also affect the establishment rate. Both *Aegiceras corniculatum* and *Avicennia marina* are mostly at the outer fringe (seaward) among other mangroves and *Avicennia marina* is also a pioneer species, however, even those species fail to establish at location 1 and location 2. From our observation, it is suspected that the condition of location 1 and location 2, especially the seaward side is not optimal for the seedlings to establish and grow. The contractor is recommended to replant the seedlings and review if the planting location should be moved to a more landward side or other locations (like next to location 3 (Photo 3.9) which the current condition of the seedlings is good) to improve the survival rate.

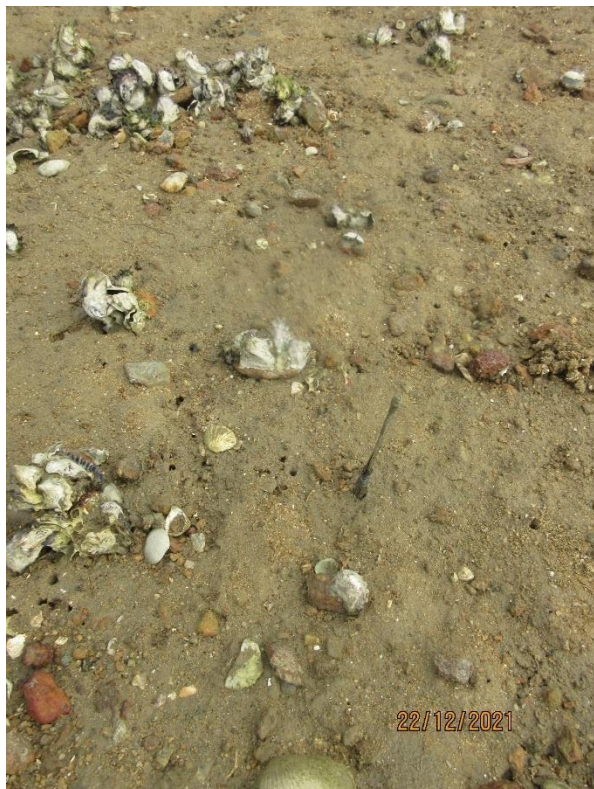
Photo 3.2 Seedling with the poor condition is kept declining (no leaves but still alive)

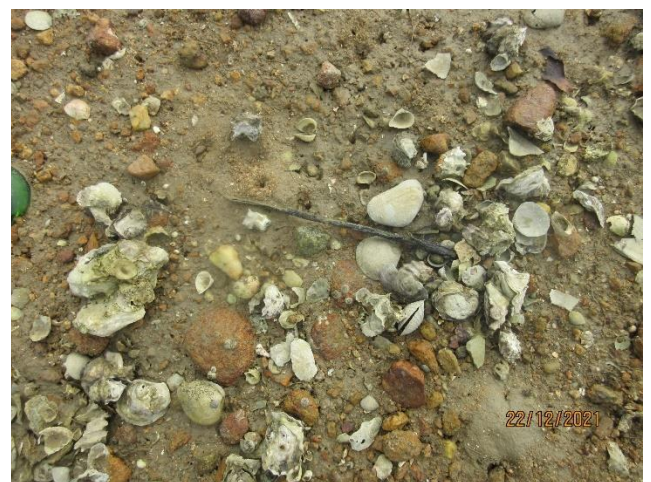
Photo 3.3 Dead Seedling

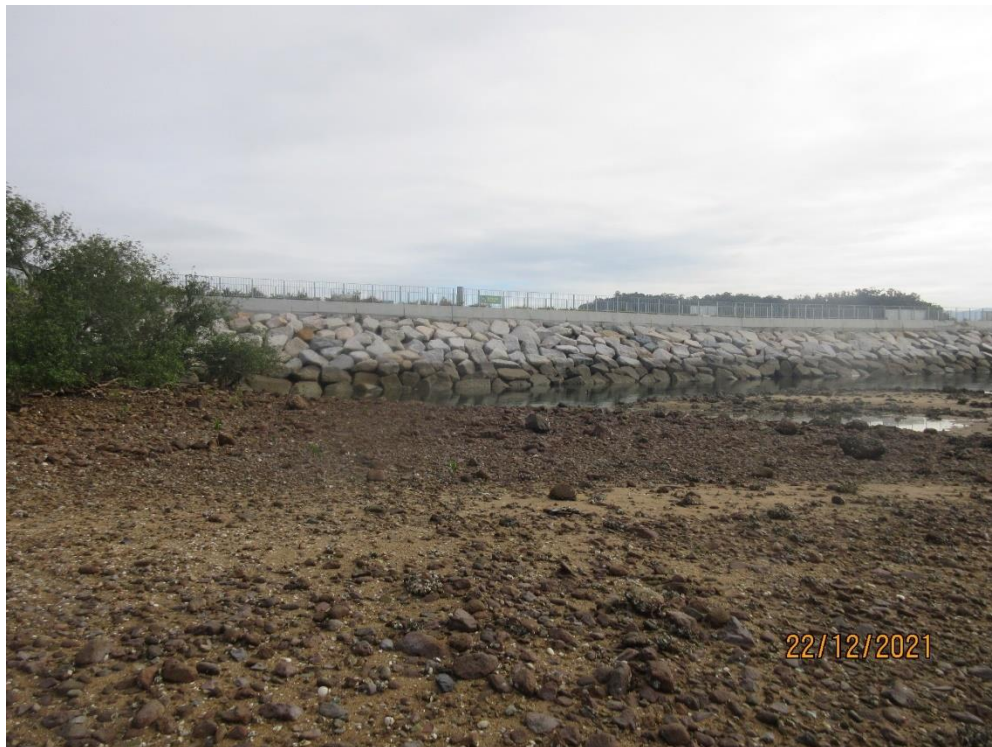
Photo 3.4 A large amount of the seedlings were dead and in poor condition, some of them with very short dead stem remain

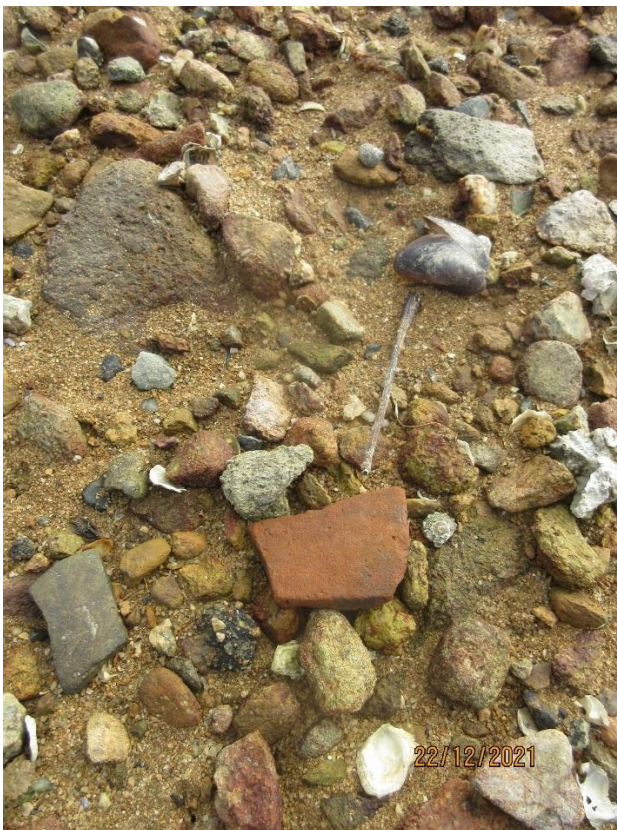
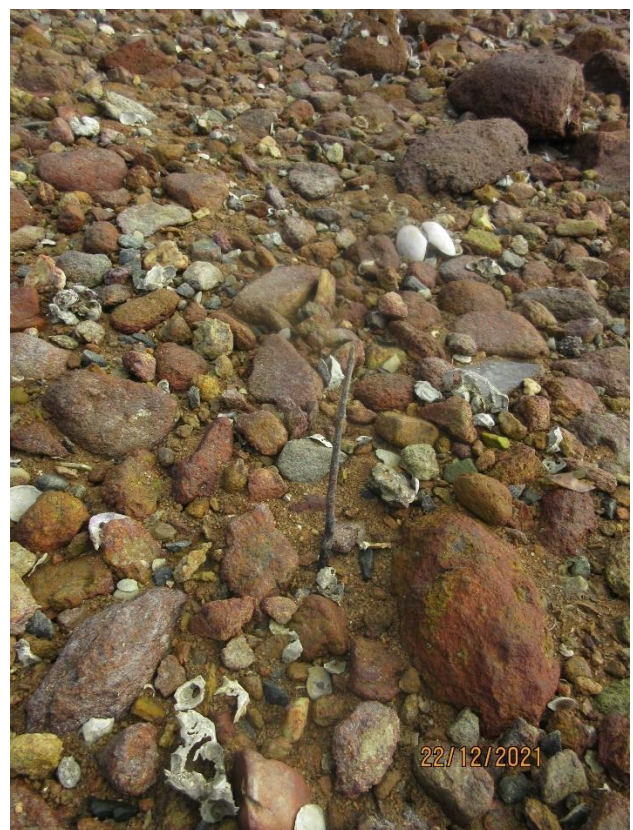
Photo 3.5a and 3.5b Dried and decay seedlings

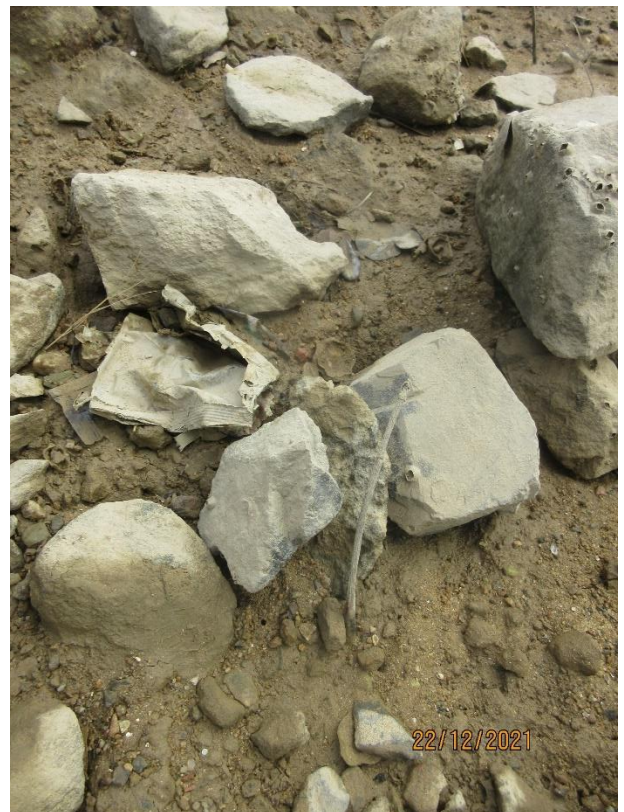
Photo 3.8 Dead and poor condition seedlings at the seaward side

Based on the observation from Sep to Dec, only the seedlings at the landward side thrive. The seedlings at the seaward side showed poor health and death even at location 3, which the general condition of the seedling is the best among those 3 locations. Those poor health seedlings with no sign to re-sprout and are expected to decline and be washed away by the tidal over time, which could be concluded in the recent inspections.

Since the mangrove distribution and survival is primarily determined by sea level and its fluctuations, other secondary factors are air temperature, salinity, ocean currents, storms, shore slope, and soil substrate also affect the establishment rate. Both *Aegiceras corniculatum* and *Avicennia marina* are mostly at the outer fringe (seaward) among other mangroves and *Avicennia marina* is also a pioneer species, however, even those species fail to establish at location 1 and location 2. From our observation, it is suspected that the condition of location 1 and location 2, especially the seaward side is not optimal for the seedlings to establish and grow. The contractor is recommended to replant the seedlings and review if the planting location should be moved to a more landward side or other locations (like next to location 3 (Photo 3.9) which the current condition of the seedlings is good) to improve the survival rate.
