PROJECT No.: TCS/00874/16

**CEDD CONTRACT NO. CV/2012/05 –
BATHING BEACH AT LUNG MEI, TAI PO**

**POST-CONSTRUCTION MONITORING AND AUDIT
REPORT (JANUARY TO FEBRUARY 2022)**

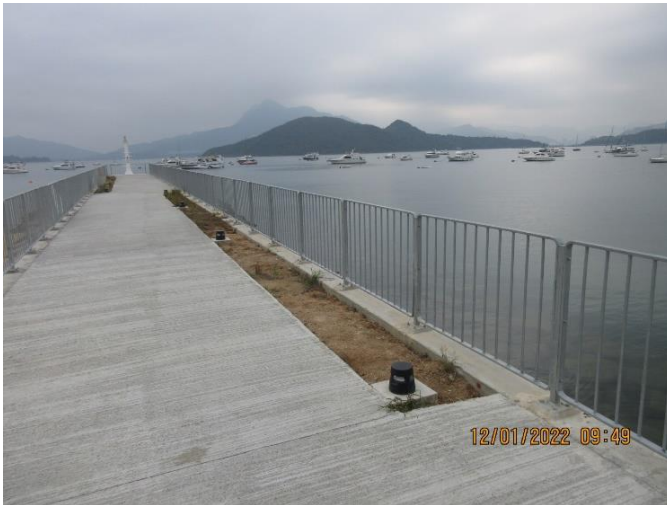
Photo I.

1. Some of the plants in the planters on the Western groyne were wilted and should be removed and replaced. (Photo I)
2. Some ties and stakes were detached at Western Box Culvert which should be tightened up to standard. (Photo J)

Some of the plants in the planters on the Western groyne were wilted and removed

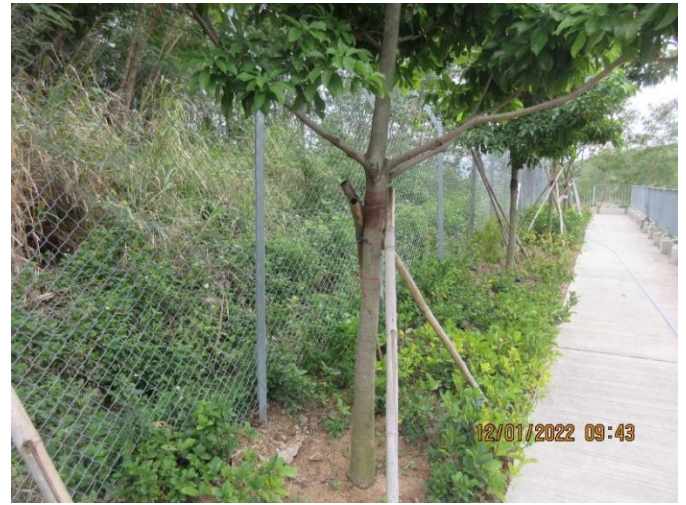
Photo J.

Some ties and stakes were detached at Western Box Culvert

1. The Contractor(s) is/are reminded to check the guying and staking of all retained/newly planted trees to ensure the tree supporting systems are properly installed, in order and not causing any damage to the trees.
2. The Contractor(s) is/are reminded to replant the plants at Western groyne and Eastern box culvert.

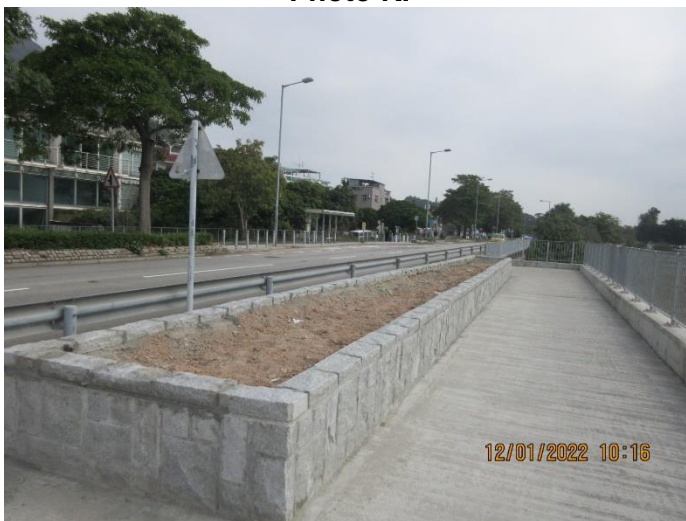
Photo K.

3. The planters at the Eastern box culvert were repaired and enlarged and the plants in the planters were removed. Replacement planting should be provided. (Photo K and Photo L)

The planters at the Eastern box culvert were repaired and enlarged

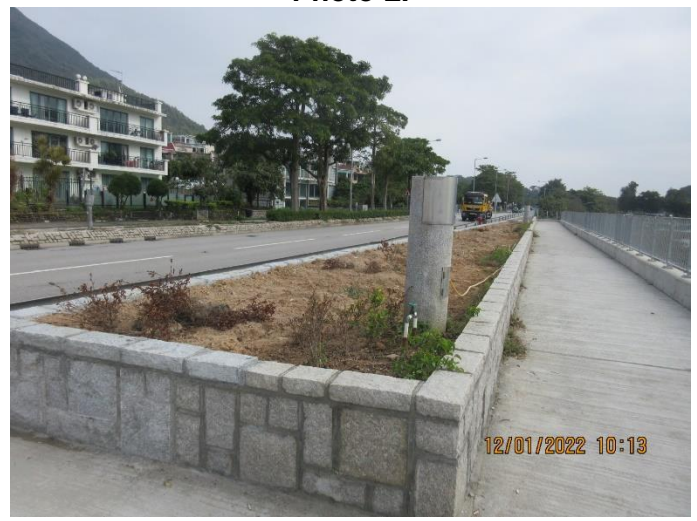
Photo L.

The plants in the planters were removed

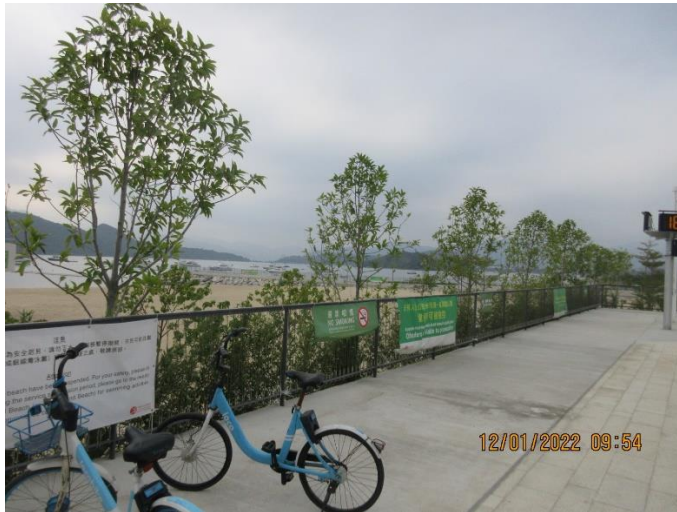
Photo M.

1. Two nos. of dead trees (*Michelia x alba*) were replaced. (Photo M)
2. The Contractor was reminded to follow the observation provided in the checklist with their horticulture sub-contractor.
3. The updated as-planted drawing received.
 Planter P14 and P3B: Confirmed Plant material is removed and replaced by grey pebbles.
 Planter P7: Confirmed change of plant species from *Rhapis exceisa* to *Schefflera arboricola*
 Confirmed *Bauhinia glauca* is not shown on the plan.

The dead tree (*Michelia x alba*) was replaced

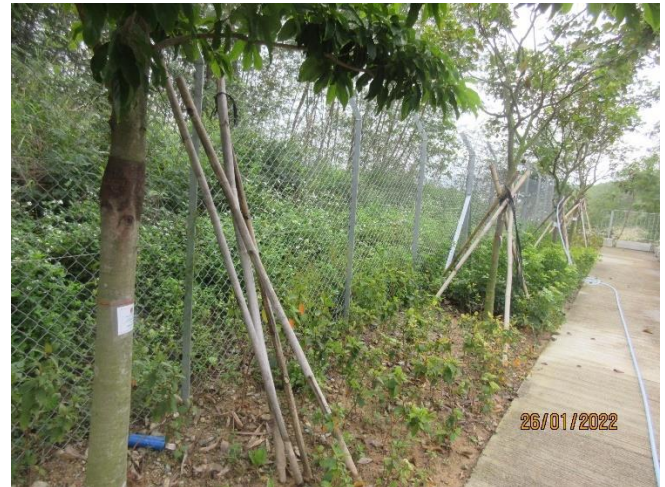
Photo J.

Some ties and stakes were detached at Western Box Culvert

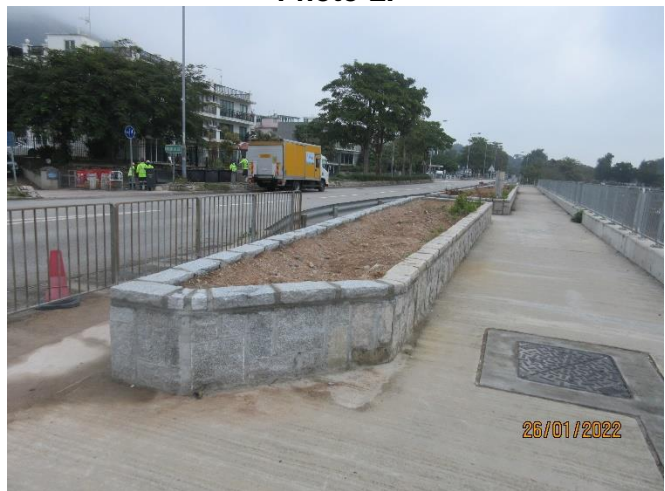
Photo L.

The planters at the Eastern box culvert were repaired and enlarged and the plants in the planters were removed

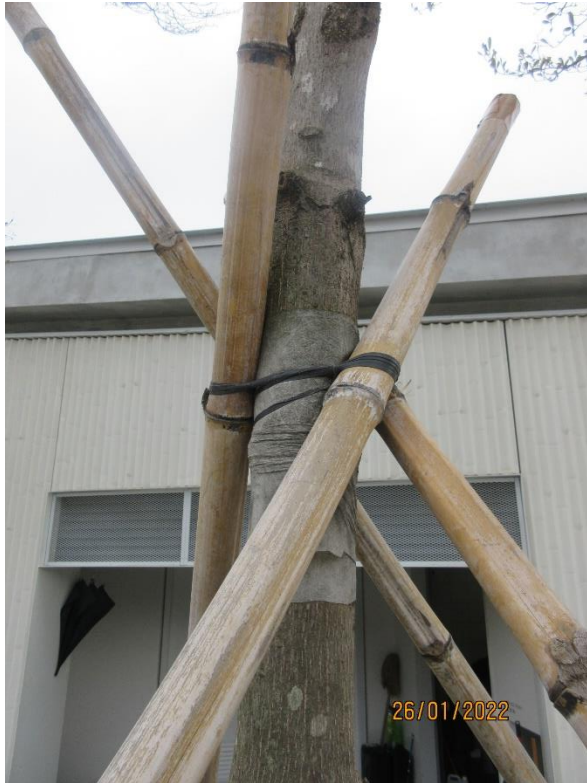
Photo M.

Some ties and stakes already girdled and affected the growth of the trees.

1. Girdling by the ties and stakes was observed on some of the trees. Contractors are required to adjust the ties to avoid the damage of the tree.
2. The Contractor(s) is/are reminded to check the guying and staking of all retained/newly planted trees to ensure the tree supporting systems are properly installed, in order and not causing any damage to the trees.
3. The Contractor(s) is/are reminded to replant the plants at Western groyne and Eastern box culvert.

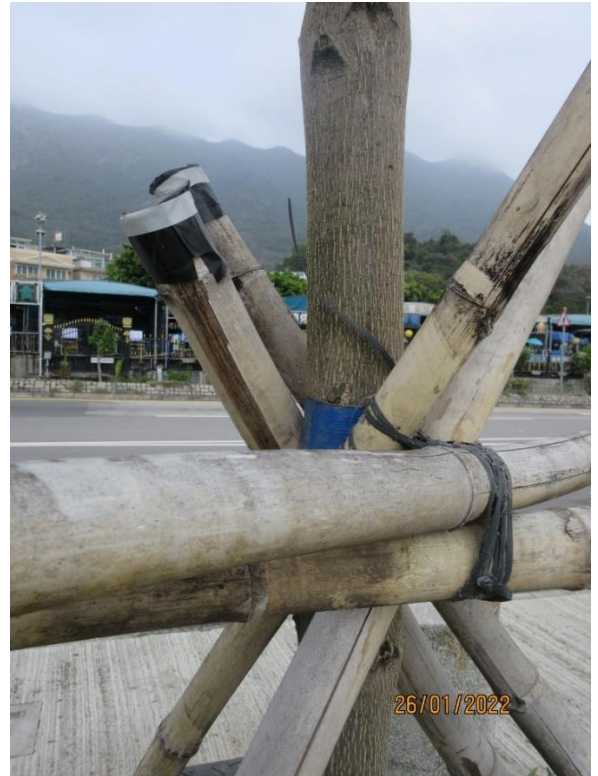
Photo N.

Some ties and stakes already girdled and affected the growth of the trees.

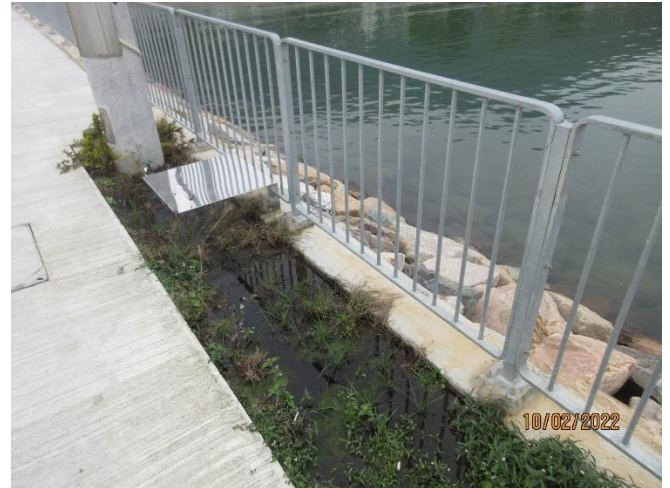
Photo J.

Poor soil drainage is found in one planter in Eastern Groyne

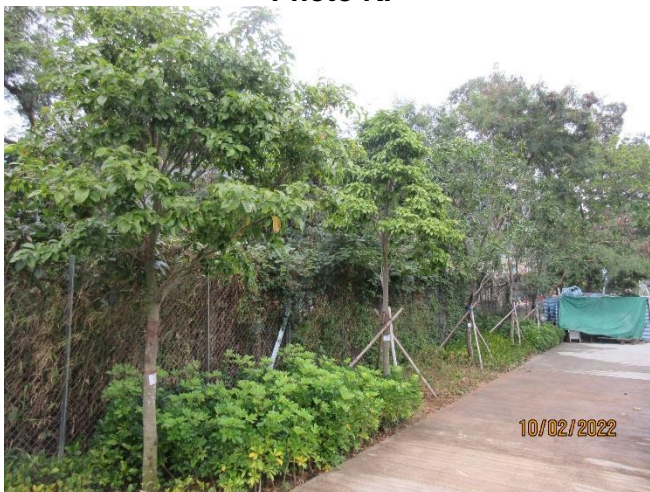
Photo K.

Some ties and stakes were detached at Western Box Culvert

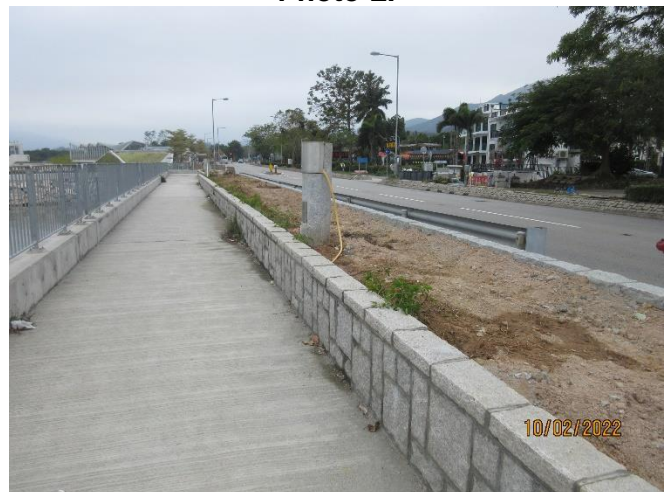
Photo L.

The planters at the Eastern box culvert were repaired and enlarged and the plants in the planters were removed

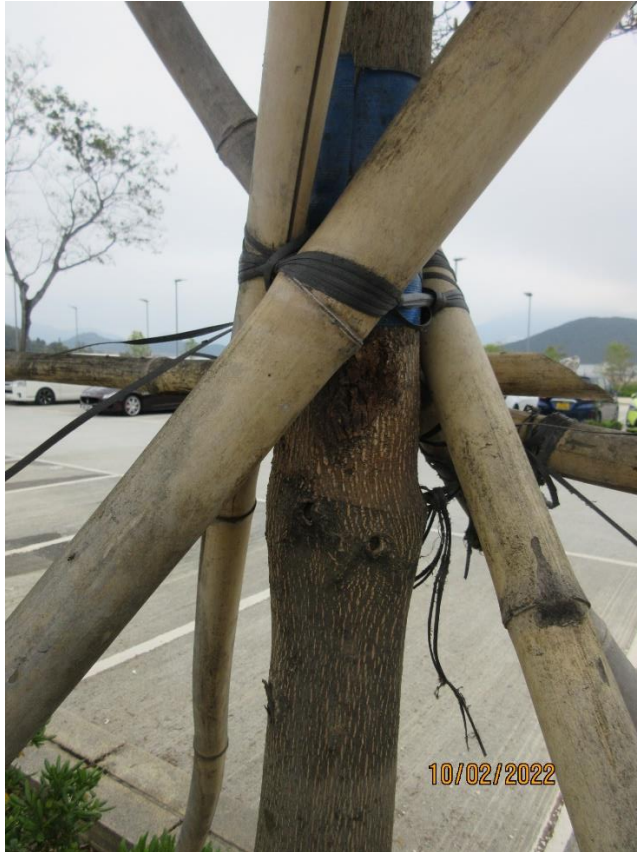
Photo M.

Some ties and stakes already girdled and affected the growth of the trees.

1. Girdling by the ties and stakes was observed on some of the trees. Contractors are required to adjust the ties to avoid the damage of the tree.
2. The Contractor(s) is/are reminded to check the guying and staking of all retained/newly planted trees to ensure the tree supporting systems are properly installed, in order and not causing any damage to the trees.
3. The Contractor(s) is/are reminded to replant the plants at Western groyne and Eastern box culvert.

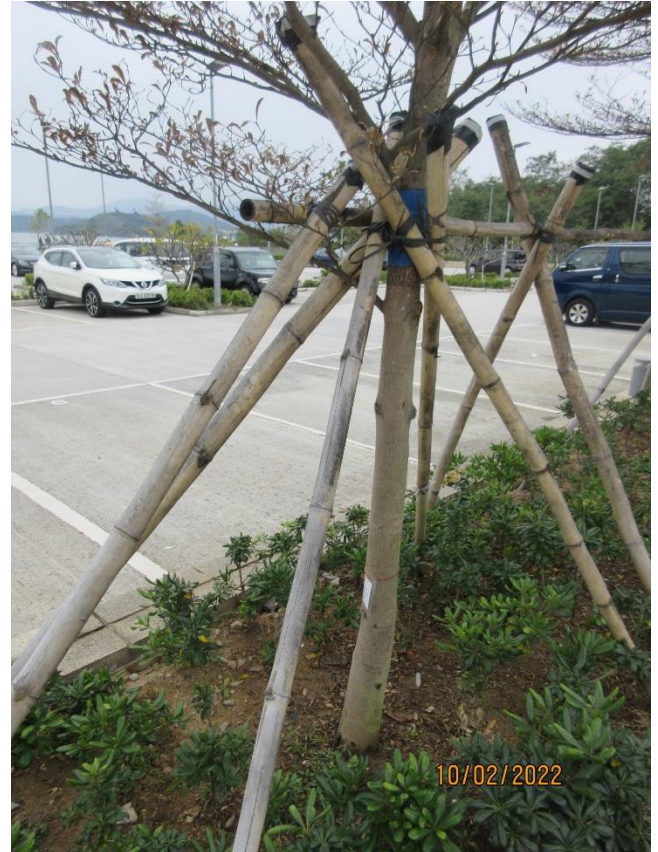
Photo N.

Some ties and stakes already girdled and affected the growth of the trees.

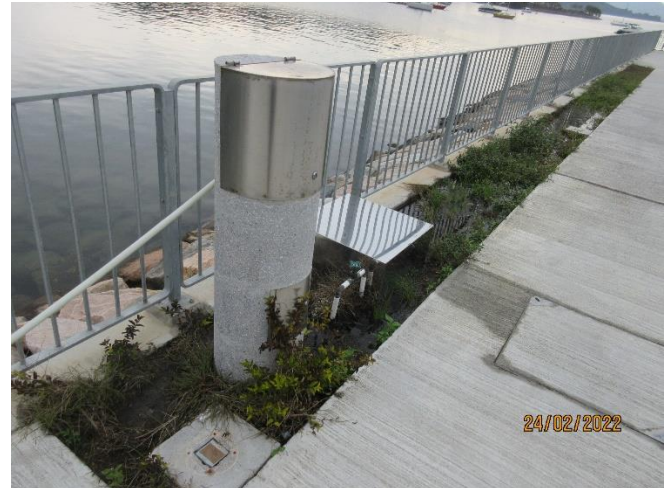
Photo J.

1.4	Is the soil drain well?	✓			Poor soil drainage is found in one planter in Eastern Groyne
1.5	Are the weeds controlled at an acceptable level?	✓			
1.6	Are the debris controlled at an acceptable level?	✓

Poor soil drainage is found in one planter in Eastern Groyne

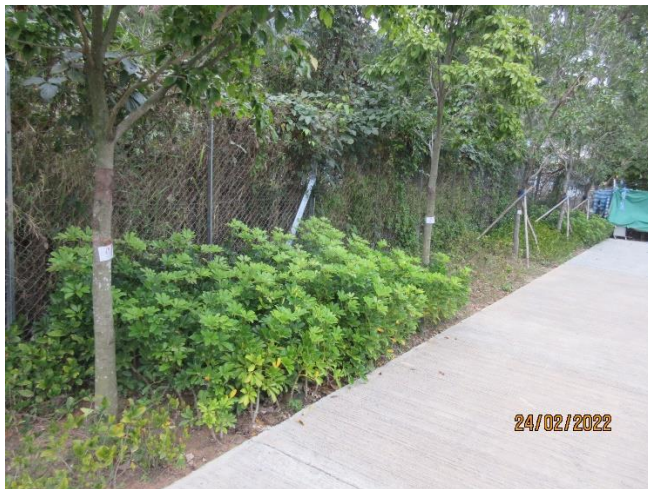
Photo K.

Some ties and stakes were detached at Western Box Culvert

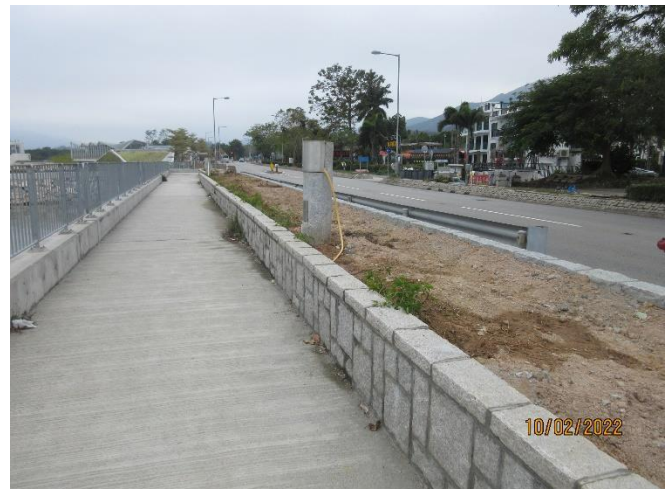
Photo L.

The planters at the Eastern box culvert were repaired and enlarged and the plants in the planters were removed

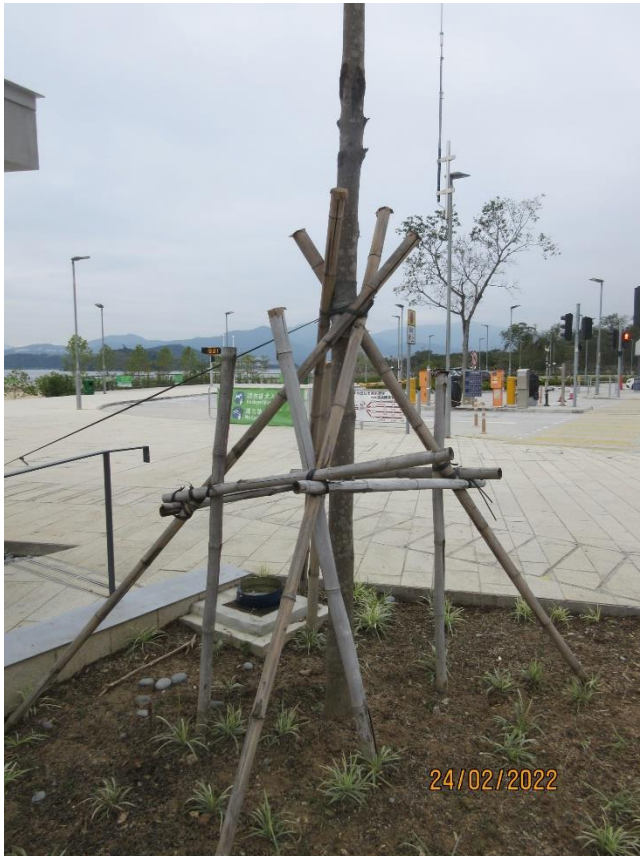
Photo M.

Some ties and stakes already girdled and affected the growth of the trees.

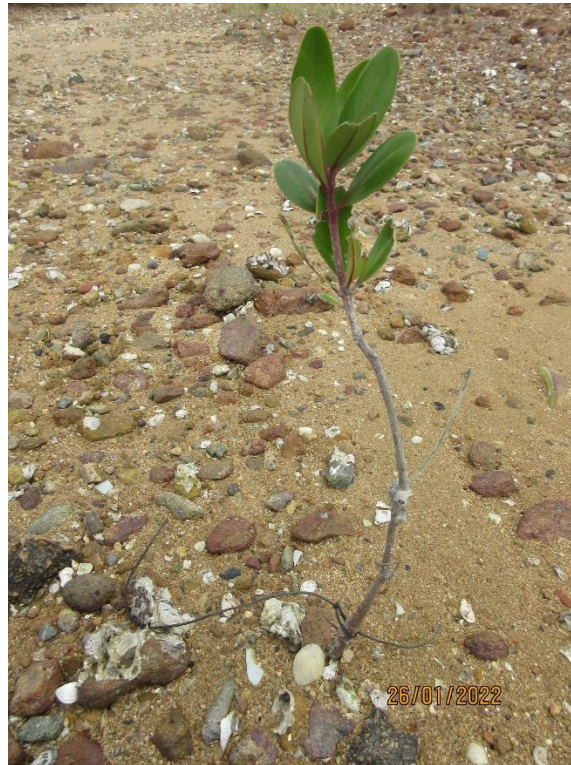
Photo 3.1 The seedling on the most landward side has leaves and is in good condition

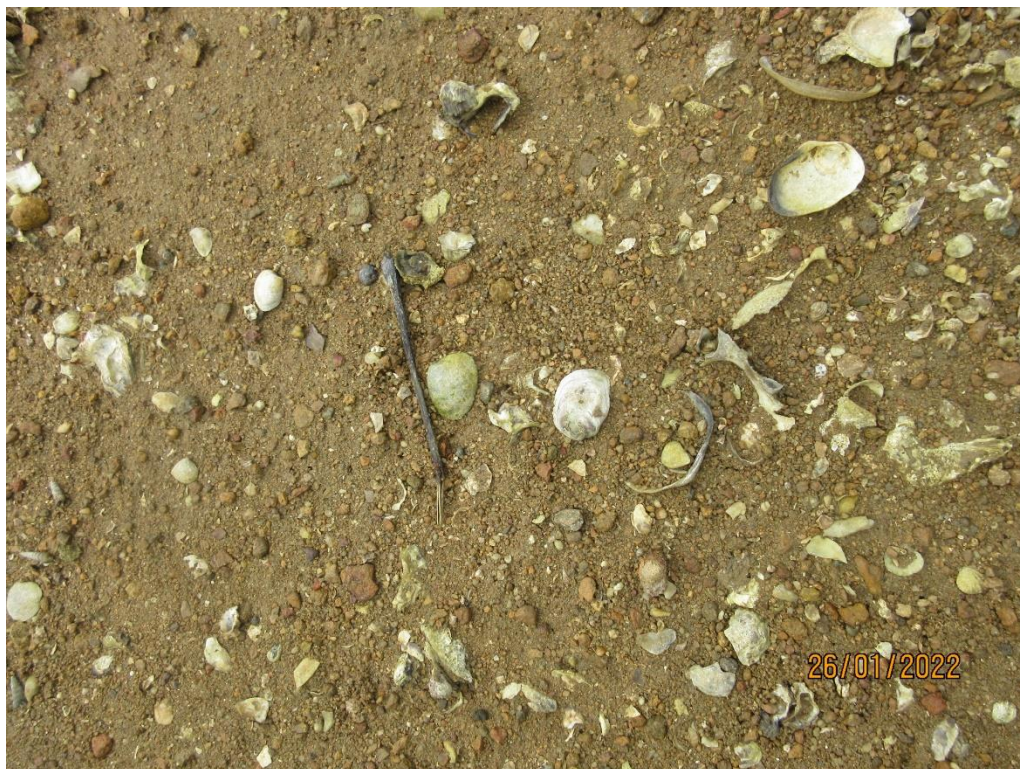
Photo 3.2 large amount of the seedlings were dead and in poor condition, some of them with very short dead stem remain

Based on the observation from Sep to Jan, only the seedlings at the landward side thrive. The seedlings at the seaward side showed poor health and death even at location 3, which the general condition of the seedling is the best among those 3 locations. Those poor health seedlings with no sign to re-sprout and are expected to decline and be washed away by the tidal over time, which could be concluded in the recent inspections.

Since the mangrove distribution and survival is primarily determined by sea level and its fluctuations, other secondary factors are air temperature, salinity, ocean currents, storms, shore slope, and soil substrate also affect the establishment rate. Both *Aegiceras corniculatum* and *Avicennia marina* are mostly at the outer fringe (seaward) among other mangroves and *Avicennia marina* is also a pioneer species, however, even those species fail to establish at location 1 and location 2. From our observation, it is suspected that the condition of location 1 and location 2, especially the seaward side is not optimal for the seedlings to establish and grow. The contractor is recommended to replant the seedlings and review if the planting location should be moved to a more landward side or other locations (like next to location 3 (Photo 3.6) which the current condition of the seedlings is good) to improve the survival rate.

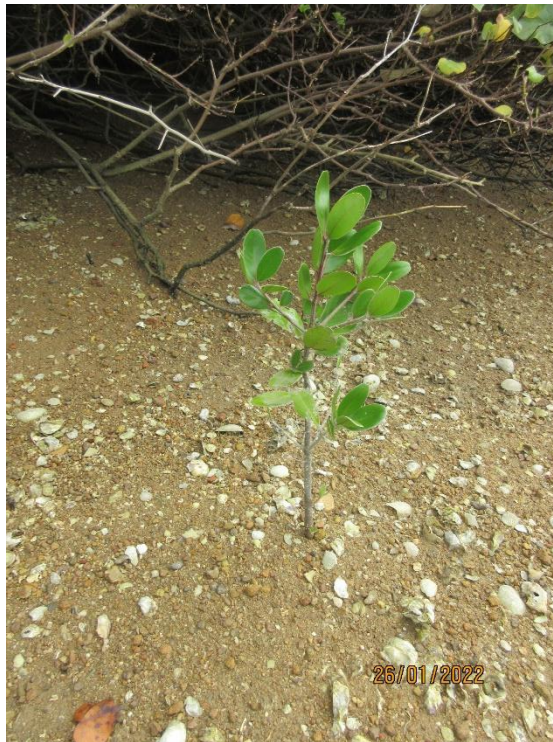
Photo 3.3 The seedling on the most landward side has leaves and is in good condition

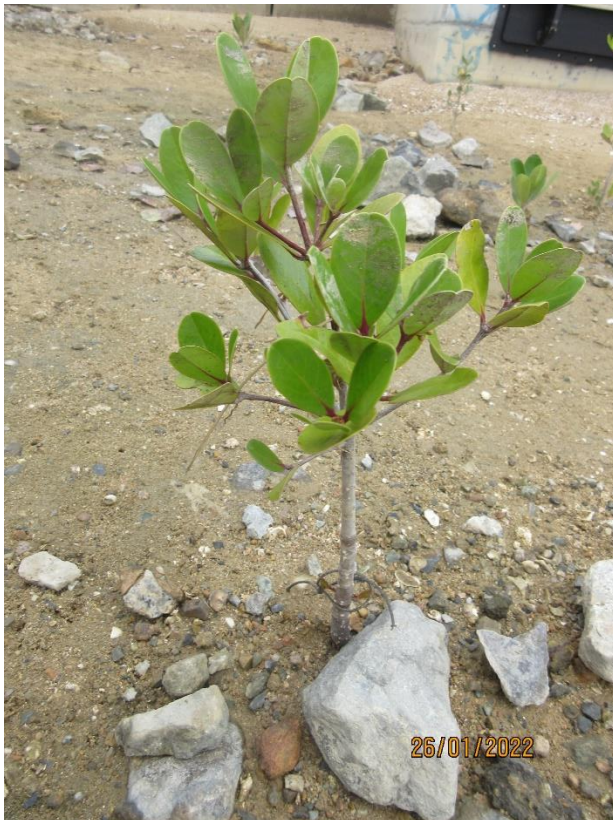
Photo 3.4 Seedling with good condition

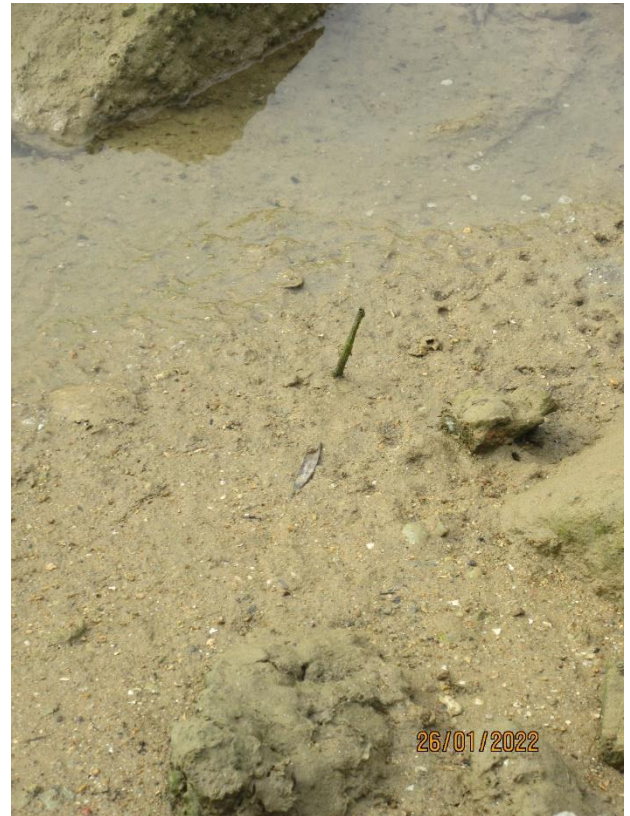
Photo 3.5 Dead and poor condition seedlings at the seaward side

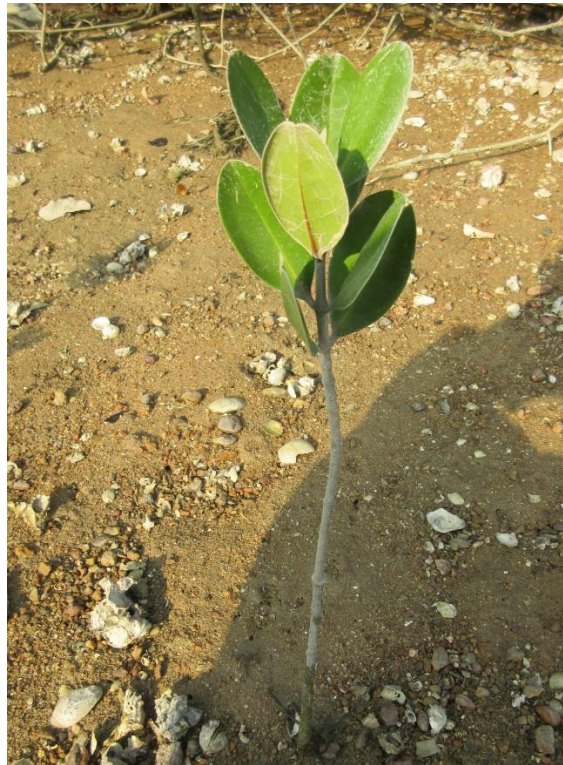
Photo 3.1 The seedling on the most landward side has leaves and is in good condition

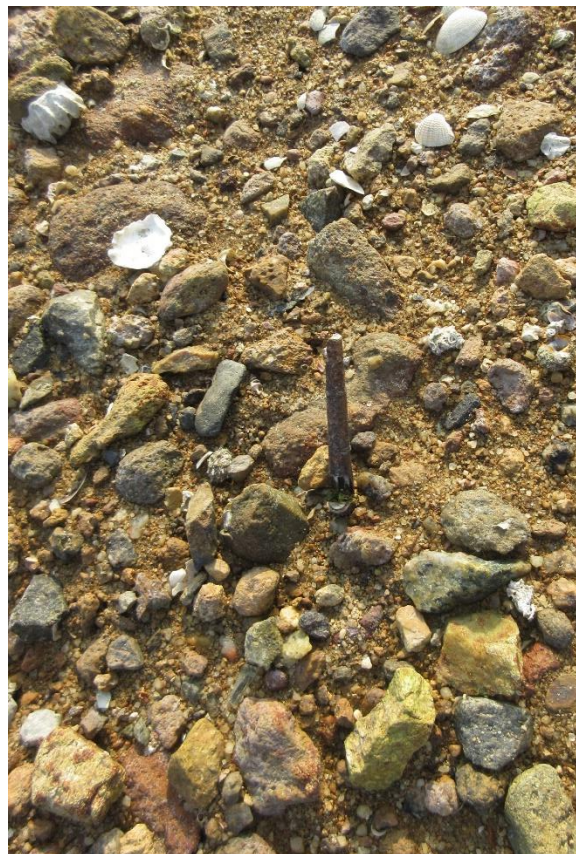
Photo 3.2 large amount of the seedlings were dead and in poor condition, some of them with very short dead stem remain

Based on the observation from Sep to Feb, only the seedlings at the landward side thrive. The seedlings at the seaward side showed poor health and death even at location 3, which the general condition of the seedling is the best among those 3 locations. Those poor health seedlings with no sign to re-sprout and are expected to decline and be washed away by the tidal over time, which could be concluded in the recent inspections.

Since the mangrove distribution and survival is primarily determined by sea level and its fluctuations, other secondary factors are air temperature, salinity, ocean currents, storms, shore slope, and soil substrate also affect the establishment rate. Both *Aegiceras corniculatum* and *Avicennia marina* are mostly at the outer fringe (seaward) among other mangroves and *Avicennia marina* is also a pioneer species, however, even those species fail to establish at location 1 and location 2. From our observation, it is suspected that the condition of location 1 and location 2, especially the seaward side is not optimal for the seedlings to establish and grow. The contractor is recommended to replant the seedlings and review if the planting location should be moved to a more landward side or other locations (like next to location 3 (Photo 3.6) which the current condition of the seedlings is good) to improve the survival rate.

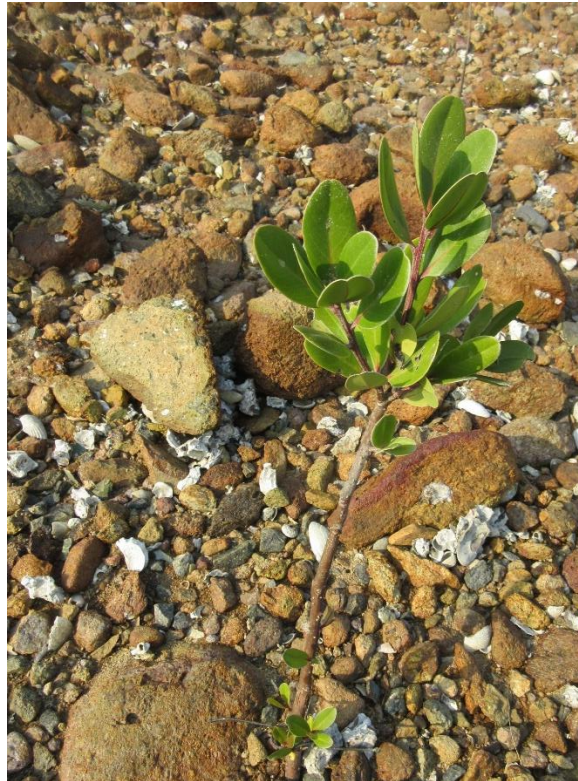
Photo 3.3 The seedling on the most landward side has leaves and is in good condition

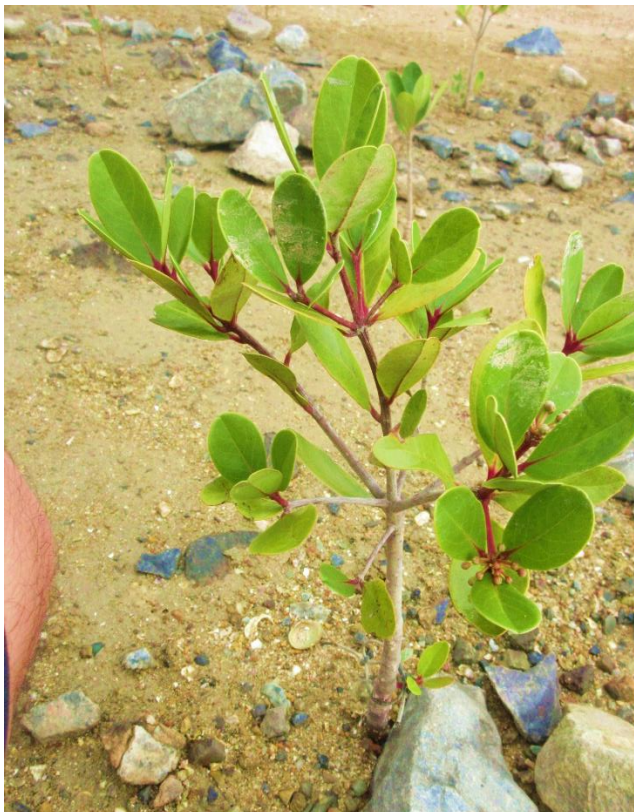
Photo 3.4 Seedling with good condition

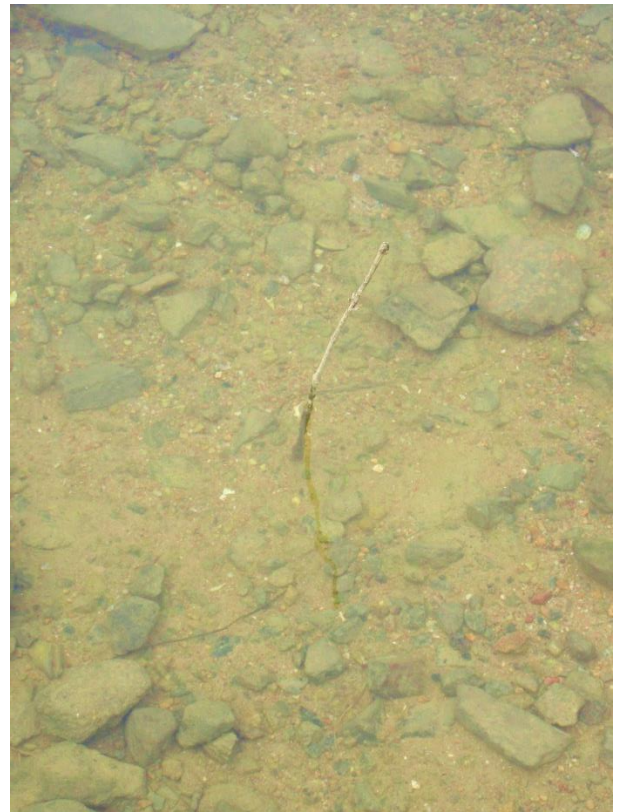
Photo 3.5 Dead and poor condition seedlings at the seaward side
