**CEDD CONTRACT NO. CV/2012/05 –
BATHING BEACH AT LUNG MEI, TAI PO**

**POST-CONSTRUCTION MONITORING AND AUDIT
REPORT (MARCH TO APRIL 2022)**

PREPARED FOR
WELCOME CONSTRUCTION CO., LTD.

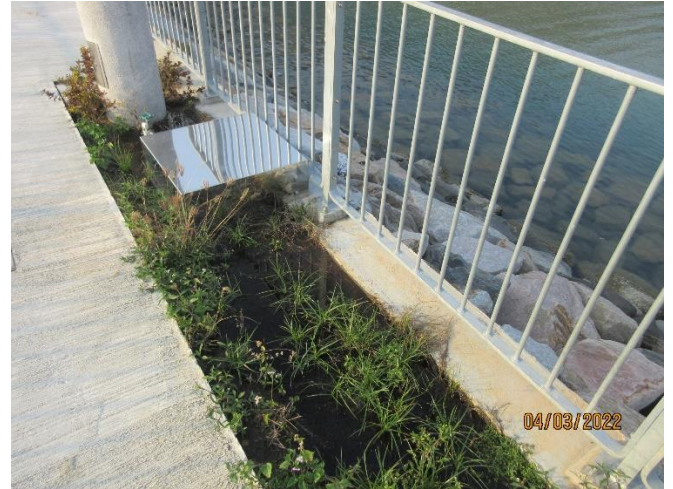
Photo J.

Poor soil drainage is found in one planter in Eastern Groyne

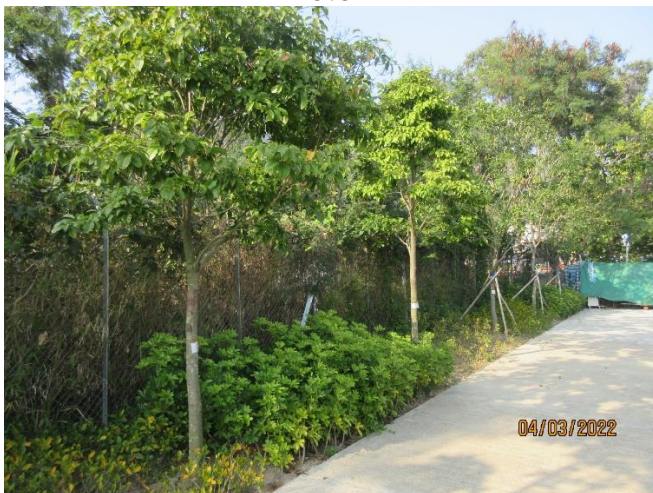
Photo K.

Some ties and stakes were detached at Western Box Culvert

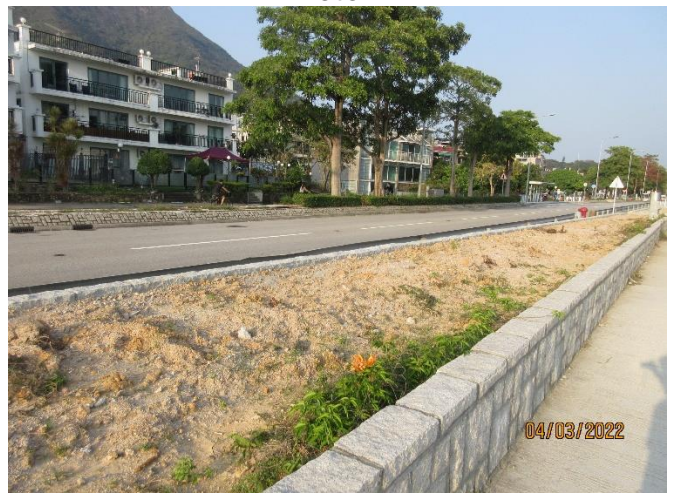
Photo L.

The planters at the Eastern box culvert were repaired and enlarged and the plants in the planters were removed

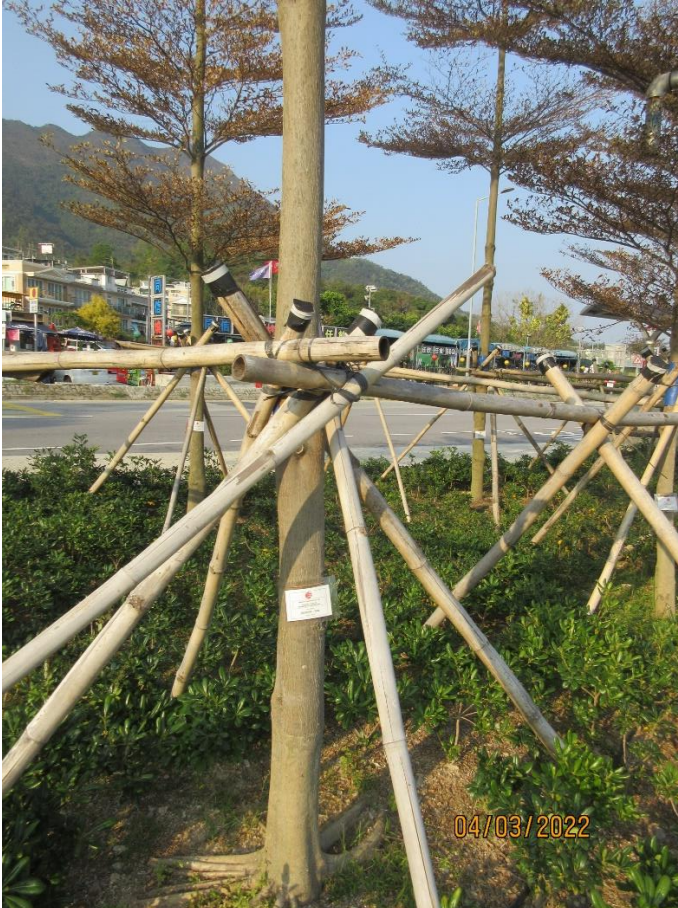
Photo M.

Some ties and stakes already girdled and affected the growth of the trees.

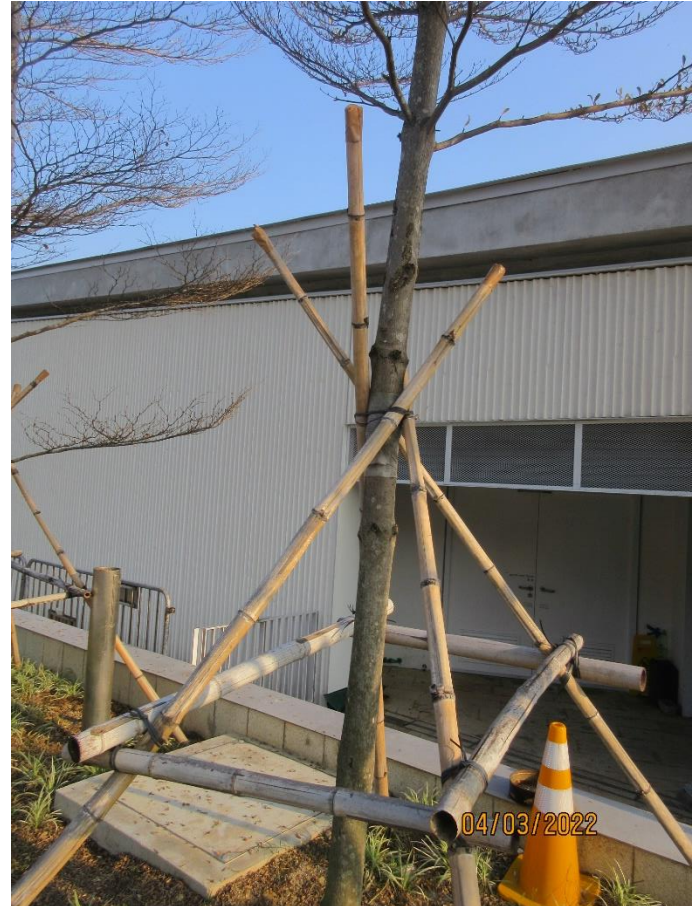
Photo N.

Some ties and stakes already girdled and affected the growth of the trees.

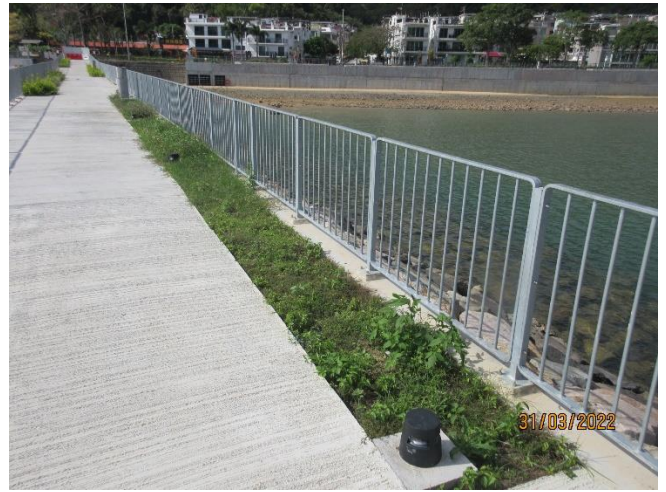
Photo J.

Poor soil drainage is found in one planter in Eastern Groyne

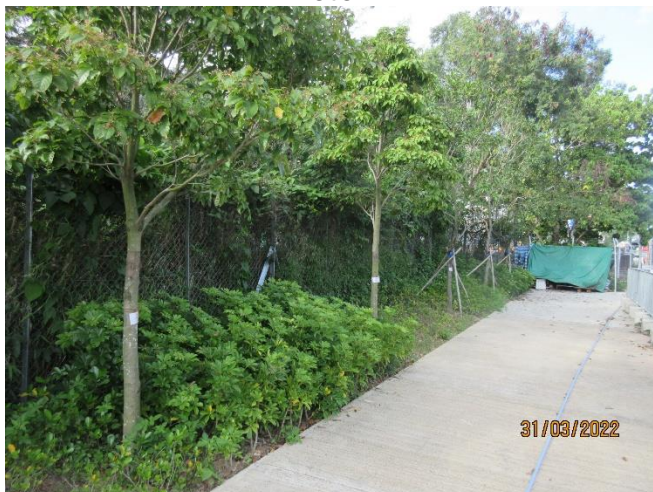
Photo K.

Some ties and stakes were detached at Western Box Culvert

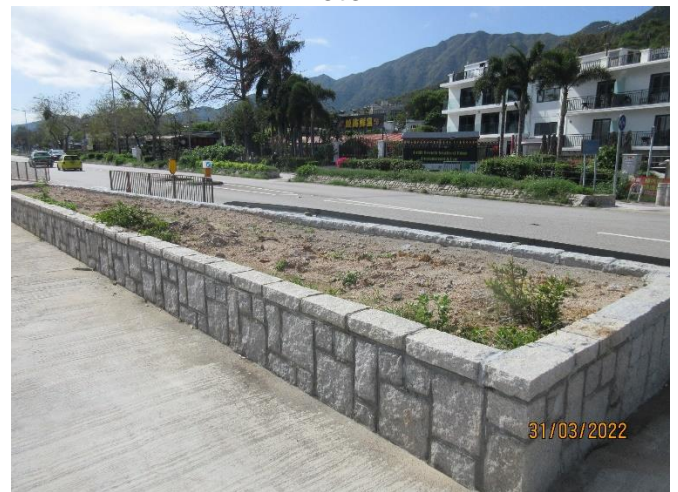
Photo L.

The planters at the Eastern box culvert were repaired and enlarged and the plants in the planters were removed

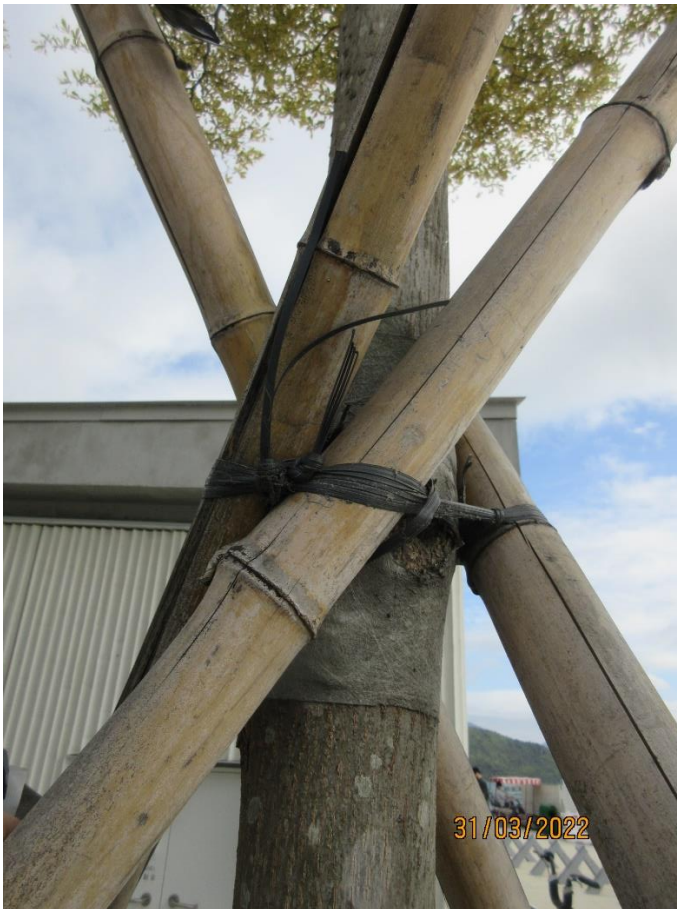
Photo M.

Some ties and stakes already girdled and affected the growth of the trees.

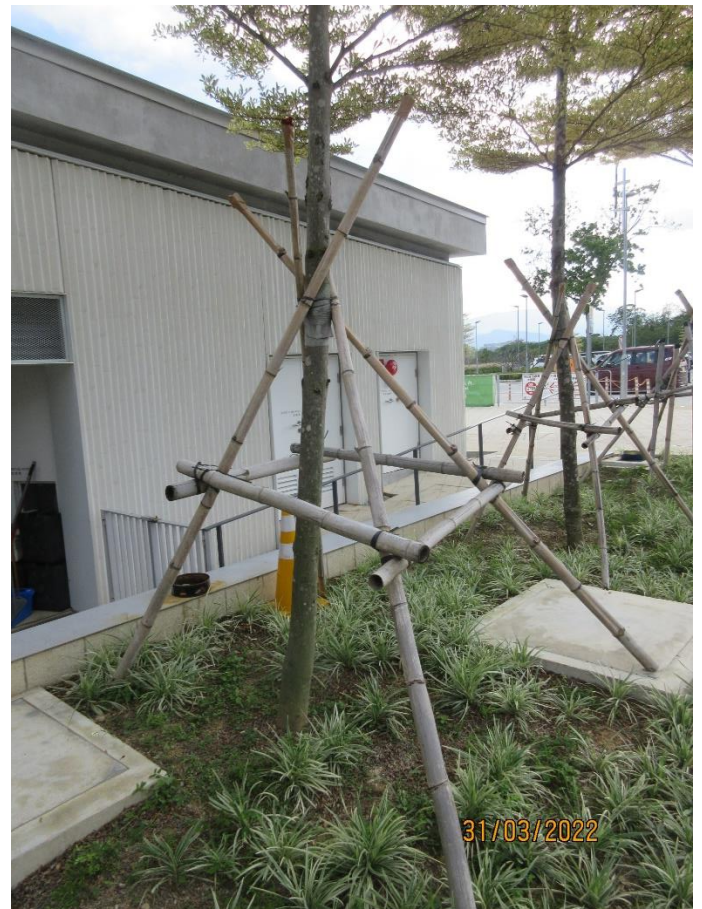
Photo N.

Some ties and stakes already girdled and affected the growth of the trees.

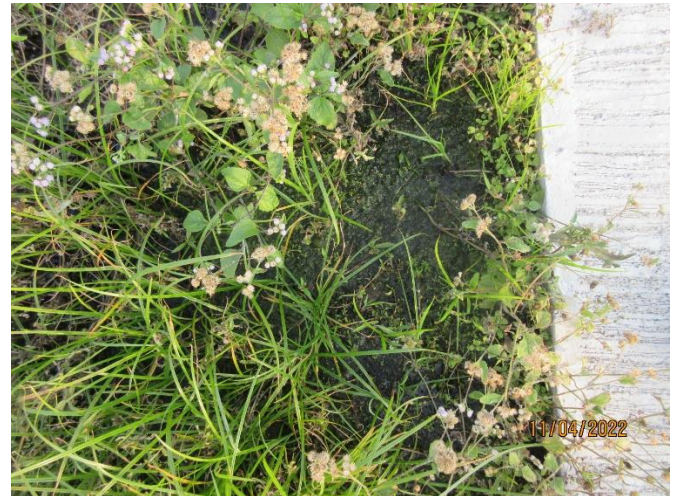
Photo J.

Poor soil drainage is found in one planter in Eastern Groyne

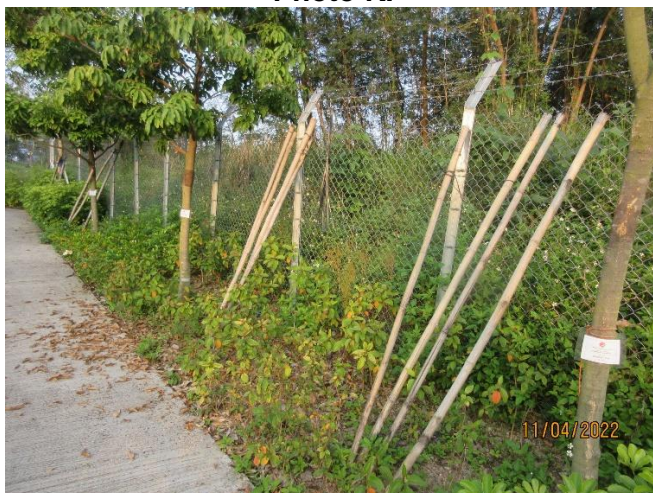
Photo K.

Some ties and stakes were detached at Western Box Culvert

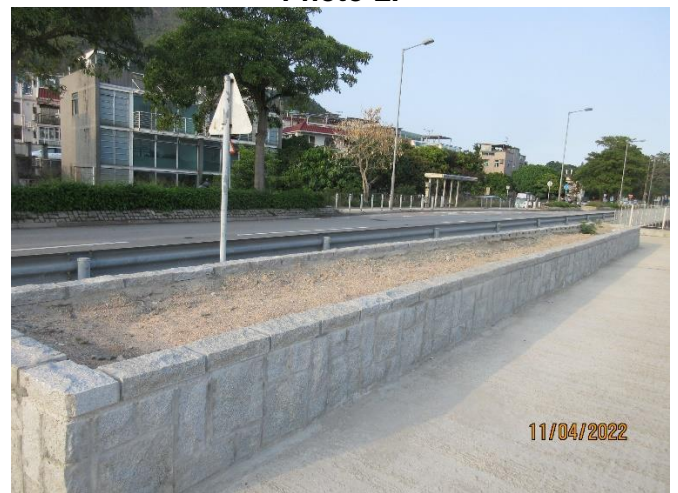
Photo L.

No plants in the Eastern box culvert planters

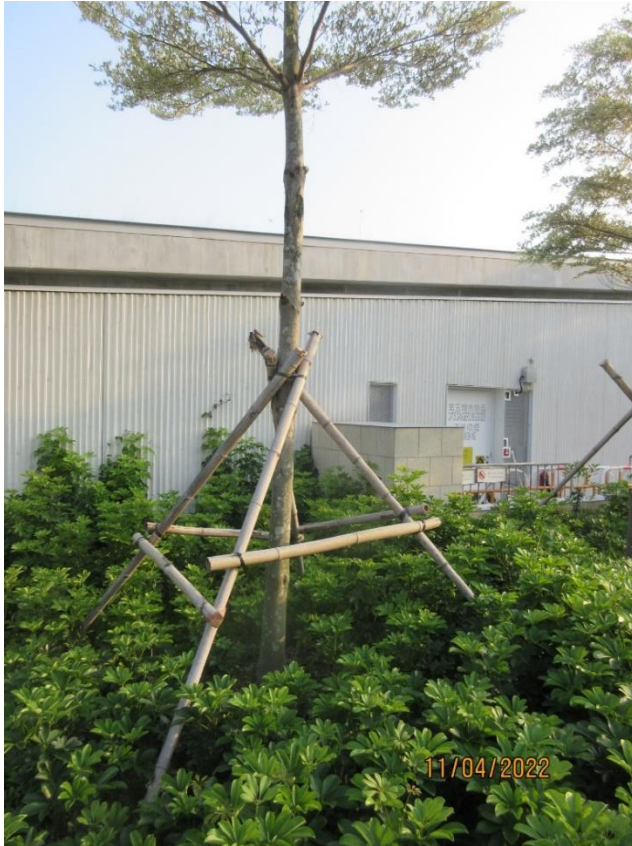
Photo M.

Some ties and stakes already girdled and affected the growth of the trees.

1. Girdling by the ties and stakes was observed on some of the trees. Contractors are required to adjust the ties and remove the unnecessary ties to avoid damage to the tree as a matter of urgency or tree replacement may be required before rejection from maintenance authority during handover.
2. The Contractor(s) is/are reminded to check the guying and staking of all retained/newly planted trees to ensure the tree supporting systems are properly installed, in order and not causing any damage to the trees.
3. The Contractor(s) is/are reminded to replant the plants at Western groyne and Eastern box culvert, and tackle the poor soil drainage issue in Eastern Groyne.
4. Urgent rectification by the contractor(s) is required to achieve sufficient establishment for plantings

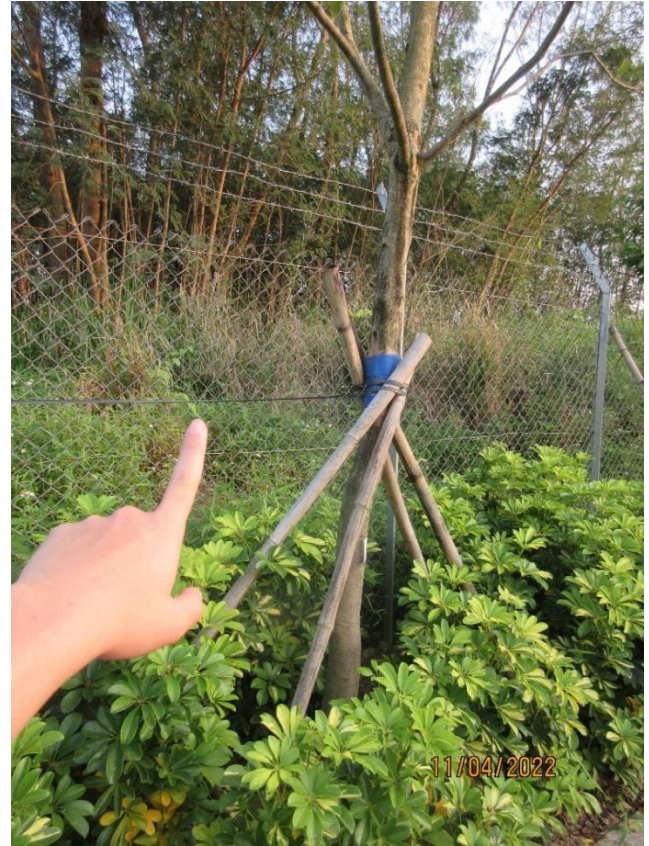
Photo N.

Some ties and stakes already girdled and affected the growth of the trees.
Some unnecessary ties are attached between the trees

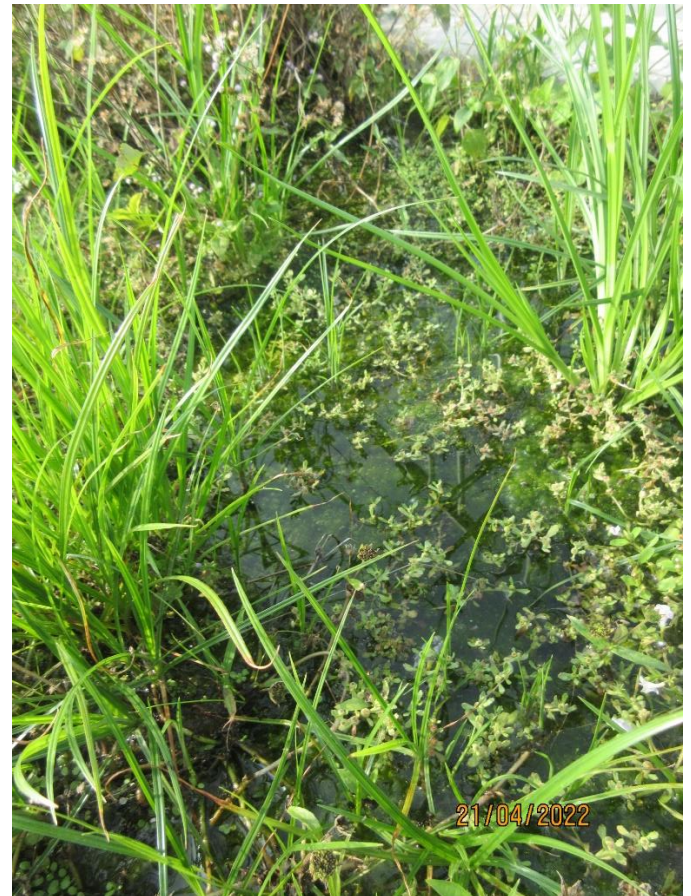
Photo J.

Poor soil drainage is found in one planter in Eastern Groyne

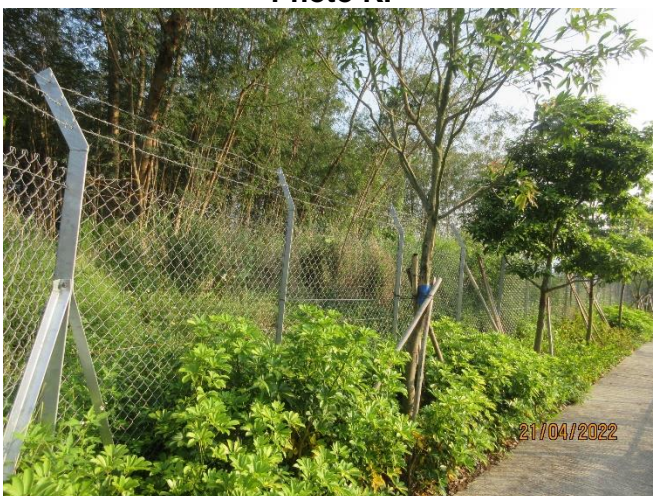
Photo K.

Some ties and stakes were detached at Western Box Culvert

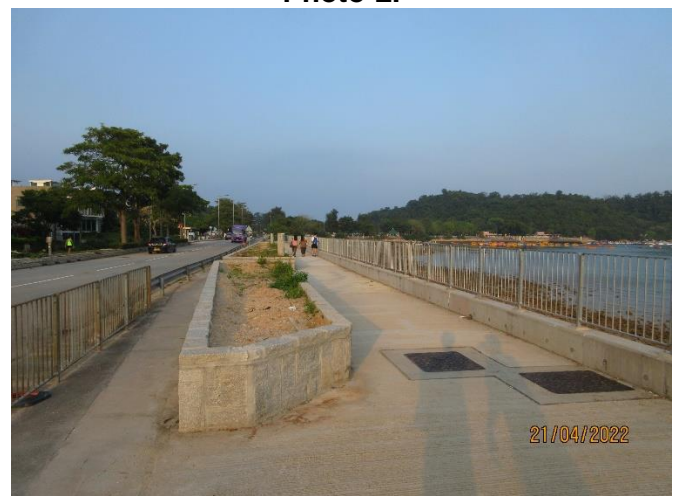
Photo L.

No plants in the Eastern box culvert planters

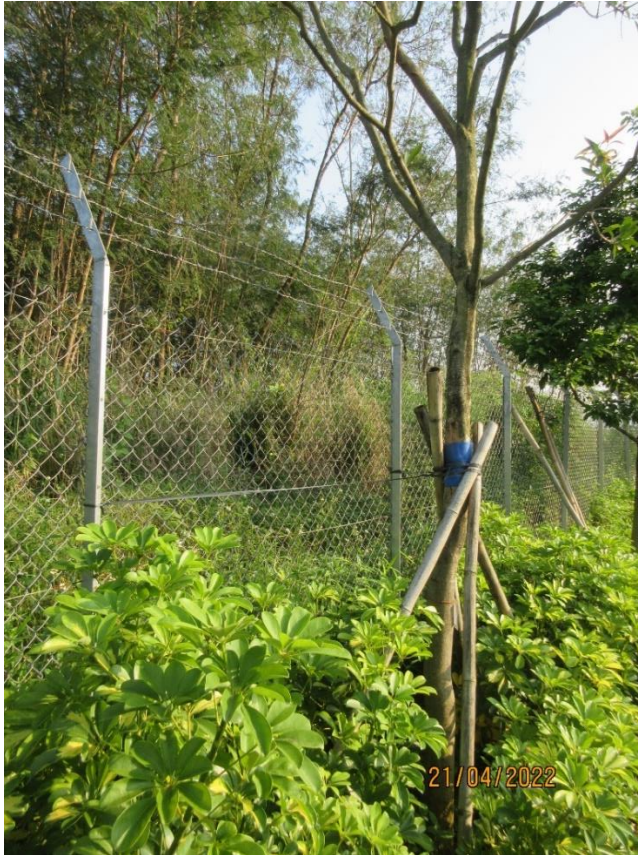
Photo M.

Some ties and stakes already girdled and affected the growth of the trees.

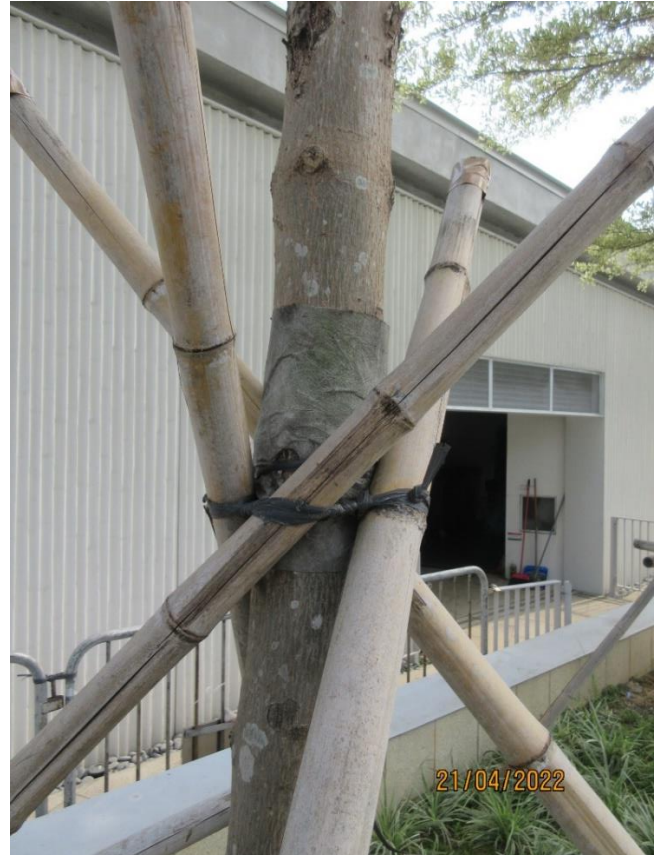
Photo N.

Some ties and stakes already girdled and affected the growth of the trees.
Some unnecessary ties are attached between the trees

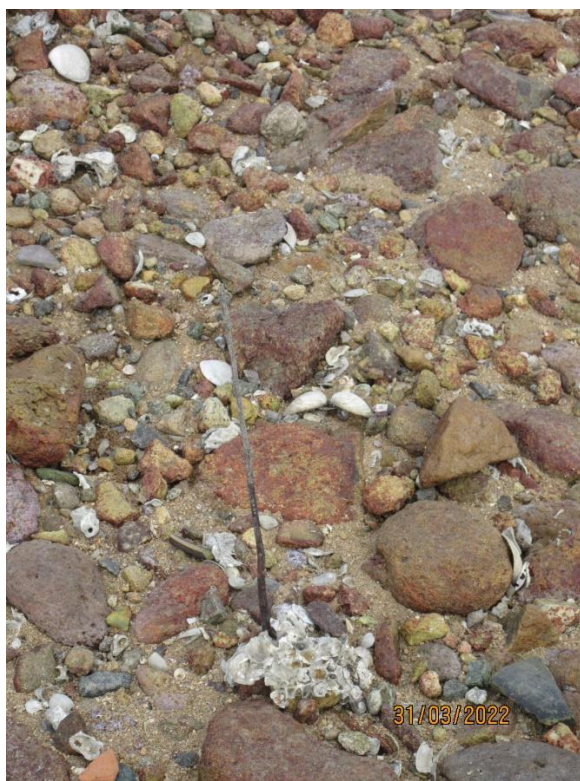
Photo 3.2 large amount of the seedlings were dead and in poor condition, some of them with very short dead stem remain

Since the mangrove distribution and survival is primarily determined by sea level and its fluctuations, other secondary factors are air temperature, salinity, ocean currents, storms, shore slope, and soil substrate also affect the establishment rate. Both *Aegiceras corniculatum* and *Avicennia marina* are mostly at the outer fringe (seaward) among other mangroves and *Avicennia marina* is also a pioneer species, however, even those species fail to establish at location 1 and location 2. From our observation, it is suspected that the condition of location 1 and location 2, especially the seaward side is not optimal for the seedlings to establish and grow. The contractor is recommended to replant the seedlings and review if the planting location should be moved to a more landward side or other locations (like next to location 3 (Photo 3.6) which the current condition of the seedlings is good) to improve the survival rate.

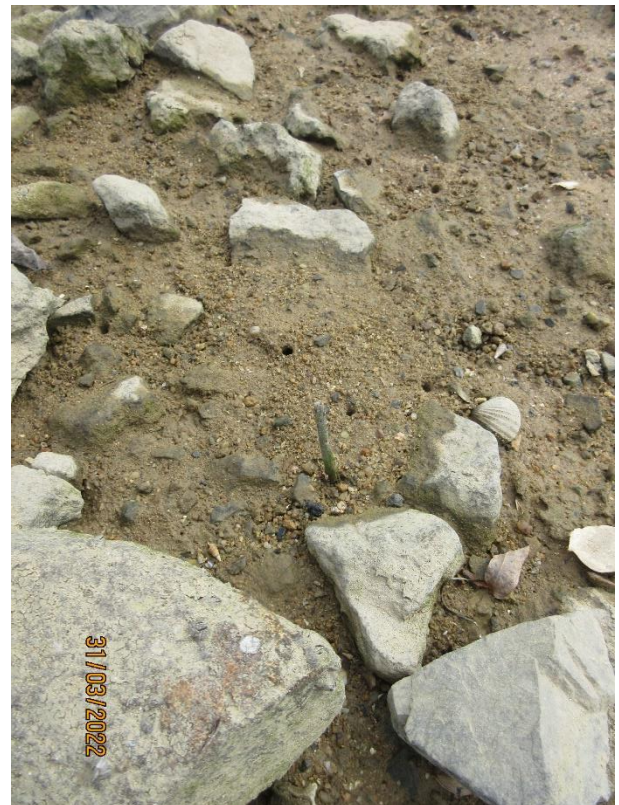
Photo 3.5 Dead and poor condition seedlings at the seaward side

Based on the observation from Sep to Mar, only the seedlings at the landward side thrive. The seedlings at the seaward side showed poor health and death even at location 3, which the general condition of the seedling is the best among those 3 locations. Those poor health seedlings with no sign to re-sprout and are expected to decline and be washed away by the tidal over time, which could be concluded in the recent inspections.

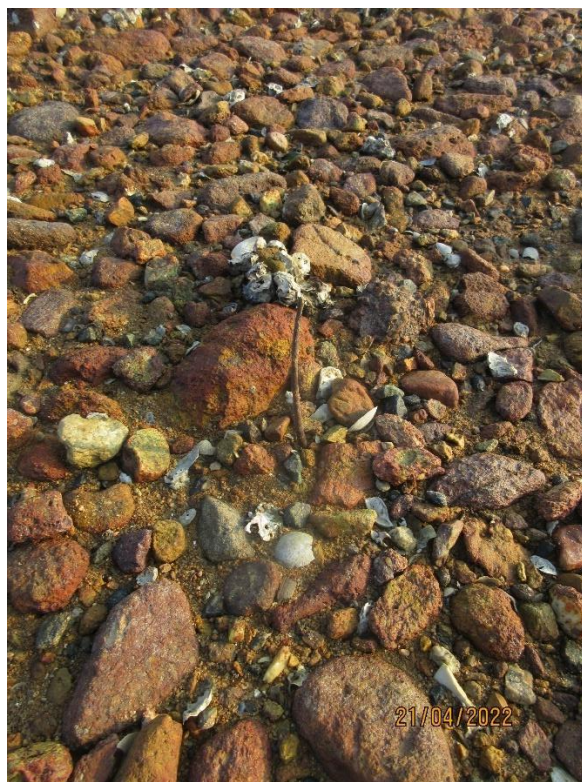
Photo 3.2 large amount of the seedlings were dead and in poor condition, some of them with very short dead stem remain

Since the mangrove distribution and survival is primarily determined by sea level and its fluctuations, other secondary factors are air temperature, salinity, ocean currents, storms, shore slope, and soil substrate also affect the establishment rate. Both *Aegiceras corniculatum* and *Avicennia marina* are mostly at the outer fringe (seaward) among other mangroves and *Avicennia marina* is also a pioneer species, however, even those species fail to establish at location 1 and location 2. From our observation, it is suspected that the condition of location 1 and location 2, especially the seaward side is not optimal for the seedlings to establish and grow. It is highly recommended that the contractor should replant the seedlings and the planting locations should be further landward side or other locations (like next to location 3 (Photo 3.6) which the current condition of the seedlings is good) to improve the survival rate.

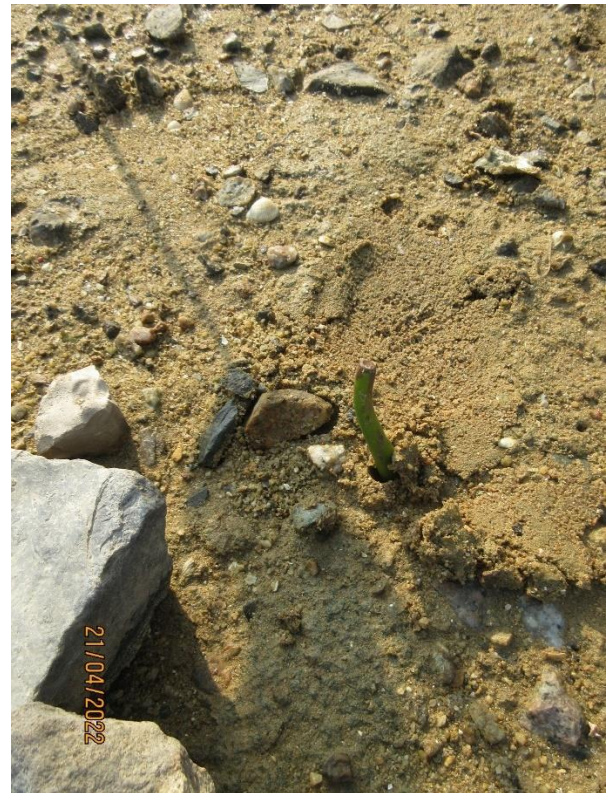
Photo 3.5 Dead and poor condition seedlings at the seaward side

Based on the observation from Sep to Apr, only the seedlings at the landward side thrive. The seedlings at the seaward side showed poor health and death even at location 3, which the general condition of the seedling is the best among those 3 locations. Those poor health seedlings with no sign to re-sprout and are expected to decline and be washed away by the tidal over time, which could be concluded in the recent inspections.
