PROJECT No.: TCS/00874/16

**CEDD CONTRACT NO. CV/2012/05 –
BATHING BEACH AT LUNG MEI, TAI PO**

**POST-CONSTRUCTION MONITORING AND AUDIT
REPORT (MAY TO JUNE 2022)**

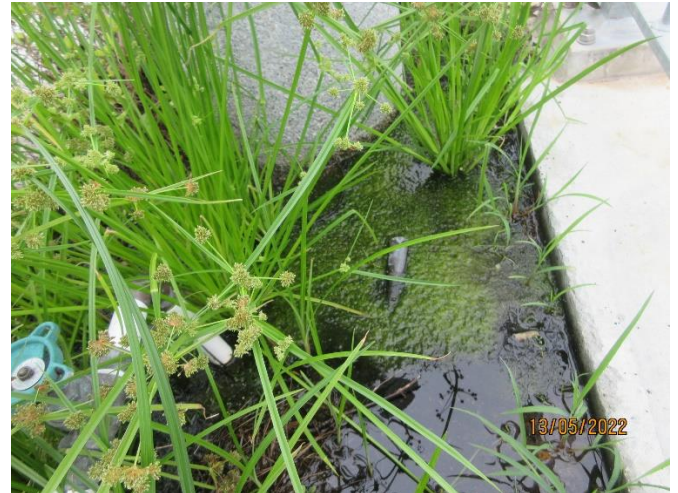
Photo J.

Poor soil drainage is found in one planter on the Eastern groyne.

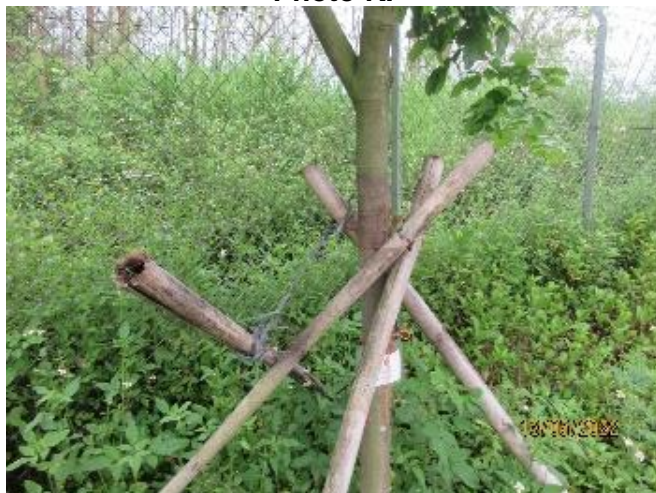
Photo K.

Some ties and stakes were detached at the Western box culvert.

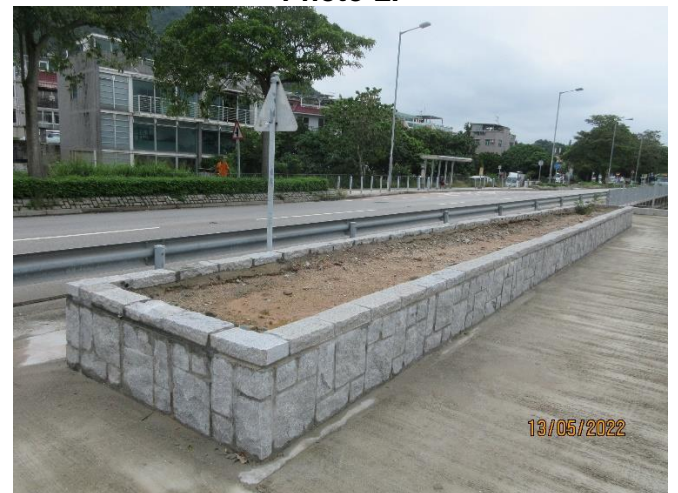
Photo L.

No plants in the Eastern box culvert planters.

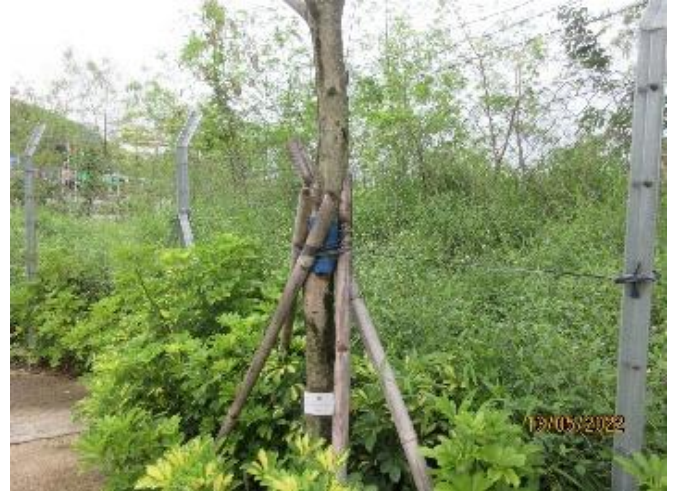
Photo N.

Some ties and stakes already girdled and affected the growth of the trees. Some unnecessary ties are attached to the trees.

1. Girdling by the ties and stakes was observed on some of the trees. The Contractor(s) is/are required to adjust the ties and remove the unnecessary ties to avoid damage to the tree as a matter of urgency or tree replacement may be required before rejection from maintenance authority during handover.
2. The Contractor(s) is/are reminded to check the guying and staking of all retained/newly planted trees to ensure the tree supporting systems are properly installed, in order and not causing any damage to the trees.
3. The Contractor(s) is/are reminded to replant the plants at the Western groyne and the Eastern box culvert, and tackle the poor soil drainage issue on the Eastern groyne.

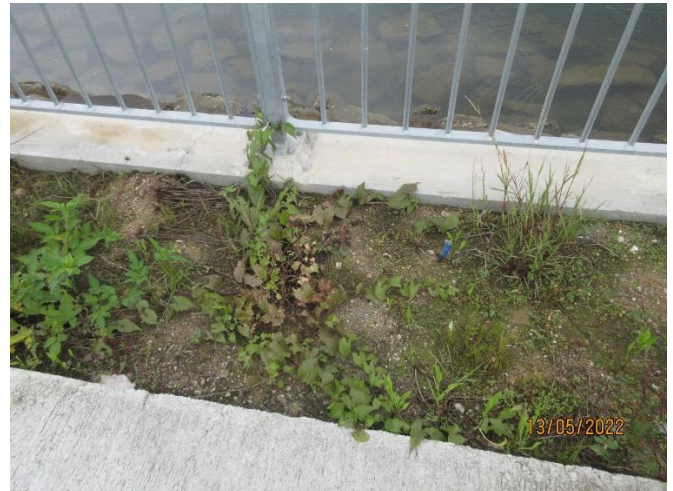
Photo P.

Mikania micrantha and weeds were found in the planters on the Western groyne.

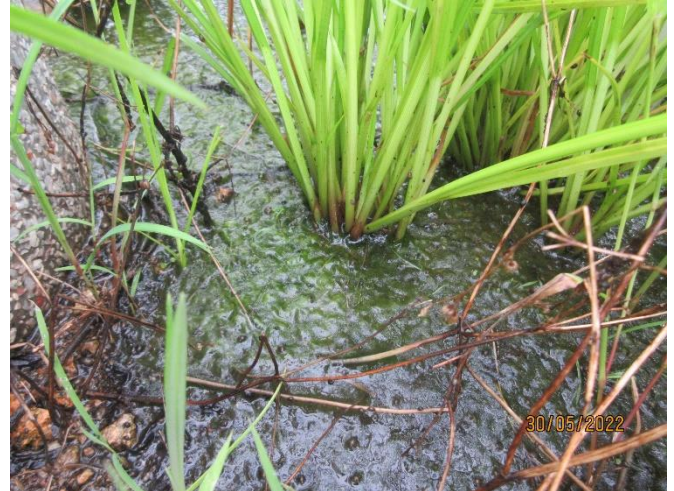
Photo J.

Poor soil drainage and serious water logging is found in one planter on the Eastern groyne.

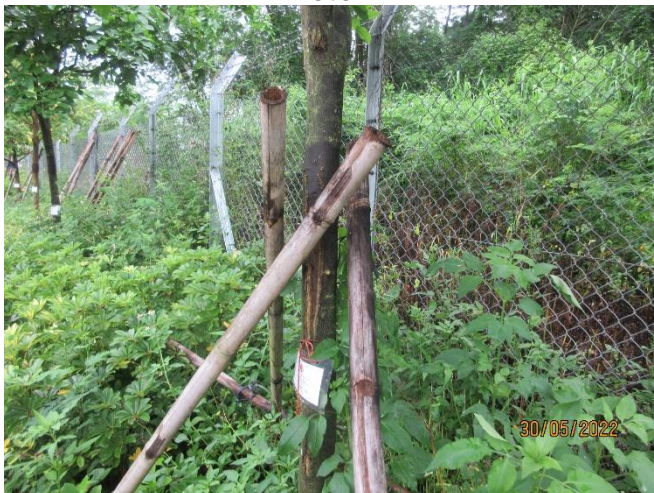
Photo K.

Some ties and stakes were detached at the Western box culvert.

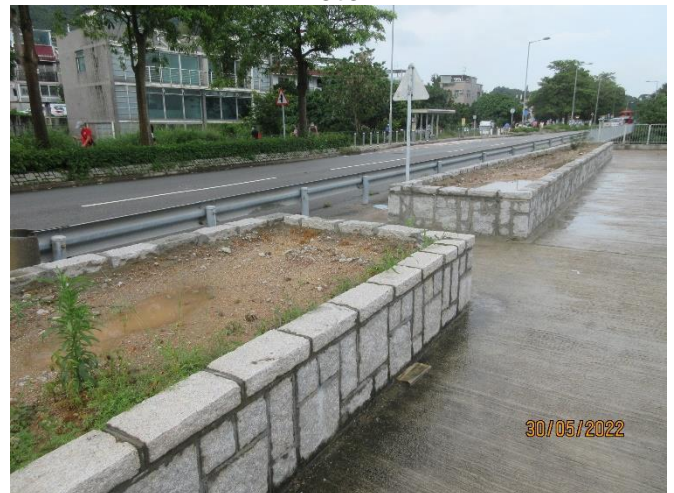
Photo L.

No plants in the Eastern box culvert planters.

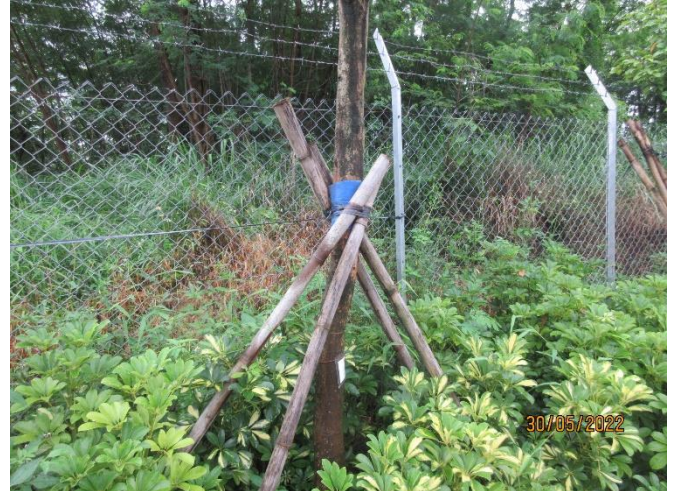
Photo N.

Some ties and stakes already girdled and affected the growth of the trees. Some unnecessary ties are attached between the trees.

1. Trunk Girdling by the ties and stakes was observed on some of the trees. The Contractor(s) is/are required to adjust the ties and remove the unnecessary ties to avoid damage to the tree as a matter of urgency or tree replacement may be required before rejection from maintenance authority during handover.
2. The Contractor(s) is/are reminded to adjust or remove if necessary the guying and staking of all retained/newly planted trees to ensure the tree supporting systems are properly installed, in order

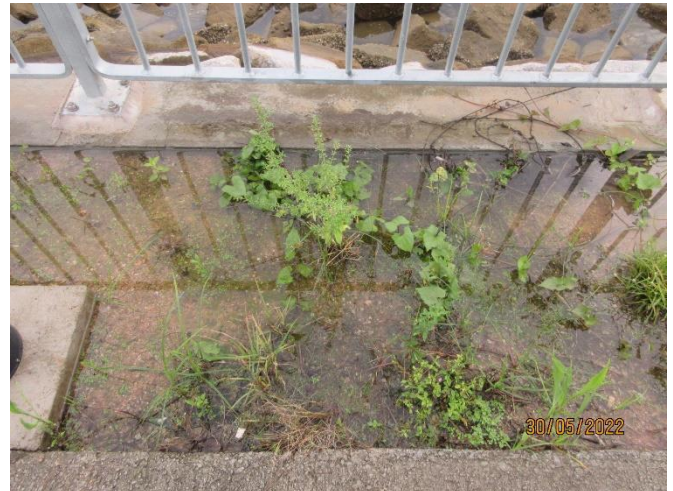
Photo P.

Mikania micrantha and weeds were found in the planters on the Western groyne.

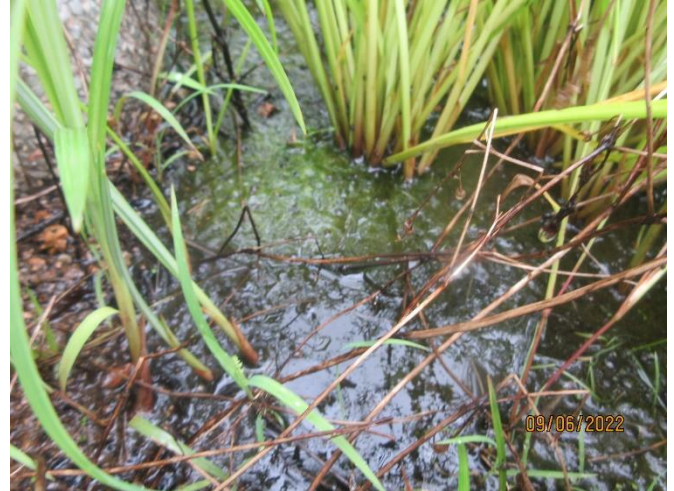
Photo J.

Poor soil drainage with water logging is found in one planter on the Eastern groyne.

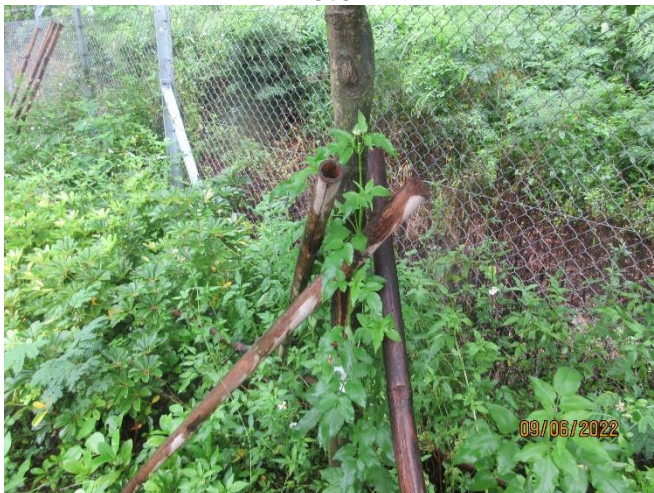
Photo K.

Some ties and stakes were detached at the Western box culvert.

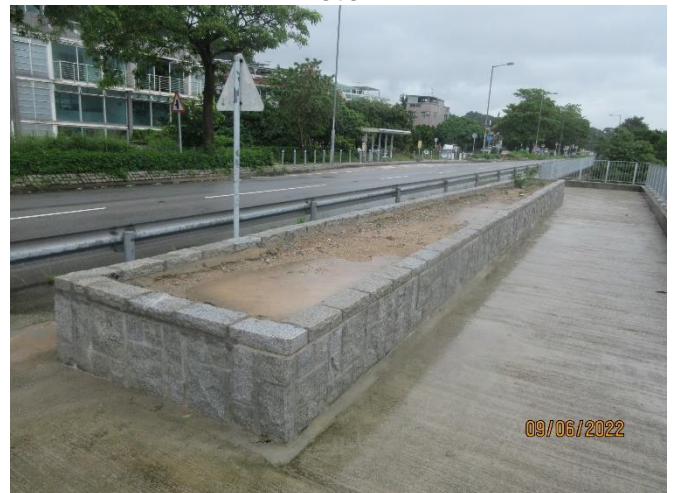
Photo L.

No plants in the Eastern box culvert planters.

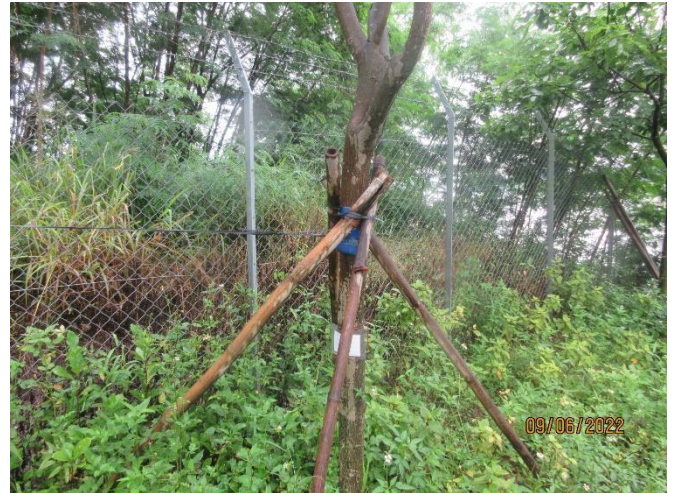
Photo N.

Some ties and stakes already girdled and affected the growth of the trees. Some unnecessary ties are attached between the trees.

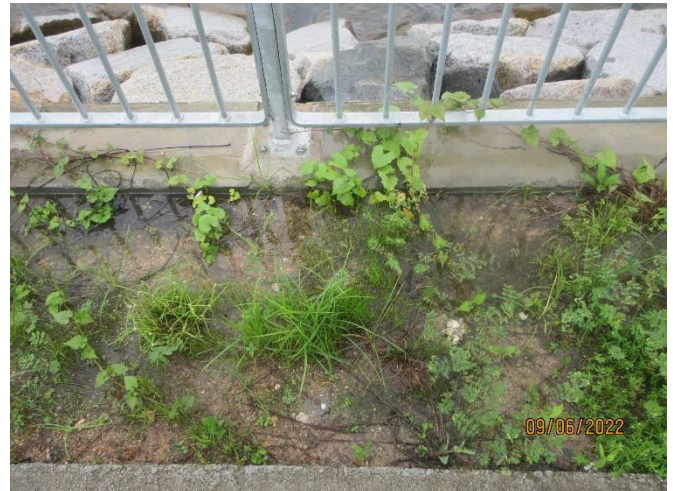
Photo P.

Mikania micrantha and weeds were found in the planters on the Western groyne.

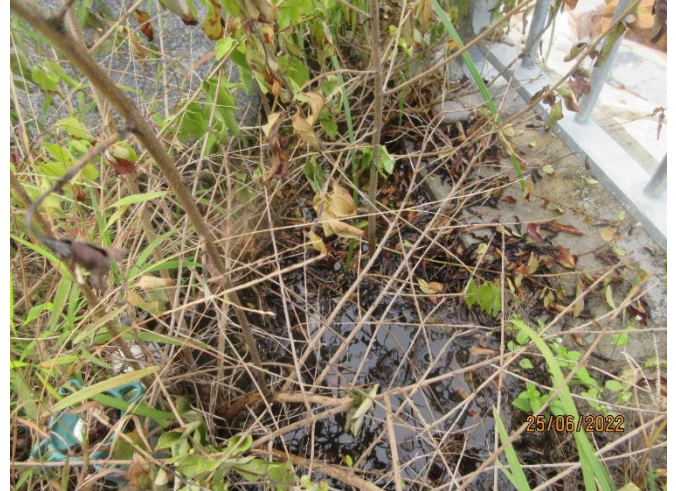
Photo J.

Poor soil drainage with water logging is found in one planter on the Eastern groyne.

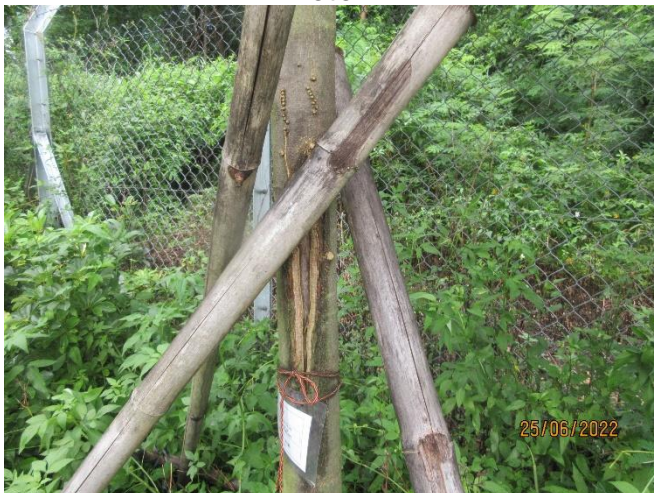
Photo K.

Some ties and stakes were detached at the Western box culvert.

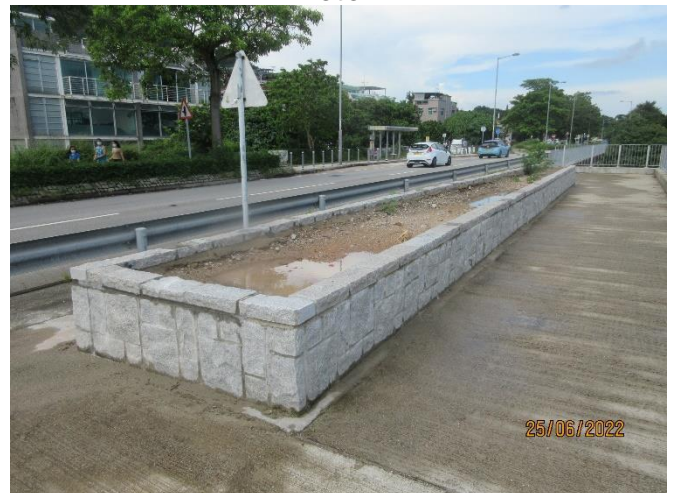
Photo L.

No plants in the Eastern box culvert planters.

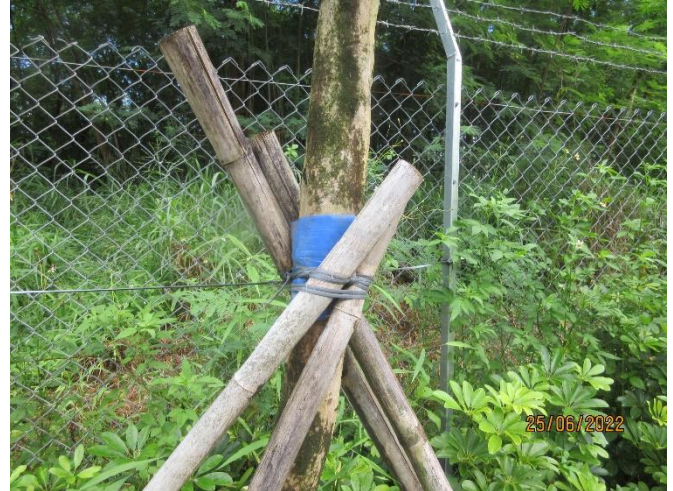
Photo N.

Some ties and stakes already girdled and affected the growth of the trees. Some unnecessary ties are attached between the trees.

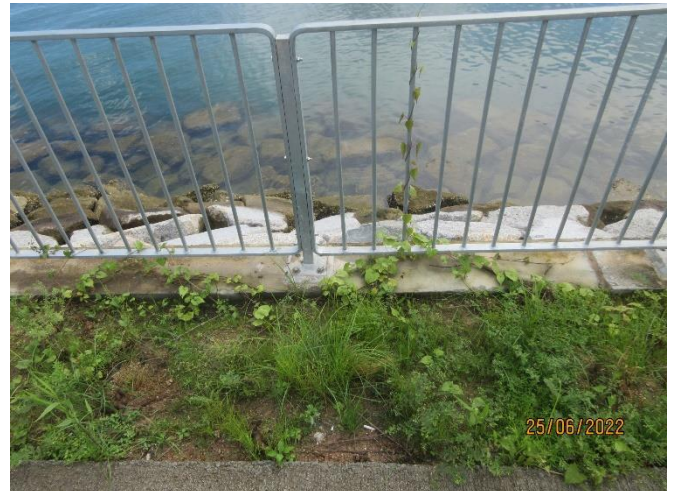
Photo P.

Mikania micrantha and weeds were found in the planters on the Western groyne.

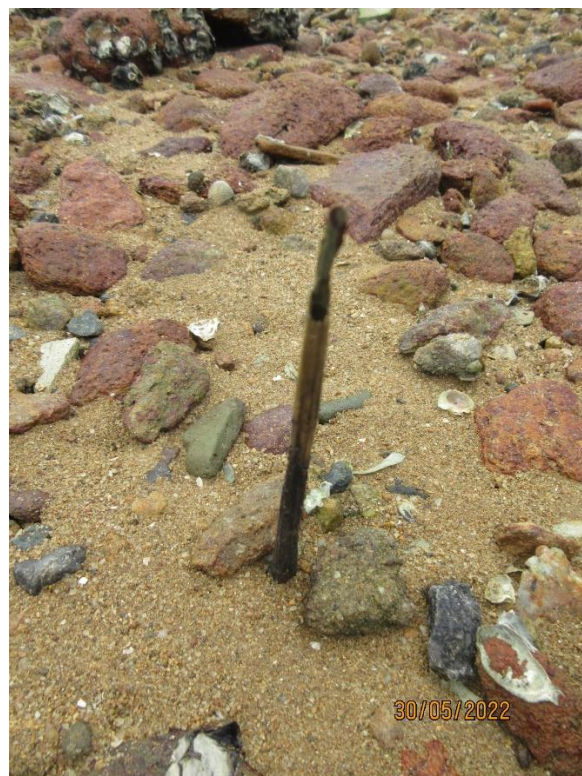
Photo 3.2 large amount of the seedlings were dead and in poor condition, some of them with very short dead stem remain

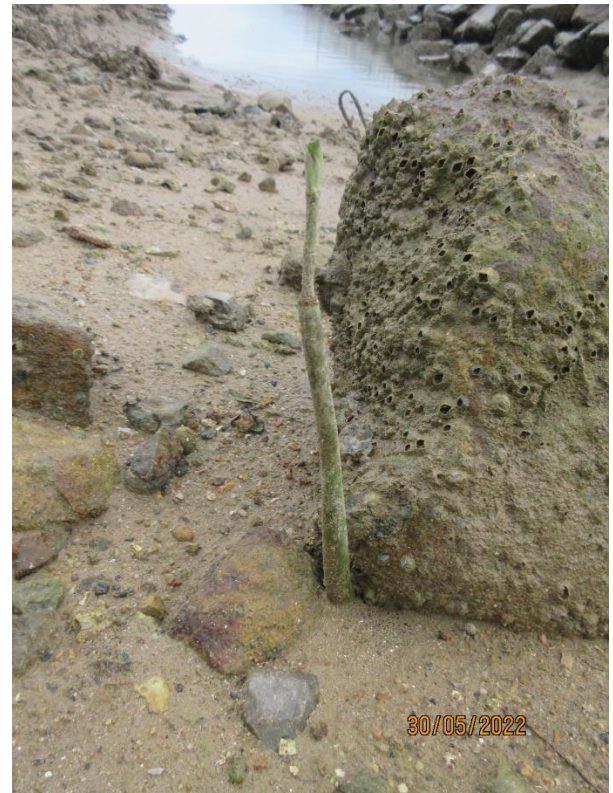
Photo 3.5 Dead and poor condition seedlings at the seaward side

Based on the observation from Sep 2021 to May 2022, only the seedlings at the landward side thrive. The seedlings at the seaward side showed poor health and death even at location 3, which the general condition of the seedling is the best among those 3 locations. Those poor health seedlings with no sign to re-sprout and are expected to decline and be washed away by the tidal over time, which could be concluded in the recent inspections.

Since the mangrove distribution and survival is primarily determined by sea level and its fluctuations, other secondary factors are air temperature, salinity, ocean currents, storms, shore slope, and soil substrate also affect the establishment rate. Both *Aegiceras corniculatum* and *Avicennia marina* are mostly at the outer fringe (seaward) among other mangroves and *Avicennia marina* is also a pioneer species, however, even those species fail to establish at location 1 and location 2. From our observation, it is suspected that the condition of location 1 and location 2, especially the seaward side is not optimal for the seedlings to establish and grow. It is highly recommended that the contractor should replant the seedlings and the planting locations should be further landward side or other locations (like next to location 3 (Photo 3.6) which the current condition of the seedlings is good) to improve the survival rate.

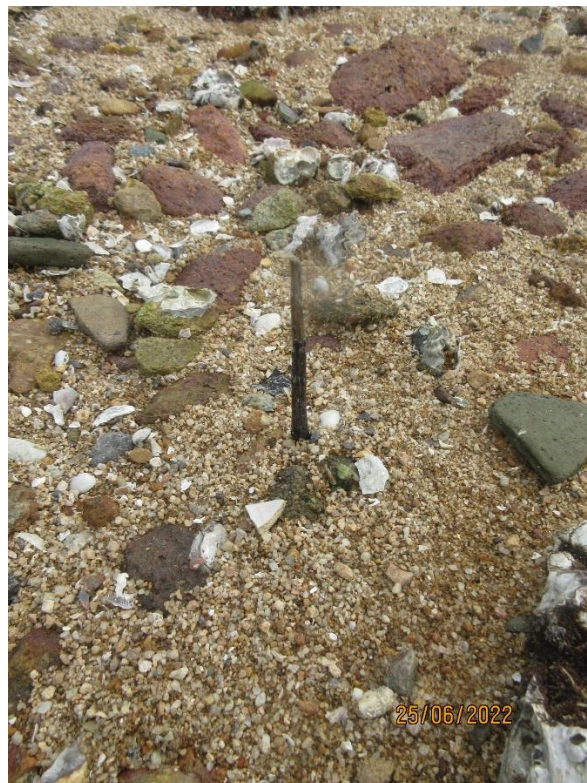
Photo 3.2 large amount of the seedlings were dead and in poor condition, some of them with very short dead stems remain

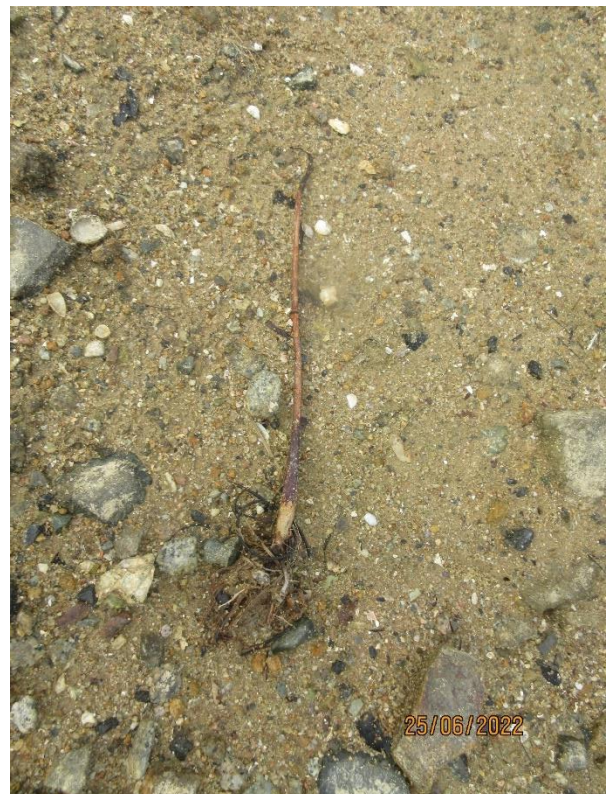
Photo 3.5 Dead and poor condition seedlings at the seaward side

Based on the observation from Sep 2021 to Jun 2022, only the seedlings on the landward side thrive. The seedlings on the seaward side showed poor health and death even at location 3, which the general condition of the seedling is the best among those 3 locations. Those poor health seedlings with no sign of re-sprout and expected to decline and be washed away by the tidal over time, which could be concluded in the recent inspections.

Since the mangrove distribution and survival are primarily determined by sea level and its fluctuations, other secondary factors are air temperature, salinity, ocean currents, storms, shore slope, and soil substrate also affect the establishment rate. Both *Aegiceras corniculatum* and *Avicennia marina* are mostly at the outer fringe (seaward) among other mangroves and *Avicennia marina* is also a pioneer species, however, even those species fail to establish at location 1 and location 2. From our observation, it is suspected that the condition of location 1 and location 2, especially the seaward side is not optimal for the seedlings to establish and grow. It is highly recommended that the contractor should replant the seedlings and the planting locations should be further landward side or in other locations (like next to location 3 (Photo 3.6) where the current condition of the seedlings is good) to improve the survival rate.

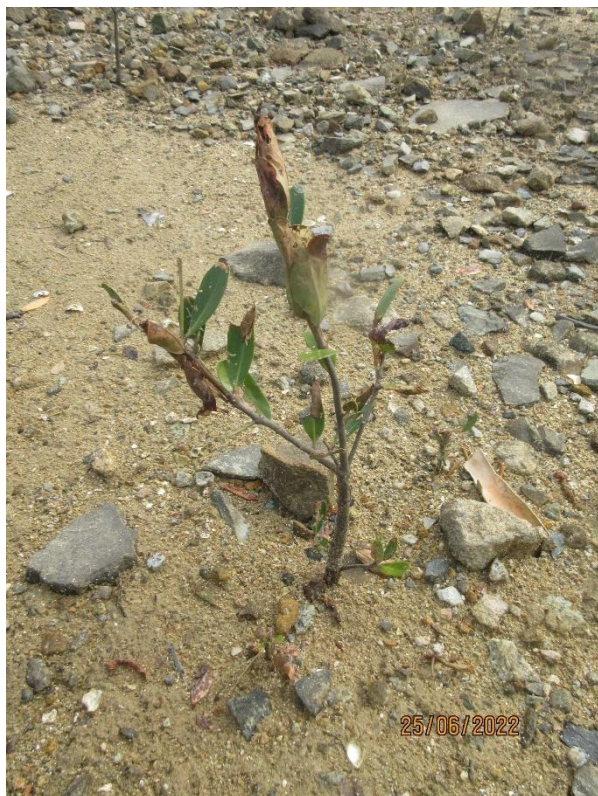
Photo 3.6 Pest infestation

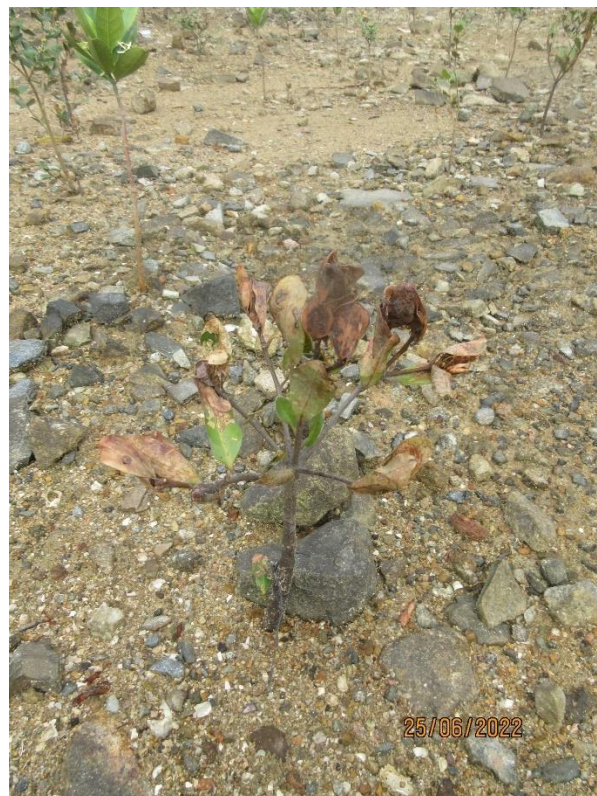
Photo 3.7 Pest infestation
