**CEDD CONTRACT NO. CV/2012/05 –
BATHING BEACH AT LUNG MEI, TAI PO**

**POST-CONSTRUCTION MONITORING AND AUDIT
REPORT (JULY TO AUGUST 2022)**

PREPARED FOR
WELCOME CONSTRUCTION CO., LTD.

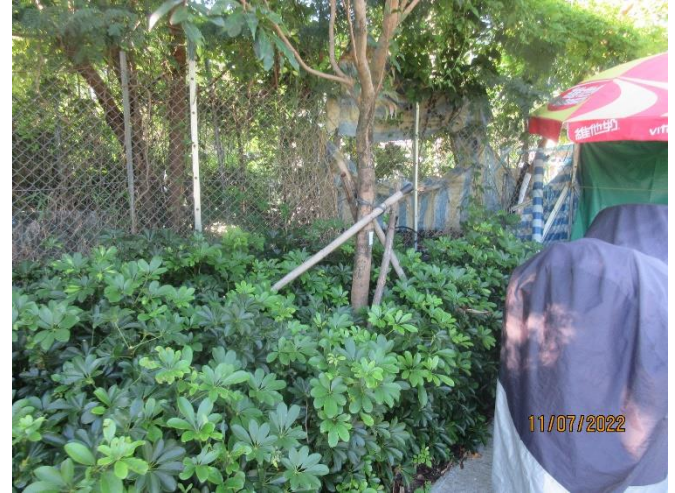
Photo J.

Some ties and stakes were detached at the Western box culvert.

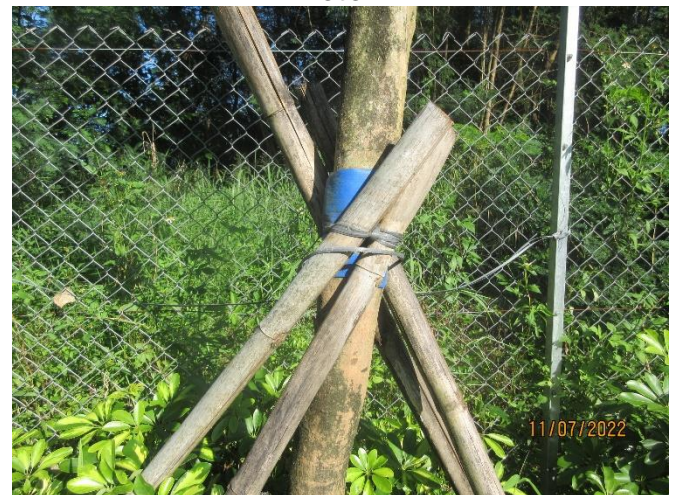
Photo L.

Some ties and stakes already girdled and affected the growth of the trees.

- Trunk Girdling by the ties and stakes was observed on some of the trees. The Contractor(s) is/are required to adjust the ties and remove the unnecessary ties to avoid damage to the tree as a matter of urgency or tree replacement may be required before rejection from maintenance authority during handover.
- The Contractor(s) is/are reminded to adjust or remove if necessary the guying and staking of all retained/newly planted trees to ensure the tree supporting systems are properly installed, in order

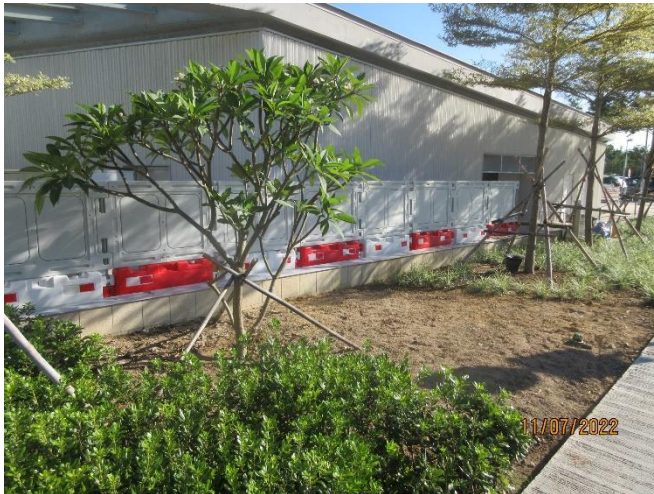
Photo M.

Some of the *Angelonia angustifolia* in the planters along the Ting Kok Road were still missing.

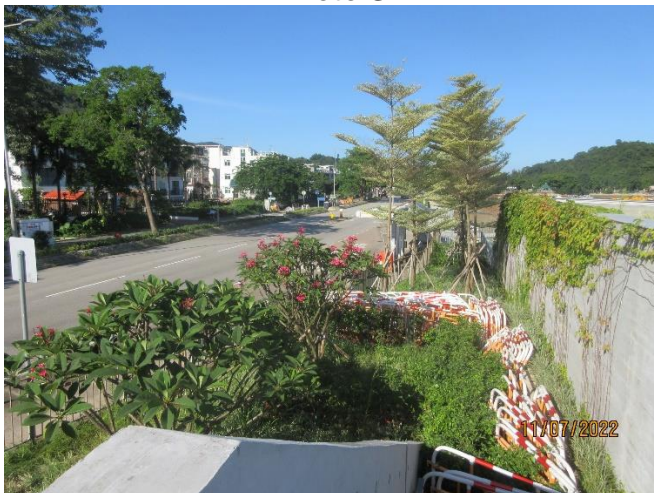
Photo S

The Railing & debris damage the planters at the planter near Ting Kok Road

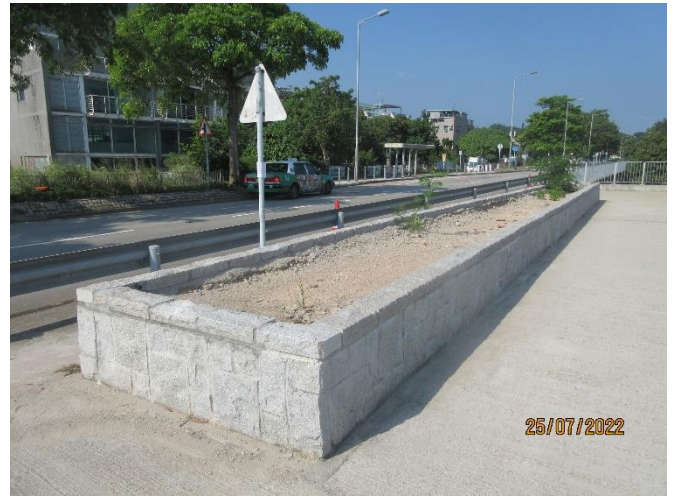
Photo J.

No plants in the Eastern box culvert planter.

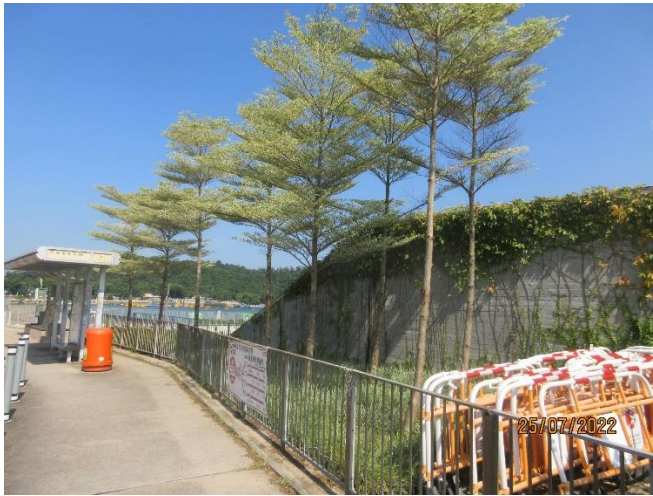
Photo Q.

The Railing & debris damage the planters at the planter near Ting Kok Road

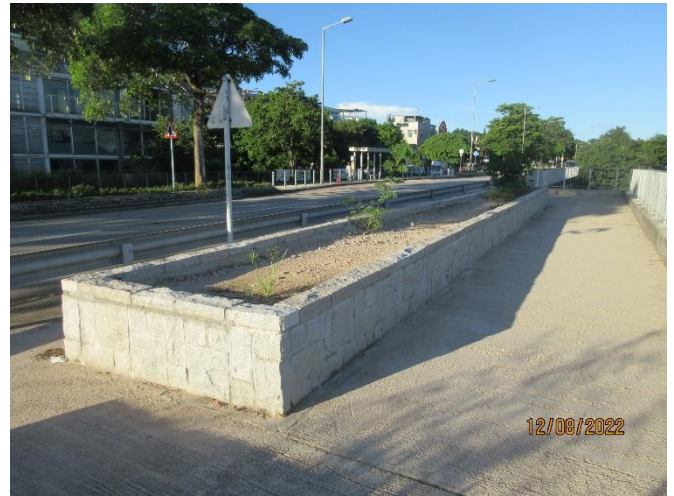
Photo J.

No plants in the Eastern box culvert planter.

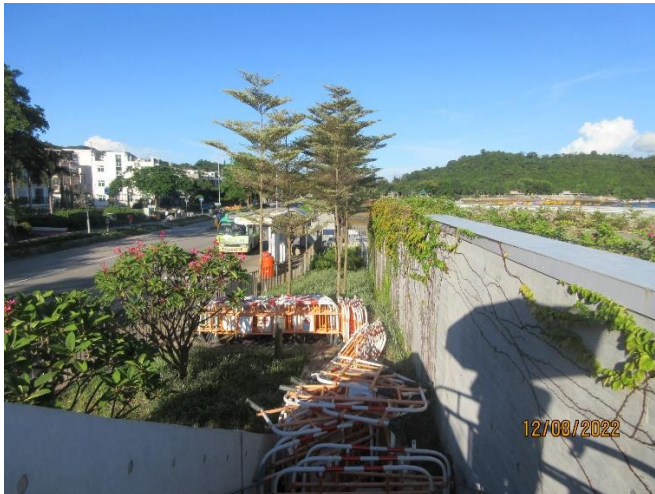
Photo O.

The Railing & debris damage the planters at the planter near Ting Kok Road

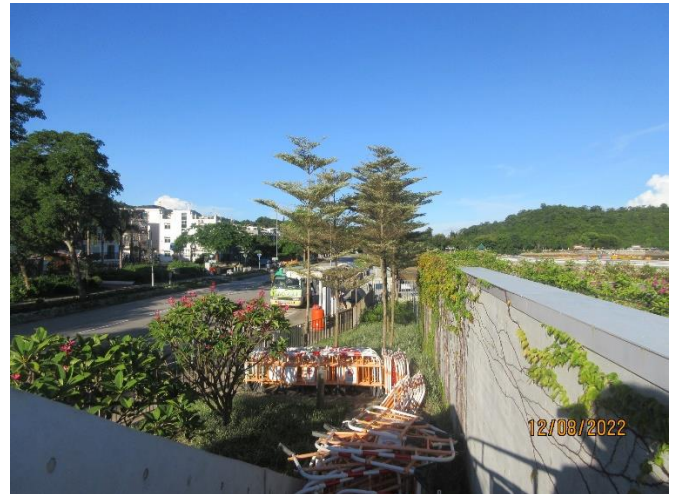
Photo P.

The Railing & debris damage the planters at the planter near Ting Kok Road

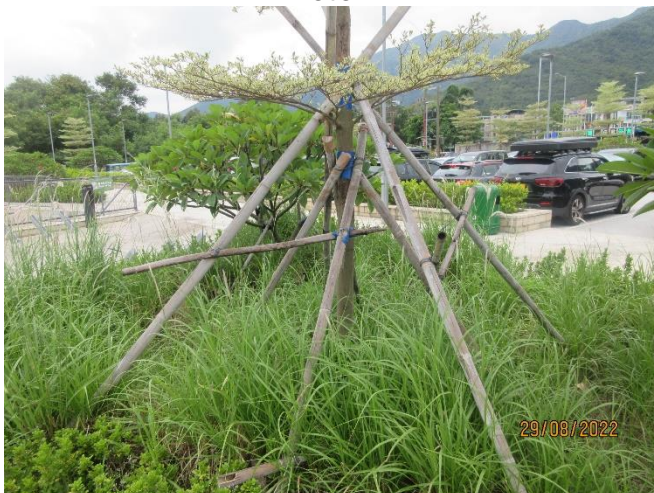
Photo K.

3. Some stakes were broken (Photo K).
4. A *Michelia x alba* (T047) in the car park was found slightly tilted (Photo L).
5. The plants in the Eastern box culvert planter were removed without replacement (Photo M).

Some stakes were broken.

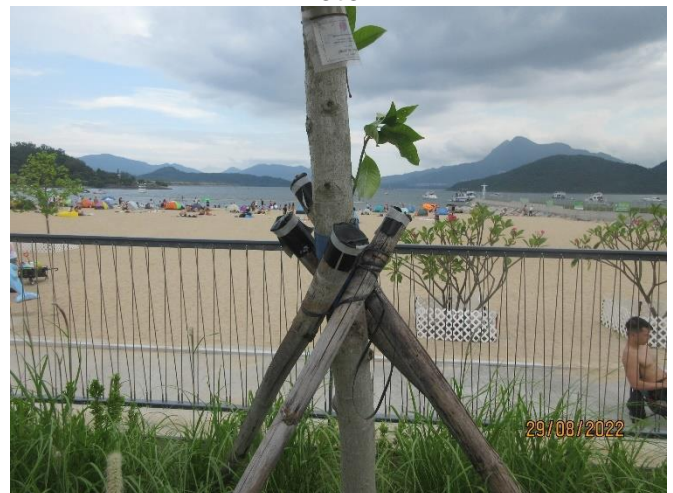
Photo L.

A *Michelia x alba* was found slightly tilted.

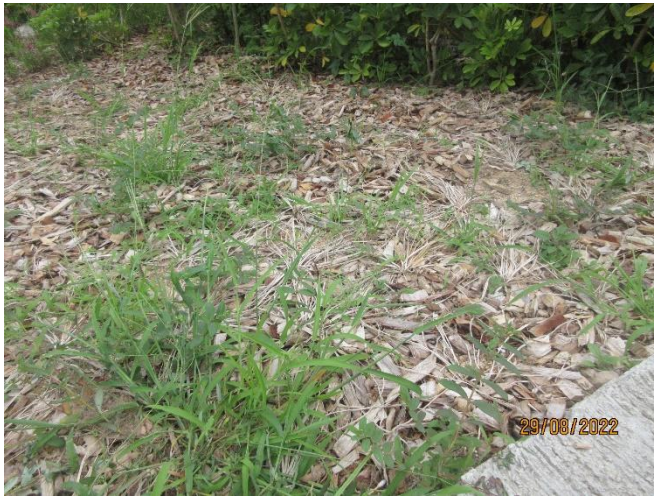
Photo Q.

6. *Pennisetum alopecuroides* in the outdoor shower were replaced with *Bougainvillea spectabilis* (Photo N).
7. Some of the newly planted *Ophiopogon jaburan* were found dead (Photo Q).

Some of the newly planted *Ophiopogon jaburan* were found dead.

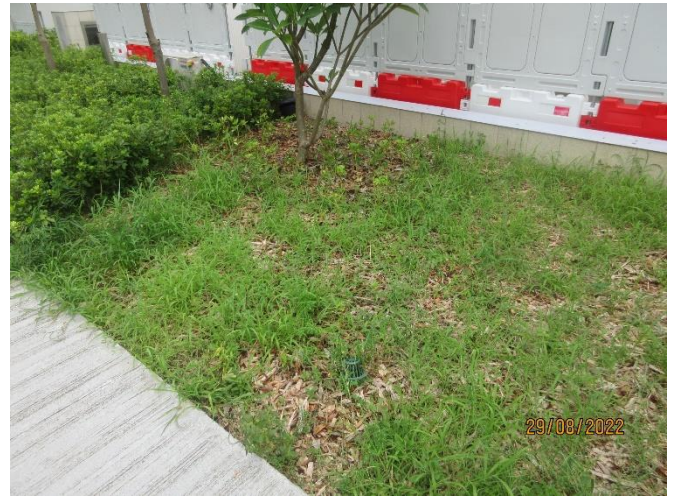
Photo R.

8. Some weeds were found in the planters along the Ting Kok Road (Photo R).
9. Some *Pueraria sp.* were found in planters and extending to the footpath in the Western box culvert (Photo S).

Some weeds were found in the planters along the Ting Kok Road.

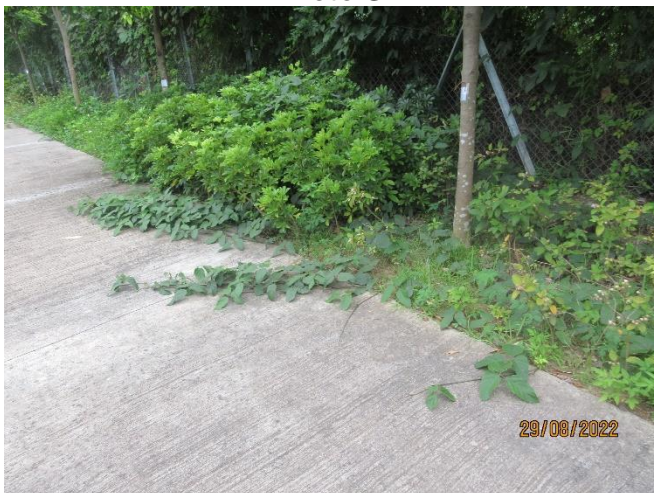
Photo S.

Some *Pueraria sp.* were found in planters and extending to footpath in the Western box culvert.

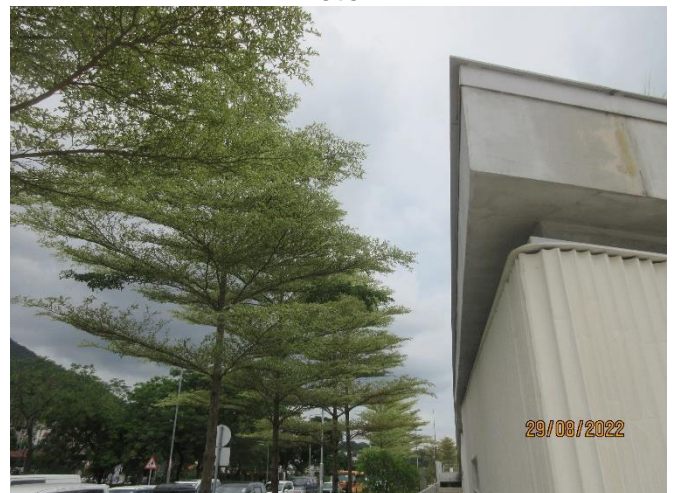
Photo T.

10. Reverted variegated leaves are observed on a *Terminalia mantaly variegata* along the Ting Kok Road (Photo T).
11. The Railing & debris damage the planters at the planter near Ting Kok Road (Photo U)

Reverted variegated leaves were observed on a *Terminalia mantaly variegata*.

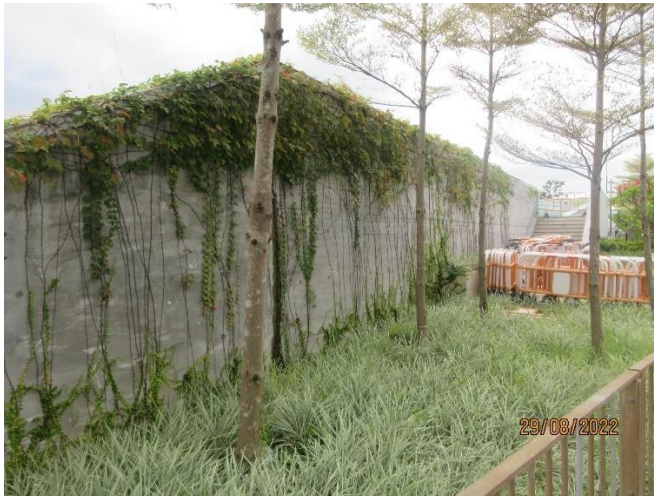
Photo U.

The Railing & debris damage the planters at the planter near Ting Kok Road

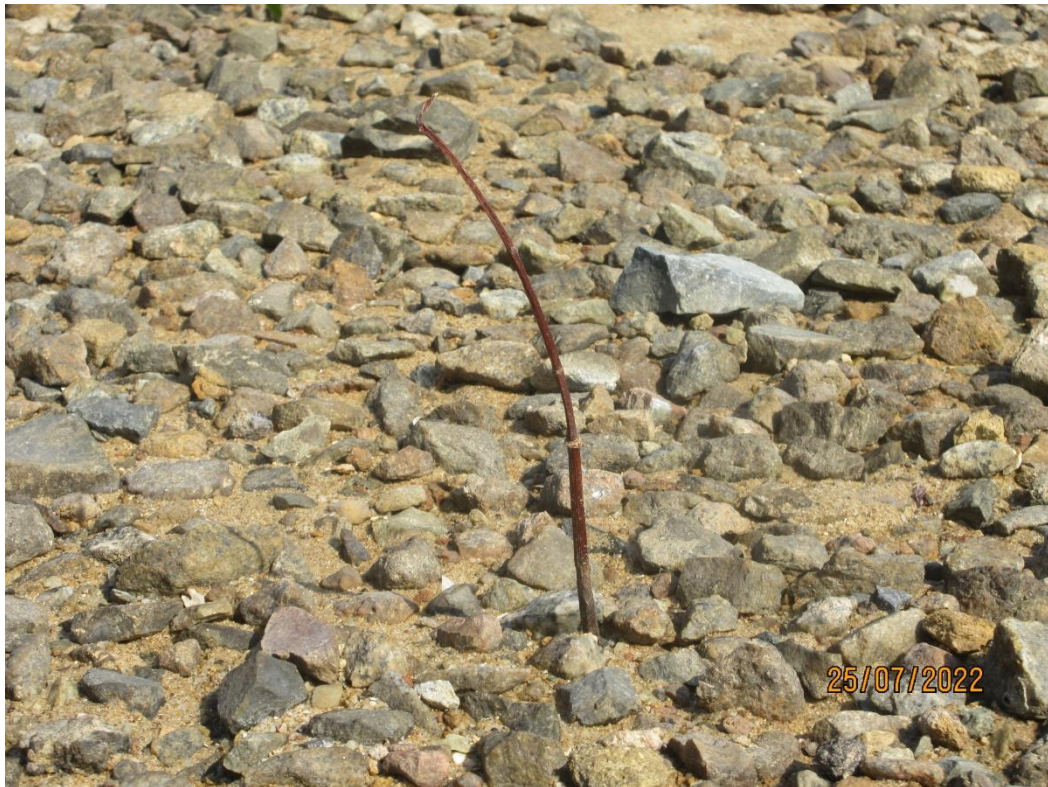
Photo 3.7 Declining seedling

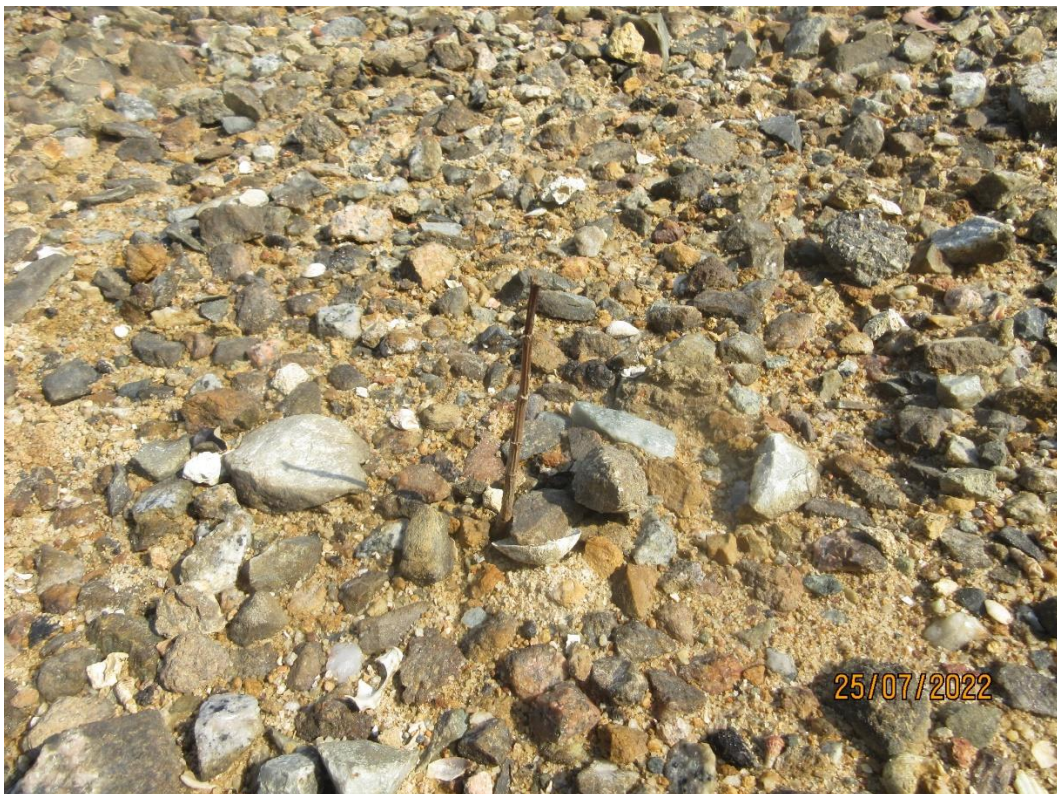
Photo 3.8 Dead seedling

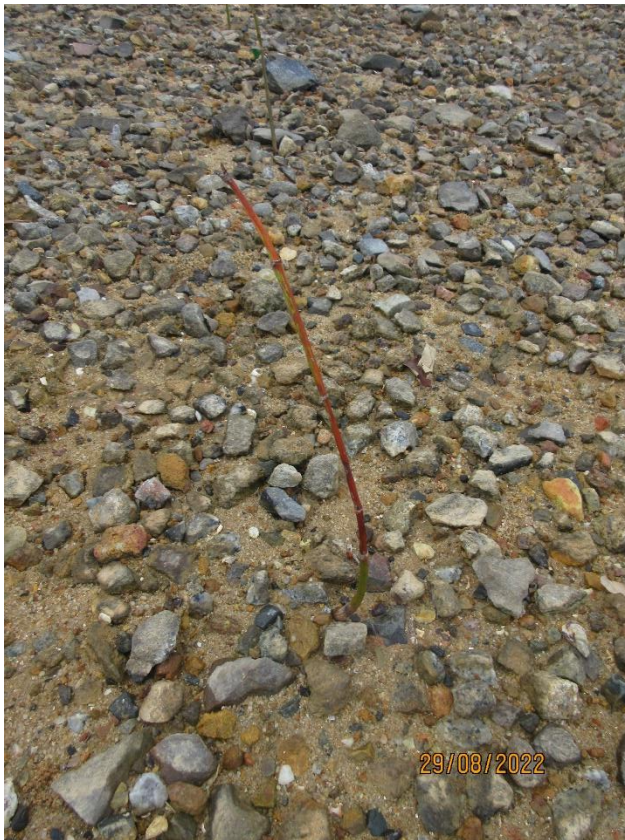
Photo 3.7 Declining seedling

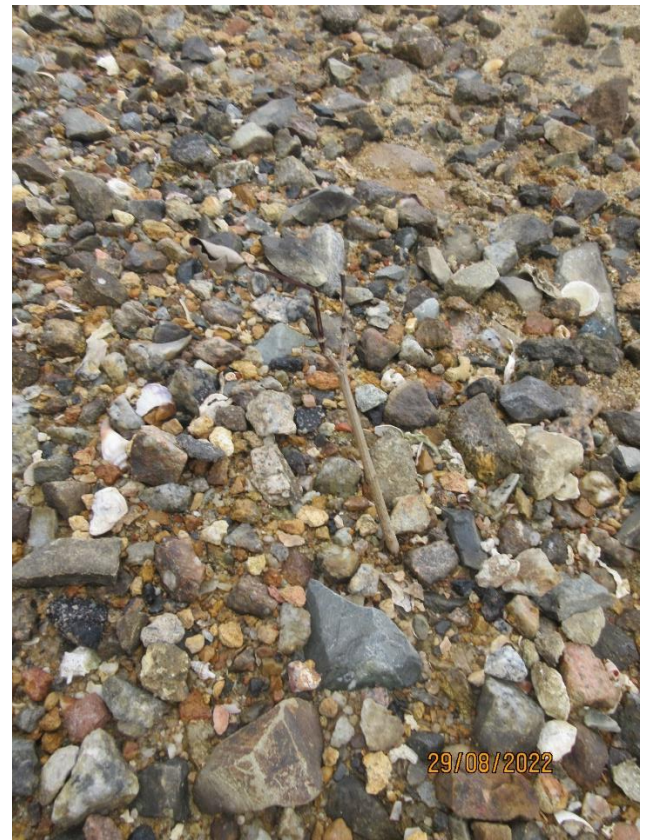
Photo 3.8 Dead seedling
