CLP Power Hong Kong Ltd

Renewable Energy Supply on Town Island (Construction Phase): 1st Monthly Environmental Site Audit Report

April 2011

This is the first *Monthly Environmental Site Audit Report* presenting the key findings and observations of the site audit conducted on 15 April 2011.

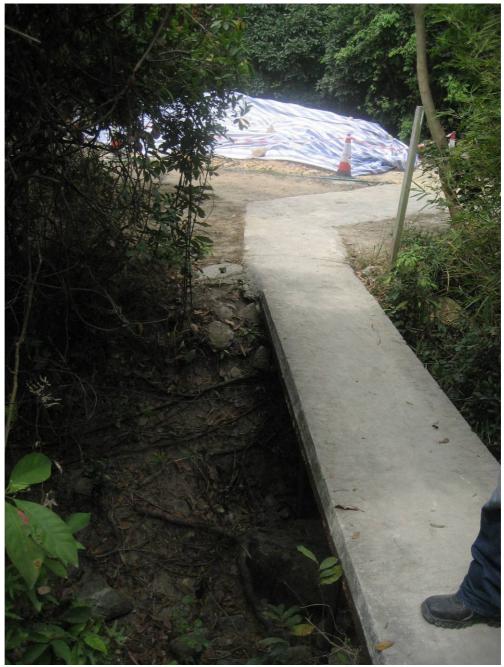
It was observed that temporary stockpiling (soil) was located next to the stream. The Contractor was therefore reminded to remove the stockpile as far as possible away from the stream before 22 April 2011 (see Photo 1 in *Annex B*).

- 1 Temporary stockpile was observed to be located near the stream.
- 2 It was observed that the temporary stockpile of soil may be located outside the site boundary.
- 3 Rubbish binwas not provided within the site boundary.

Photo 1 - Temporary stockpile was observed located next to the stream.

- 1 The Contractor was recommended to remove the stockpile as far as possible away from the stream before 22 April 2011.
- 2 The Contractor was recommended to check and confirm the site boundary of the Project. If the temporary stockpile is located outside the site boundary, the temporary stockpile should be moved within the site boundary.
- 3 The Contractor was recommended to provide sufficient rubbish bins within the site boundary and was reminded to segregate the

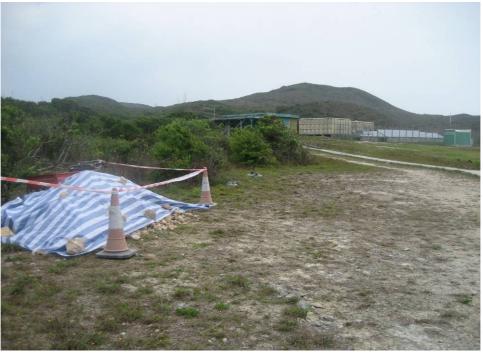
It was observed that temporary stockpile of soil has been re-located (see Photo 2 in *Annex B*). The Contractor has been advised to check and confirm the site boundary of the Project. If the temporary stockpile is located outside the site boundary, the temporary stockpile should be moved within the site boundary immediately.

Photo 2 - Temporary stockpile that was observed maybe located outside the site boundary.
