CLP Power Hong Kong Ltd

Renewable Energy Supply on  
Town Island (Construction  
Phase): *3rd Monthly  
Environmental Site Audit Report*

June 2011

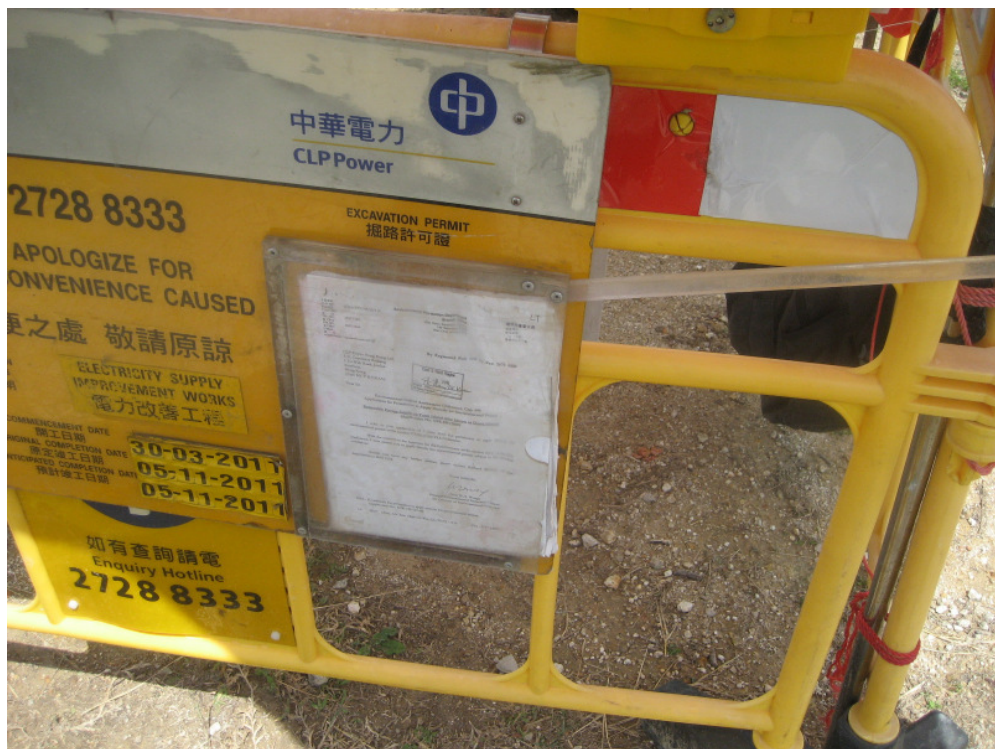
- 1 Environmental permit could not be taken out from the plastic box folder as the documents inside the box folder were too thick.
- 2 Stagnant water was observed on the tarpaulin sheet at site 1.
- 3 Erosion was observed at the worksite for underground pipe and cabling works and eroded soil was accumulate at low-lying area.

Photo 1 - The environmental permit and other documents were too thick and could not be taken out from the box folder.

- The environmental permit could not be taken out from the plastic box folder as the documents inside the folder were too thick (See Photo 1 in Annex B). The Contractor was suggested to add one more plastic box folder for the environmental permit within one week.
- Stagnant water was also observed on the tarpaulin sheets covering the stockpiles at Site 1 (See Photo 2 in Annex B). The Contractor has been reminded to remove the stagnant water immediately.
- Erosion was observed at the worksite for underground pipe and cabling works and eroded soil was accumulated at low-lying area (See Photo 3 in Annex B). The Contractor was recommended to add sand bags to act as slit trap to prevent eroded soil being washed away to low-lying area within one week.

- 1 The Contractor was suggested to add one more plastic box folder for the environmental permit within one week.
- 2 The Contractor was reminded to remove the stagnant water immediately.
- 3 The Contractor was suggested to add sand bags to act as silt trap to prevent eroded soil being washed away to low-lying area within one week.

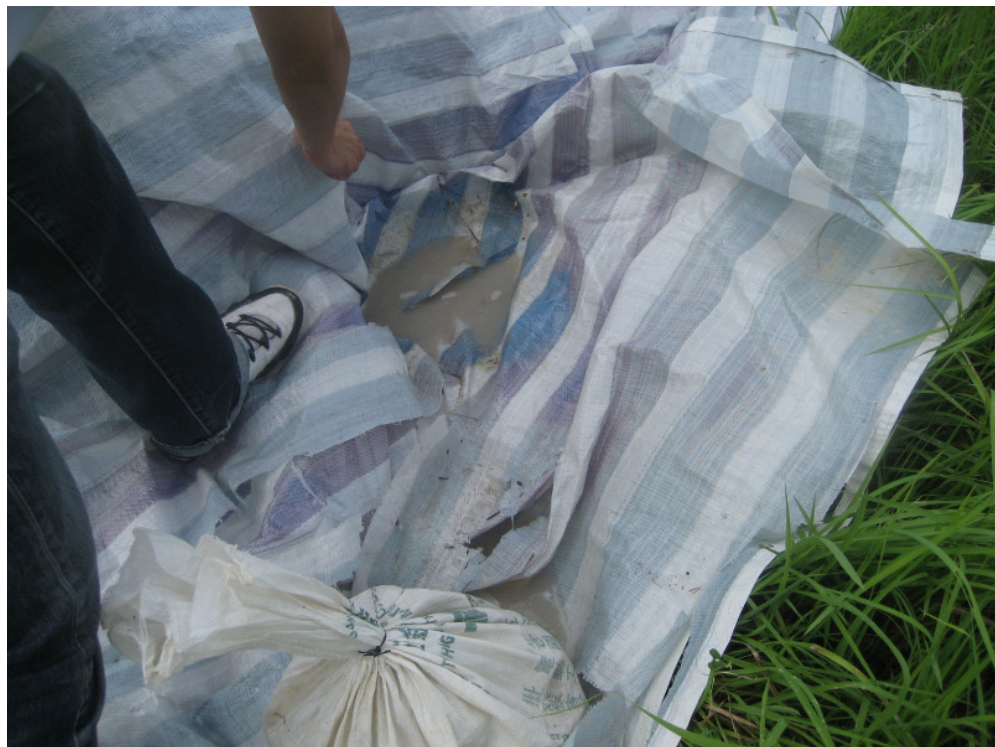
Photo 2 - Stagnant water was observed on the tarpaulin sheet covering the stockpile located at Site 1.

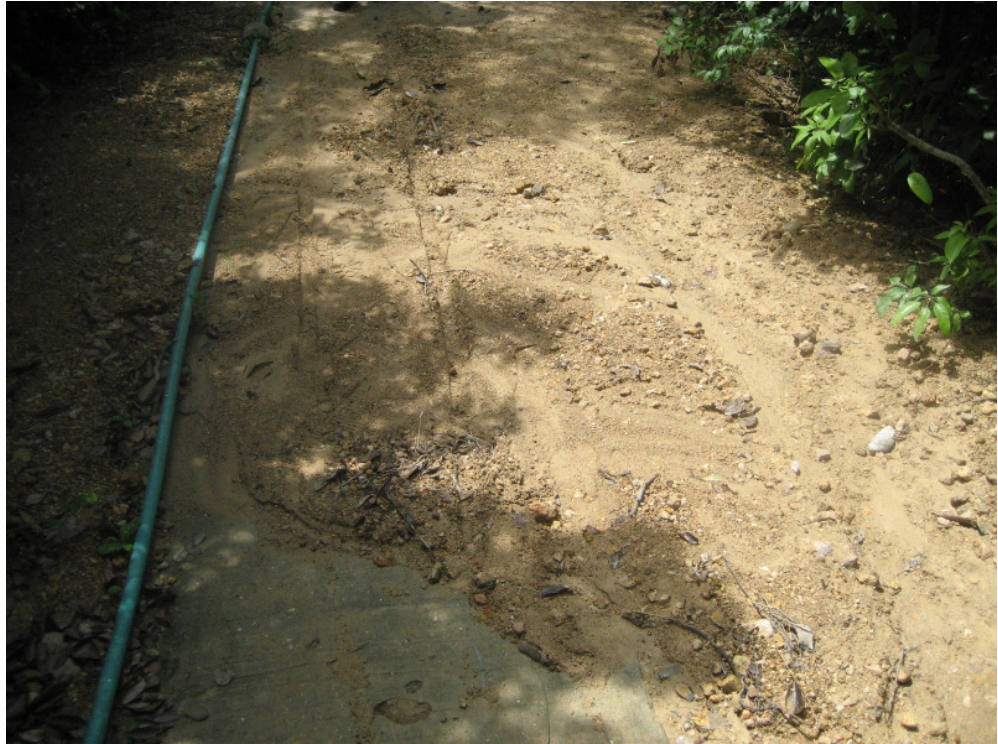
Photo 3 – Erosion was observed at the worksite for underground pipe and cabling works and eroded soil was accumulated at low-lying area.
