CLP Power Hong Kong Ltd

Renewable Energy Supply on Town Island (Construction Phase): 4th Monthly Environmental Site Audit Report

July 2011

Reference 0129569

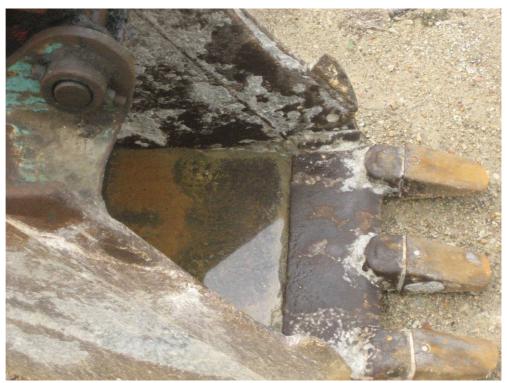
• Stagnant water was observed inside the scoop of excavator at site 1 (See Photo 1). The Contractor was reminded to remove the stagnant water and turns the scoop upside down to prevent accumulation of stagnant water.

Photo 1 - Stagnant water was observed inside the scoop of excavator at site 1.

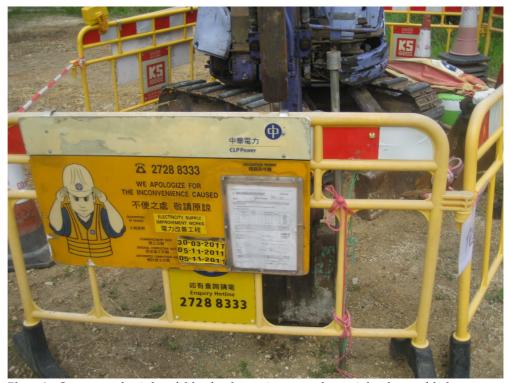
- One more plastic box folder for the environmental permit has been added (See Photo 2).
- Sand bags have been added at the worksite for underground pipe and cabling works to act as silt trap to prevent eroded soil from being washed away to low-lying areas (See Photo 3).

Photo 2 - One more plastic box folder for the environmental permit has been added.

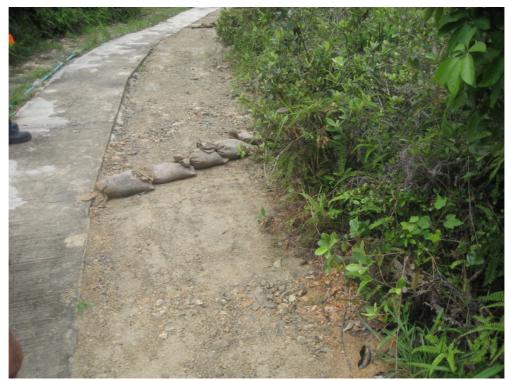
Photo 3 - Sand bags have been added at the worksite for underground pipe and cabling works to act as silt trap to prevent eroded soil from being washed away to low-lying areas.
