CLP Power Hong Kong Ltd

Renewable Energy Supply on
Town Island (Construction
Phase): *2nd Monthly
Environmental Site Audit Report*

May 2011

Reference 0129569

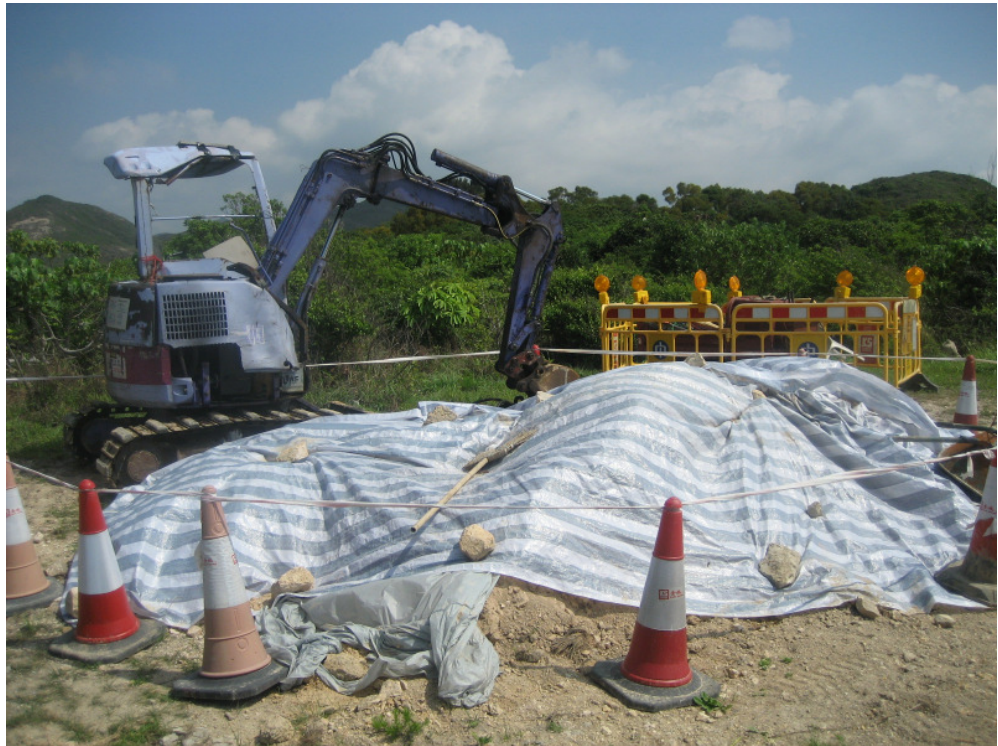
It was observed that stockpiles (soil) were still found lying adjacent to the stream and at Site 1. Although the stockpiles were packed in bags, there is still a potential risk of having adverse impacts to the environment during rainy days. The Contractor has been reminded to remove the stockpiles within two weeks. (See Photo 1 and Photo 2 in *Annex B*).

Photo 1 - Stockpile was observed at Site 1.

- 1 The Contractor was reminded to remove the stockpiles within two weeks.
- 2 The Contractor was reminded to remove the stagnant water immediately and frequently inspect and clear stagnant water during regular weekly site inspection.

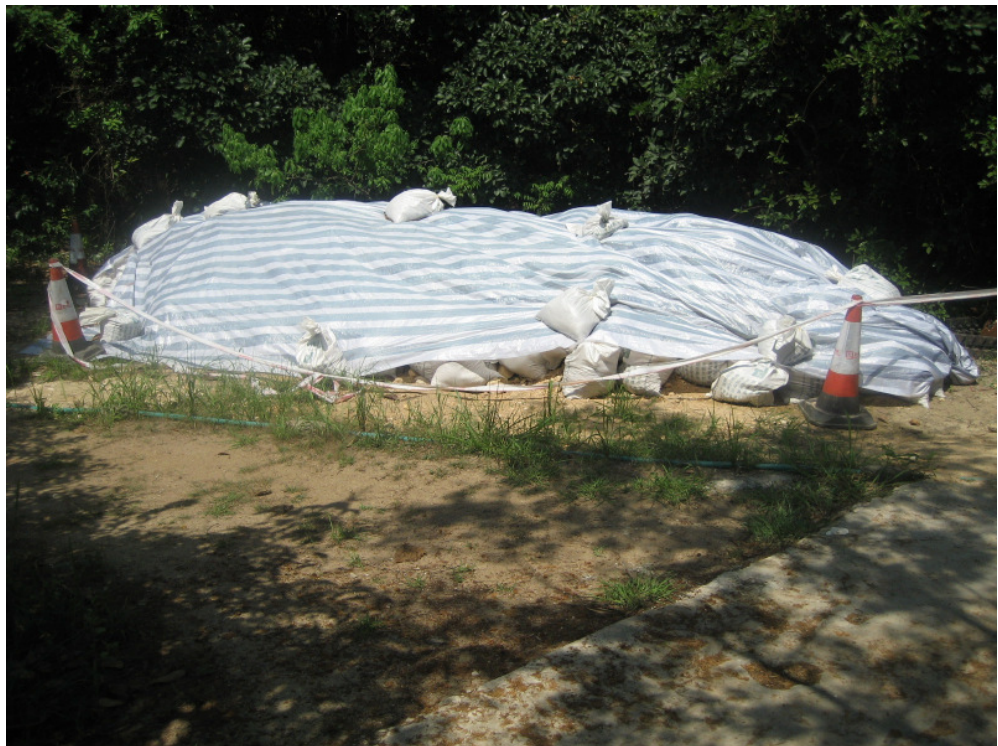
Photo 2 - Stockpile was observed adjacent to the stream.

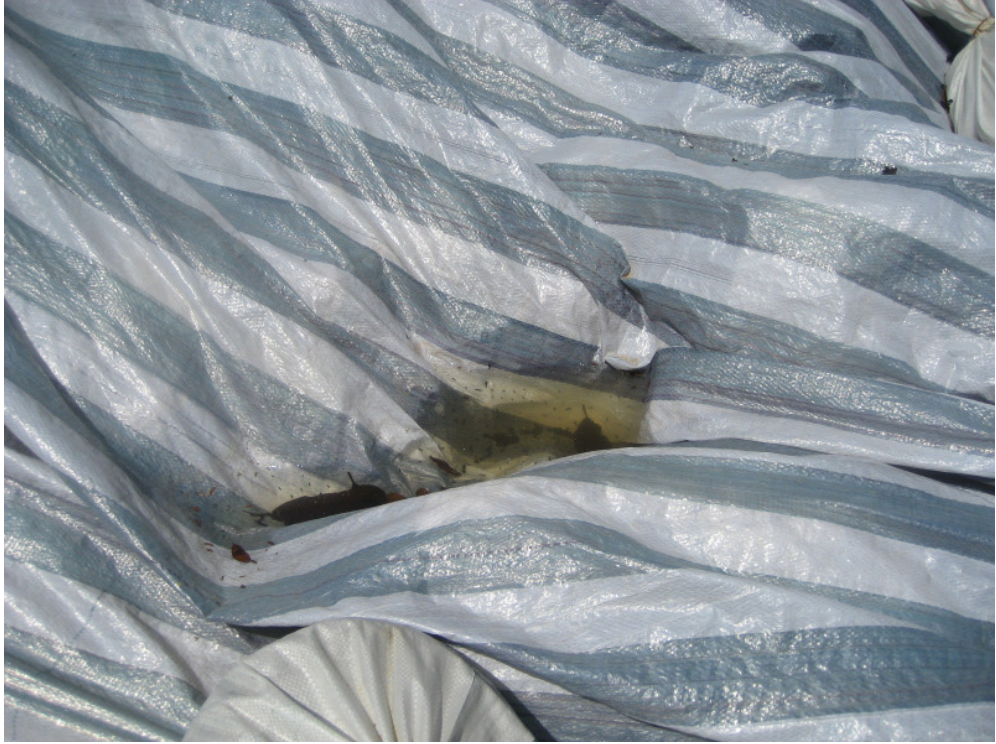
Stagnant water was also observed on the tarpaulin sheets covering the stockpiles abutting the stream and at Site 1 (See Photo 3 in *Annex B*). The Contractor has been reminded to remove the stagnant water immediately and frequently inspect and clear stagnant water during regular weekly inspection.

Photo 3 – Stagnant water was observed on the tarpaulin sheet covering the stockpile located next to the stream.
