Renewable Energy Supply on Town Island (Construction Phase): 5th Monthly Environmental Site Audit Report

August 2011

Reference 0129569

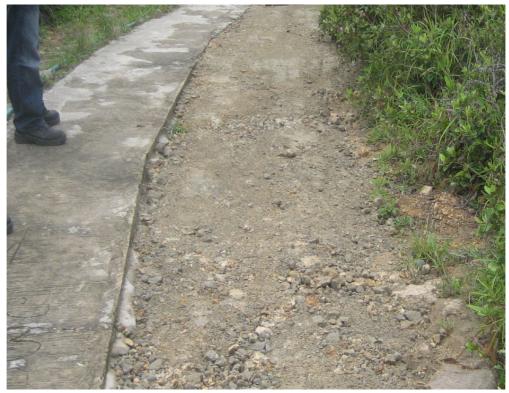
The fifth monthly environmental site audit was conducted on 12 August 2011. No construction activities were observed during the site inspection and the worksite for underground pipe and cabling works has been reinstated (Photo 1). No specific observation was identified from the site inspection..

Photo 1 - The worksite for underground pipe and cabling works have been reinstated.
