Renewable Energy Supply on  
Town Island (Construction  
Phase): *6th Monthly  
Environmental Site Audit Report*

September 2011

Reference 0129569

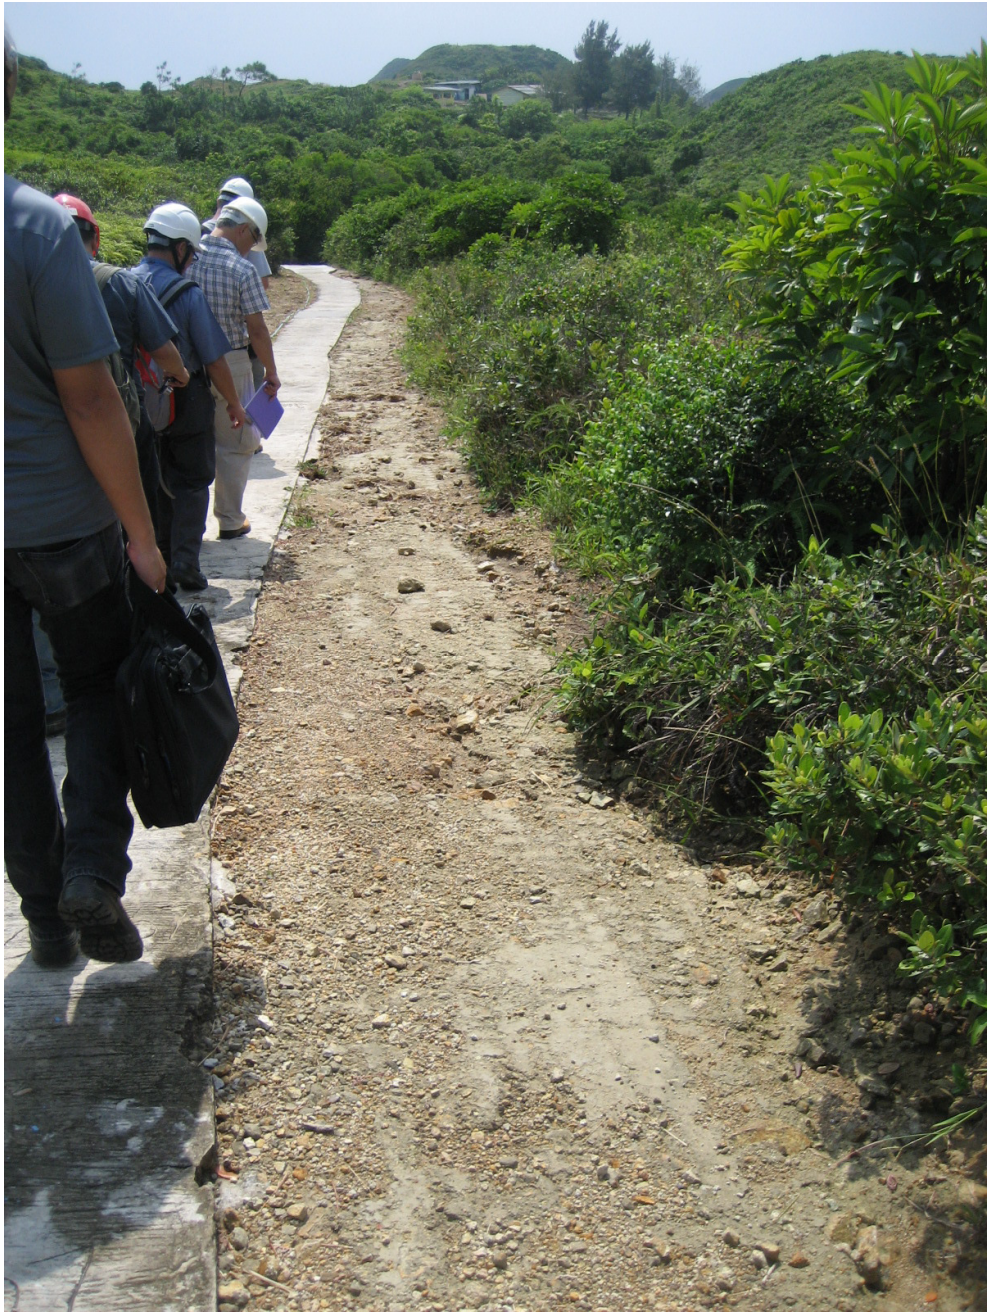
The sixth monthly environmental site audit was conducted on 16 August 2011. No construction activities were observed during the site inspection. The worksite for underground pipe and cabling works has been reinstated (*Photo 1*). All the temporary worksites have been reinstated. One observation was recorded during the site audit and is described below:

Photo 1 - The worksite for underground pipe and cabling works have been reinstated.

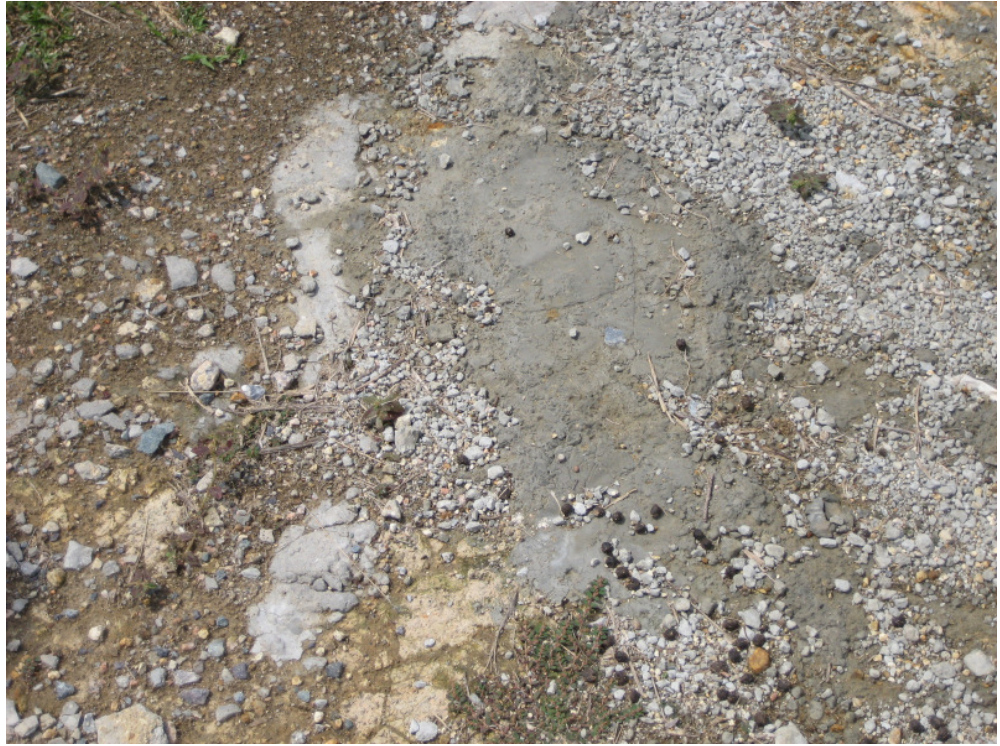
- Concrete was observed on ground near Site 1 (See *Photo 2*). The Contractor was reminded to remove the concrete to ensure the site is reinstated.

- 1 - Concrete stain was observed on ground near site 1

Photo 2 – Concrete stain near Site 1.

- 1 - The Contractor was reminded to remove the concrete stain to ensure the site is reinstated.

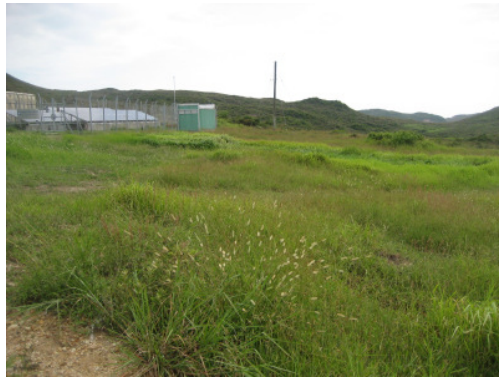
Photo 3 – An Overview of Site 1.

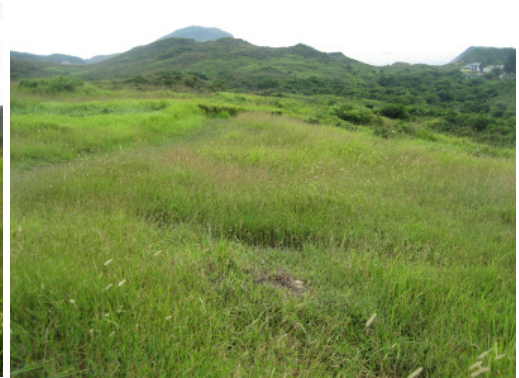
Photo 4 – An Overview of Site 1.

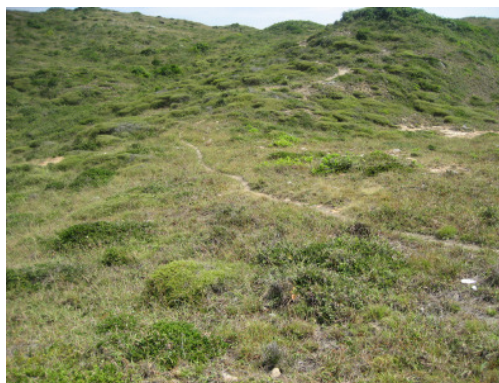
Photo 5 – An Overview of Site 2.

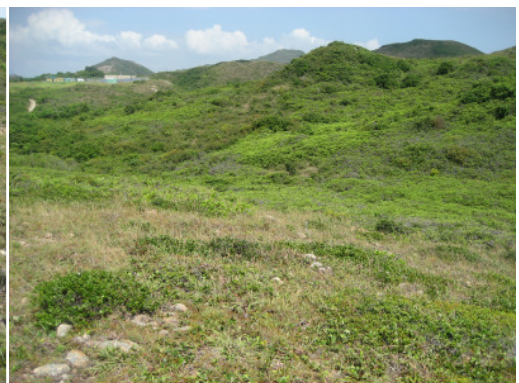
Photo 6 – An Overview of Site 2.
