CLP Power Hong Kong Ltd

Renewable Energy Supply on Town Island (Construction Phase): 7th Monthly Environmental Site Audit Report

October 2011

This is the seventh *Monthly Environmental Site Audit Report* presenting the key findings and observations of the site audit conducted on 18 October 2011.

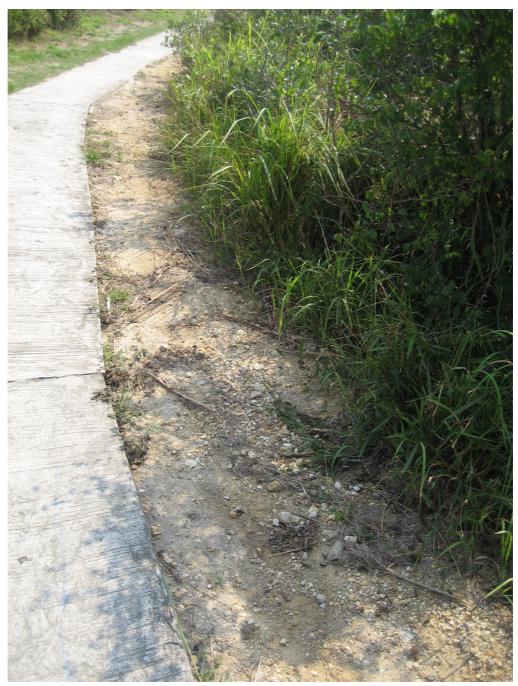
The seventh monthly environmental site audit was conducted on 18 October 2011. No construction activities were observed during the site inspection. The temporary worksites for underground pipe and cabling works have been reinstated (*Photo 1*). No specific observation was identified from the site inspection.

Photo 1 - The worksite for underground pipe and cabling works have been reinstated.

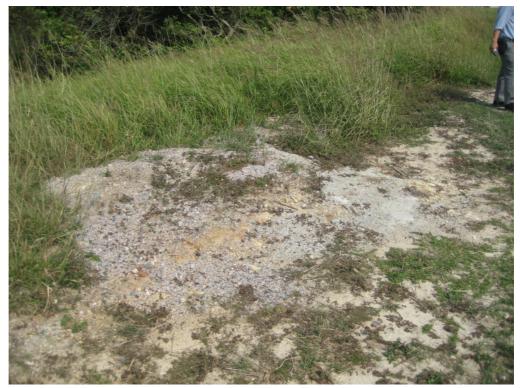
• The concrete stain on ground at Site 1 has been removed (*Photo 2*).

Photo 2 – The concrete stain on ground at Site 1 has been removed.
