CLP Power Hong Kong Ltd

Renewable Energy Supply on  
Town Island (Construction  
Phase): *8th Monthly*  
*Environmental Site Audit Report*

November 2011

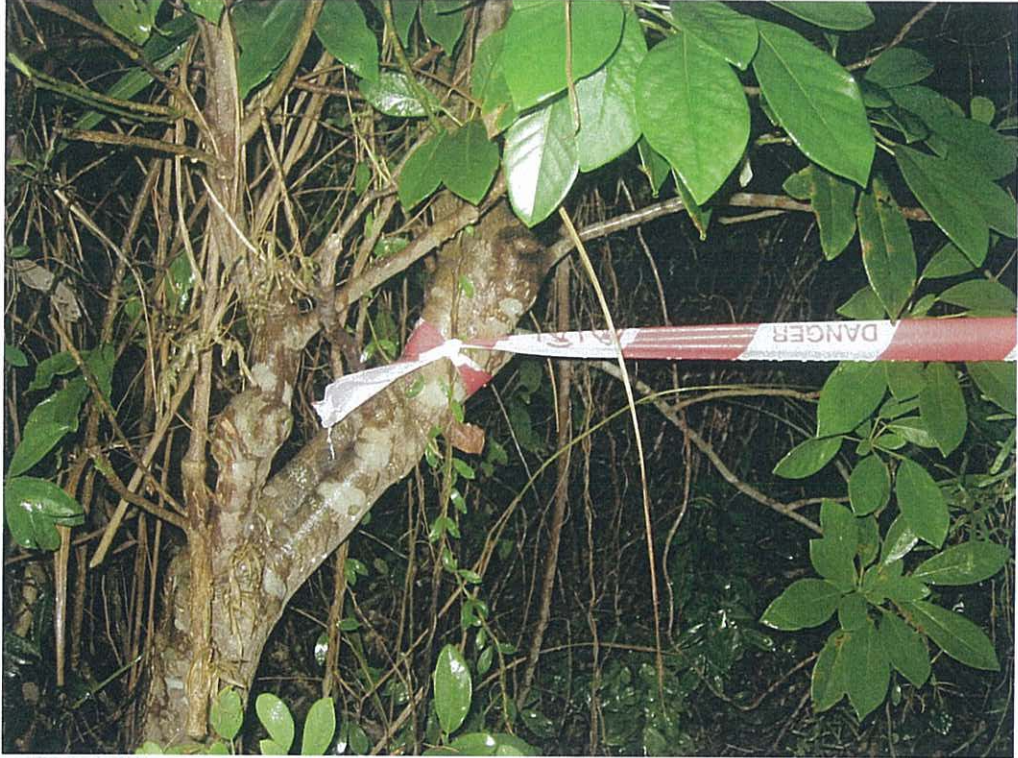
- 1) Warning tap was observed tied on trees at the temporary worksite for underground pipe and cabling works.
- 2) Some paint marking on soil and grassland was observed at the temporary worksite for underground pipe and cabling works.

Photo 1 - Plastic warning tape was observed tied on trees at the temporary worksite for underground pipe and cabling works.

- 1) The Contractor was reminded to remove the warning tap in order to protect the trees.
- 2) The Contractor was reminded to remove the paint marking and reinstate the site.

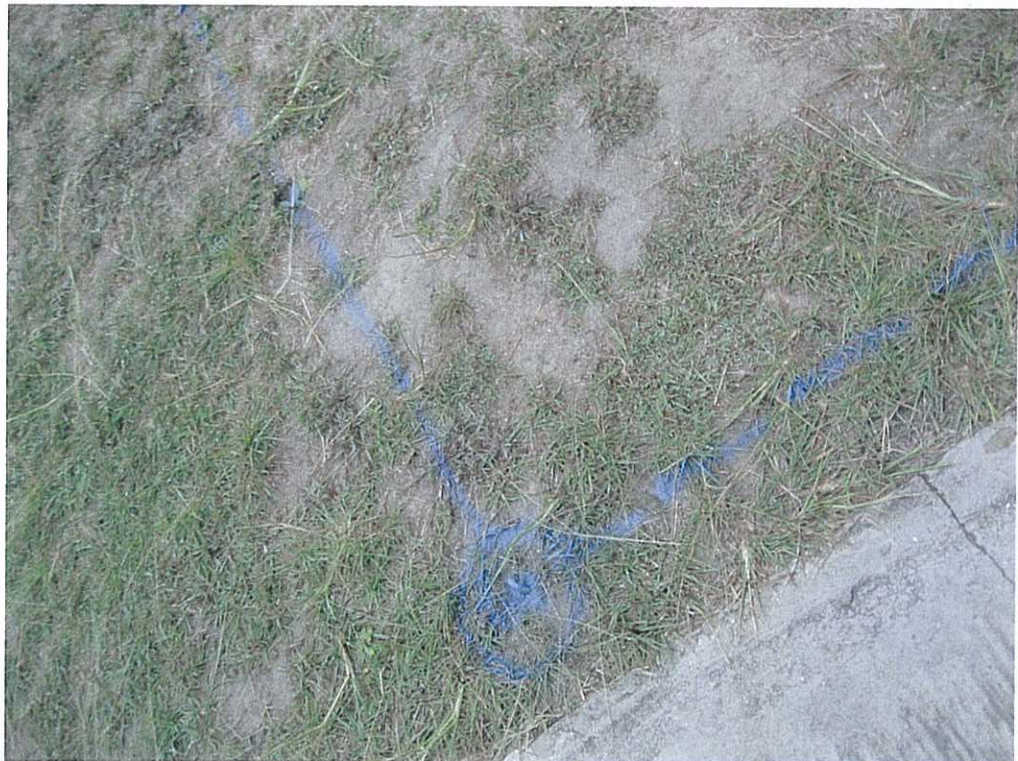
Photo 2 - Some paint marking on soil and grassland was observed at the temporary worksite for underground pipe and cabling works.
