CLP Power Hong Kong Ltd

Renewable Energy Supply on  
Town Island (Construction  
Phase): *9th Monthly  
Environmental Site Audit Report*

December 2011

This is the ninth *Monthly Environmental Site Audit Report* presenting the key findings and observations of the site audit conducted on 14 December 2011.

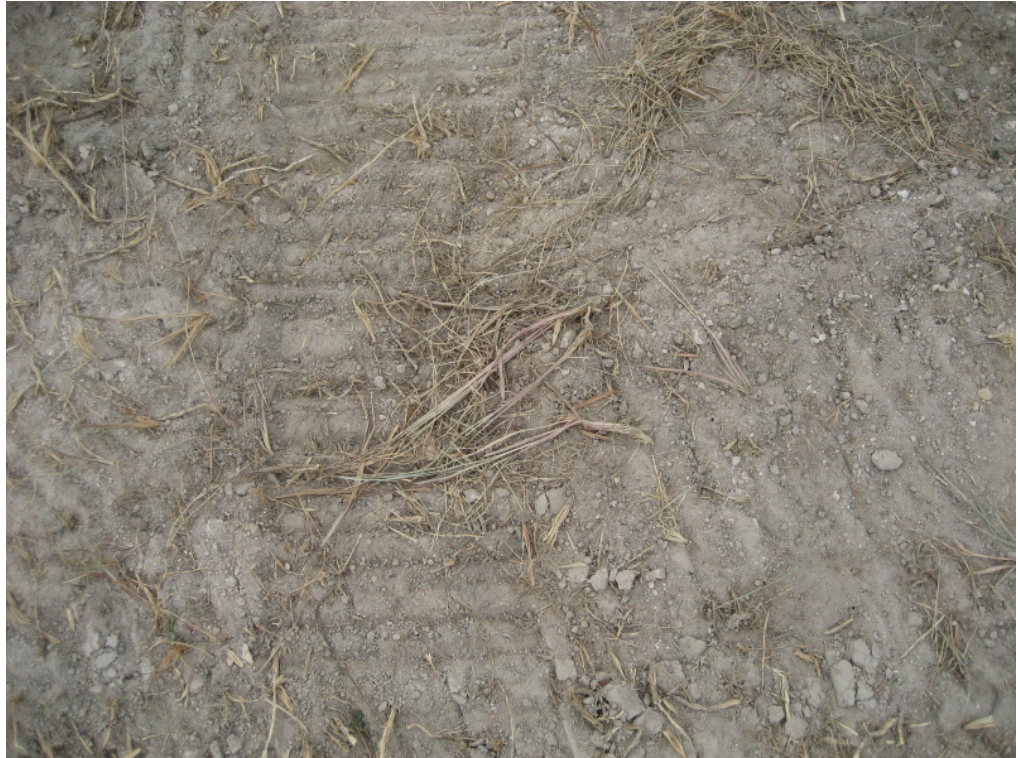
- Exposed soil surface was observed dusty at Site 1 after site clearance works (Photo 1). The Contractor was reminded to regularly wet the exposed surface of the site to avoid generation of dust.

Photo 1 – Exposed soil surface was observed dusty at Site 1 after site clearance works.

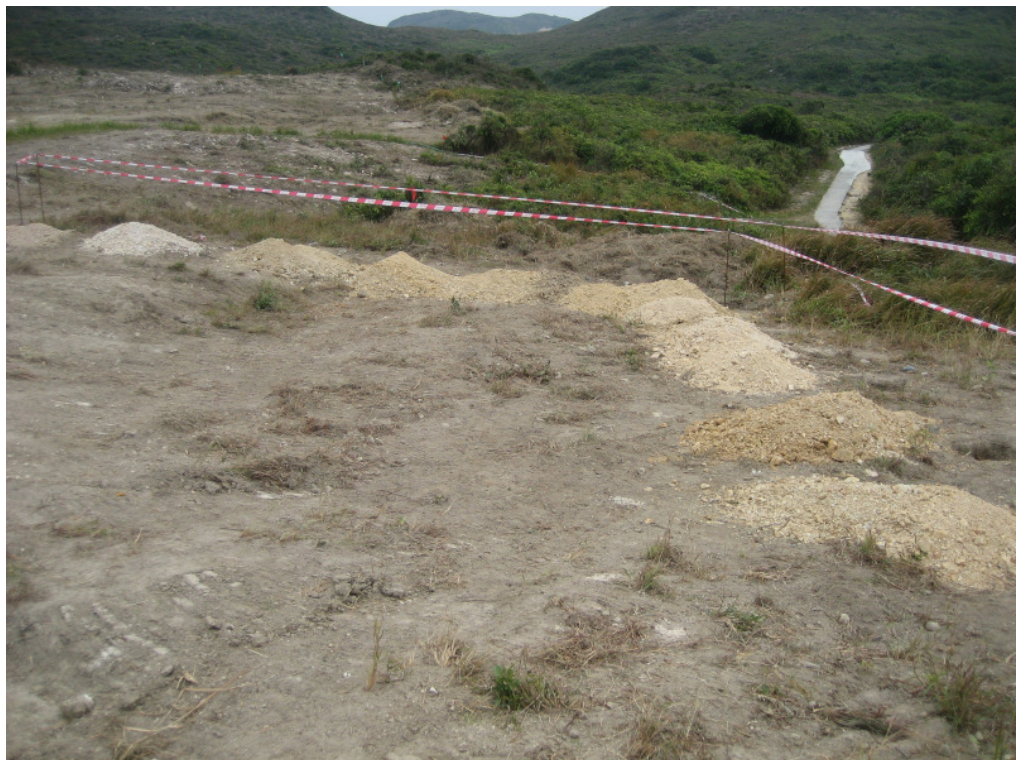
- The excavated material was observed not being covered at Site 1 (Photo 2). The Contractor was reminded to properly cover the excavated material by impervious sheet. The excavated material has been covered by impervious sheet on 16 December 2011 (Photo 7) as reported by the Contractor.

Photo 2 – The excavated material was observed not being covered at Site 1.

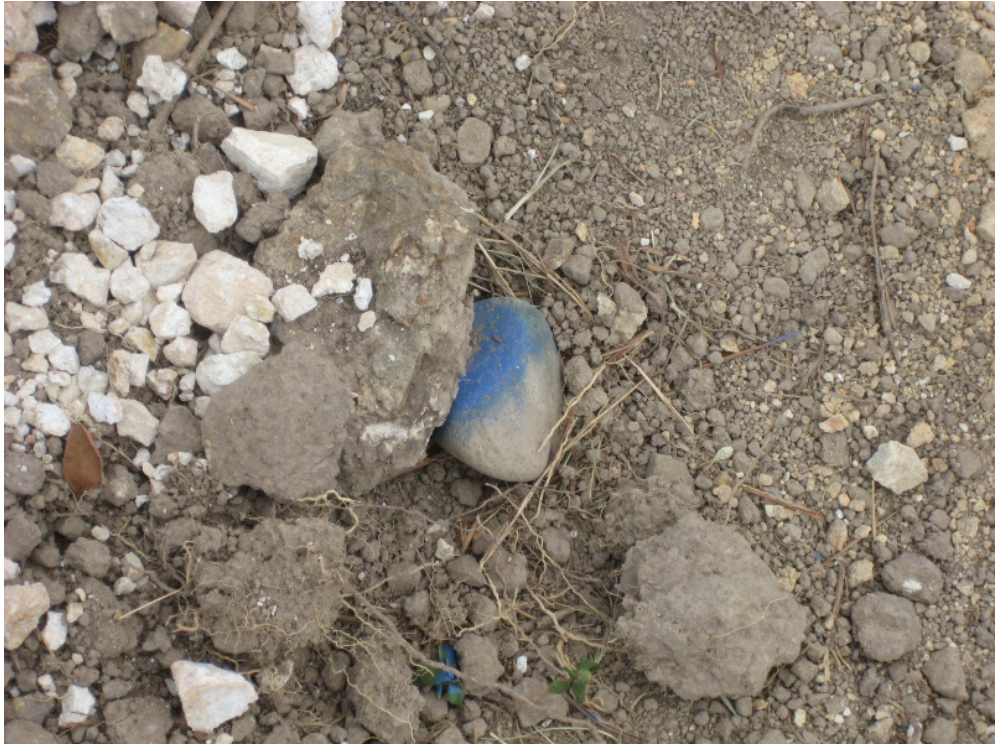
- Soil which contaminated by spray paint was observed mixed with excavated soil at Site 1 (Photo 3). The Contractor was reminded to separate the contaminated soil from excavated soil and dispose of it as chemical waste.

Photo 3 – Soil which contaminated by spray paint was observed mixed with excavated soil at Site 1.

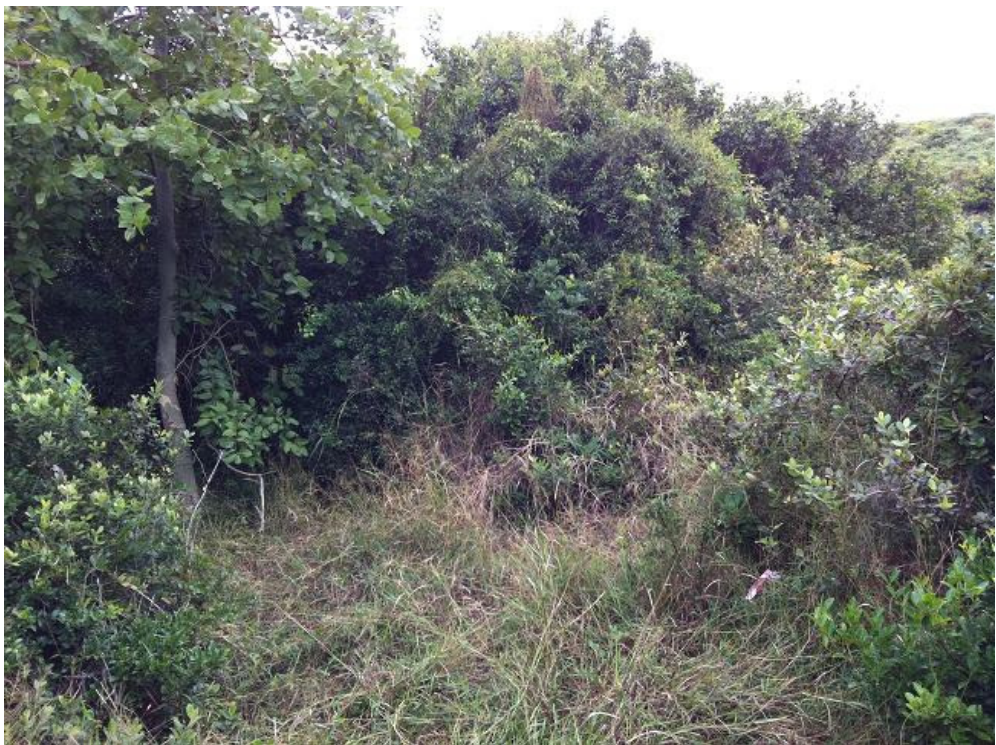
Photo 4 – Plastic warning tapes tied on trees at the temporary worksite for underground pipe and cabling works has been removed.

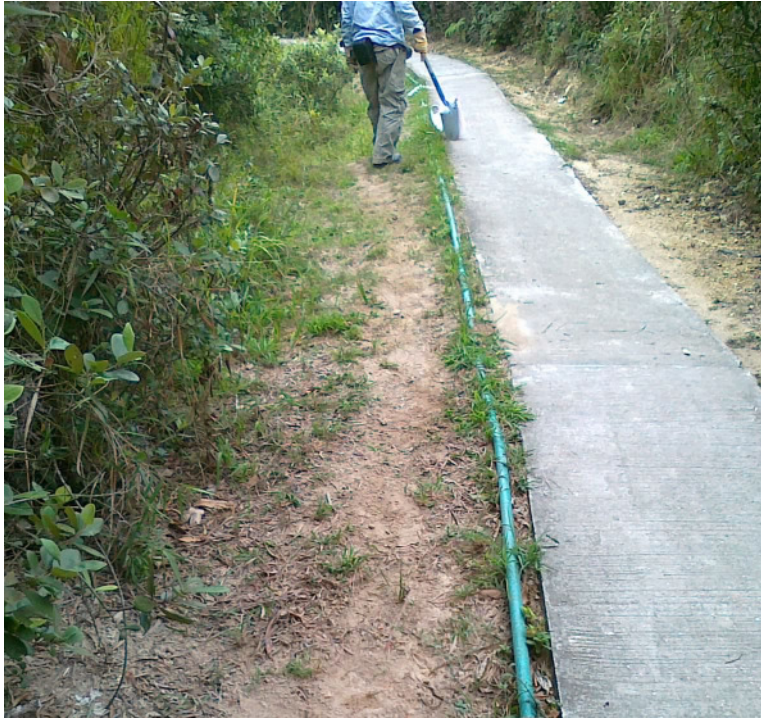
Photo 5 – The paint marking on soil and grassland at the temporary worksite for underground pipe and cabling works has been removed and the work sites has been reinstated.

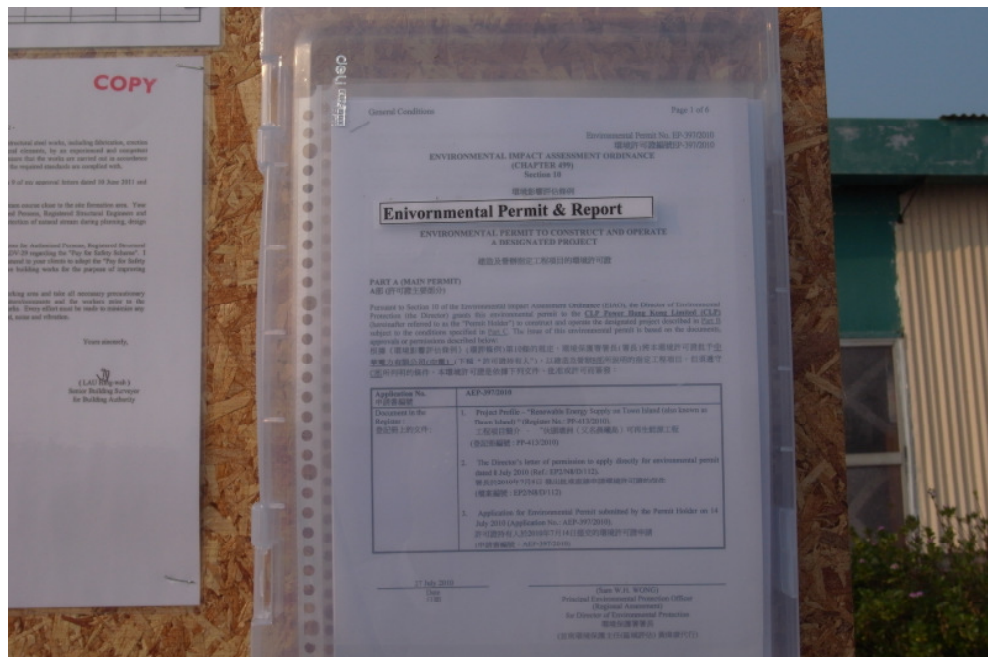
- Environmental permit was not displayed at Site 1. The Contractor was reminded to display the Environmental Permit at the work sites. The Environmental Permit has been displayed at Site 1 on 16 December 2011 (Photo 6) as reported by the Contractor.

Photo 6 – The Environmental Permit has been displayed at Site 1.

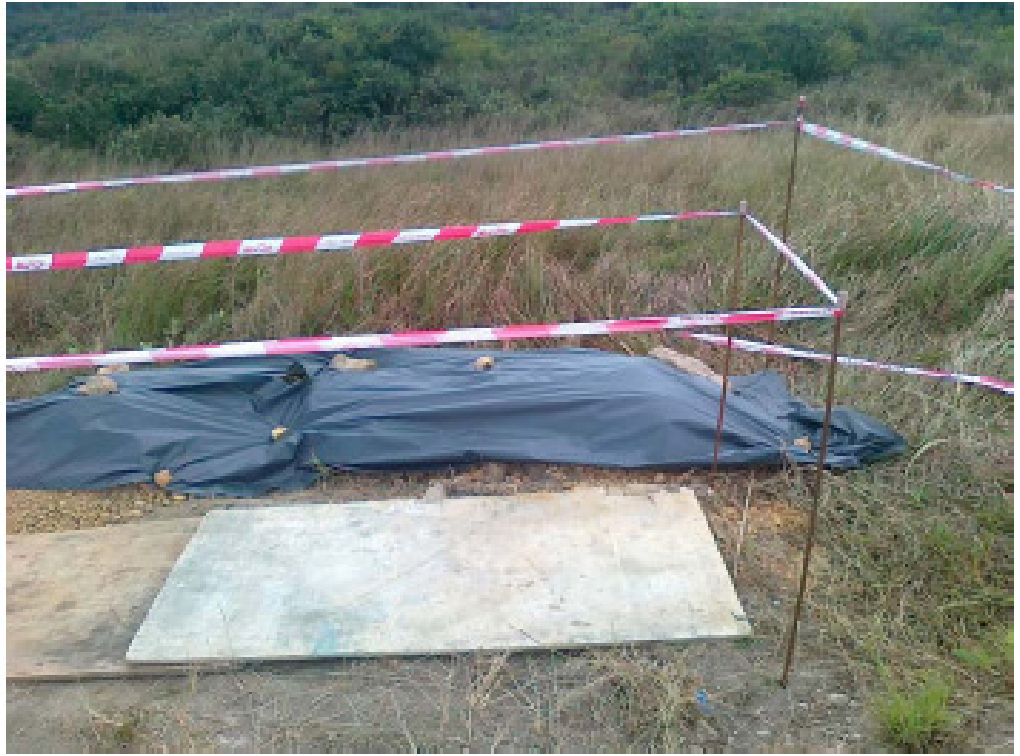
Photo 7 – The excavated material has been covered by impervious sheet.
