Renewable Energy Supply on Town Island (Construction Phase): 10th Monthly Environmental Site Audit Report

January 2012

This is the tenth *Monthly Environmental Site Audit Report* presenting the key findings and observations of the site audit conducted on 11 January 2012.

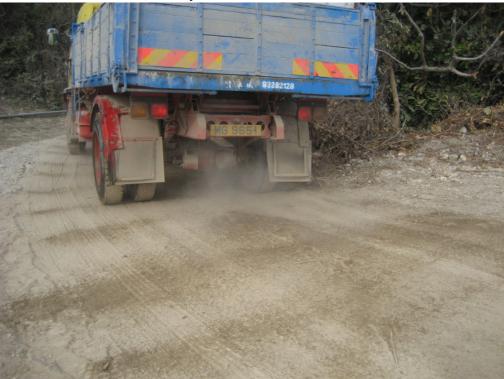
1) It was observed that dust generated at haul road by truck during leaving the construction worksite at Site 1.

Photo 1 – Dust was generated at haul road when trucks leaving the site at the exit of Site 1.

1) The Contractor was reminded to wash the tyre of the truck before it leaving the site.

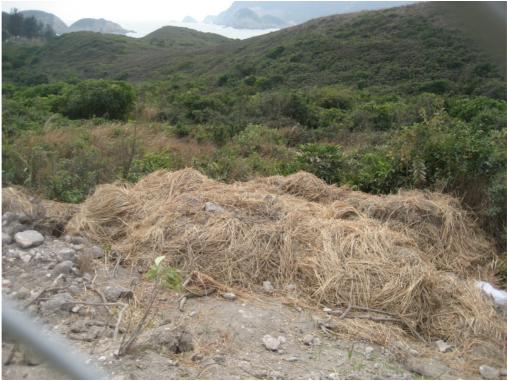
2) General refuses, construction materials and grass stockpites were observed outside the site boundary at Site 1 and Site 2.

Photo 2 – Grass stockpiles were storing outside the site boundary at Site 1.

The Contractor was reminded to remove the general refuses and construction materials. Also the Contractor was reminded to store the grass stockpiles inside the site boundary.

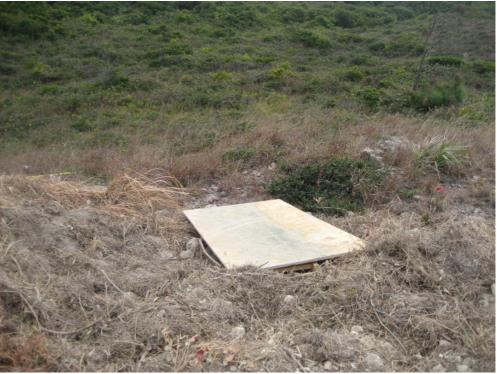
Photo 3 – Construction material and general refuses were observed outside the site boundary at Site 1.

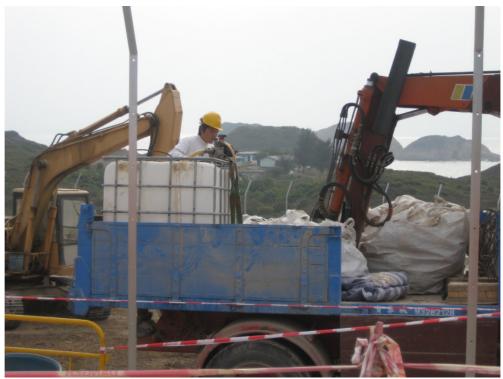
Photo 4 – Regularly wetting the exposed surface of the site has been done by the Contractor.
