CLP Power Hong Kong Ltd

Renewable Energy Supply on
Town Island (Construction
Phase): *11th Monthly
Environmental Site Audit Report*

February 2012

Reference 0129569

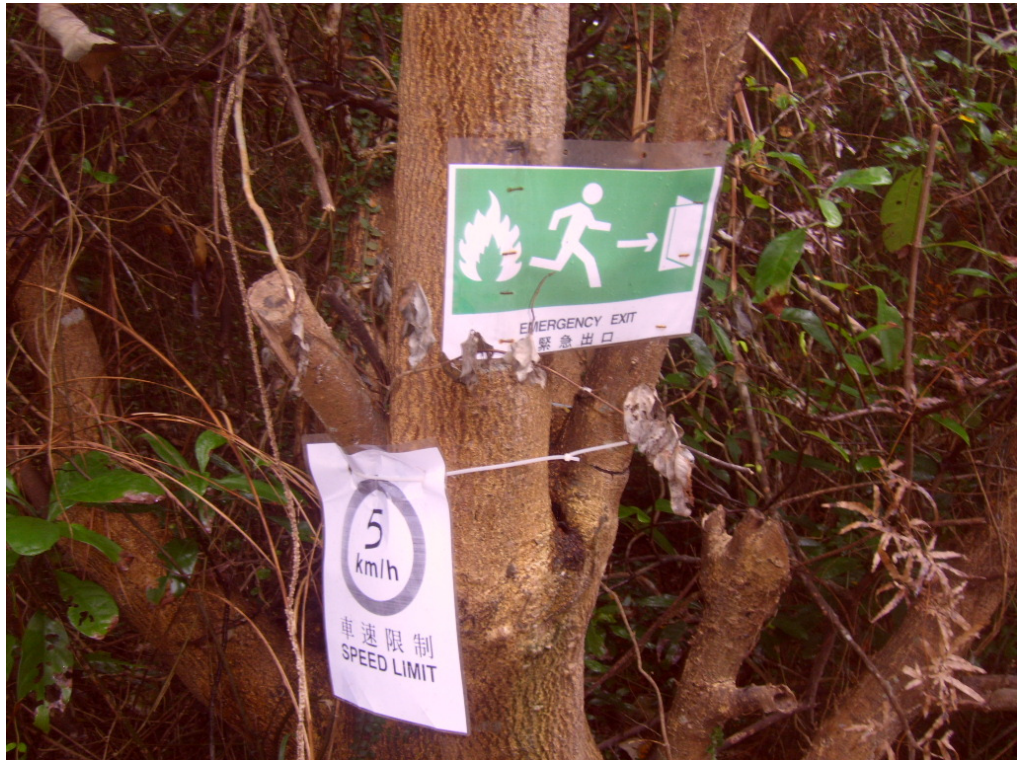
- Warning sign was observed tied on tree trunk near haul road at Site 1 (*Photo 1*). The Contractor was reminded to remove the warning sign and suggested to display the warning sign independent from the trees.
- A stone was observed on the branches of tree near Site 1 (*Photo 2*). The Contractor was reminded to remove the stone.
- Plastic bag was observed wrapping on the trunks of trees near the haul road between Site 1 and Site 2 (*Photo 3*). The Contractor was reminded to remove the plastic bag and provide a tree protection zones in order to protect the trees.

Photo 1 – Warning sign was observed tied on tree trunk near haul road at Site 1.

- 1) The Contractor was reminded to remove the warning sign and suggested to display the warning sign independent from the trees.
- 2) The Contractor was reminded to remove the stone.
- 3) The Contractor was reminded to remove the plastic bag and provide a tree protection zones in order to protect the trees.

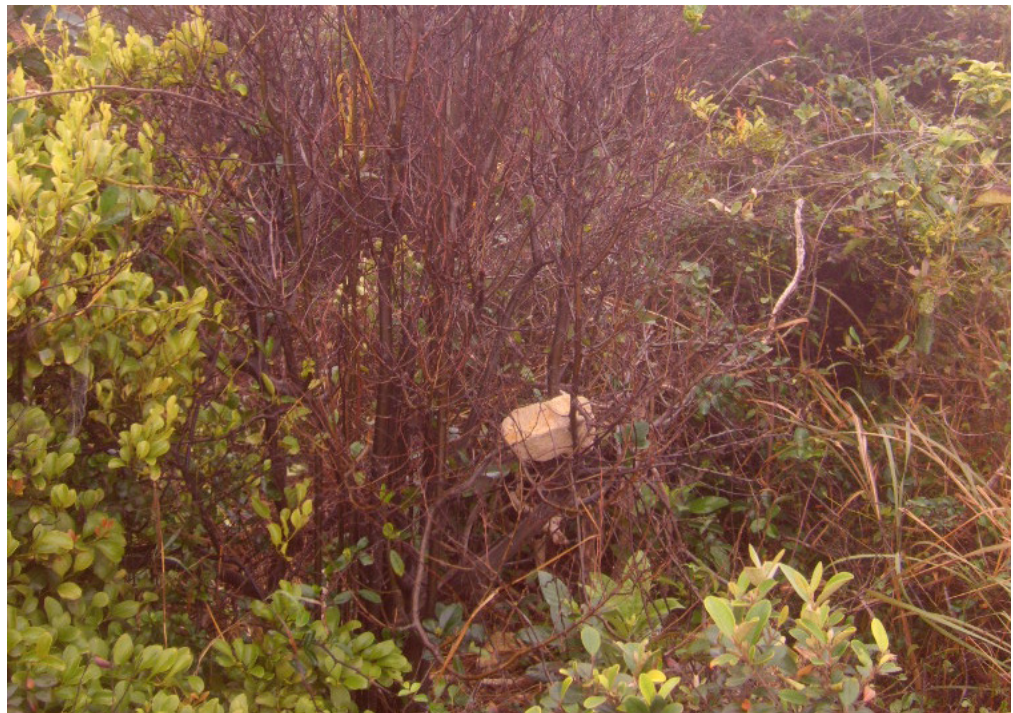
Photo 2 – Rock was observed on the branches of tree near Site.

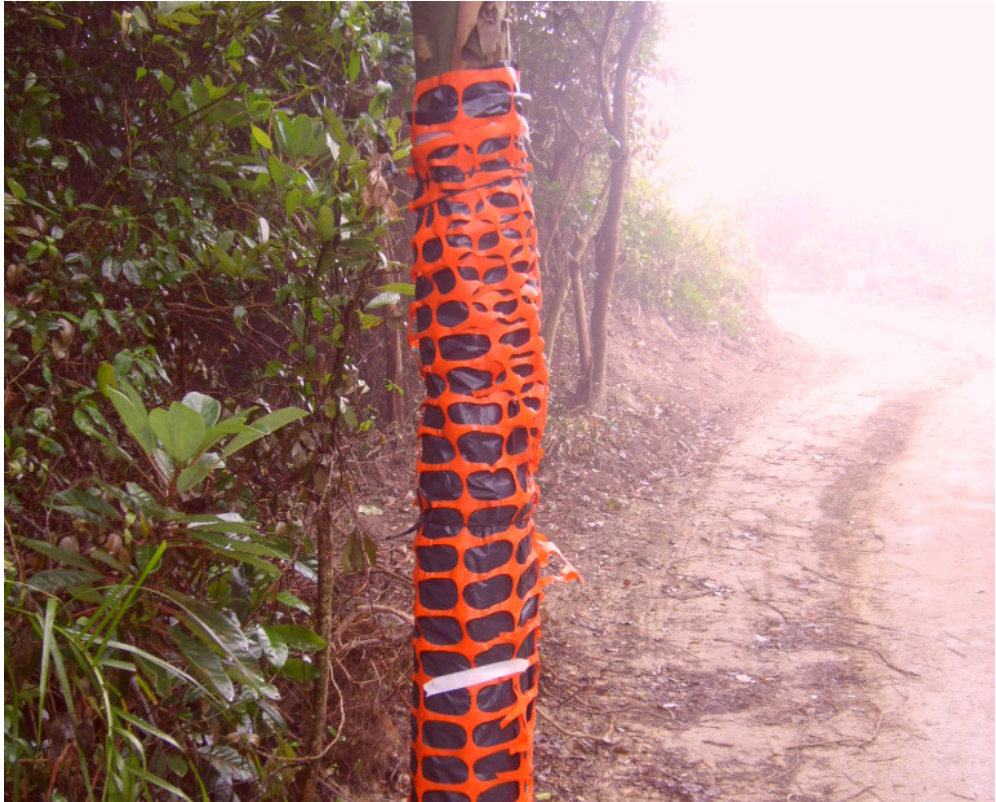
Photo 3 – Plastic bag was observed wrapping on the trunks of trees near the haul road between Site 1 and Site 2.

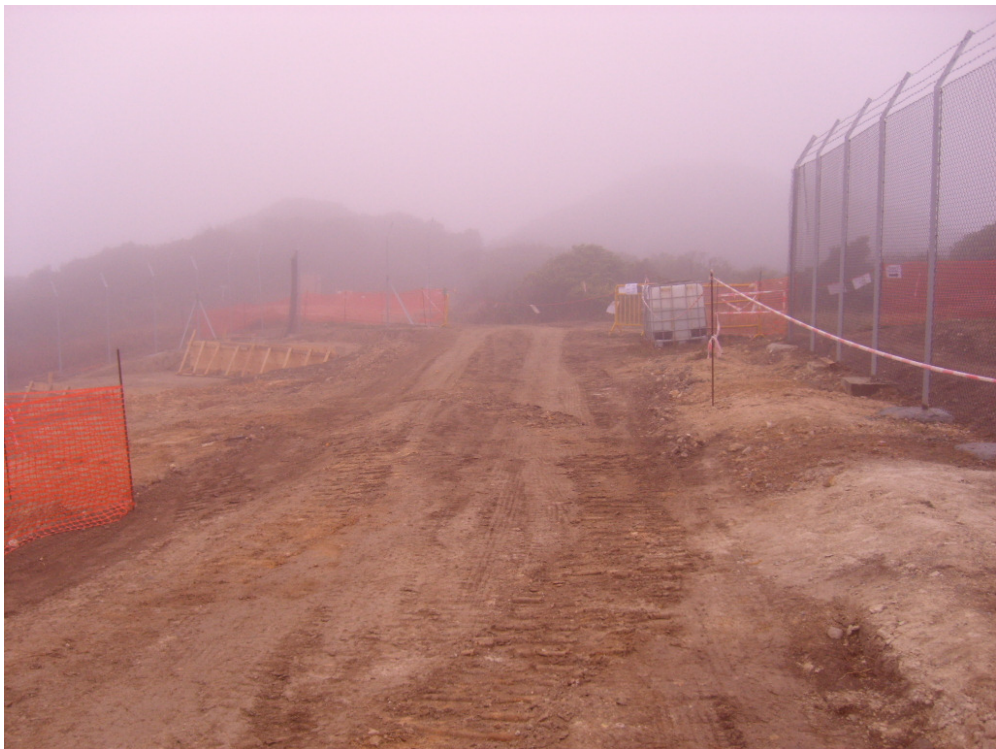
- Water tank has been provided at exit of Site 1 for washing the wheels of trucks leaving the construction site (*Photo 4*).
- General refuse and construction material outside the site boundary has been removed and the grass stockpile stored outside the site boundary has been relocated and stored within the site boundary.

Photo 4 – Water tank has been provided at exit of Site 1 for washing the wheels of trucks leaving the construction site.
