CLP Power Hong Kong Ltd

Renewable Energy Supply on Town Island (Construction Phase): 12th Monthly Environmental Site Audit Report

March 2012

Renewable Energy Supply on Town Island (Construction Phase): 12th Monthly Environmental Site Audit Report March 2012

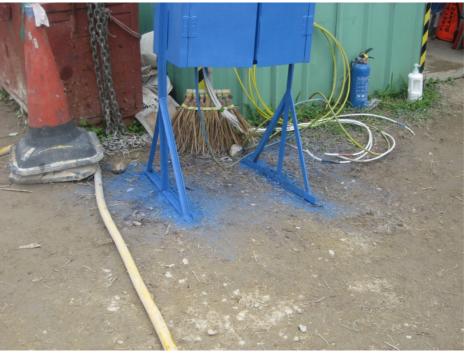
- Painting stain was observed on ground at Site 1 (*Photo 1*). The Contractor was reminded to remove the contaminated soil and dispose off as chemical waste.

Photo 1 – Painting stain was observed on ground at Site 1.

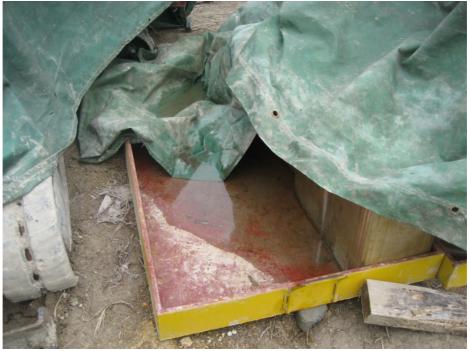
- Stagnant water was observed in drip trays at Site 1 and empty drums at Site 2 (*Photo 2 and 3*). The Contractor was reminded to remove the stagnant water and properly cover the drip trays and empty drums to prevent accumulation of stagnant water.

Photo 2 – Stagnant water was observed in drip traps at Site 1.

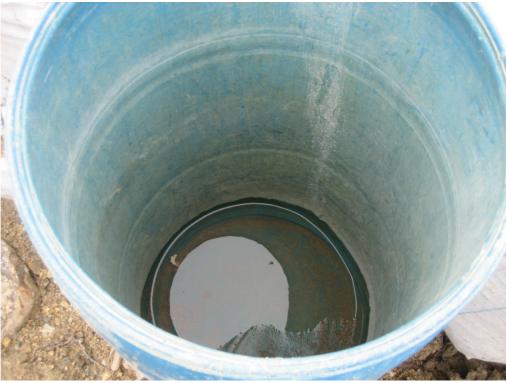
Photo 3 – Stagnant water was observed in empty drums at Site 2

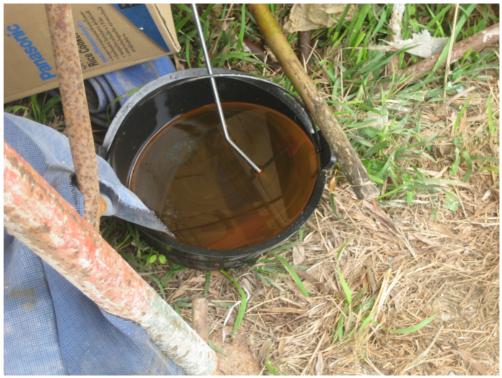
- Bucket with chemical was observed storing in drip tray and without cover. Spillage was also observed next to the bucket (*Photo 4*). The Contractor was reminded to provide cover and drip tray for the bucket containing chemical and remove the contaminated soil and dispose off as chemical waste.

Photo 4 – Bucket with chemical was observed storing without cover and drip tray. Spillage was observed next to the bucket.

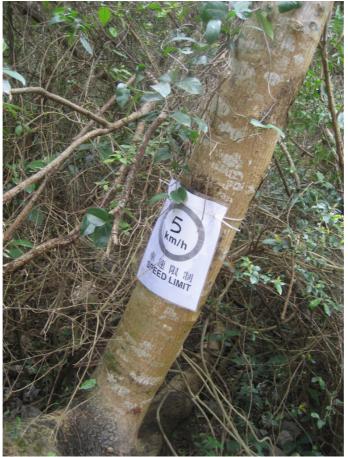
- Road sign was observed tied on tree trunk near haul road at Site 1 (*Photo 5*). The Contractor was reminded to remove the warning sign and suggested to display the warning sign independent from the trees.

Photo 5 – Road sign was observed tied on tree trunk near haul road at Site 1.
