CLP Power Hong Kong Ltd

Renewable Energy Supply on
Town Island (Construction
Phase): *13th Monthly
Environmental Site Audit Report*

April 2012

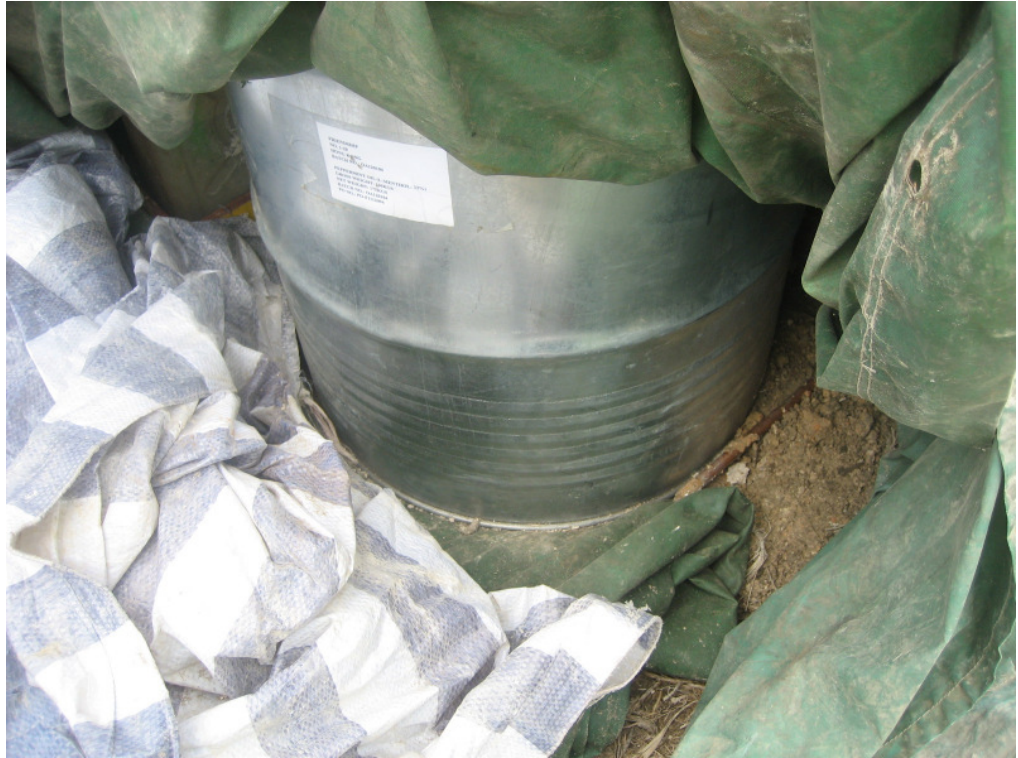
- 1) An oil drum was observed storing without drip tray at Site 1.
- 2) Stagnant water was observed inside bucket and on tarpaulin sheep at Site 2.
- 3) The haul road crossing the stream was observed without earth bund.

Photo 1 – An oil drum was observed storing without drip tray at Site 1.

- 1) The Contractor was reminded to provide drip trap for the oil drum within 3 working days.
- 2) The Contractor was reminded to remove the stagnant water immediately.
- 3) The Contractor was reminded to provide earth bund at the edge of the haul road to avoid earth material entering into the stream.

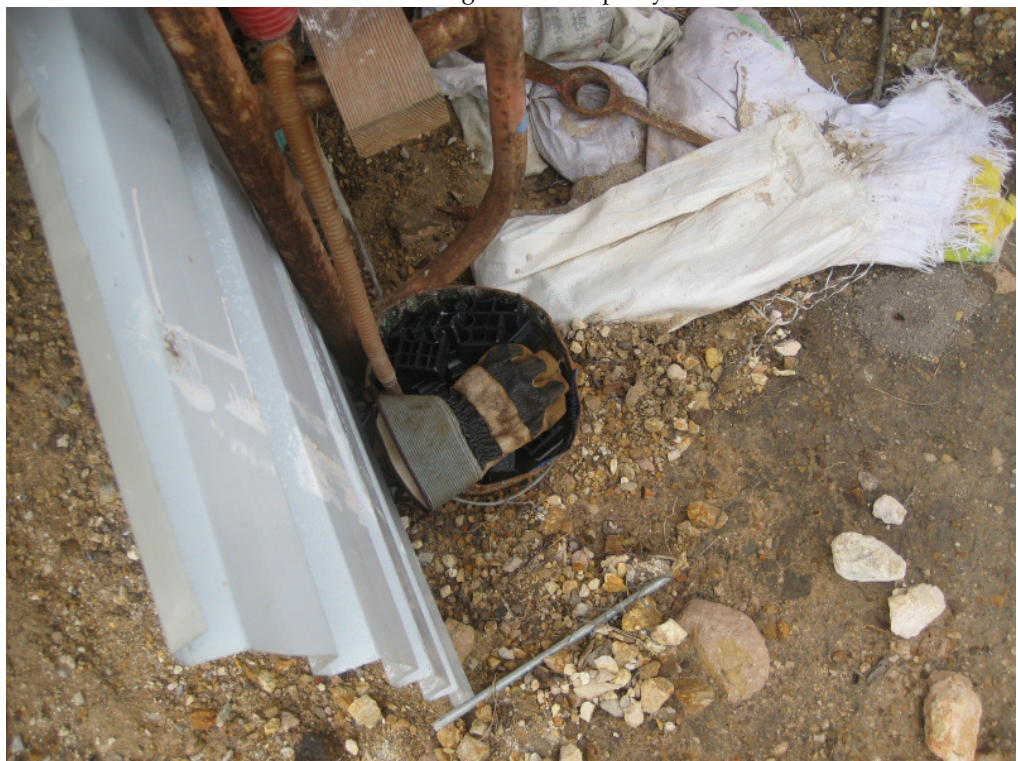
Photo 2 – Stagnant water was observed inside bucket and on tarpaulin sheet at Site 2.

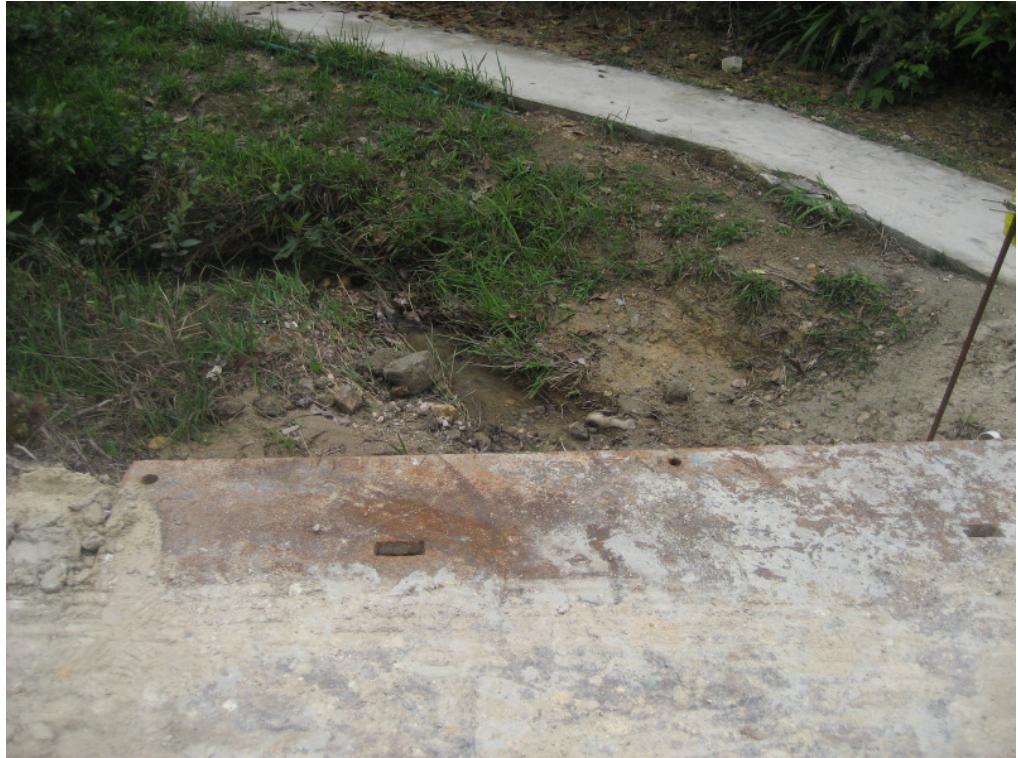
Photo 3 – The haul road crossing the stream was observed without earth bund.
