CLP Power Hong Kong Ltd

Renewable Energy Supply on Town Island (Construction Phase): 14th Monthly Environmental Site Audit Report

May 2012

This is the fourteenth *Monthly Environmental Site Audit Report* presenting the key findings and observations of the site audit conducted on 11 May 2012.

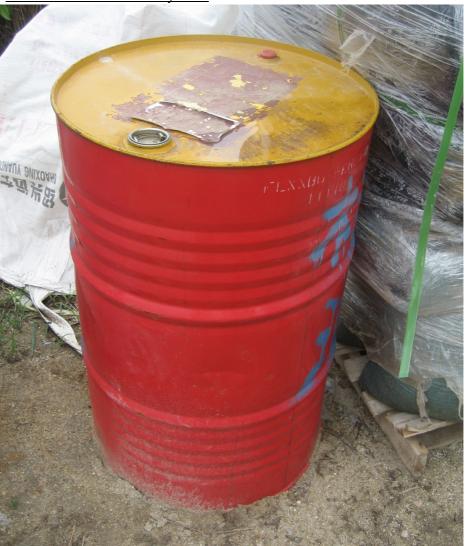
Photo 1 – An oil drum was observed without a drip tray at Site 1.

- An oil drum was observed without a drip tray at Site 1 (Photo 1). The Contractor was reminded to provide a drip tray for the oil drum within 3 working days.
- Construction materials were observed storing outside the site boundary at Site 1 (Photo 2). The Contractor was reminded to keep those construction materials within the site boundary.

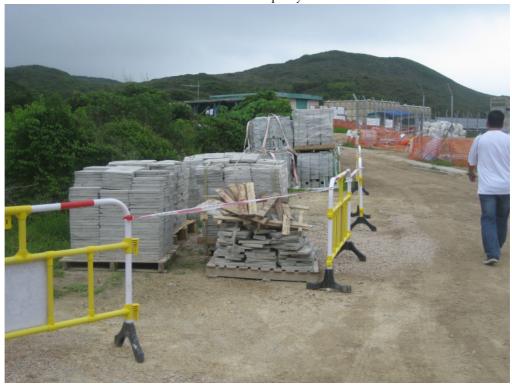
Photo 2 – Construction materials were observed storing outside the site boundary at Site 1.

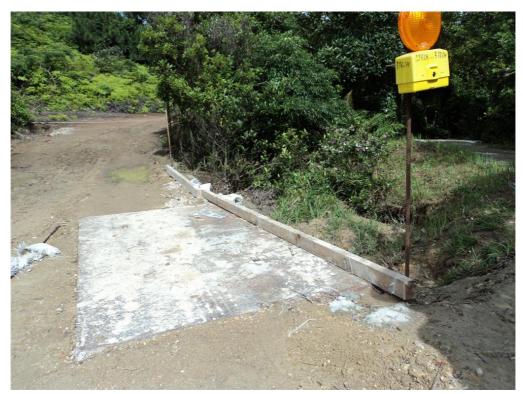
Photo 3-A bund has been provided for the haul road crossing the stream.

- A drip tray has been provided for the oil drum stored next to the site office.
- Stagnant waters inside a bucket and on tarpaulin sheet at Site 2 have been removed.
- A bund has been provided for the haul road crossing the stream (Photo 3).
