Renewable Energy Supply on
Town Island (Construction
Phase): *15th Monthly
Environmental Site Audit Report*

June 2012

This is the fifteenth *Monthly Environmental Site Audit Report* presenting the key findings and observations of the site audit conducted on 15 June 2012.

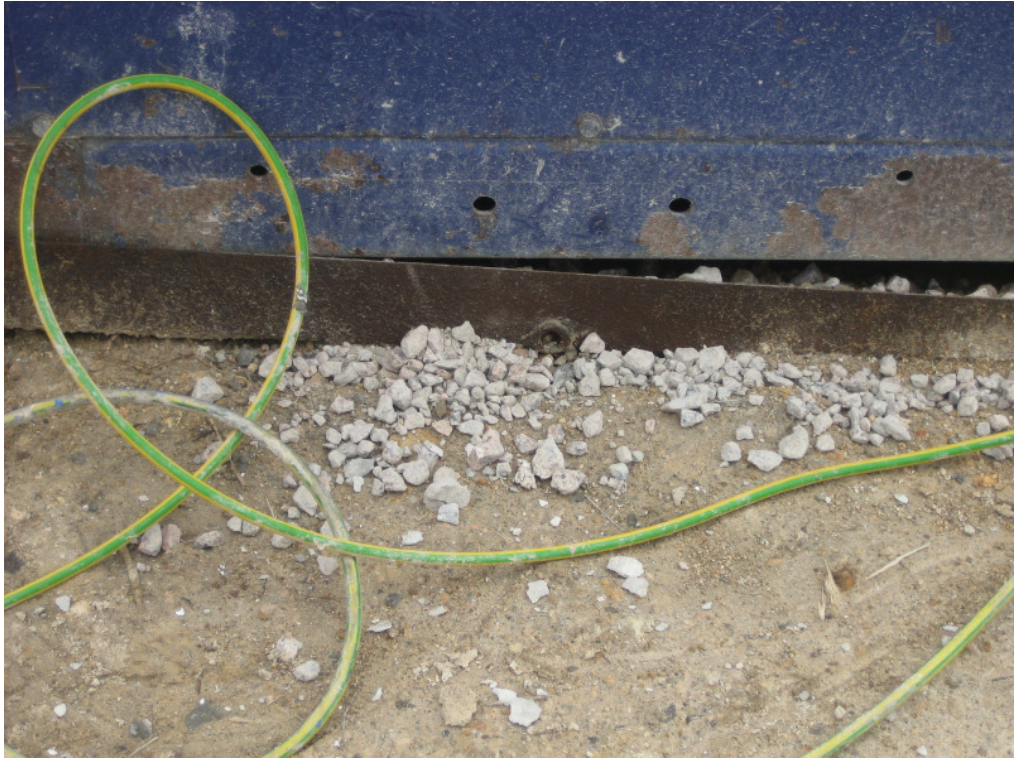
- 1) Drip tray for the generator at Site 1 was observed with a hole being un-plugged.
- 2) Construction materials were observed storing outside the site boundary at Site 1.

Photo 1 – Drip tray for the generator at Site 1 was observed with a hole being un-plugged.

- 1) The Contractor was reminded to plug the hole immediately.
- 2) The Contractor was reminded to keep those construction materials within the site boundary.

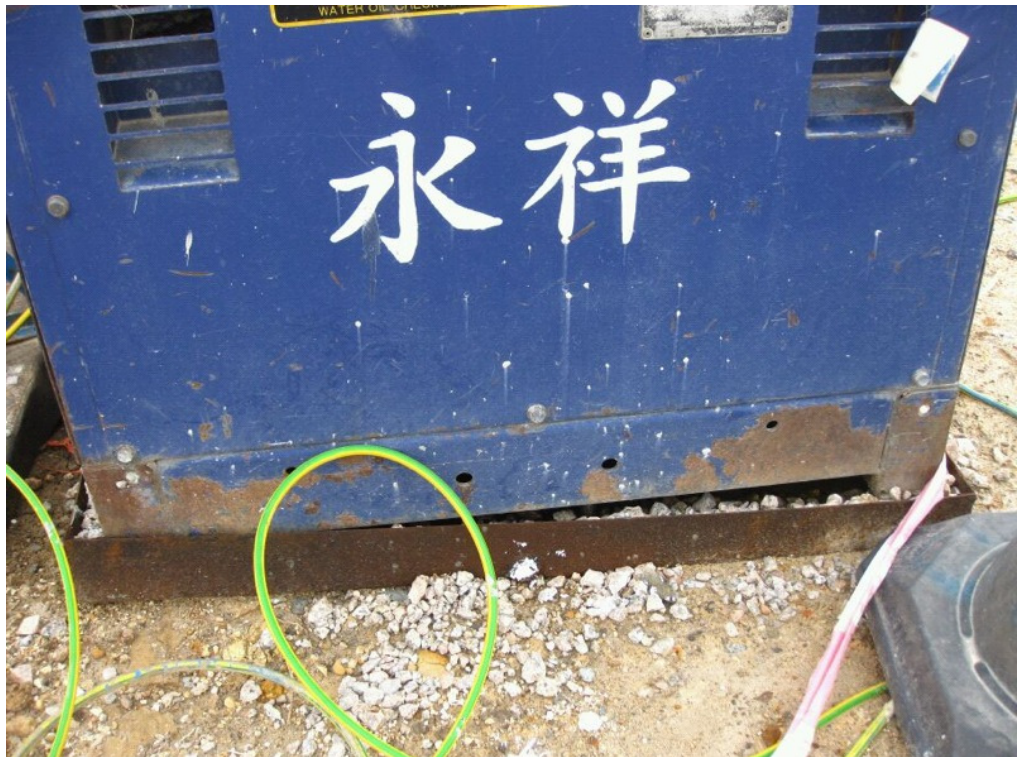
Photo 2 – The Contractor has plugged the hole immediately.

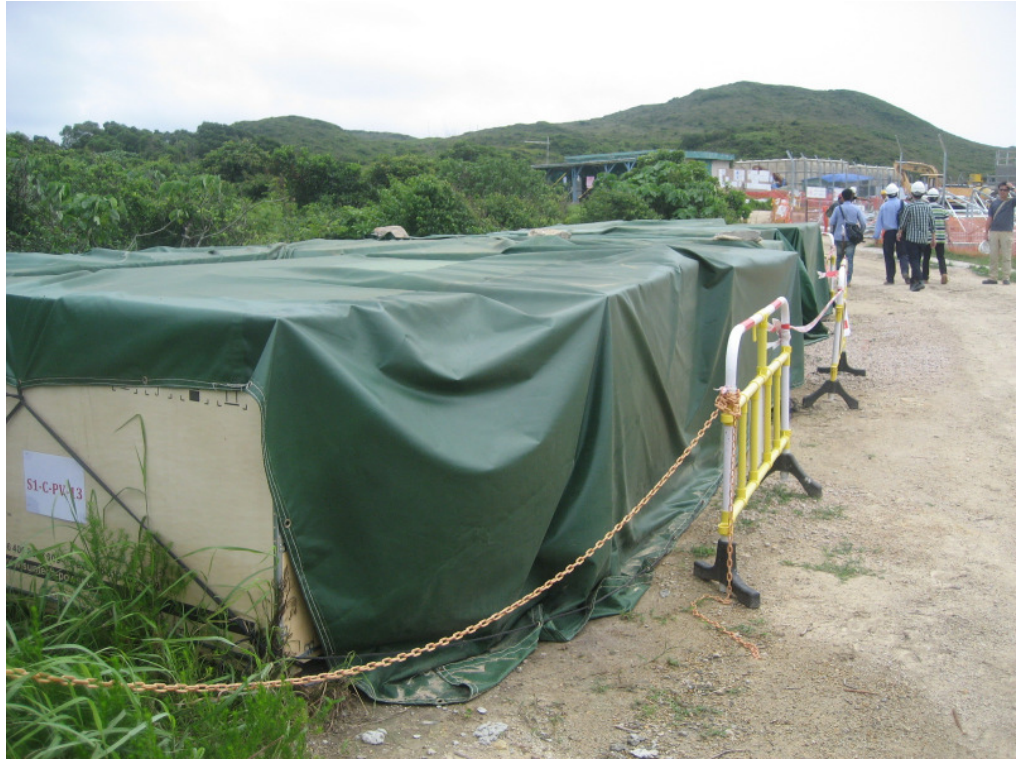
Photo 3 – Construction materials were observed storing outside the site boundary at Site 1.

- Drip tray for the generator at Site 1 was observed with a hole being unplugged (*Photo 1*). The Contractor has plugged the hole immediately (*Photo 2*).
- Construction materials were observed storing outside the site boundary at Site 1 (*Photo 3*). The Contractor was reminded to keep those construction materials within the site boundary.
