CLP Power Hong Kong Ltd

Renewable Energy Supply on
Town Island (Construction
Phase): *16th Monthly*
Environmental Site Audit Report

July 2012

Reference 0129569

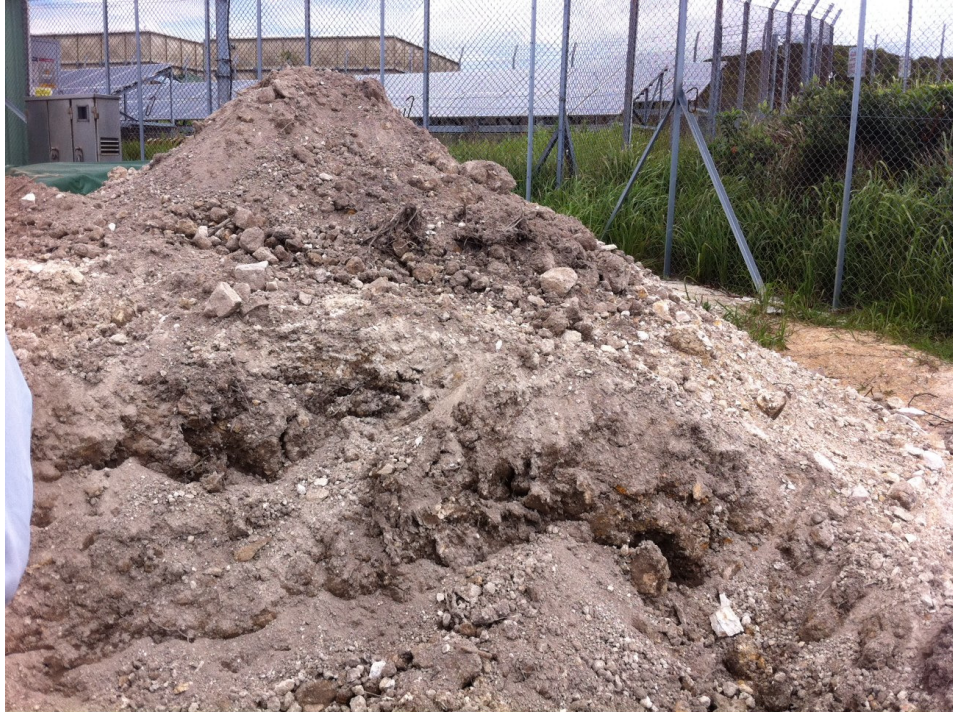
- 1) Dusty stockpile was observed not being properly covered at Site 1.
- 2) Cement stain was observed outside the site boundary at Site 2.

Photo 1 – Dusty stockpile was observed not being properly covered at Site 1.

- 1) The Contractor was reminded to cover the dusty stockpile properly.
- 2) The Contractor was reminded to remove the cement stain.

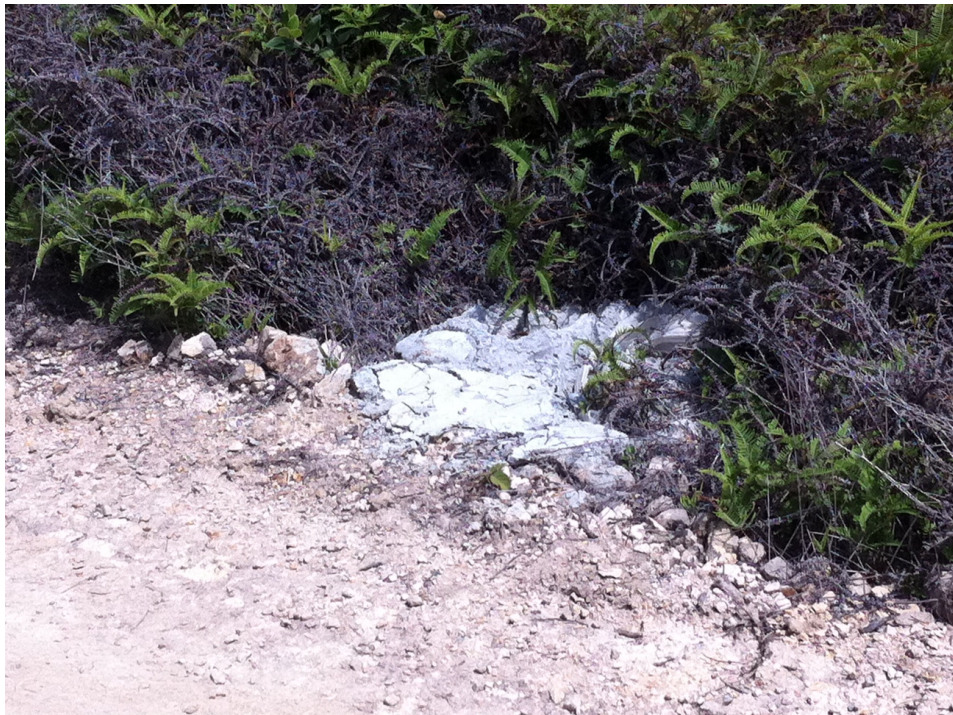
Photo 2 – Cement stain was observed outside the site boundary at Site 2.
