Renewable Energy Supply on Town Island (Construction Phase): 17th Monthly Environmental Site Audit Report

August 2012

Reference 0129569

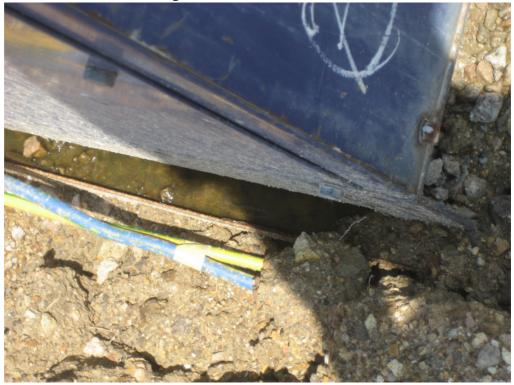
- Stagnant water was observed in the drip tray under the generator at Site 1 (*Photo 1*). The Contractor was asked to remove the stagnant water.
- Construction wastes were observed in the stream between Site 1 and Site 2.(Photo 2). The Contractor was asked to remove the construction wastes.
- General refuse was not properly stored at the designated area (for example the waste skip at Site 2). The Contractor was asked to store the general refuse properly at designated areas with cover.

Photo 1 – Stagnant water in the drip tray under the generator at Site 1.

2) The Contractor was asked to remove the stagnant water properly.
L	
	ignatures: CRepresentative: CLP Representative: Contractor: 3784
	A H
(N	laring: Andrew Fung) (Name: Raymond Ho) (Name: Mic Kwok)

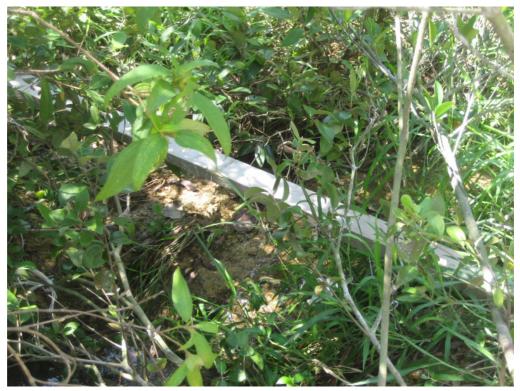
- Site 1 construction site.
	- Site 2 construction site.
Į	
[Notes / Issues Recorded On Site
	1) Construction wastes were observed in the stream between Site 1 and Site 2. Also general refuse was not properly stored at the designated area for example waste skip at Site 2. 2) Staggant water was observed in the drip troy under the page of the stage.
	Stagnant water was observed in the drip tray under the generator at Site 1.
L	
ľ	Corrective Actions
	The Contractor was asked to remove the construction wastes from stream and to store the general refuse properly at designated area with cover.

Photo 2 – Construction waste in the stream between Site 1 and Site 2.

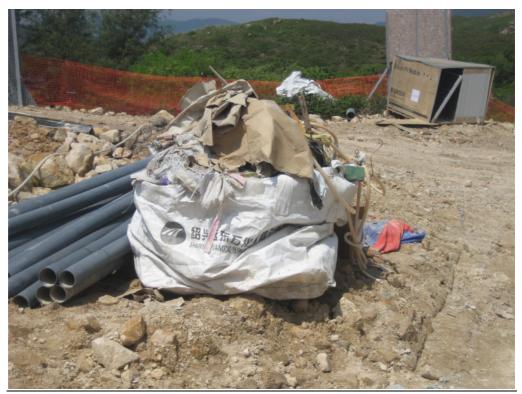
Photo 2 – General refuse was not properly stored at the designated area.
