CLP Power Hong Kong Ltd

Renewable Energy Supply on Town Island (Construction Phase): 19th Monthly Environmental Site Audit Report

October 2012

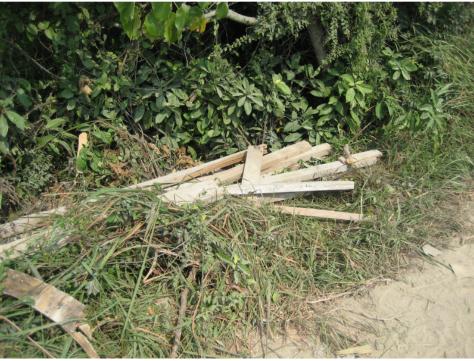
- Construction waste was dumped outside the boundary of Site 1 (*Photo 1*). The Contractor removed the construction waste immediately once notified; and
- Oil stain was found on the ground after the relocation of the generator at Site 1 (*Photo 2*). The Contractor removed the oil stain and disposed of it as chemical waste immediately once notified.

Photo 1 – Construction waste was dumped outside the boundary of Site 1

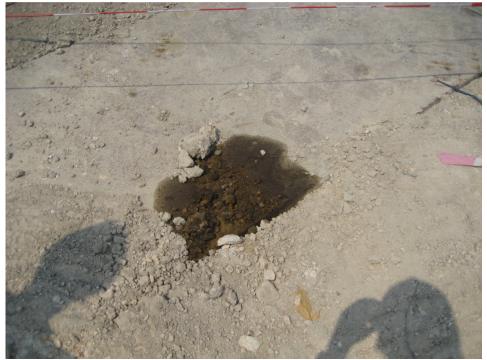
Photo 2 – Oil stain was observed on the ground after removing the generator

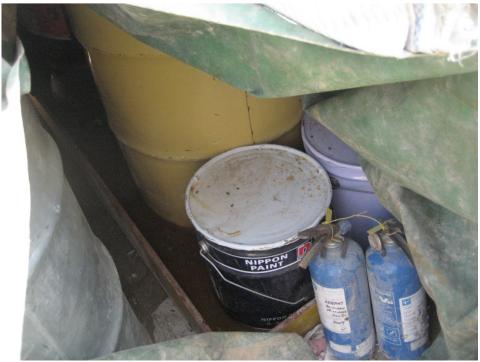
• Drip trays had been provided for the chemical drums at Site 1 (*Photo 3*).

Photo 3 – Drip trays had been provided for the chemical drums at Site 1
