CLP Power Hong Kong Ltd

Renewable Energy Supply on Town Island (Construction Phase): 20th Monthly Environmental Site Audit Report

November 2012

Reference 0129569

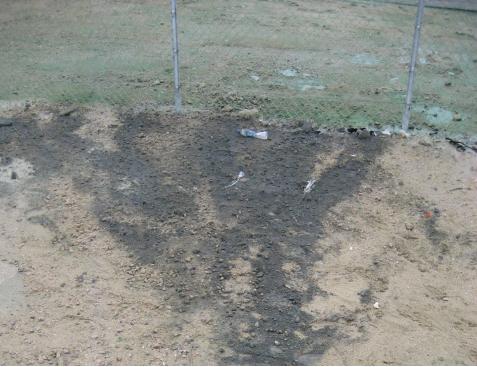
• Chemical stain was found on the ground near the entrance of Site 1 (*Photo* 1). The Contractor removed the chemical stain and disposed of it as chemical waste immediately once notified (*Photo* 2).

1) Chemical stain was found on the ground near the entrance of Site 1.

Photo 1 – Chemical stain was found on the ground near the entrance of Site 1.

1) The Contractor has removed the chemical stain immediately.

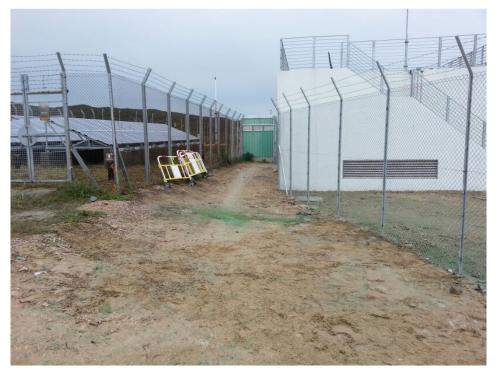
Photo 2 – Chemical stain had been removed following notification.
