TEST REPORT

PENTA-OCEAN CONSTRUCTION CO. LTD.

**OPERATION OF FILL BANK AT
TSEUNG KWAN O AREA 137 AND
BARGING FACILITIES AT HONG
KONG ISLAND AND MUI WO
(CONTRACT NO.: CV/2005/05)**

**MONTHLY EM&A REPORT
(JULY 2005)**

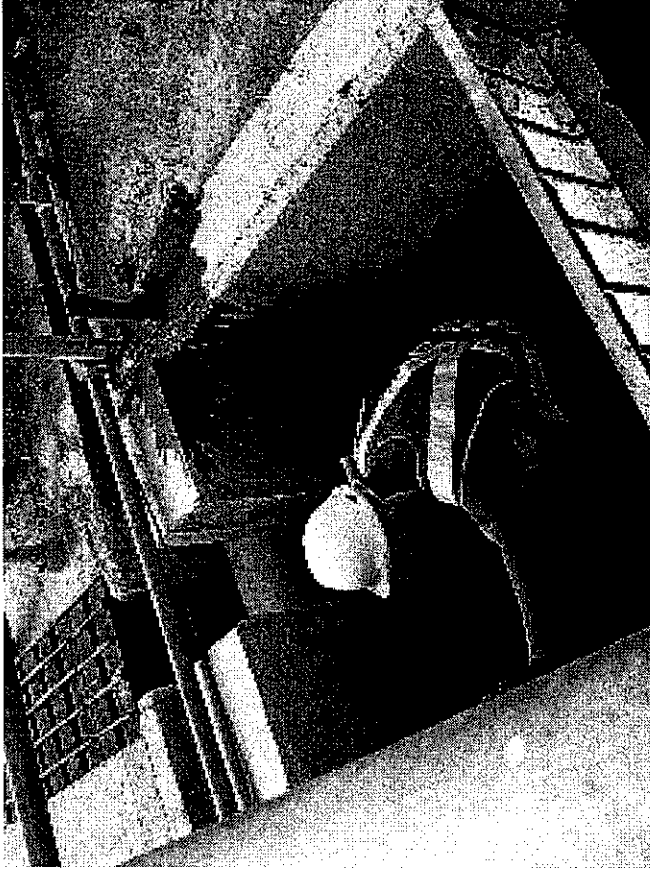
Photo No.: PICT0854

4	Rain water was accumulated in drip tray near Work Shop at Portion i. The Contractor was reminded to drain the rain water immediately.	The stagnant water was cleared.	27 July 2005
5	Rain water was accumulated in drainage channel near Gammon Site Office at Portion K. The Contractor was reminded to provide insecticide to the drainage system regularly in order to prevent mosquito breeding.	Larvicide granule was applied to the drainage channel near Gammon Site Office at Portion K.	27 July 2005
