Contract No. HY/2003/19

**Improvement to Tung Chung Road
between Lung Tseng Tau and Cheung Sha**

**Bi-Monthly EM&A Report for Ecological
Mitigation Audit and Landscape & Visual
Resources Audit (Version 1.0)**

January 2010

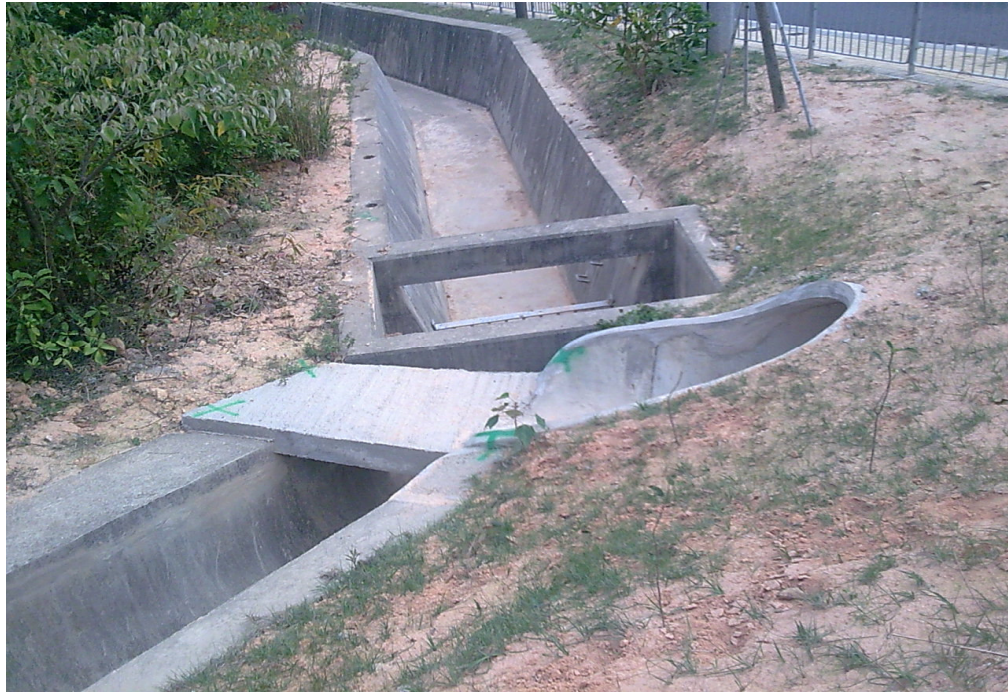
(1) Opening of Wildlife Tunnel (C)

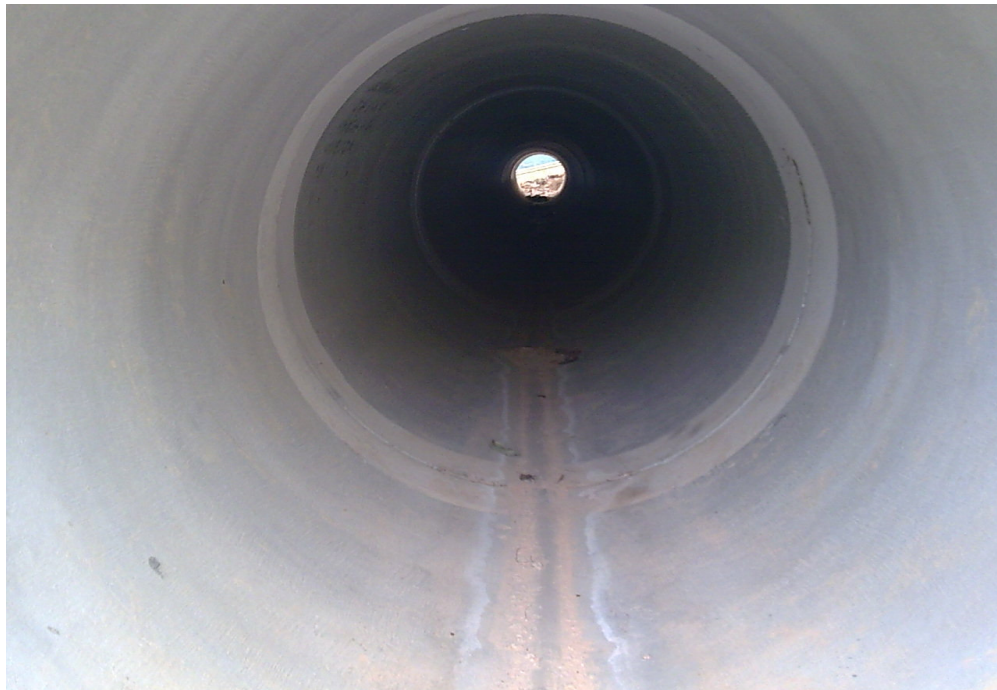
(2) Circular and smooth surface of the wildlife tunnel may cause difficulty in movement of organisms especially for mammals.	2 & 7
	(3) No shelter and/or hiding place is provided at or near the wildlife tunnels, organisms will be at risk when passing through or accessing the tunnels. Avoidance for the use of the tunnels by organisms is therefore resulted.	1, 2, 3, 5 & 7
Location and Orientation of the wildlife tunnels	(1) The opening of wildlife tunnels cannot be seen at the natural habitats of organisms. Organisms cannot notice the presence of wildlife tunnel when they are moving along the shrub near the tunnel.	3 & 4

(2) Inside Wildlife Tunnel (C)

Recommendations	Description	Reference in Appendix B	Reason
	(3) Roughen the surface of the wildlife tunnels	-	
Reduce avoidance of organisms to the wildlife tunnels	(1) Adjusting the openness ratio of the wildlife tunnels.	Clause 4.5 & 4.6	Openness ratio of the wildlife tunnel will affect the sense of safety of organism while using the tunnel.

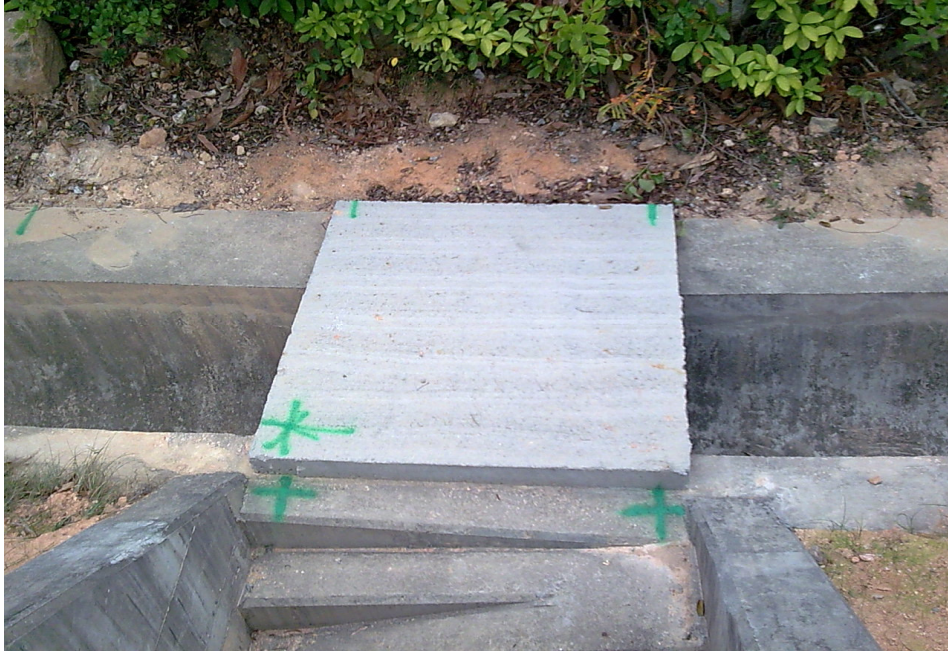
Suggested Reason	Description	Reference Photo
Difficulty to access the wildlife ramps	(1) The height of each step of wildlife ramps may cause inaccessibility to organisms and the total length of the sloped steps is too long for amphibian especially for the tiny organisms (e.g. Romer's Tree Frog).	3 & 7
Substratum and Surface of the wildlife ramps	(1) The surface and substratum of the wildlife ramps is only made up of artificial materials. This makes the tunnel less attractive to wild organisms.	3

(3) Opening of Wildlife Tunnel with Wildlife Ramp (B)

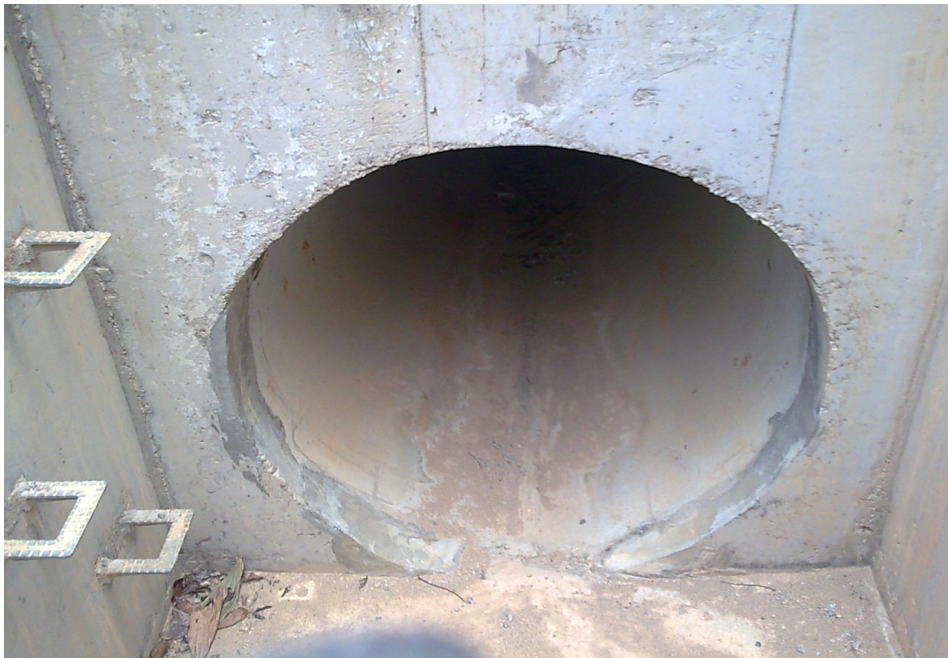
(4) Opening of Wildlife Tunnel (B)

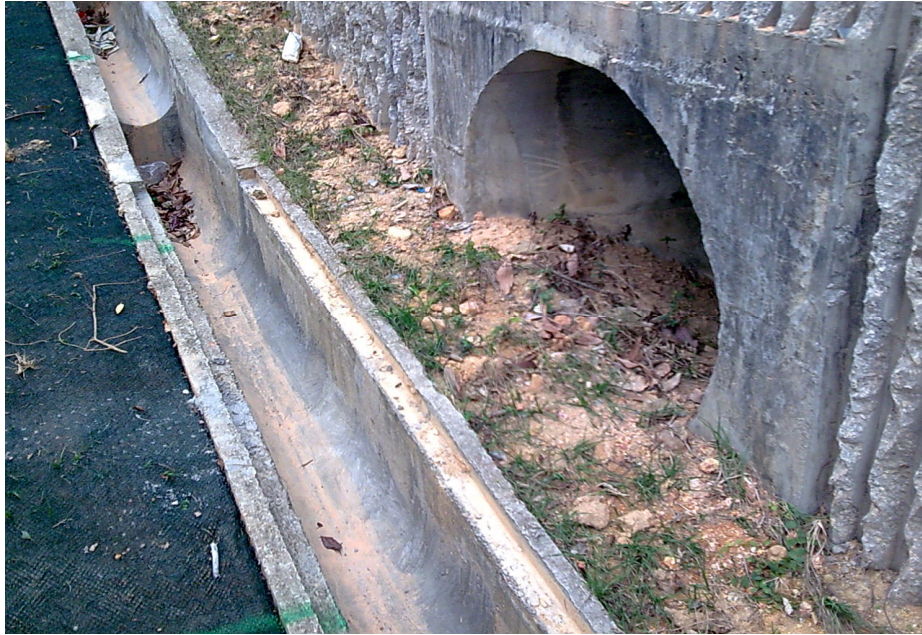
(5) Opening / Entracne of the Wildlife Tunnel (B)

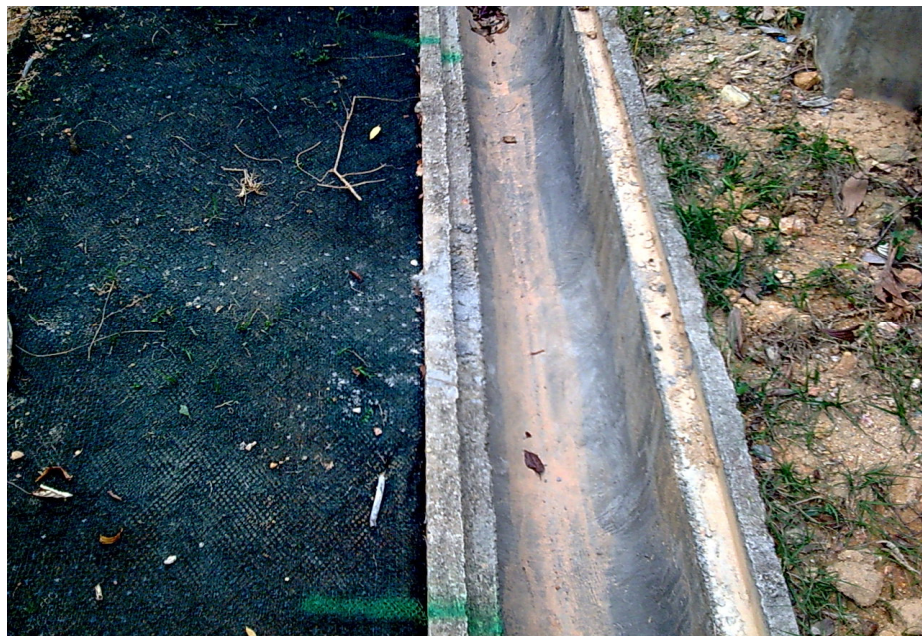
(6) Area at the opening of Wildlife Tunnel (B)

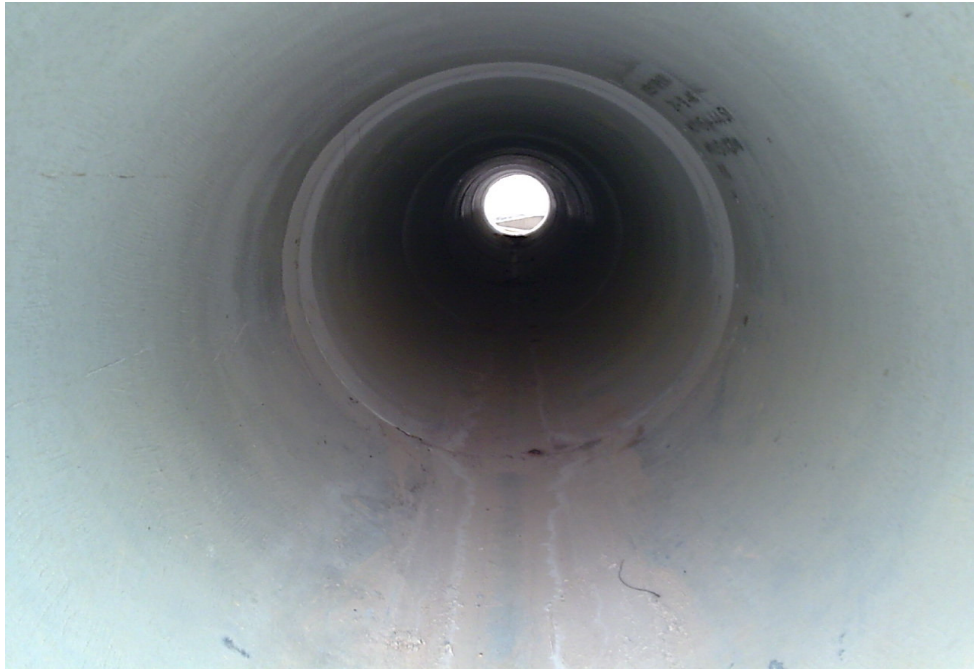
(7) Inside Wildlife Tunnel (B)

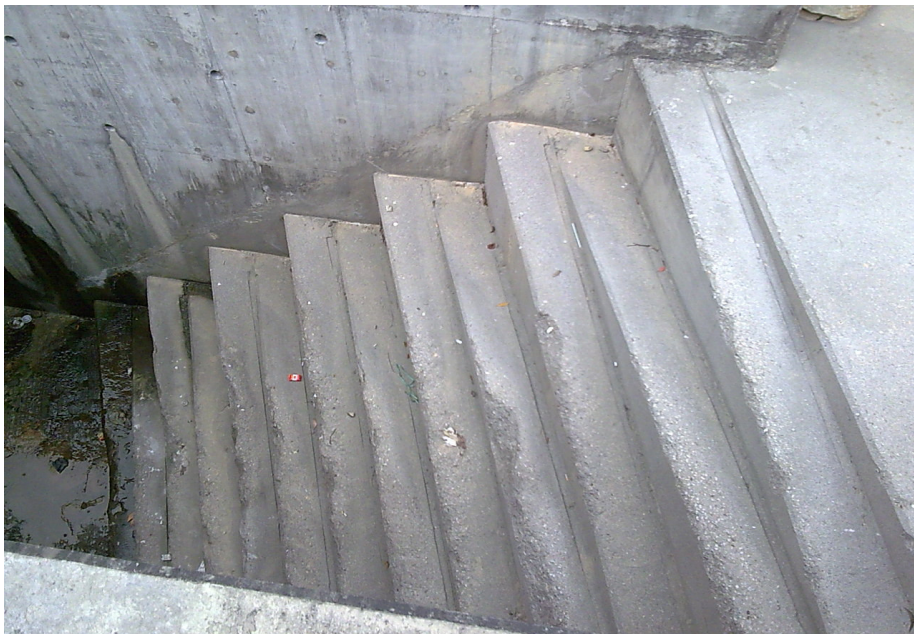
(8) The sloped Step at Wildlife Ramp (A)

Recommendations	Description	Reference in Appendix B	Reason
Increase the accessibility of the wildlife ramps	(1) Reduce the height of each step of the wildlife ramps.	-	
	(2) Installation of fencing mechanism near the wildlife ramps.	Section 5	Fencing system can guide organisms to the mitigation measures.
	(3) Increase the area of the platform at the opening of the wildlife ramps.	-

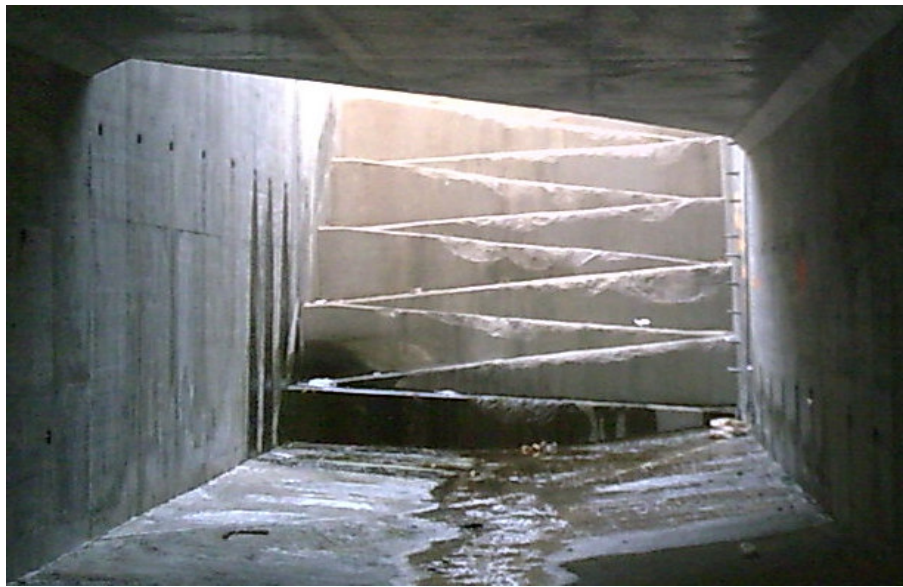
(9) Inside the Wildlife Tunnel (A)
