Contract No. HY/2003/19

**Improvement to Tung Chung Road
between Lung Tseng Tau and Cheung Sha**

**Report for Ecological Mitigation Audit and
Landscape & Visual Resources Audit
(Version 1.0)**

November 2009

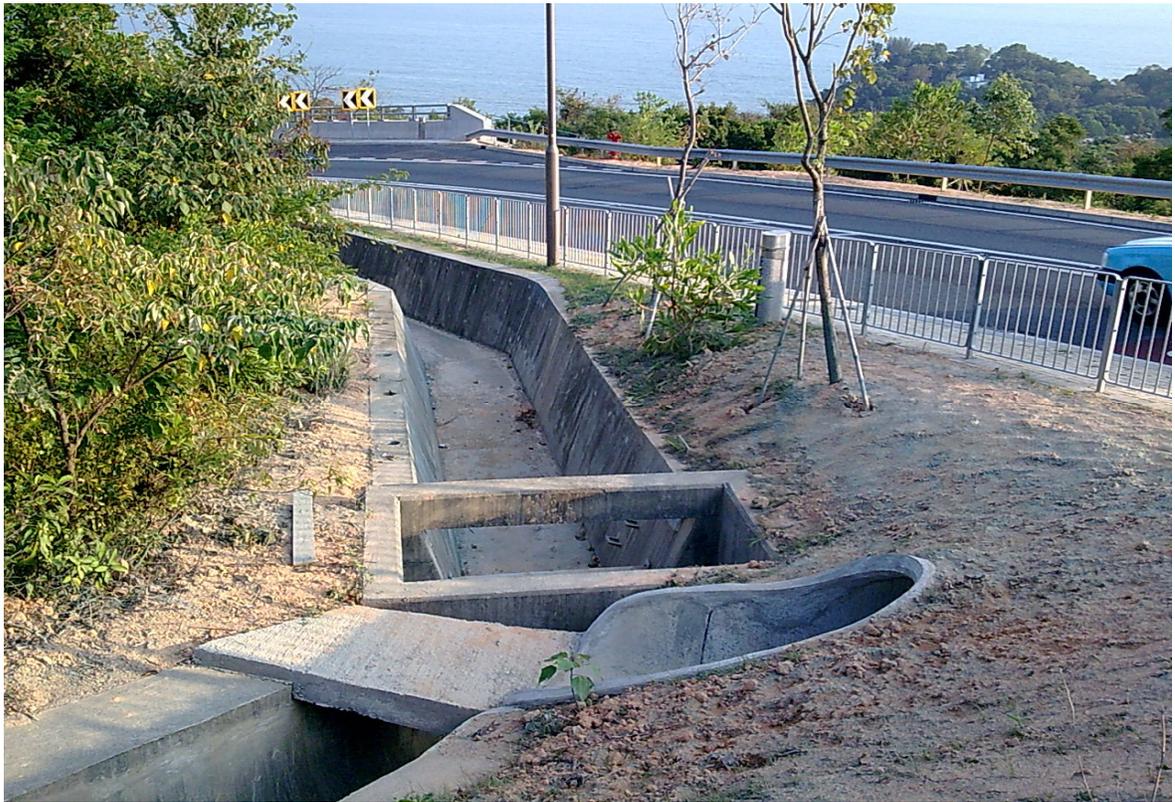
(1) opening of Wildlife Tunnel

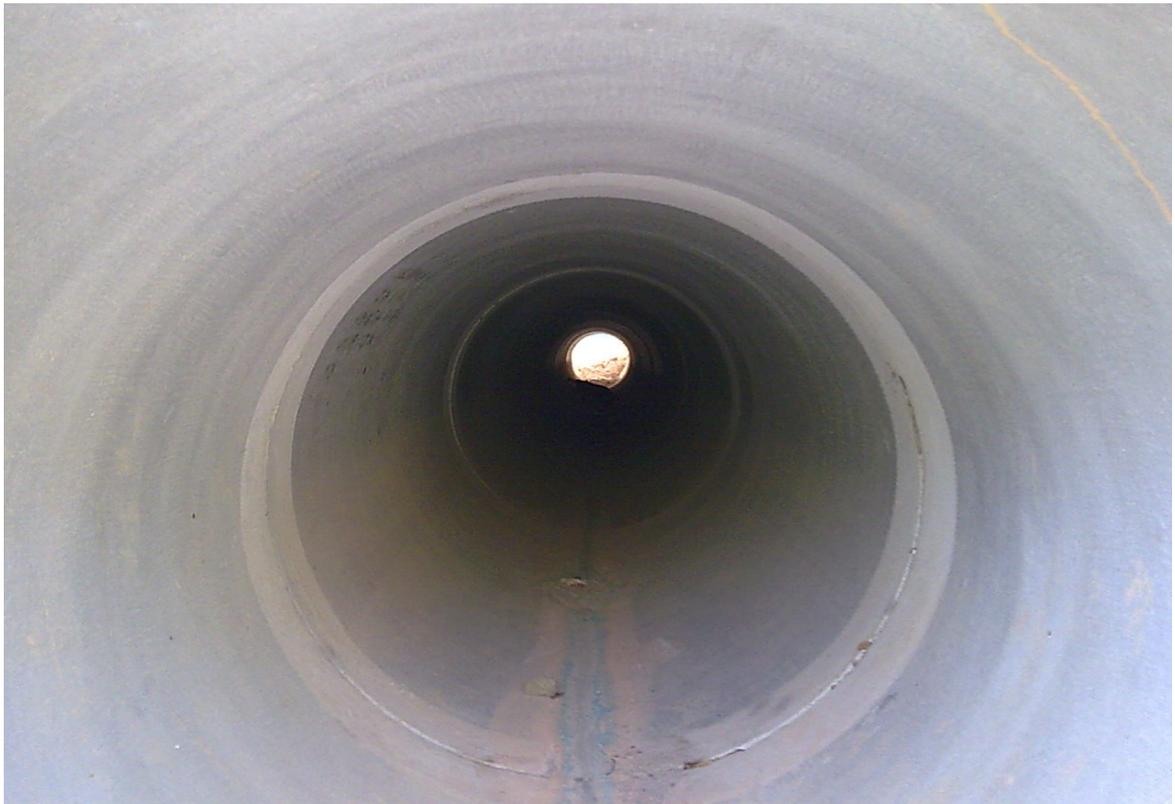
(2) Circular and smooth surface of the wildlife tunnel may cause difficulty in movement of organisms especially for mammals.	2
	(3) No shelter and/or hiding place is provided at or near the wildlife tunnels, organisms will be at risk when passing through or accessing the tunnels. Avoidance for the use of the tunnels by organisms is therefore resulted.	1, 2, 3 & 8
Location and Orientation of the wildlife tunnels	(1) The opening of wildlife tunnels cannot be seen at the natural habitats of organisms. Organisms cannot notice the presence of wildlife tunnel when they are moving along the shrub near the tunnel.	3 & 4

(2) Inside Wildlife Tunnel

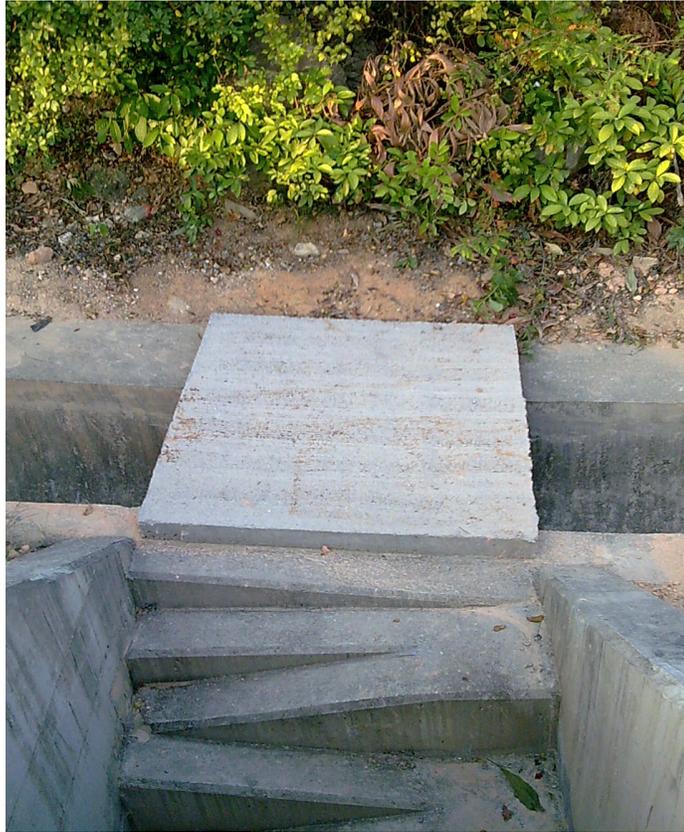
Suggested reason	Description	Reference Photo
Difficulty to access the wildlife ramps	(1) The height of each step of wildlife ramps may cause inaccessibility to organisms and the total length of the sloped steps is too long for amphibian especially for the tiny organisms (e.g. Romer's Tree Frog).	3 & 7
Substratum and Surface of the wildlife ramps	(1) The surface and substratum of the wildlife ramps is only made up of artificial materials. This makes the tunnel less attractive to wild organisms.	3

(3) Opening of wildlife tunnel with wilfe ramp

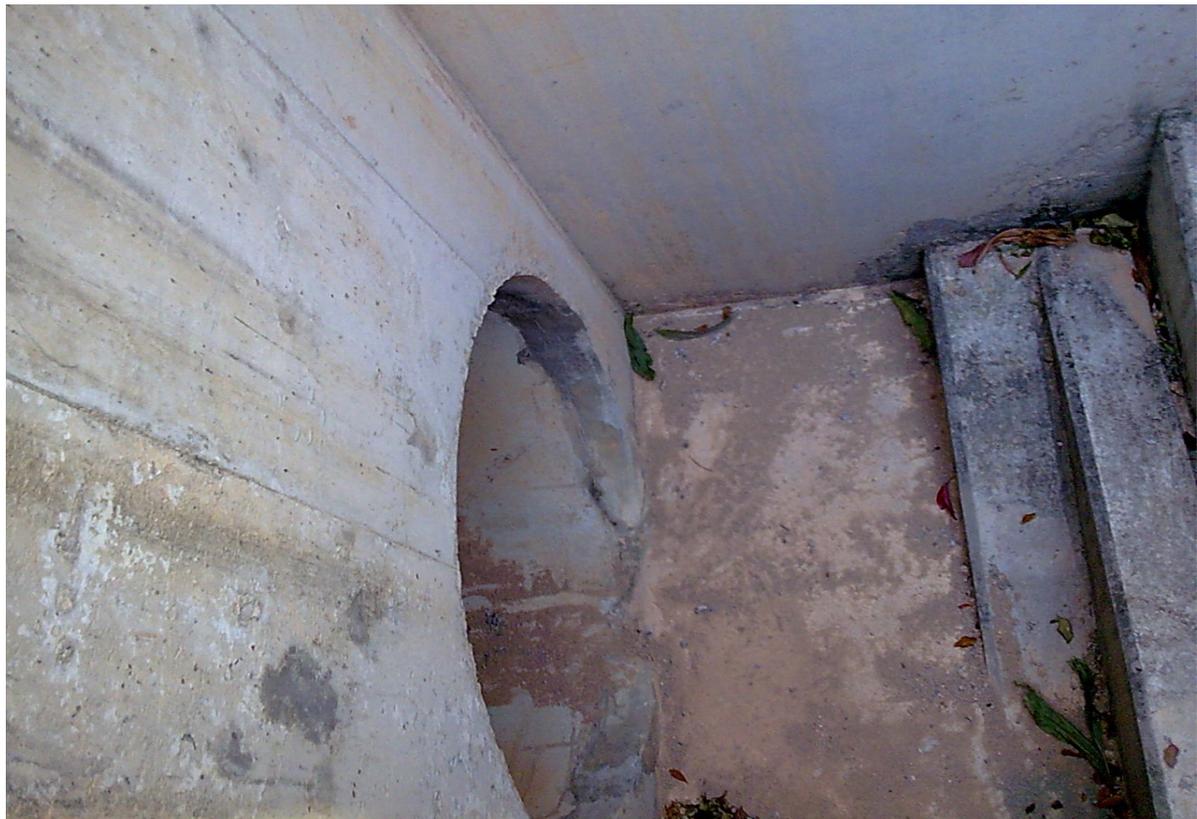
(4) Opening of wildlife tunnel with wilfe ramp

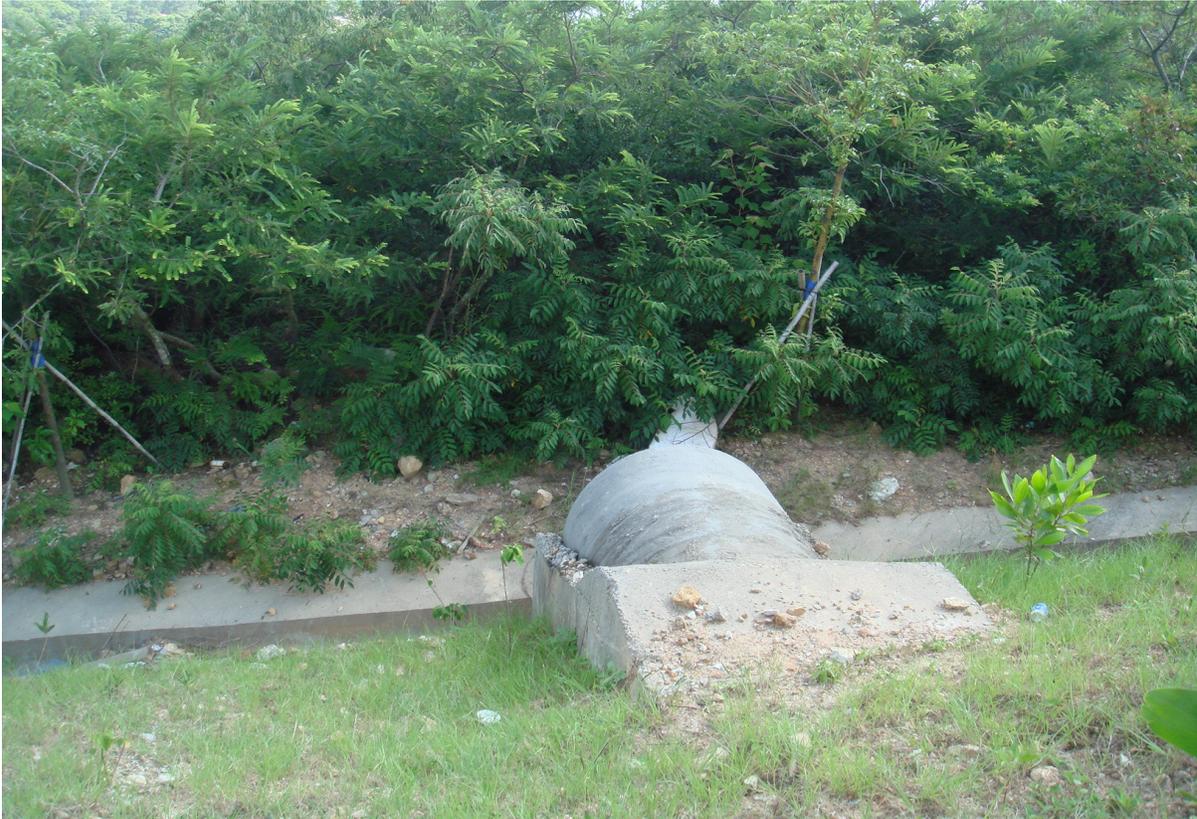
(5) Opening / Entracne of the Wildlife Tunnel

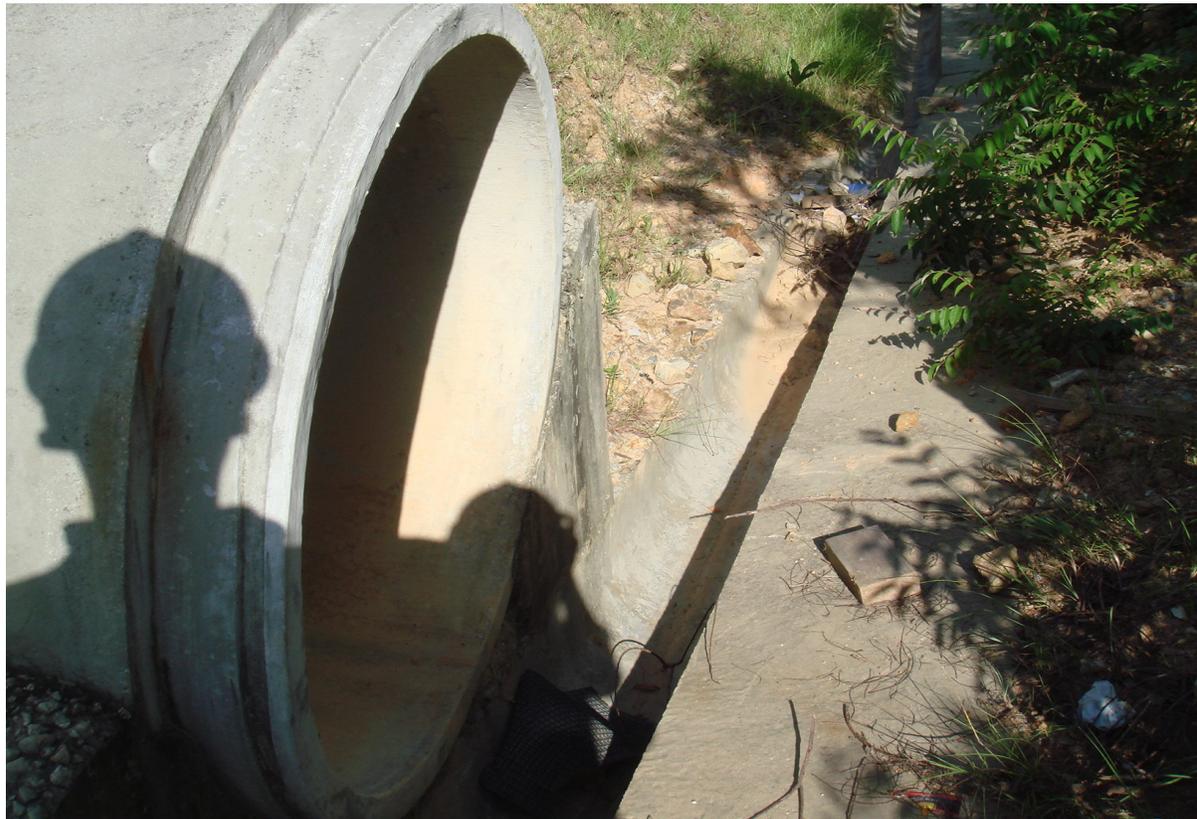
(6) Opening / Entrance of Wildlife Tunnel

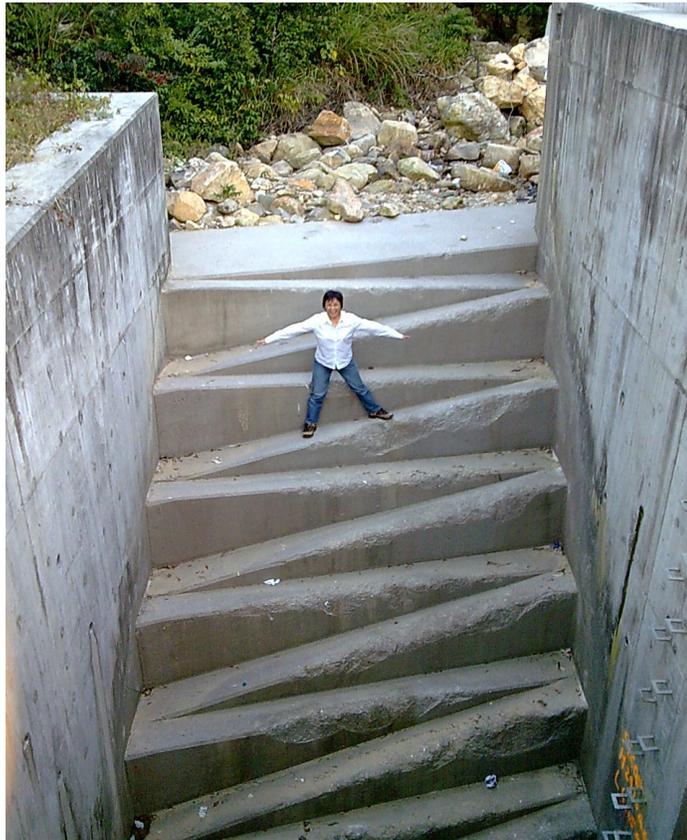
(7) The sloped step at Wildlife Ramp (Stream 15)

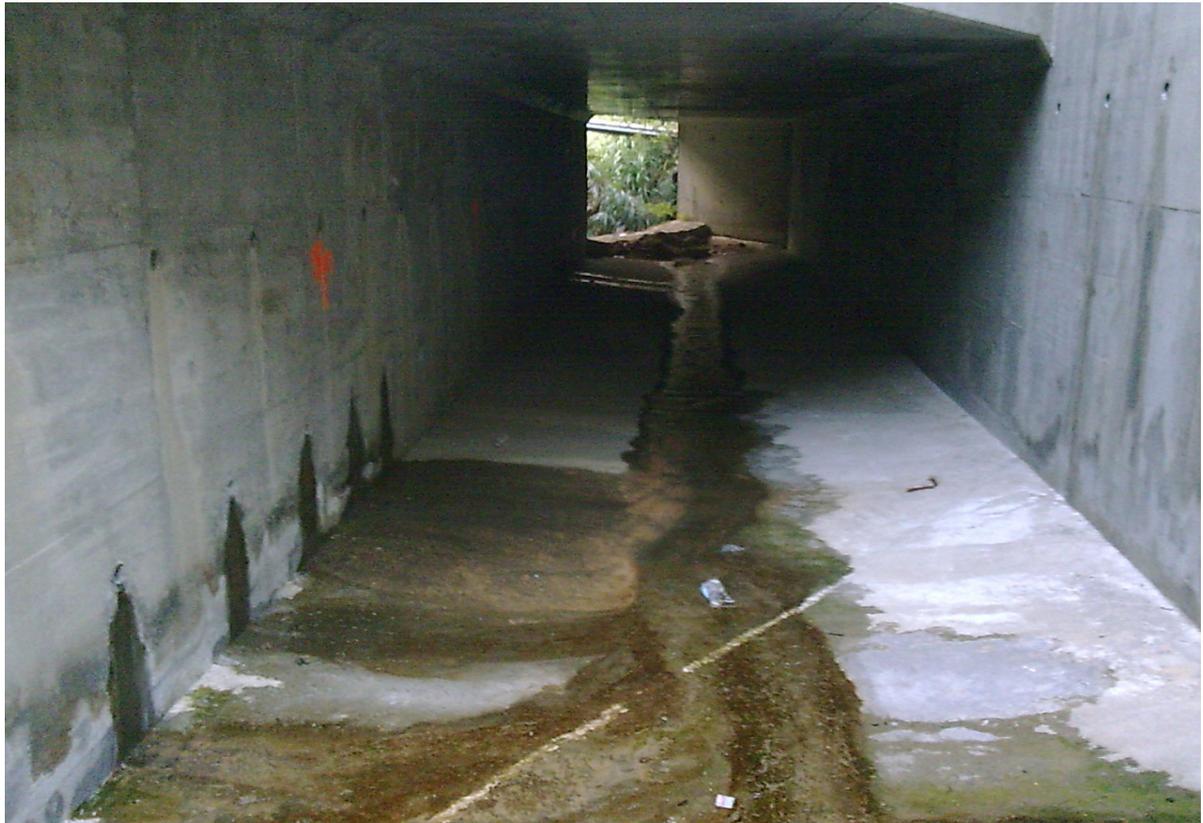
(8) Inside the Wildlife Tunnel(Stream 15)

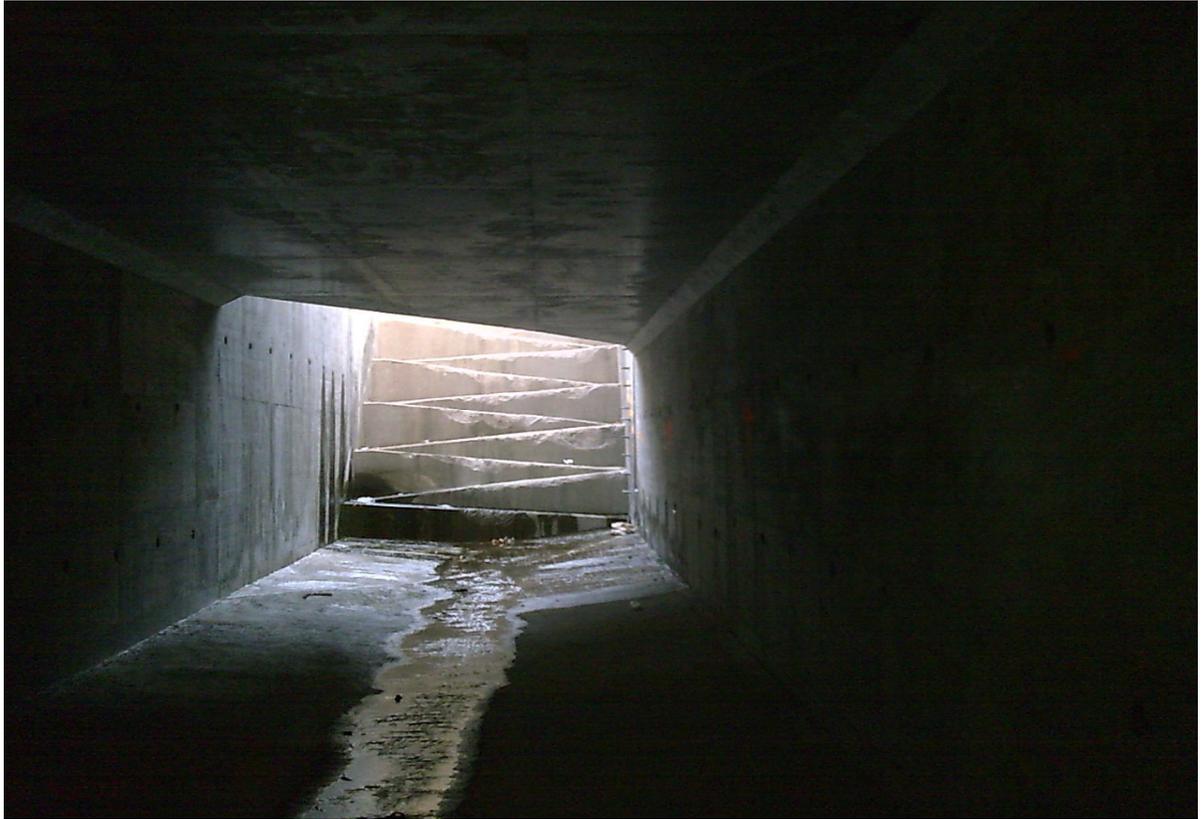
(9) Another view inside the Wildlife Tunnel (Stream 15)

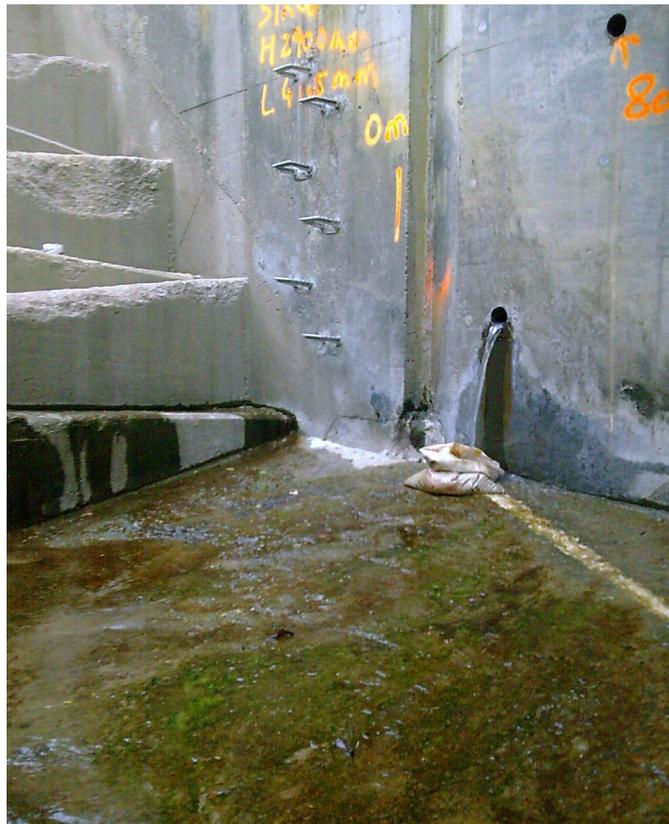
(10) The wall of the Wildlife tunnel (Stream 15)
