ECO Aviation Fuel Services Limited

PERMANENT AVIATION FUEL FACILITY

ANNUAL AUDIT REPORT

Date: March 2013

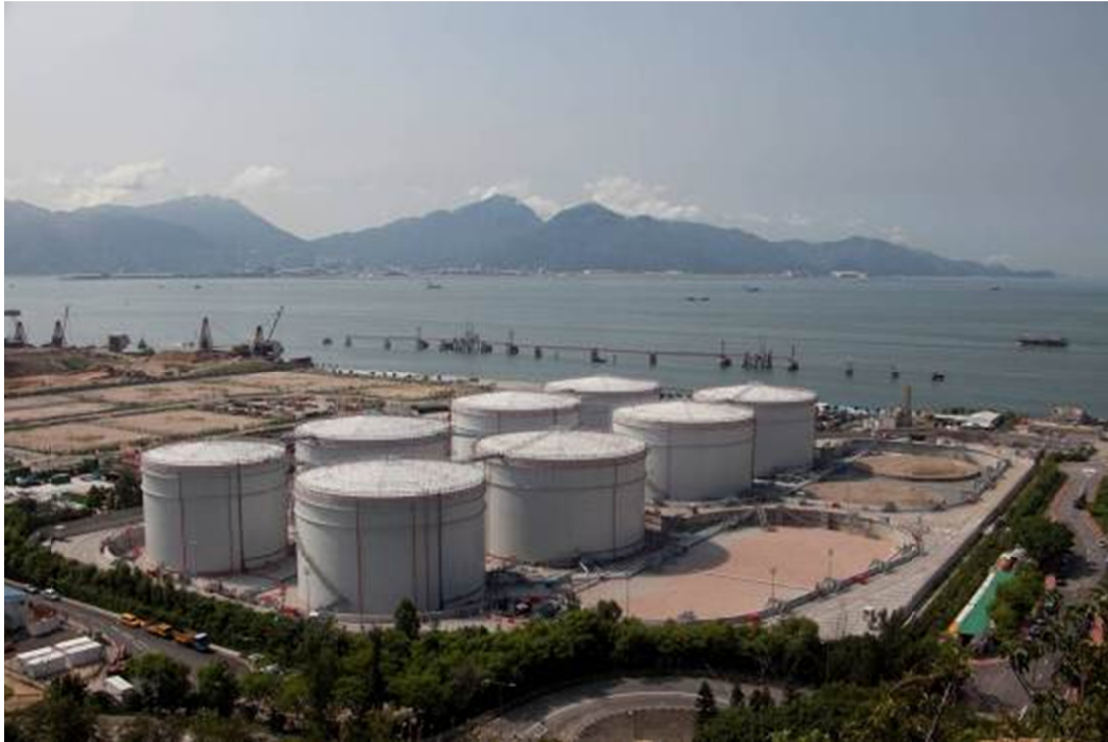
(1) All eight tanks are located within bunded compounds

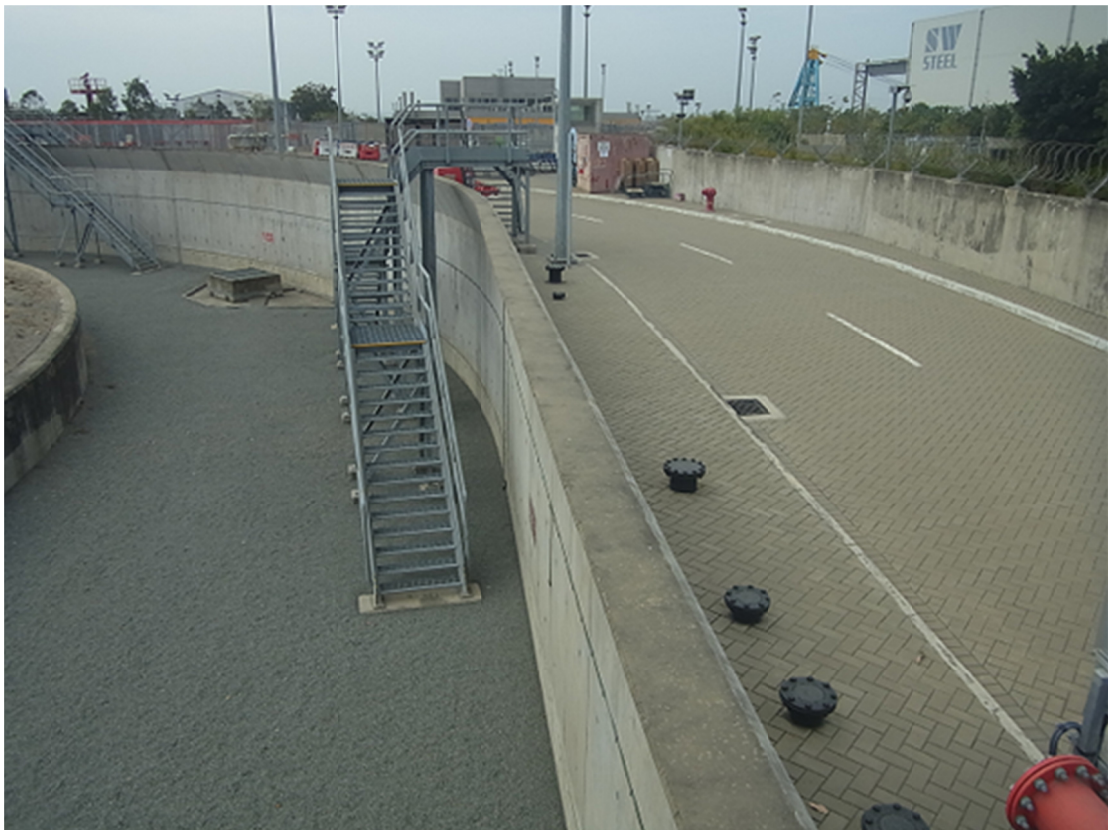
(2) Phase 1a bunded compound is partly sunken below the level of ground outside the bunds

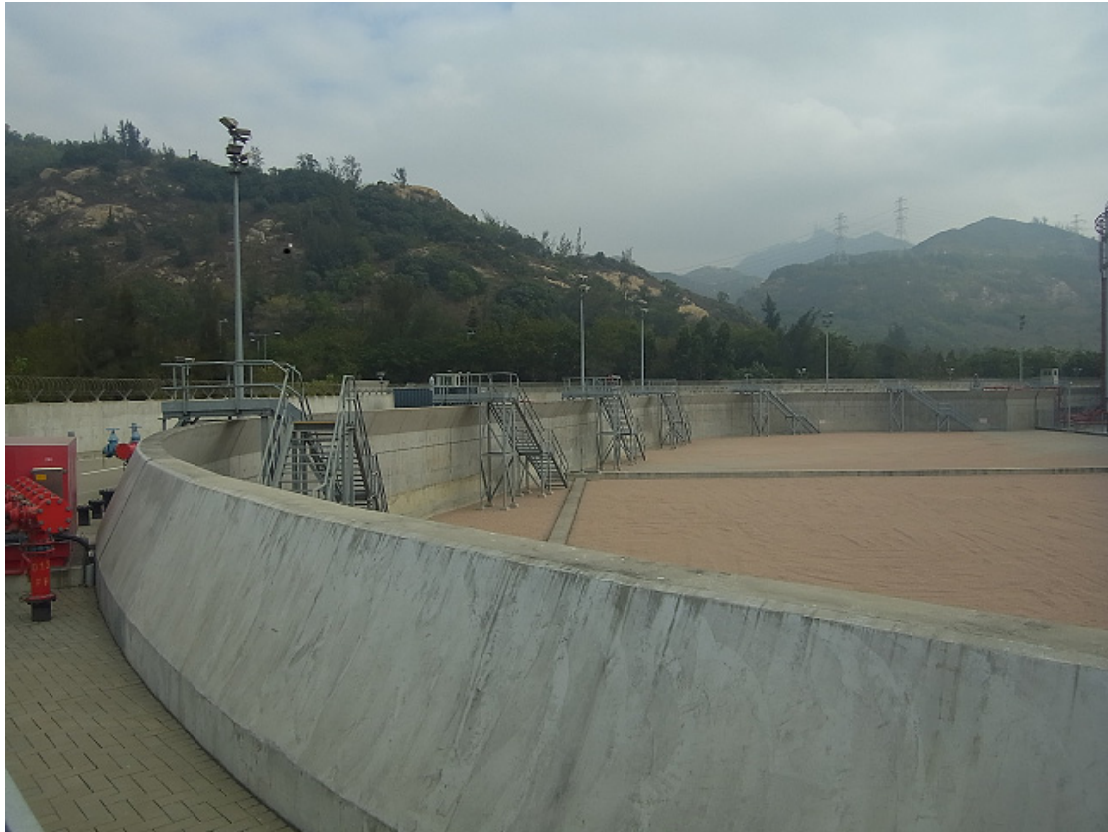
(3) Phase 1b bunded compound is partly sunken below the level of ground outside the bunds

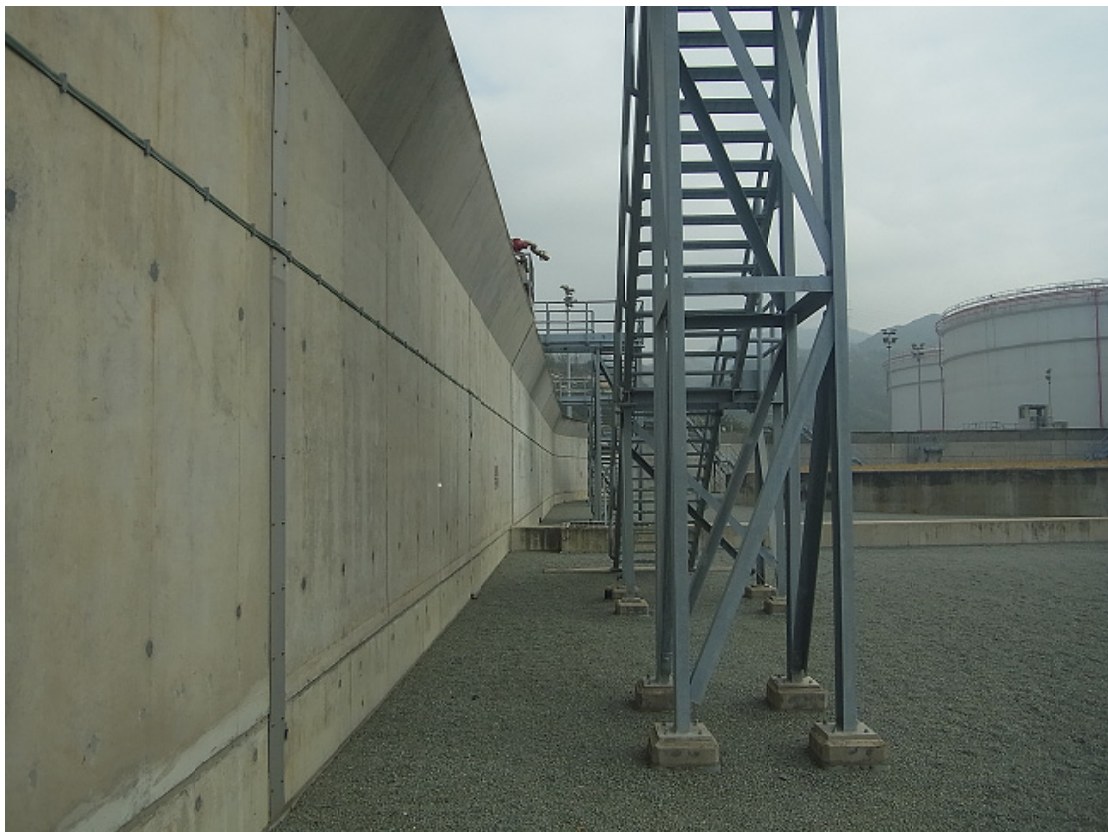
(4) Wave deflector provided at top of the bunds

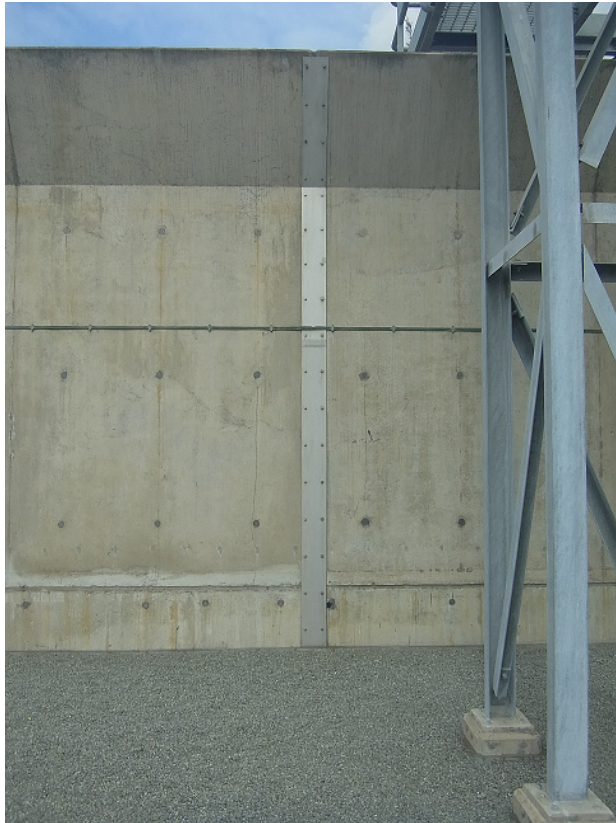
(5) Visible parts of the joints are covered by stainless steel plates on the inside at phase 1a bund

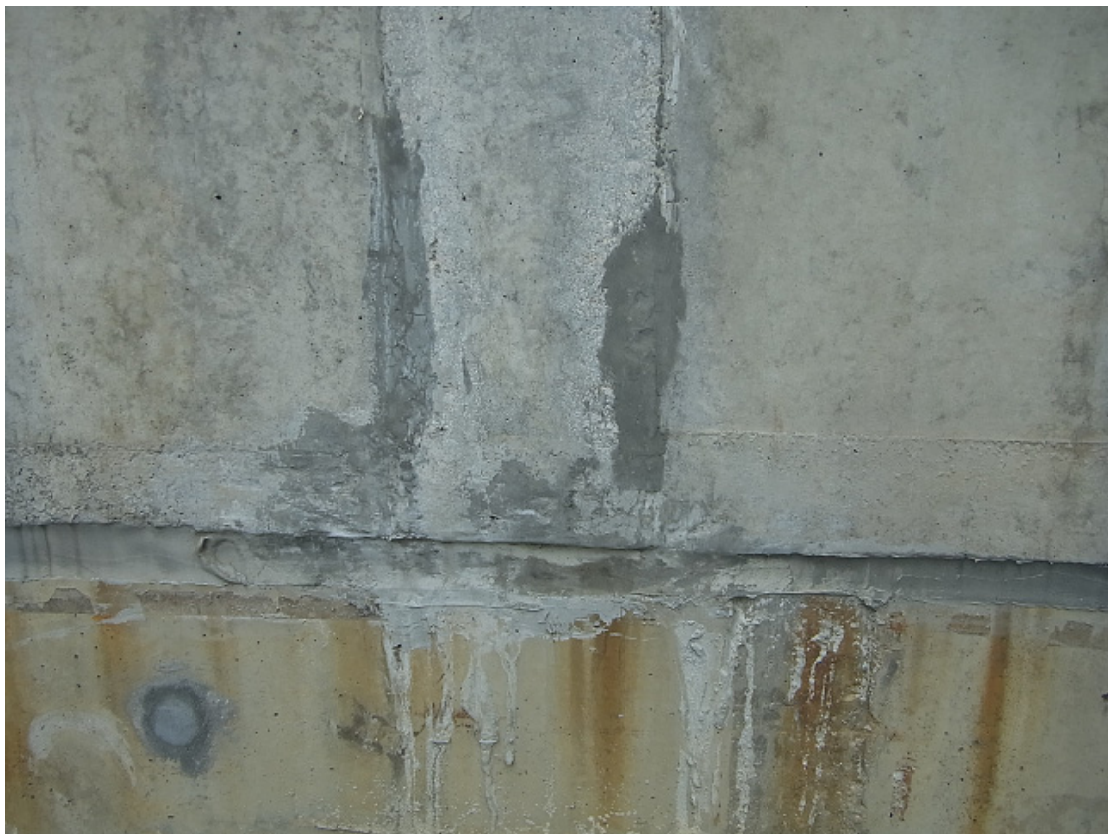
(6) Maintenance works have been performed on sealant at joints

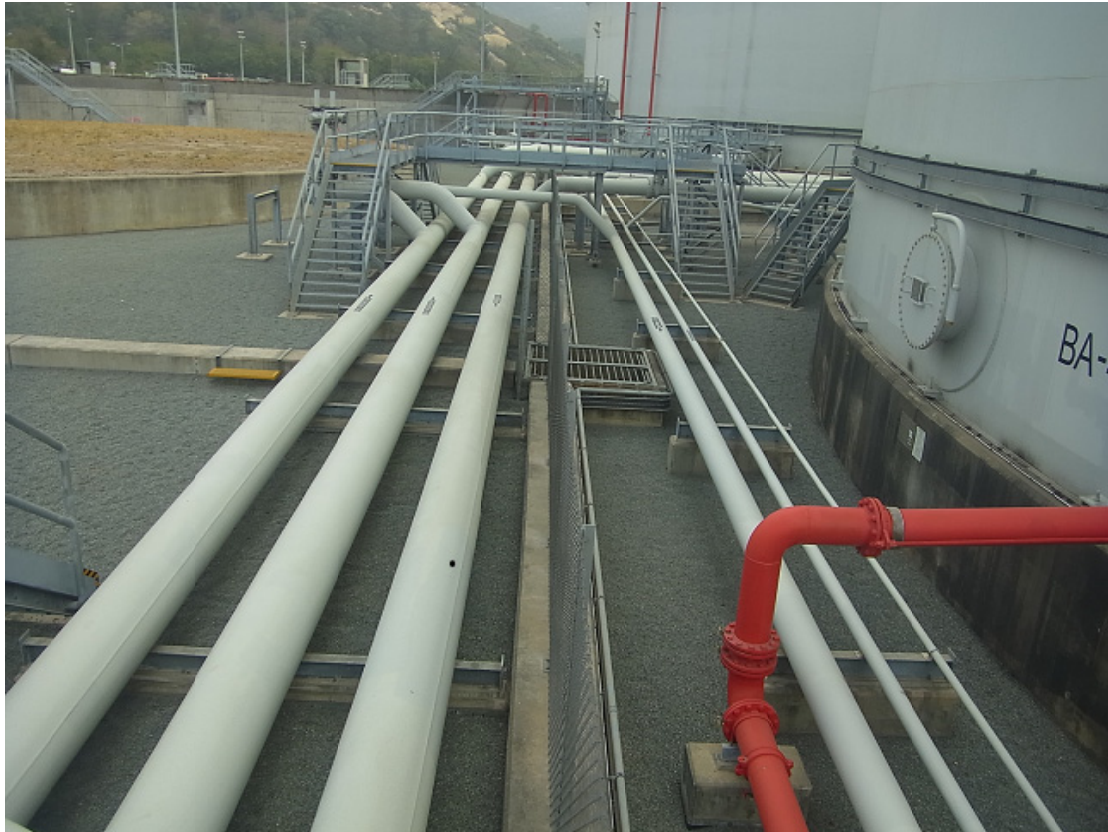
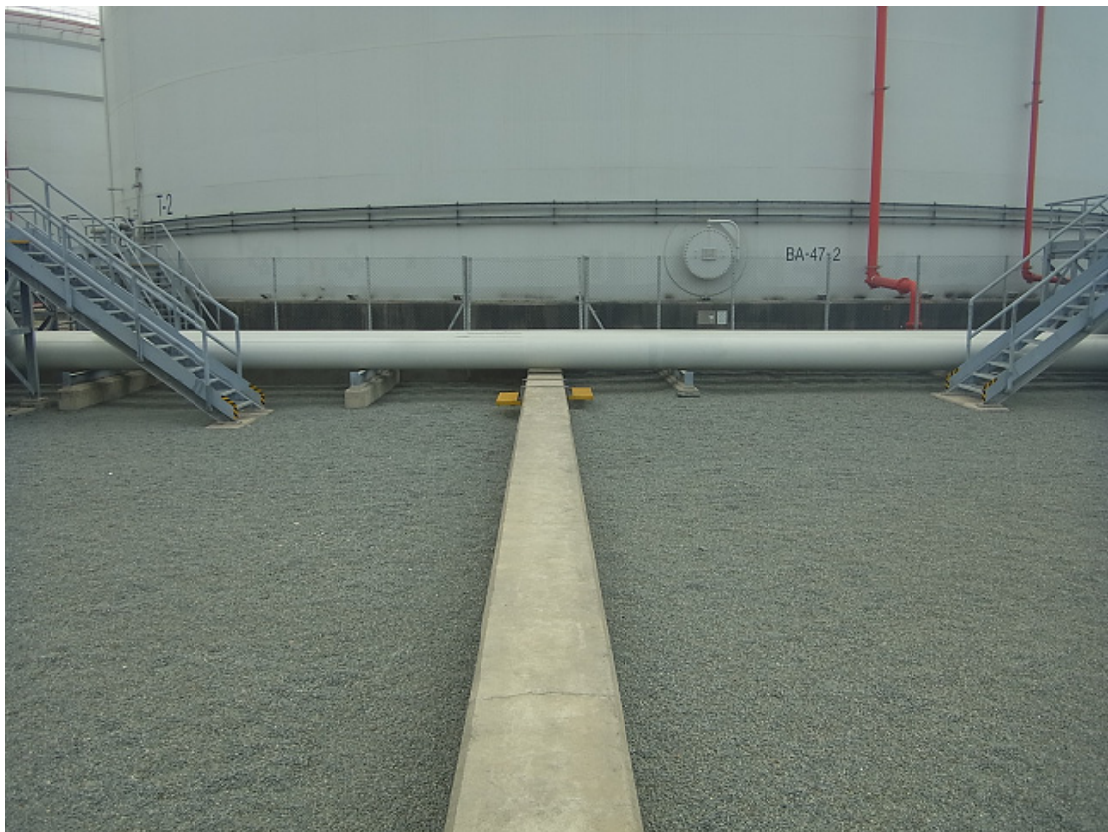
(7) Intermediate bund walls are provided in place near T-01-002

(8) Intermediate bund walls are provided in place near T-01-002

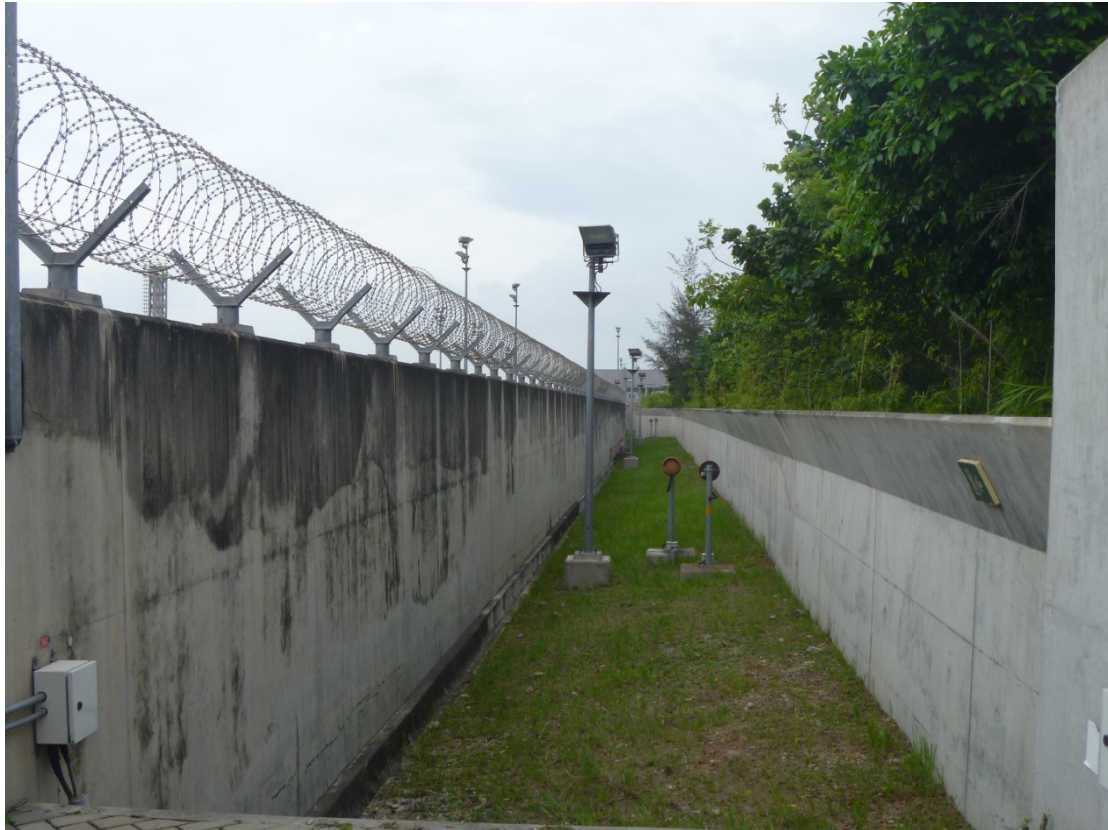
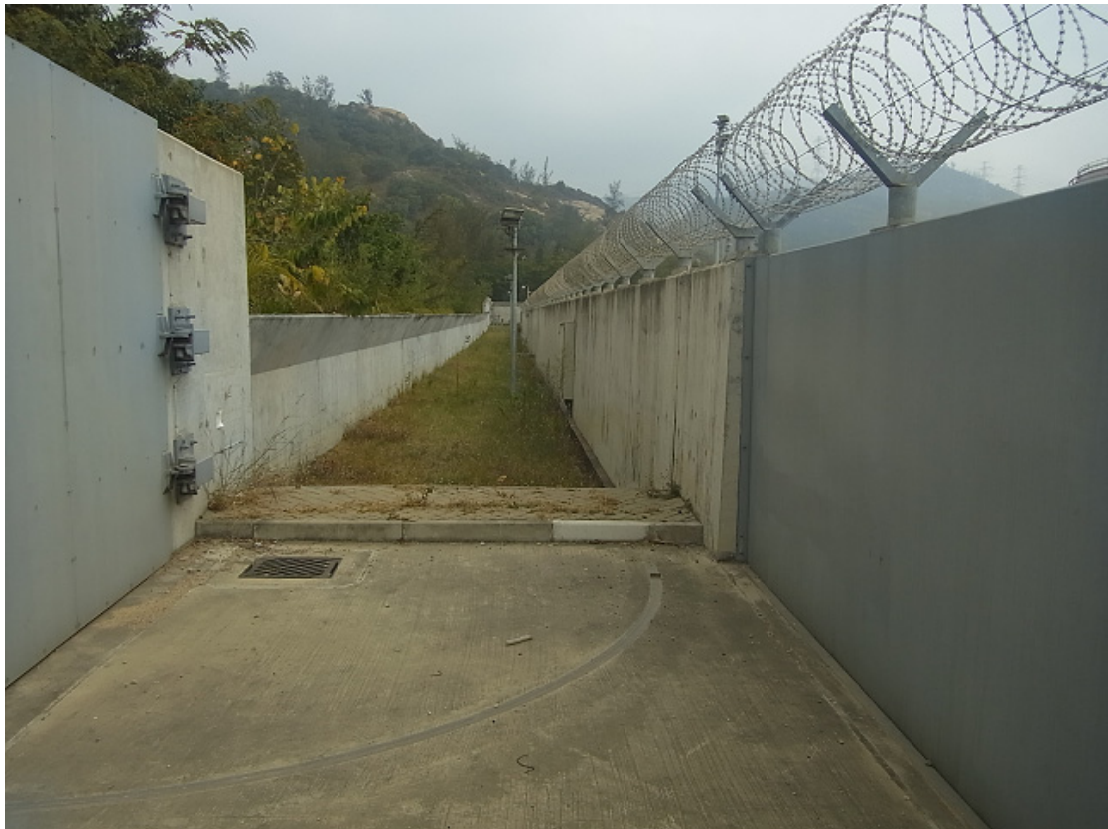
(9) Two impervious security walls are provided outside the bunded compounds

(10) Two impervious security walls are provided outside the bunded compounds

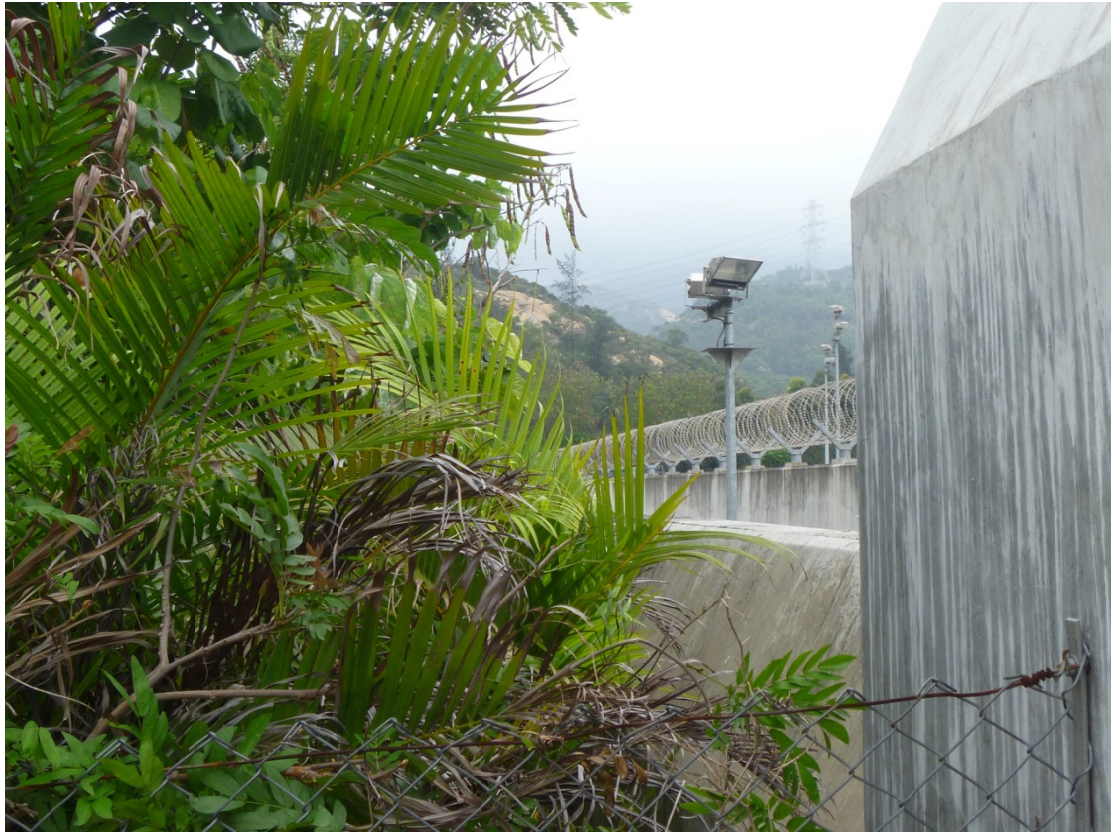
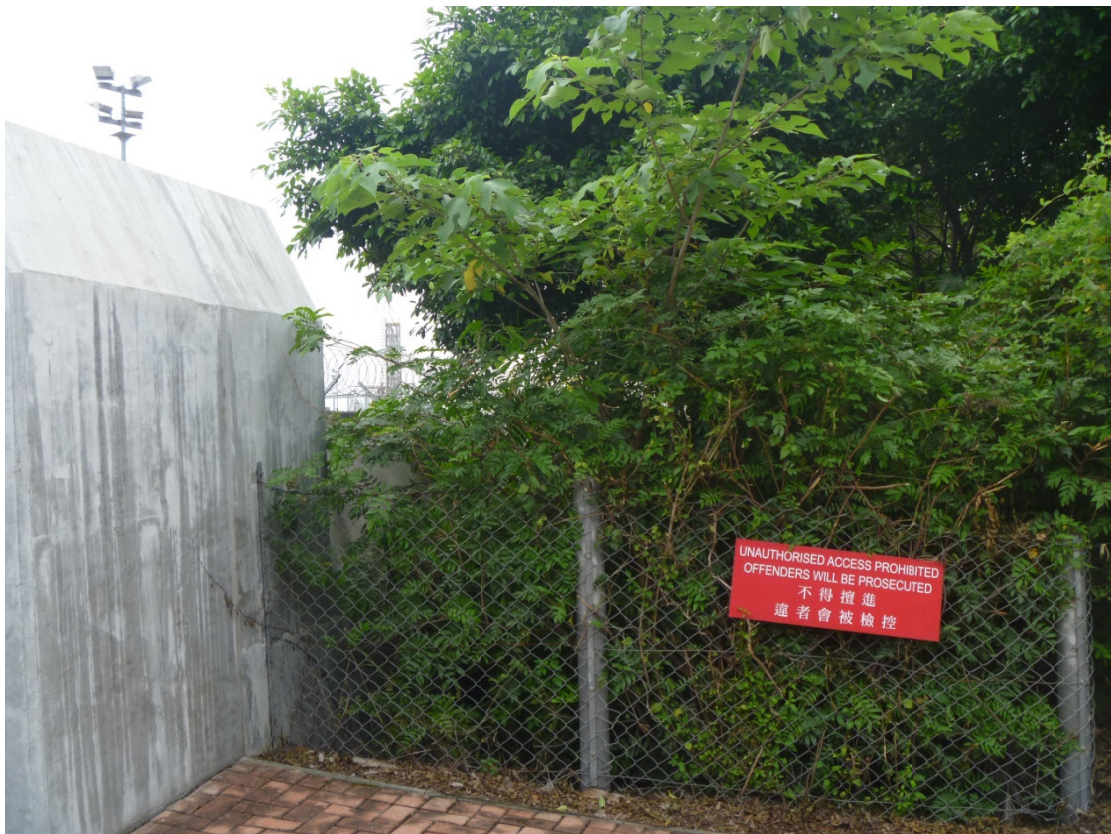
(11) Landscaped berm is maintained at least 1.5m high

(12) Landscaped berm is maintained at least 1.5m high

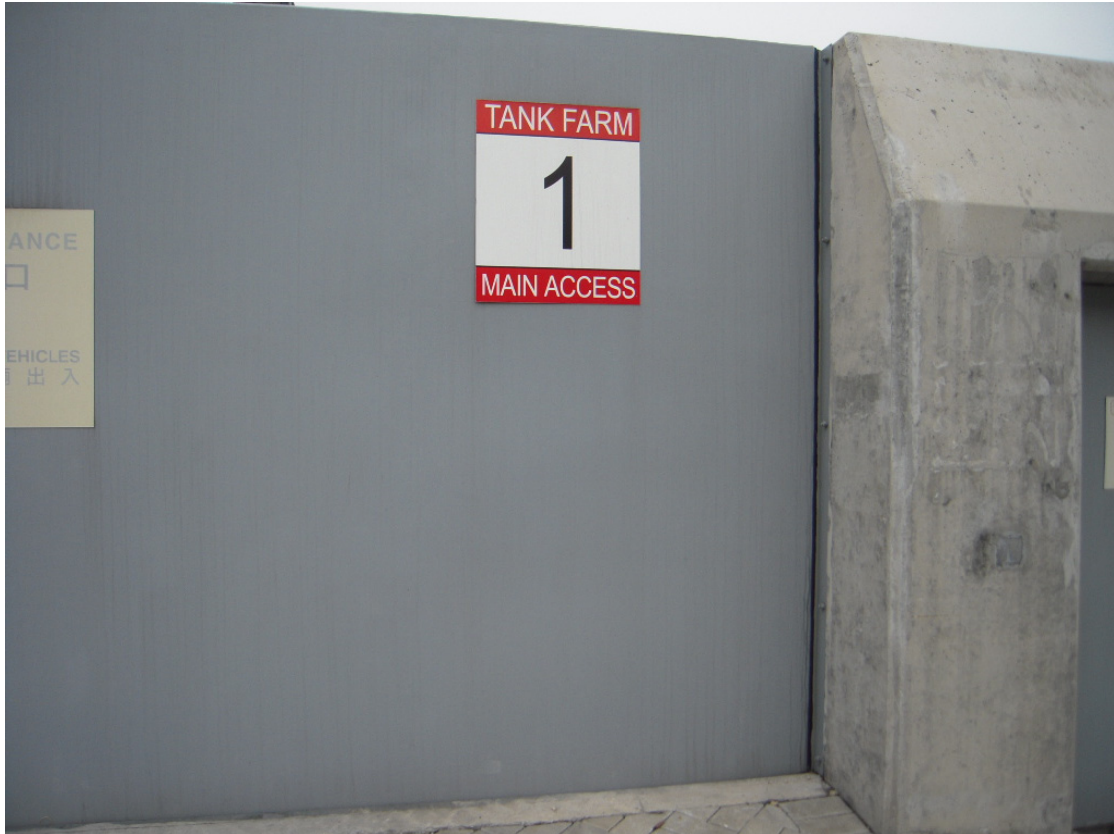
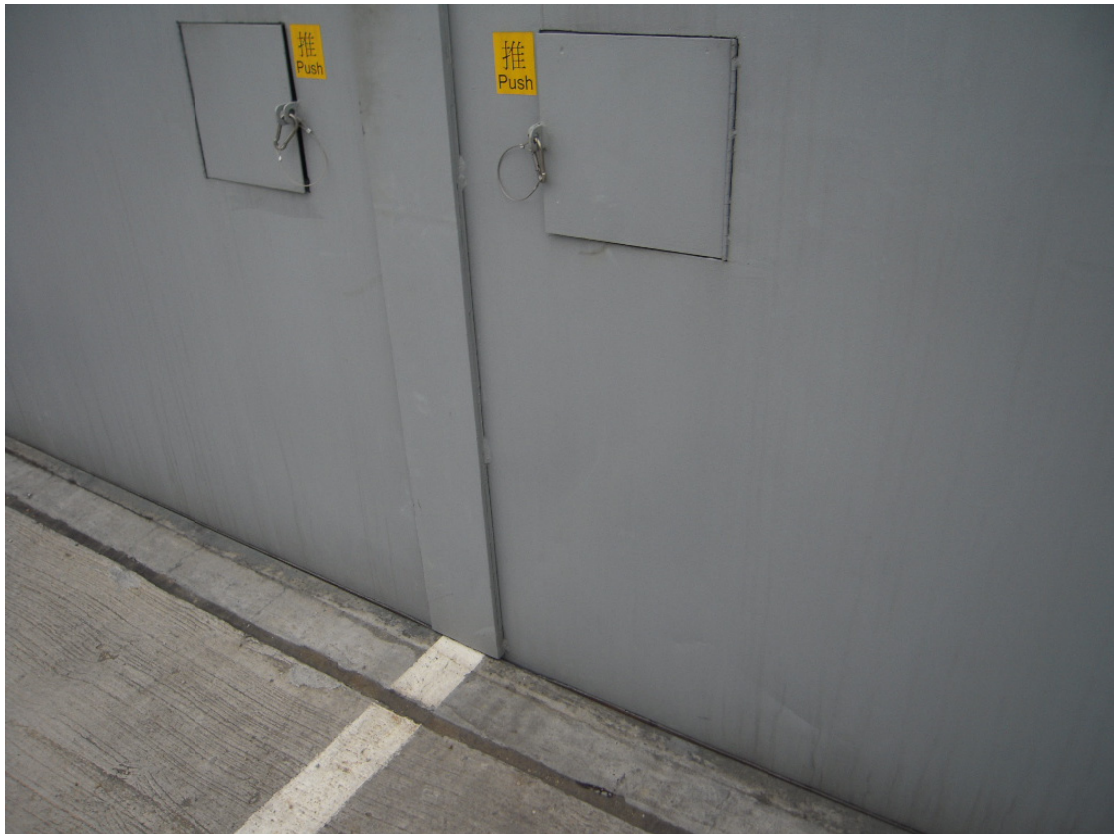
(13) Gates at security walls with sealant are maintained in good condition

(14) Gates at security walls with sealant are maintained in good condition

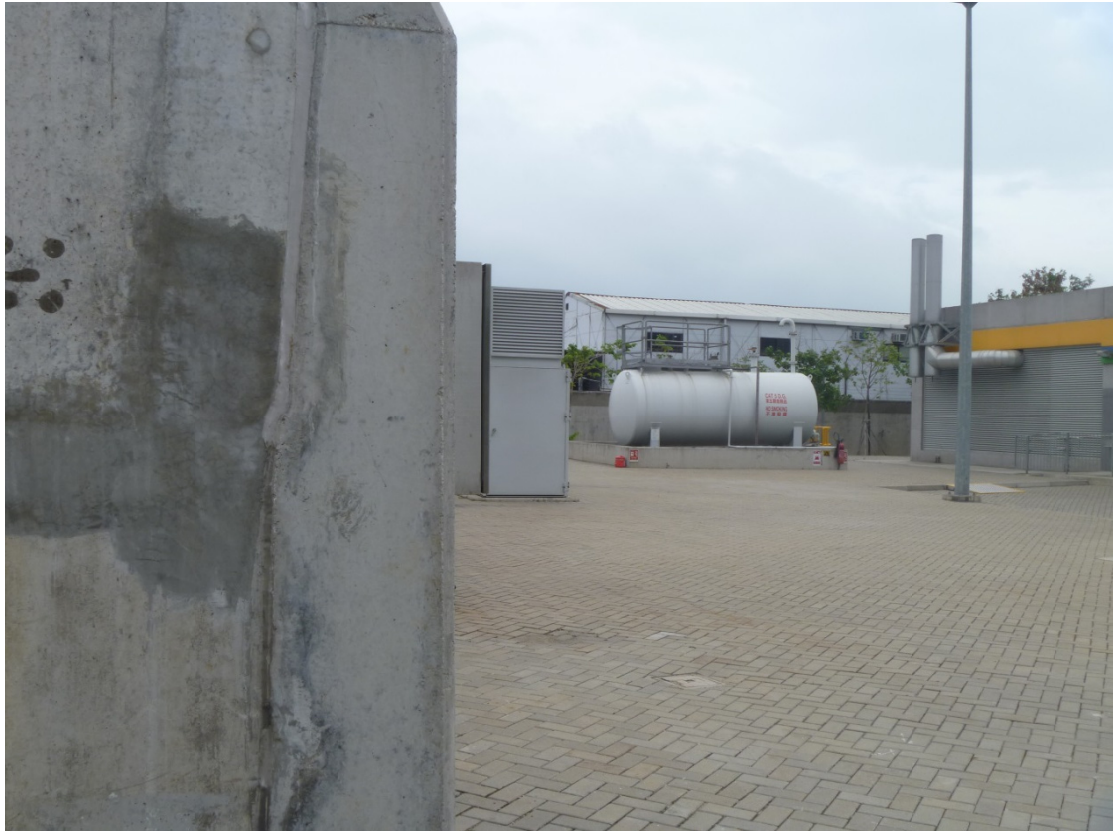
(15) This shows the thickness of the security wall provided

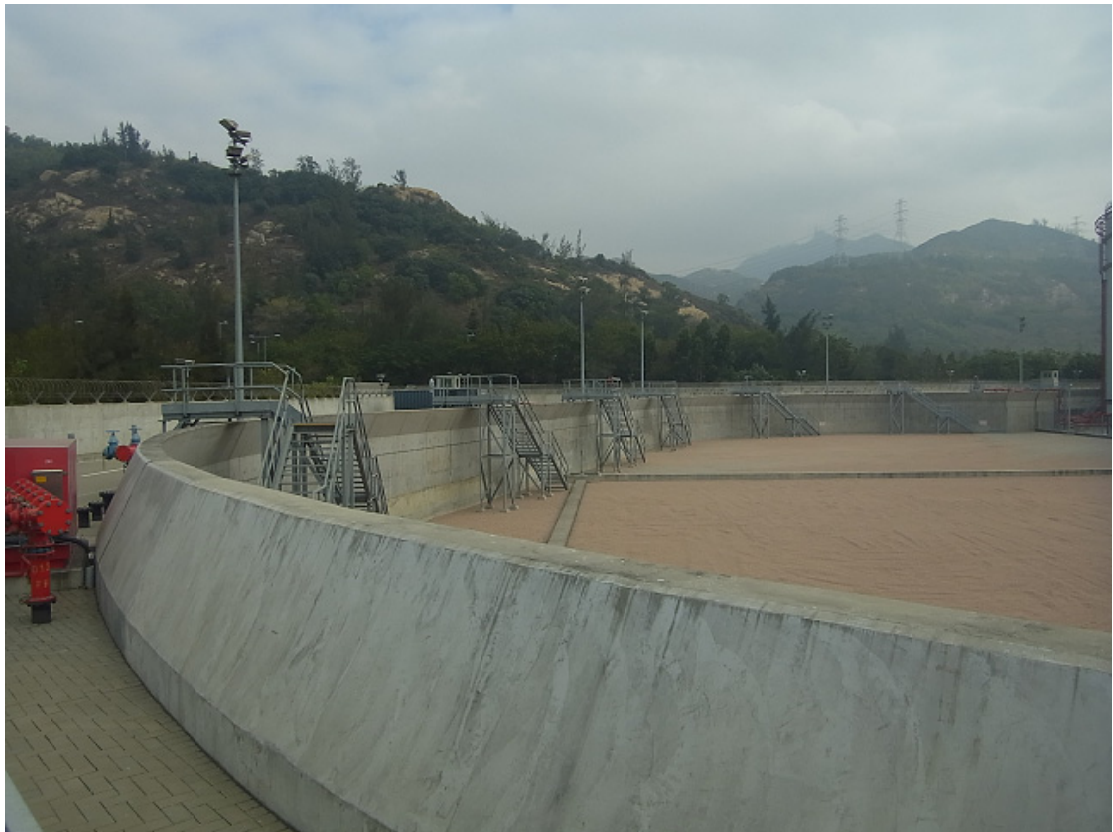
(16) This shows the thickness of the bund wall provided

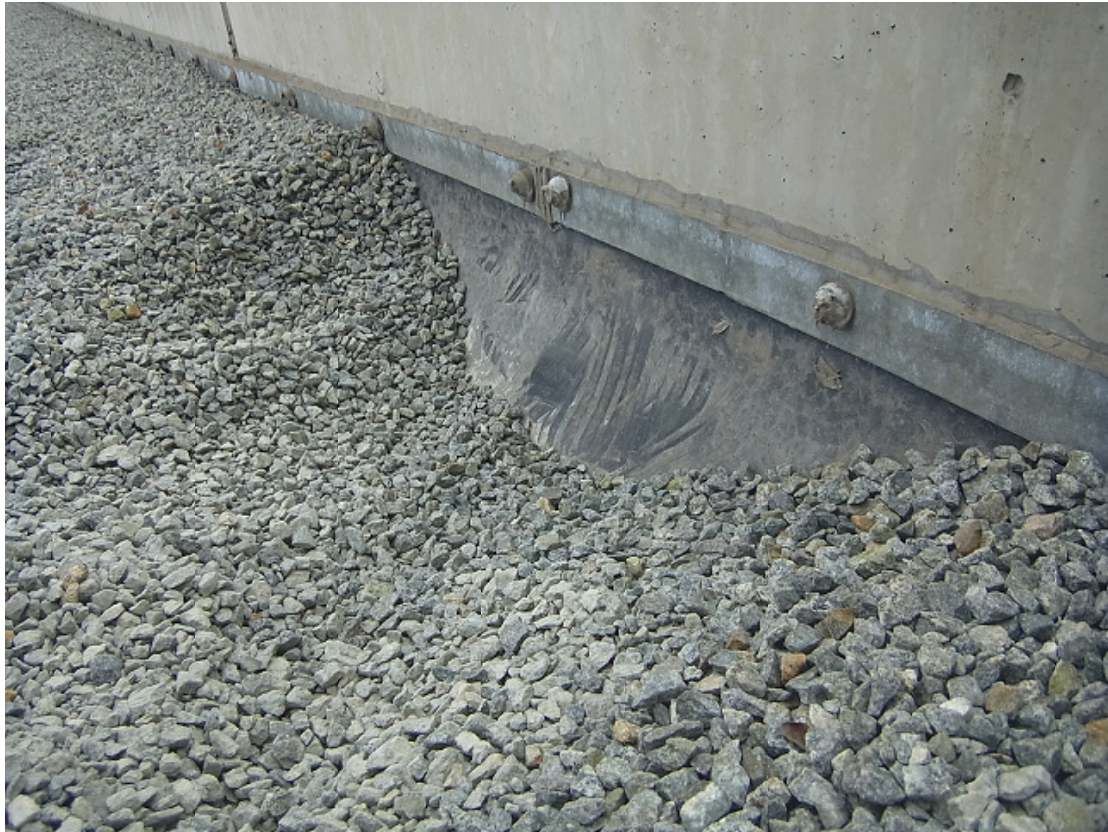
(17) Impervious lining are maintained in good condition

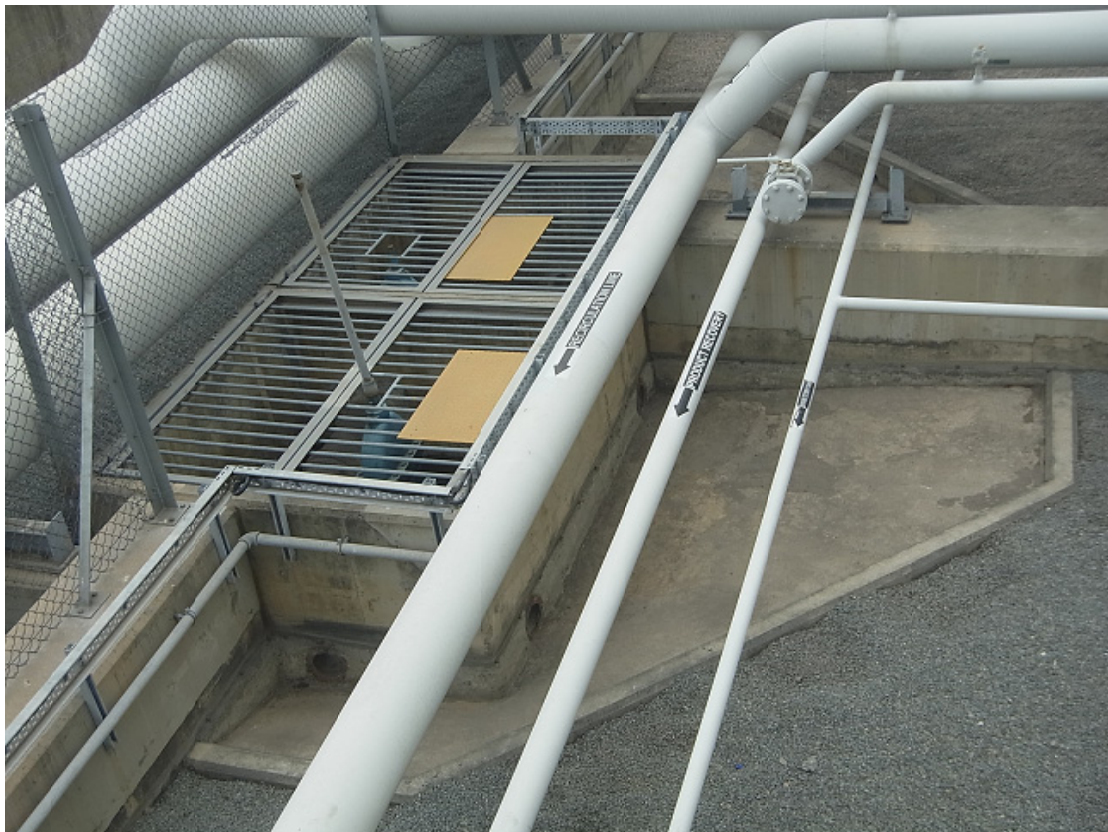
(18) Tank farm is with appropriate gradient and the drainage falls to interceptor for collection

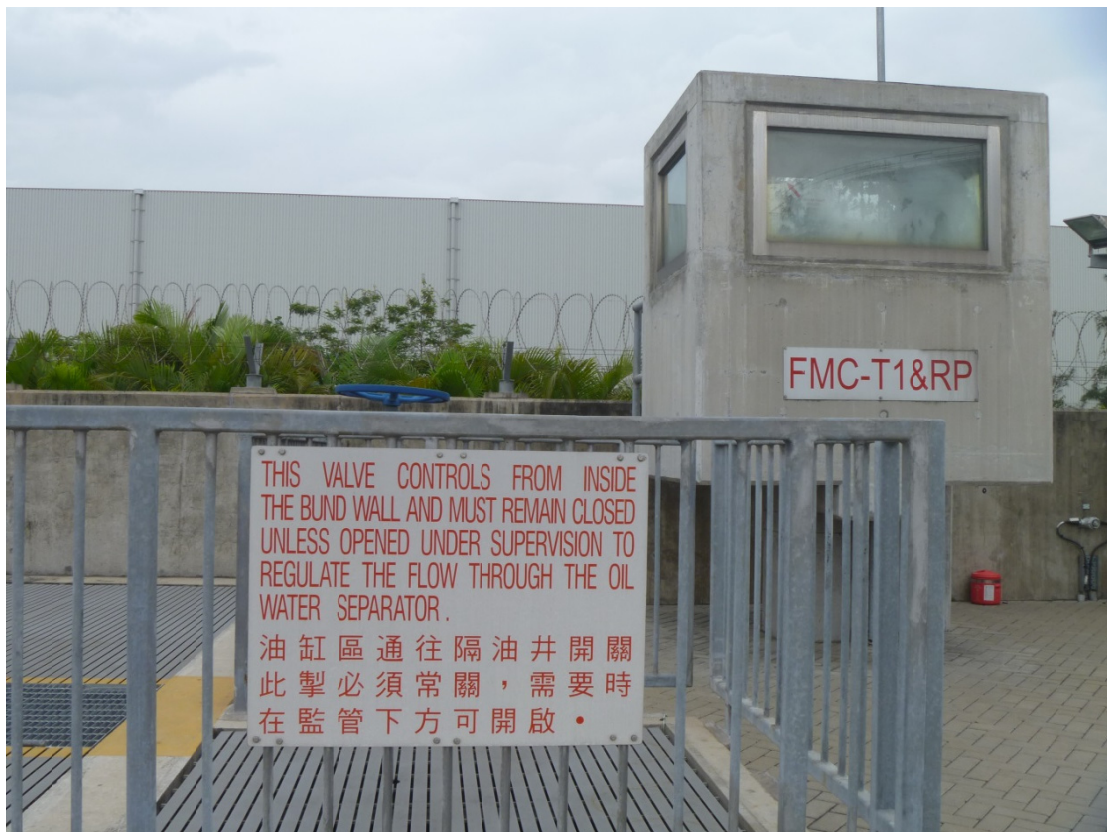
(19) Outlet valve provided for Phase 1a Interceptor with instruction sign to keep “normally closed”

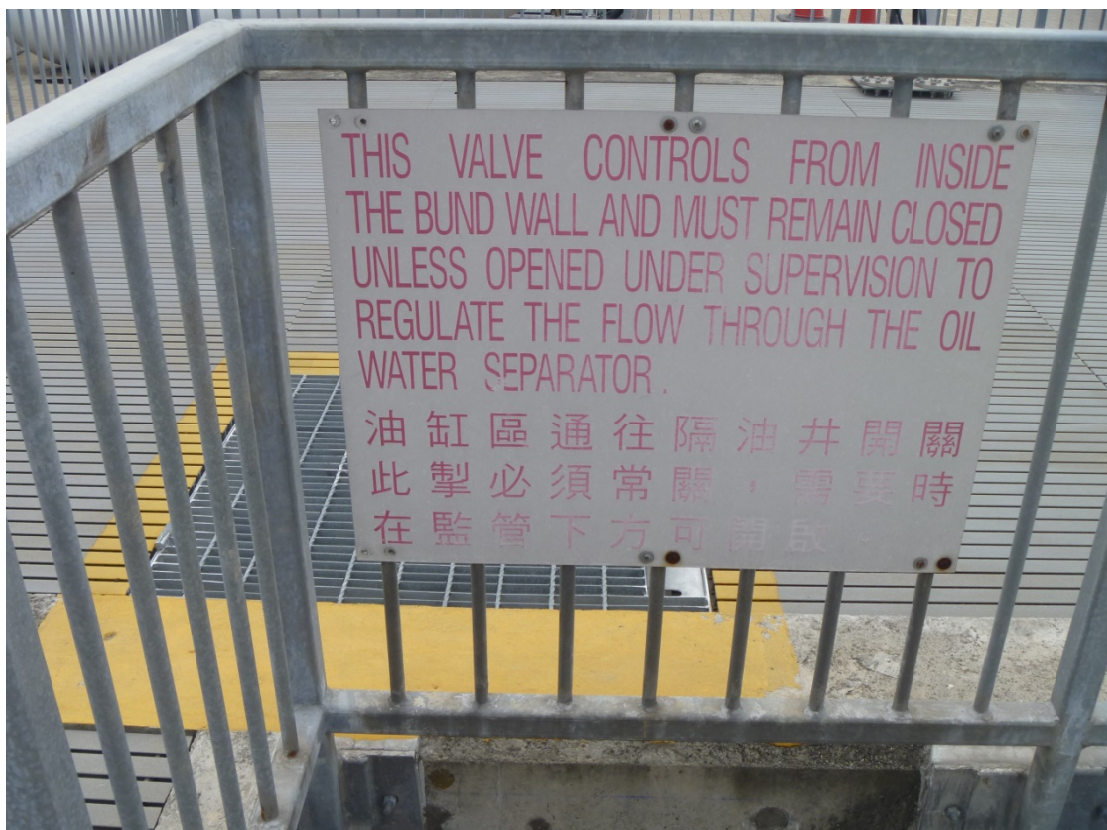
(20) Outlet valve provided for Phase 1b Interceptor with instruction sign to keep “normally closed”

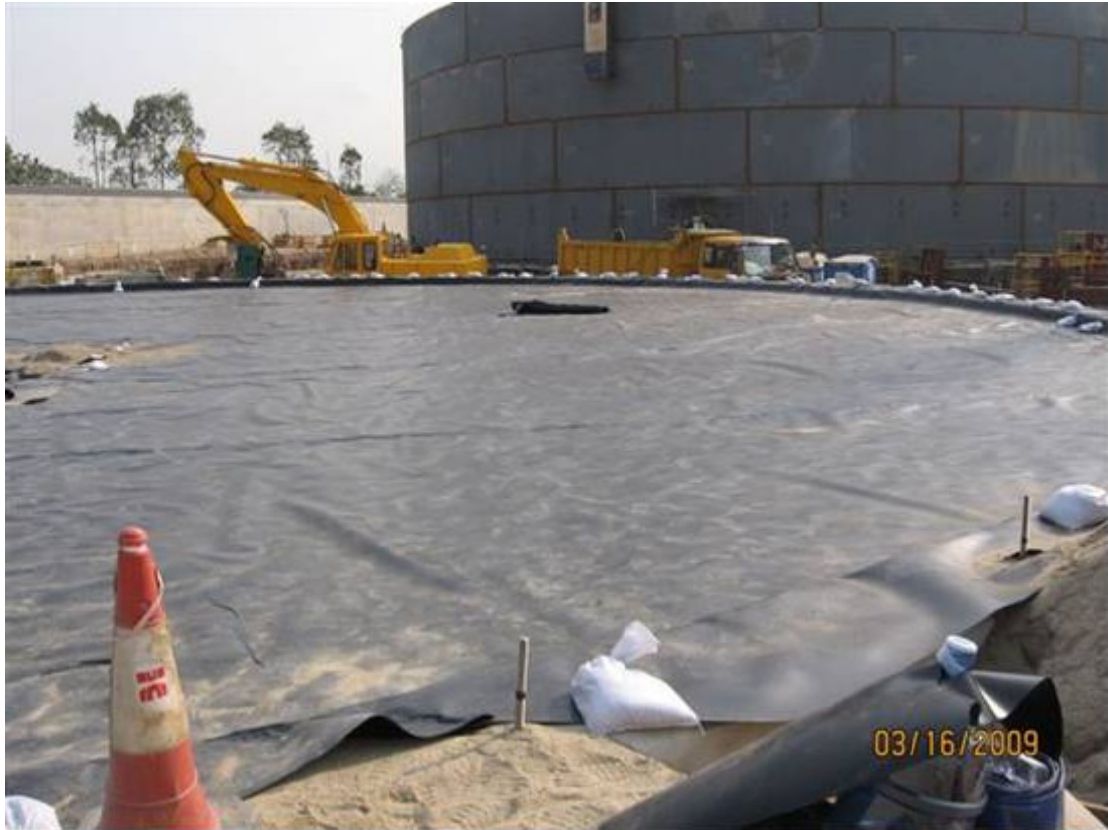
(21) Record photo shows impervious membrane being installed on top of tank foundation

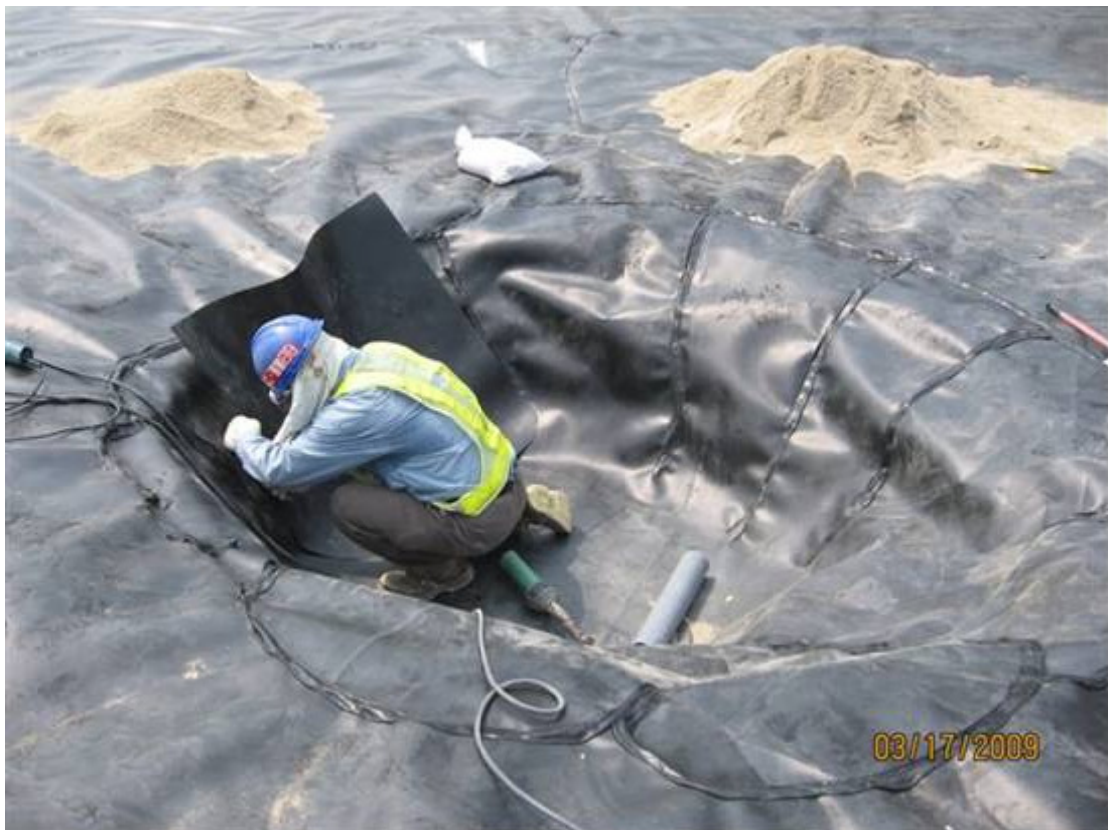
(22) Record photo shows impervious membrane laid at tank center sump with tell-tale pipe embedded for leak detection

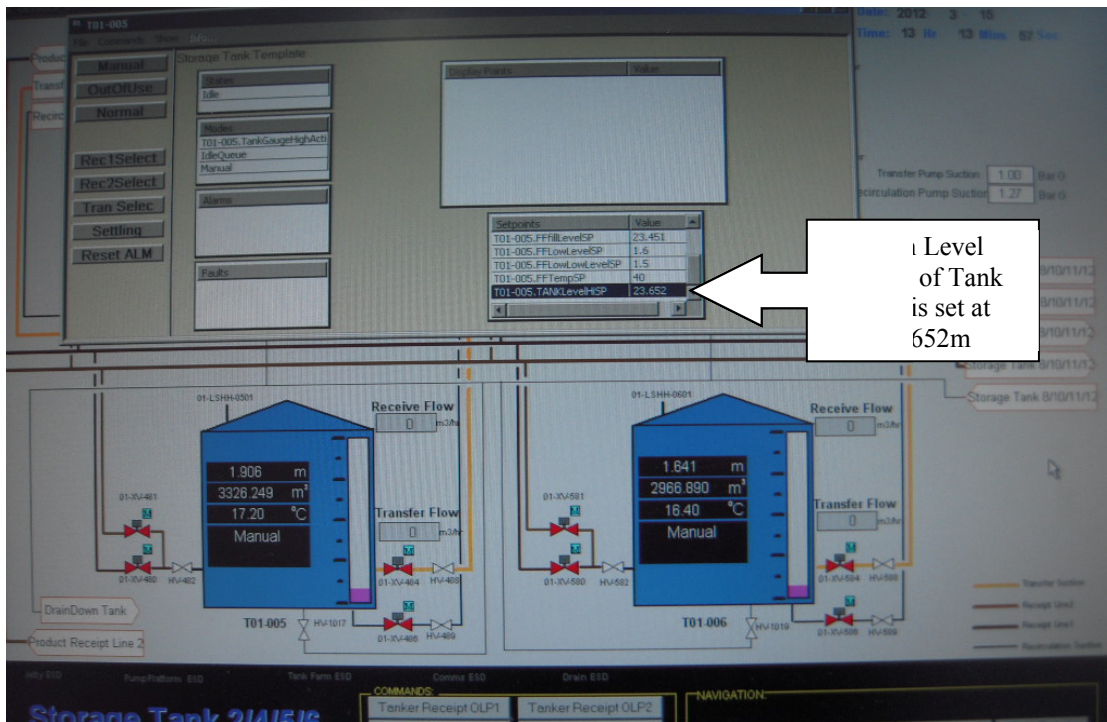
(23) High Level Alarm being set in the SCADA System

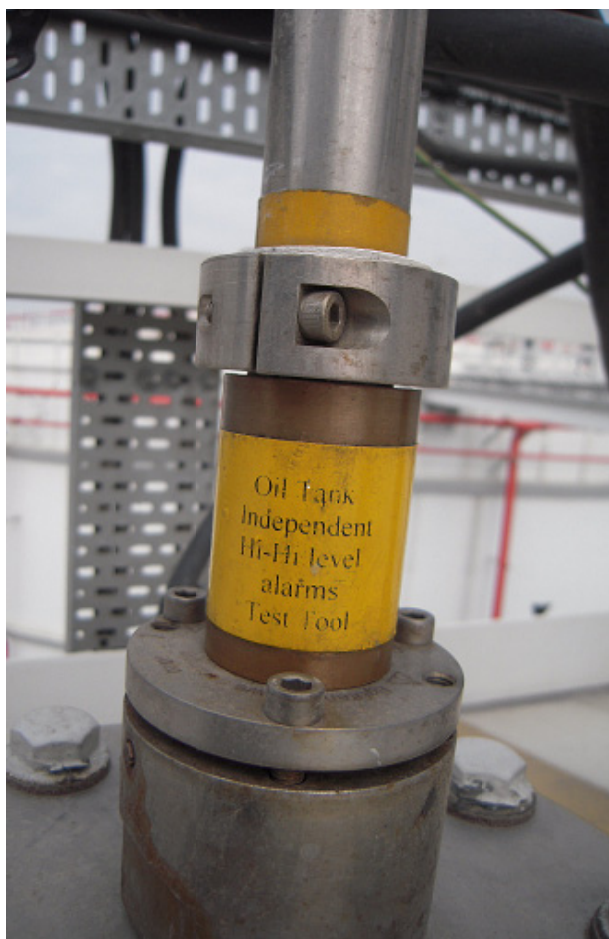
(24) Regular inspection performed on overfilling monitoring device (HH Level Alarm)

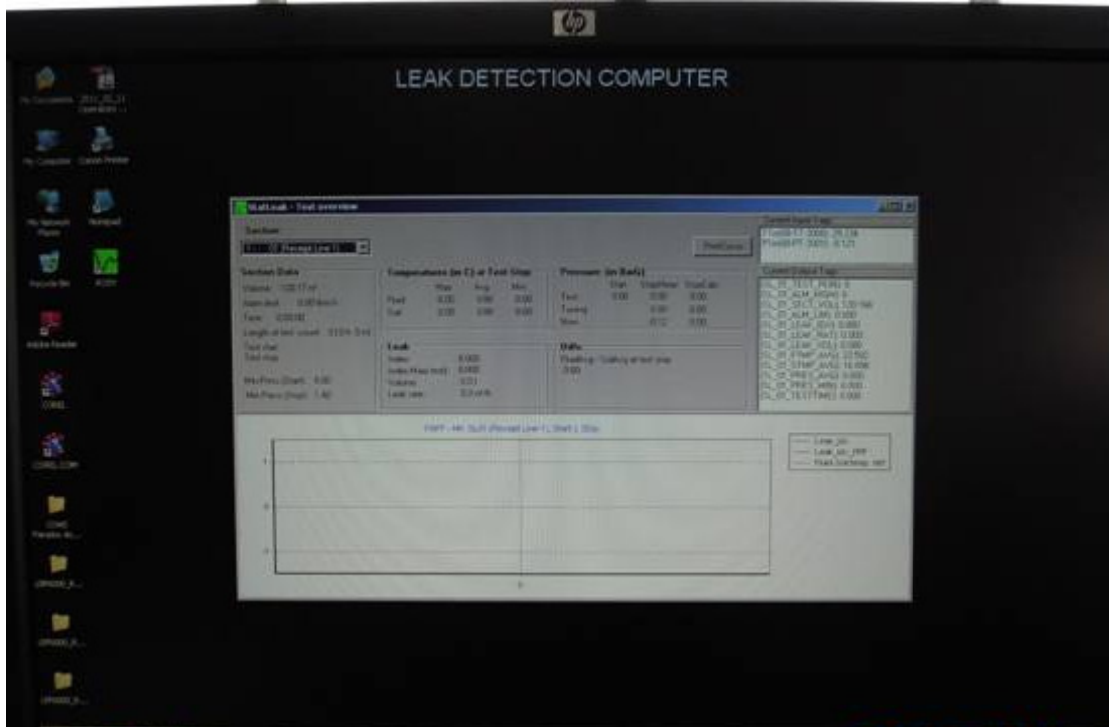
(26) Leak detection “COWI Stat Leak System” installed into computer
