ECO Aviation Fuel Services Limited

PERMANENT AVIATION FUEL FACILITY

ANNUAL AUDIT REPORT

Date: March 2013

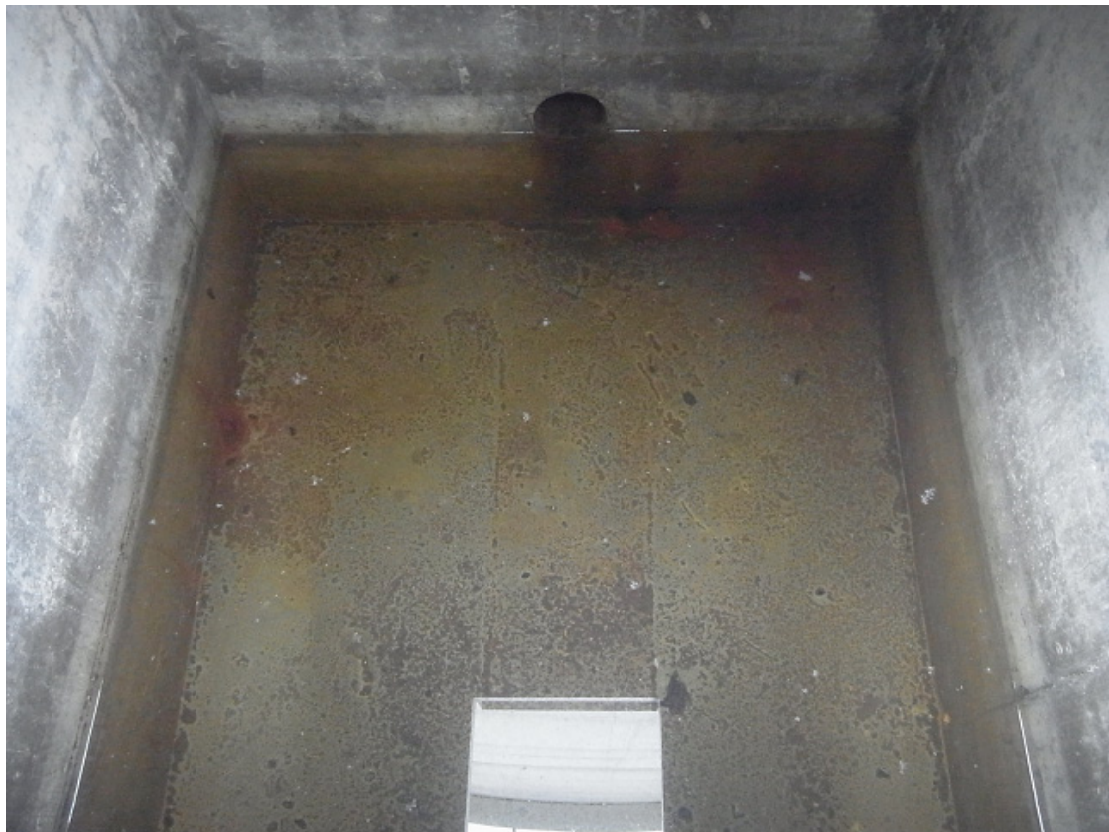
(27) Leak detection tell-tale pipe underneath the storage tank opening out to a collection chamber

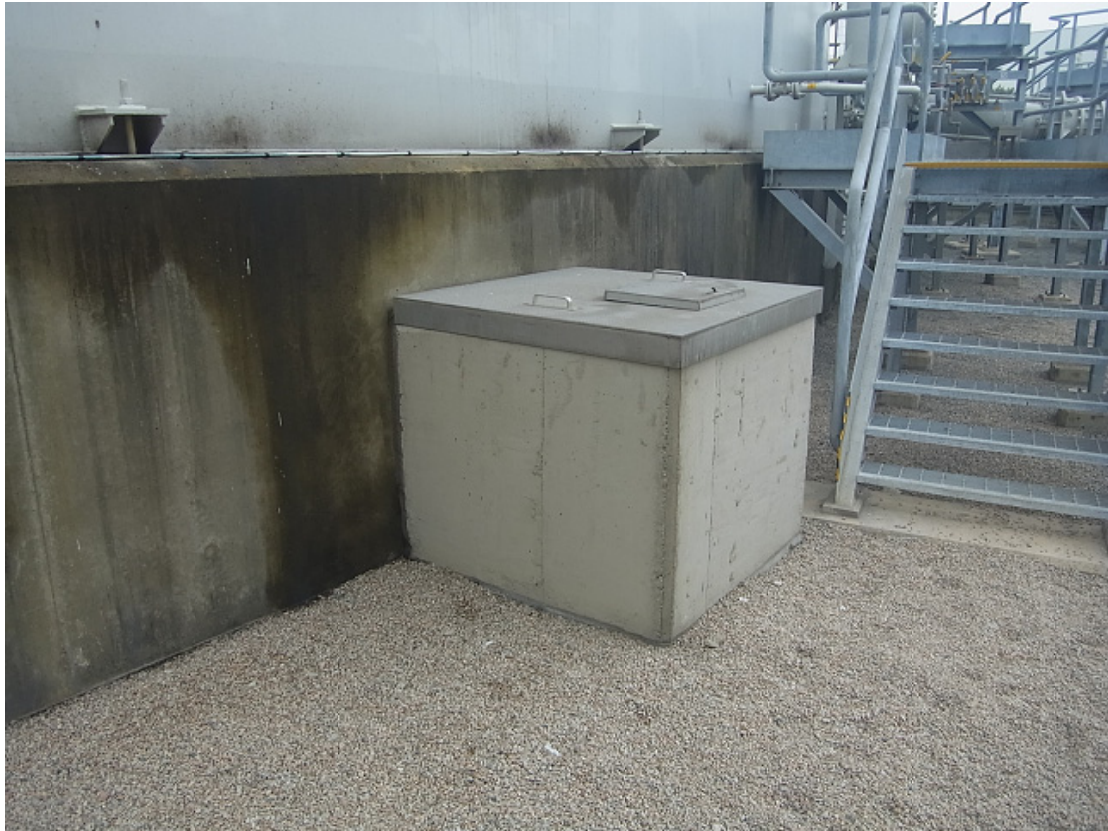
(28) Collection chamber located adjacent to tank foundation is maintained in good condition with periodic inspection

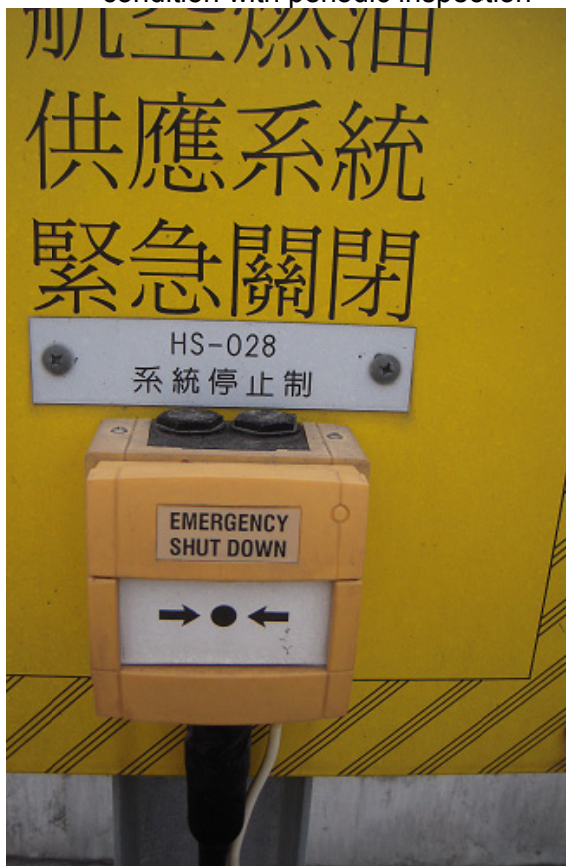
(29) ESD is maintained in good condition and being tested periodically

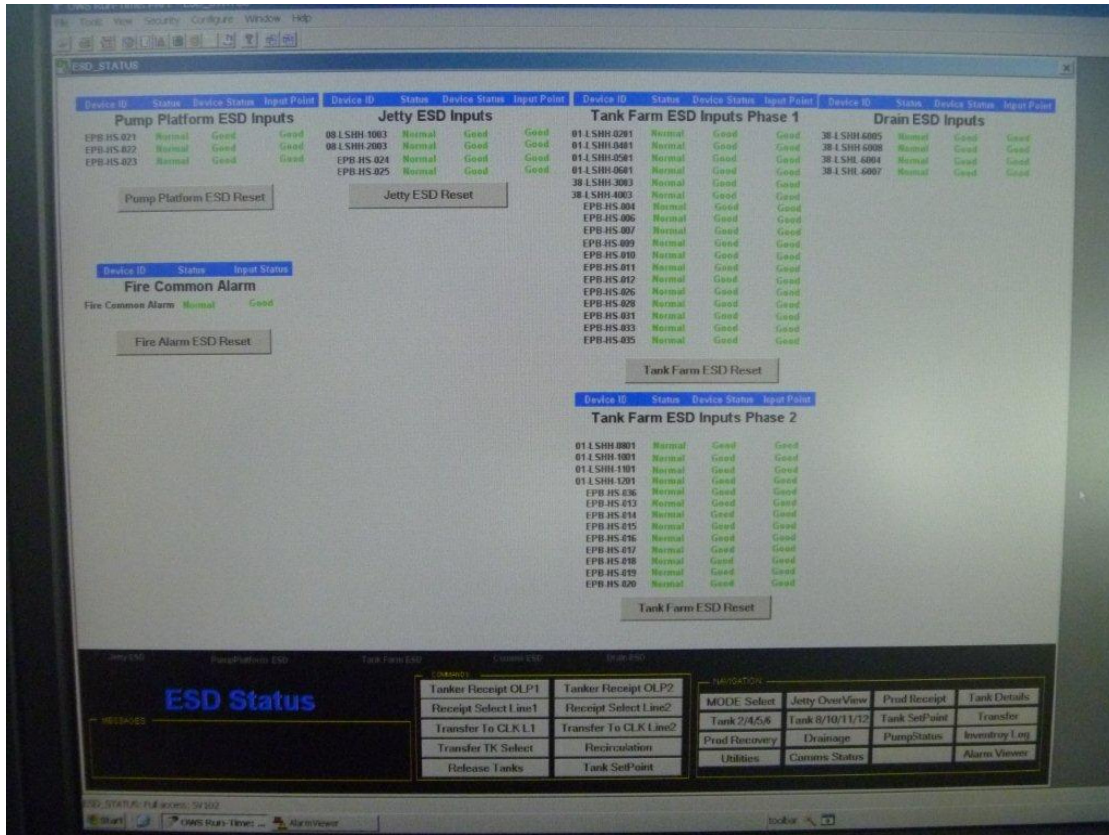
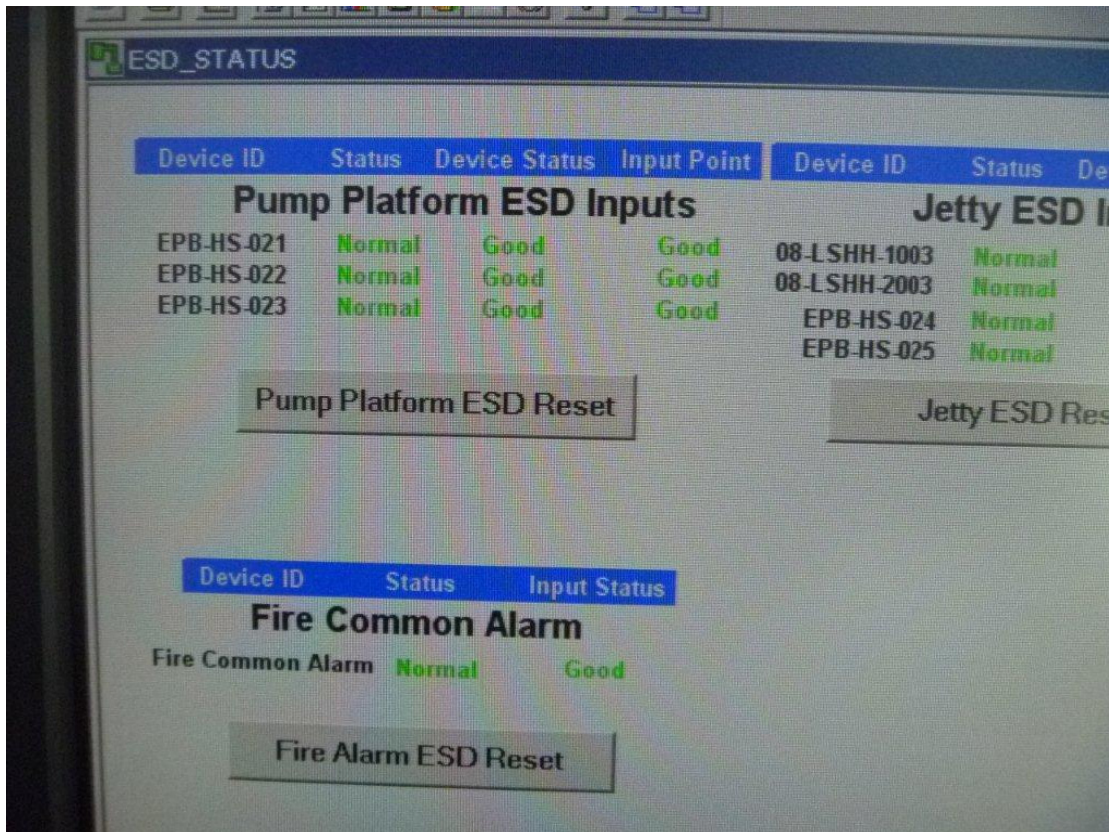
(31) The ESD regular test shown in SCADA System

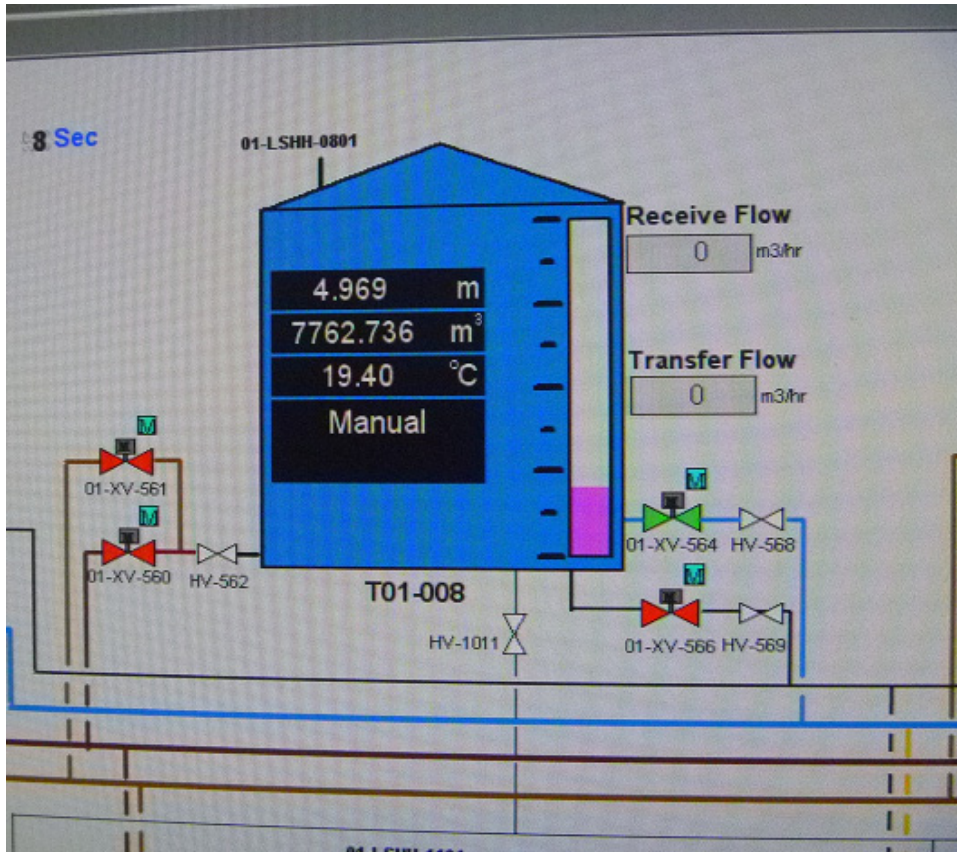
(32) The ESD test signal shown in SCADA System

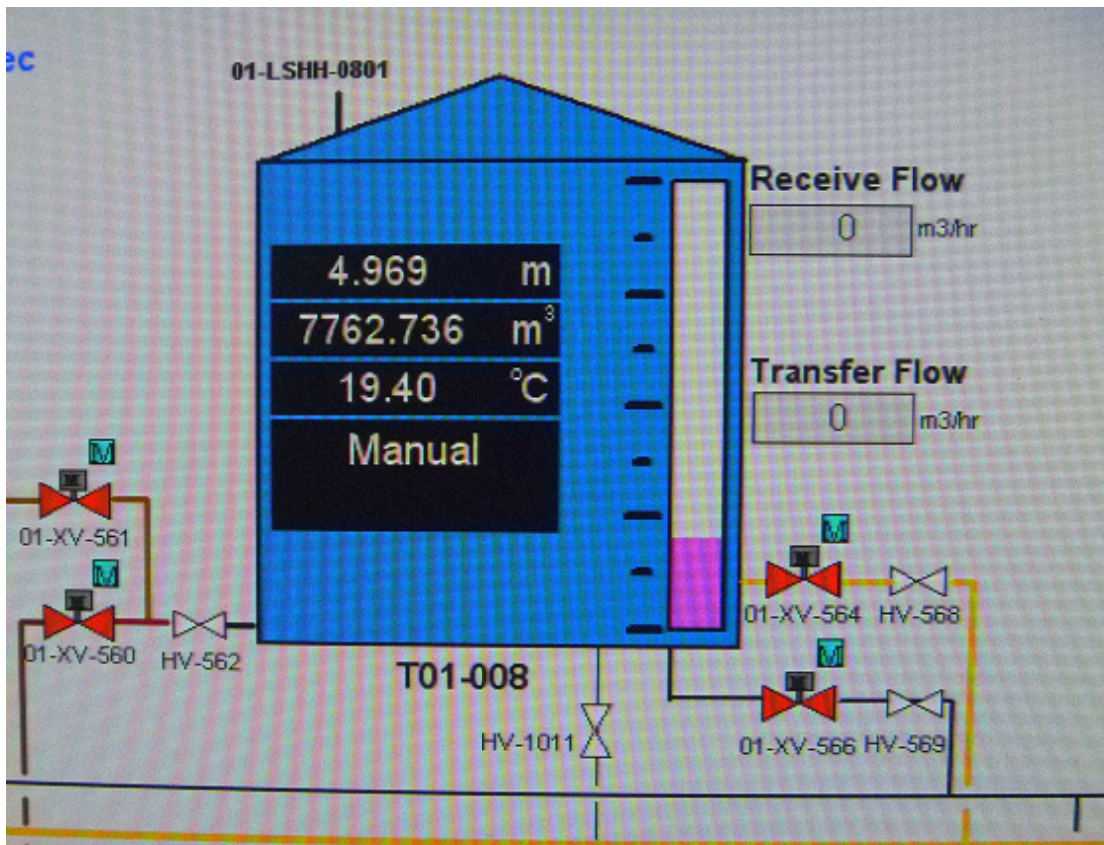
(33) Once the system received ESD test signal, the valves will close automatically and shut down the operation shown in SCADA System

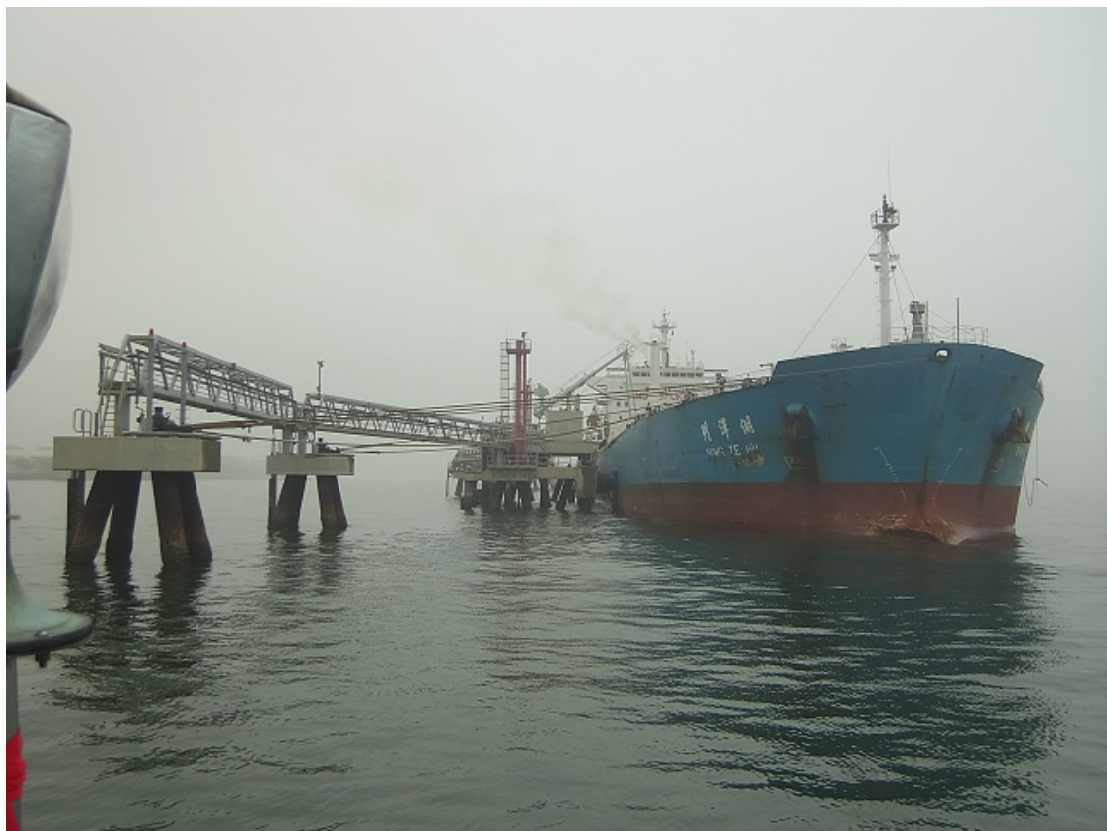
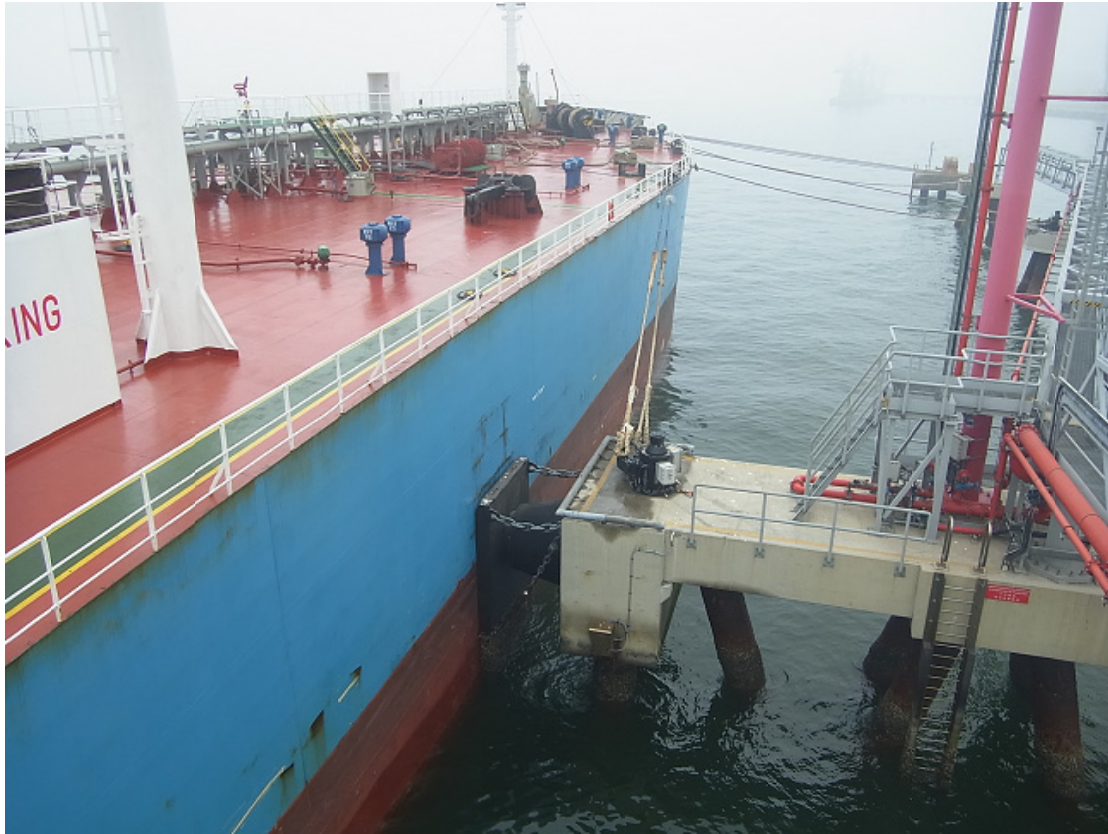
(35) Fenders installed at sea side of the jetty

(36) Fenders installed at sea side of the jetty.

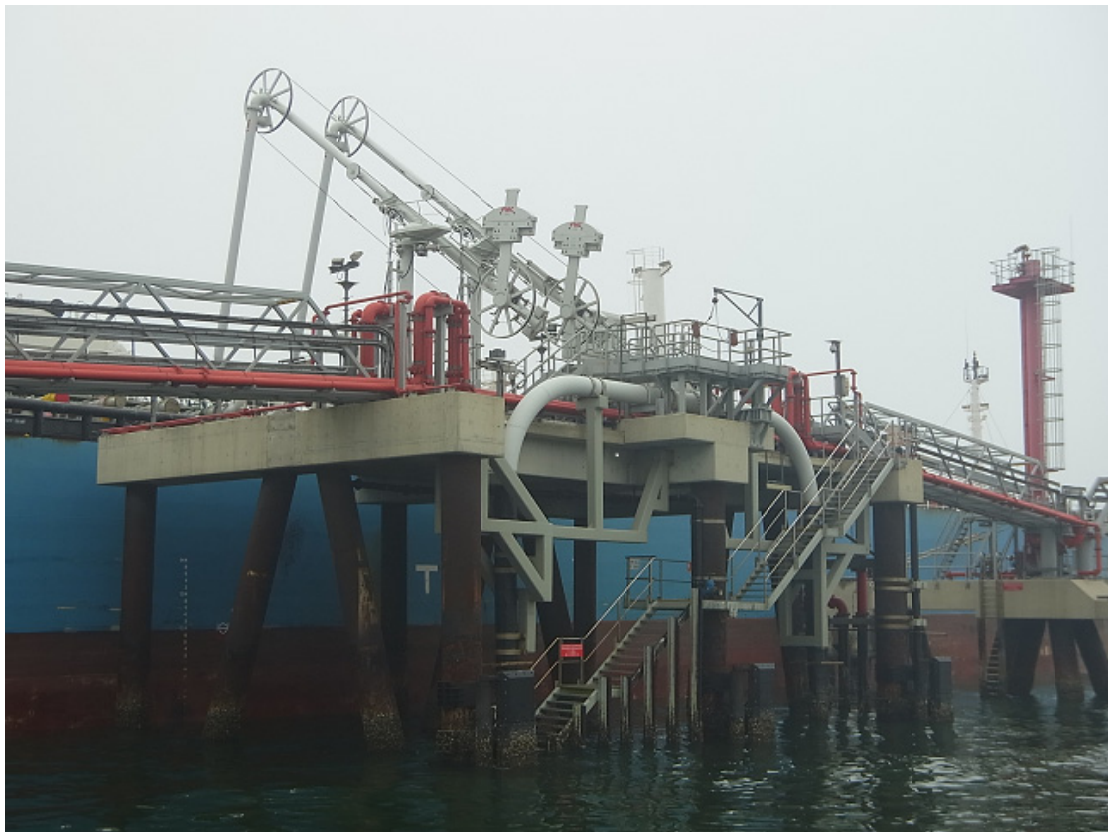
(37) Fenders installed at shore side of the jetty

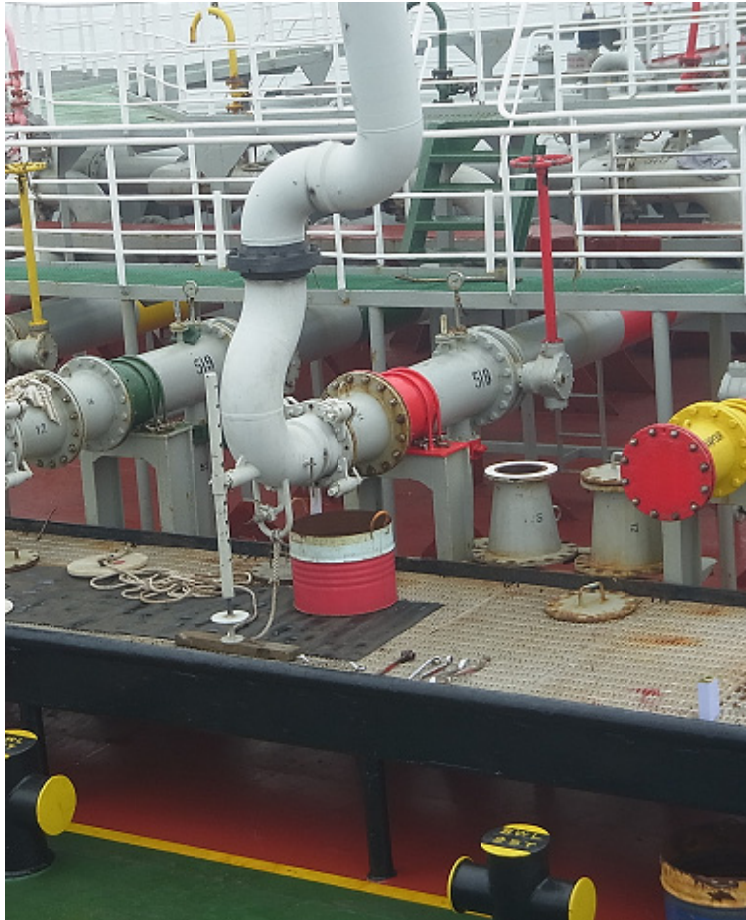
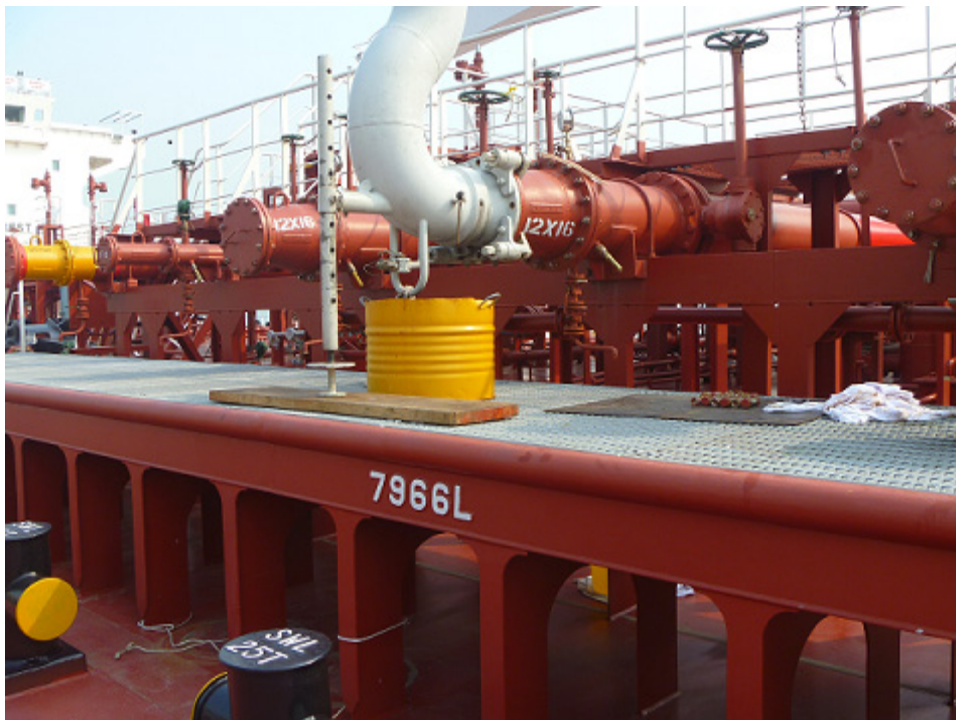
(38) Slop trays being used for coupling and de-coupling of the loading arms

(39) Slop trays being used for coupling and de-coupling of the loading arms

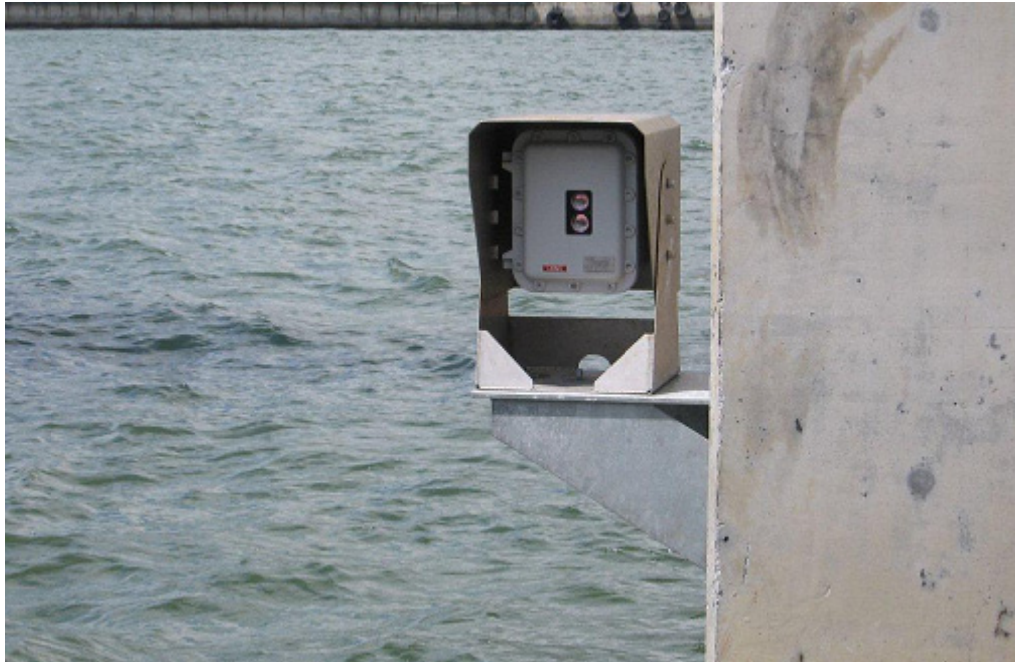
(40) Berthing aid laser box installed at Breasting Dolphin

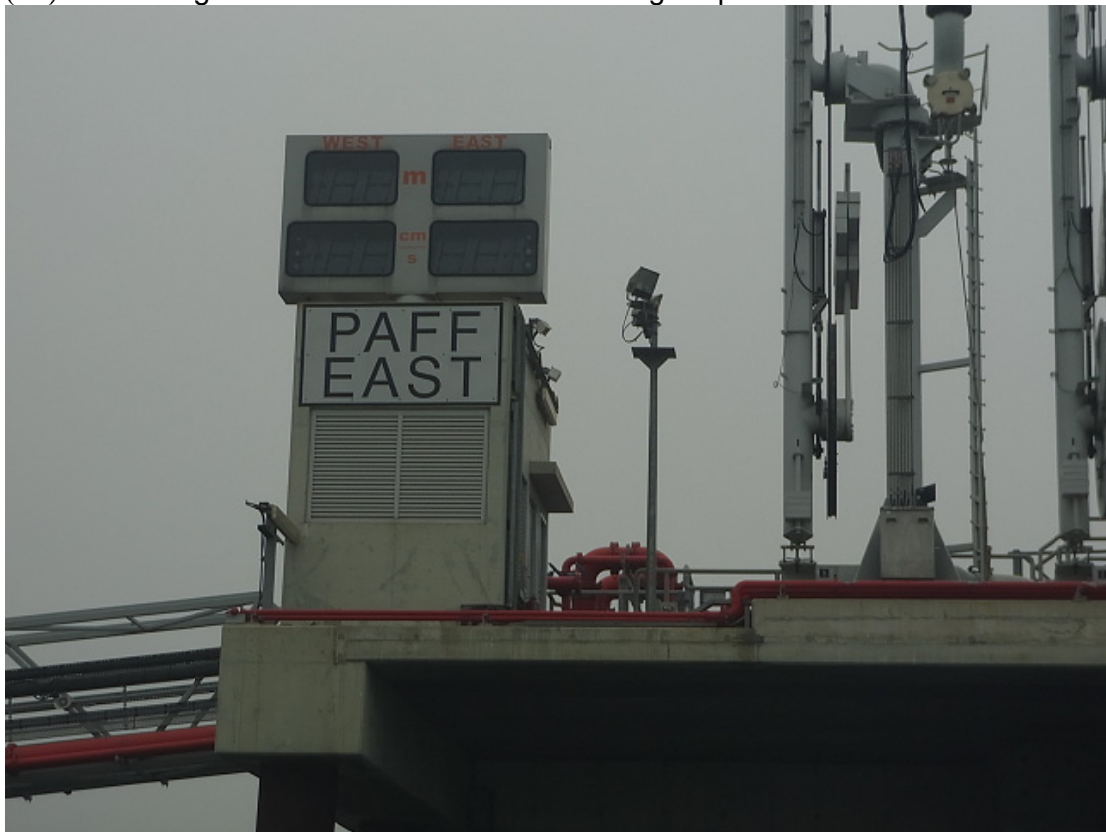
(41) Berthing aid display board installed on LP1

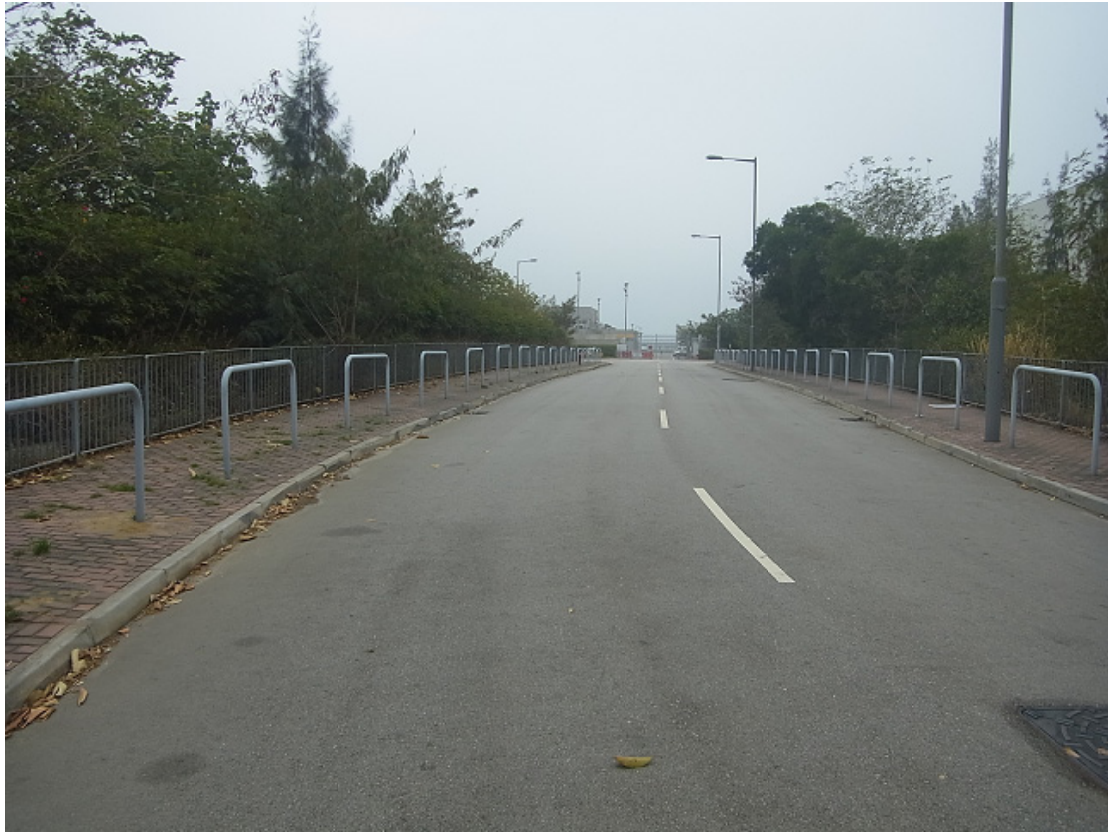
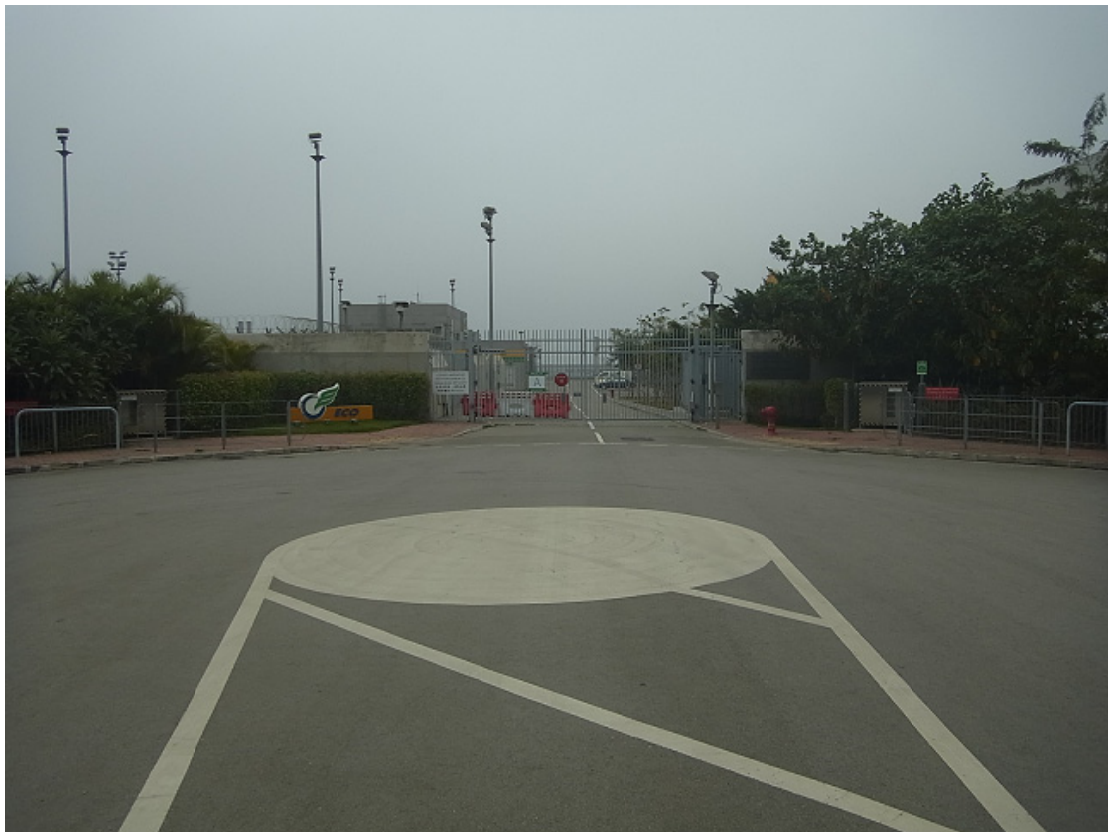
(47) Access road to PAFF designated a no waiting/parking area

(48) Access road to PAFF designated a no waiting/parking area
