PERMANENT AVIATION FUEL FACILITY

ANNUAL AUDIT REPORT

**Environmental Permit
EP-262/2007/B**

Date of Audit : 13 – 24 March 2015

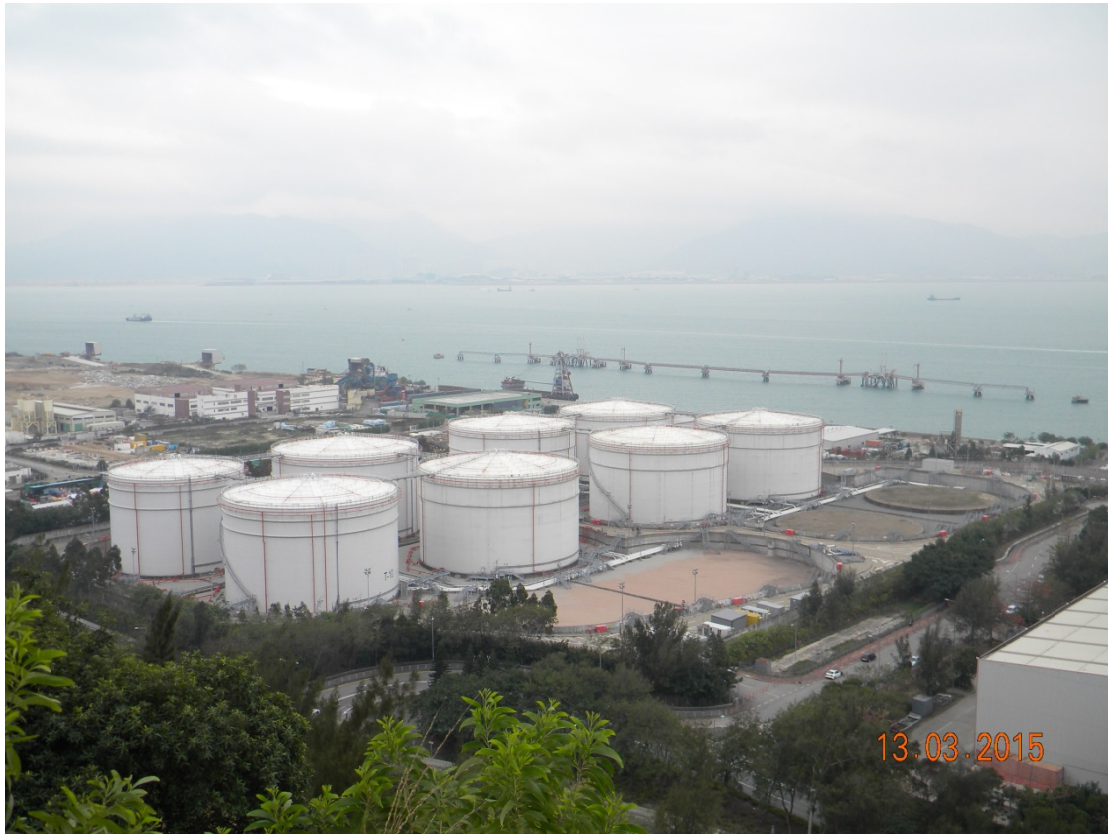
(1) All eight tanks are located within bunded compounds

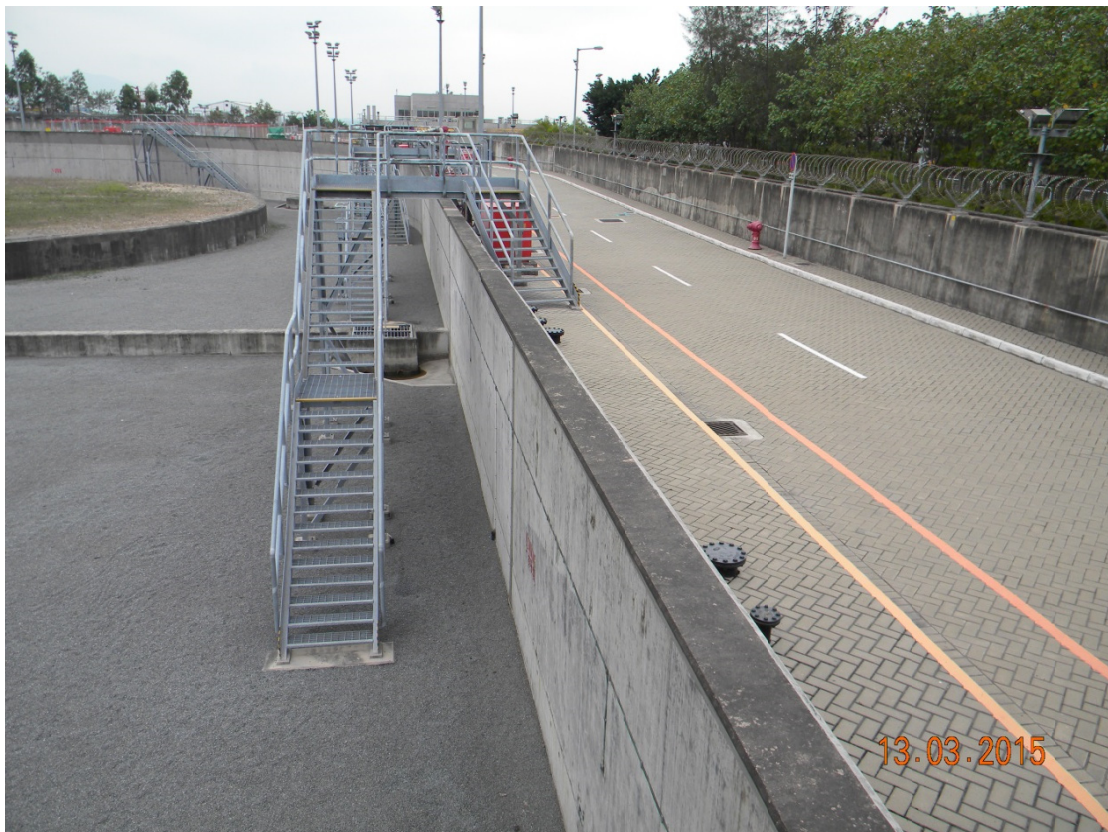
(2) Phase 1a bunded compound is partly sunken below the level of ground outside the bunds

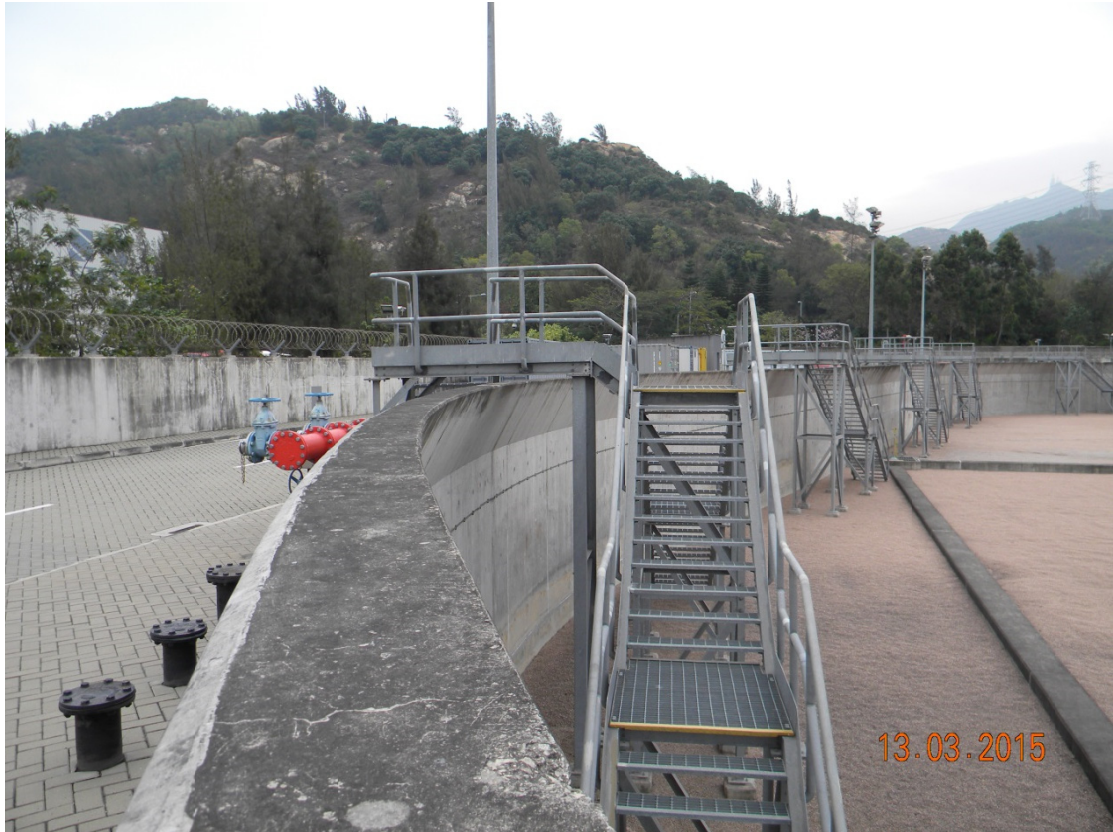
(3) Phase 1b bunded compound is partly sunken below the level of ground outside the bunds

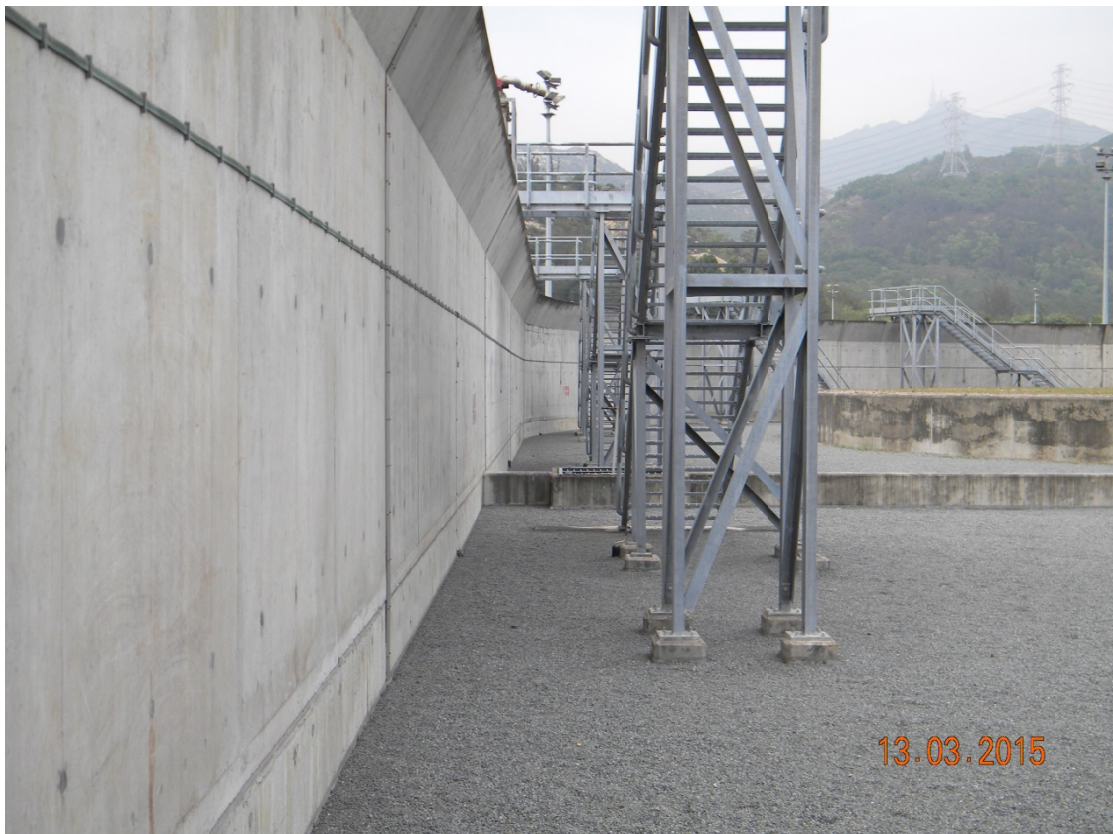
(4) Wave deflector provided at top of the bunds

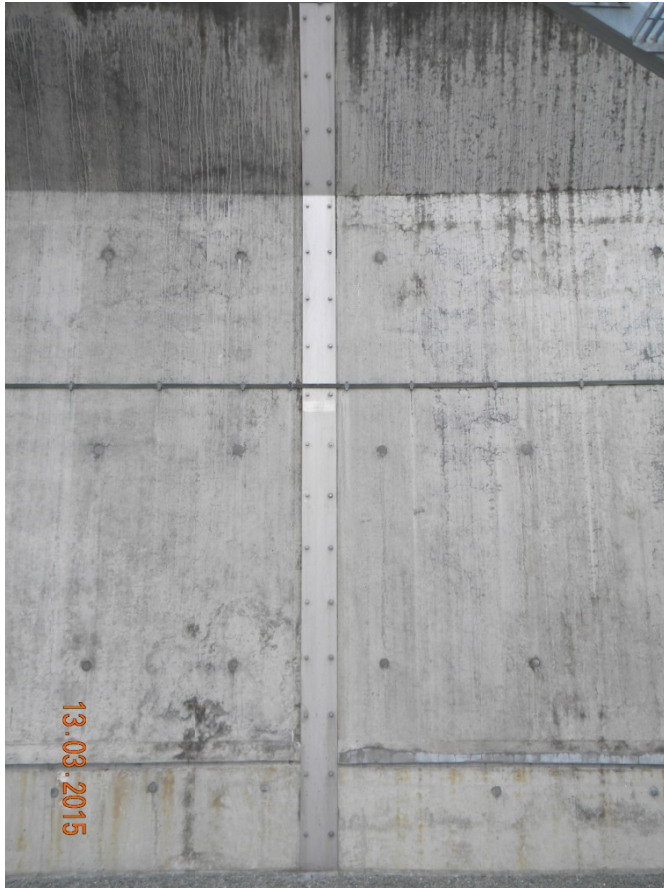
(5) Visible parts of the joints are covered by stainless steel plates on the inside at phase 1a bund

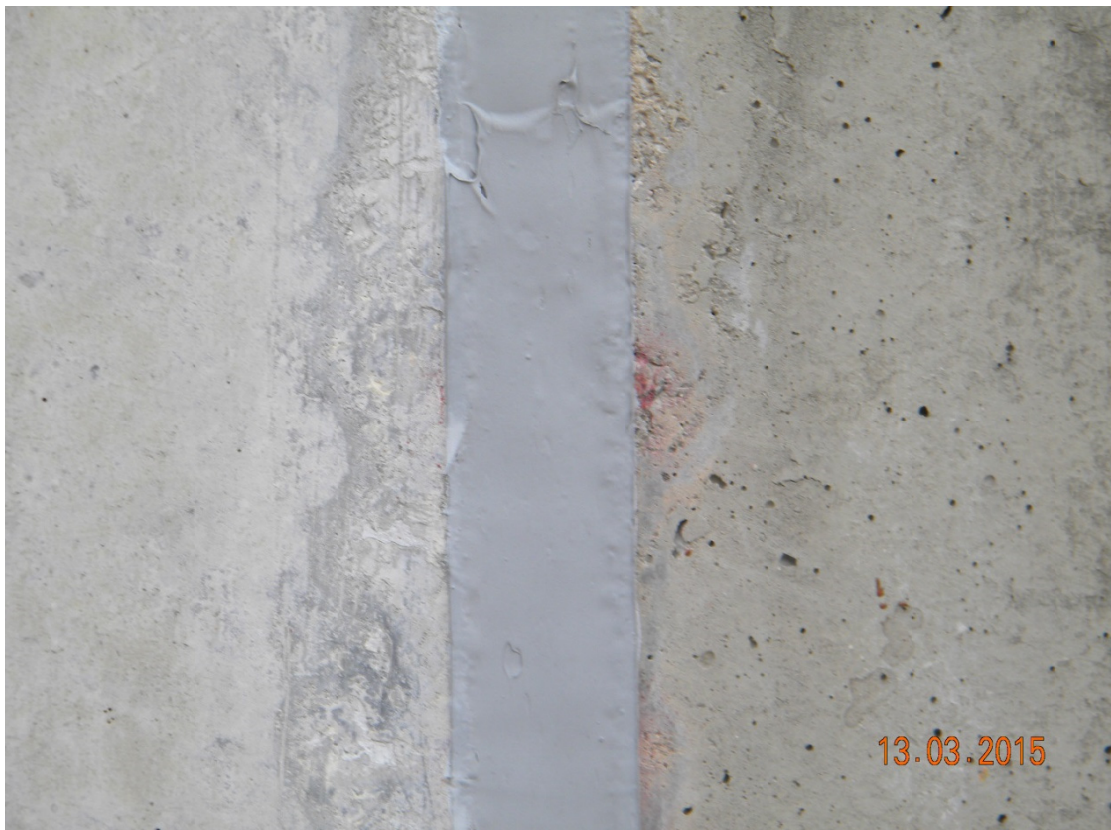
(6) Maintenance works have been performed on sealant at joints

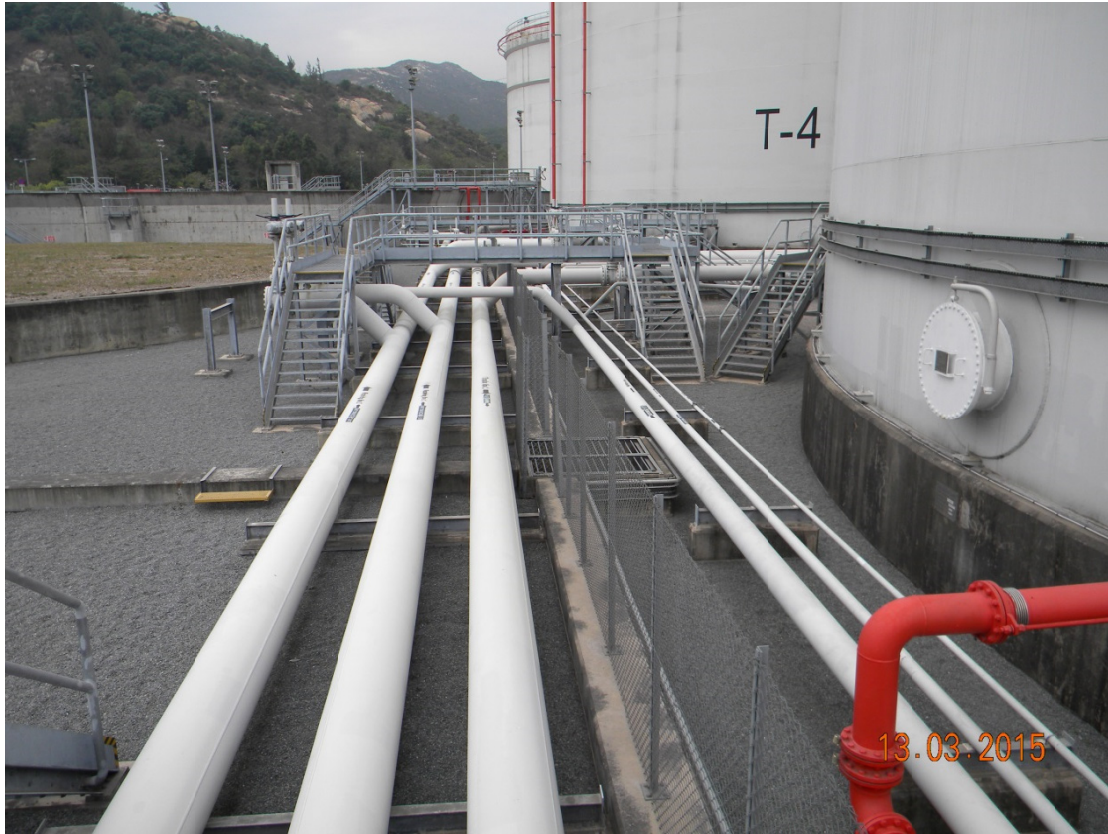
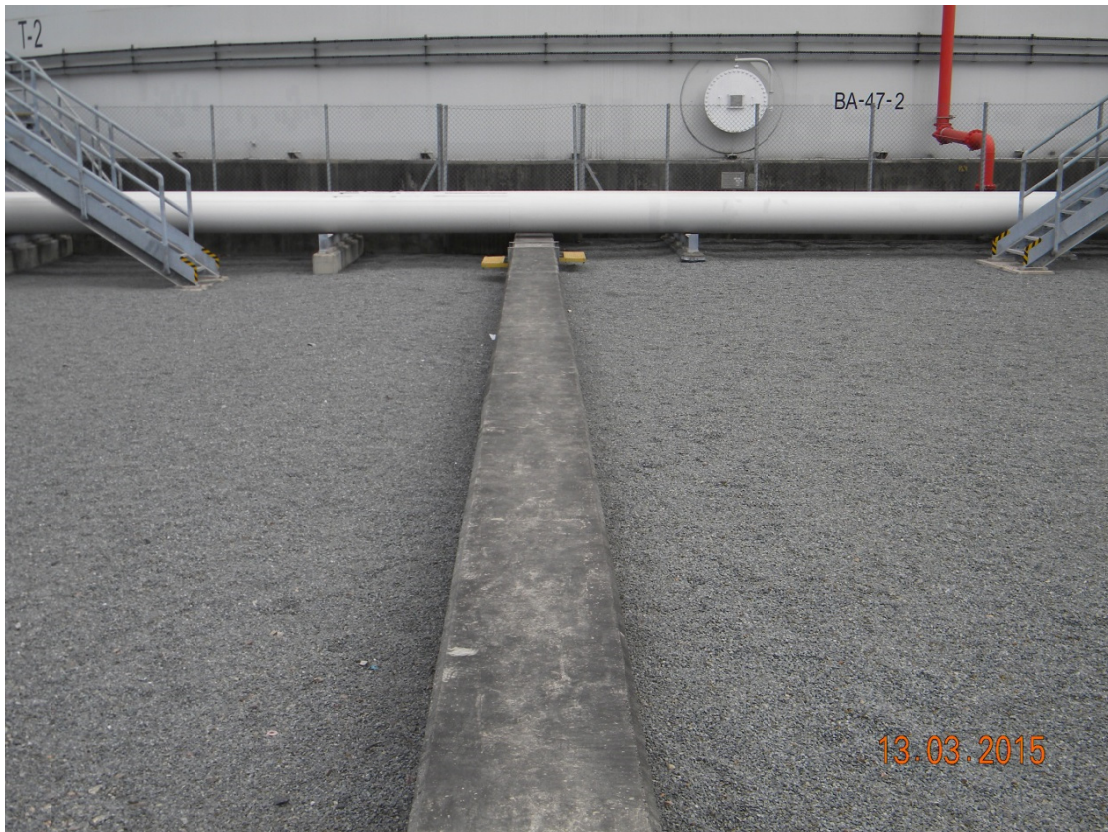
Observation	Result
There has been no change made since the completion of construction in October 2010. Photographs No. 7 & 8 show that intermediate bund walls are complete in place and properly maintained.

(7) Intermediate bund walls are provided in place near T-01-002

(8) Intermediate bund walls are provided in place near T-01-002

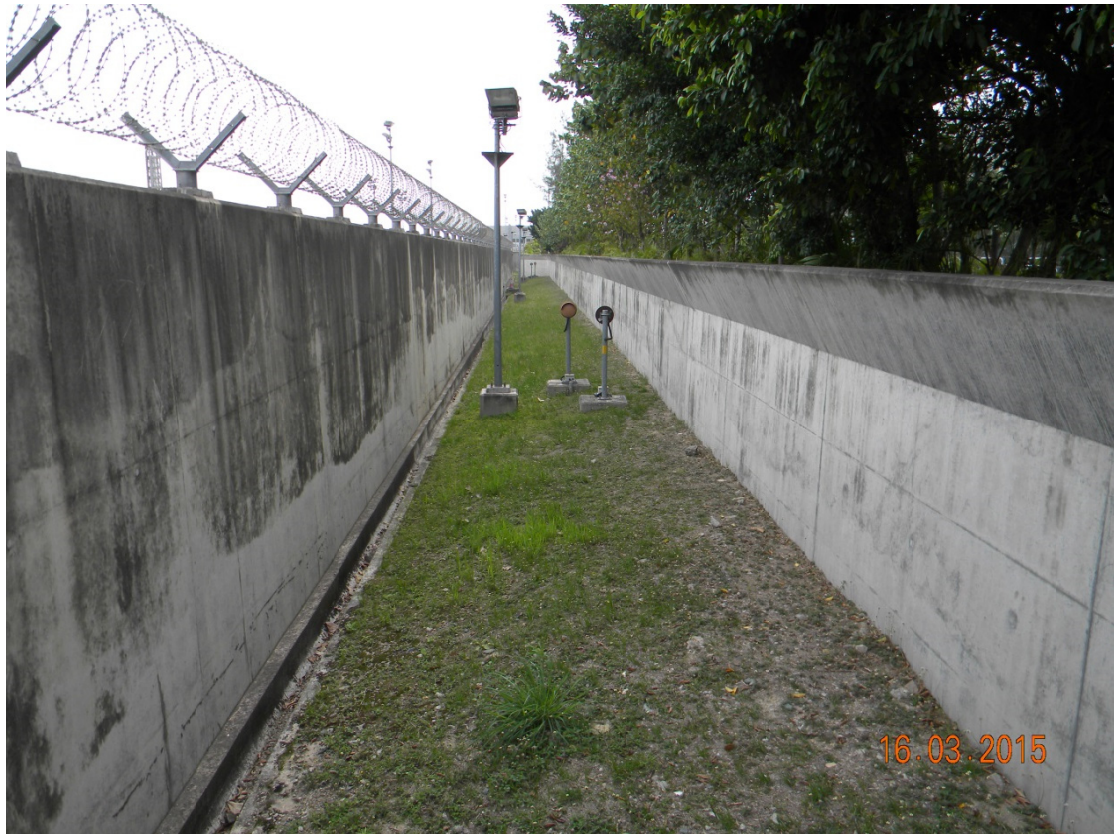
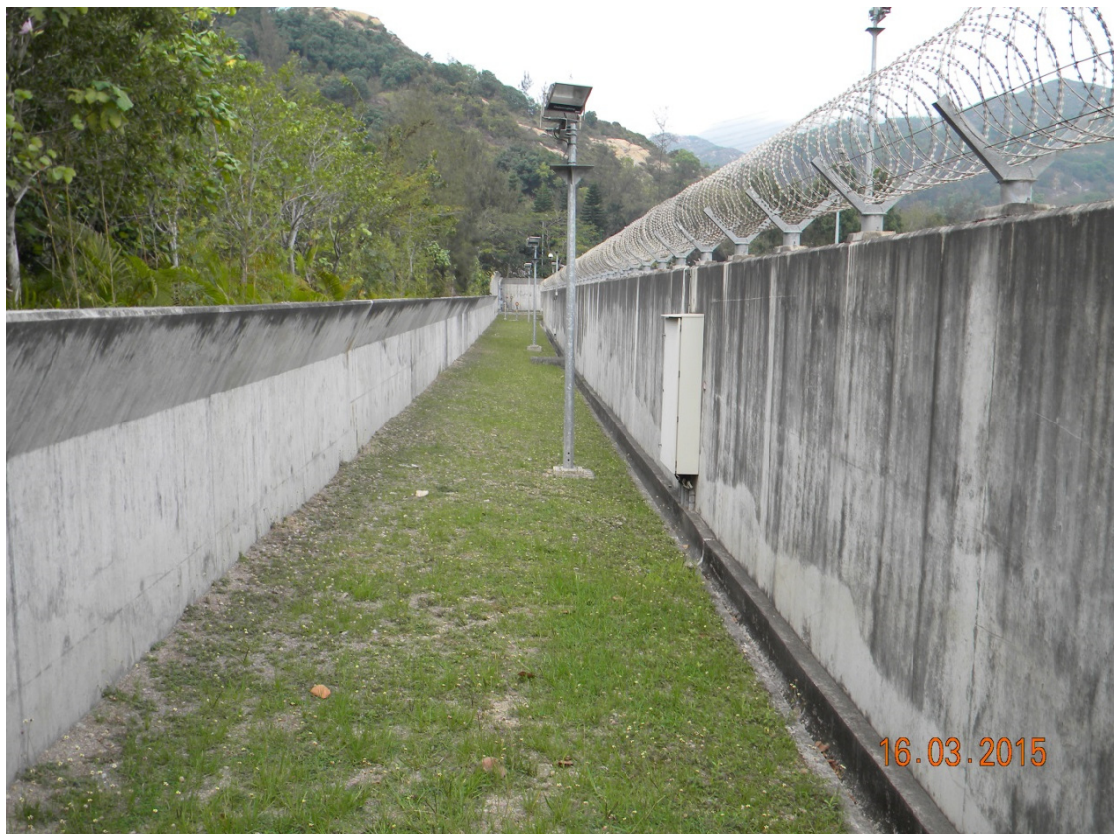
(9) Two impervious security walls are provided outside the bunded compounds

(10) Two impervious security walls are provided outside the bunded compounds

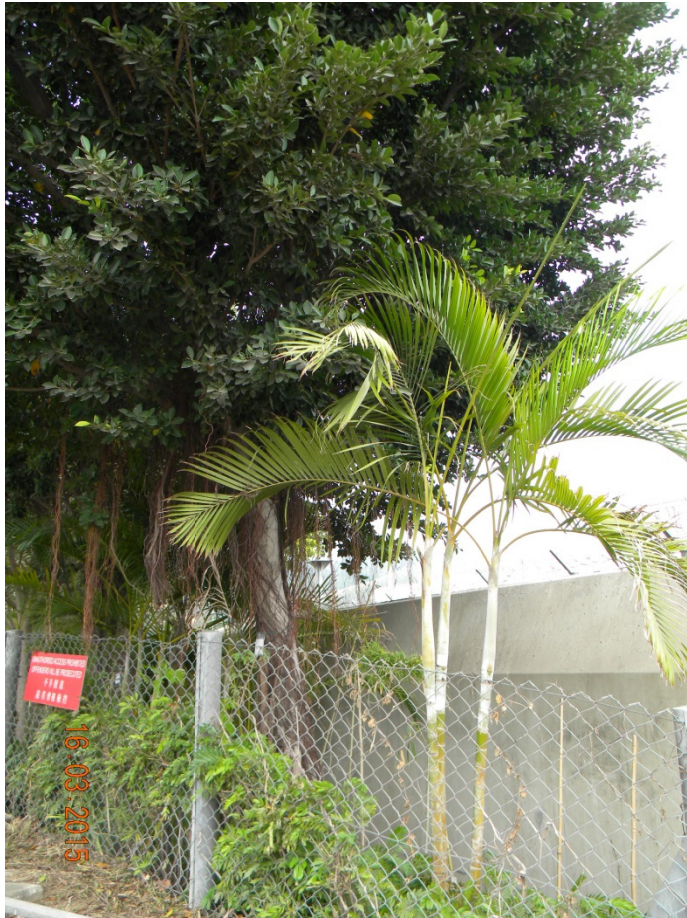
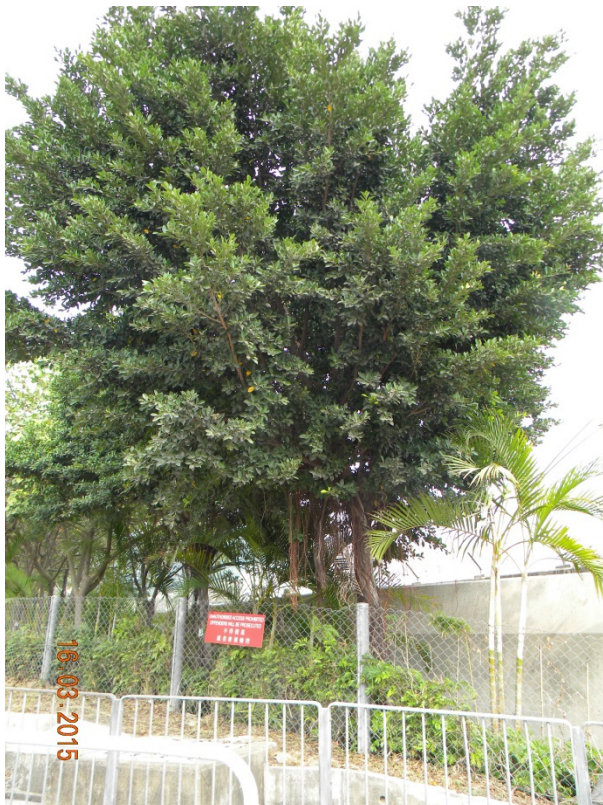
(11) Landscaped berm is maintained at least 1.5m high

(12) Landscaped berm is maintained at least 1.5m high

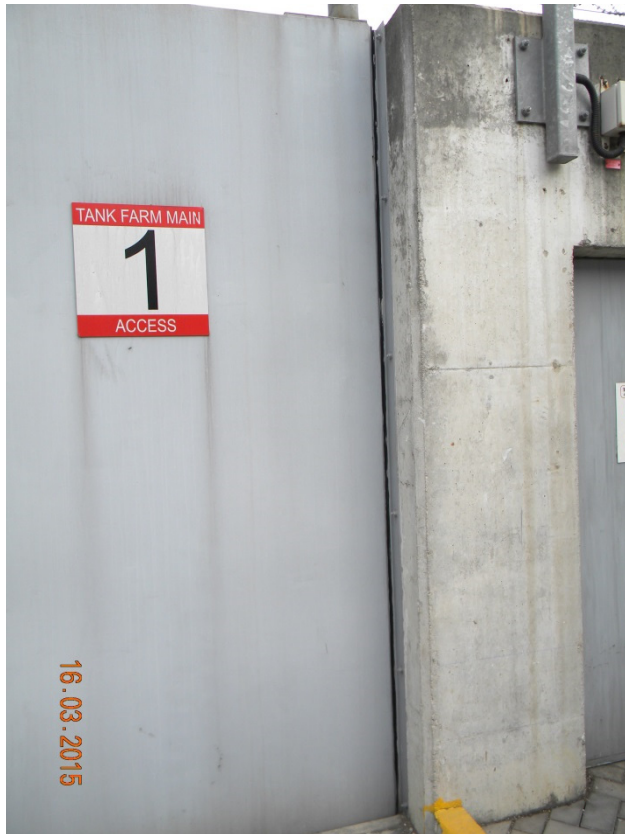
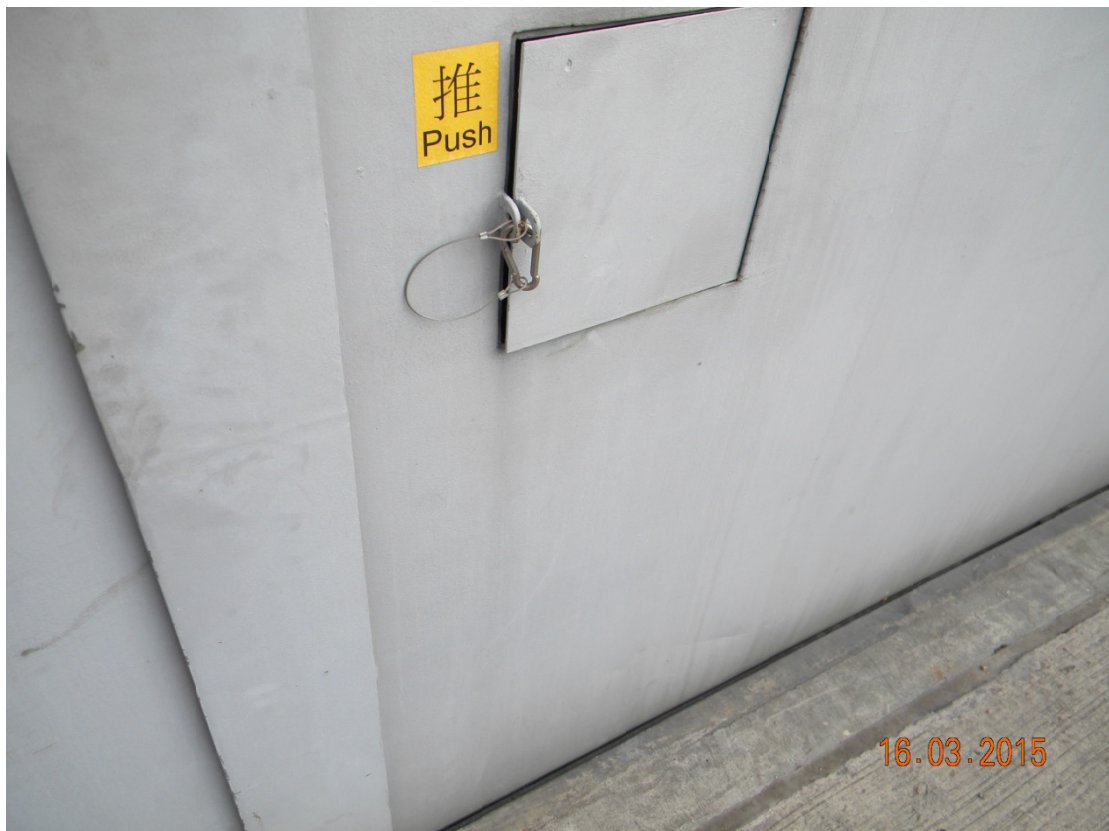
(13) Gates at security walls with sealant are maintained in good condition

(14) Gates at security walls with sealant are maintained in good condition

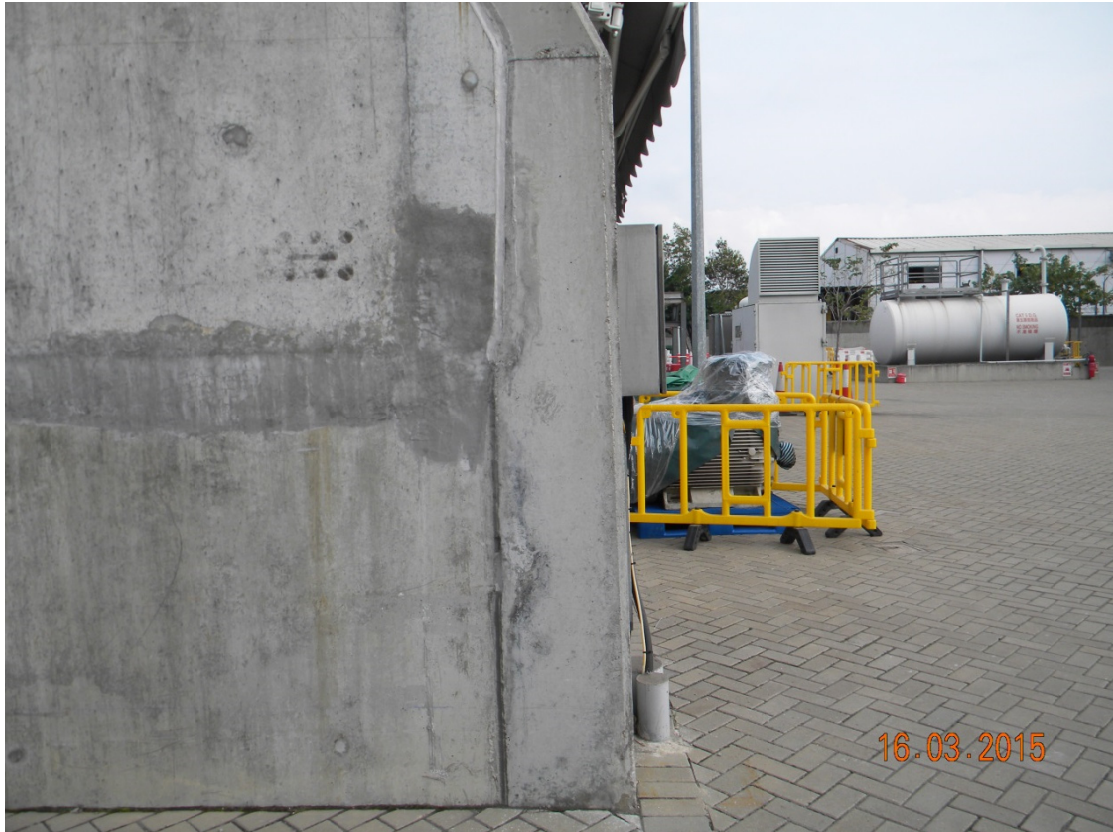
(15) This shows the thickness of the security wall provided

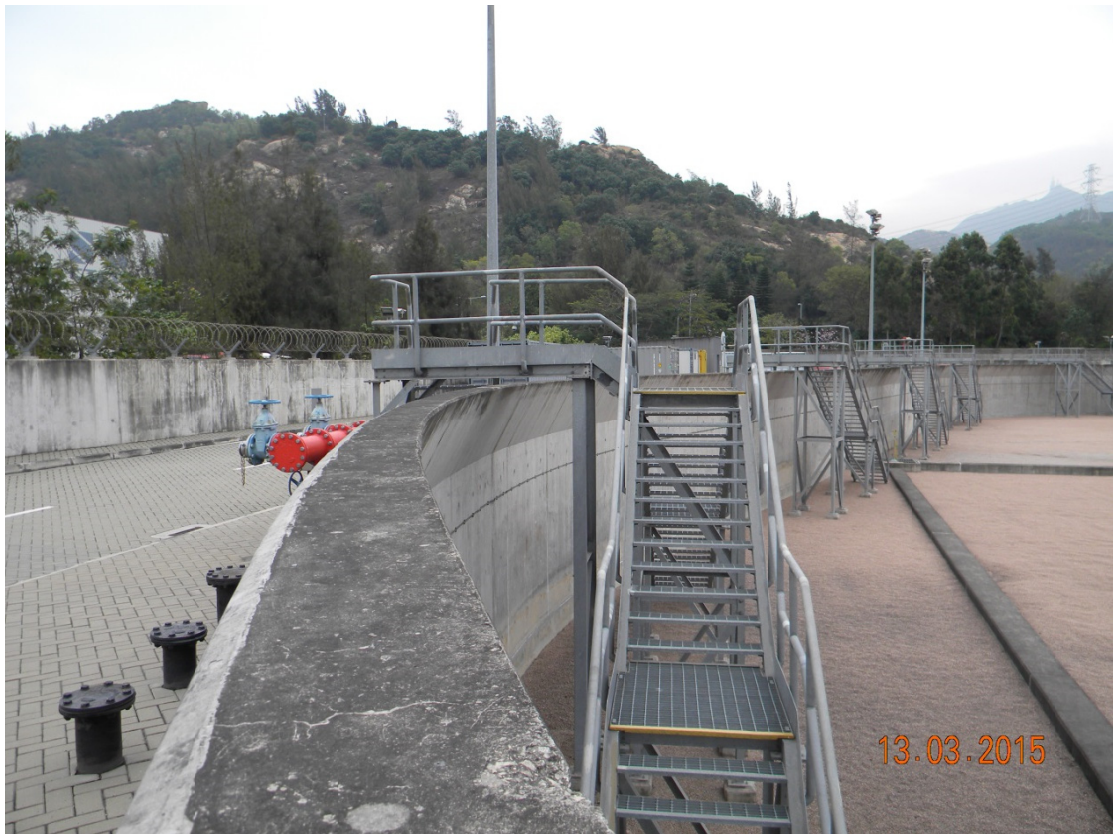
(16) This shows the thickness of the bund wall provided

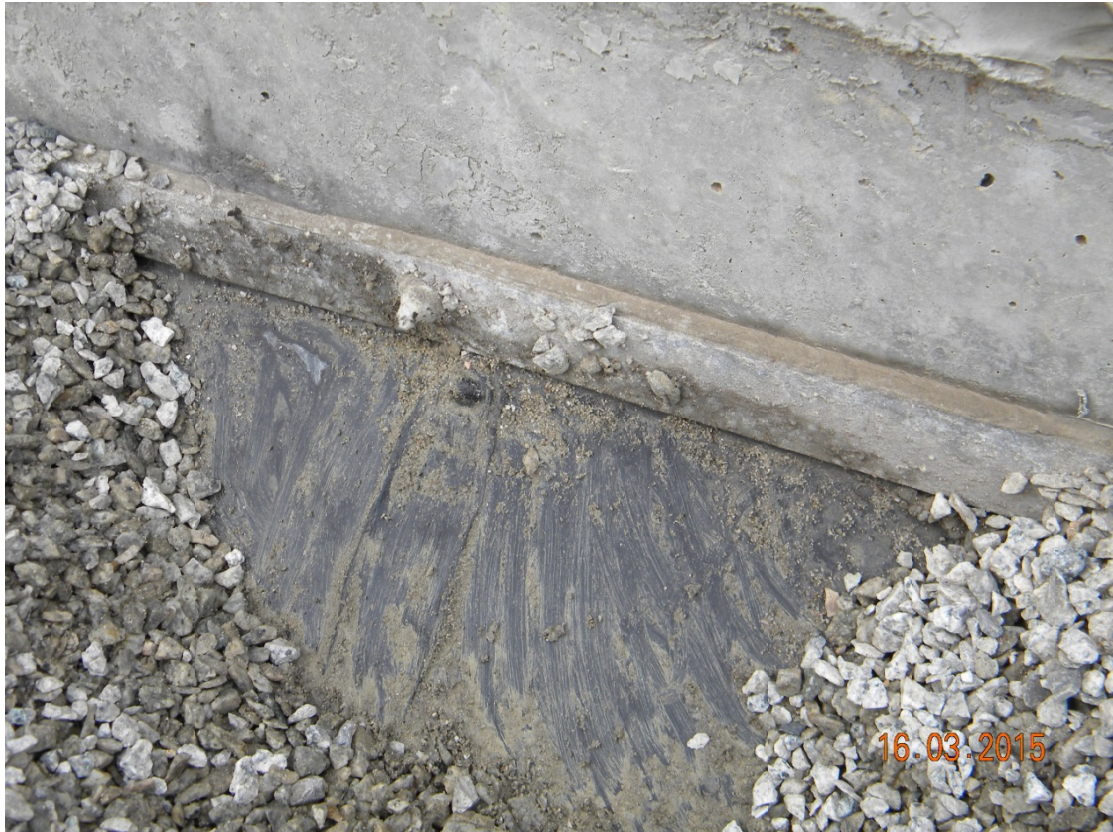
(17) Impervious lining are maintained in good condition

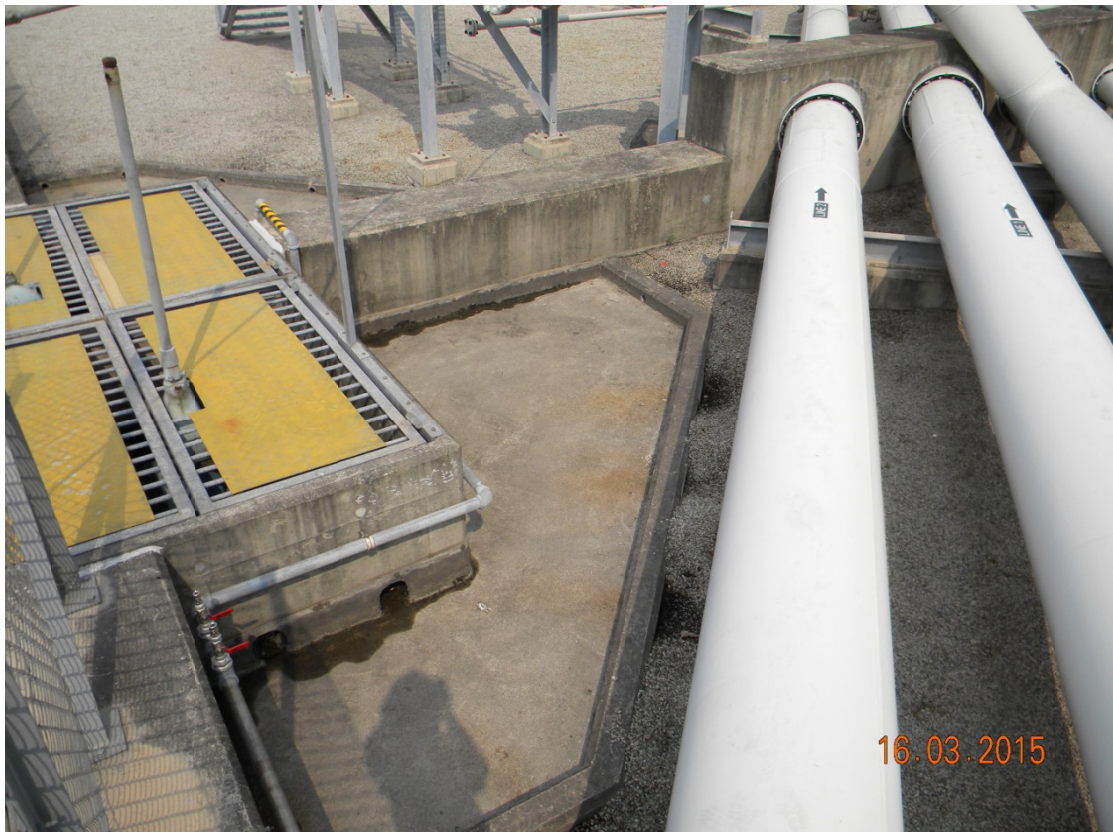
(18) Tank farm is with appropriate gradient and the drainage falls to interceptor for collection

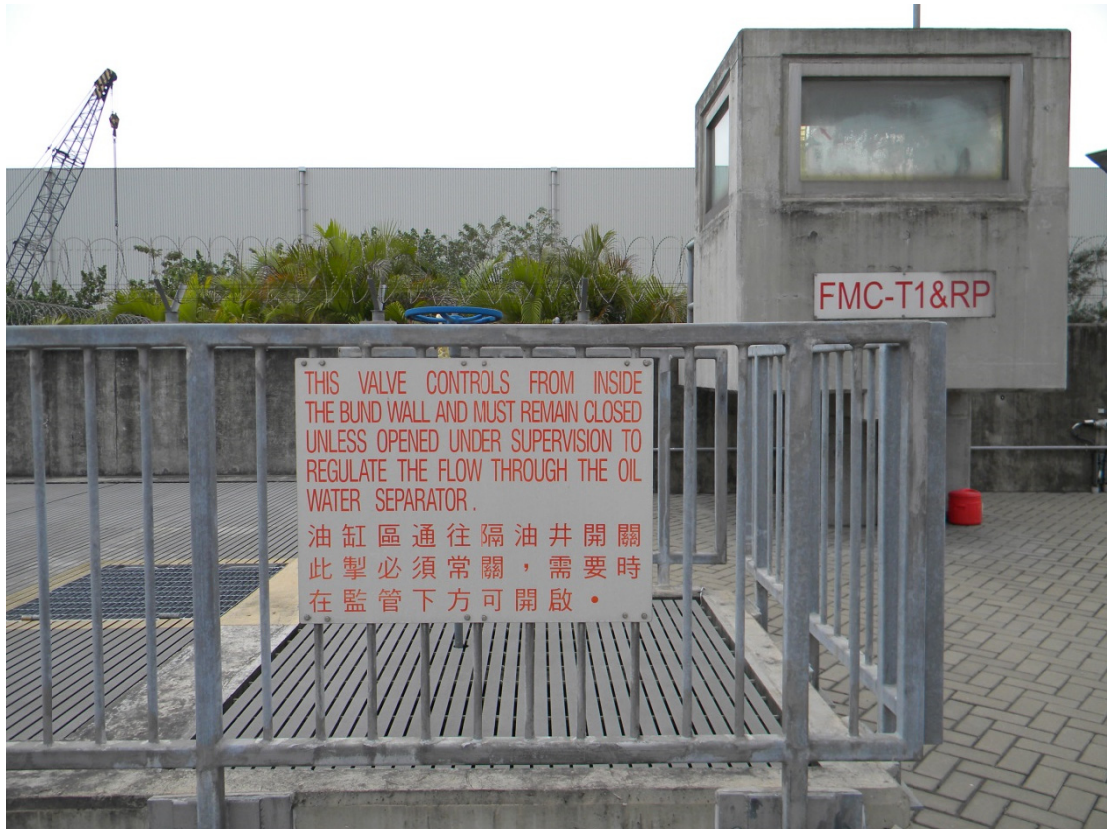
(19) Outlet valve provided for Phase 1a Interceptor with instruction sign to keep “normally closed”

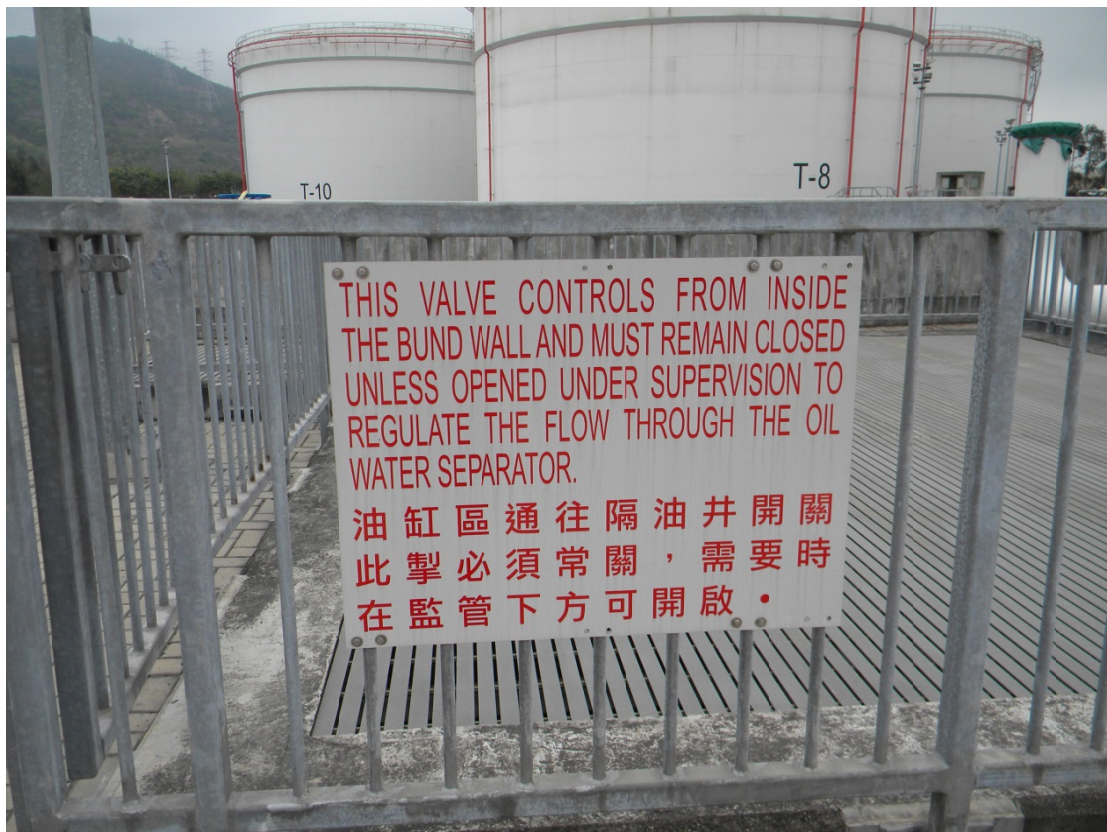
(20) Outlet valve provided for Phase 1b Interceptor with instruction sign to keep “normally closed”

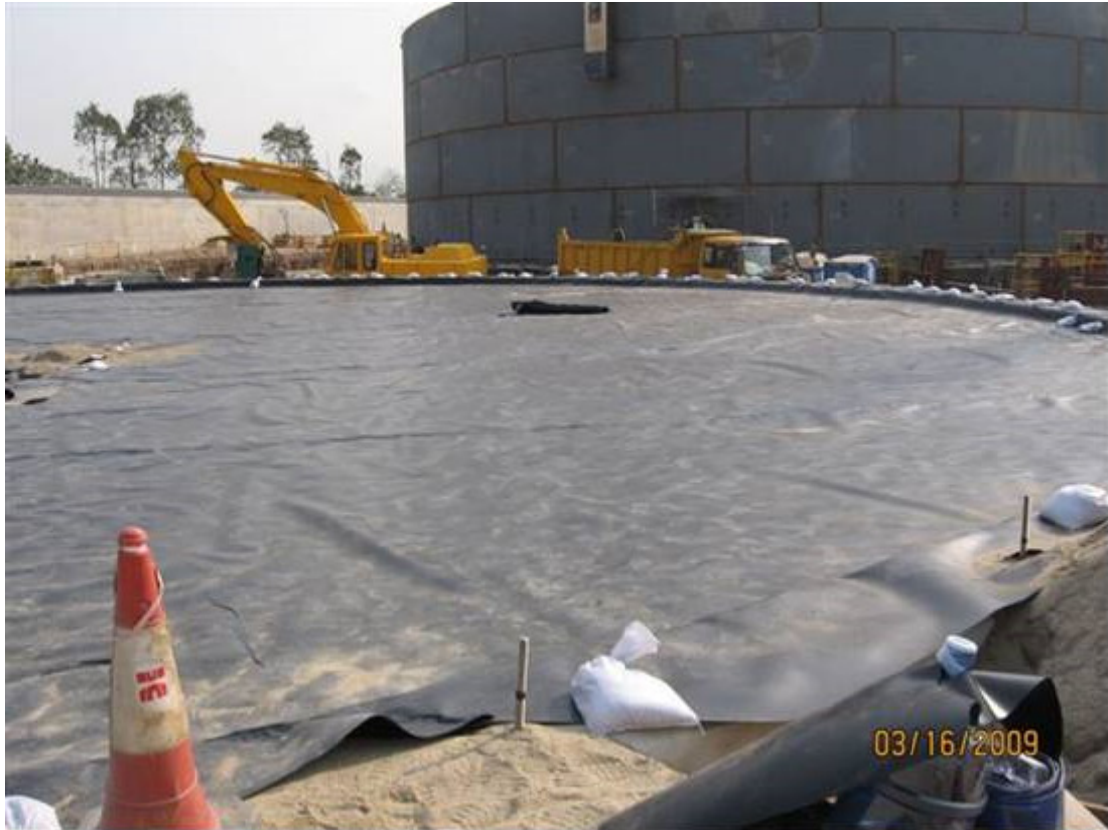
<p>There has been no change made since the completion of construction in October 2010. Photographs No. 21 & 22 show construction record of the impermeable lining at various locations.</p>	
---	--

(21) Record photo shows impervious membrane being installed on top of tank foundation

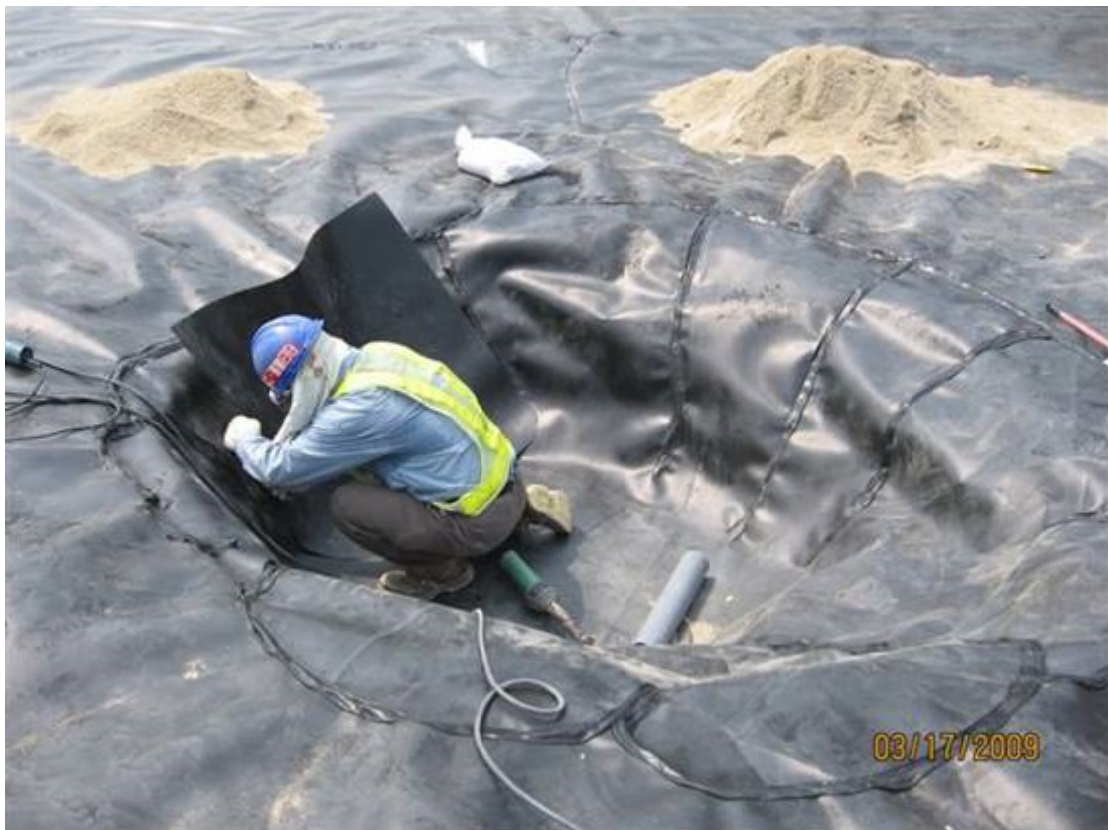
(22) Record photo shows impervious membrane laid at tank center sump with tell-tale pipe embedded for leak detection

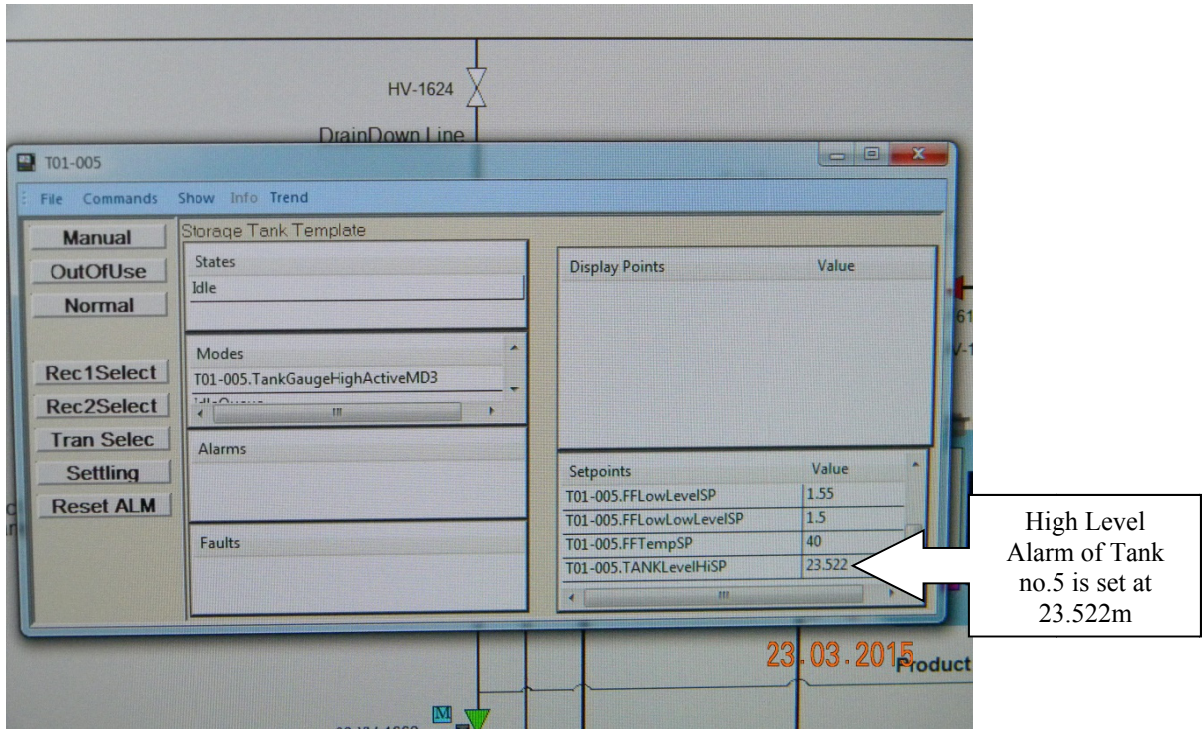
(23) High Level Alarm being set in the SCADA System

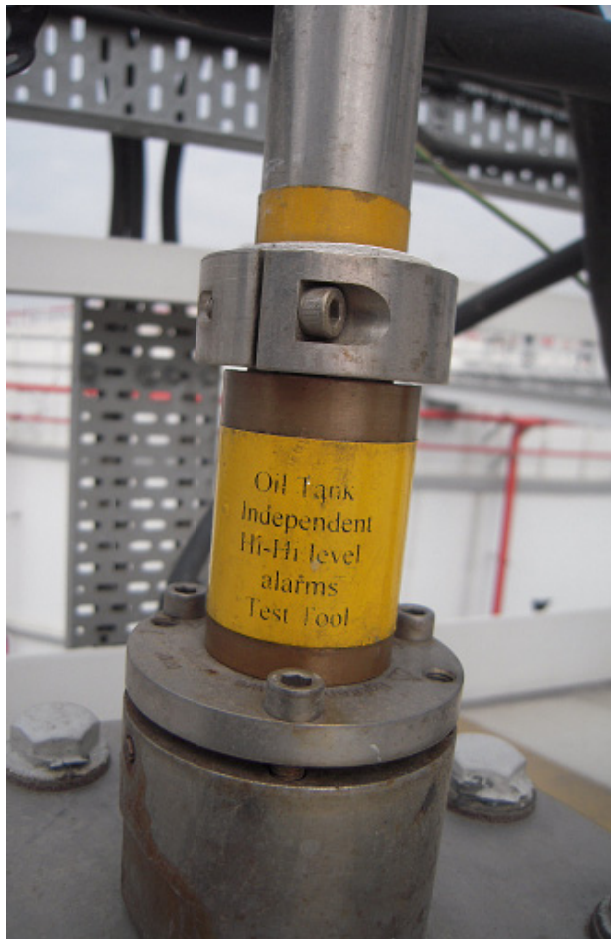
(24) Regular inspection performed on overfilling monitoring device (HH Level Alarm)

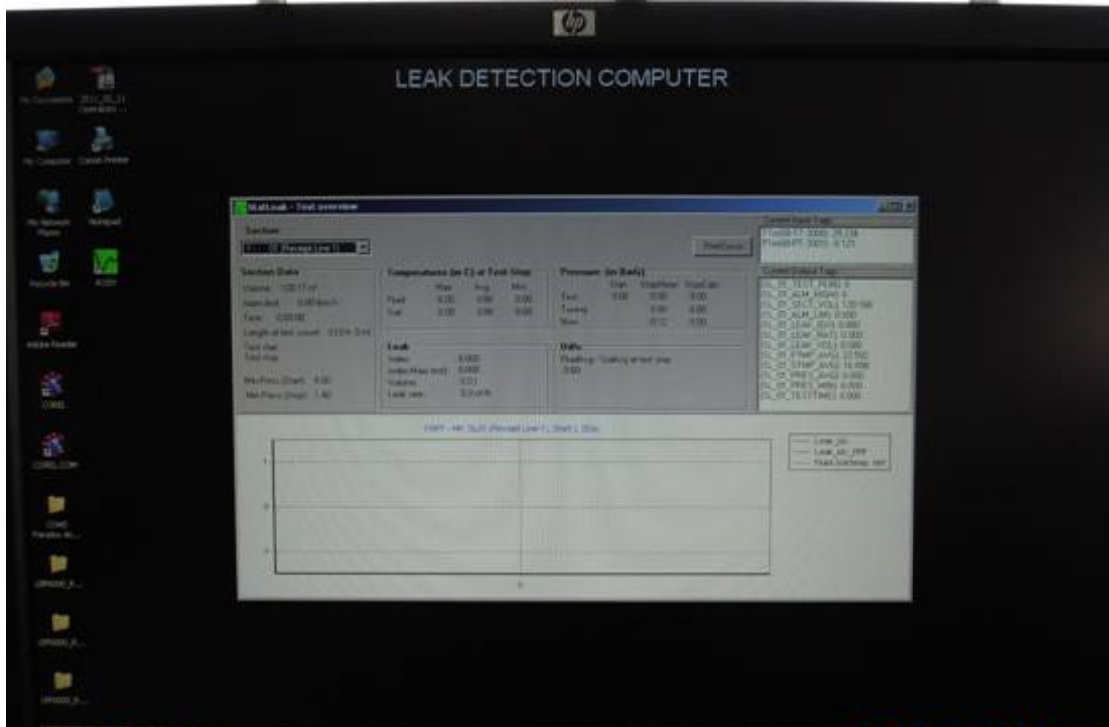
<p>The COWI Stat Leak System instrumentation has been installed and there has been minor design change after the completion of construction in October 2010. Photograph No. 26 shows the COWI Stat Leak System software has been installed on the computer. The system enhancement of the leak detection system pump and piping are in progress and pending for final integrated commissioning and automatic sequencing.</p>	
--	--

(26) Leak detection “COWI Stat Leak System” installed into computer

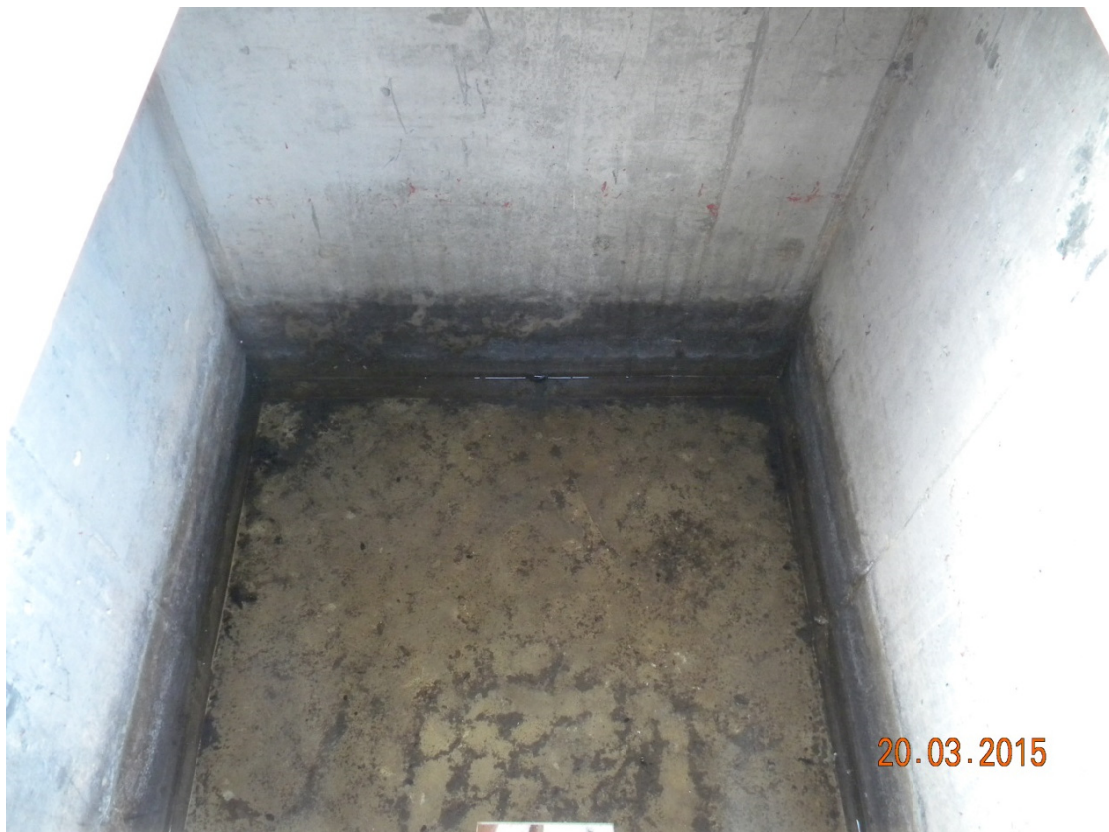
(27) Leak detection tell-tale pipe underneath the storage tank opening out to a collection chamber
