PERMANENT AVIATION FUEL FACILITY

ANNUAL AUDIT REPORT

**Environmental Permit
EP-262/2007/B**

Date of Audit : 13 – 24 March 2015

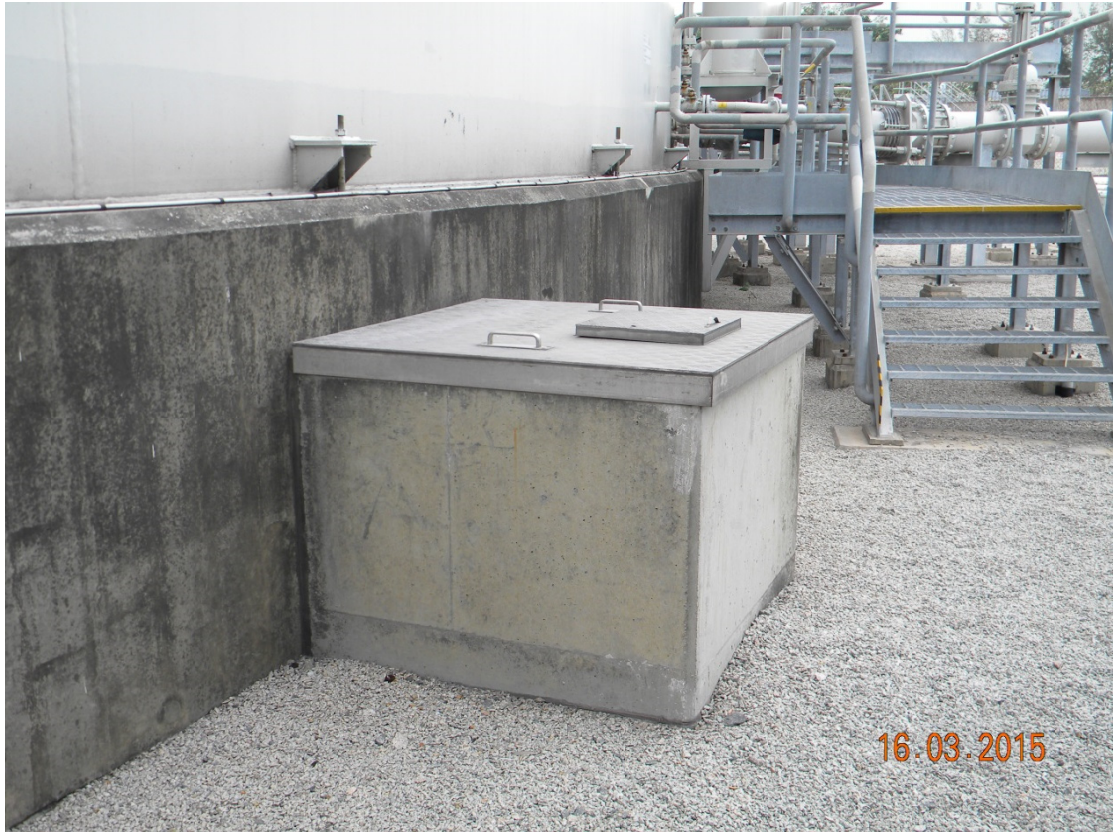
(28) Collection chamber located adjacent to tank foundation is maintained in good condition with periodic inspection

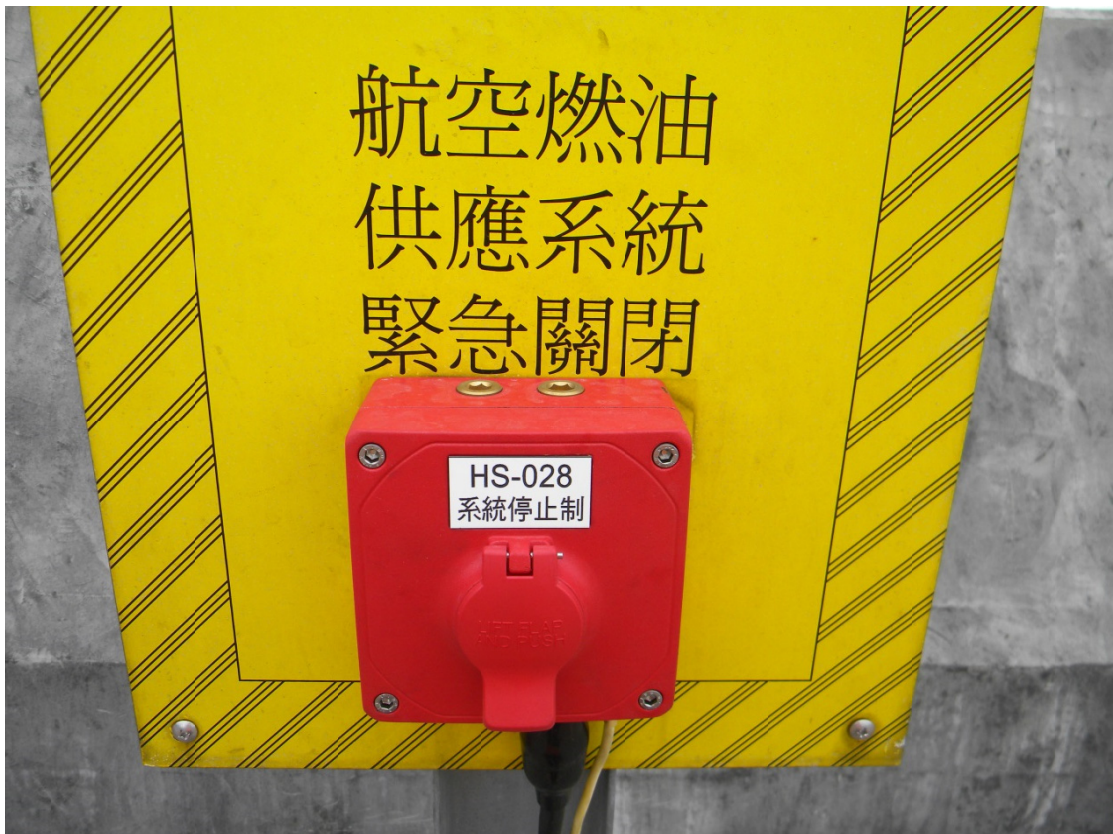
(29) ESD is maintained in good condition and being tested periodically

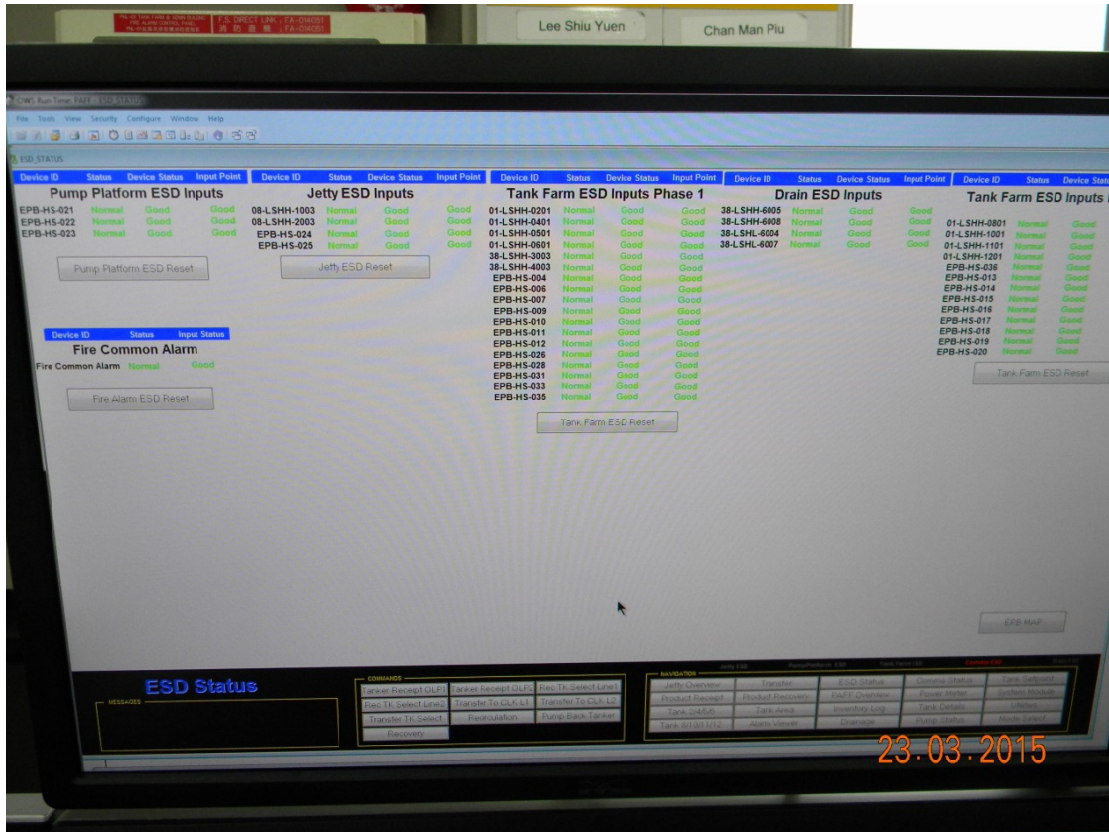
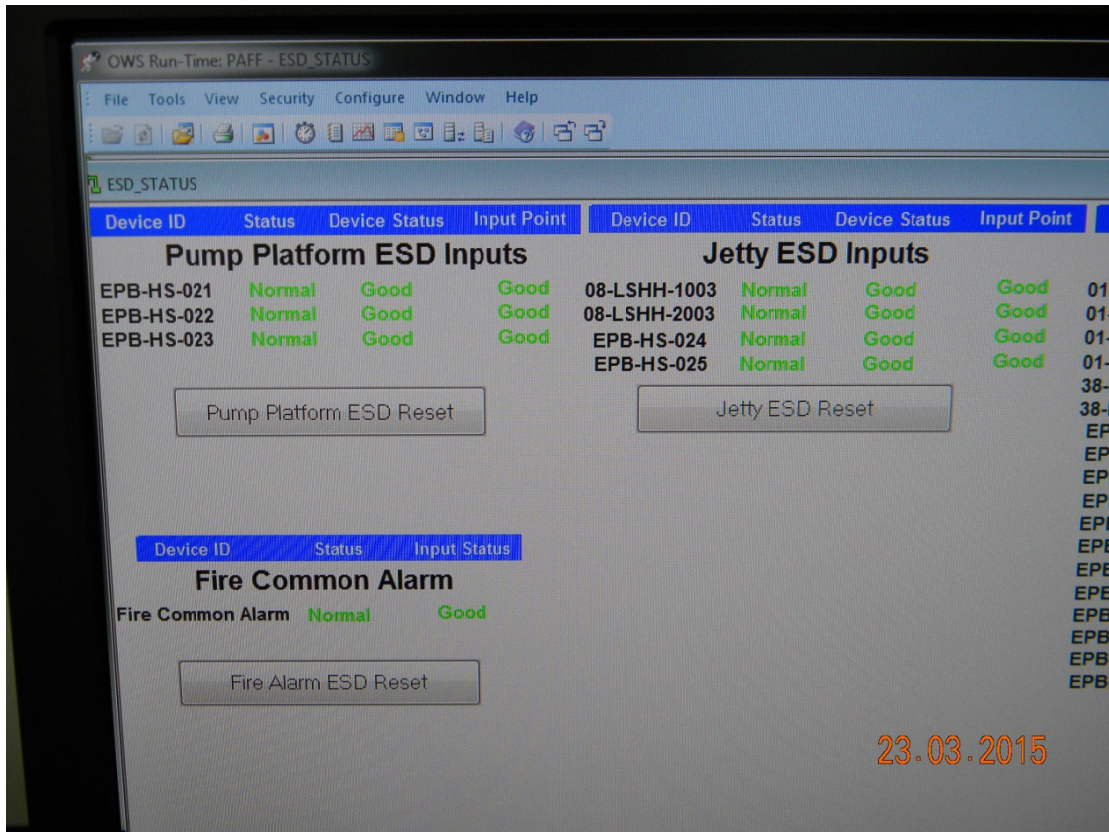
(30) The ESD regular test shown in SCADA System

(31) The ESD regular test shown in SCADA System

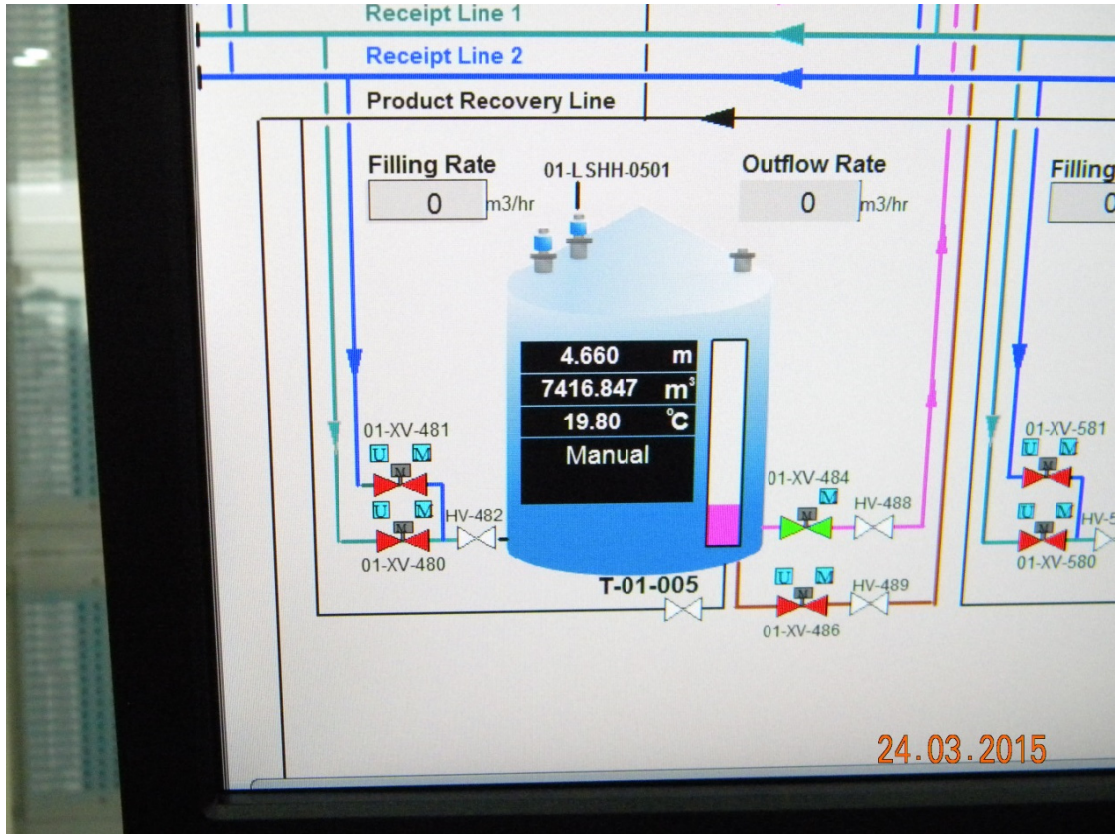
(32) The ESD test signal shown in SCADA System

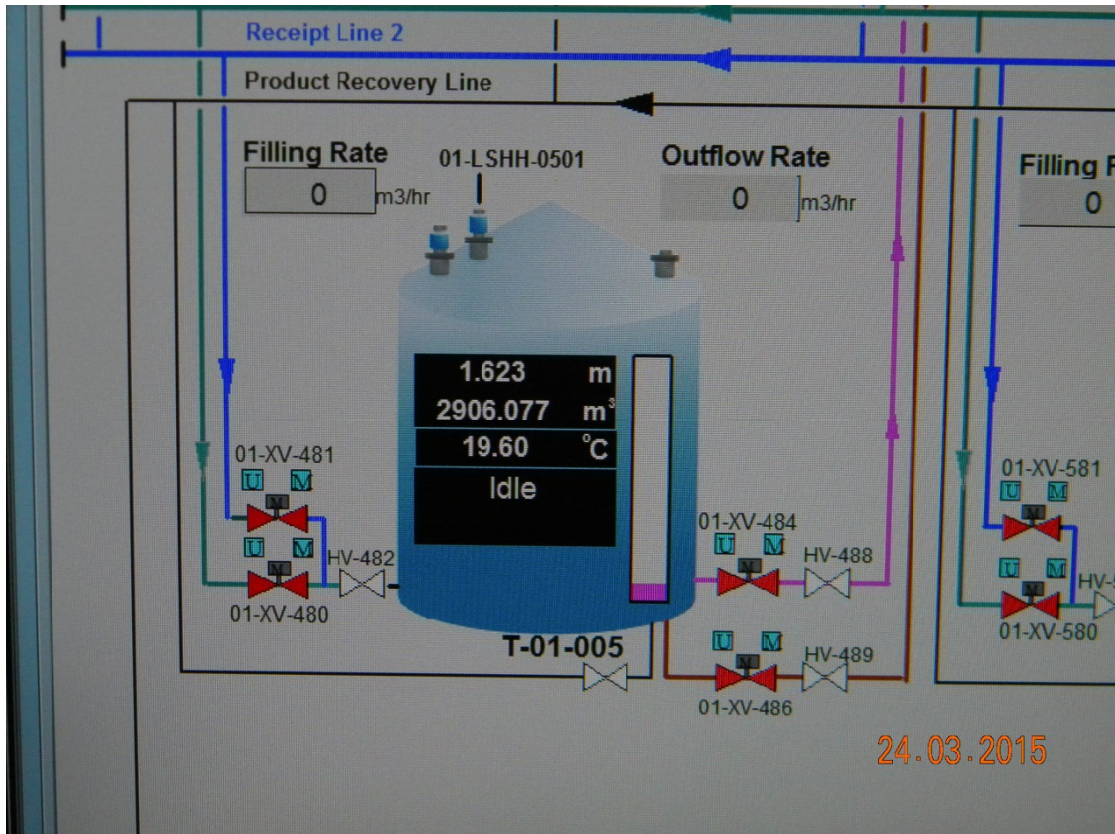
(33) Once the system received ESD test signal, the valves will close automatically and shut down the operation shown in SCADA System

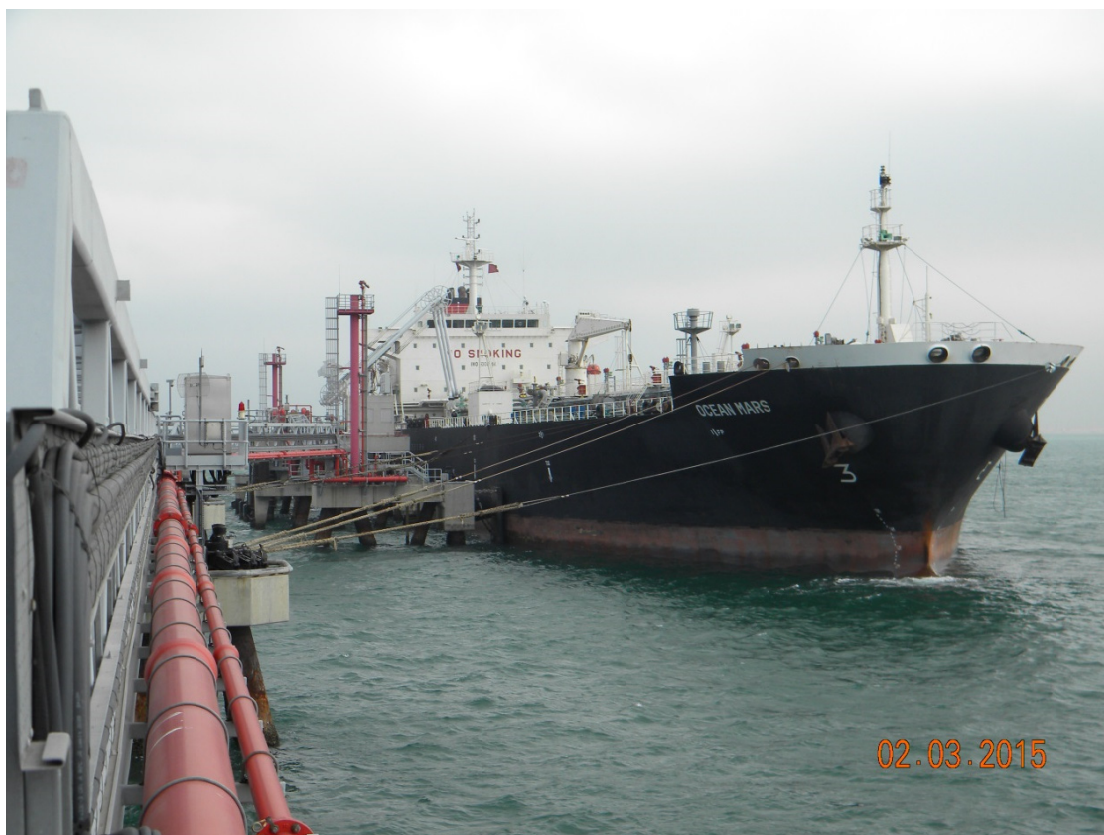
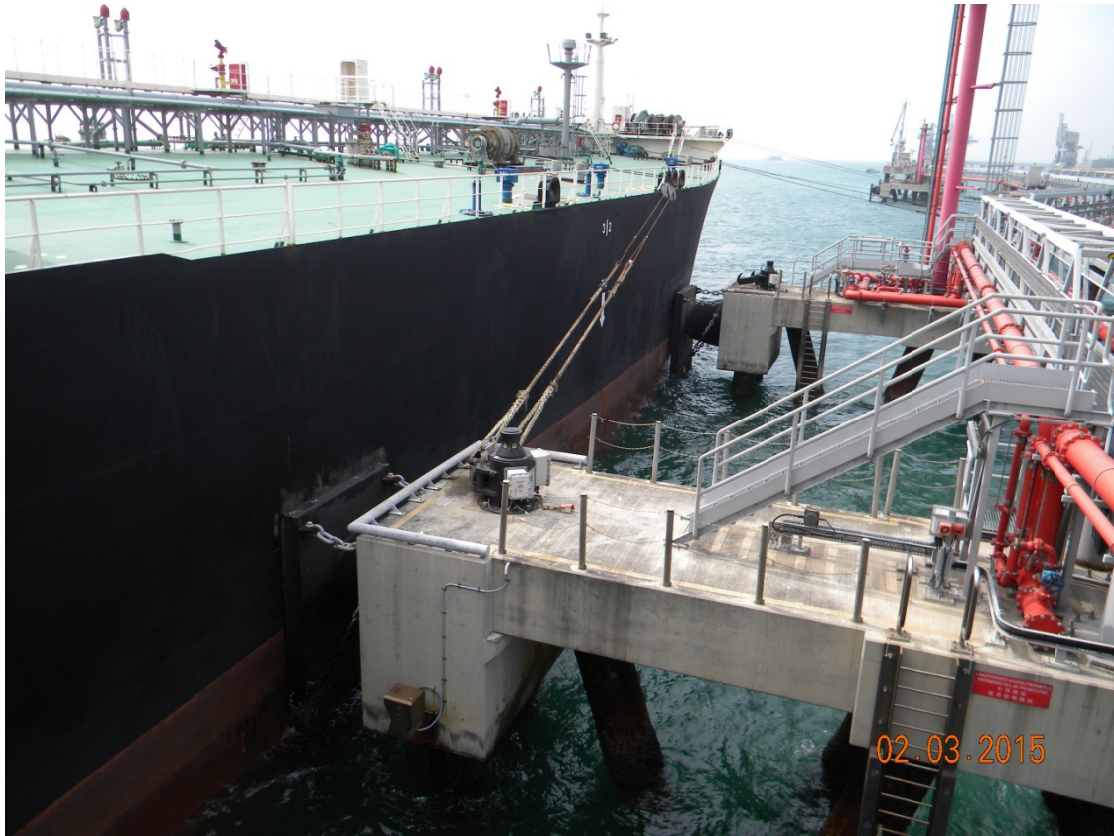
(35) Fenders installed at sea side of the jetty

(36) Fenders installed at sea side of the jetty.

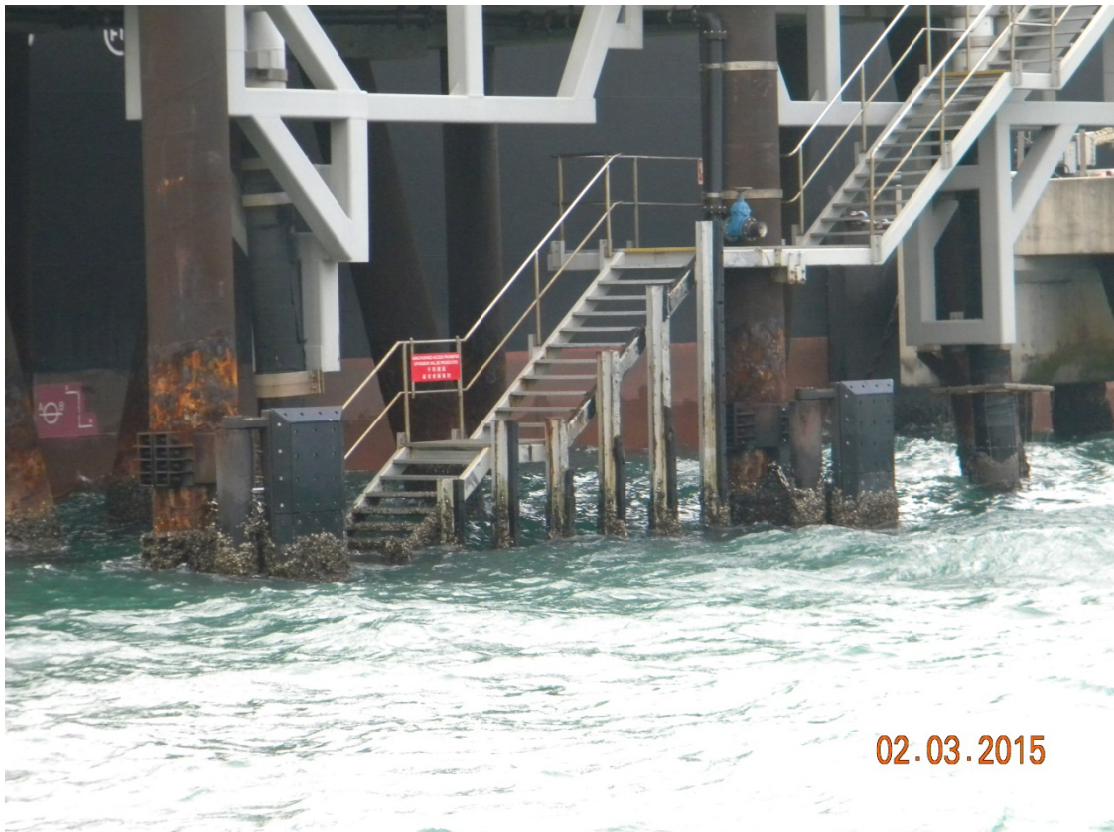
(37) Fenders installed at shore side of the jetty

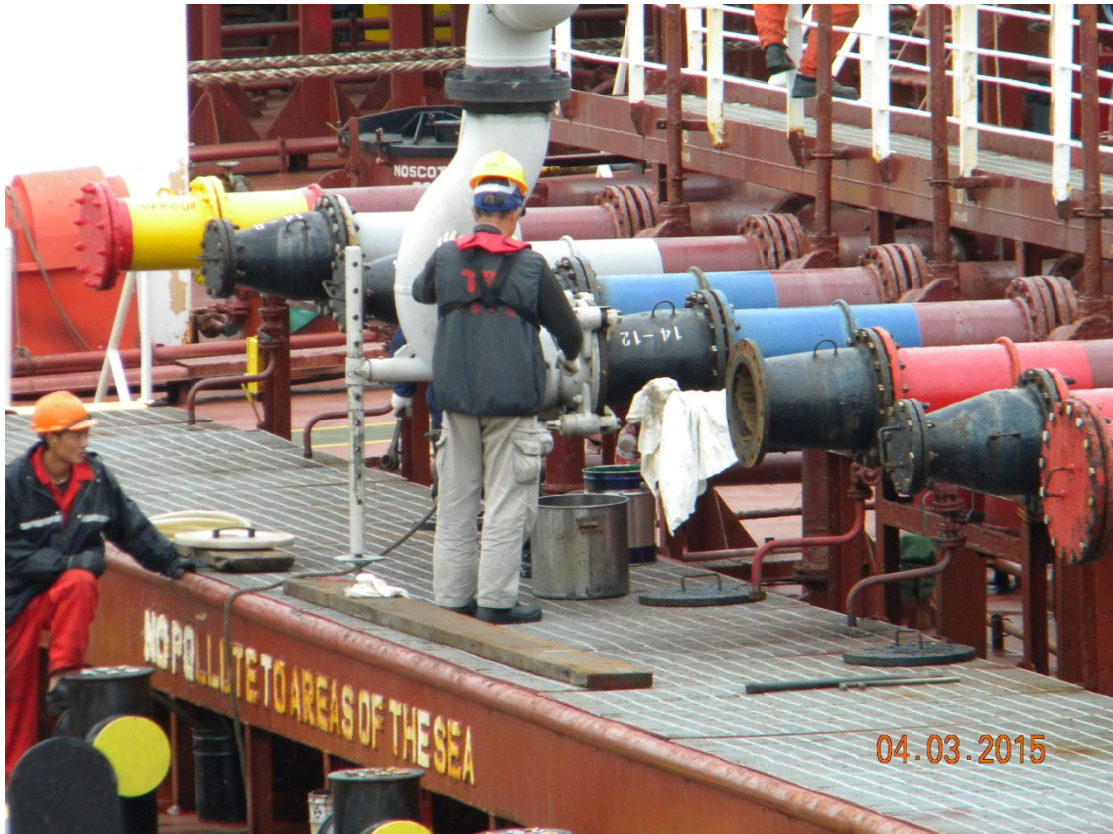
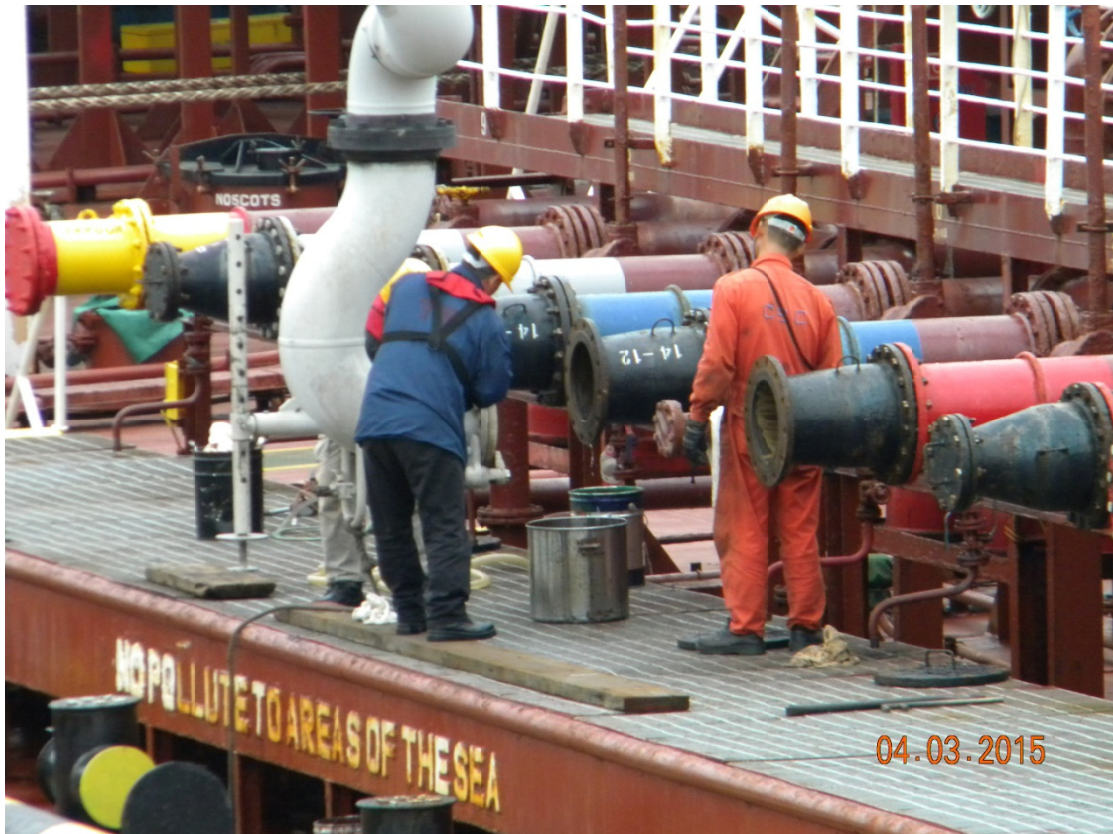
(38) Slop trays being used for coupling and de-coupling of the loading arms

(39) Slop trays being used for coupling and de-coupling of the loading arms
