ANNUAL AUDIT REPORT
For
PERMANENT AVIATION FUEL FACILITY
Environmental Permit
EP-262/2007/B

Date of Audit :		1 - 20 March 2019
Prepared By :	Michael Chung, Senior Engineer

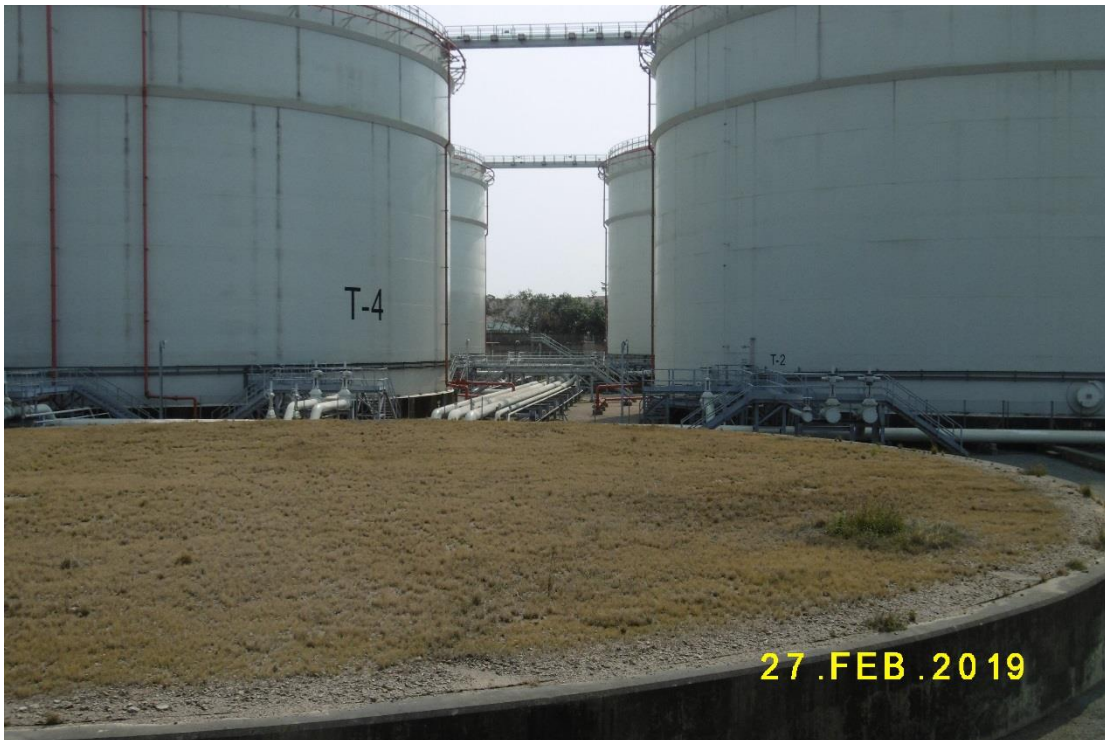
(1) Four tanks are located within bunded compound – Phase 1a

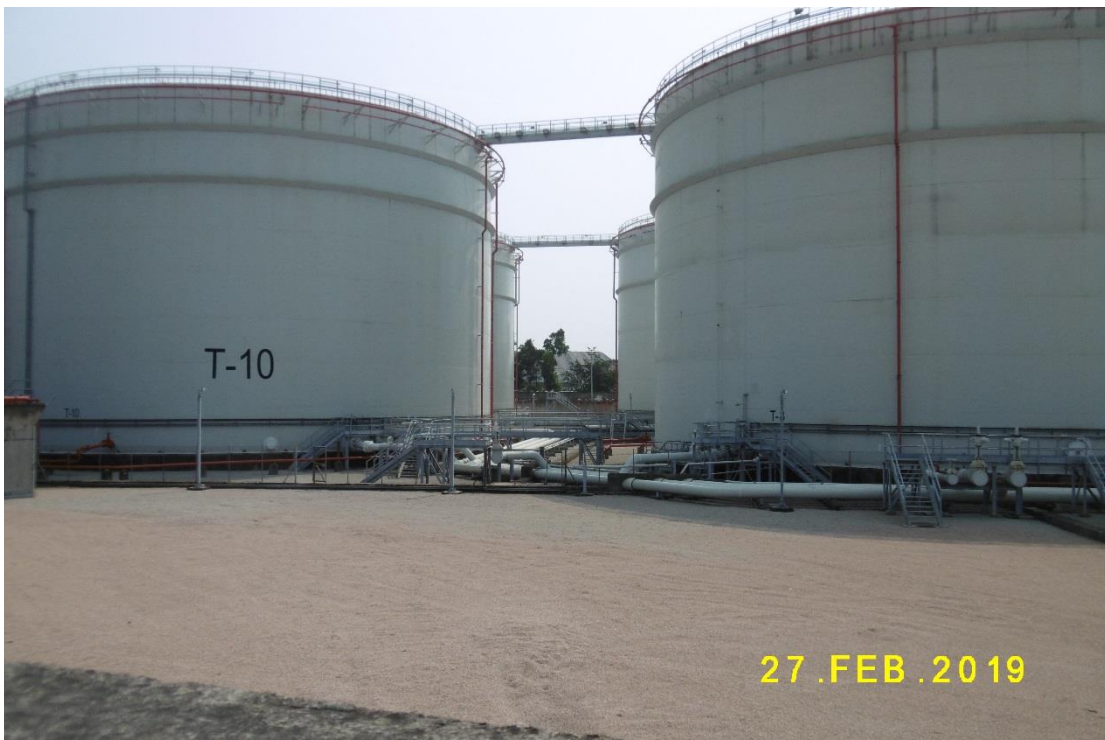
(2) Four tanks are located within bunded compound – Phase 1b

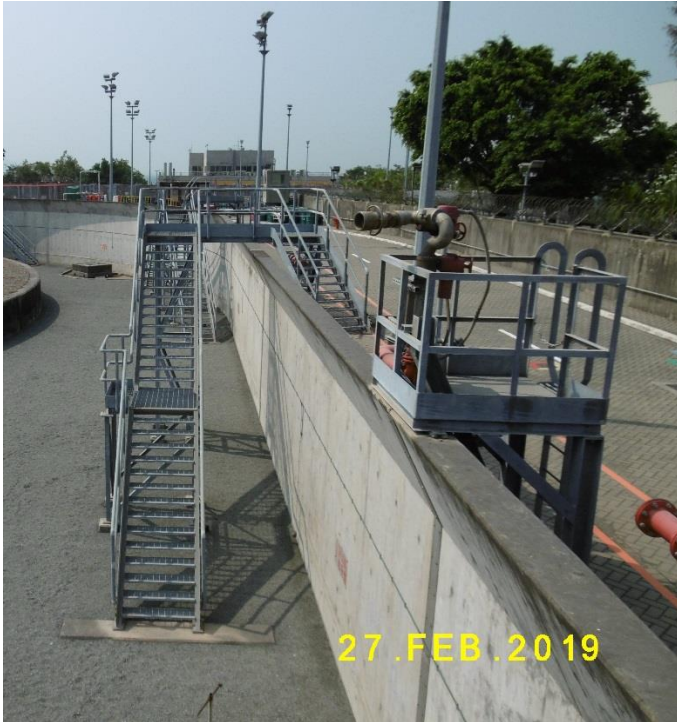
- (3) Phase 1a bunded compound is lower than the ground level outside the bunds

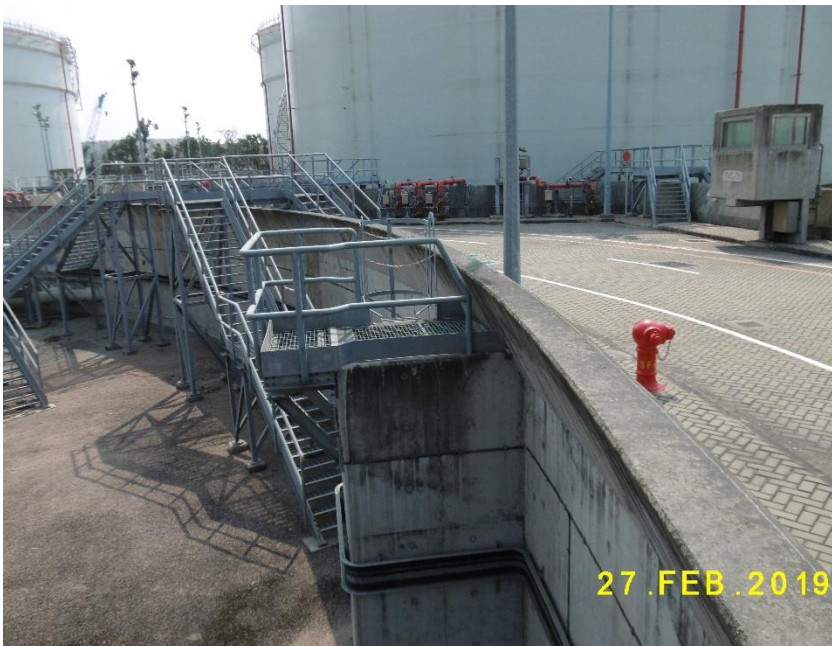
- (4) Phase 1b bunded compound is lower than the ground level outside the bunds

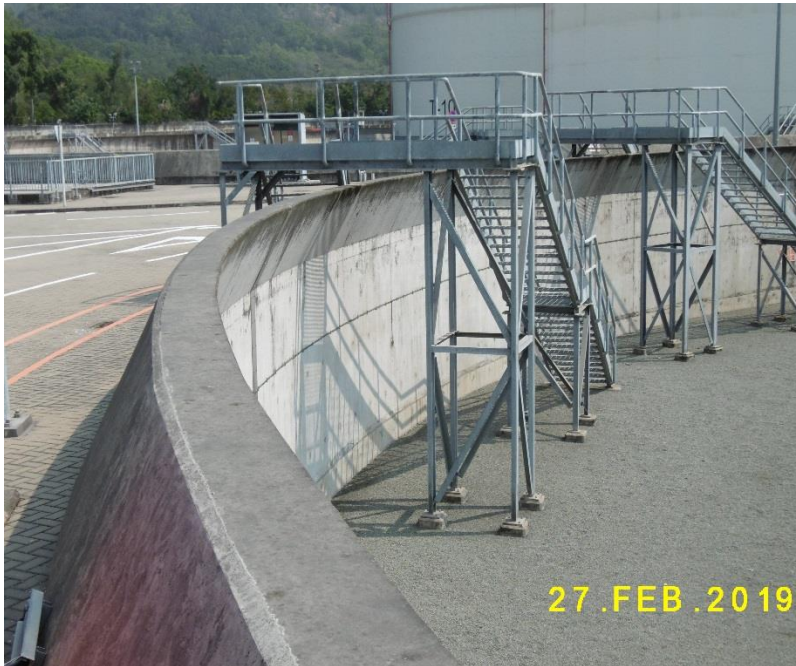
(5) Wave deflector is located at top of the bund

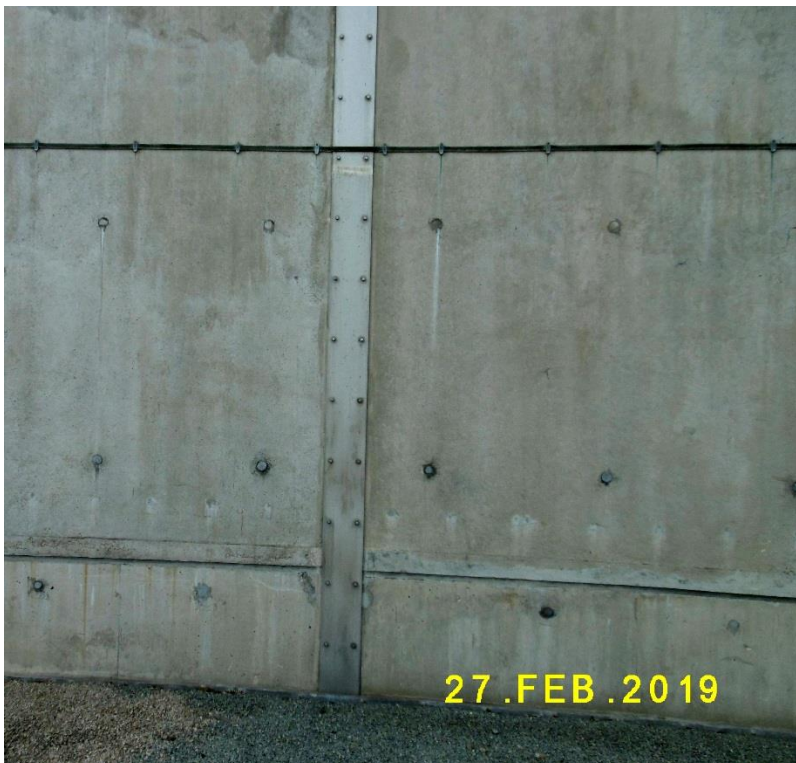
(6) Visible parts of the joints are covered by stainless steel plates on the inside at phase 1a bund

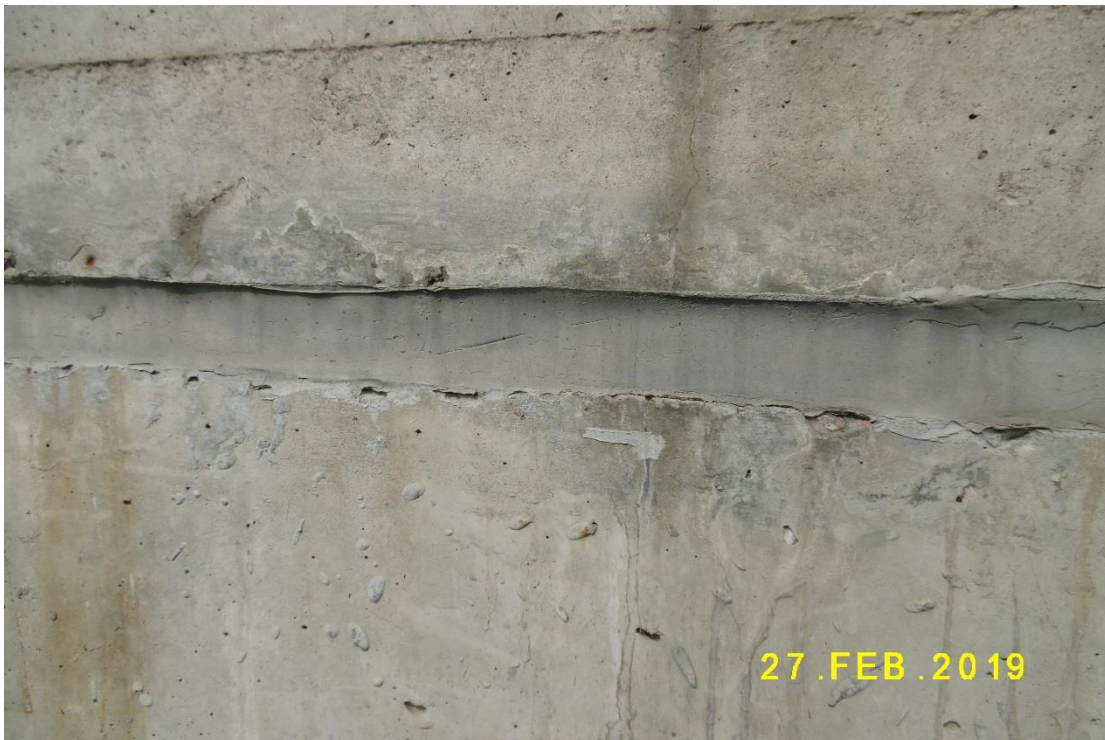
(7) Maintenance works have been performed on sealant at joints

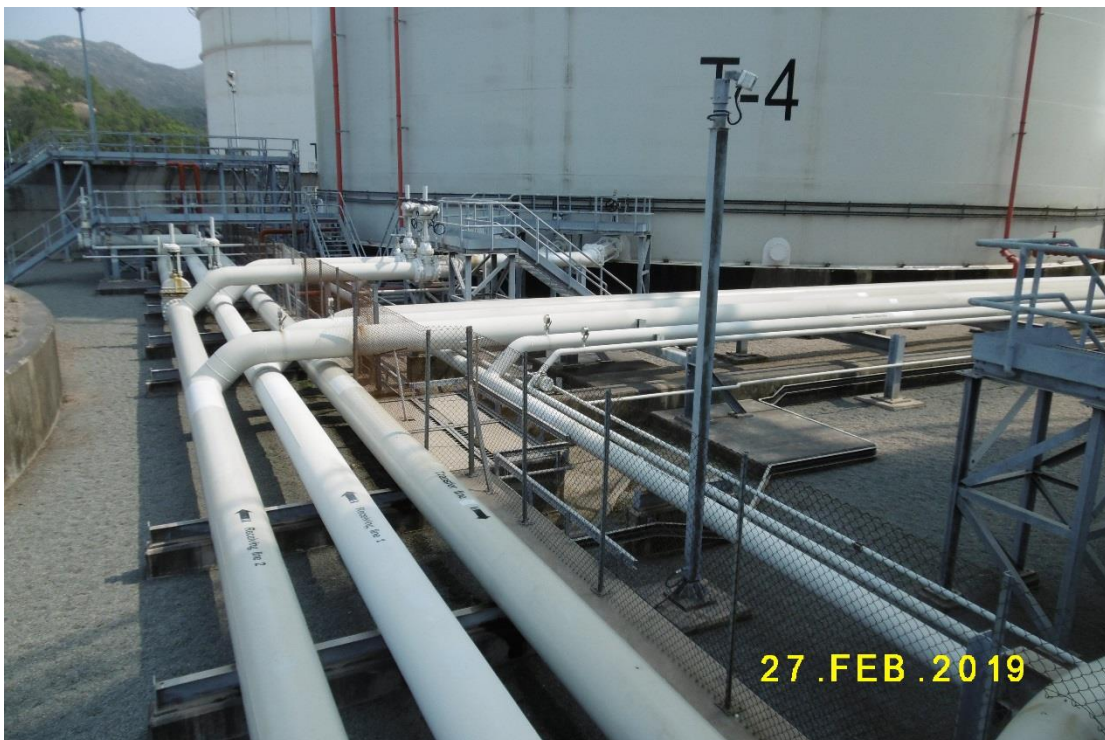
(8) Intermediate bund walls are provided in place near T-01-004

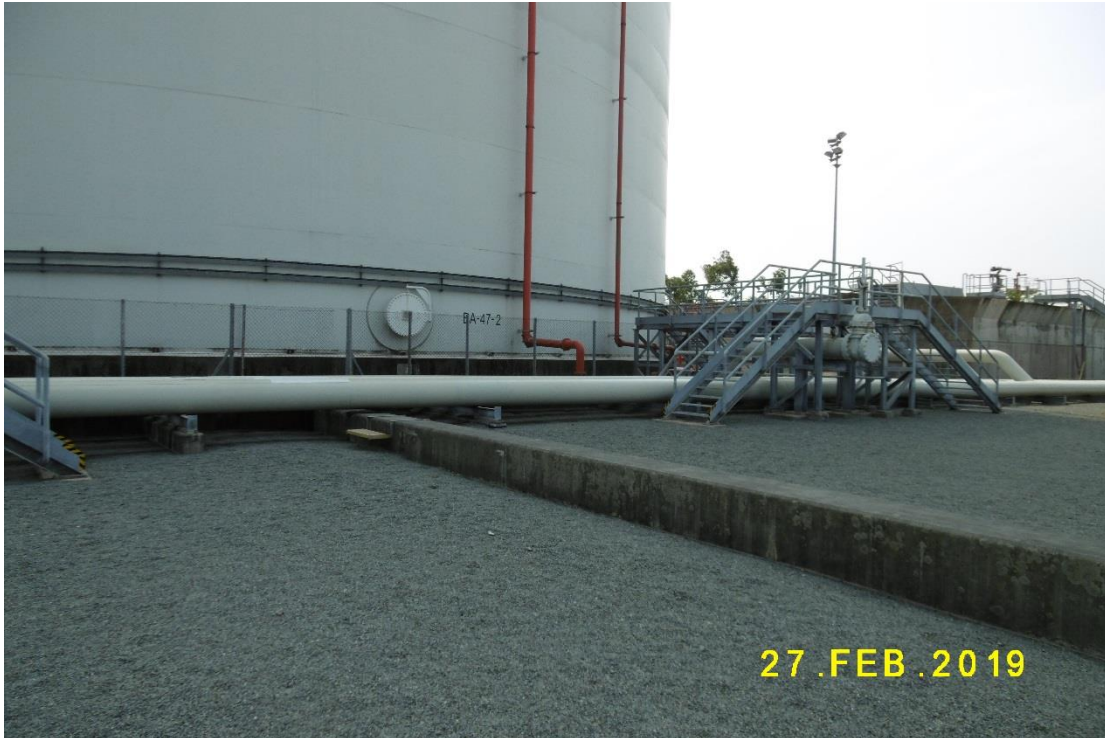
(9) Intermediate bund walls are provided in place near T-01-002

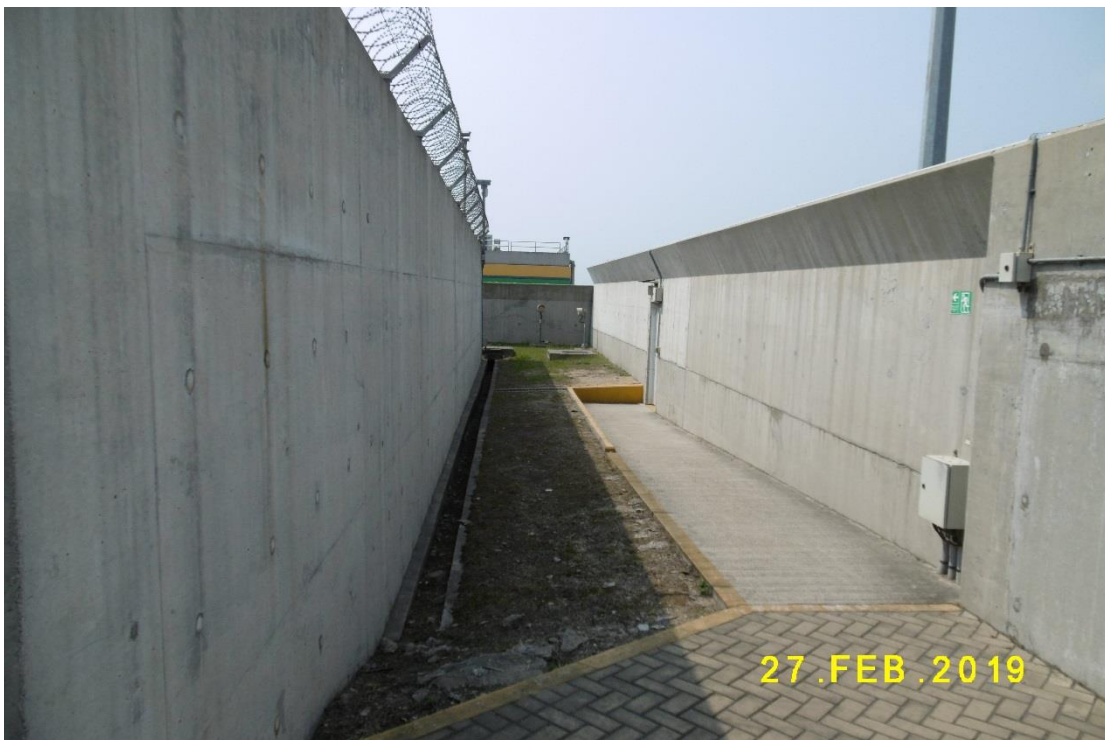
(10) Two impervious security walls are provided outside the bunded compounds

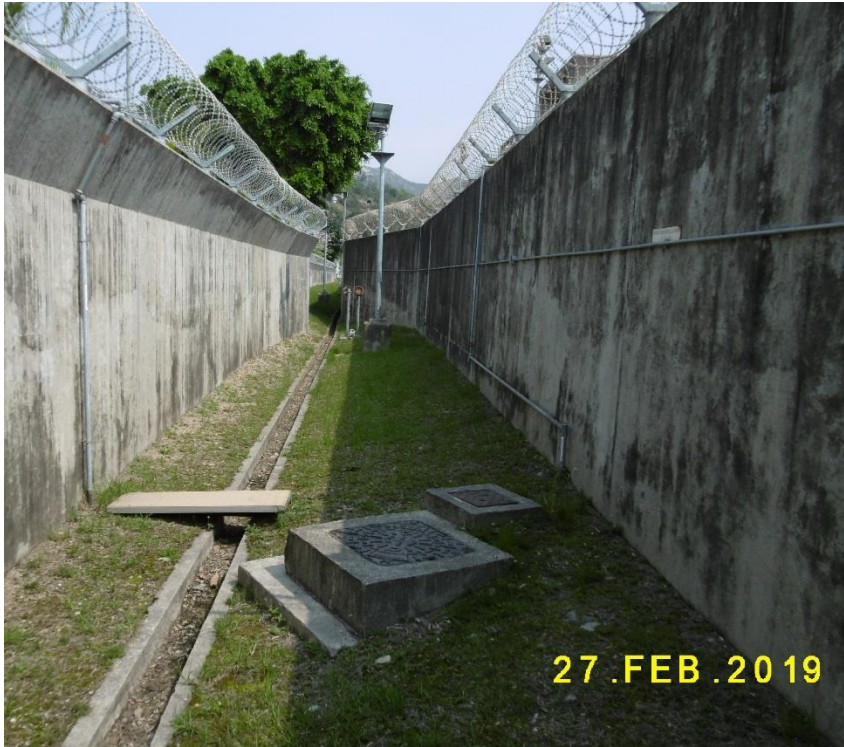
(11) Two impervious security walls are provided outside the bunded compounds

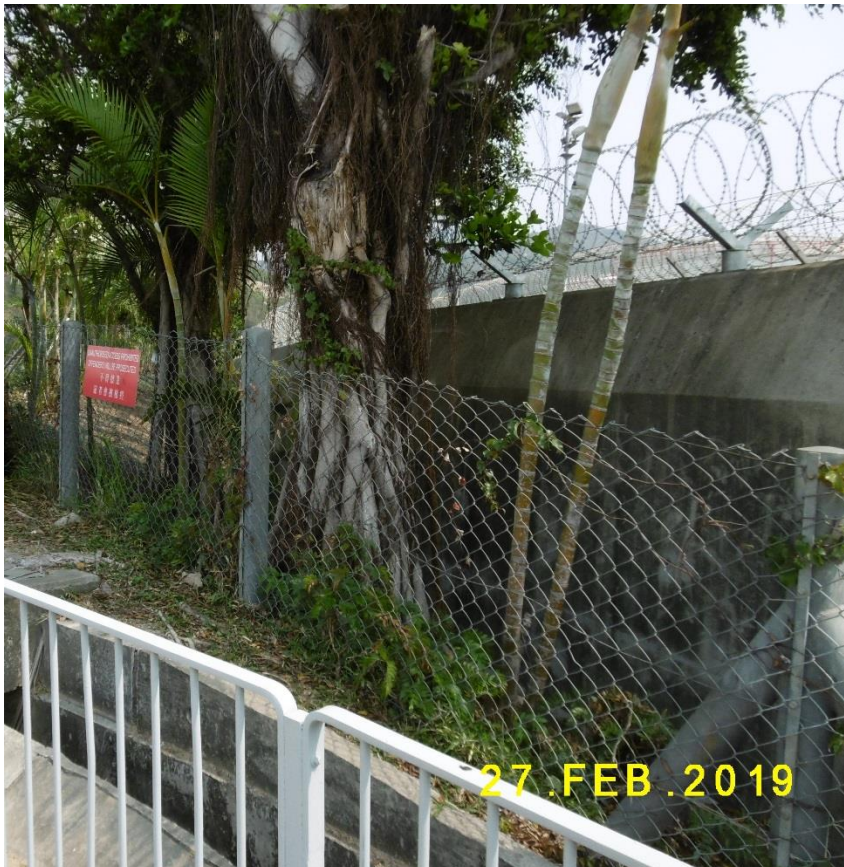
(12) Landscaped berm is maintained at least 1.5m high

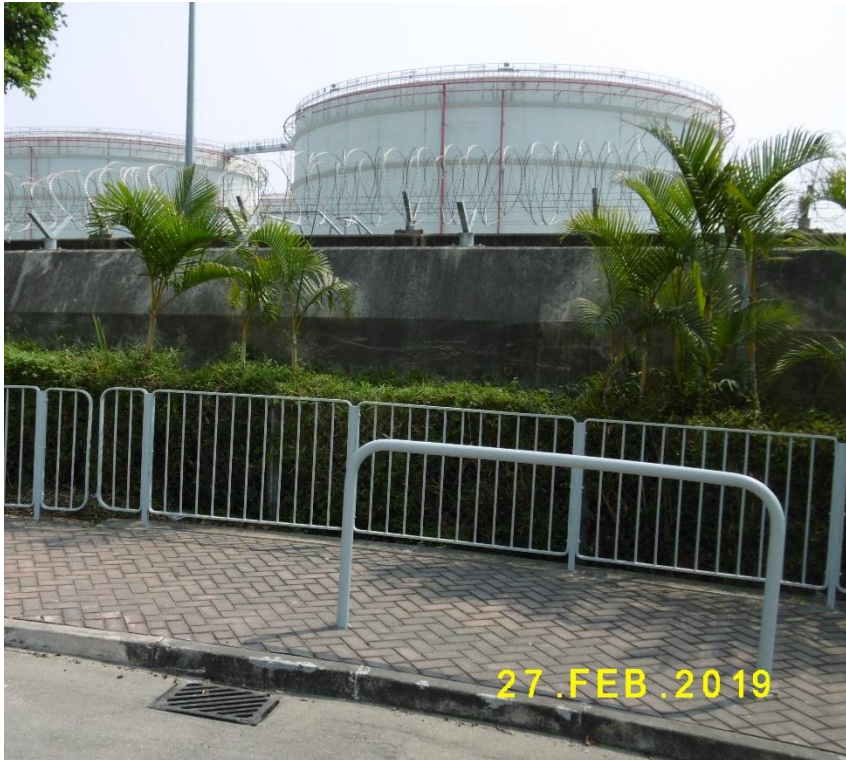
(13) Landscaped berm is maintained at least 1.5m high

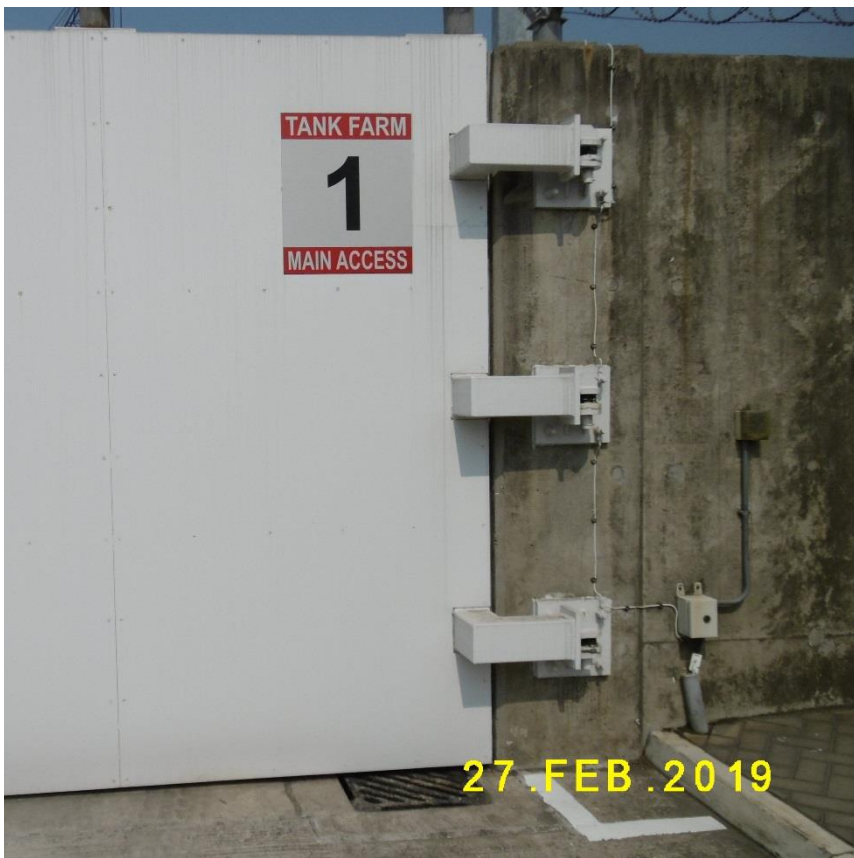
(14) Gates at security walls with sealant are maintained in good condition

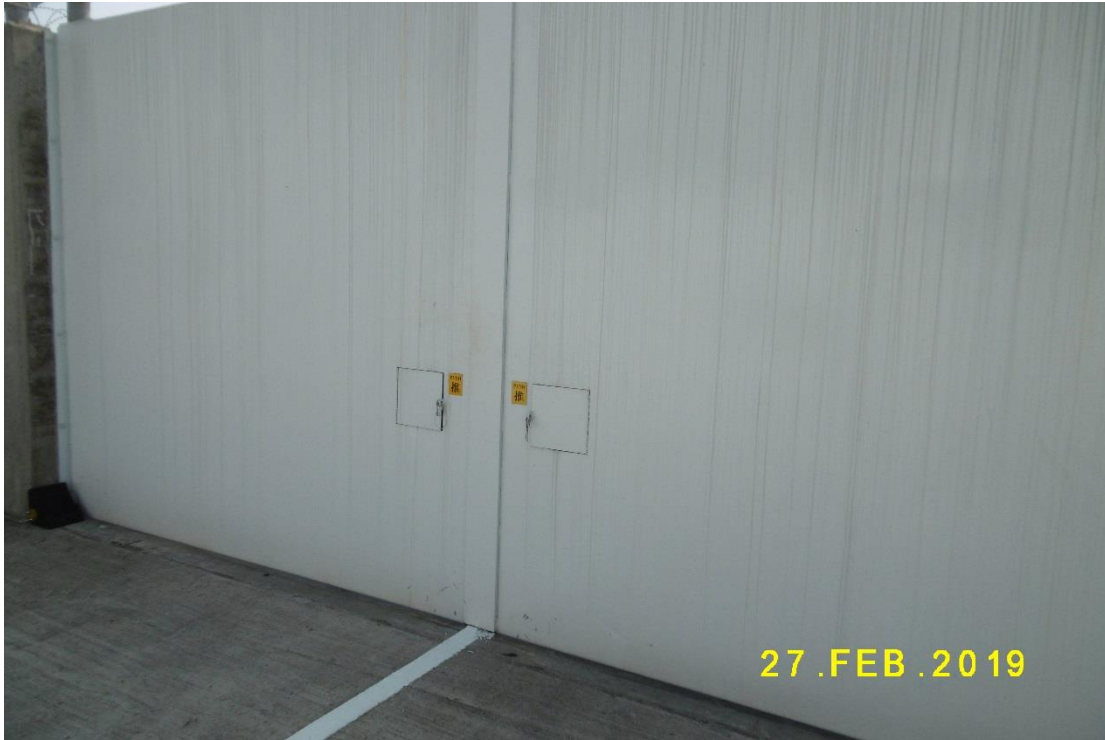
(15) Gates at security walls with sealant are maintained in good condition

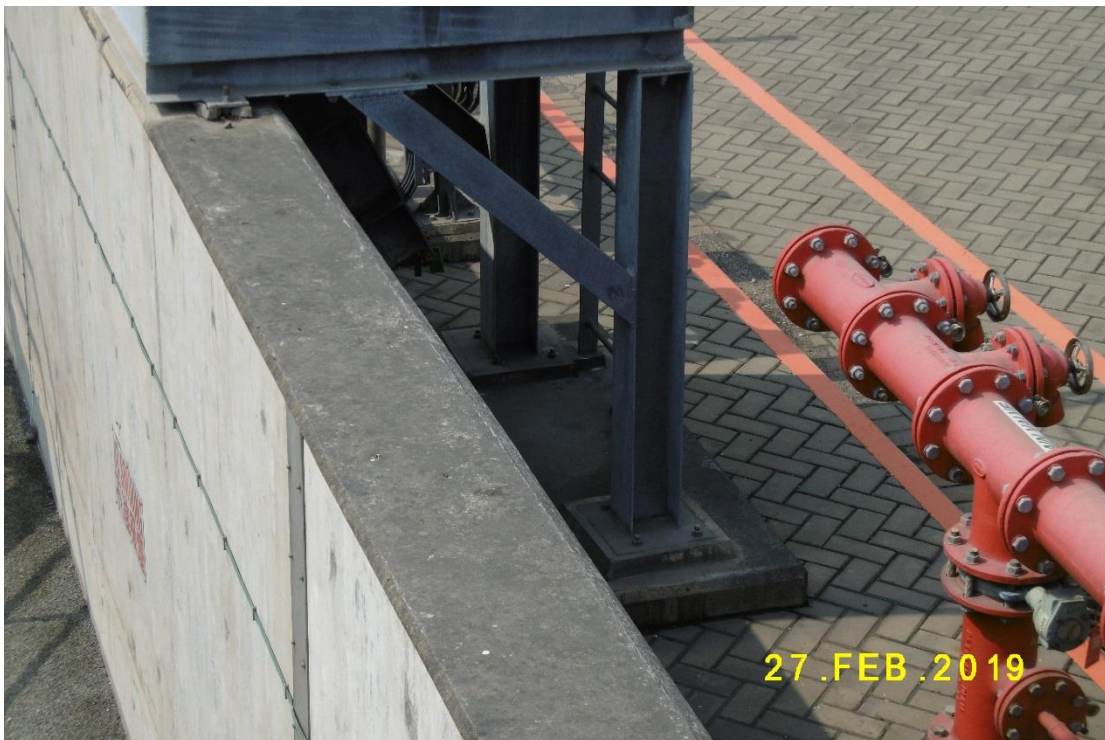
(16) This shows the thickness of the bund wall provided

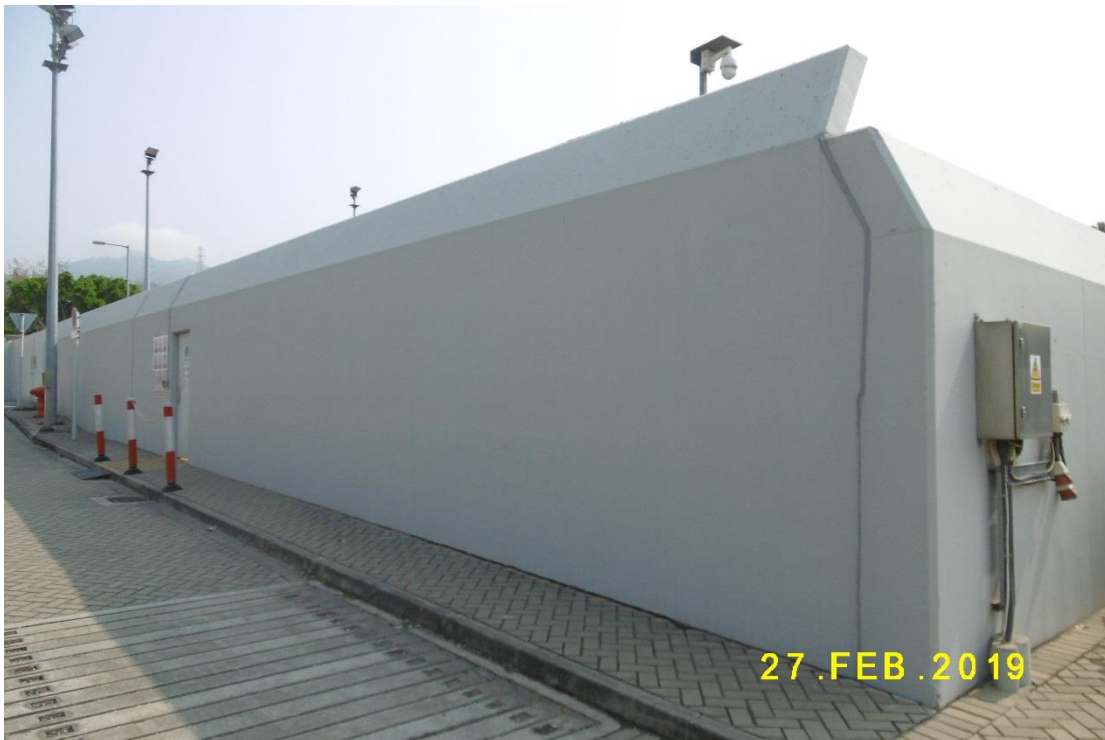
(17) This shows the thickness of the security wall provided

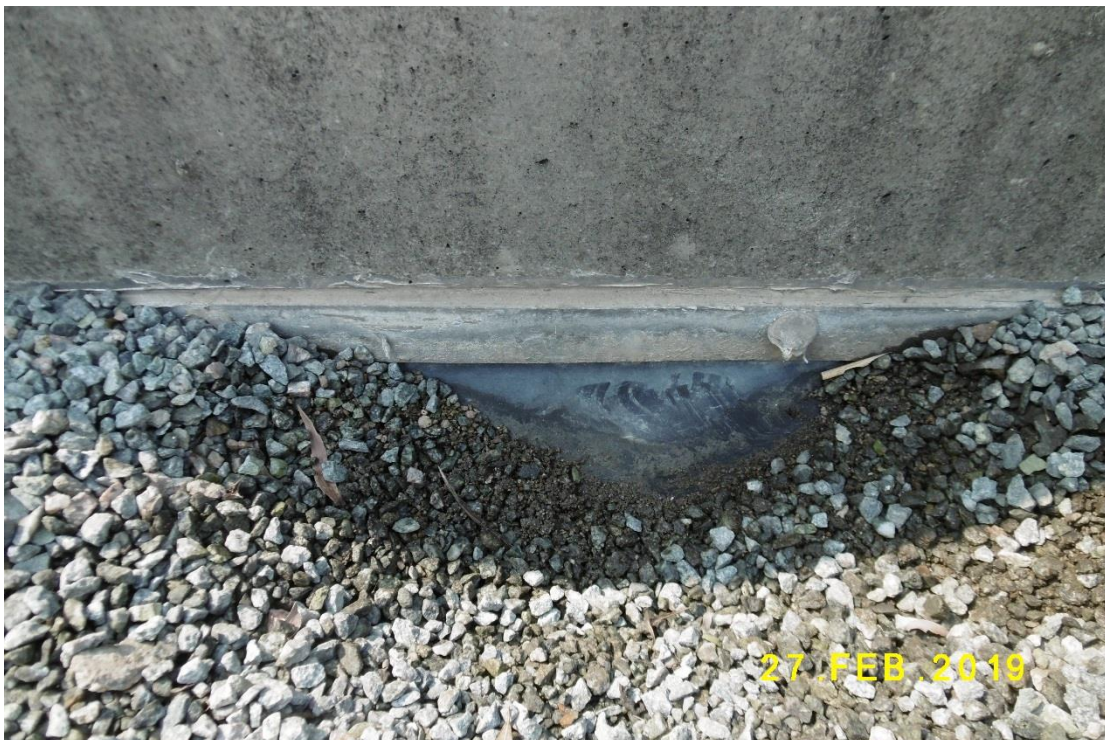
(18) Impervious lining are maintained in good condition

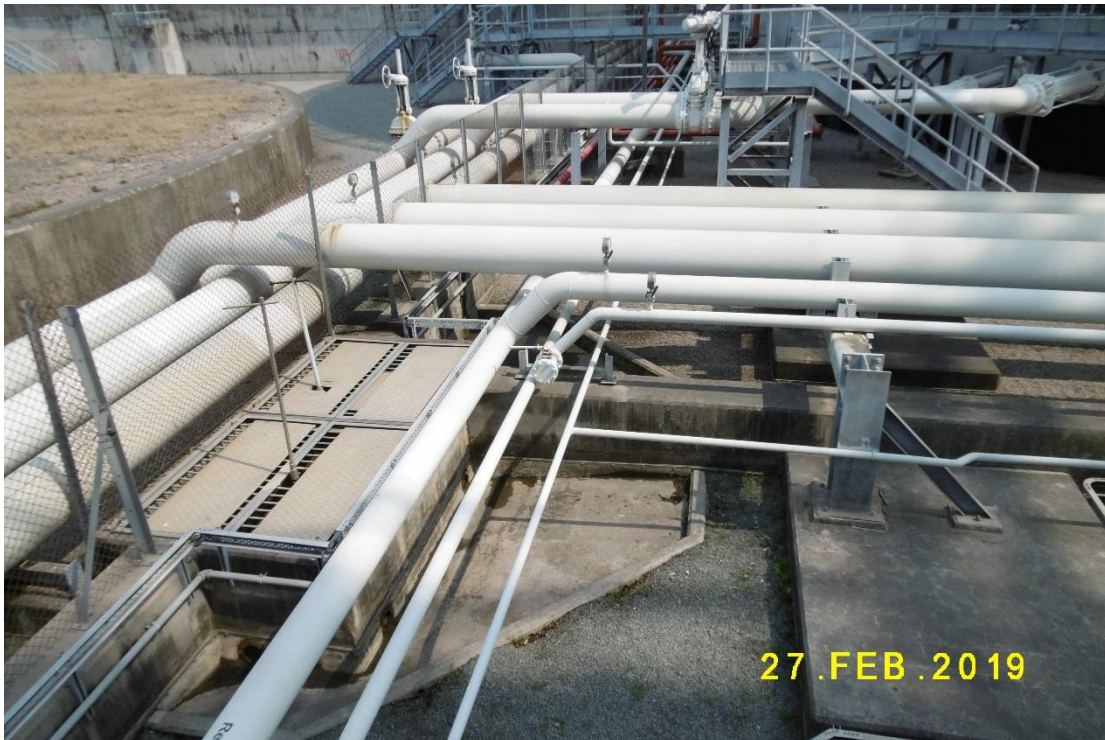
- (19) Tank farm is with appropriate gradient and the drainage falls to interceptor for collection

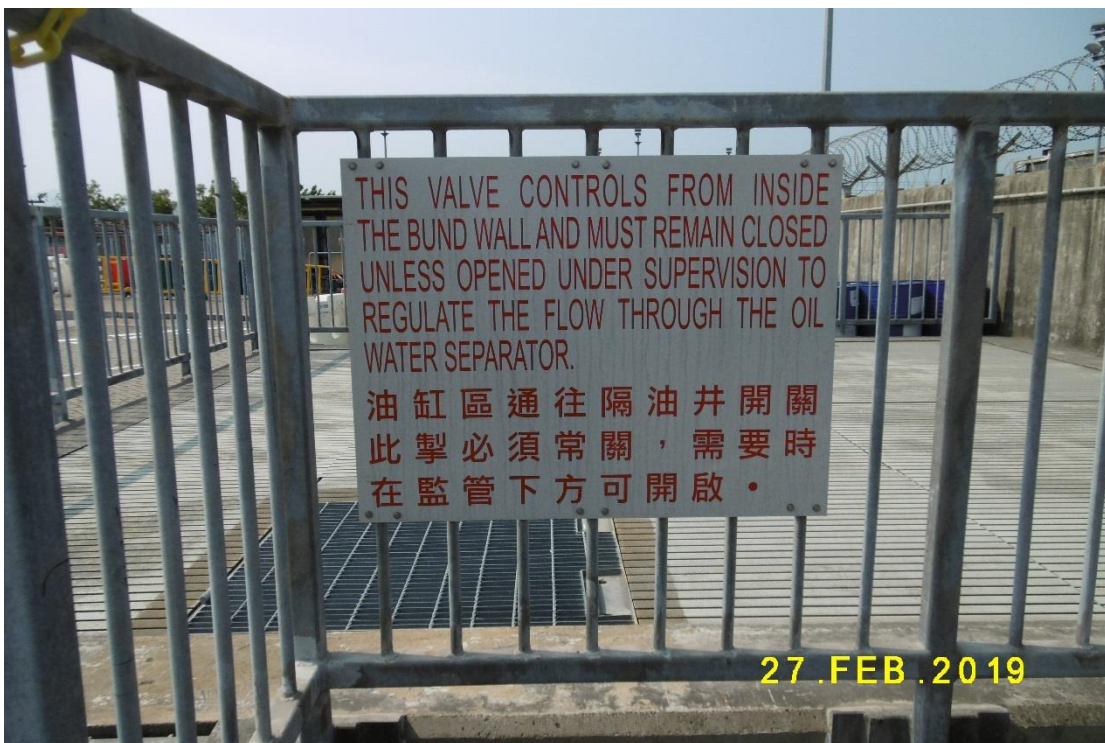
- (20) Outlet valve provided for Phase 1a Interceptor with instruction sign to keep “normally closed”

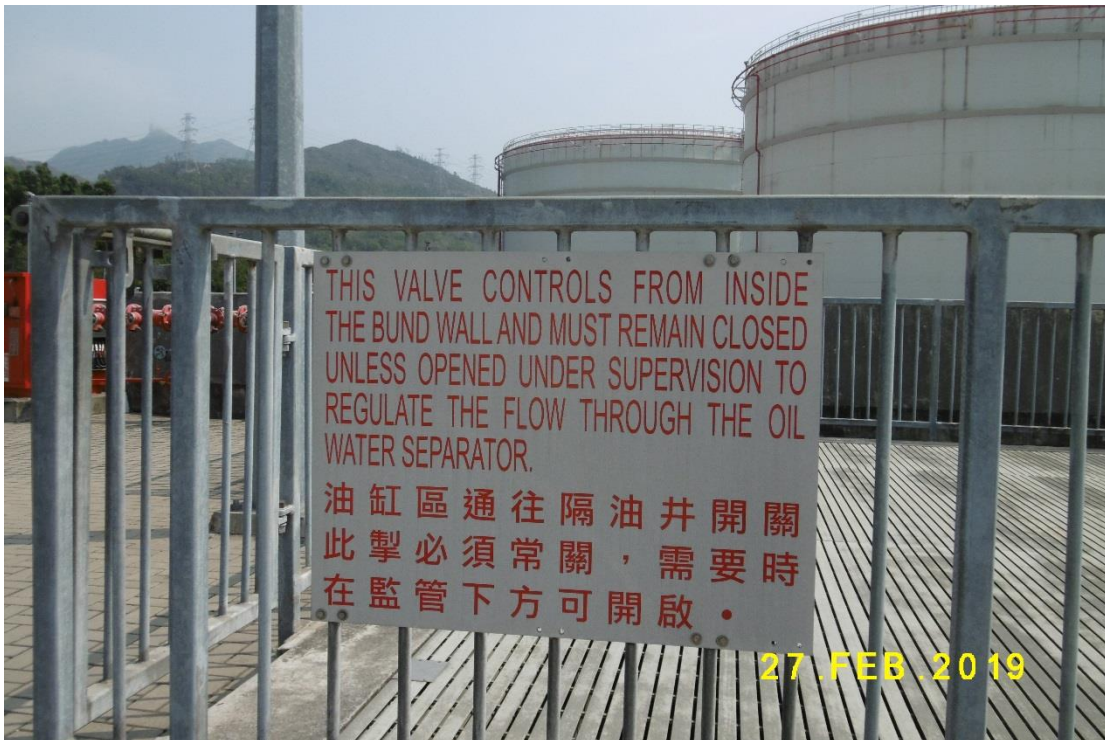
(21) Outlet valve provided for Phase 1b Interceptor with instruction sign to keep “normally closed”

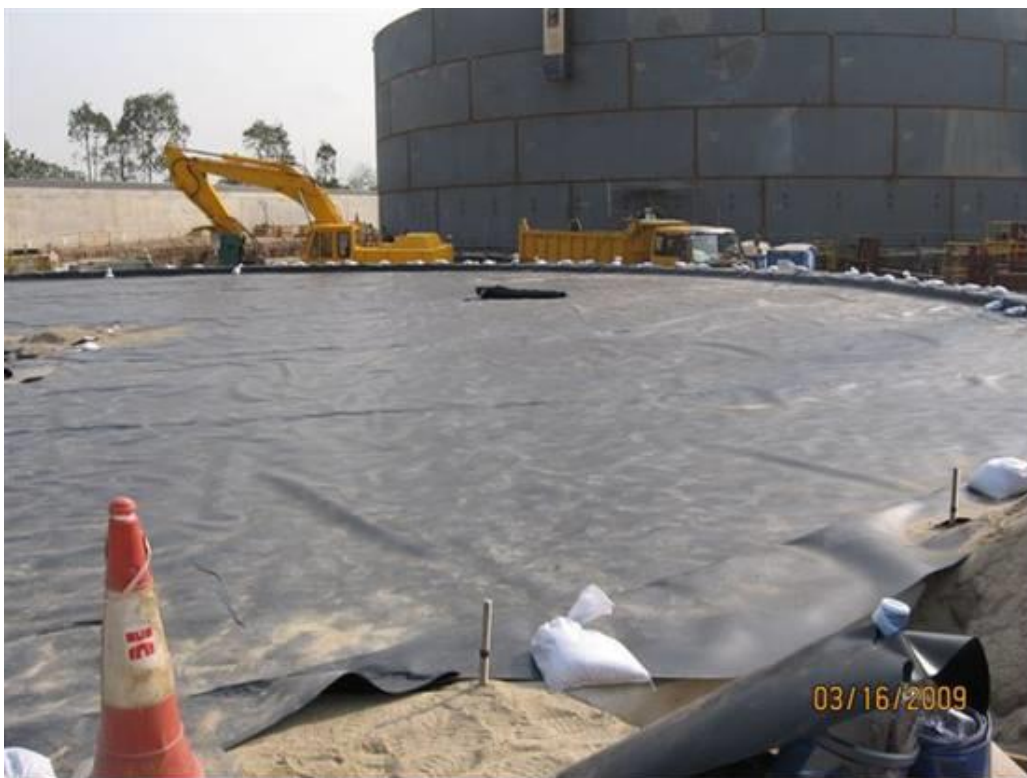
(22) Record photo shows impervious membrane being installed on top of tank foundation

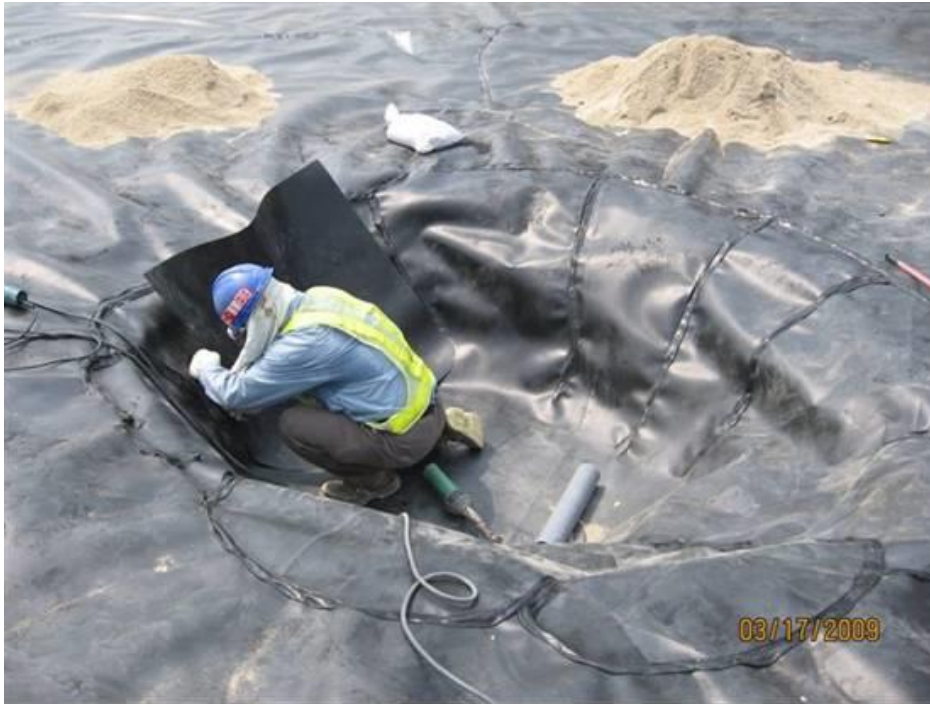
(23) Record photo shows imperious membrane laid at tank center sump with tell-tale pipe embedded for leak detection

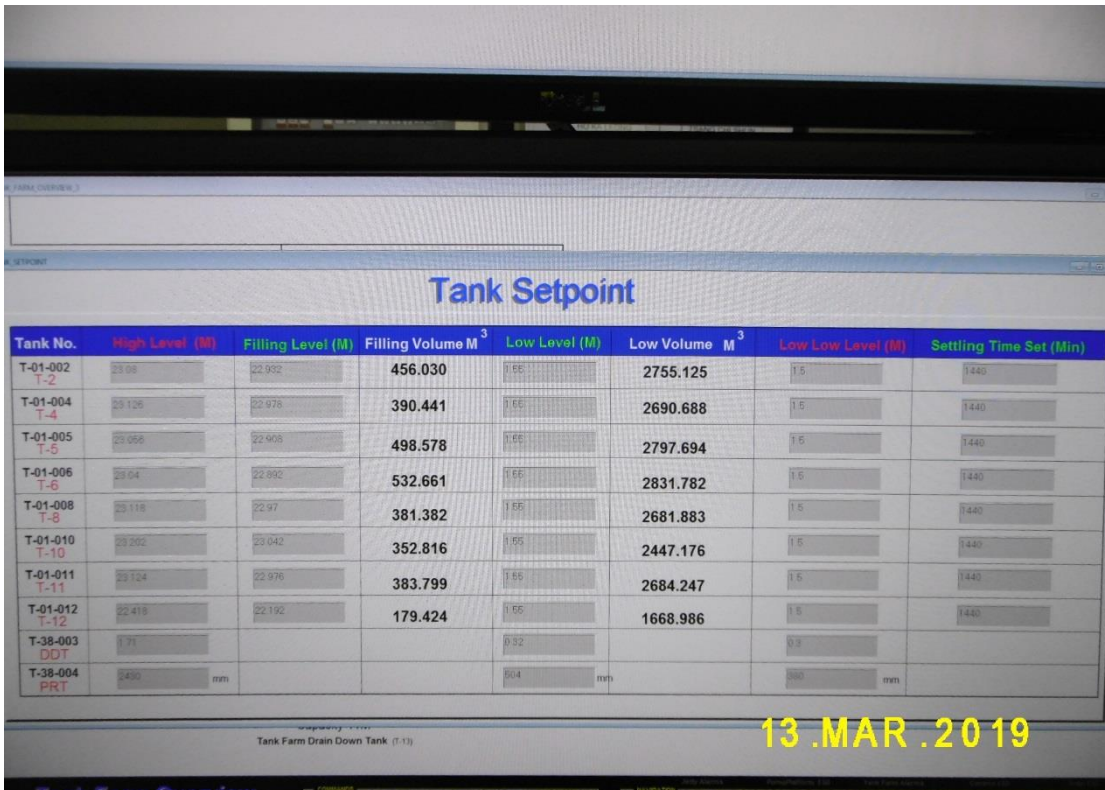
(24) High Level Alarm being set in the SCADA System

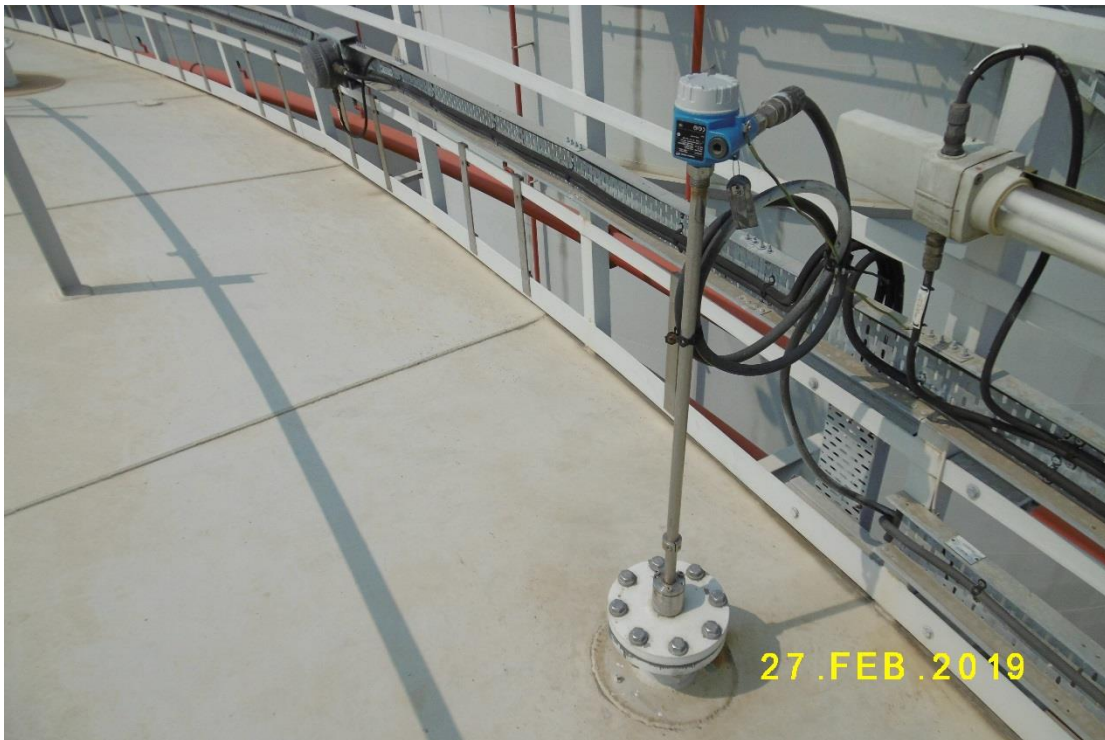
- (25) Regular inspection performed on overfilling monitoring device (High-High Level Alarm)

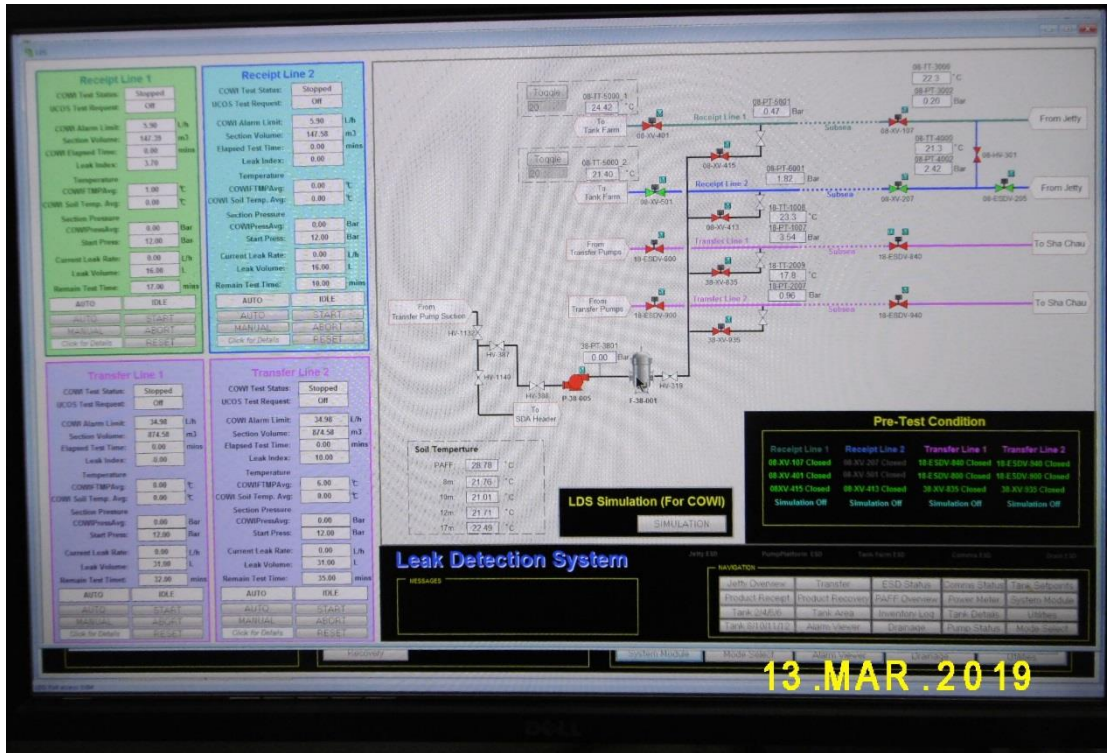
(27) Leak detection “COWI Stat Leak System” installed into computer

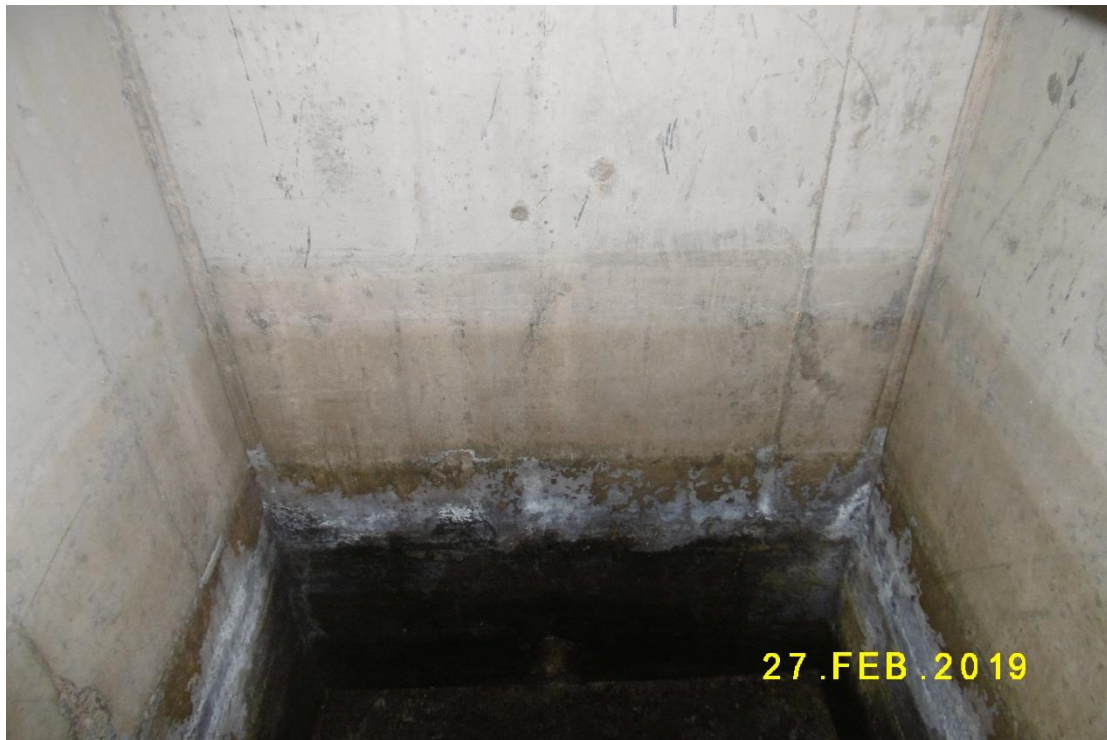
(28) Leak detection tell-tale pipe underneath the storage tank opens out to a collection chamber

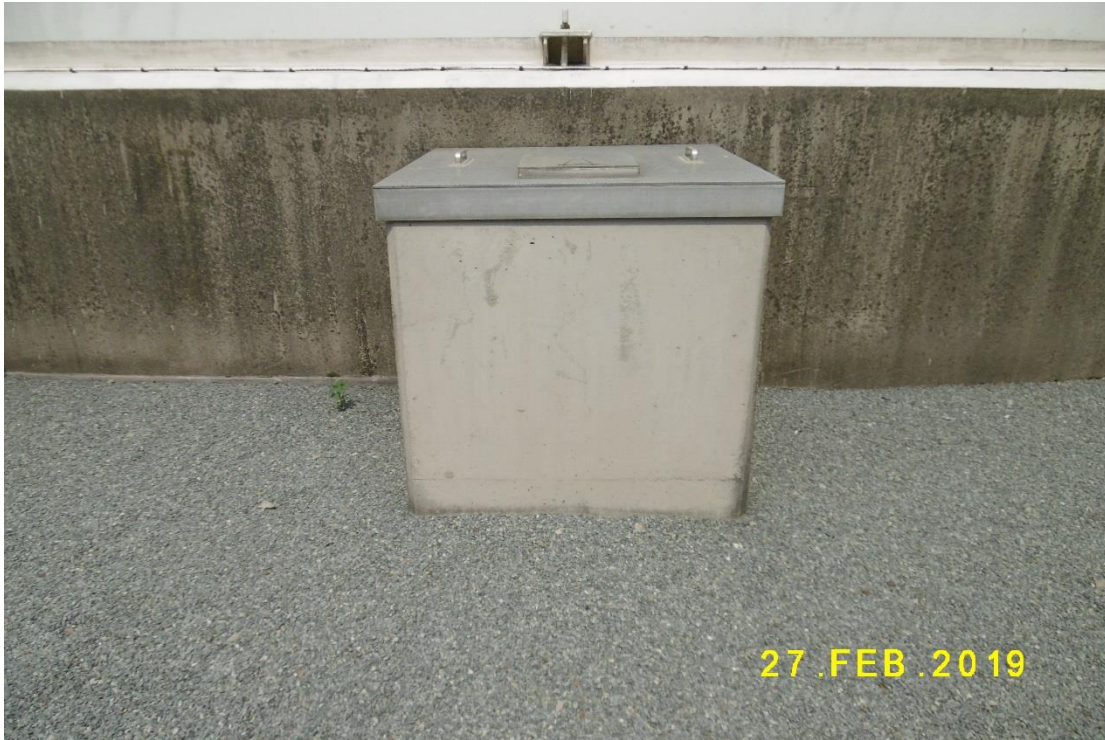
- (29) Collection chamber located adjacent to tank foundation is maintained in good condition with periodic inspection

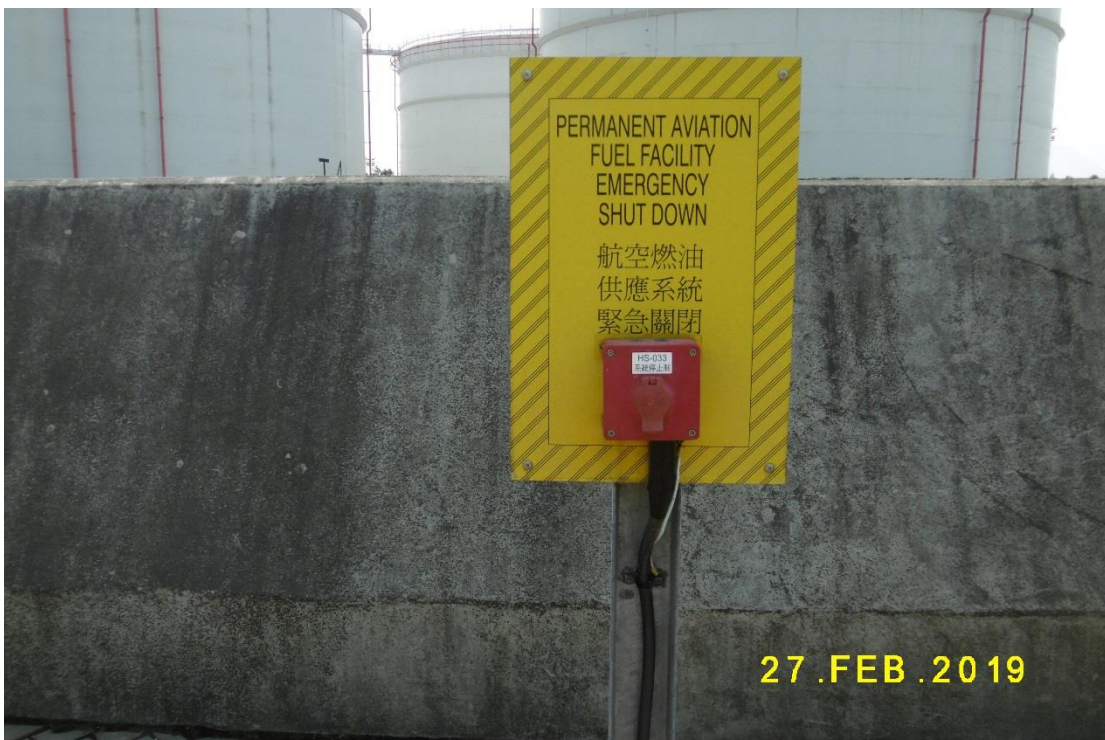
- (30) ESD device is maintained in good condition and being tested periodically
