ANNUAL AUDIT REPORT
For
PERMANENT AVIATION FUEL FACILITY
Environmental Permit
EP-262/2007/B

Date of Audit :		1 - 20 March 2019
Prepared By :	Michael Chung, Senior Engineer

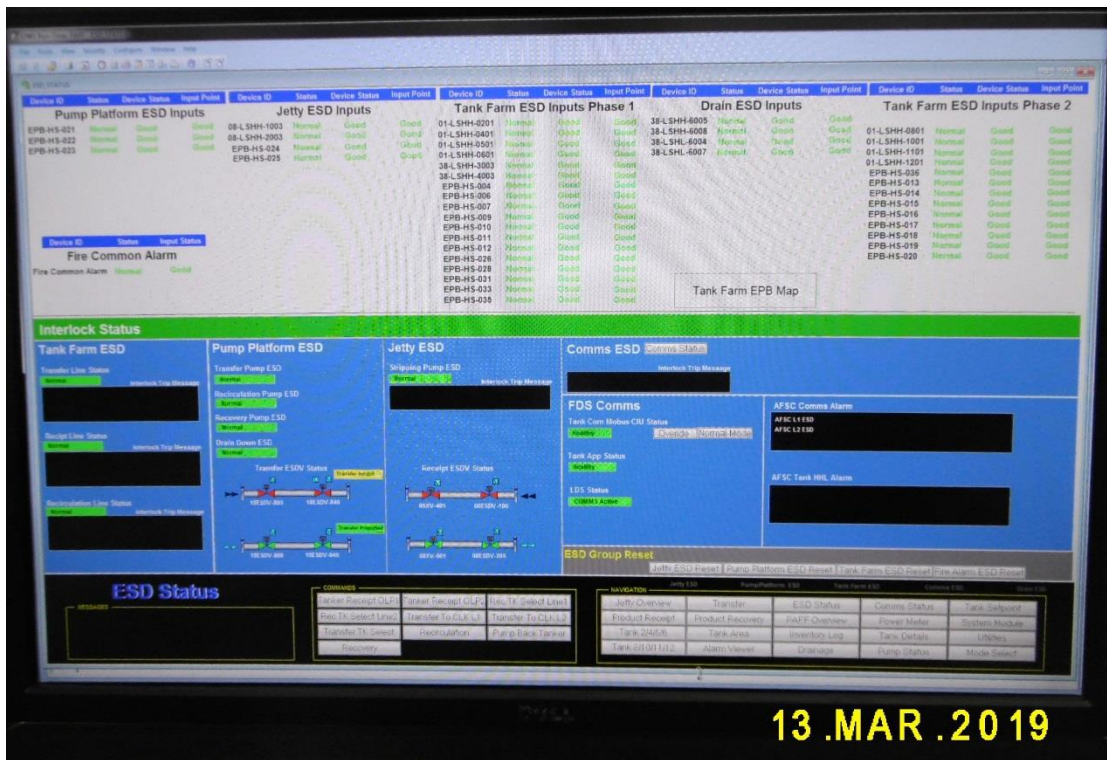
(31) The ESD regular testing as shown in SCADA System

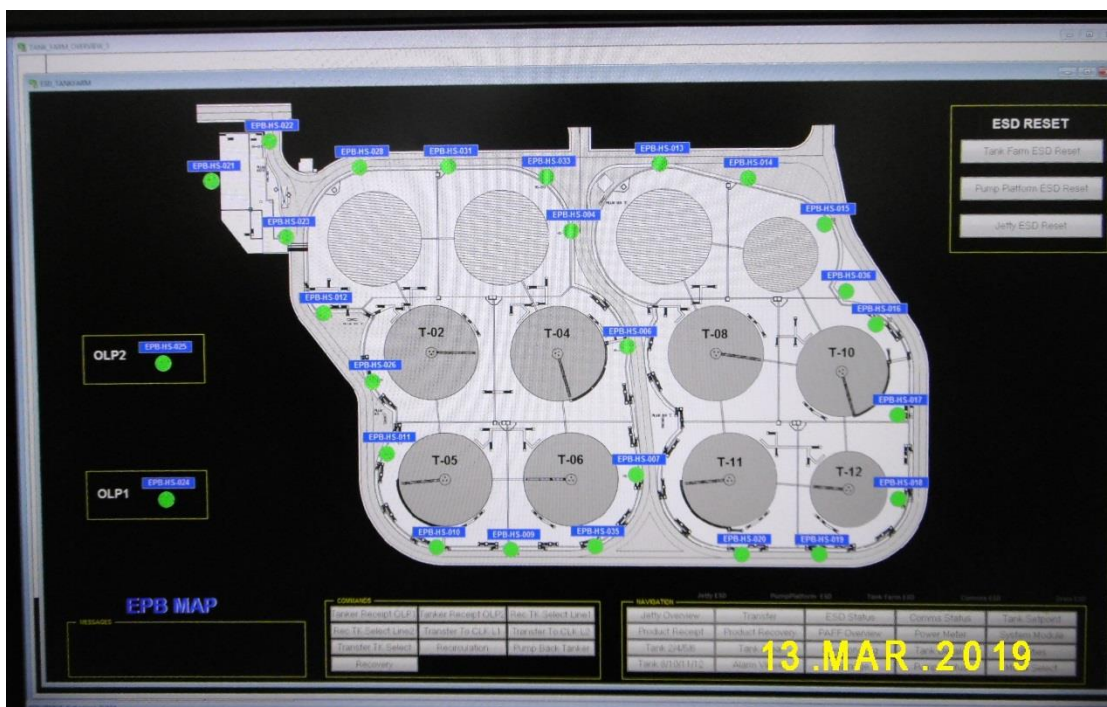
(32) The ESD regular testing as shown in SCADA System

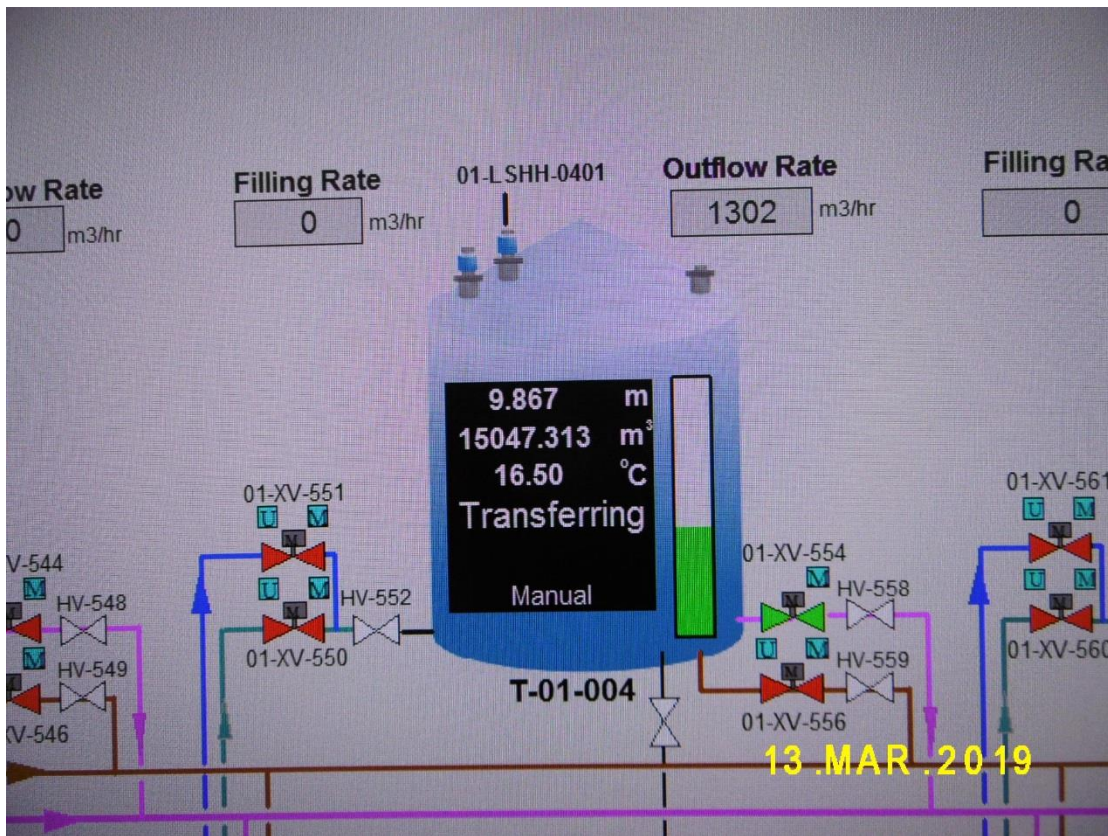
(33) The ESD test signal as shown in SCADA System

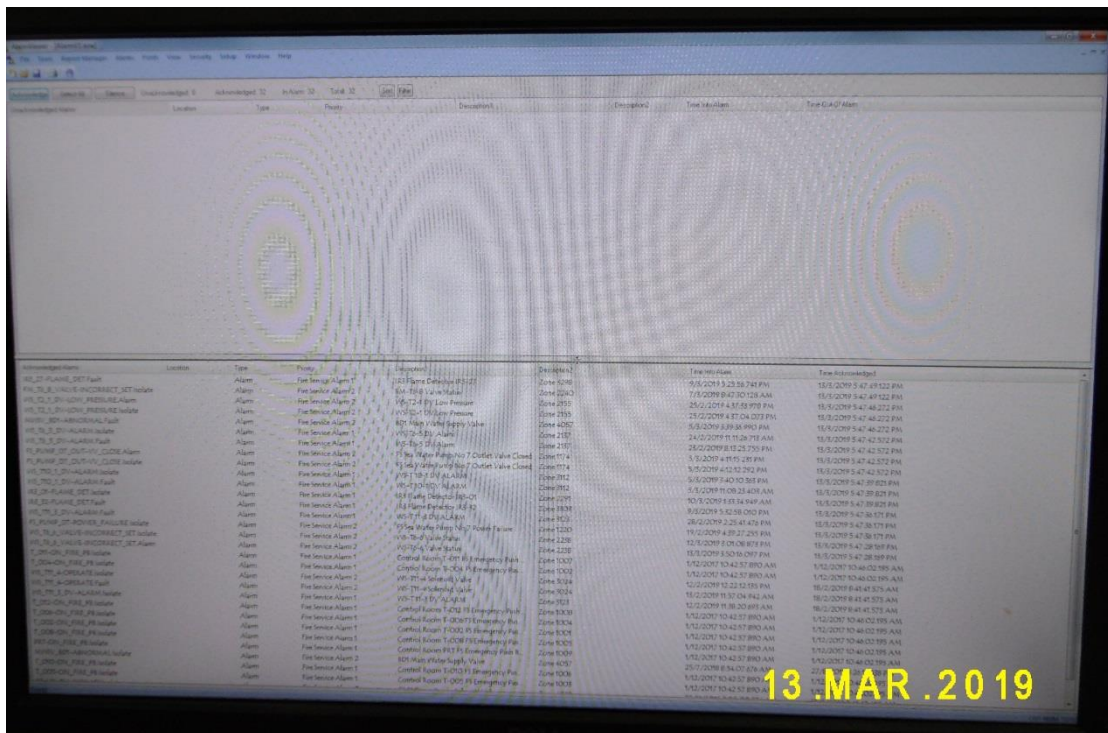
(34) Once the system received ESD test signal, the valves will be closed automatically and shut down the operation as shown in SCADA System

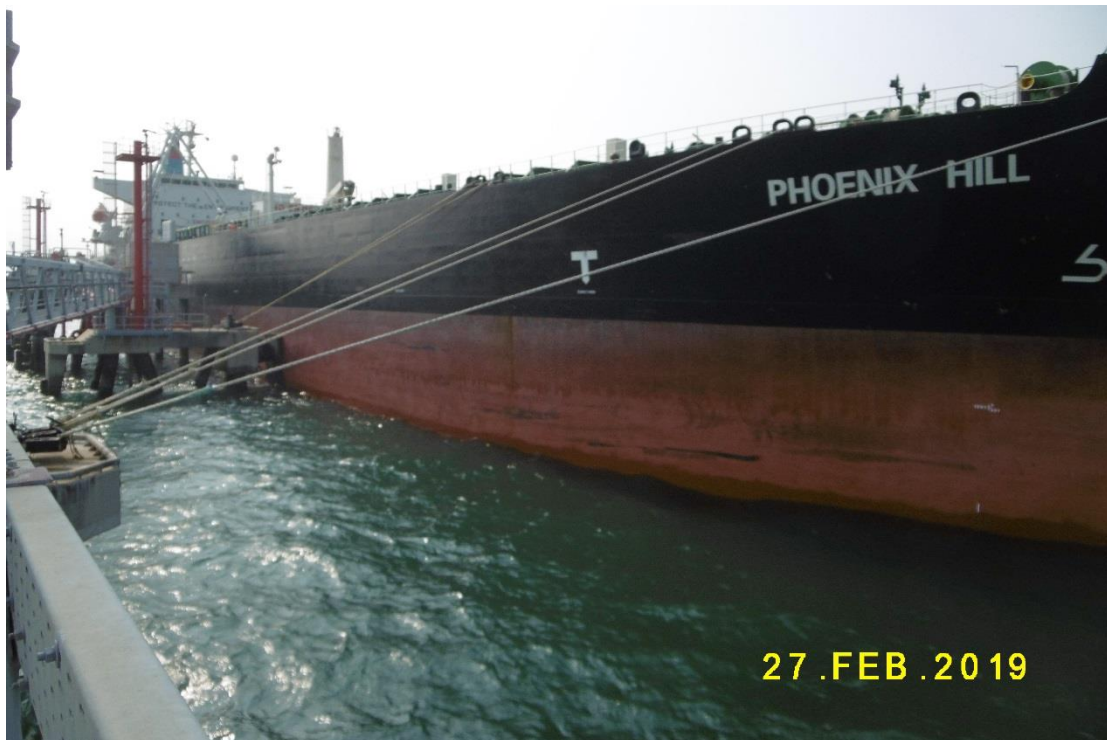
(36) Fenders are installed at sea side of the jetty

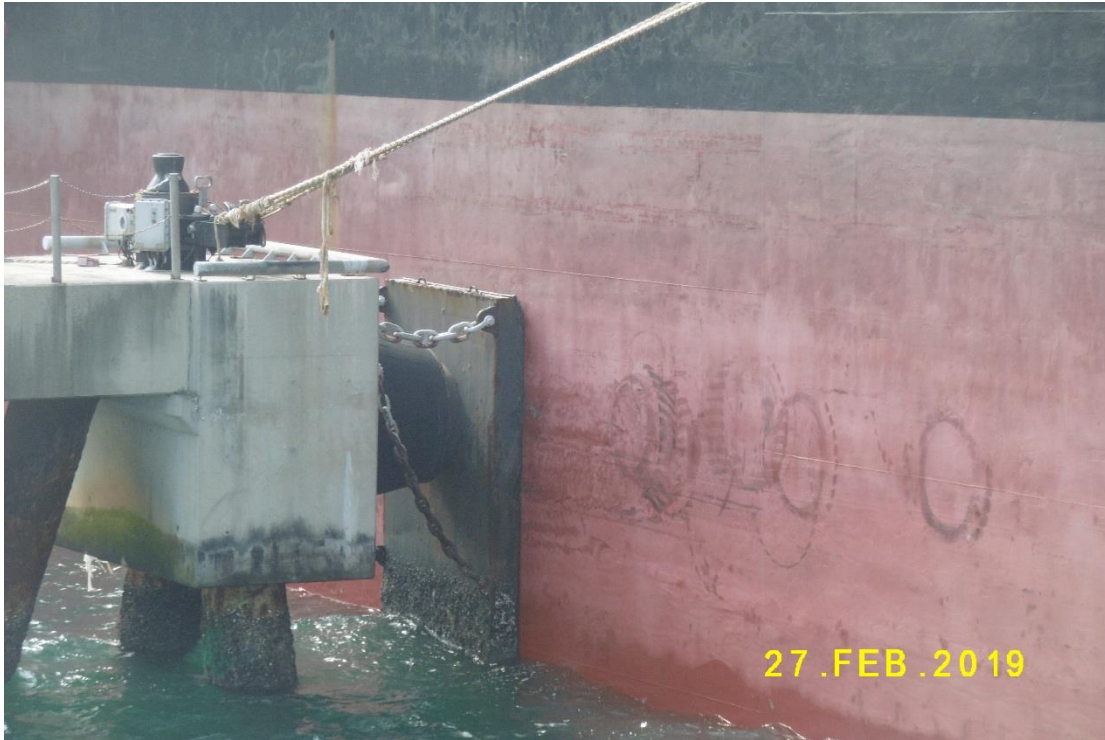
(37) Fenders are installed at sea side of the jetty

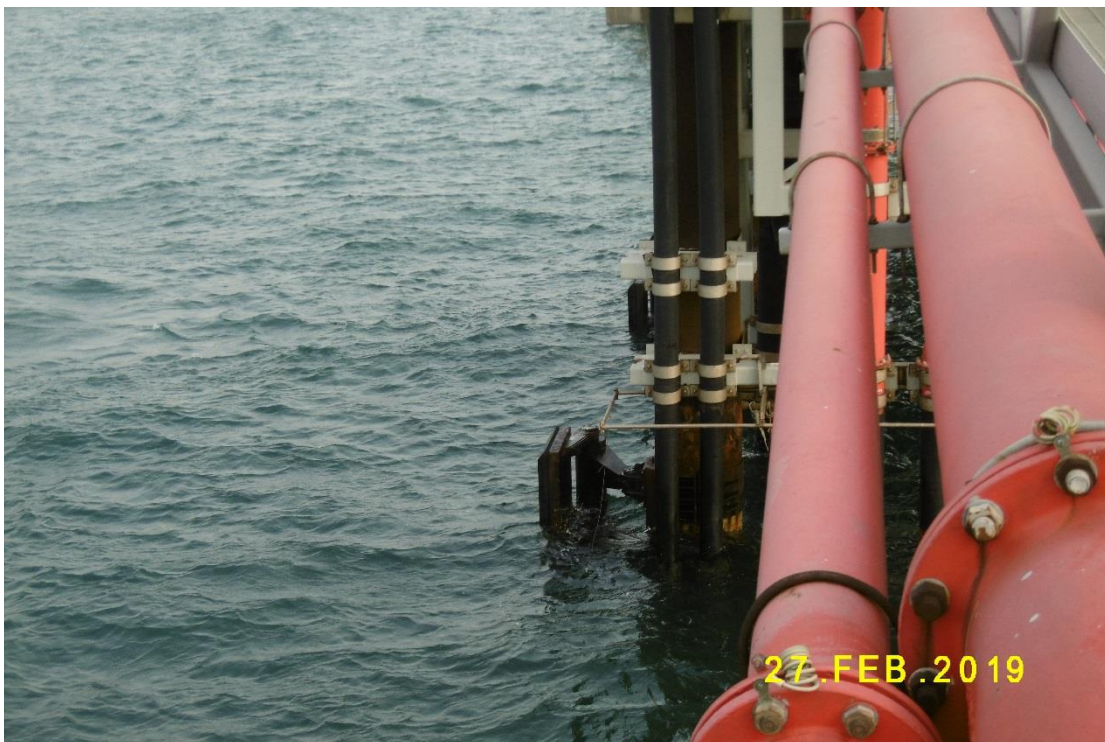
(38) Fenders are installed at shore side of the jetty

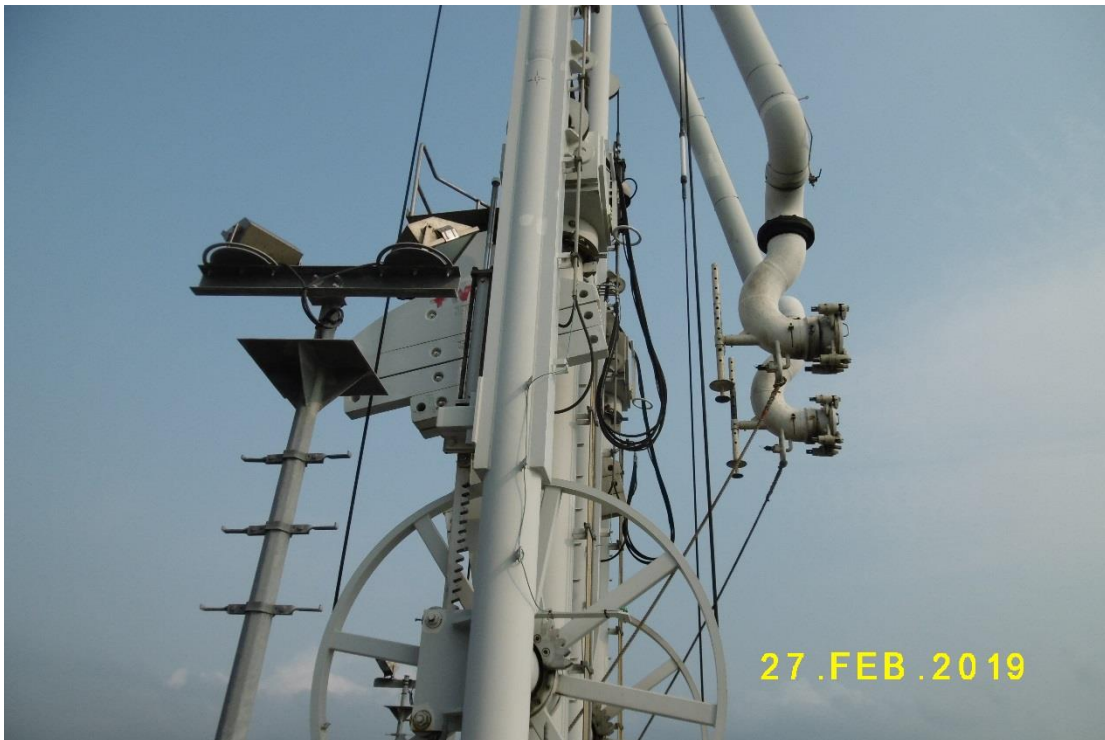
- (39) Slop collection utilities are used for coupling and de-coupling of the loading arms
