## Permanent Aviation Fuel Facility (EP-262/2007/B)

Fifth Landscape & Visual Bi-Monthly Audit Report – Jan 2011

24 January 2011

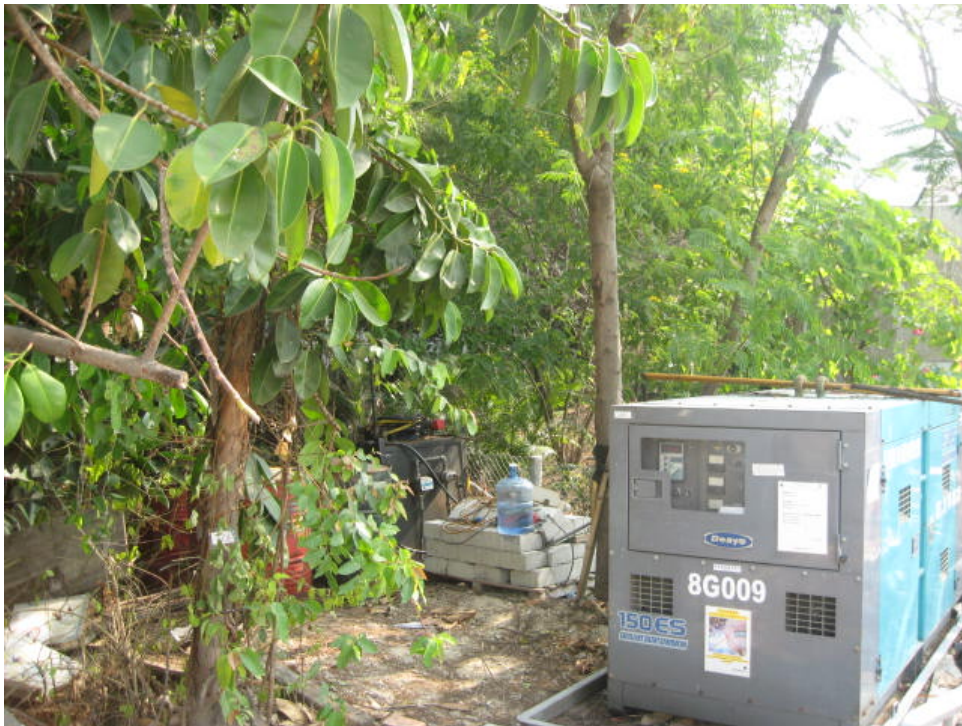
- Material debris were stored very close to the trunks of retained trees T68 and T69 during this inspection and a generator, construction materials, material debris and several drums in drip trays were still observed near retained tree (T1) (refer to *Annex A*).

**Photo 1-** Generator, construction materials, material debris and drums in drip trays were still observed near retained tree T1.

The Contractor was advised to remove all material debris stored near all retained trees immediately and ensure generator, construction materials, material debris and oil drums will not affect the nearby retained trees, or relocate them if found harmful to the trees. Contractor was also advised to keep tree root zones clear to prevent tree damage.

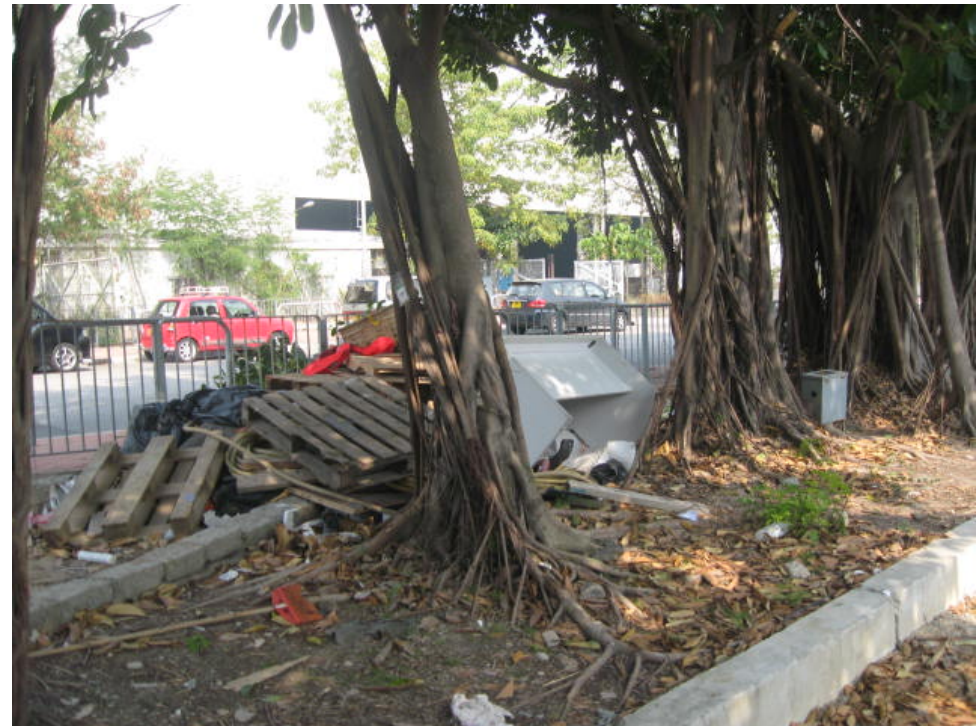
**Photo 2 -** Construction materials and debris stored very close to the trunks of retained trees T68 and T69.

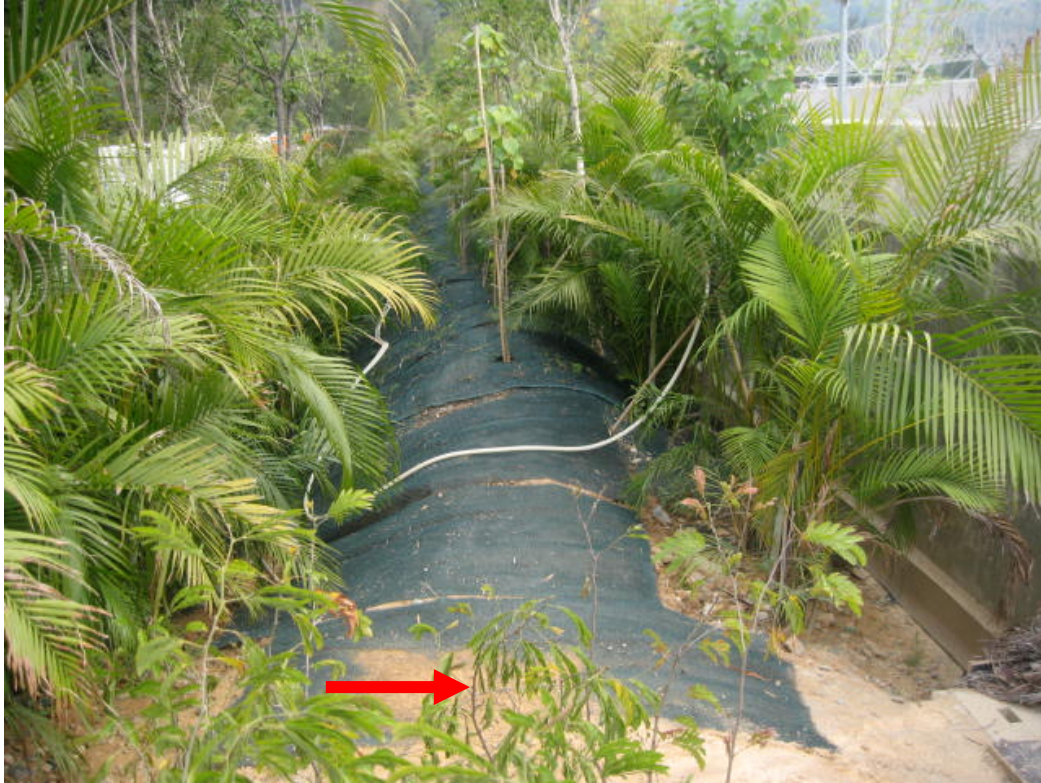
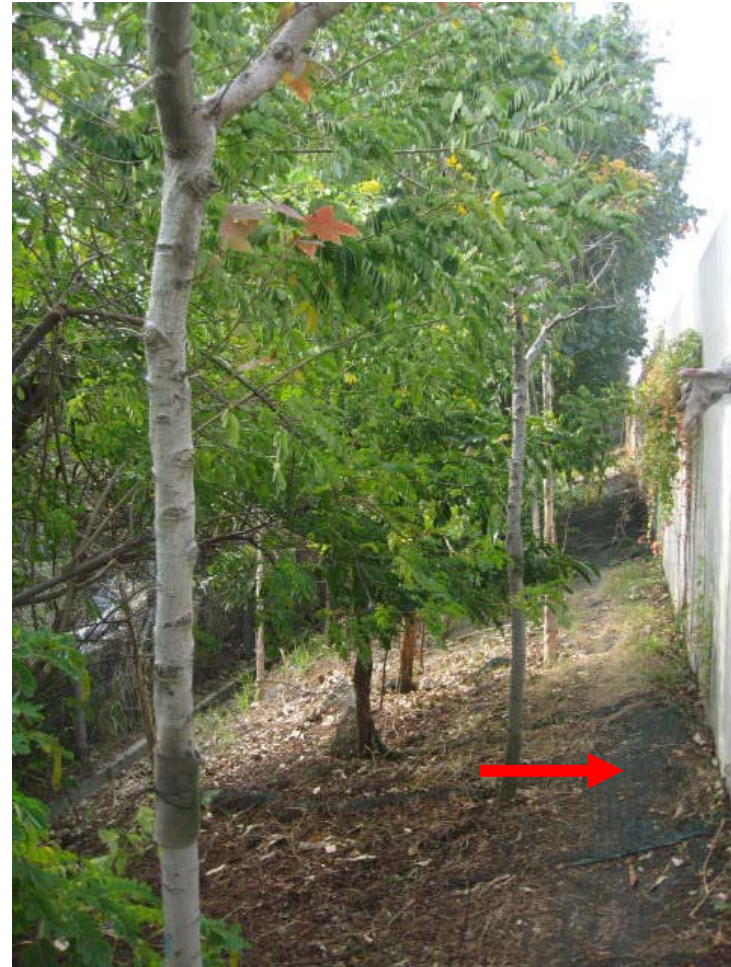
Soiling, planting, etc.	Monitoring of implementation and maintenance of soiling and planting works and against possible incursion, physical damage, fire, pollution, surface erosion, etc.	Erosion control mat is present for soil maintenance (Photo 3 & 4). No incursion, physical damage, fire, pollution or surface erosion was observed.	Not required.

**Photos 3 & 4-** Example of soil erosion control matt outside boundary wall.

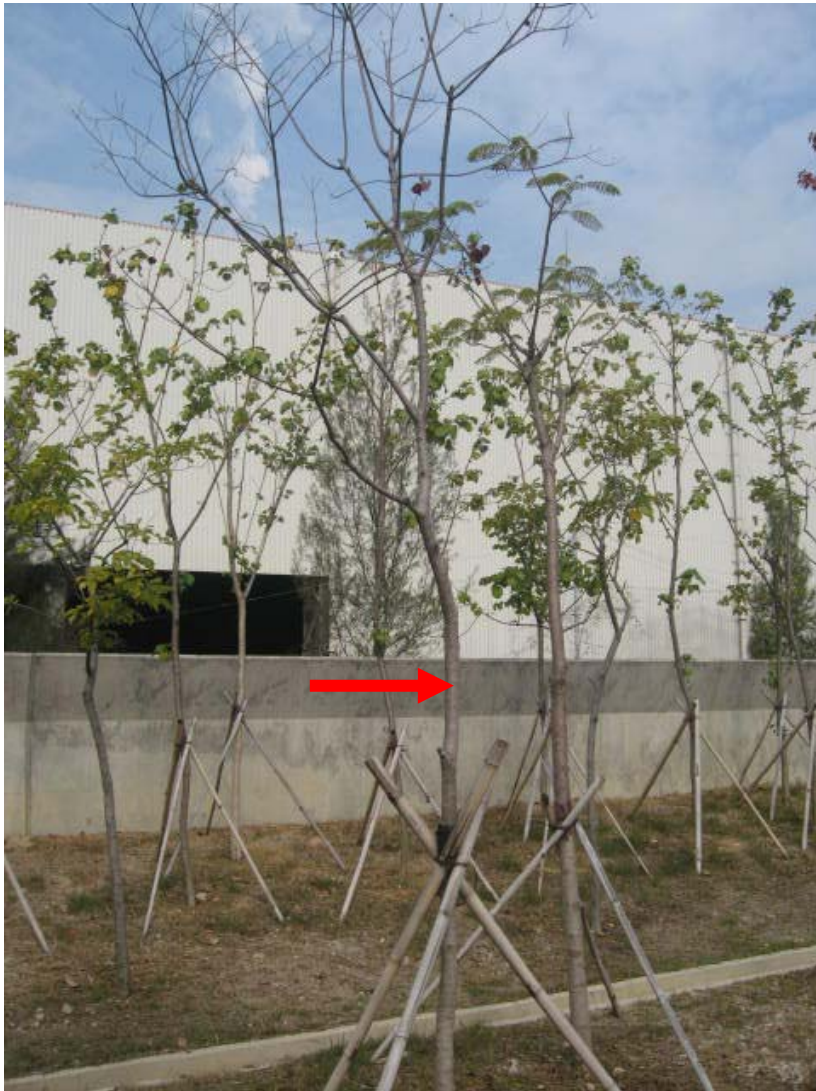
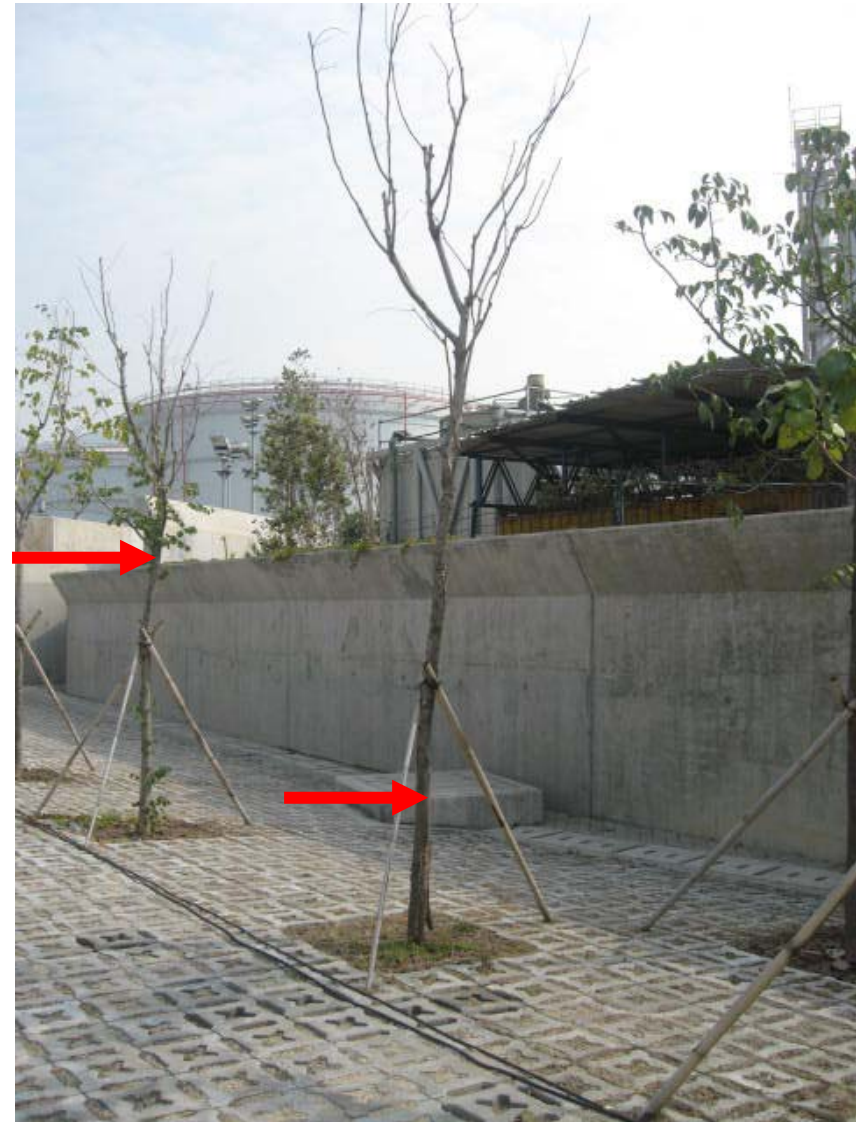
- Some trees around the site were observed to be in poor health (refer to *Annex A, Figure 1*) and had not been improved since the previous two inspections.

**Photos 5 & 6** – Examples of trees in the Operations Buildings area of Phase 1a, observed to be in poor health (similar to previous inspections).

The Contractor was recommended to review the health of all compensatory and retained trees, replace any trees if confirmed dead and take appropriate action to improve the condition of all trees in poor condition.

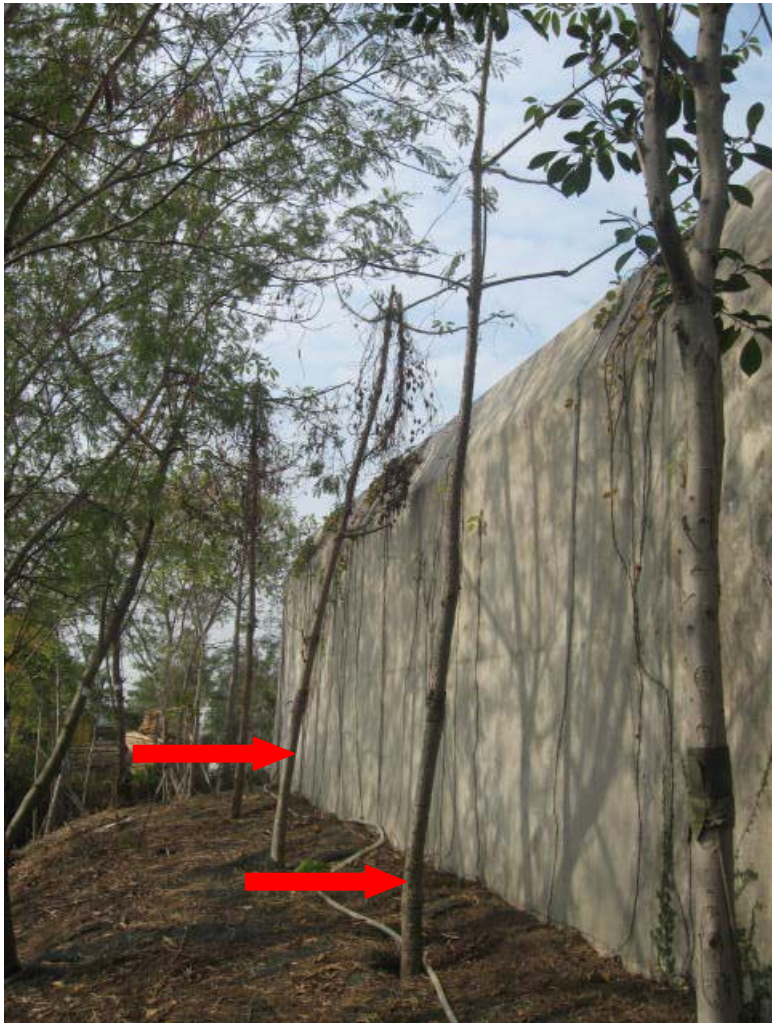
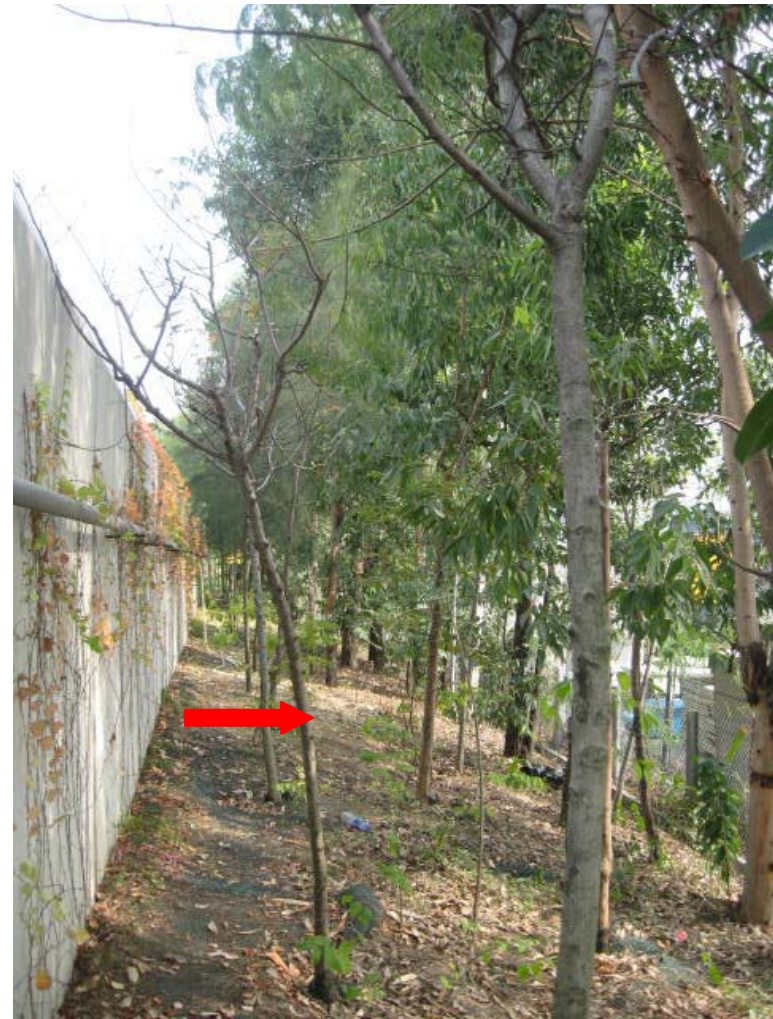
**Photos 7 & 8** – Examples of trees outside boundary wall of Phase 1a and 1b observed to be in poor health.

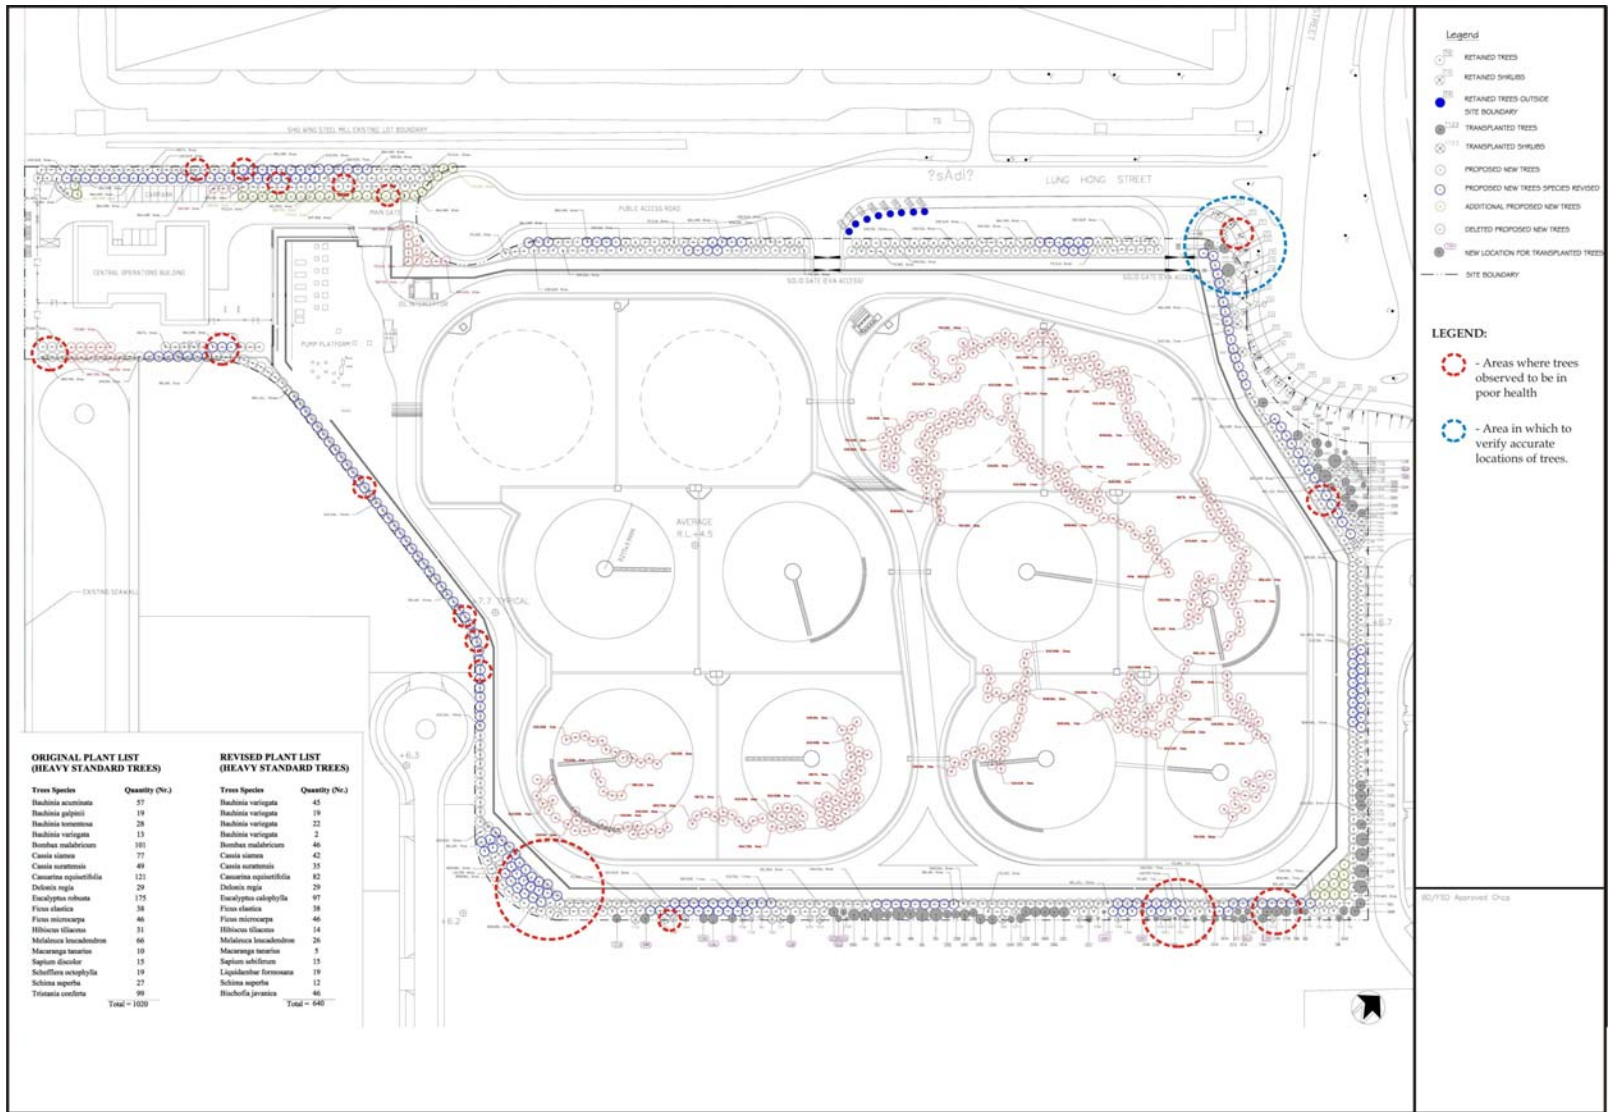
Figure 1 - Location of trees in poor health and area in which to verify accurate locations of trees
