ECO Aviation Fuel Services Limited

PERMANENT AVIATION FUEL FACILITY

DESIGN AUDIT REPORT

Report Title: Design Audit on PAFF

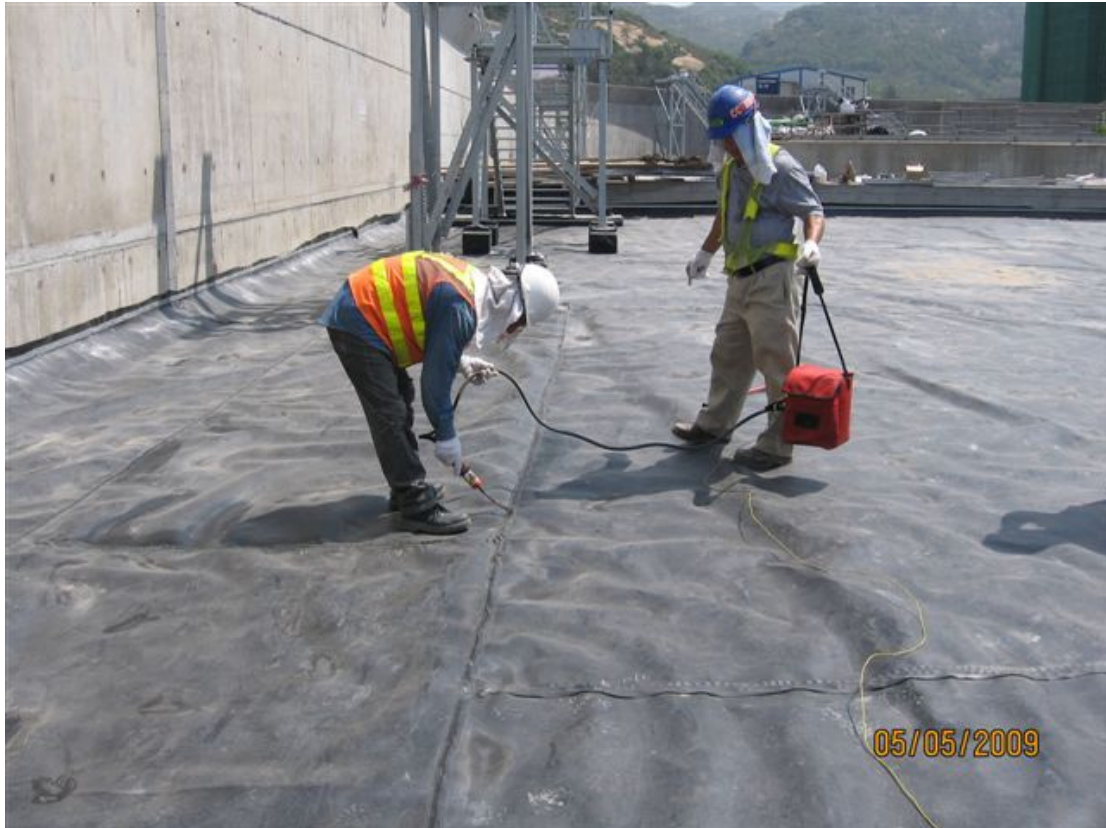
(1) Bund area 5-May-2009 Spark test for containment membrane around T1

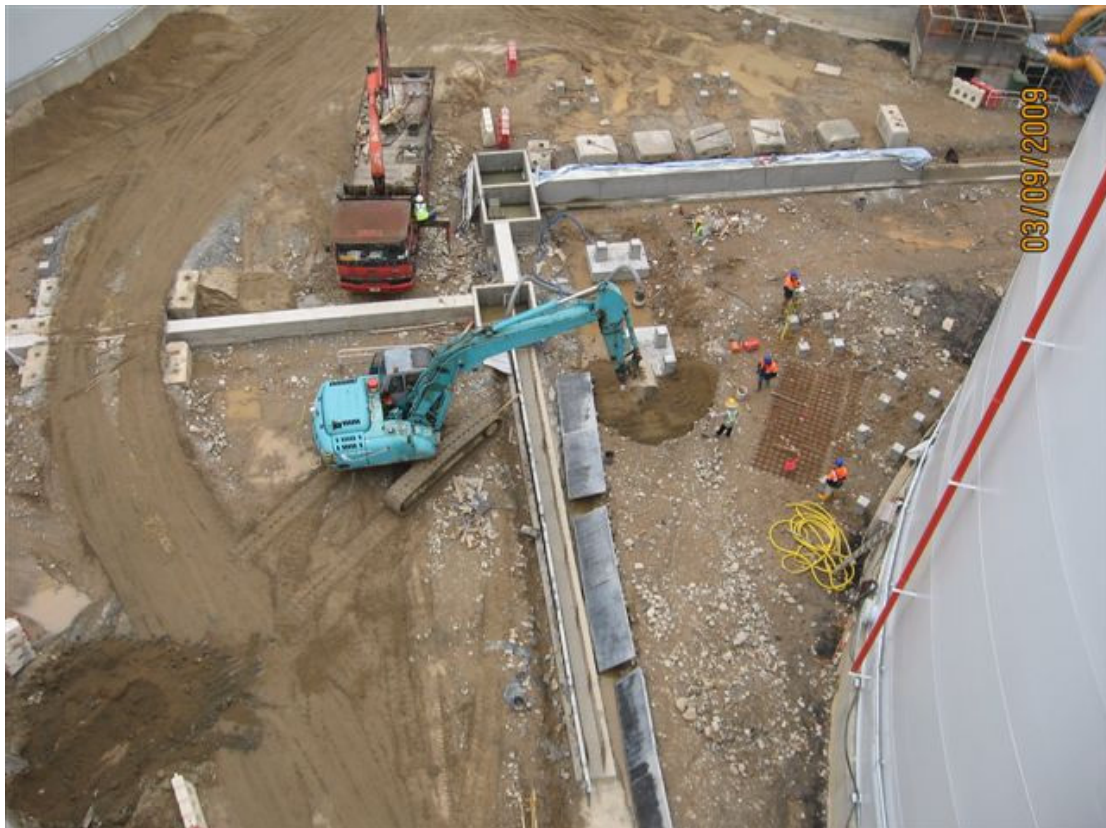
(2) Bund area 9-Mar-2009 General view for internal bund wall between T2 & T5

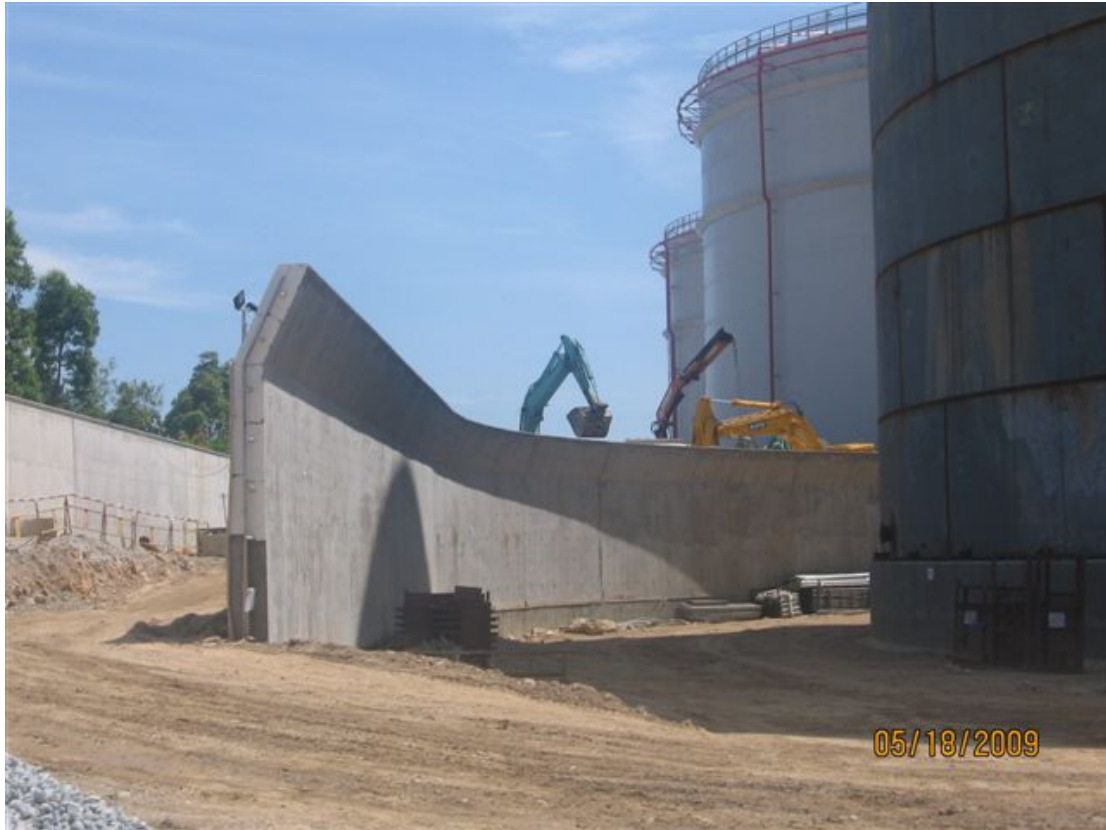
<p>Drawings PAFF/BA/02/DWG/C/1721-1724 show designed installation of wave deflectors on the bund walls. See photos No. 3 & 7.</p> <p>The wave deflectors at the bunds have been completed.</p>	<p>C</p>
--	-----------------

(3) Bund wall 18-May -2009 General view for wall slab near T11

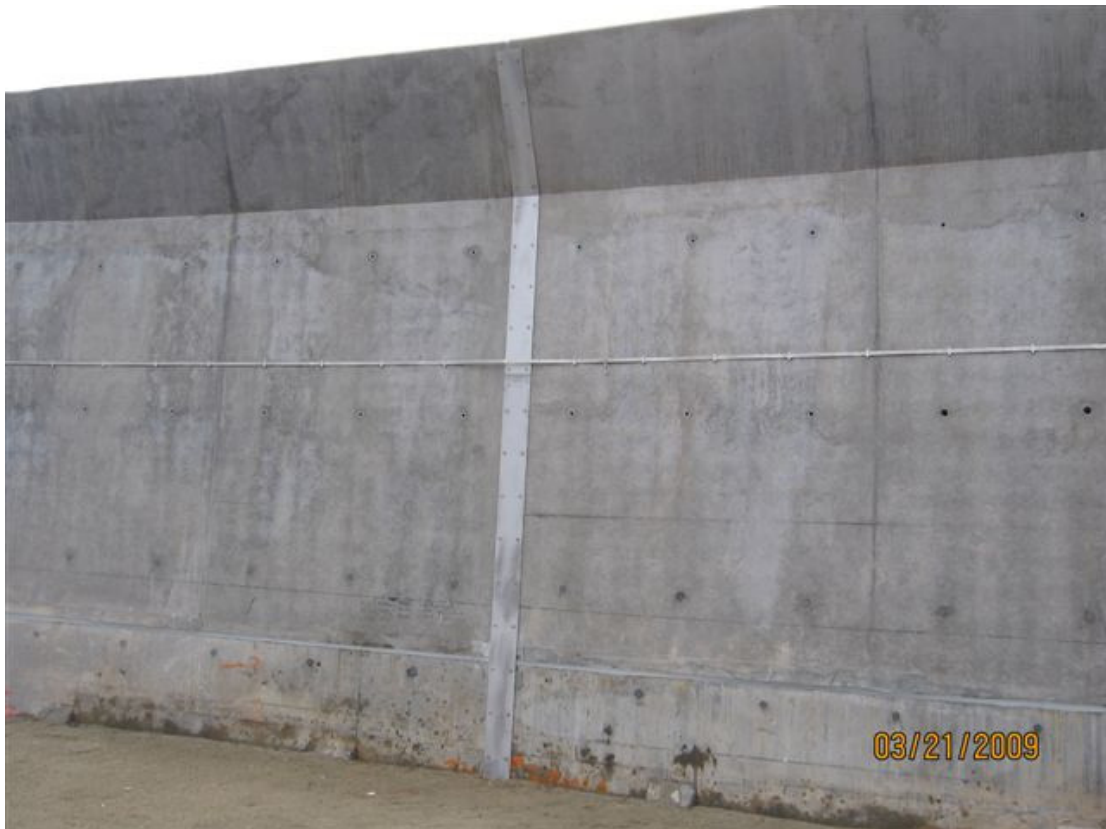
(4) Bund wall 21-Mar-2009 Condition of fire resistance steel plate installation on wall joint

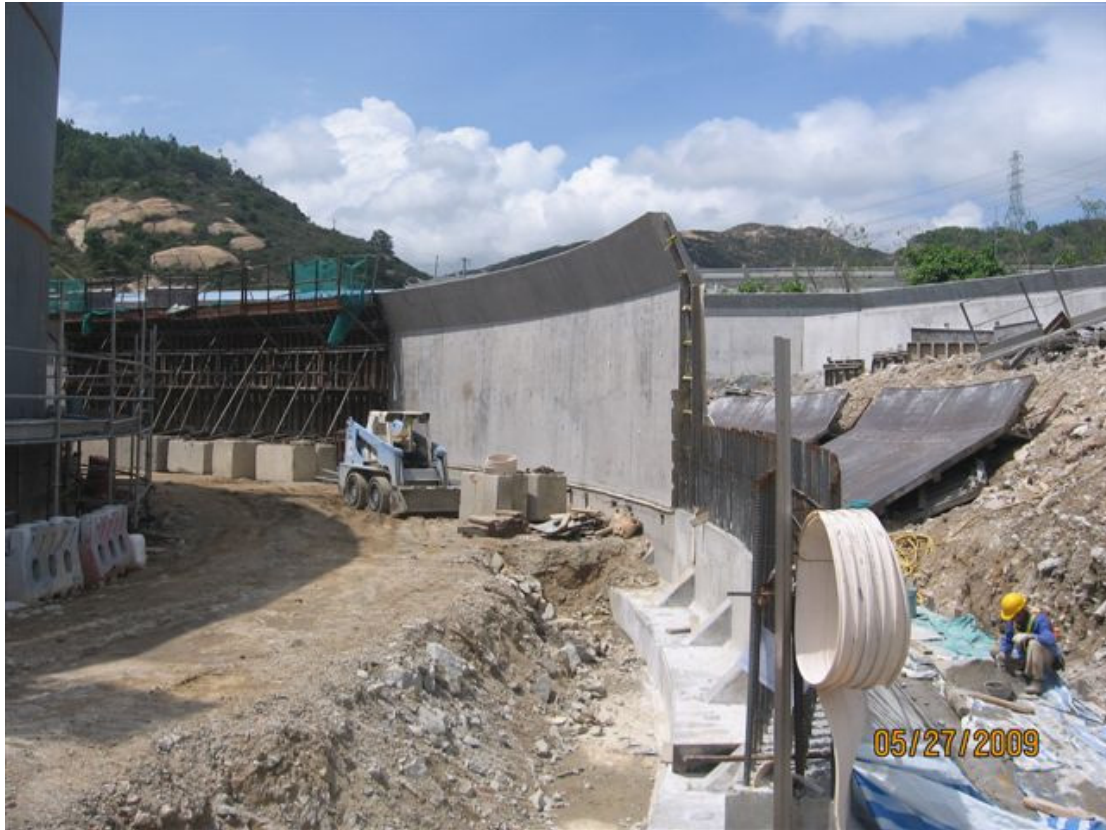
<p>Drawings PAFF/BA/02/DWG/C/1721-1724 reflect that the bunds have been designed to be partly sunken below ground level outside the bunds in the EVA. See photo No. 5.</p> <p>The bunds for Phase 1a have been completed.</p>	<p>C</p>
---	-----------------

(5) Bund wall 27-May-2009 General view for wall slab behind T12

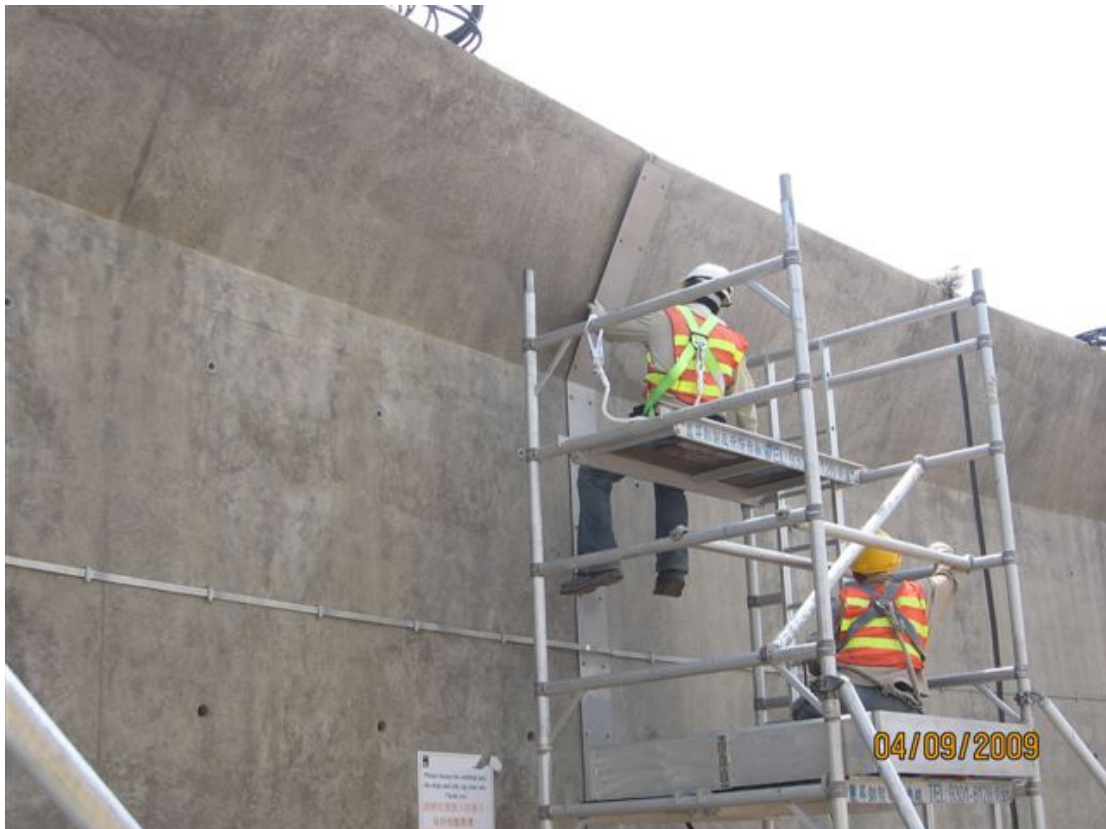
(6) Bund wall 9-Apr-2009 Erecting steel fire resistance plate at movement joint of wall

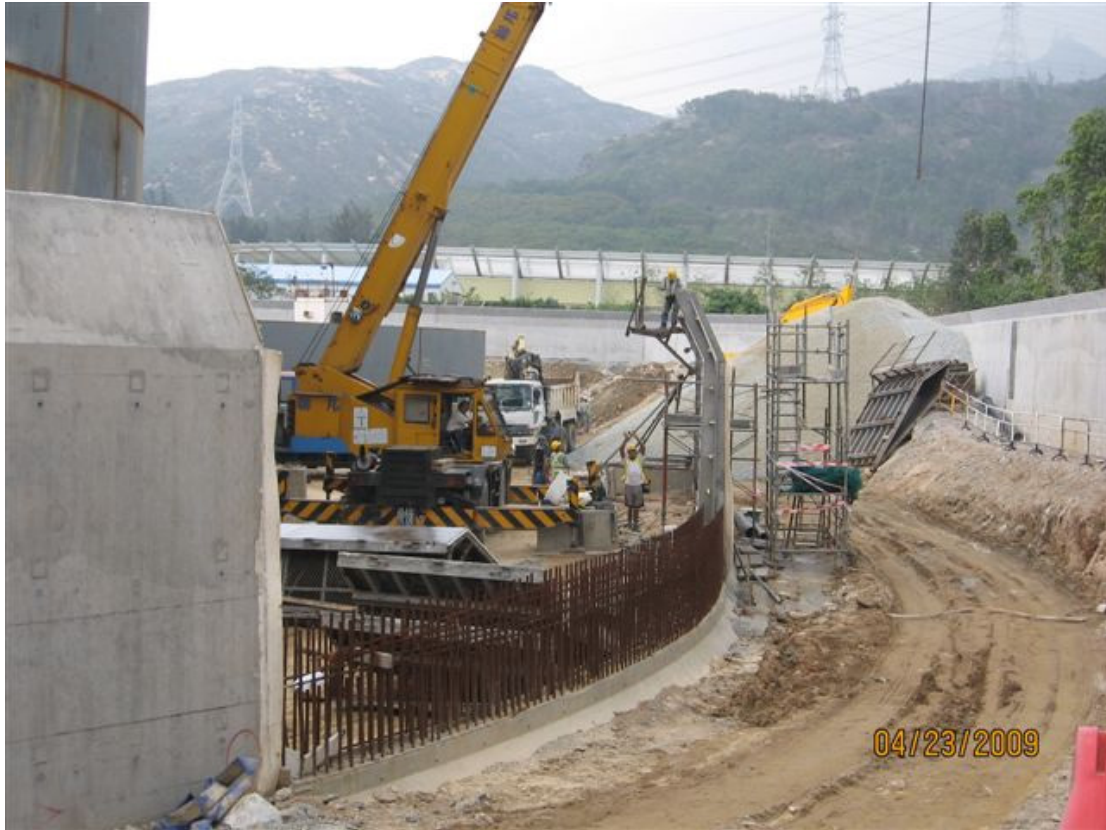
(7) Bund wall 23-Apr-2009 Stripping steel mould for wall near T11

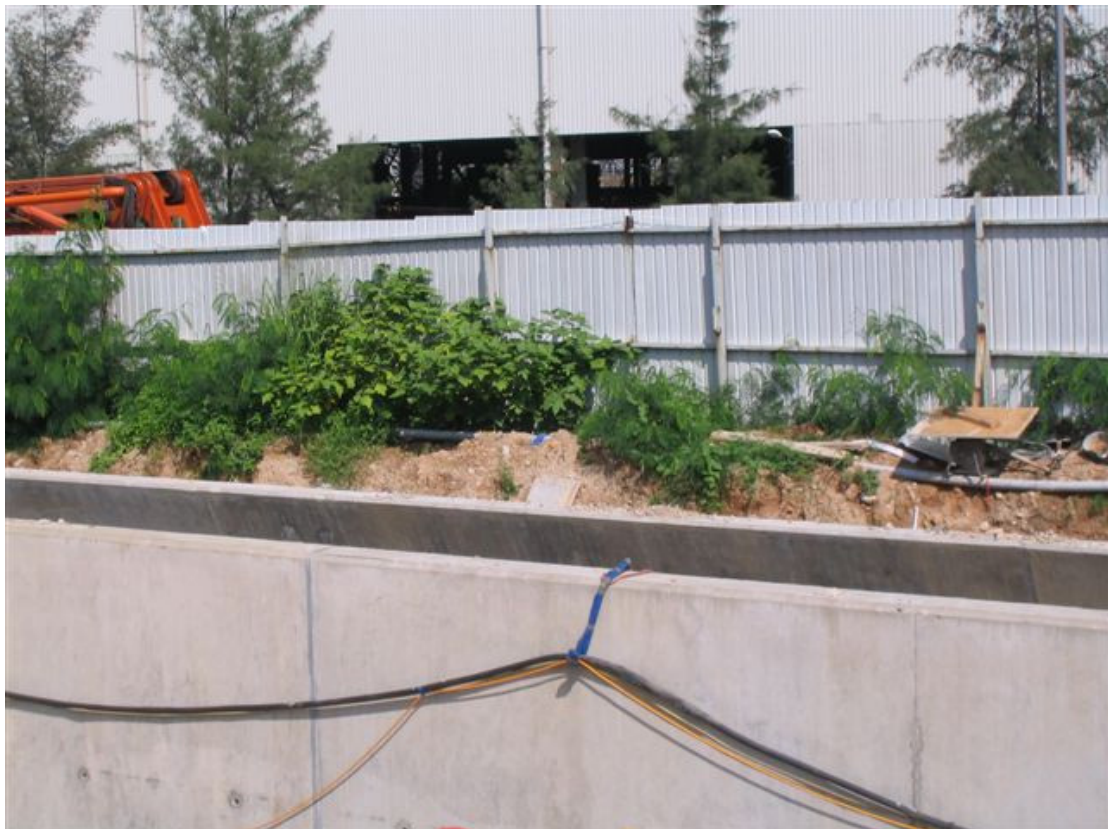
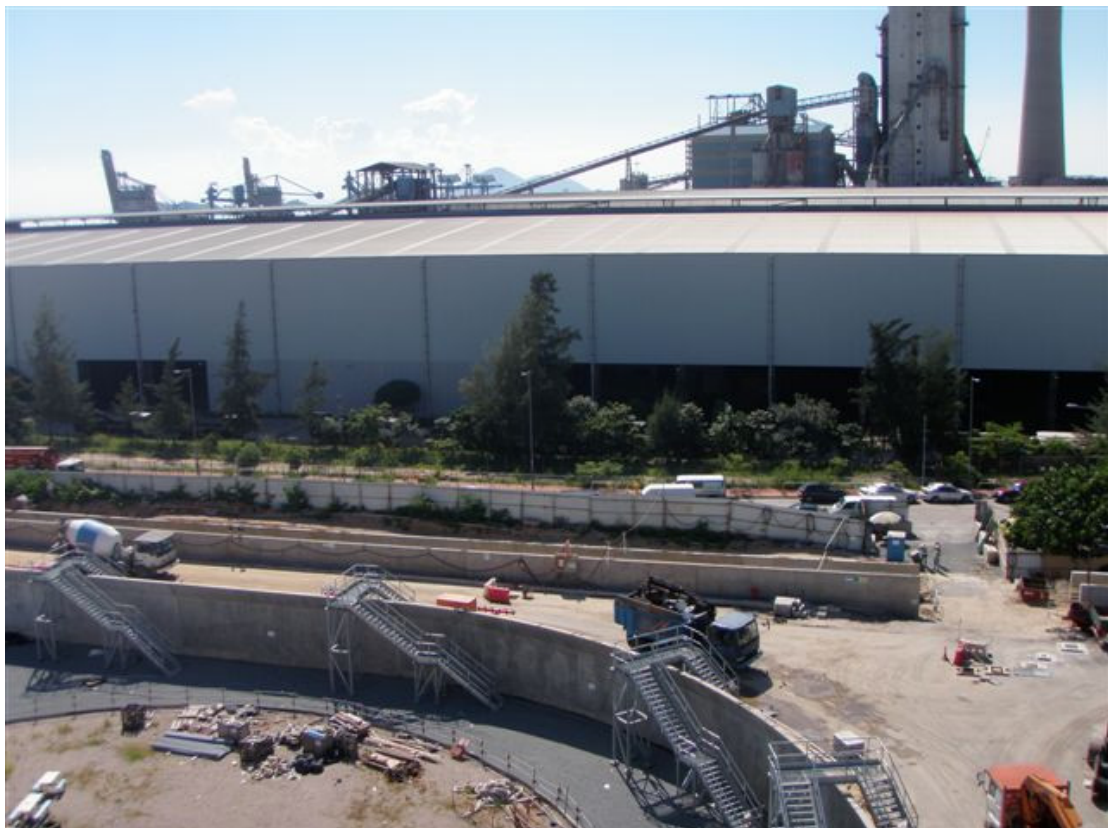
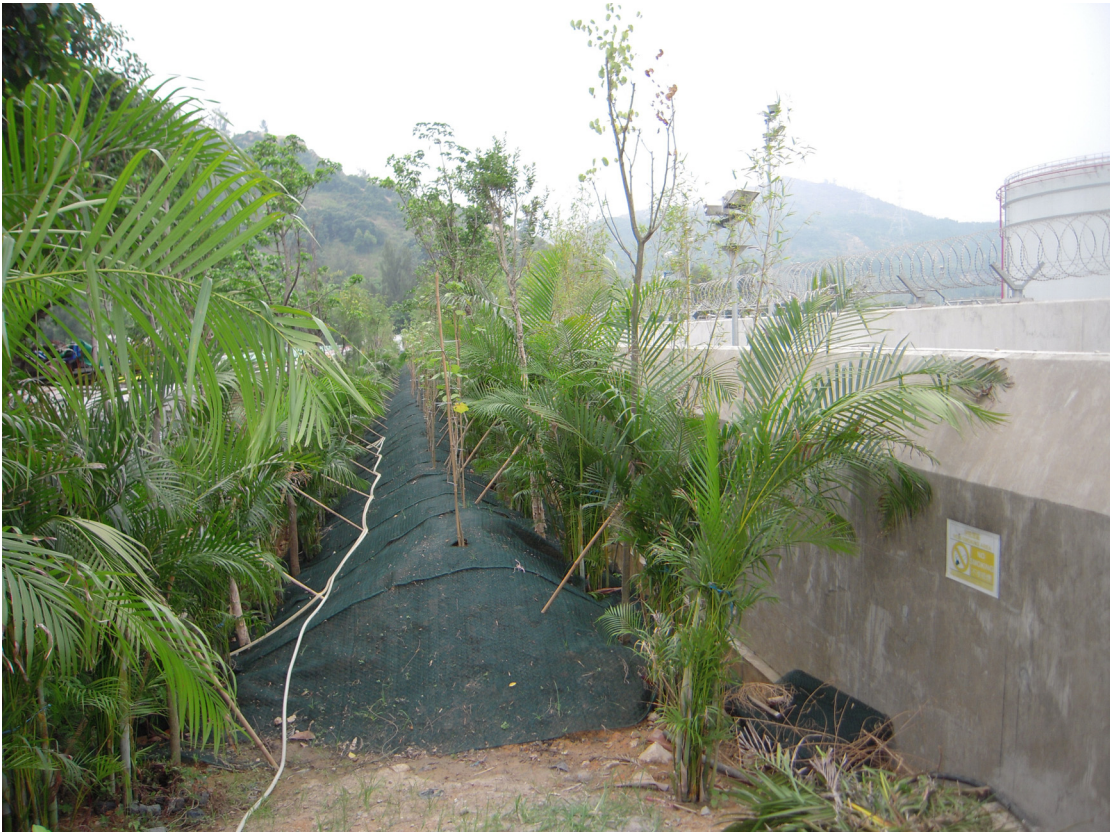
<p>Drawing PAFF/BA/02/DWG/C/1481 shows a landscaped berm of at least 1.5m high outside the outer security wall.</p> <p>See photos No. 18, 22 & 38.</p> <p>The set up has been completed.</p>	<p>C</p>
--	-----------------

(18) Landscaped berm outside the security walls 8-Jul-2009

(22) Landscaped berm outside the security walls 8-Jul-2009

(38) Landscaped Berm

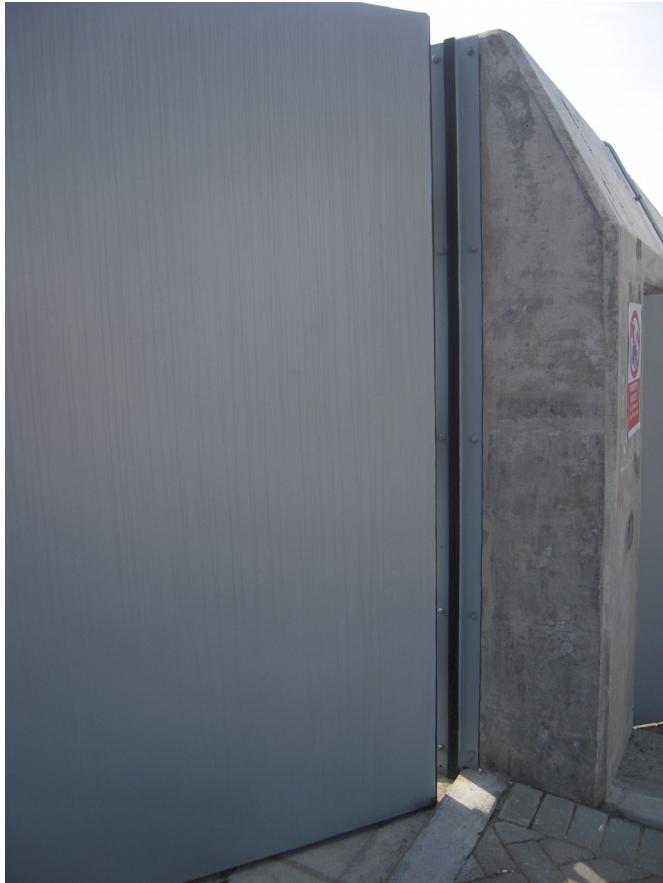
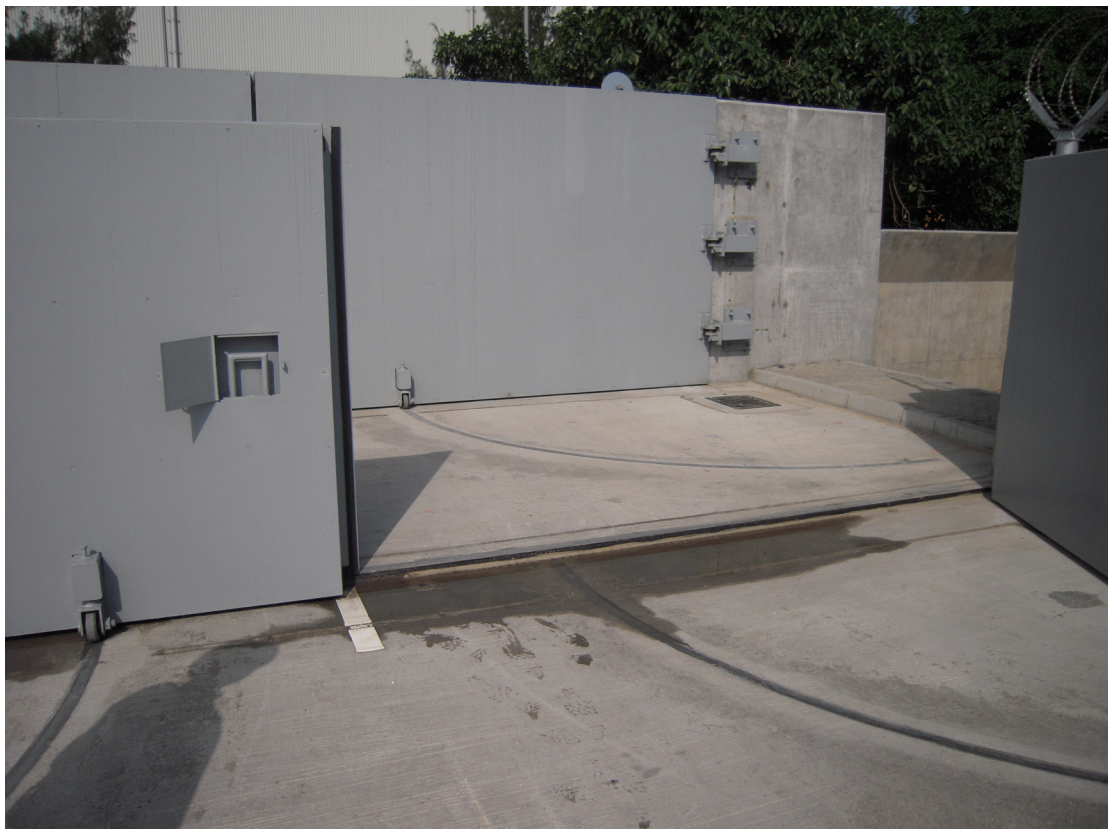
<p>Drawing PAFF/BA/02/DWG/C/1727 shows that solid gates at the security walls would provide sealing in case of any fuel spillage outside the bunded areas within the aviation fuel storage tank farm.</p> <p>The installation of gates has been completed.</p> <p>See photos No. 25 & 26.</p>	<p>C</p>
---	-----------------

(25) Photo (4-Jan-2010) showing sealing of metal gates at security wall

(26) Photo (4-Jan-2010) showing sealing of metal gates at security walls

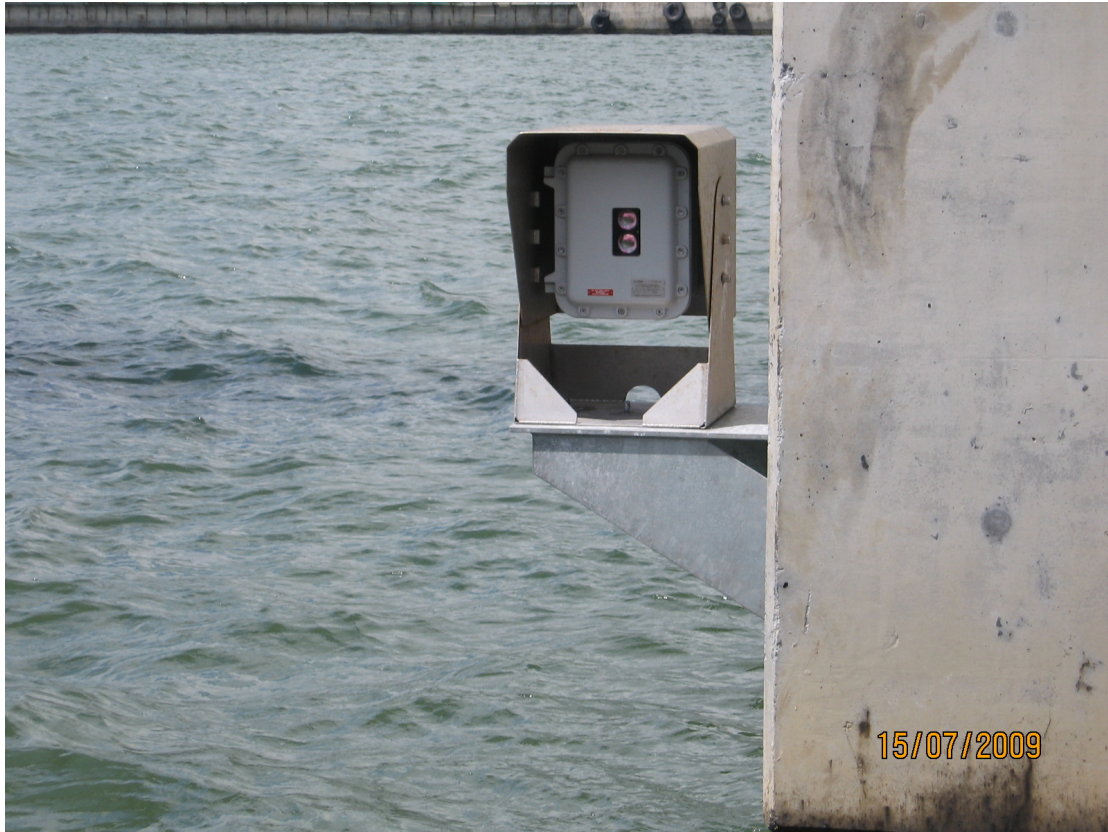
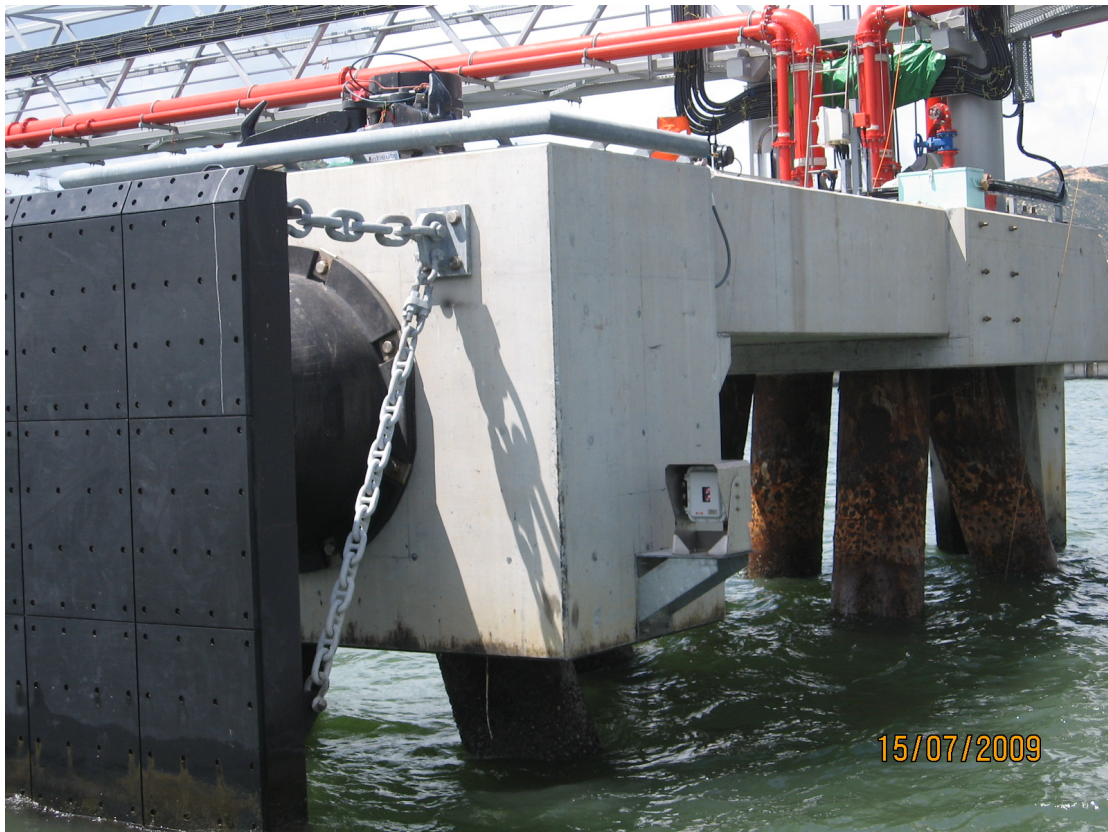
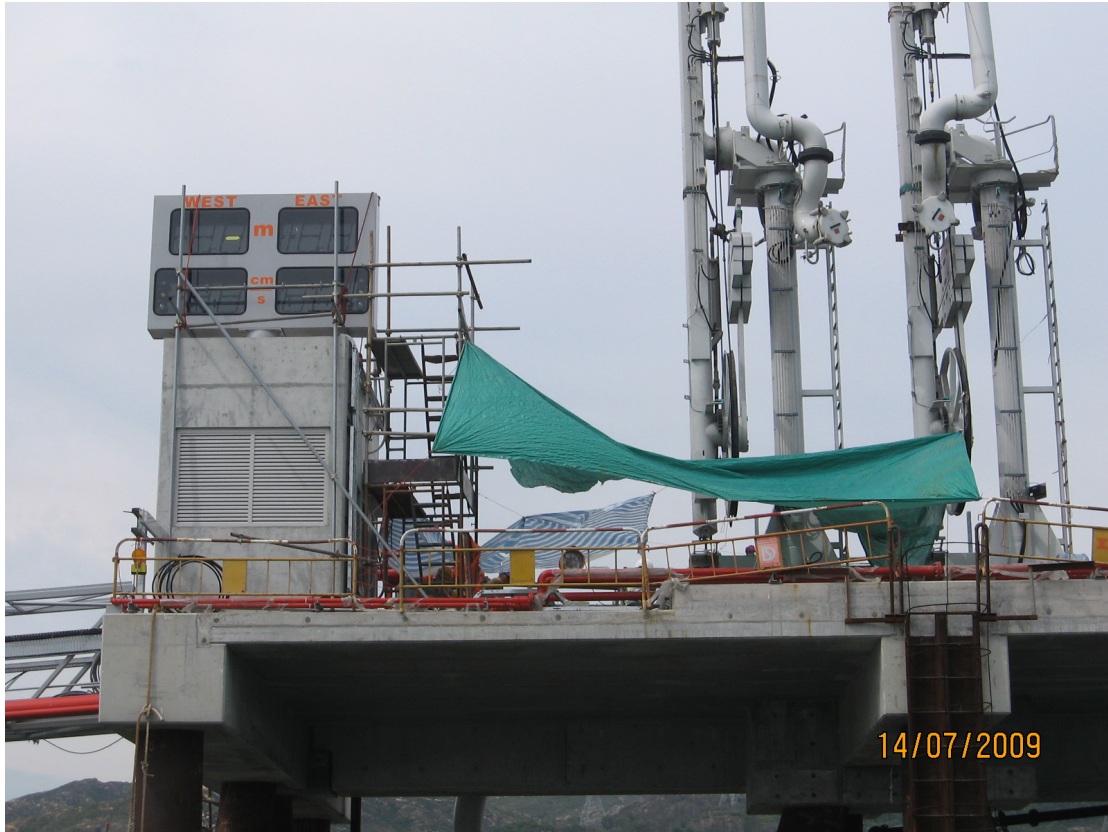
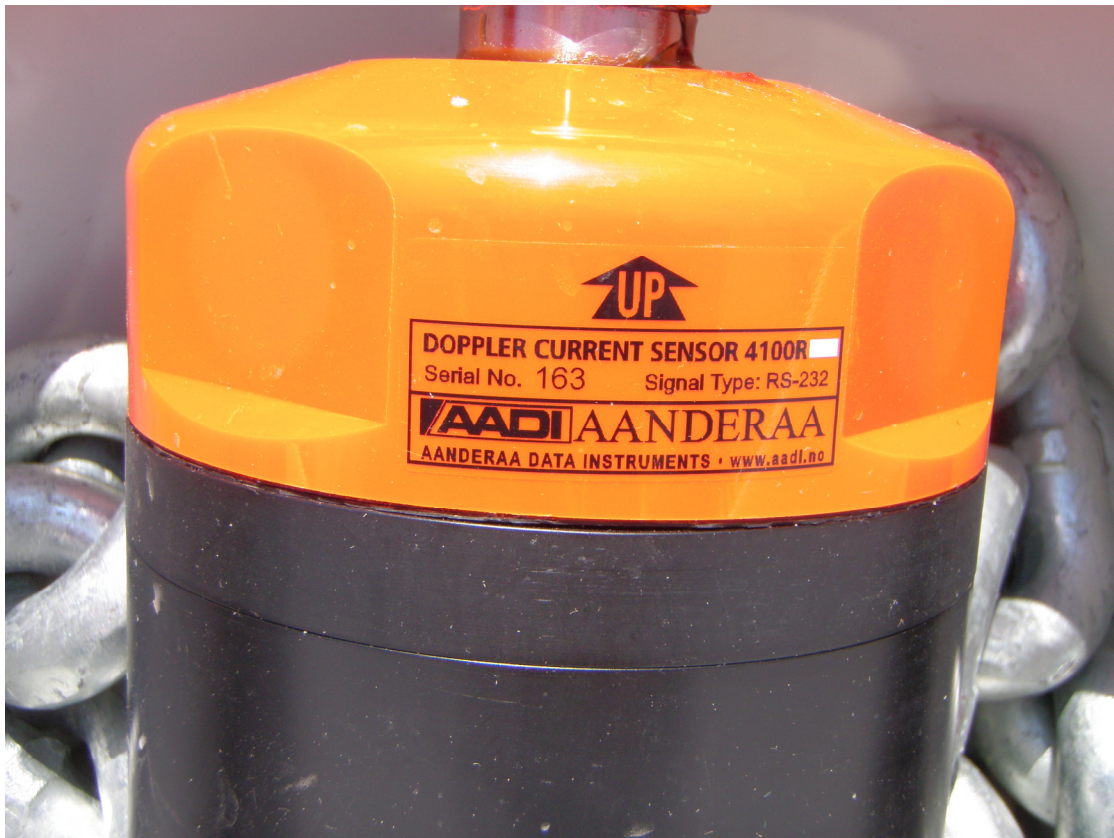
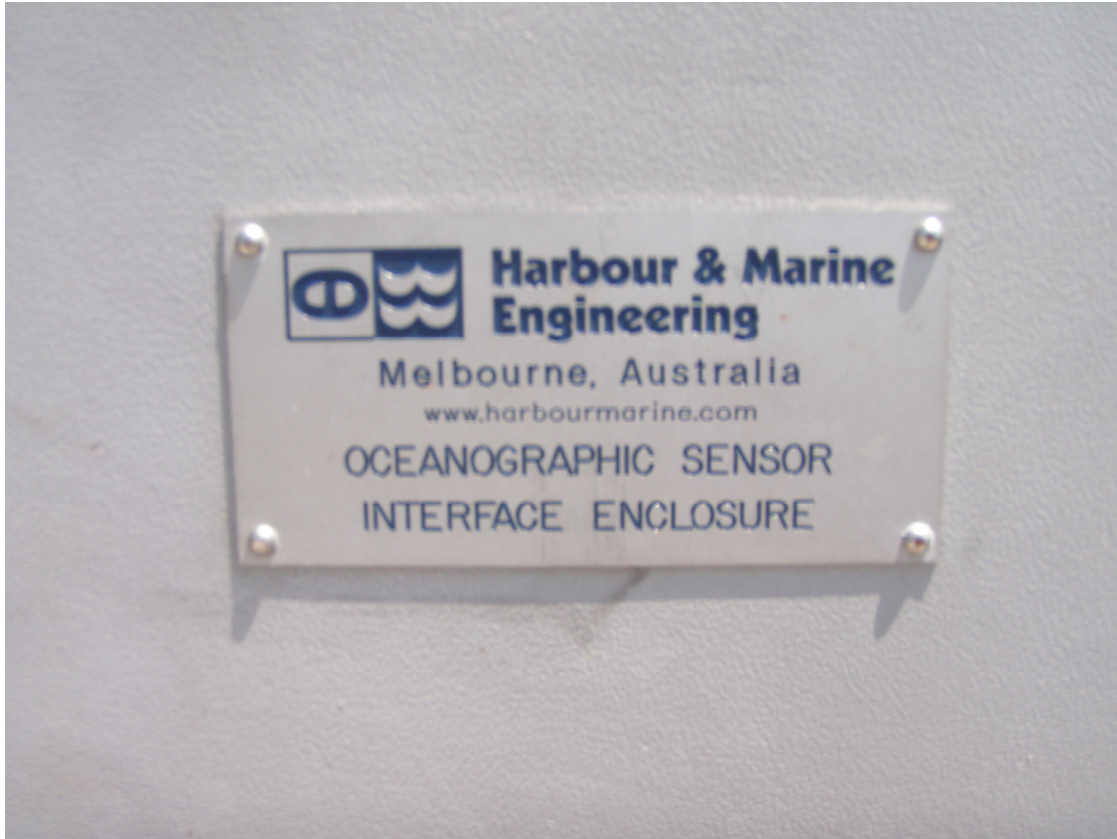
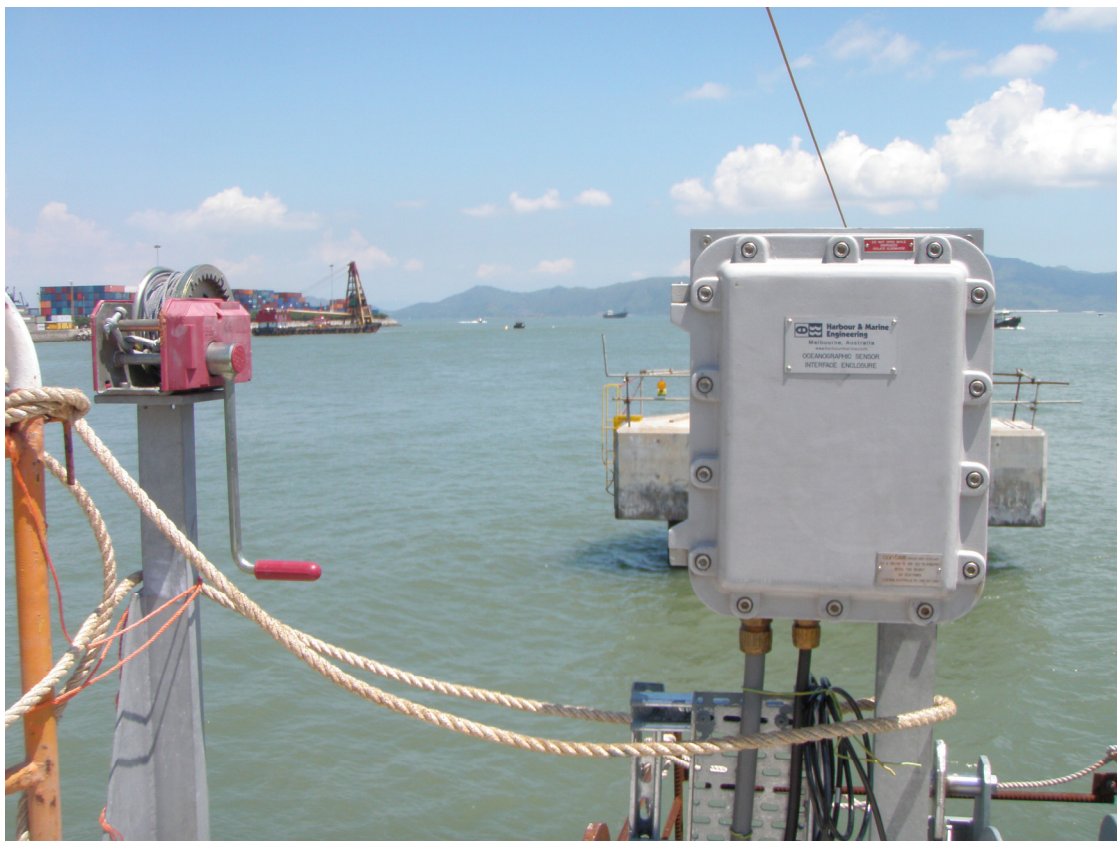
Findings	Result
<p>The two offloading platforms of PAFF Jetty are equipped with a docking aid system, SMARTDOCK DAS, manufactured by Harbour Marine. The system provides real time data of the vessel’s distance and speed of approach relative to the jetty, in the critical 0 to 300 metres zone. With this data, the Pilot and vessel’s Master can better direct tug and shipboard personnel can safely maneuver the vessel towards the jetty and therefore minimize any potential for damage to the berth or ship.</p> <p>Also the system has drift-warning monitoring capability after the mooring of the vessel.</p> <p>Besides, there are devices for measuring real time wind and current speeds and directions. See photos No. 27- 32.</p>	<p>C</p>

(27) BD 15-Jul-2009 Condition of laser box at BD2

(28) BD 15-Jul-2009 Condition of laser box at BD3

(29) LP2 14-Jul-2009 General view for display board on LP1

(30) Doppler Current Sensor

(31) Oceanographic Sensor Interface (1)

(32) Oceanographic Sensor Interface (2)

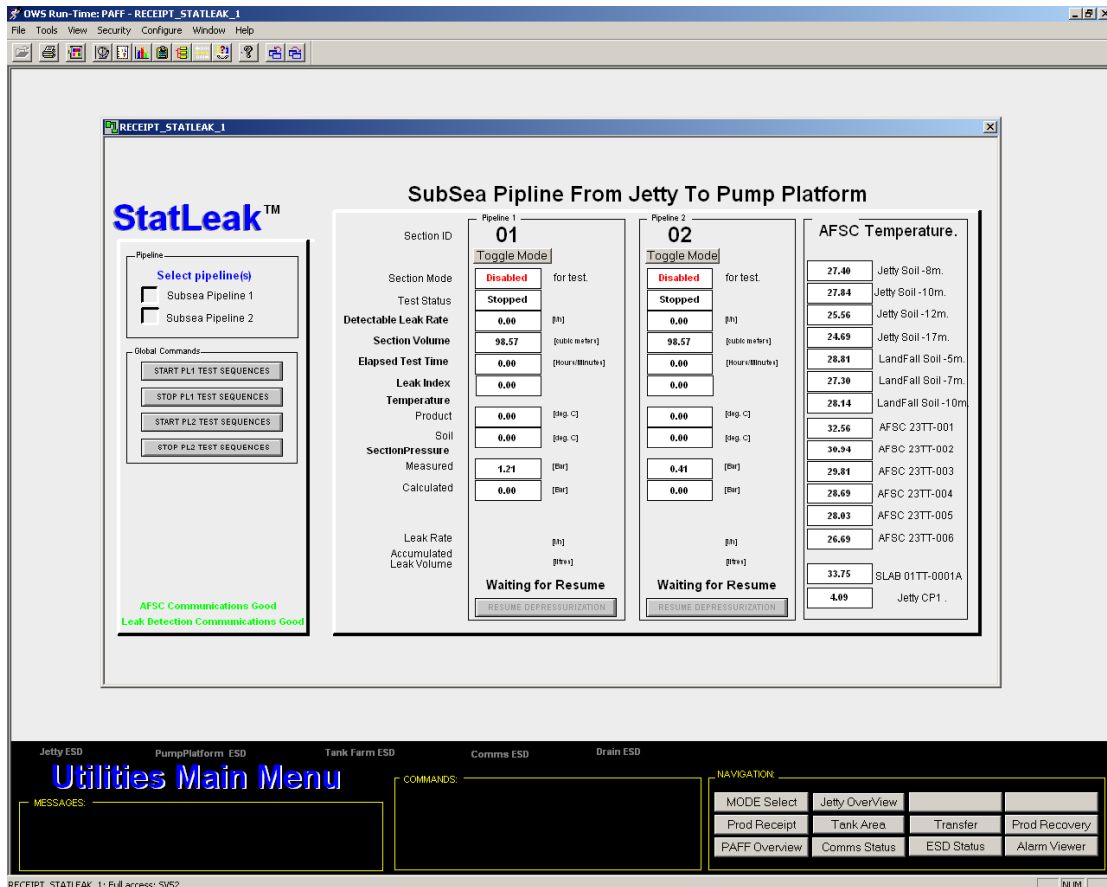
<p>Drawings PAFF/LC/01/DWG/M/0202-3 & 0207 show the installation of pipeline leakage detection system in the subsea pipelines using COWI Stat Leak System. The testing is by closing the sections of pipelines and by detecting any pressure drop within a specified period inside the pipelines. A pressure drop not due to thermal effect may indicate a possible leak in the pipeline. It will generate an alarm and activate the opening of the motor-operated valves to de-pressurize relevant pipeline section first and re-closing of them to isolate the problem section pending for immediate investigation. If leakage is confirmed, urgent repair will be arranged.</p> <p>The instrumentation has been installed for the subsea pipelines. See photos No. 40 & 41.</p>	<p>C</p>
--	-----------------

(41) Leaktest Screen

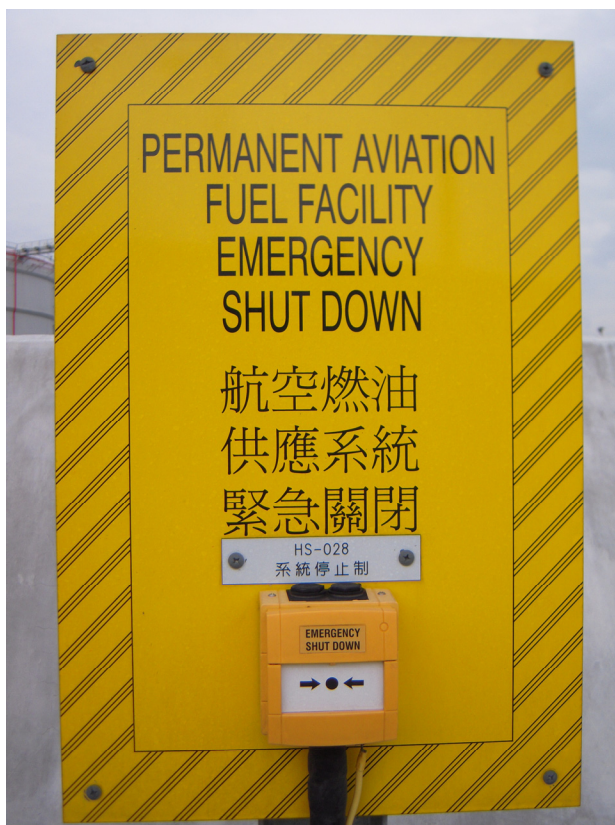
<p>Drawings PAFF/KG/02/DWG/E/7437 & PAFF/LC/03/DWG/M/0251 show the installation of manual-operated emergency shut down (ESD) buttons at the strategic points in the tank farm and on the jetty for emergency use. As soon as ESD is activated, all valves and delivery pumps will automatically shut down to isolate the fuel lines and stop the flow of fuel.</p> <p>The installation of ESD has been completed. See photos No. 39 & 42.</p>	<p>C</p>
---	-----------------

(42) ESD Device
