ANNUAL AUDIT REPORT
For
PERMANENT AVIATION FUEL FACILITY
Environmental Permit
EP-262/2007/B

Date of Audit :		27 February to 20 March 2020
Prepared By :	Michael Chung, Senior Engineer <i>mchung</i>	20 March 2020
Reviewed By :	Eddie Kwan, Facility Manager <i>Eddie Kwan</i>	20 March 2020
Approved By :	Tommy Siu, General Manager <i>Tommy Siu</i>	20 March 2020

ECO Aviation Fuel Services Limited (EAFS) is the operator of the Permanent Aviation Fuel Facility (PAFF), which is located on 9.28 ha of land at 9 Lung Hong Street, Tap Shek Kok, Tuen Mun. PAFF consists of a tank farm, a twin berth jetty and associated pipelines for receipt of aviation fuel from ocean tankers to the tank farm, and twin submarine pipelines from the tank farm to the aviation fuel receipt facility at Sha Chau Island.

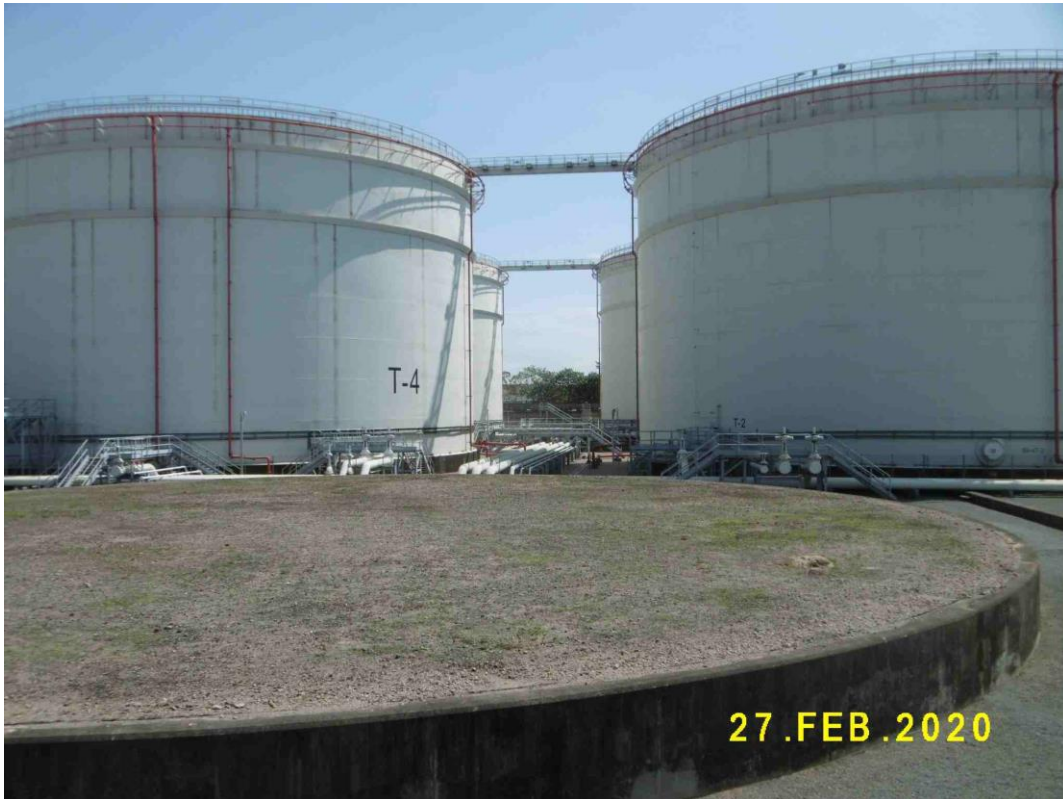
(1) Four tanks are located within bunded compound – Phase 1a

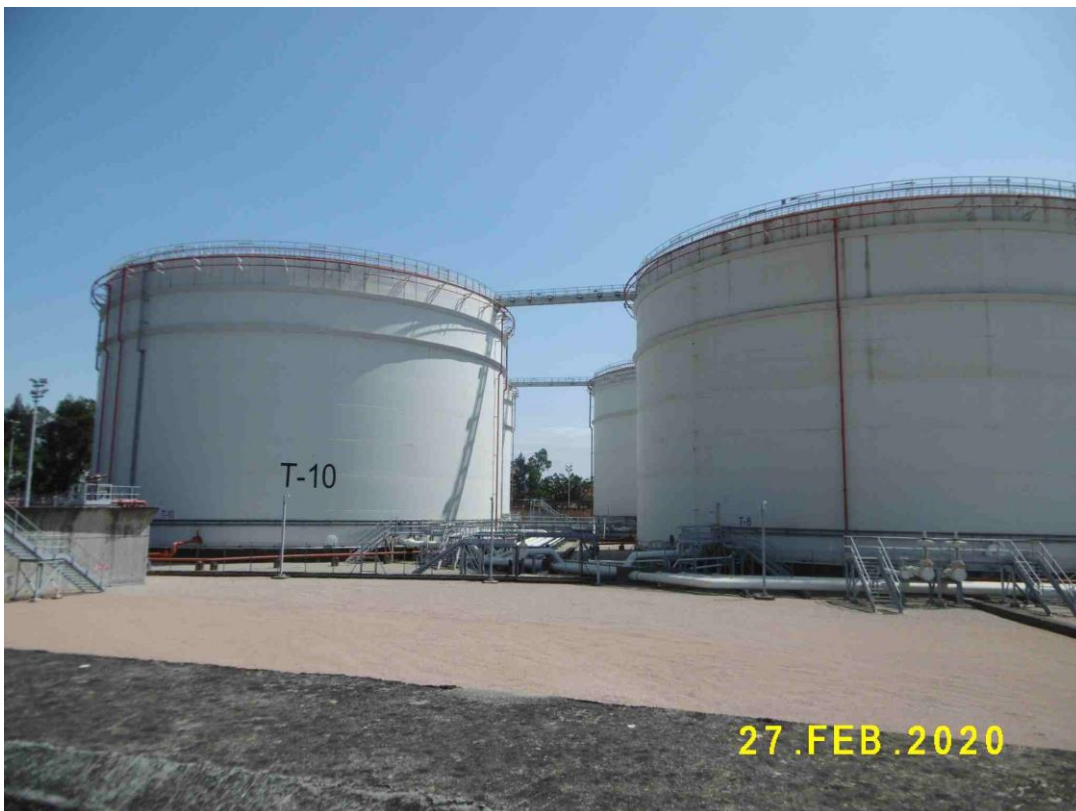
(2) Four tanks are located within bunded compound – Phase 1b

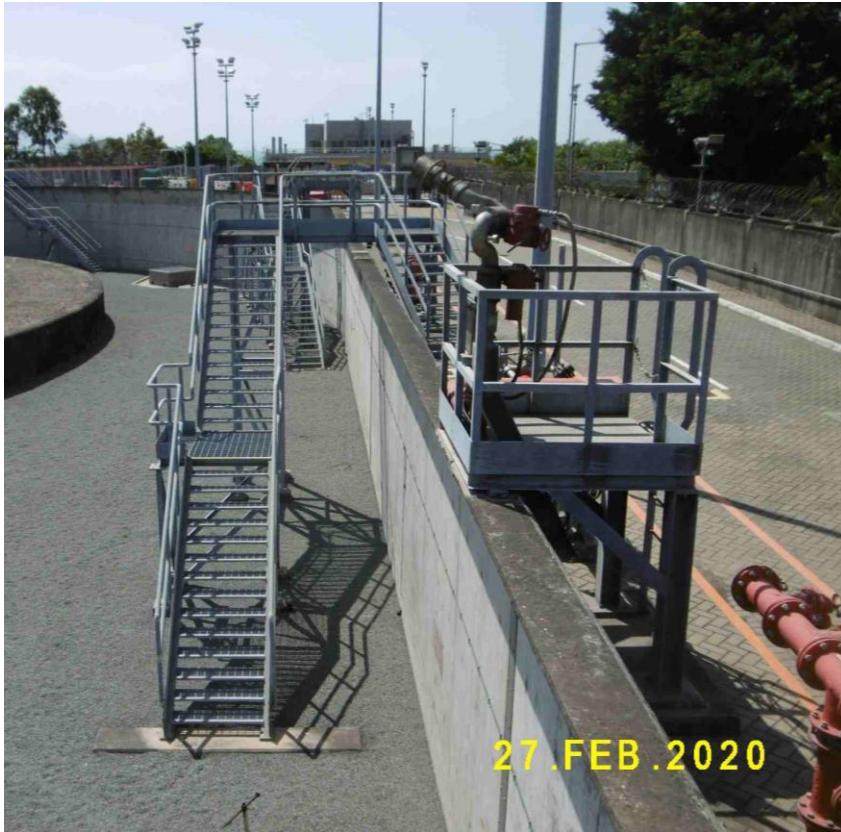
(3) Phase 1a bunded compound is lower than the ground level outside the bunds

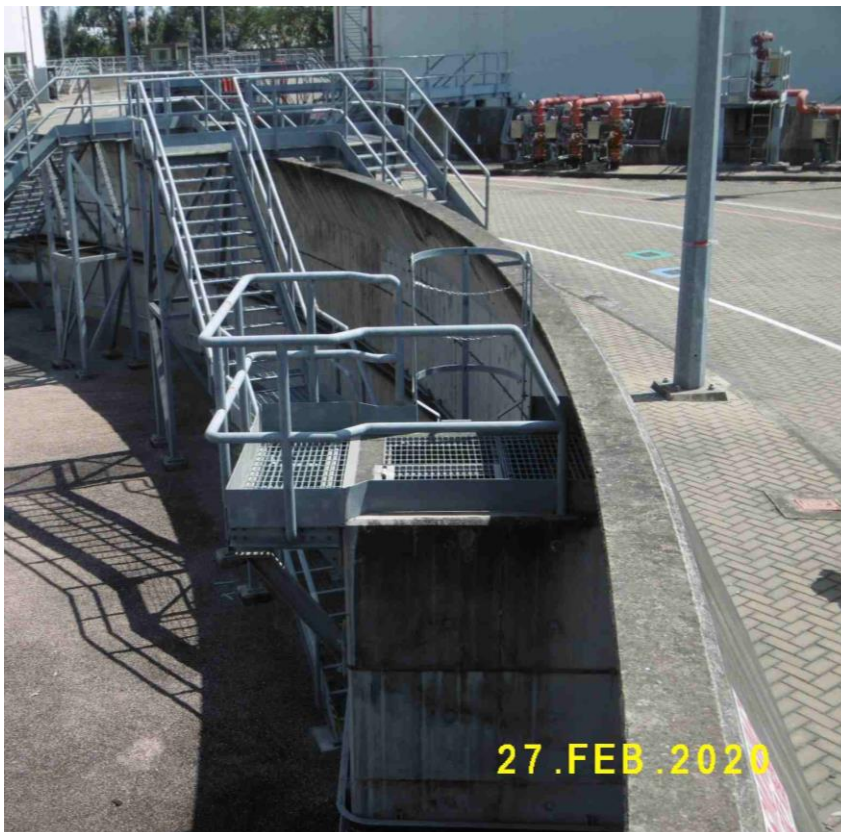
(4) Phase 1b bunded compound is lower than the ground level outside the bunds

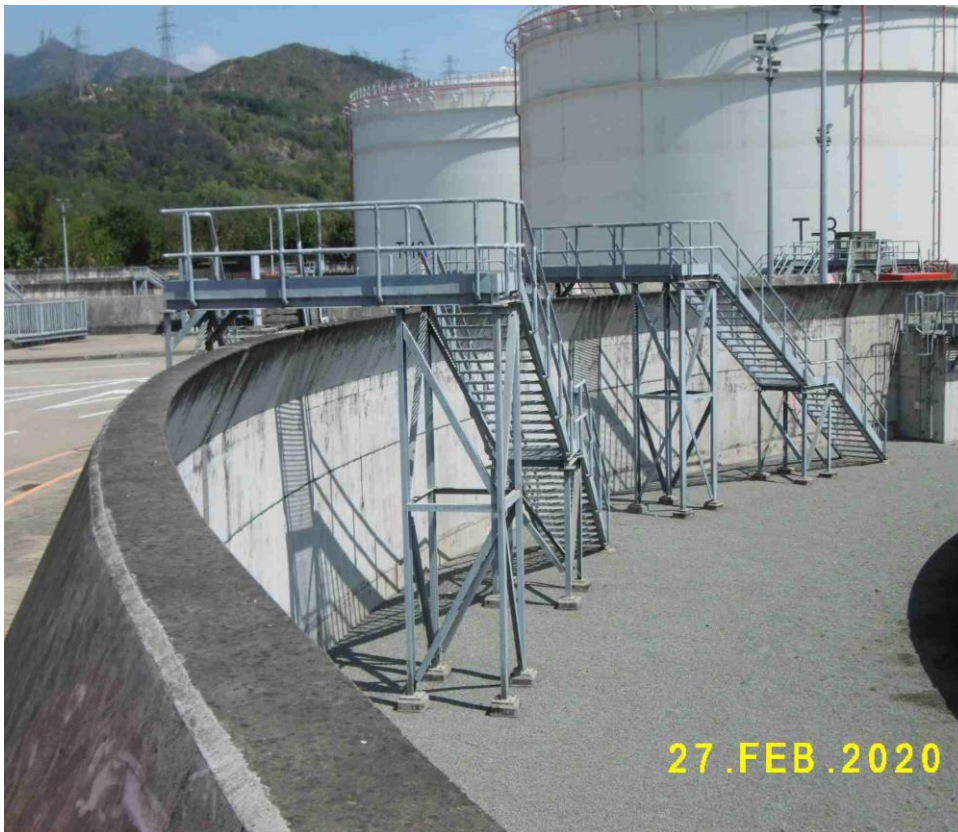
(5) Wave deflector is located at top of the bund

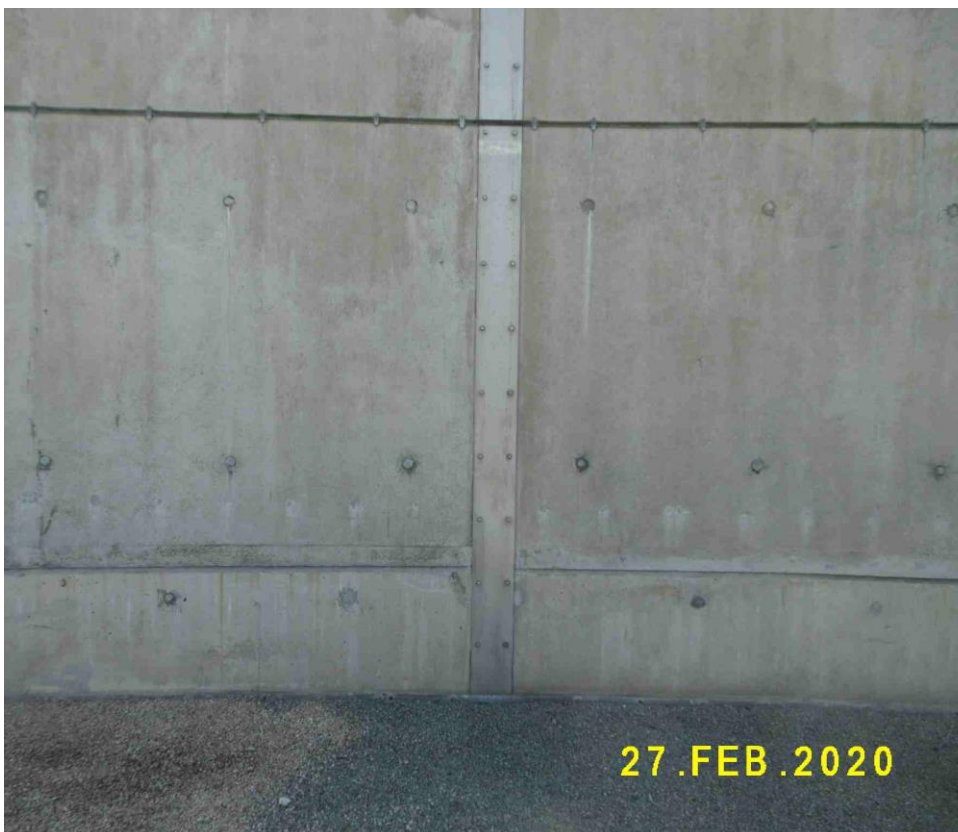
(6) Visible parts of the joints are covered by stainless steel plates on the inside at phase 1a bund

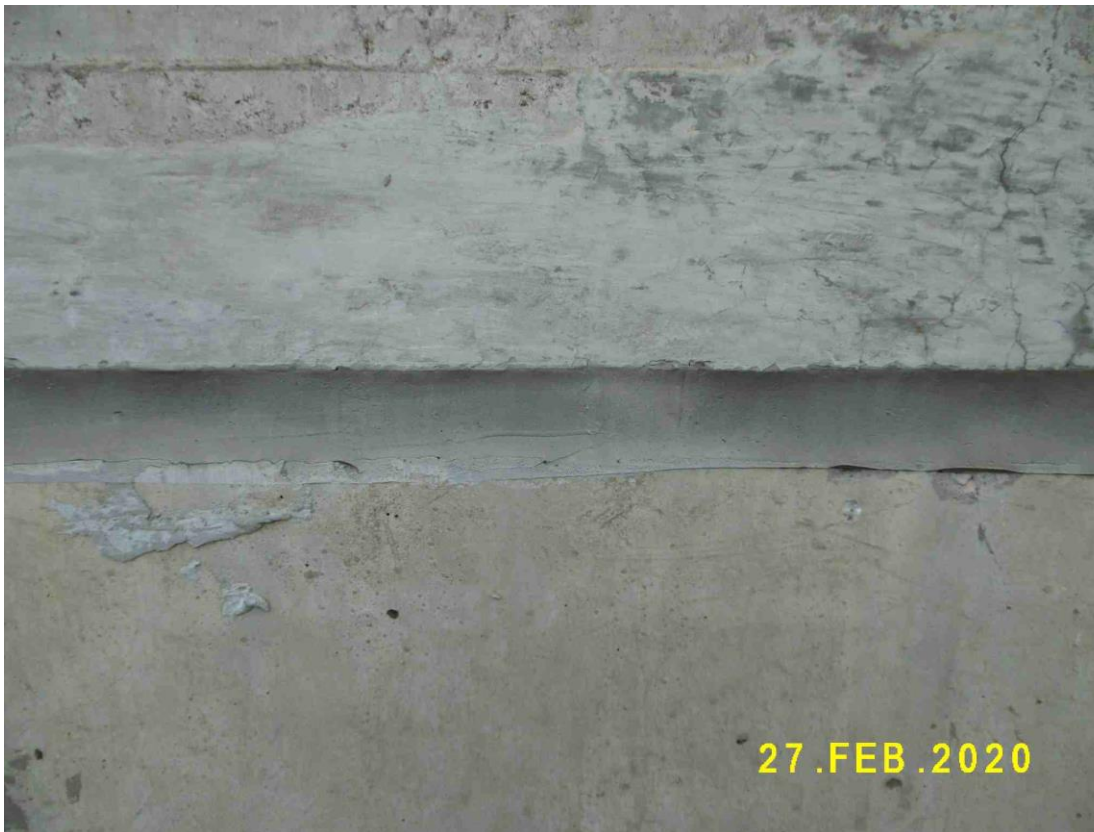
(7) Maintenance works have been performed on sealant at joints

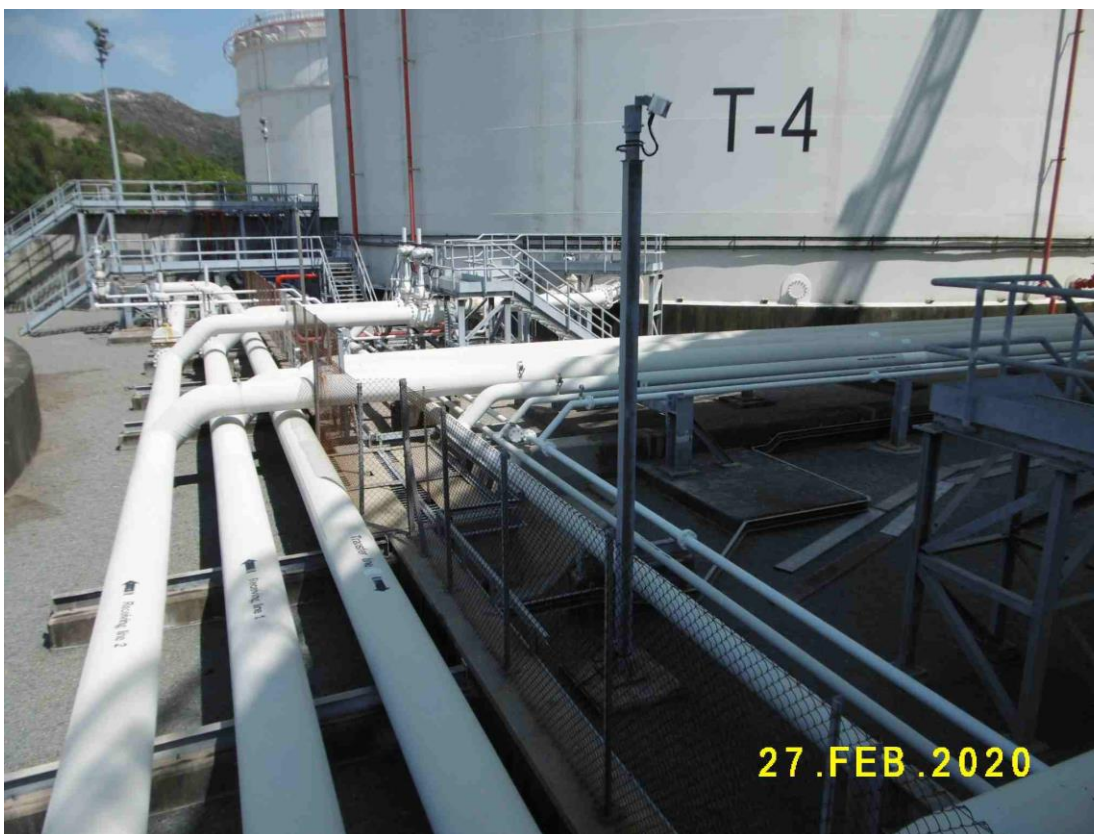
(8) Intermediate bund walls are provided in place near T-01-004

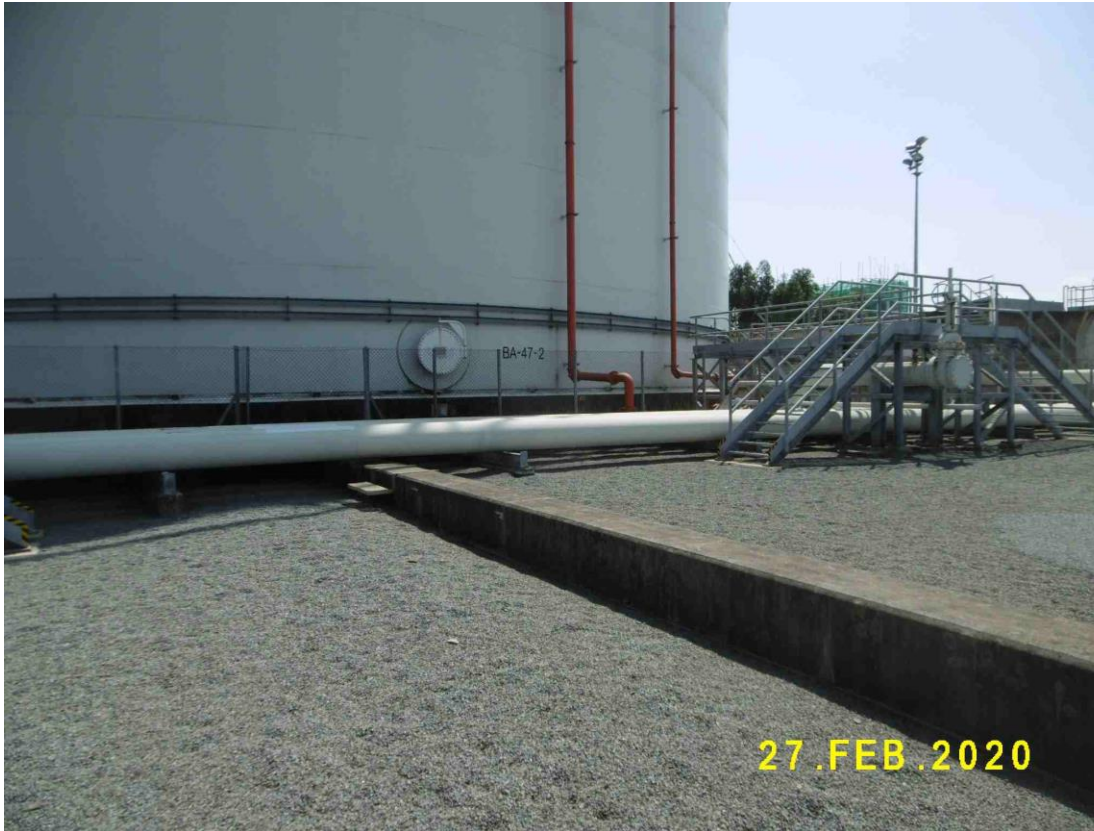
(9) Intermediate bund walls are provided in place near T-01-002

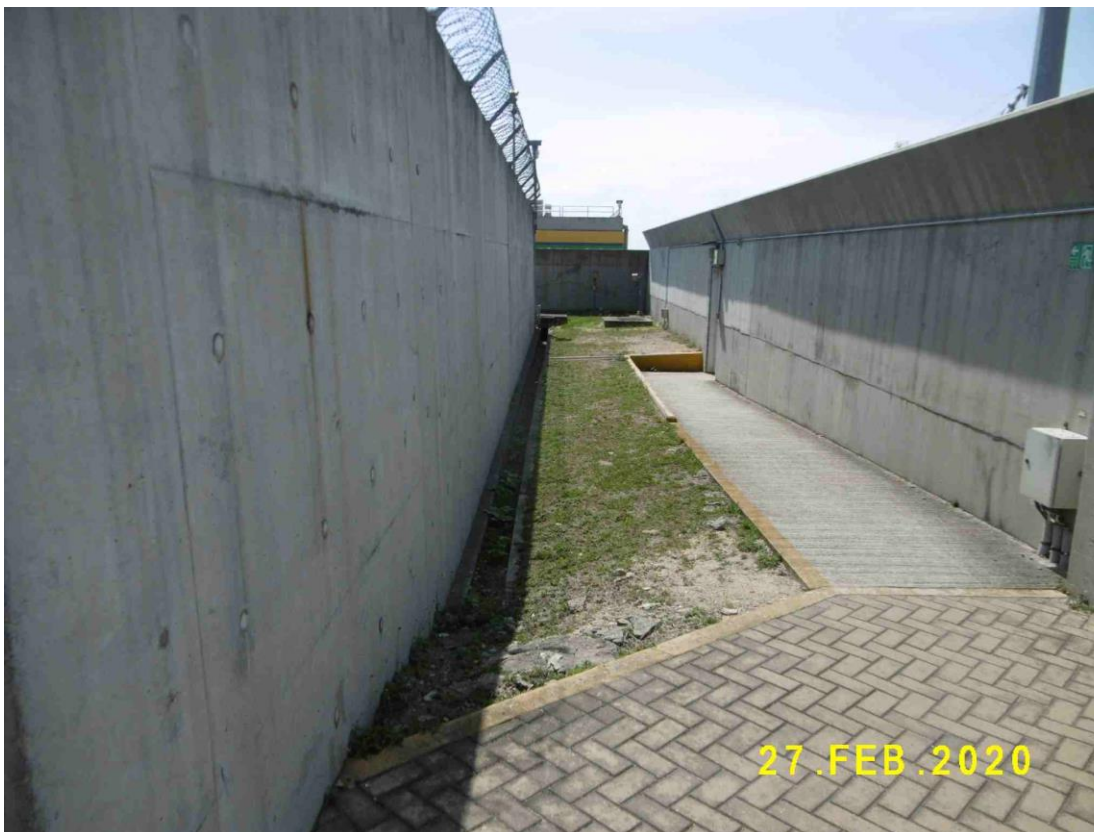
(10) Two impervious security walls are provided outside the bunded compounds

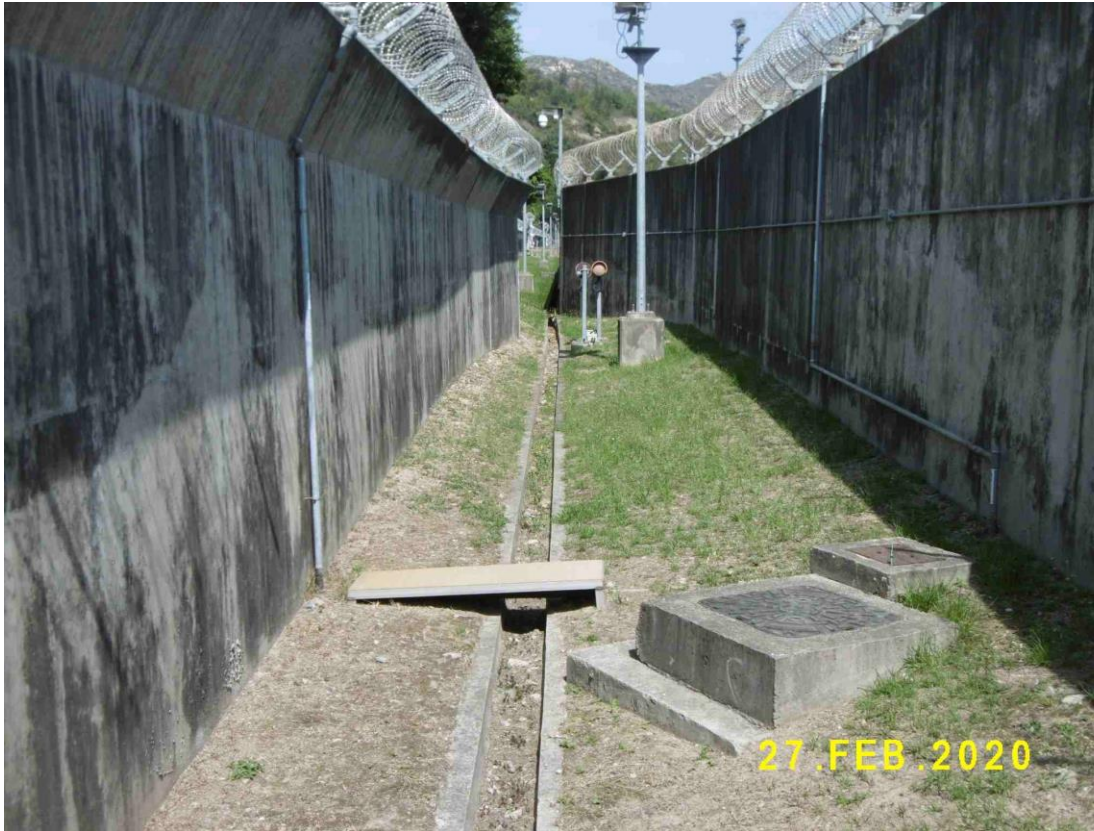
(11) Two impervious security walls are provided outside the bunded compounds

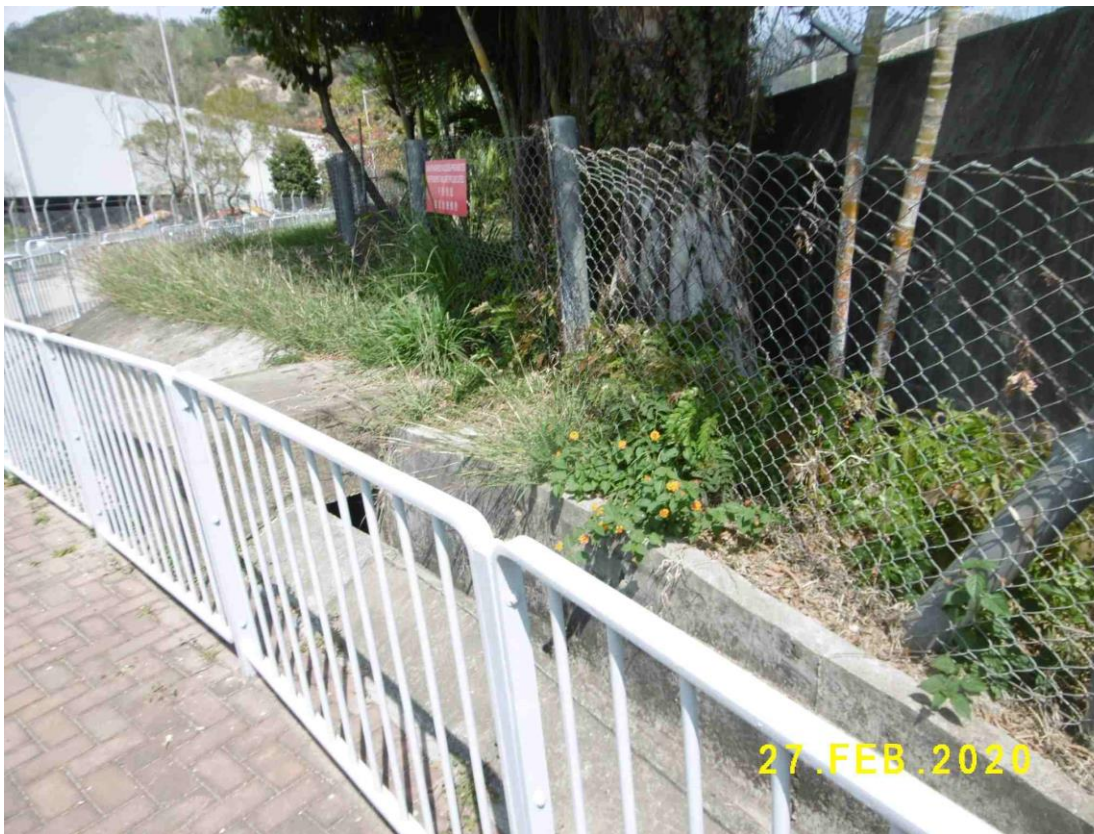
(12) Landscaped berm is maintained at least 1.5m high

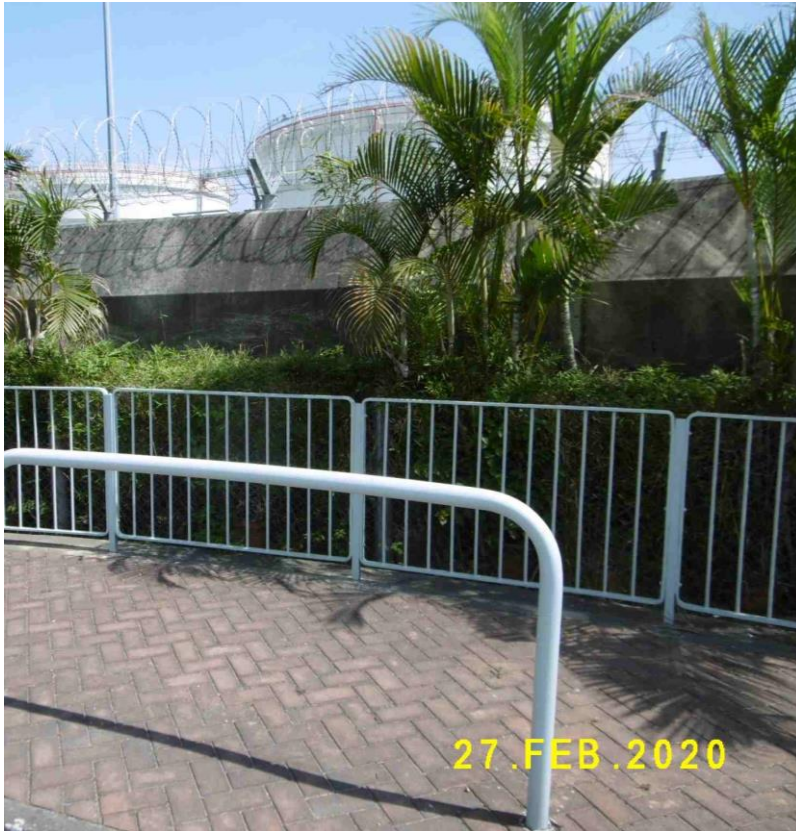
(13) Landscaped berm is maintained at least 1.5m high

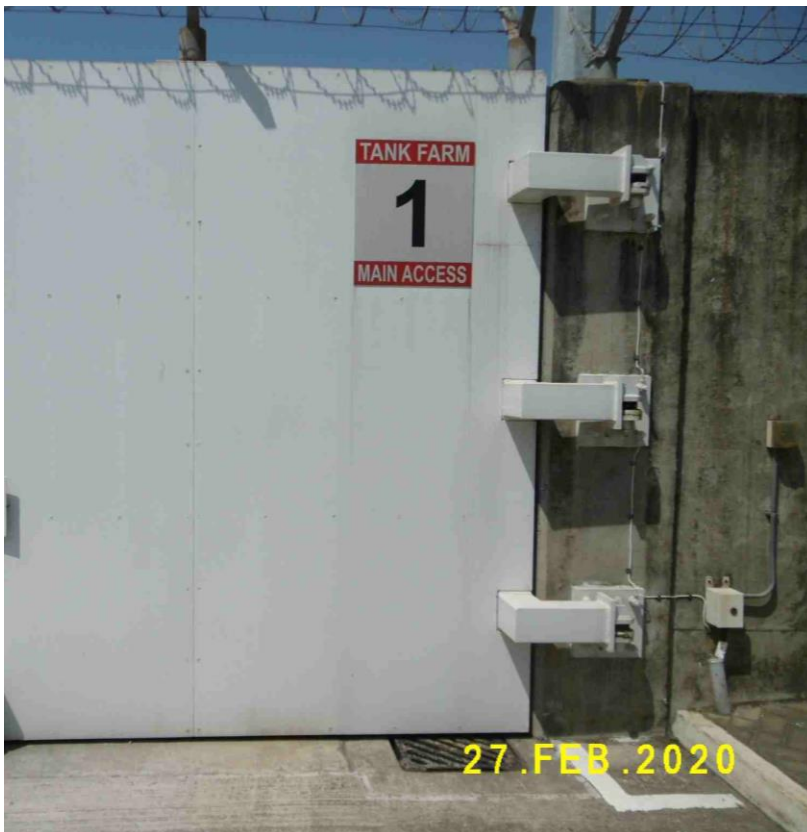
(14) Gates at security walls with sealant are maintained in good condition

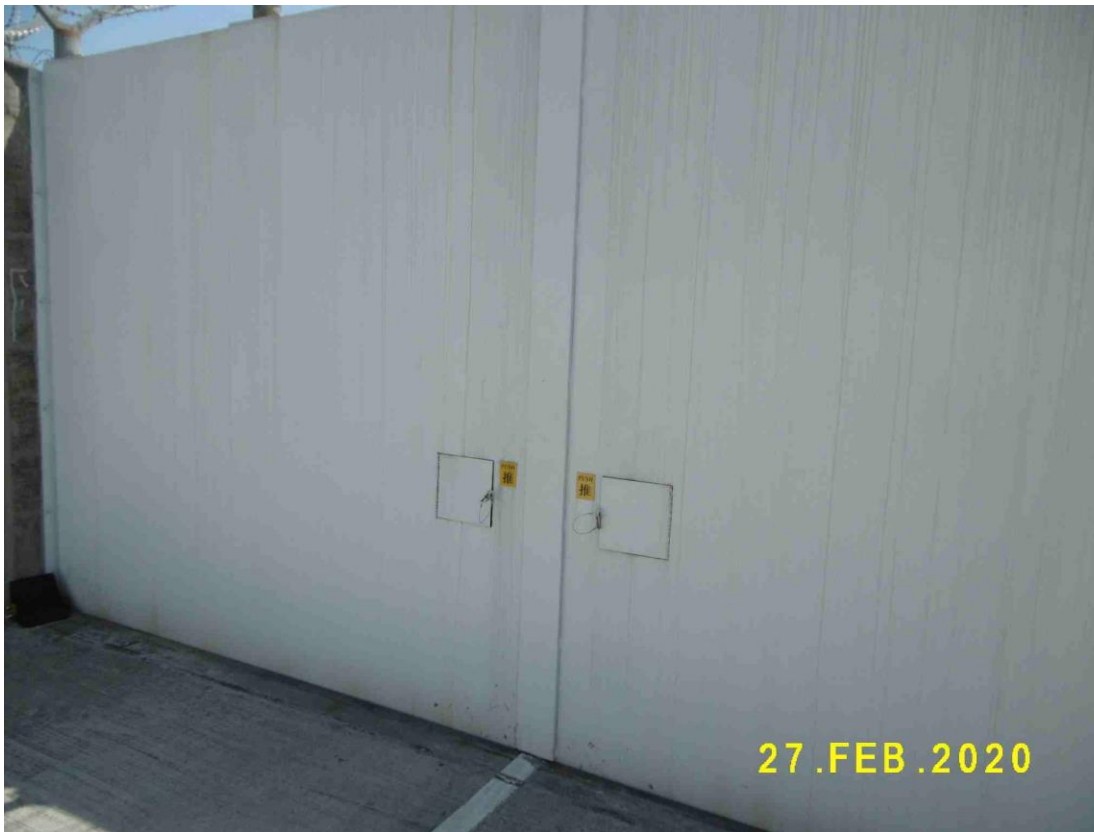
(15) Gates at security walls with sealant are maintained in good condition

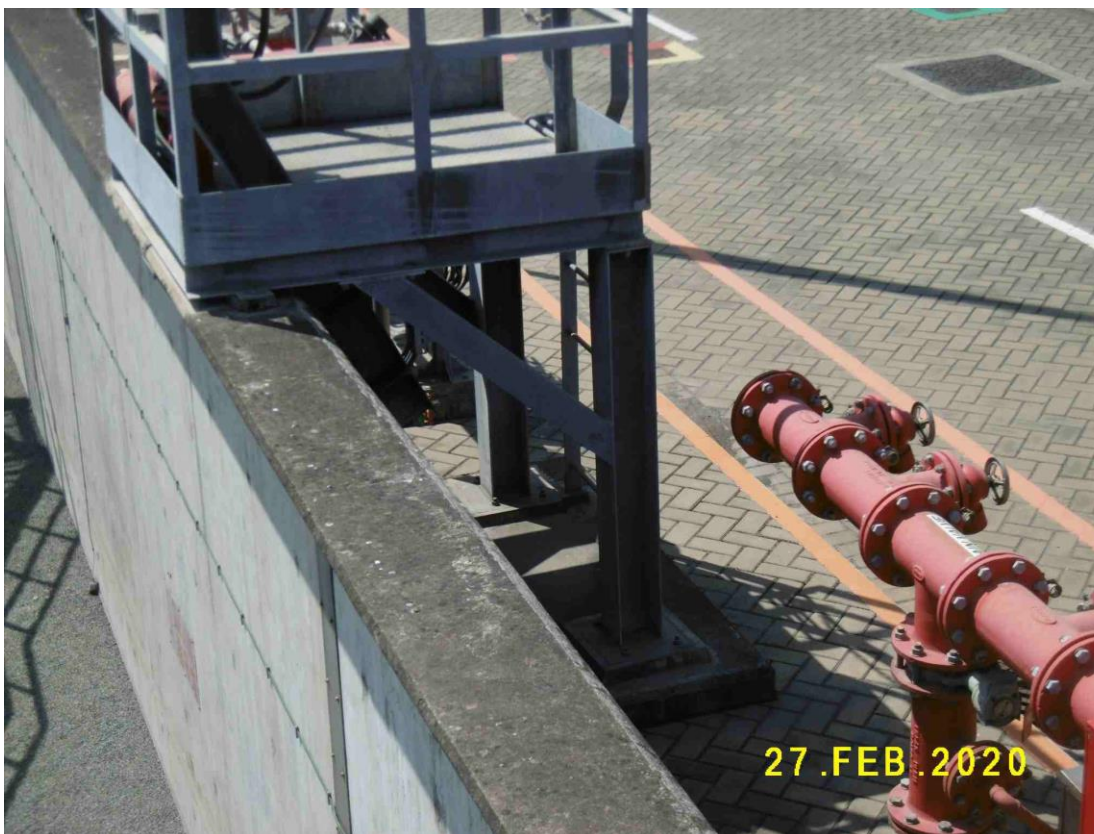
(16) This shows the thickness of the bund wall provided

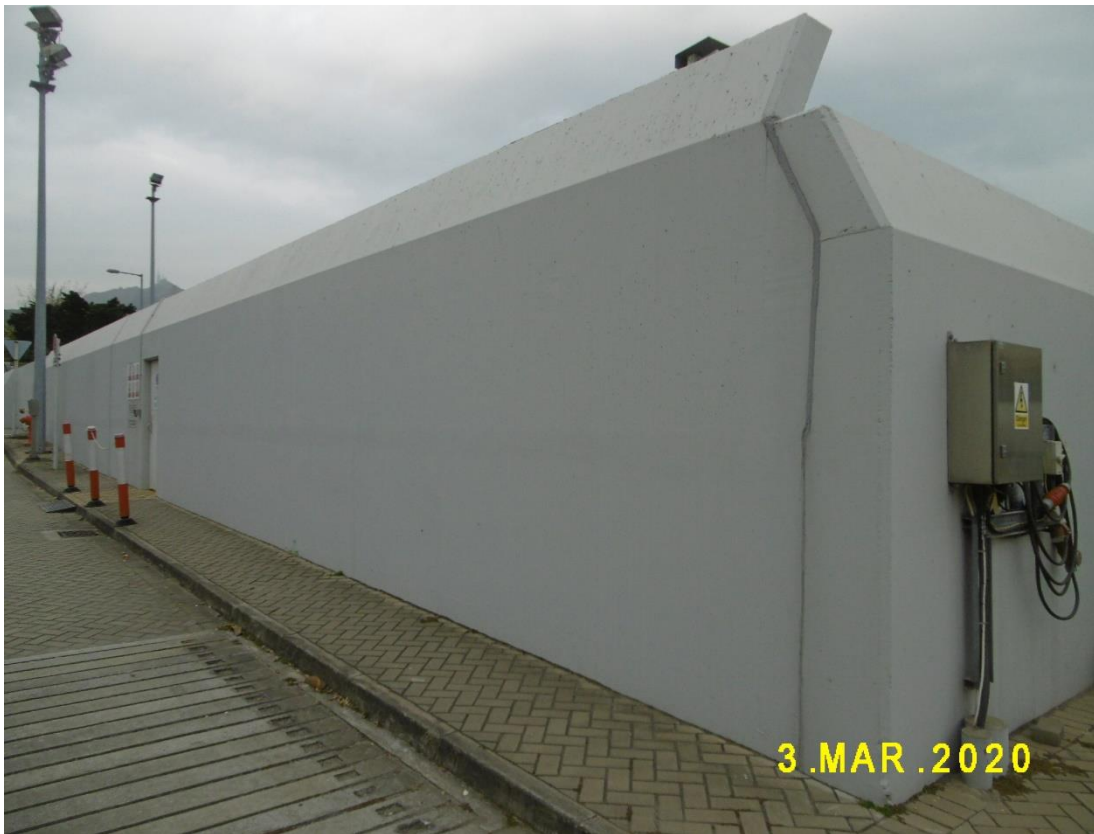
(17) This shows the thickness of the security wall provided

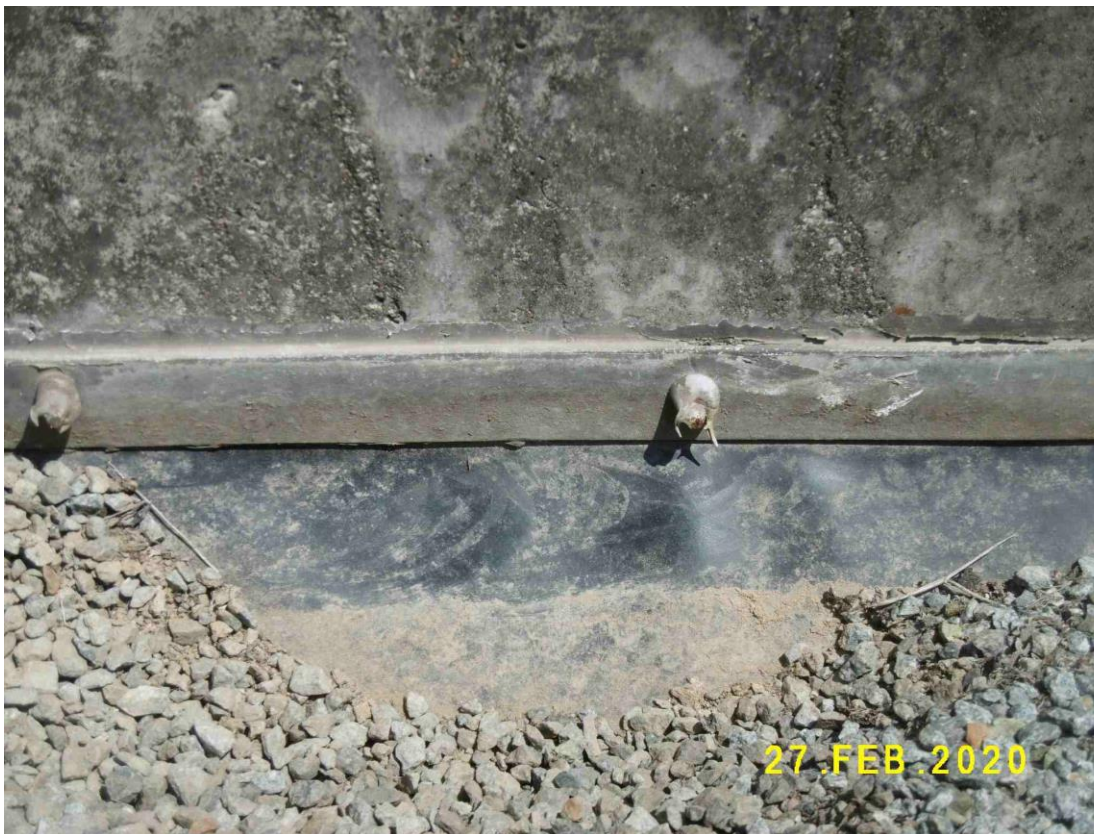
(18) Impervious lining are maintained in good condition

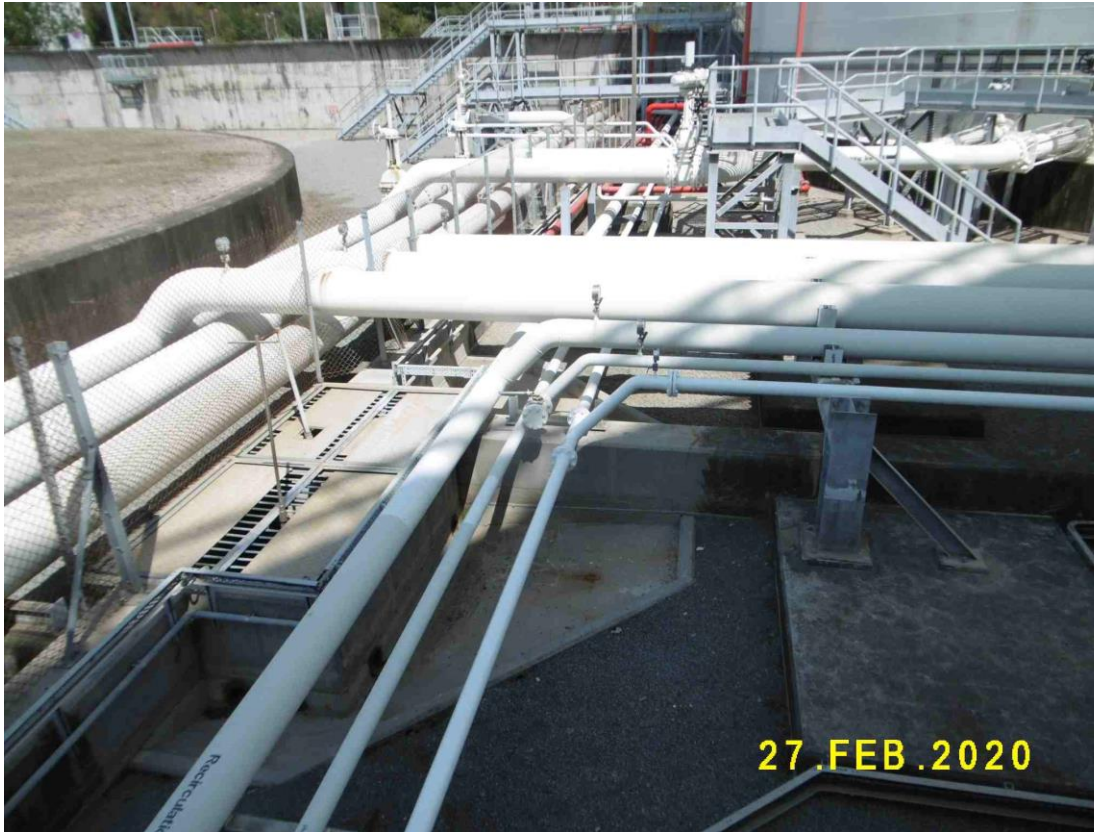
(19) Tank farm is with appropriate gradient and the drainage falls to interceptor for collection

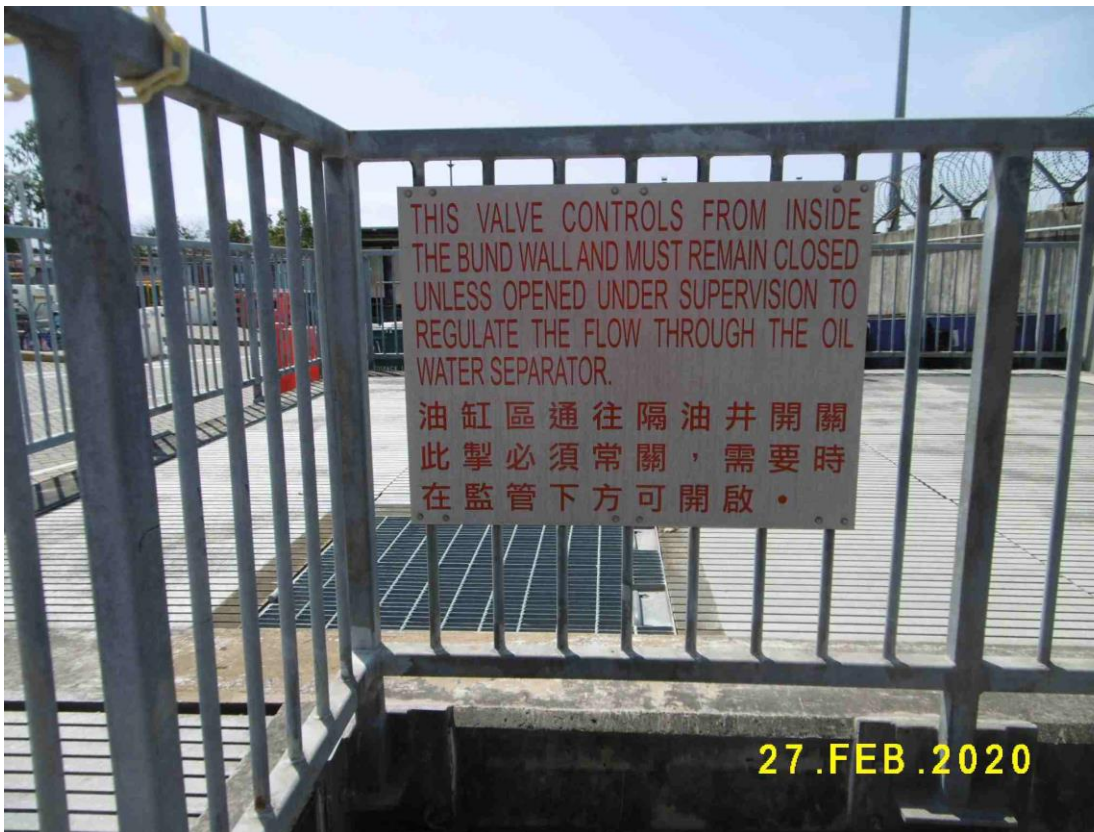
(20) Outlet valve provided for Phase 1a Interceptor with instruction sign to keep "normally closed"

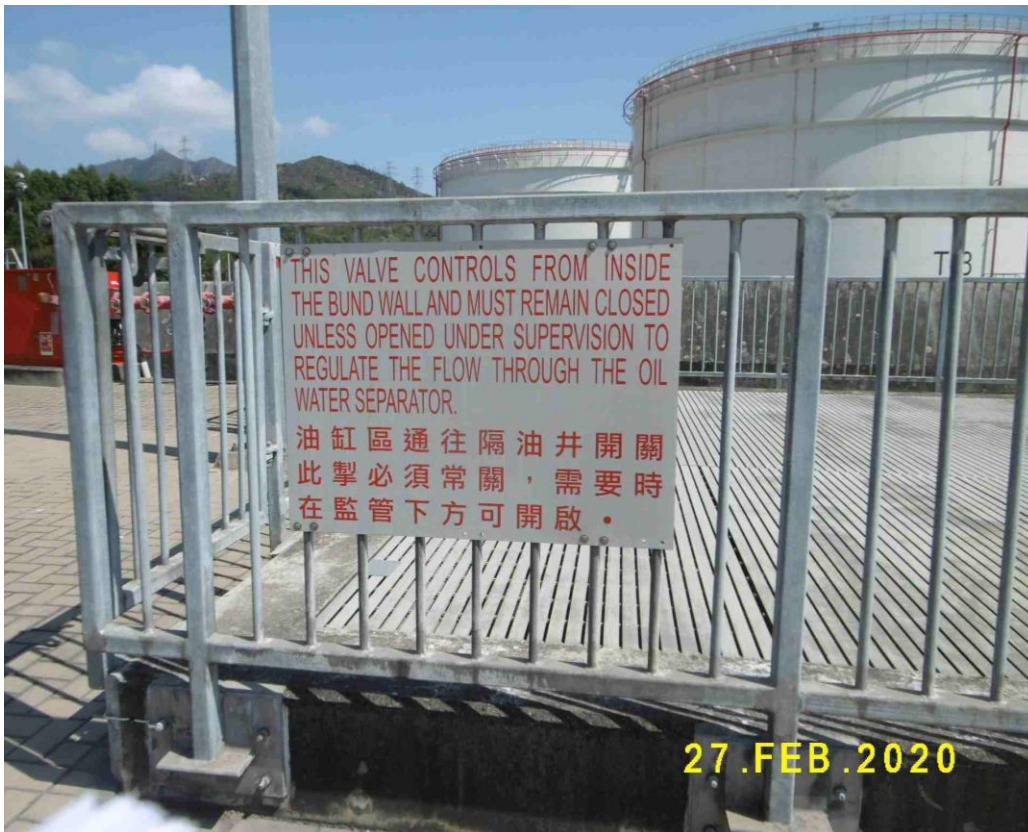
(21) Outlet valve provided for Phase 1b Interceptor with instruction sign to keep “normally closed”

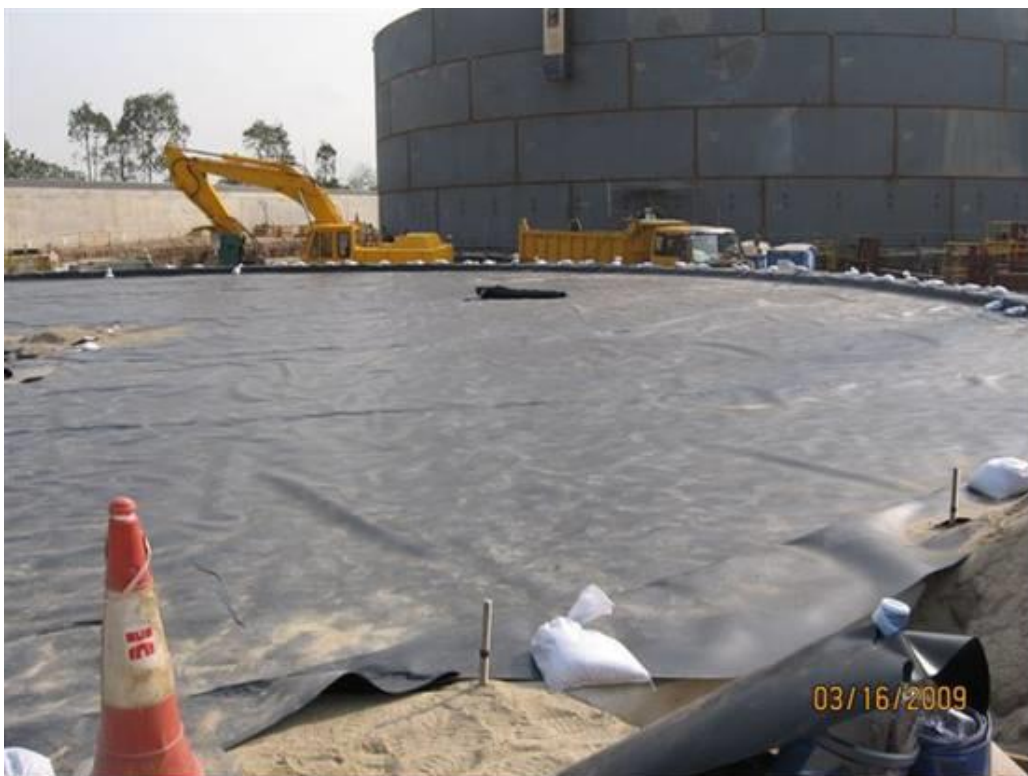
(22) Record photo shows impervious membrane being installed on top of tank foundation

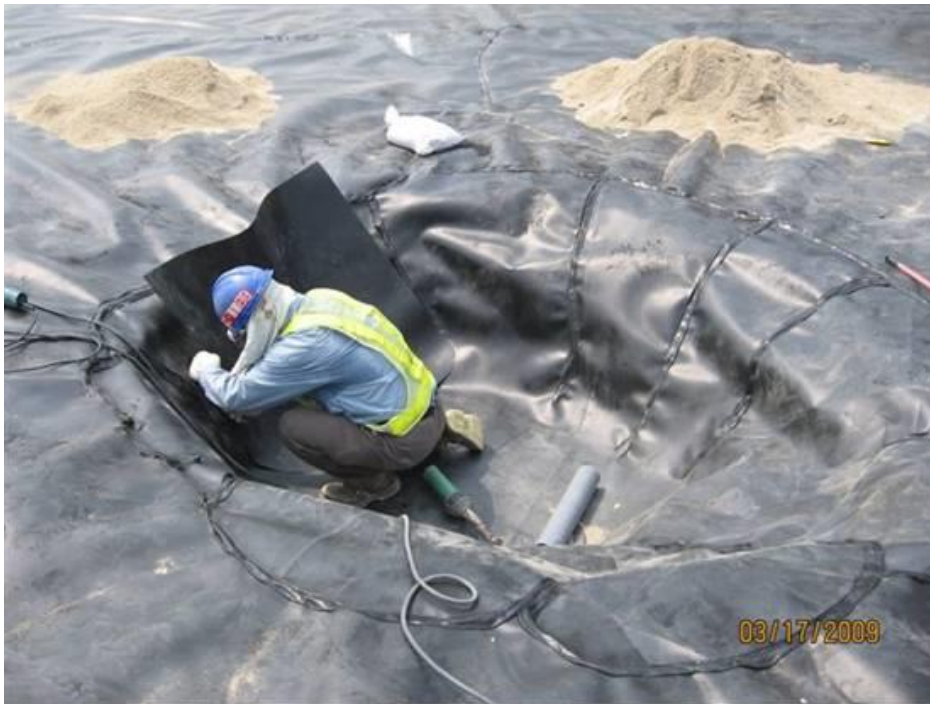
(23) Record photo shows imperious membrane laid at tank center sump with tell-tale pipe embedded for leak detection

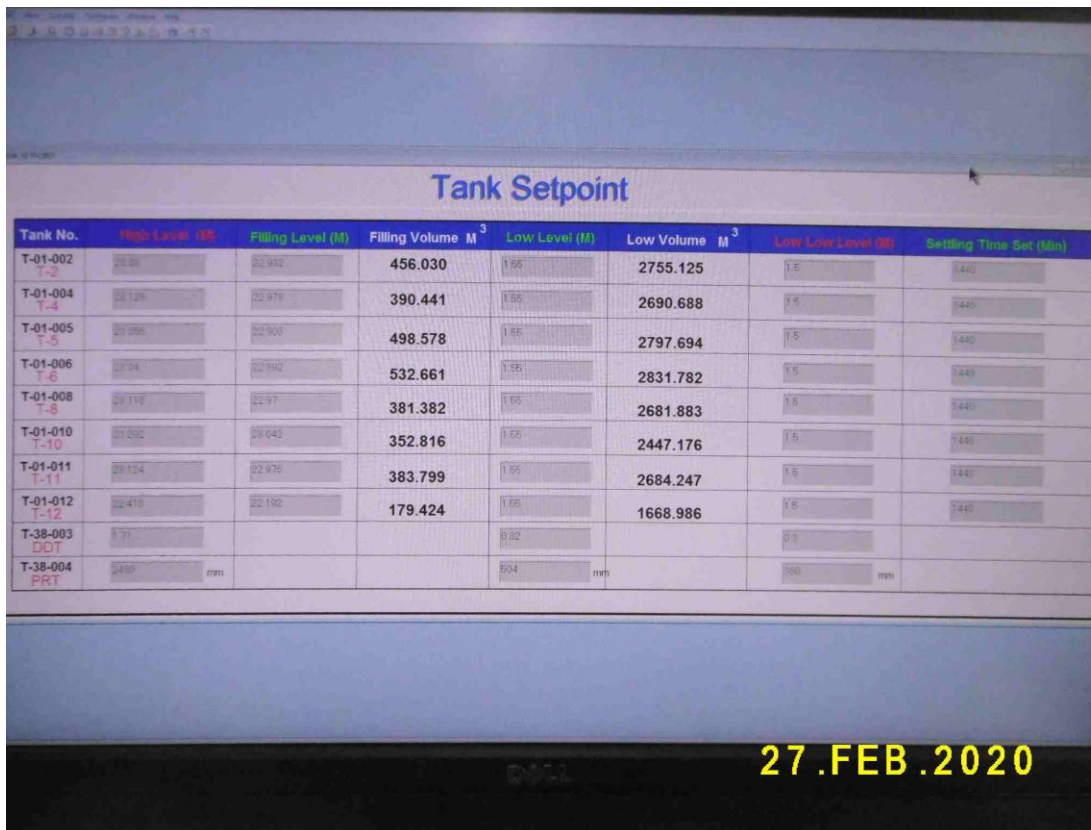
(24) High Level Alarm being set in the SCADA System

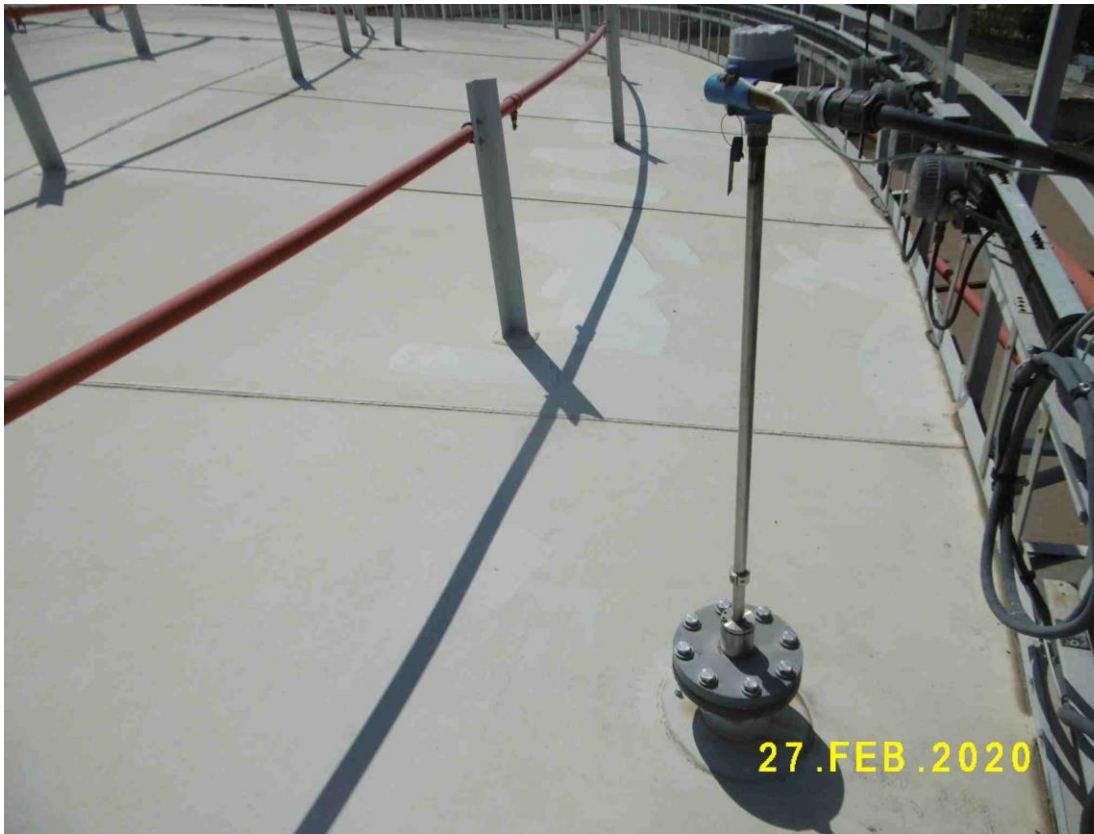
(25) Regular inspection performed on overfilling monitoring device (High-High Level Alarm)

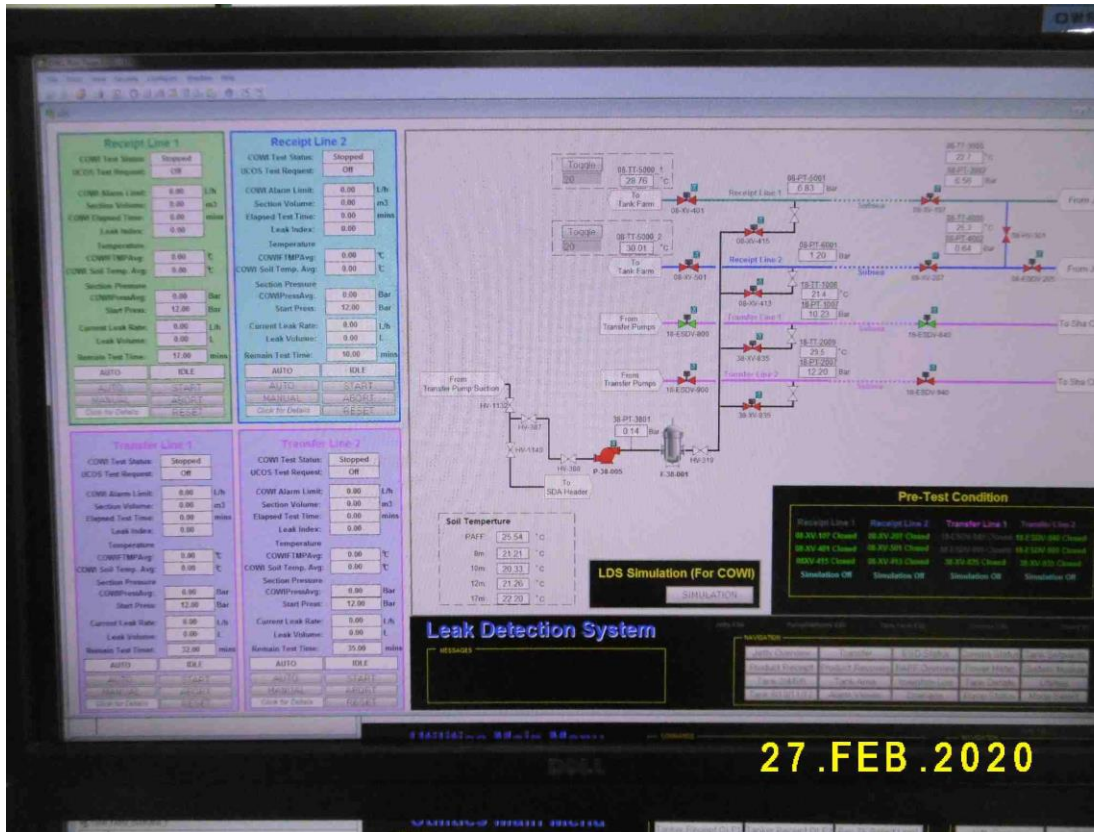
(27) Leak detection “COWI Stat Leak System” installed into computer
