ANNUAL AUDIT REPORT
For
PERMANENT AVIATION FUEL FACILITY
Environmental Permit
EP-262/2007/B

Date of Audit :		27 February to 20 March 2020
Prepared By :	Michael Chung, Senior Engineer <i>mchung</i>	20 March 2020
Reviewed By :	Eddie Kwan, Facility Manager <i>Eddie Kwan</i>	20 March 2020
Approved By :	Tommy Siu, General Manager <i>Tommy Siu</i>	20 March 2020

ECO Aviation Fuel Services Limited (EAFS) is the operator of the Permanent Aviation Fuel Facility (PAFF), which is located on 9.28 ha of land at 9 Lung Hong Street, Tap Shek Kok, Tuen Mun. PAFF consists of a tank farm, a twin berth jetty and associated pipelines for receipt of aviation fuel from ocean tankers to the tank farm, and twin submarine pipelines from the tank farm to the aviation fuel receipt facility at Sha Chau Island.

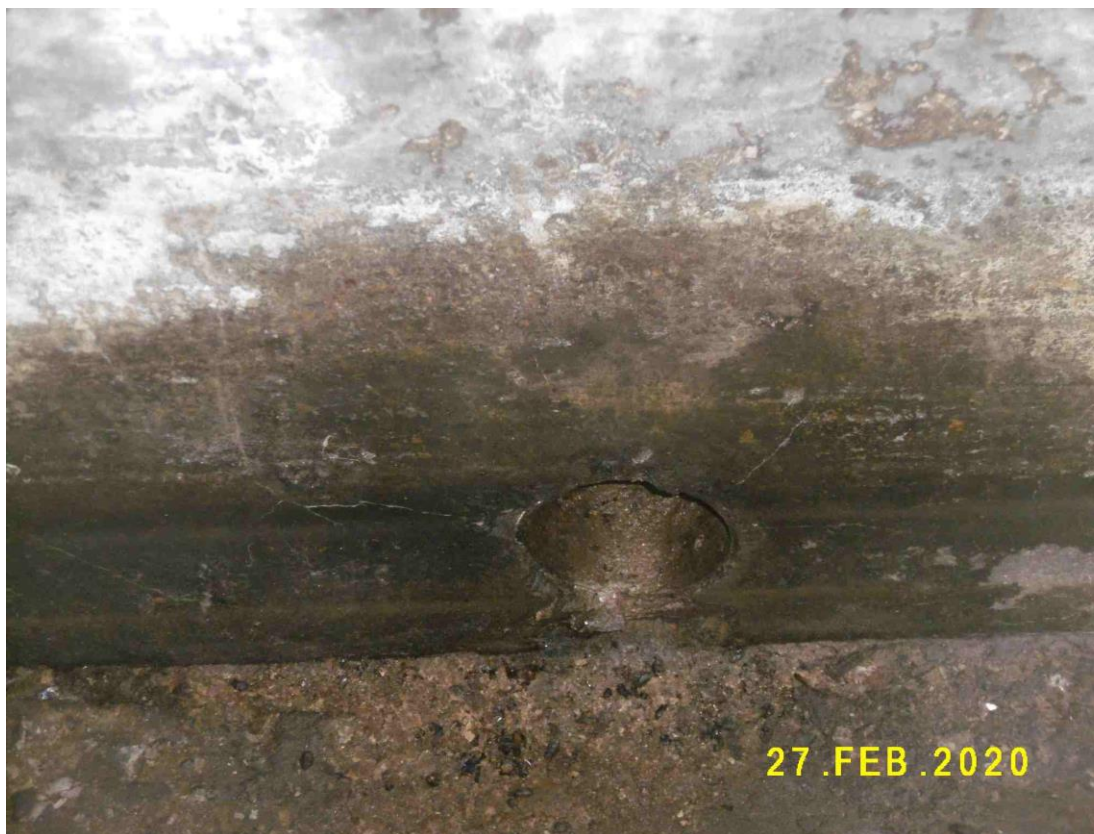
(28) Leak detection tell-tale pipe underneath the storage tank opens out to a collection chamber

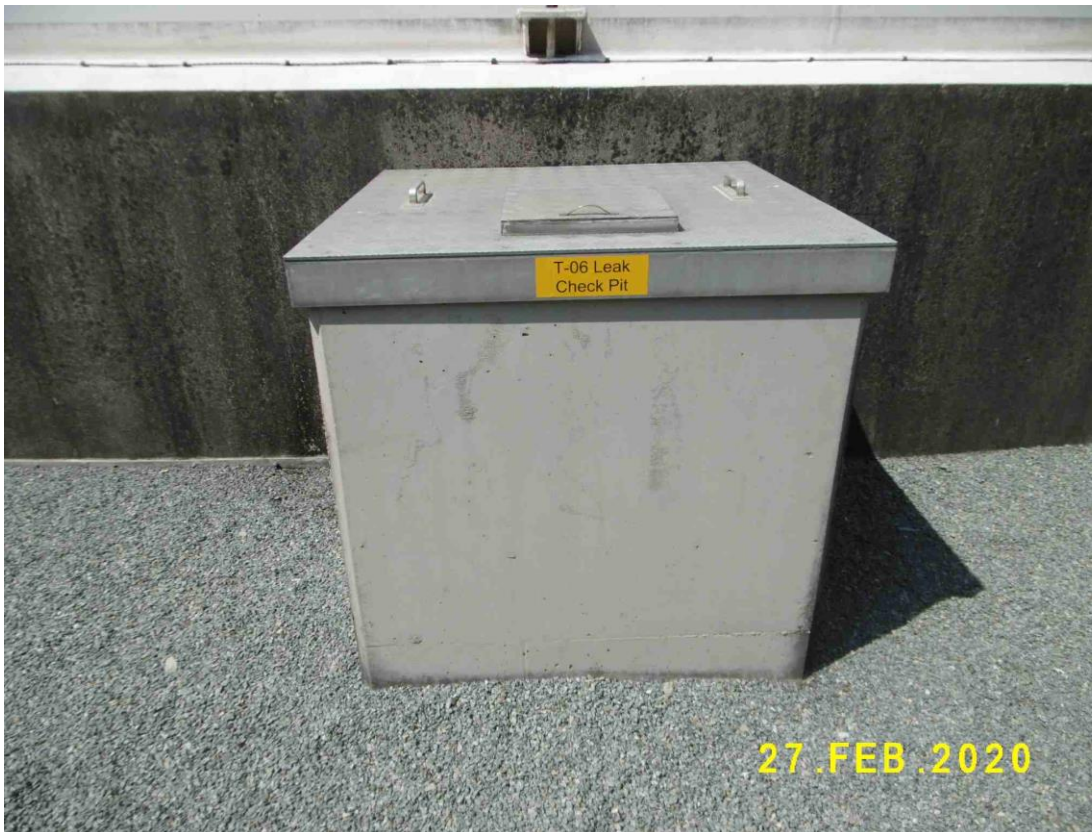
(29) Collection chamber located adjacent to tank foundation is maintained in good condition with periodic inspection

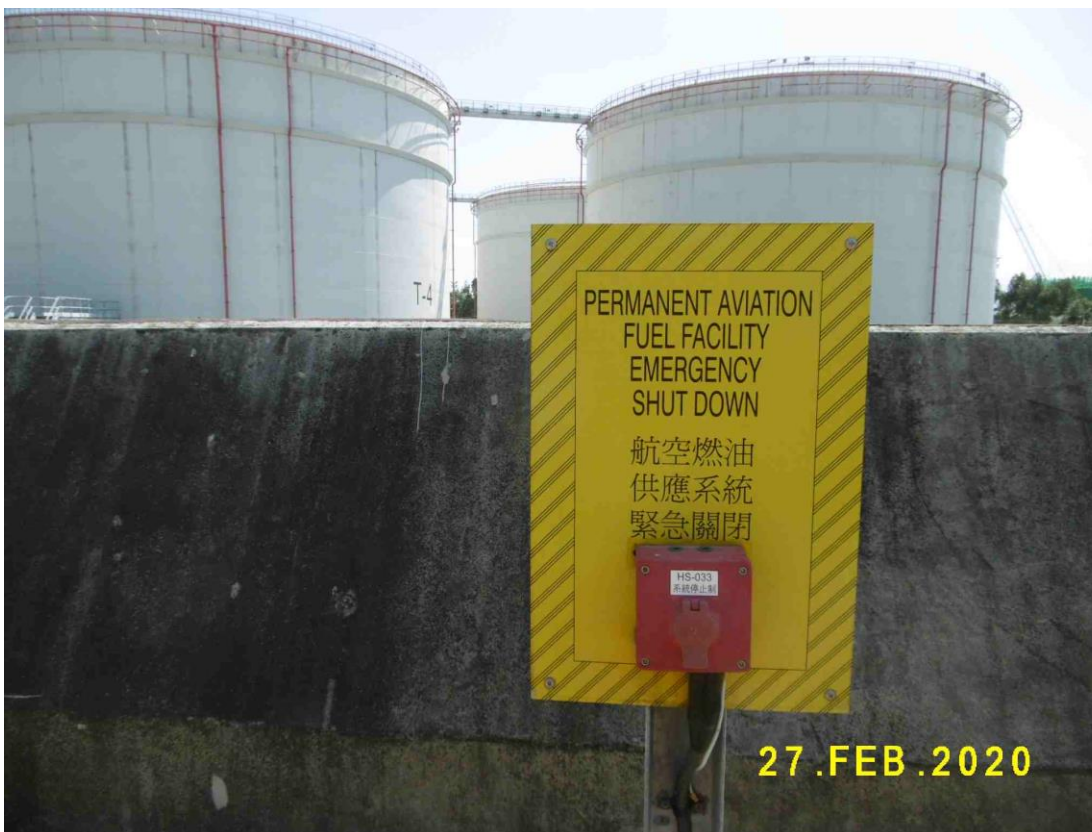
(30) ESD device is maintained in good condition and being tested periodically

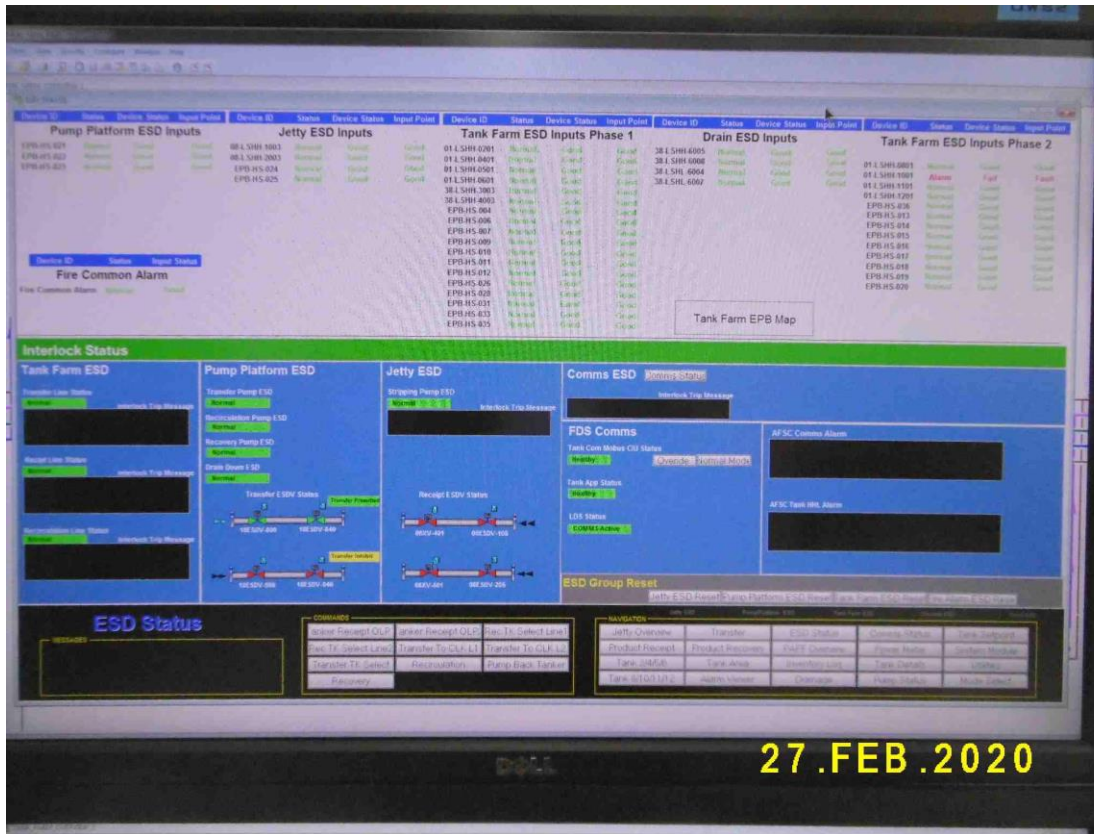
(31) The ESD regular testing as shown in SCADA System

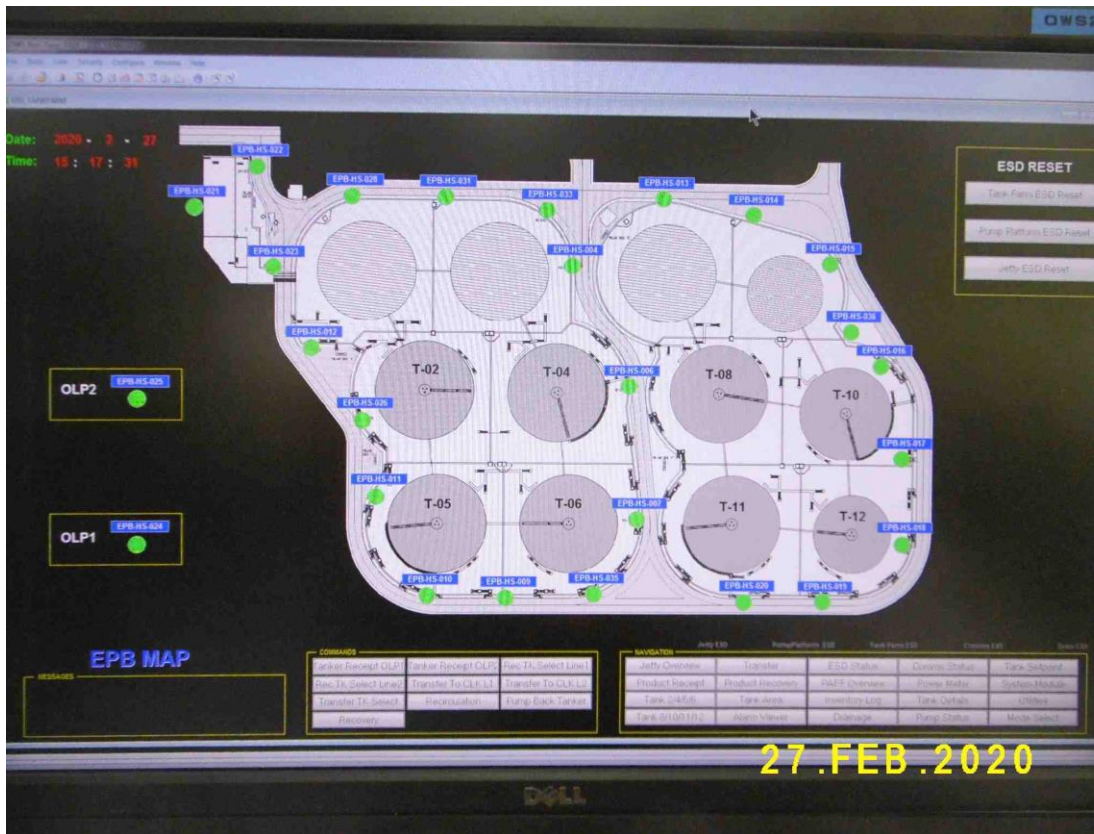
(32) The ESD regular testing as shown in SCADA System

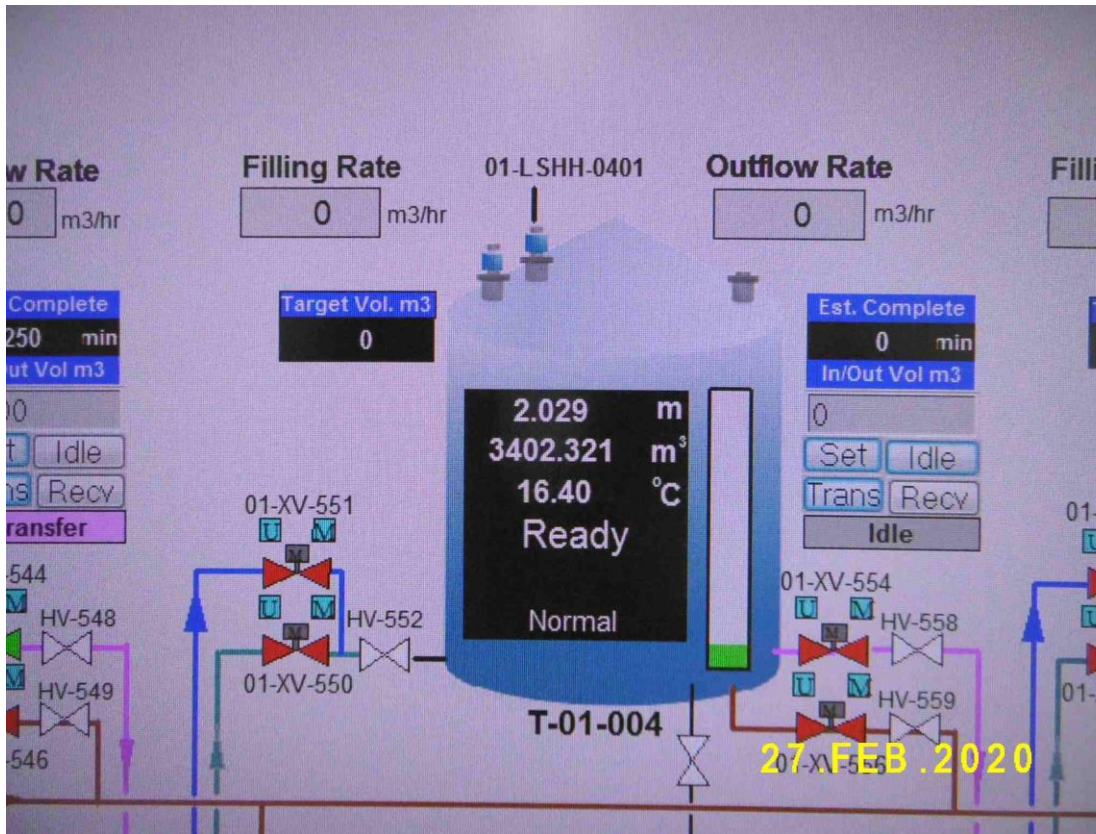
(33) The ESD test signal as shown in SCADA System

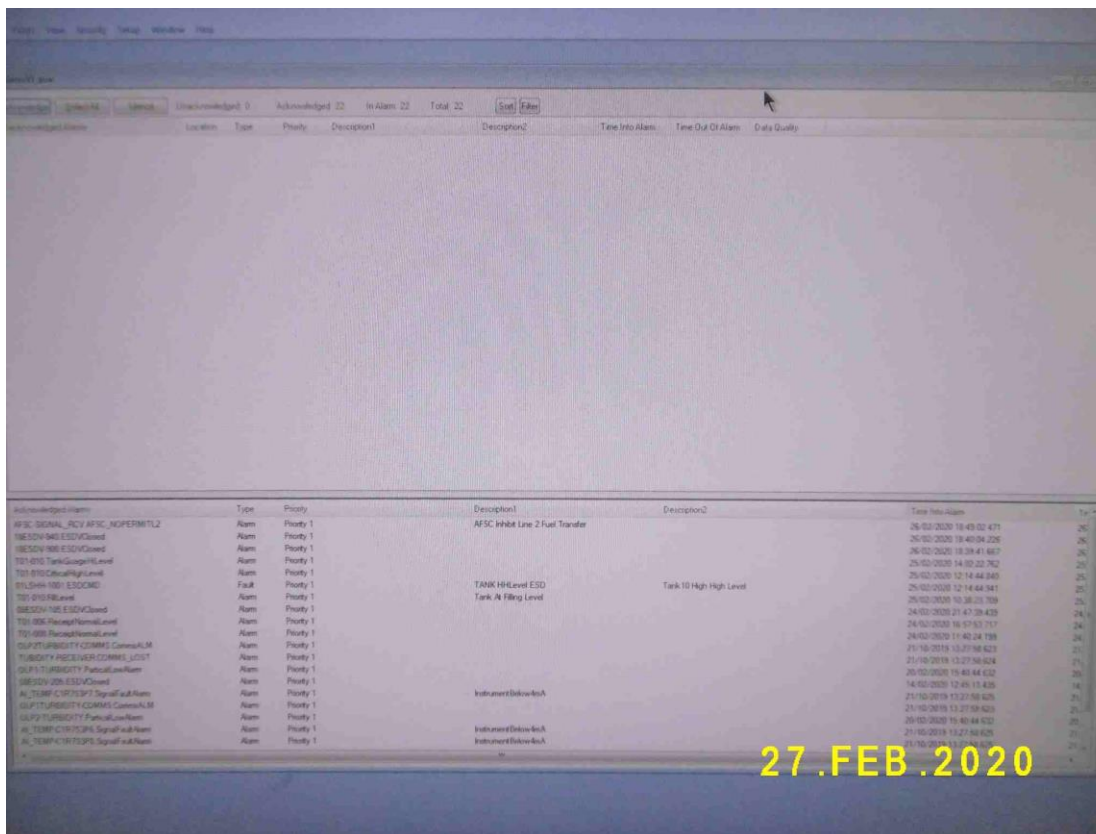
(34) Once the system received ESD test signal, the valves will be closed automatically and shut down the operation as shown in SCADA System

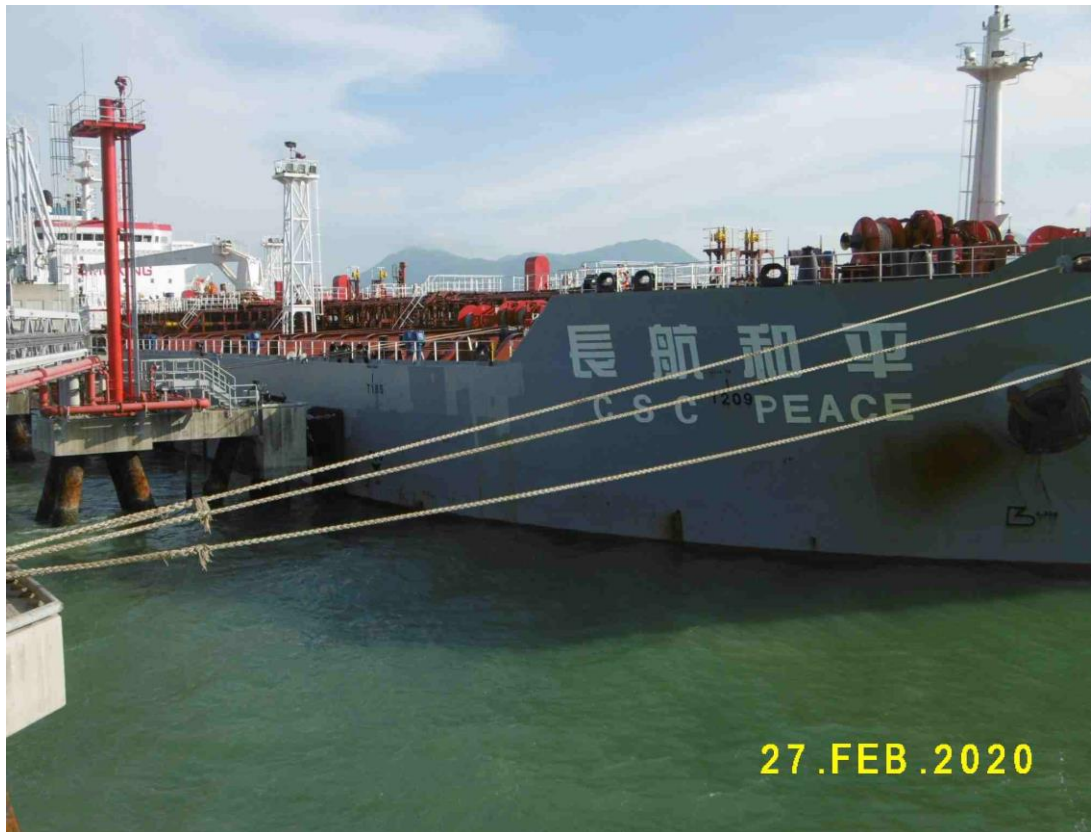
(36) Fenders are installed at sea side of the jetty

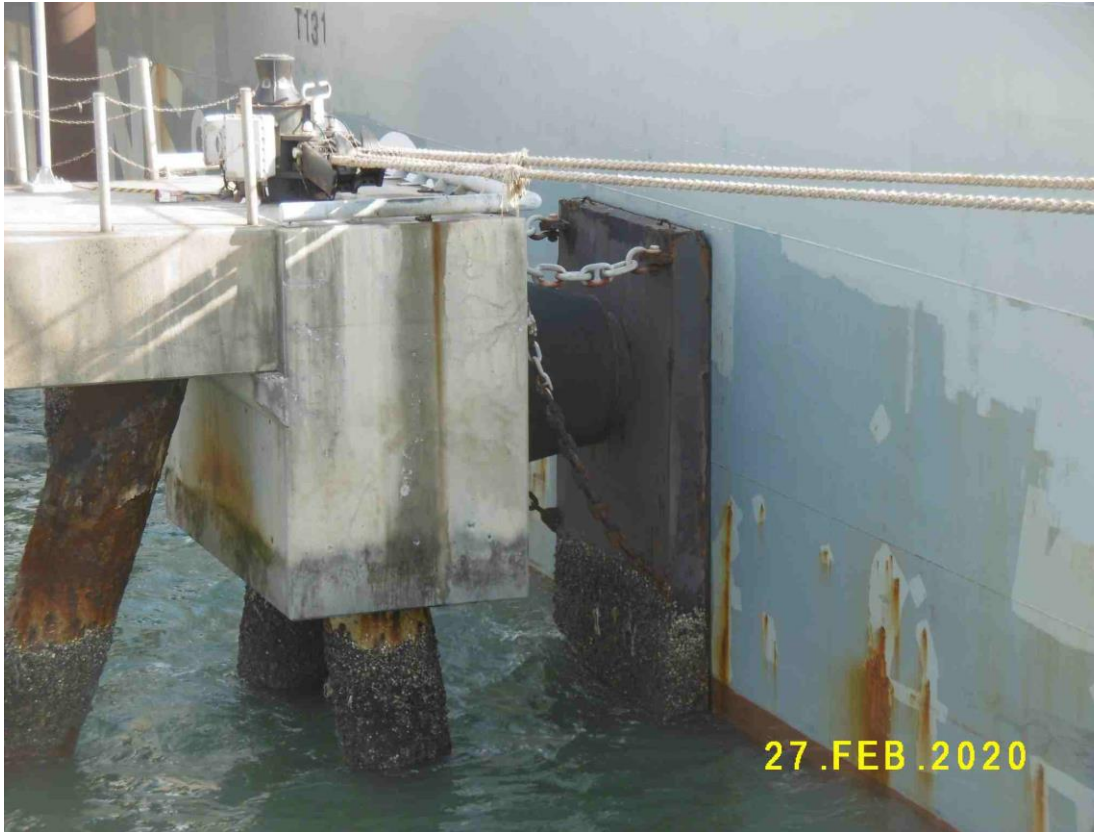
(37) Fenders are installed at sea side of the jetty

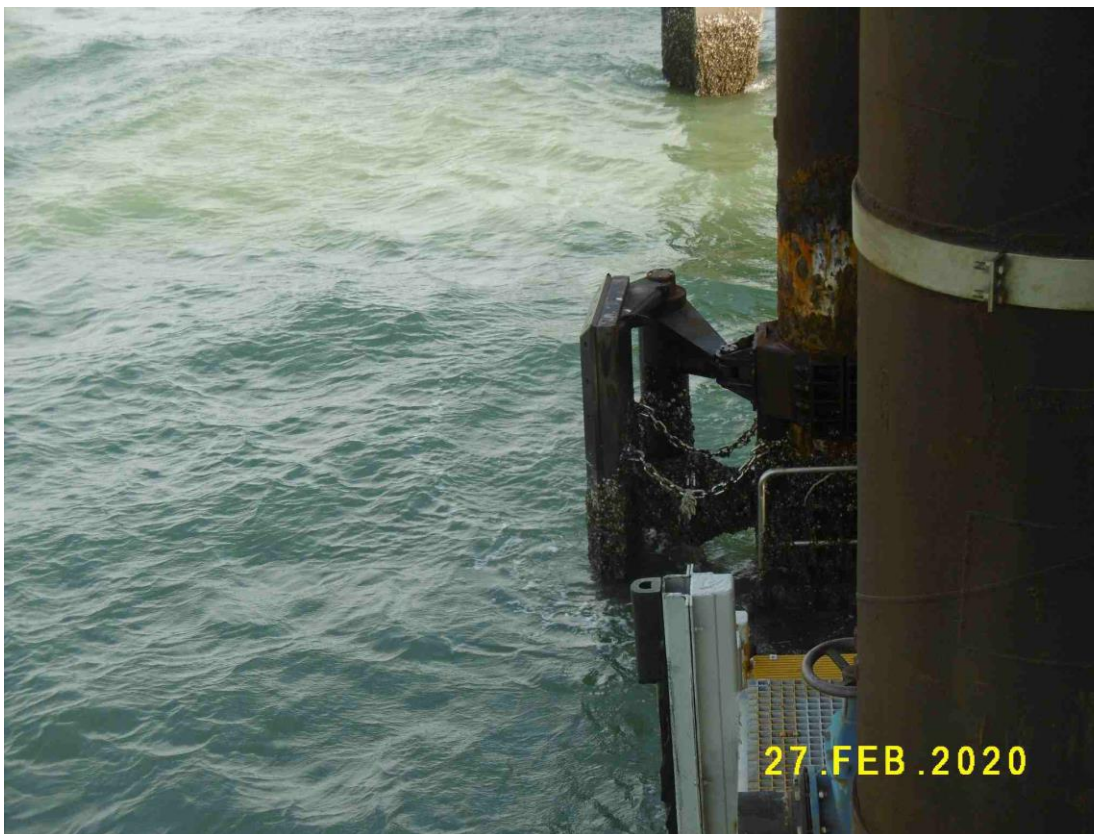
(38) Fenders are installed at shore side of the jetty

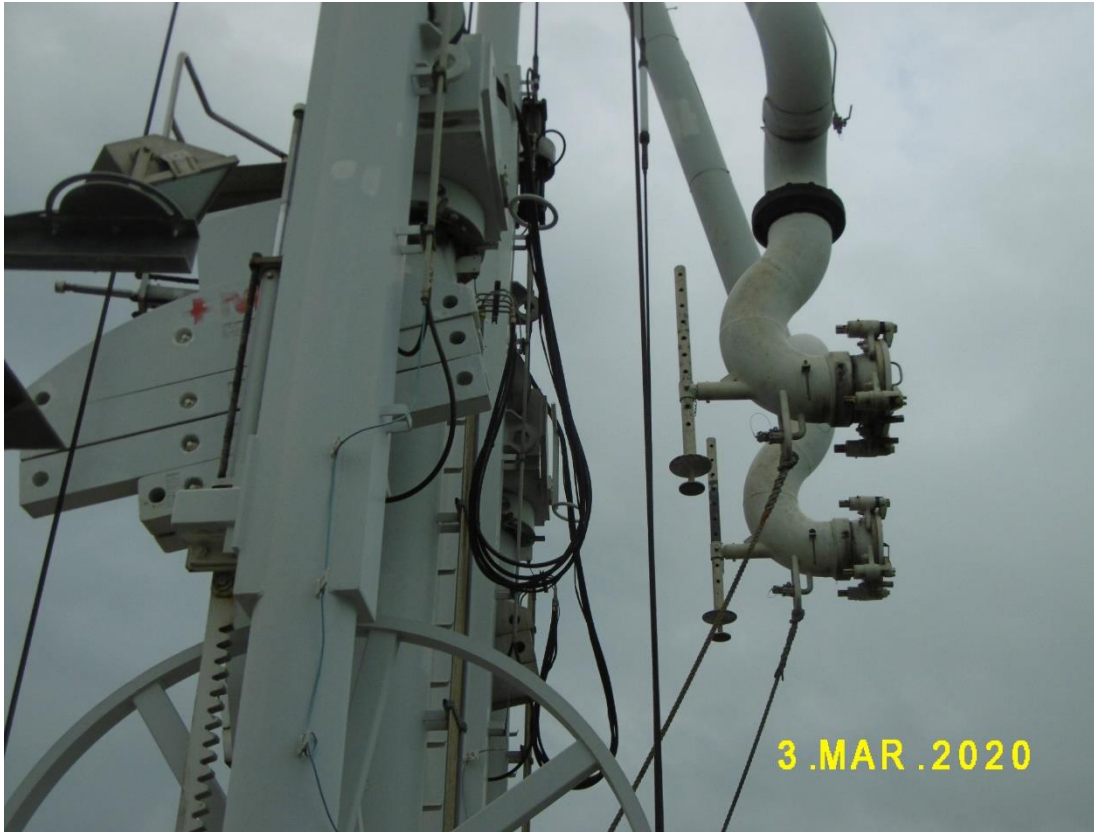
(39) Slop collection utilities are used for coupling and de-coupling of the loading arms
