Permanent Aviation Fuel Facility (EP-262/2007/B)

Fourth Landscape & Visual Bi-Monthly Audit Report – Nov 2010

6 December 2010

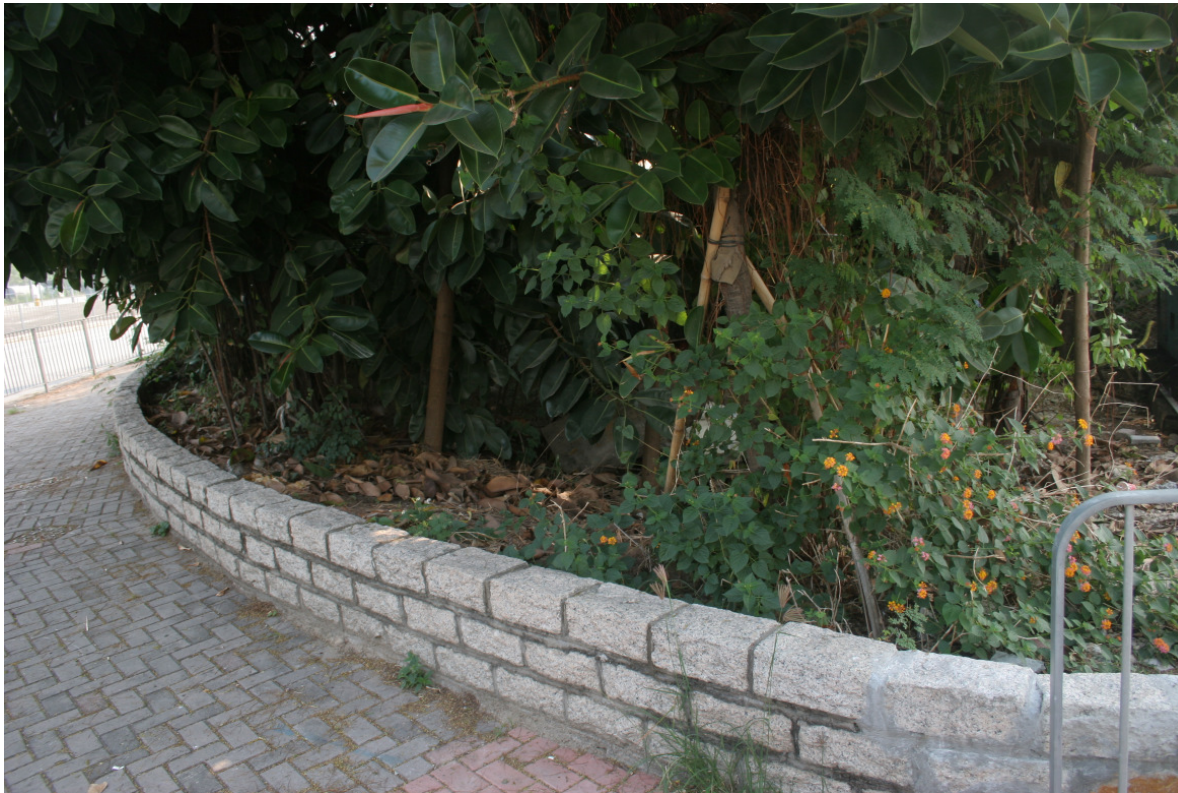
Photo 1– Stockpile of construction material observed in last inspection near Retained Trees T1 has been cleared.

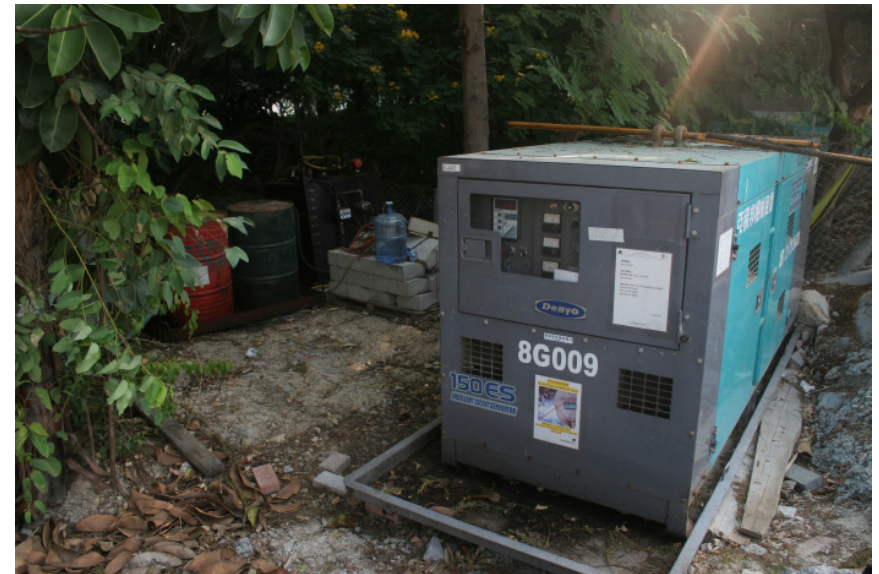
- A generator, material debris and several drums in drip trays observed near retained tree (T1) (refer to *Annex A*).

Photo 2 – Generator, material debris and drums in drip trays observed near retained tree T1

The Contractor was advised to check the location of the retained trees in this area according to the Landscape Plan and ensure generator, material debris and oil drums will not affect the nearby retained trees,, or relocate them if found harmful to the trees. Contractor was also advised to keep tree root zones clear to prevent tree damage.

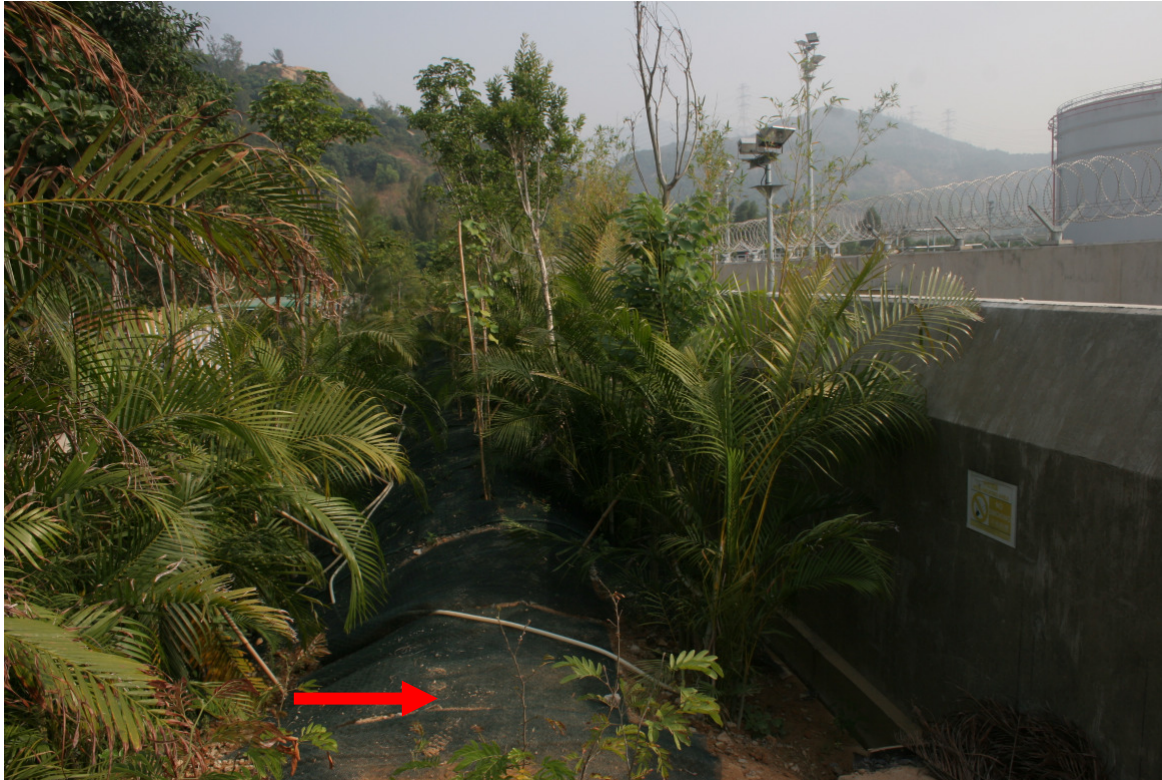
Photos 3 – Example of soil erosion control matt.

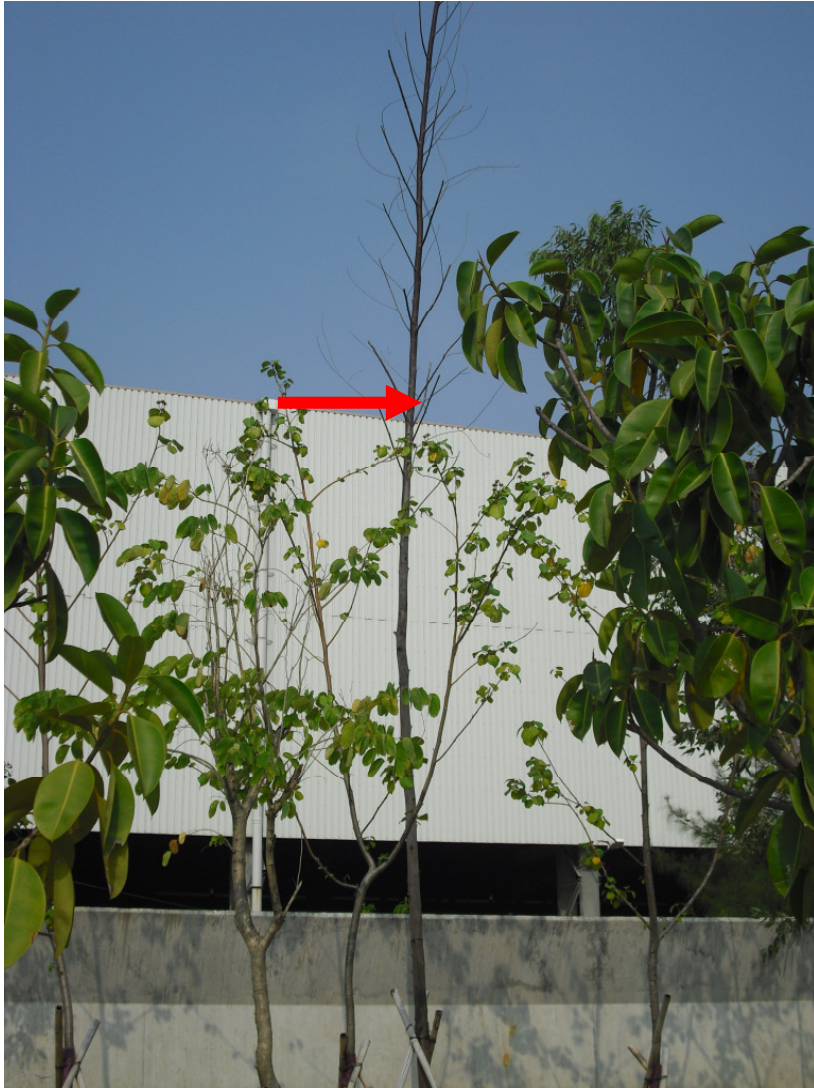
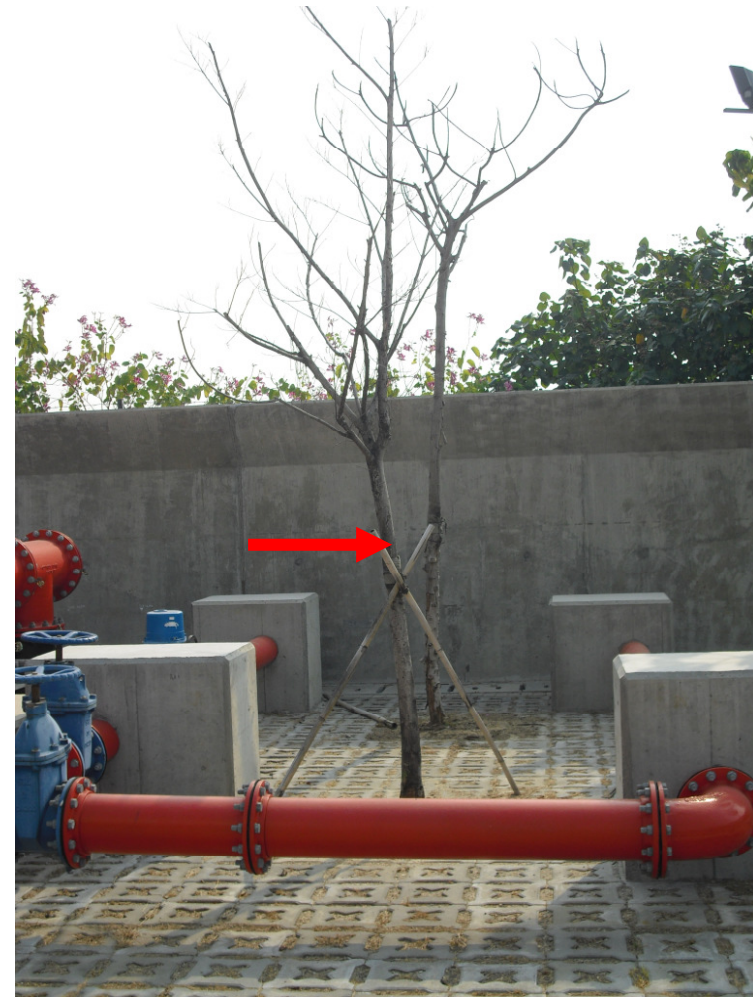
Establishment Works	Monitoring of implementation of maintenance operations during Establishment Period	The health condition of some trees in the Operations Building area of Phase 1a has not been improved since last site visit (Photo 4-5). Some trees outside the boundary wall were in poor health and slightly damaged (Photo 6-7), (Figure 1).	Contractor is recommended to review health of all compensatory and retained trees, replace any trees if confirmed dead and take appropriate action to restore the condition of the damaged trees.

Photos 4 & 5 – Examples of trees in the Operations Buildings area of Phase 1a, observed to be in poor health (similar to previous inspection).

The Contractor was recommended to review the health of all compensatory and retained trees, replace any trees if confirmed dead and take appropriate action to improve the condition of all trees in poor condition.

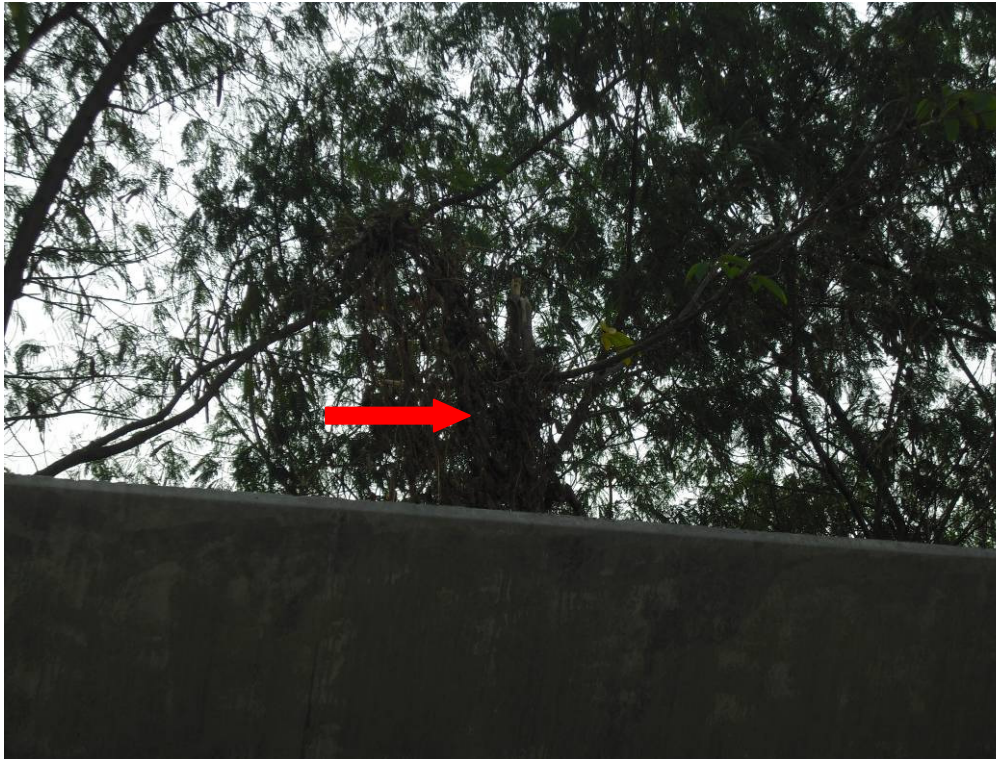
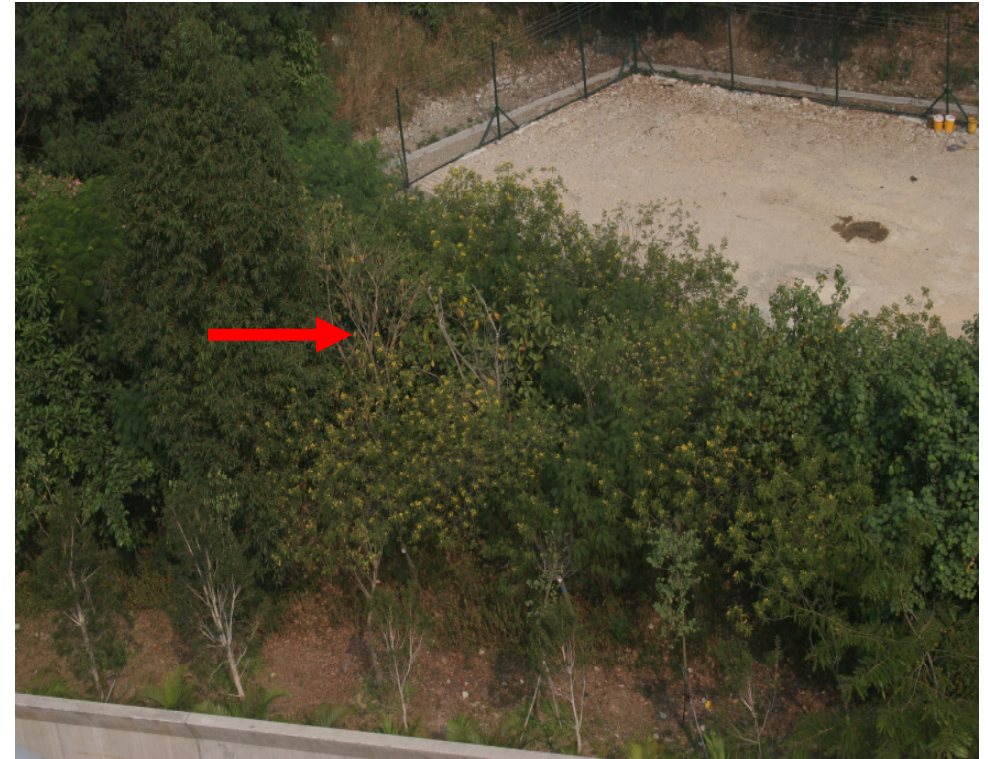
Photos 6 & 7 – Examples of trees outside boundary wall of Phase 1a and 1b observed to be in poor health.

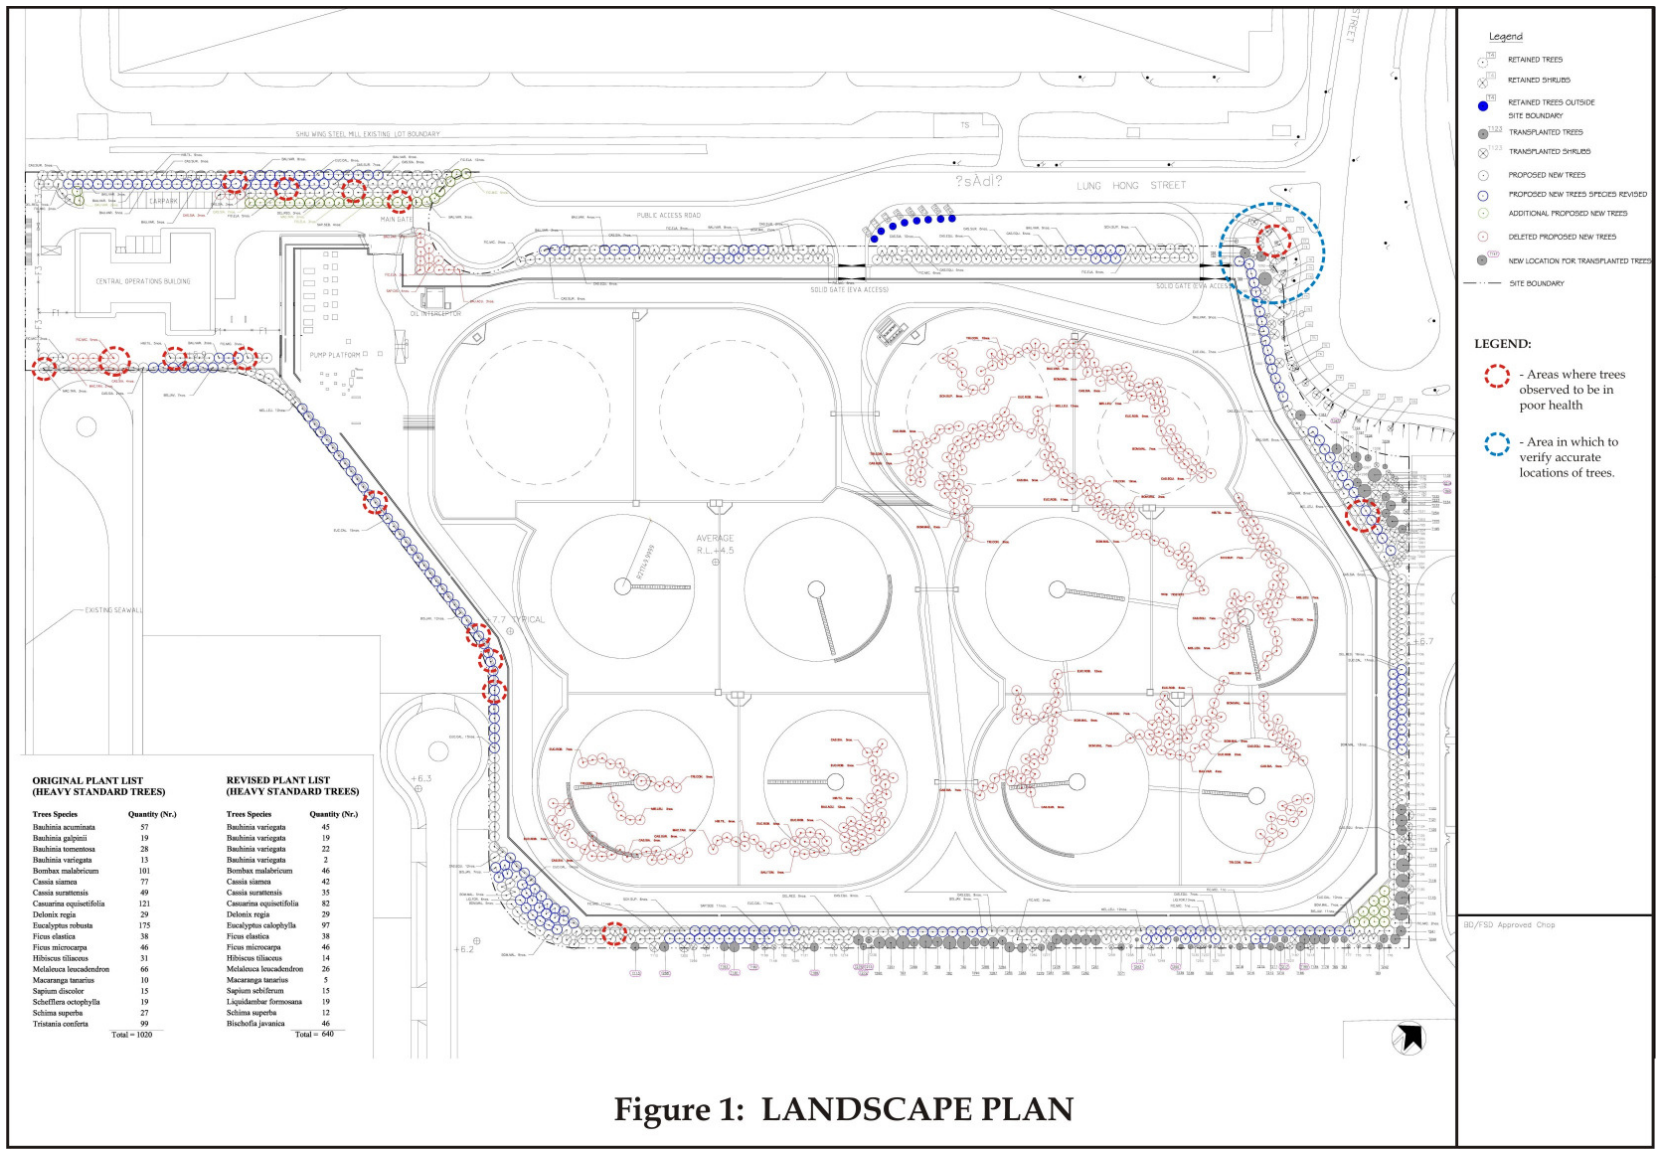
Figure 1: LANDSCAPE PLAN

- Some trees around the site were observed to be in poor health (refer to *Annex A, Figure 1*) and had not been improved since the previous inspection.

Figure 1 – Location of trees in poor health and area in which to verify accurate locations of trees
