ECO Aviation Fuel Services Limited

**ANNUAL AUDIT REPORT**  
**For**  
**PERMANENT AVIATION FUEL FACILITY**  
**Environmental Permit**  
**EP-262/2007/B**

Date of Audit :		27 February to 19 March 2021
Prepared By :	Michael Chung, Technical Manager	19 March 2021
Reviewed By :	Sylvia Har, Facility Manager	23 March 2021
Approved By :	Tommy Siu, General Manager	26 March 2021

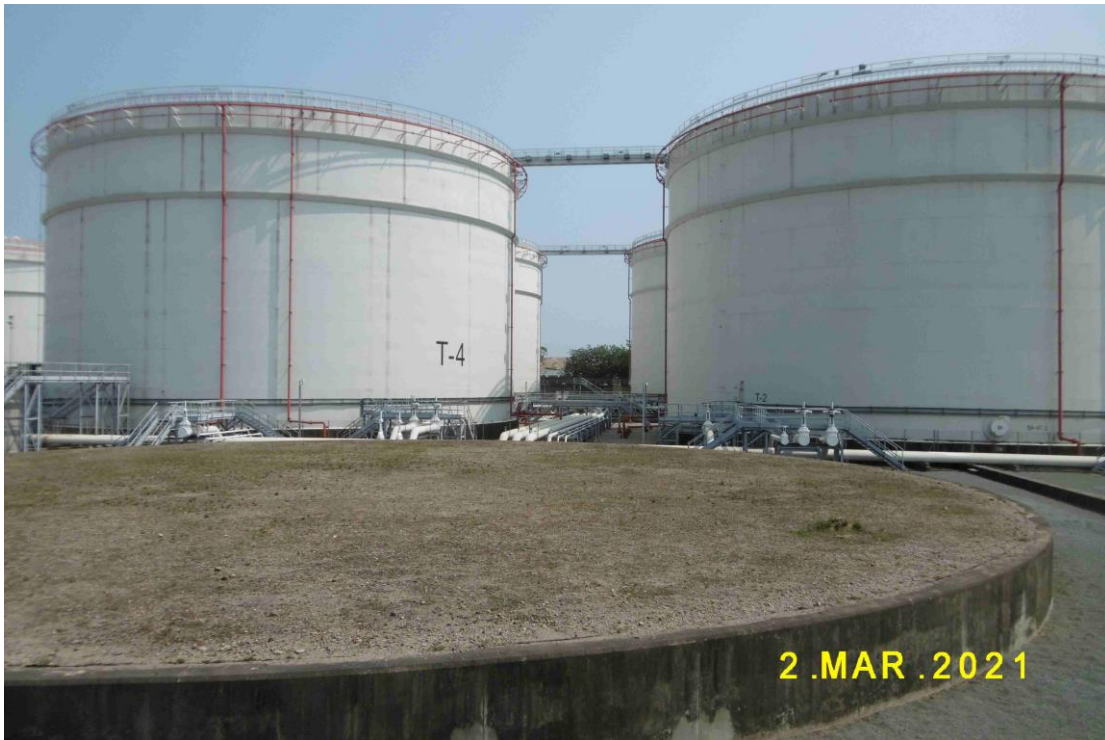
(1) Four tanks are located within bunded compound – Phase 1a

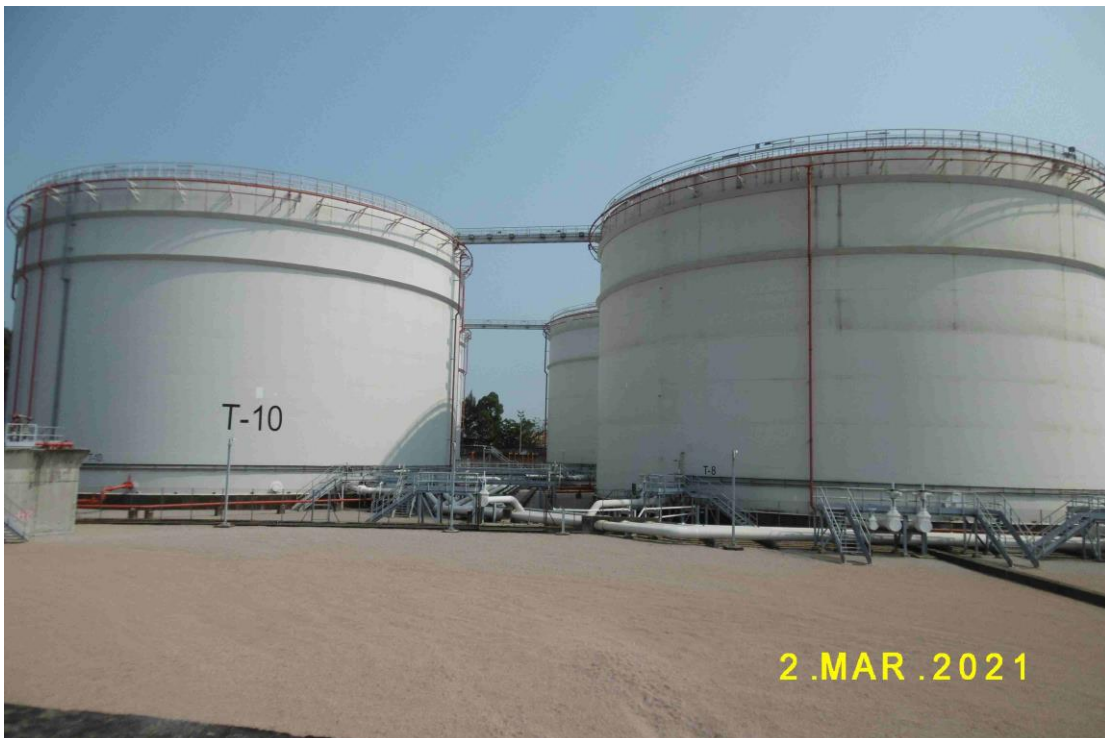
(2) Four tanks are located within bunded compound – Phase 1b

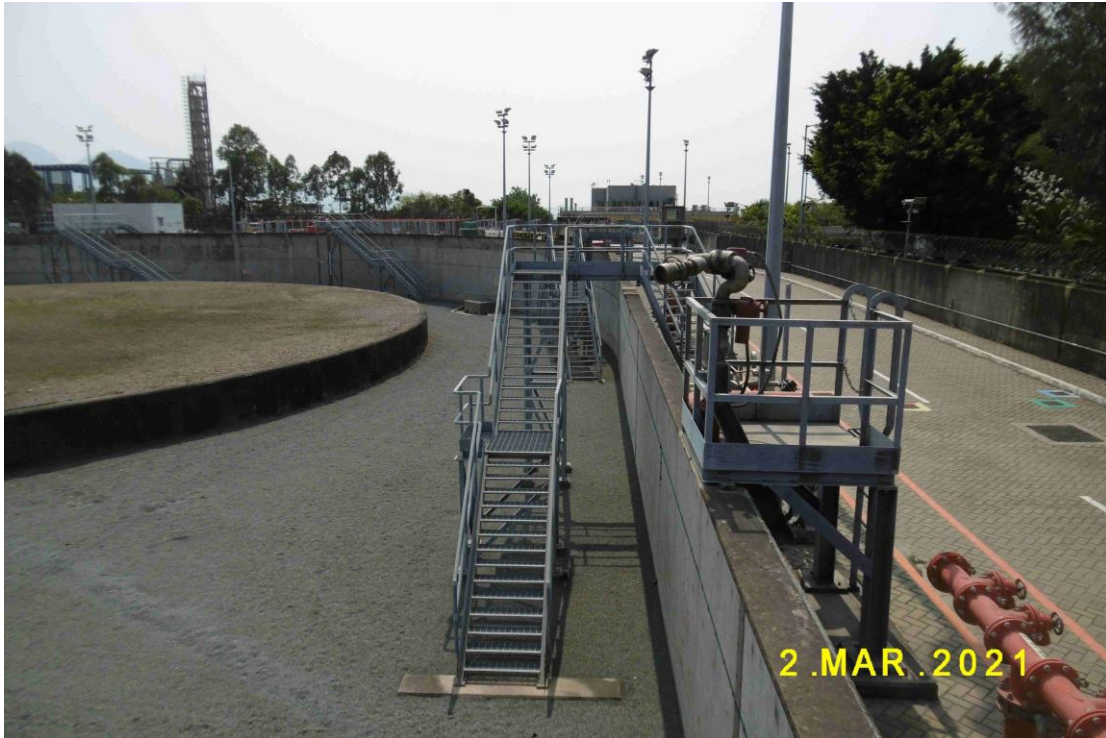
- (3) Phase 1a bunded compound is lower than the ground level outside the bunds

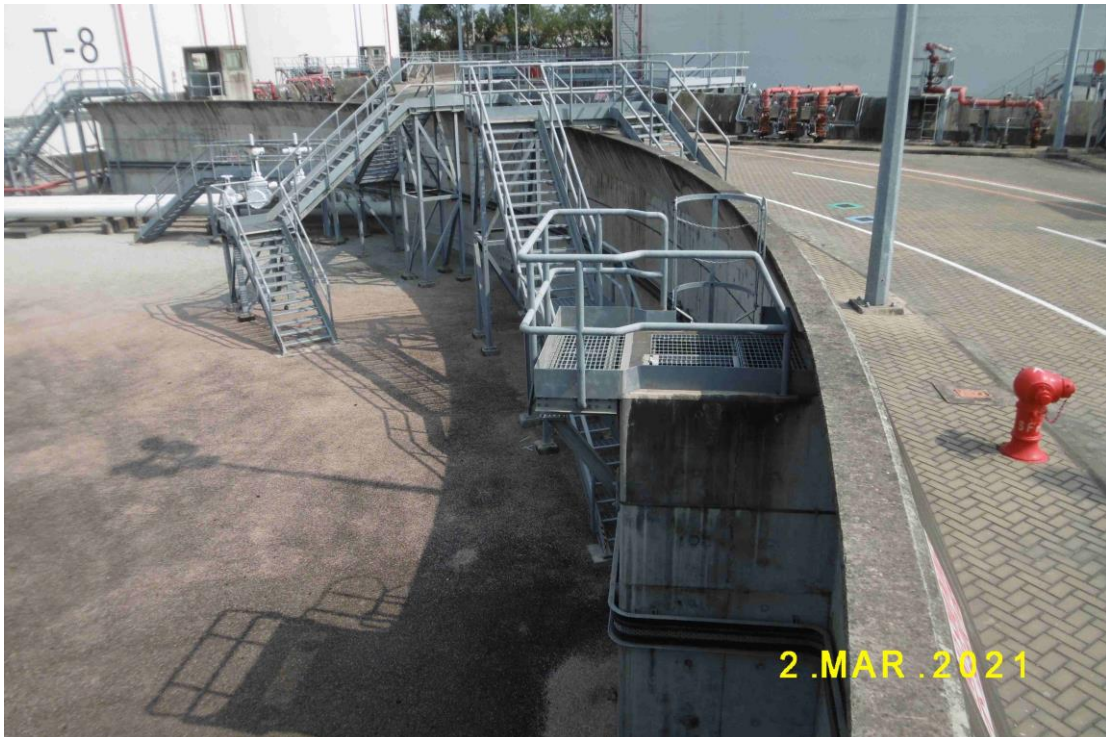
- (4) Phase 1b bunded compound is lower than the ground level outside the bunds

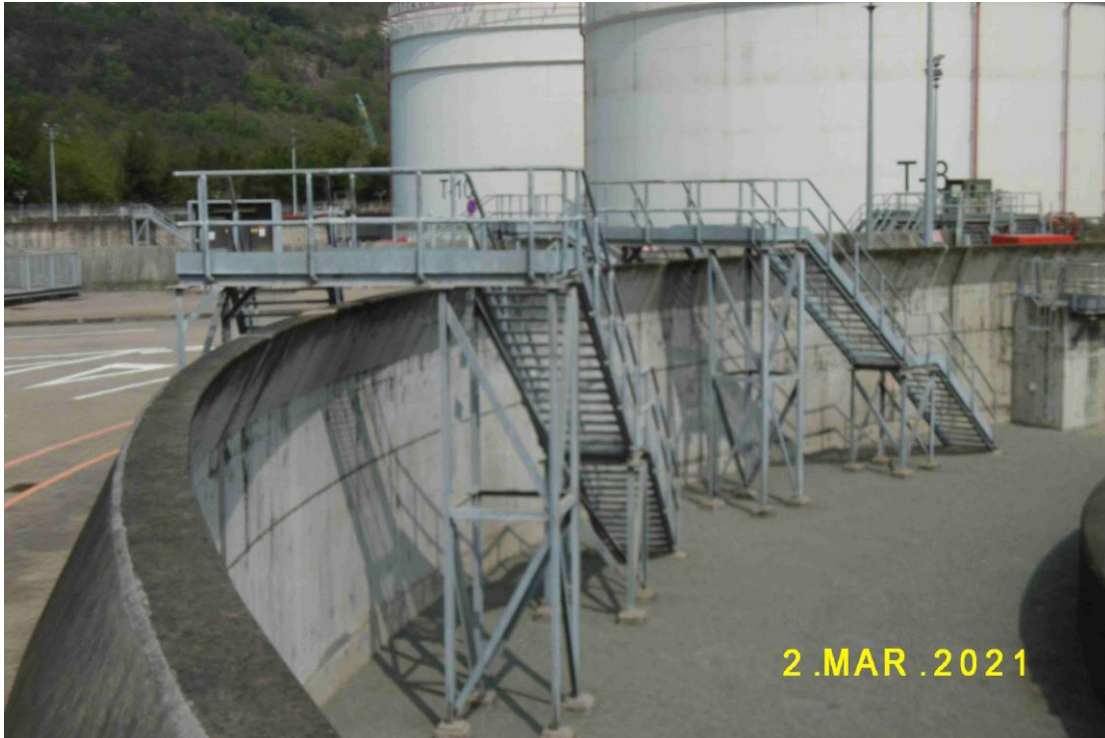
(5) Wave deflector is located at top of the bund

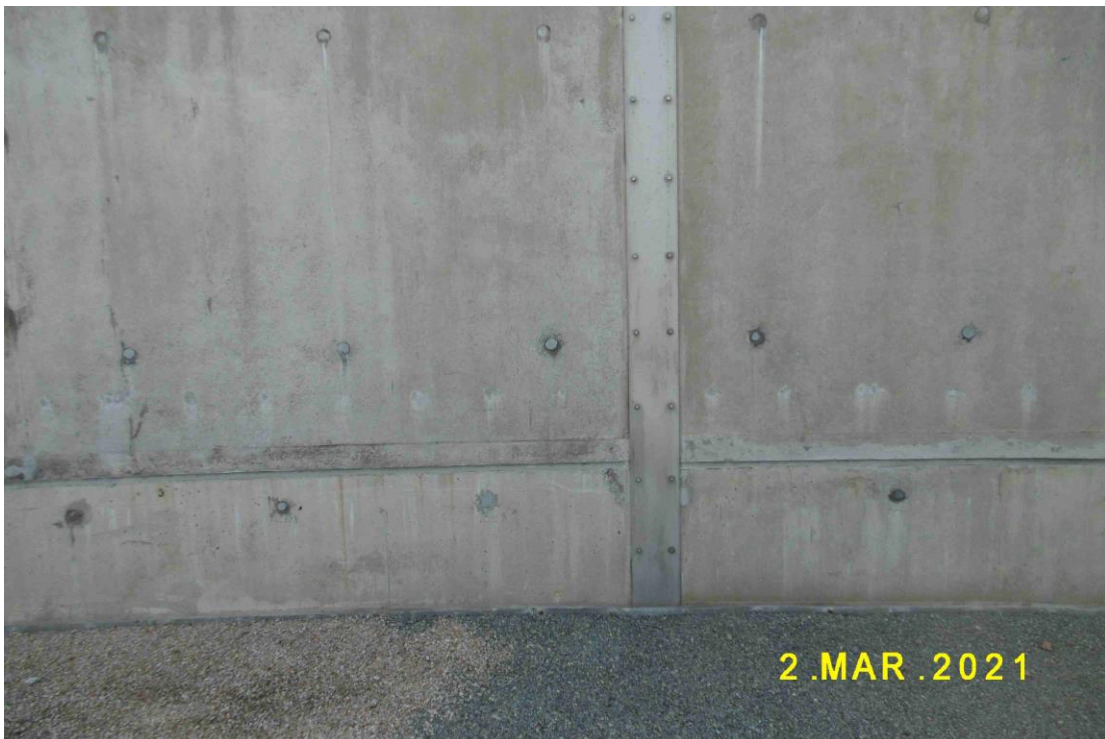
(6) Visible parts of the joints are covered by stainless steel plates on the inside at phase 1a bund

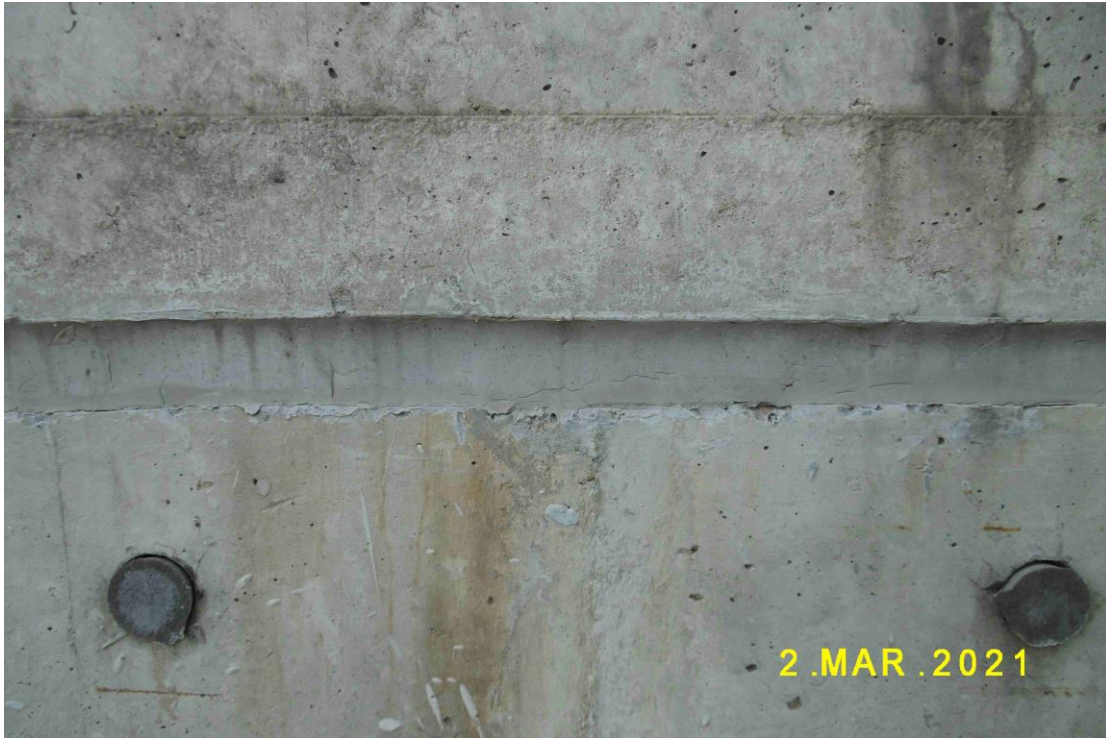
(7) Maintenance works have been performed on sealant at joints

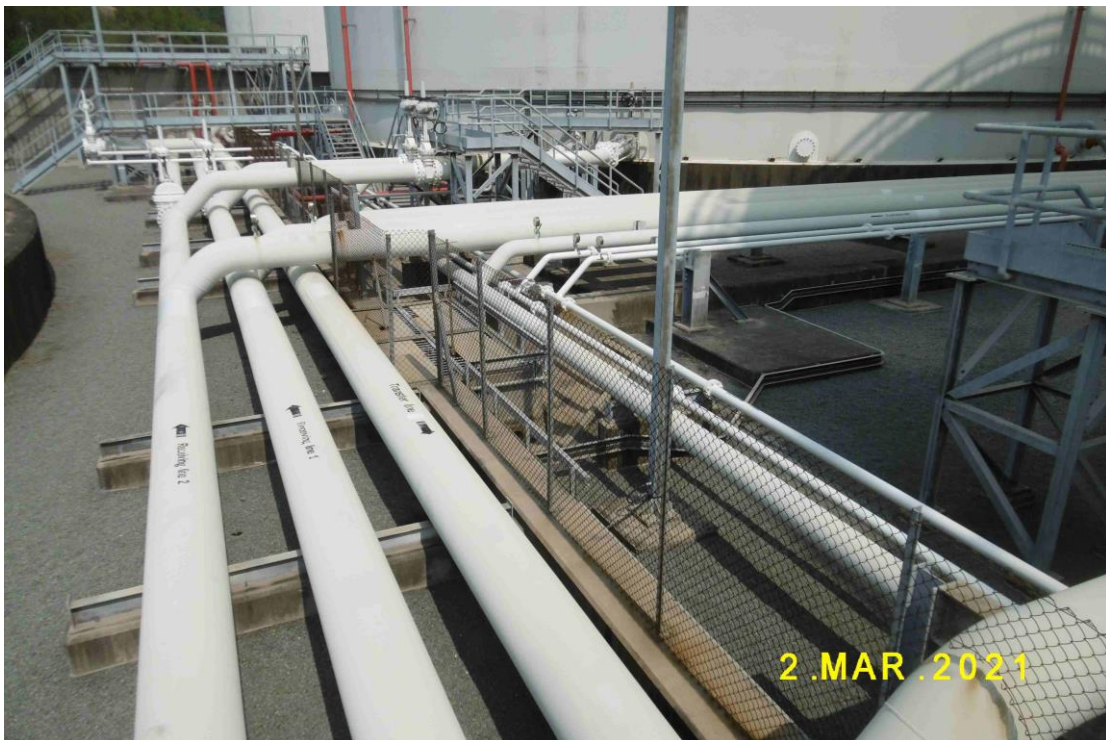
(8) Intermediate bund walls are provided in place near T-01-004

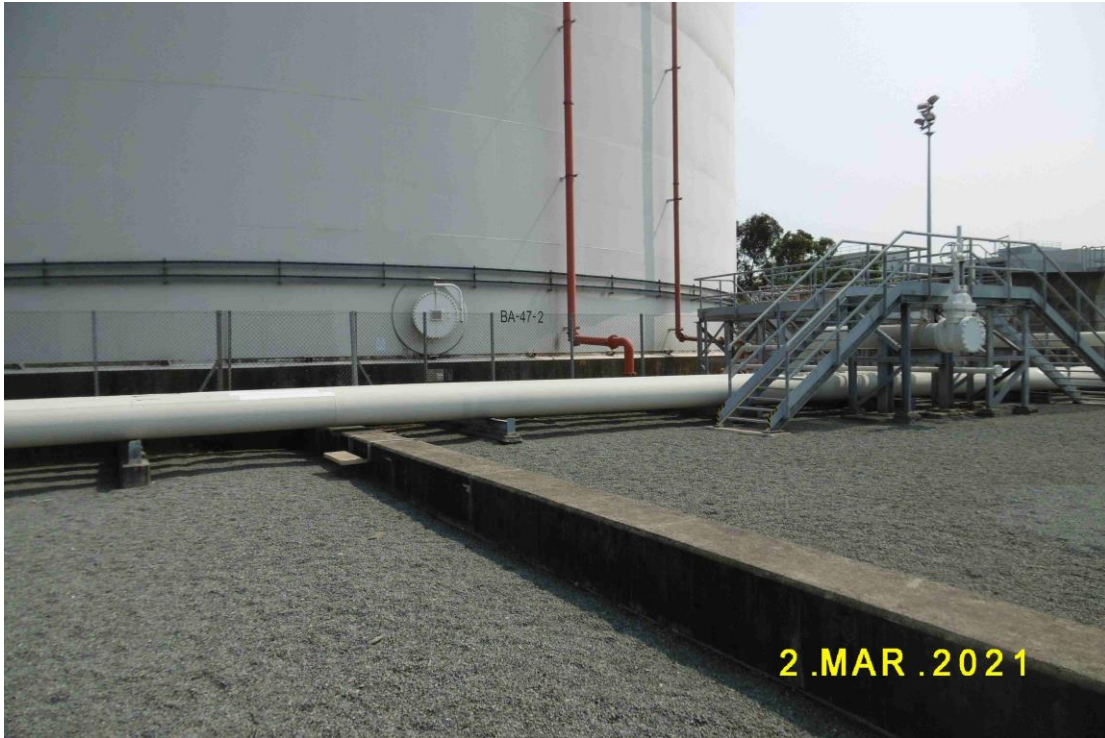
(9) Intermediate bund walls are provided in place near T-01-002

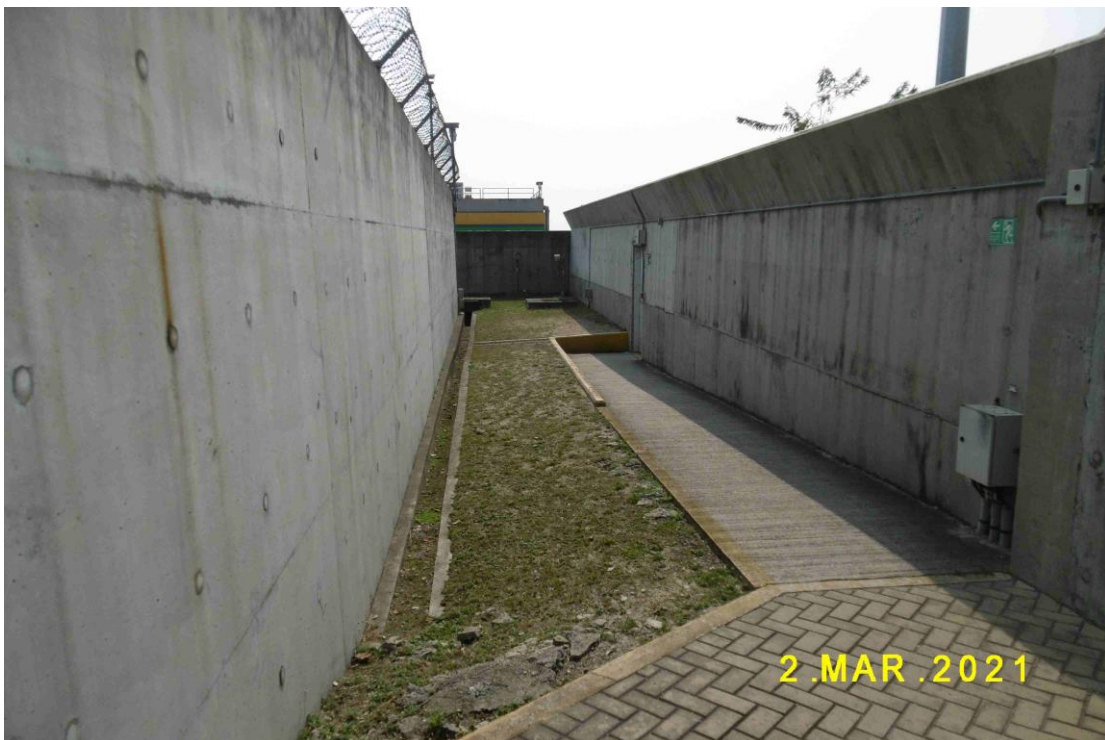
(10) Two impervious security walls are provided outside the bunded compounds

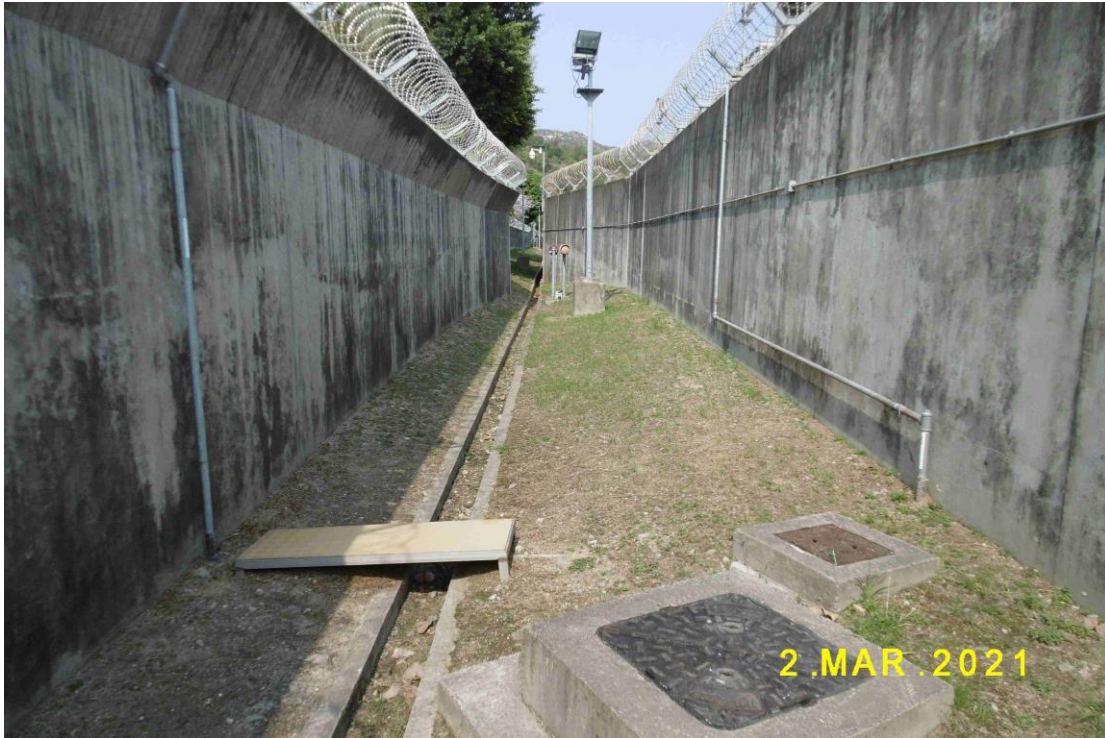
(11) Two impervious security walls are provided outside the bunded compounds

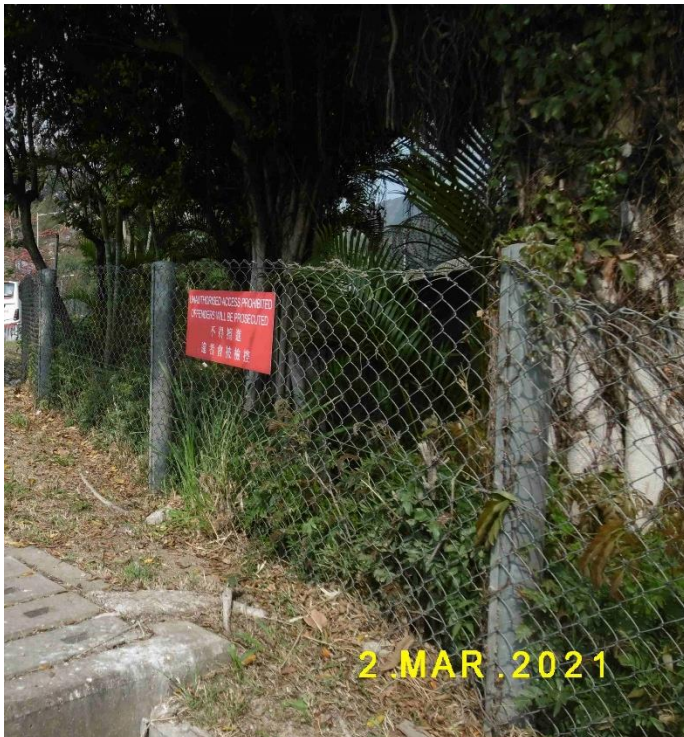
(12) Landscaped berm is maintained at least 1.5m high

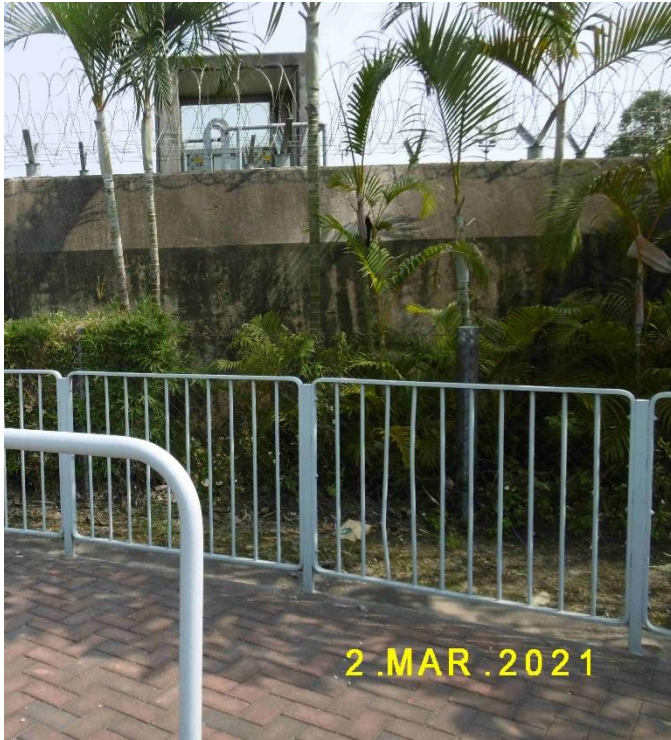
(13) Landscaped berm is maintained at least 1.5m high

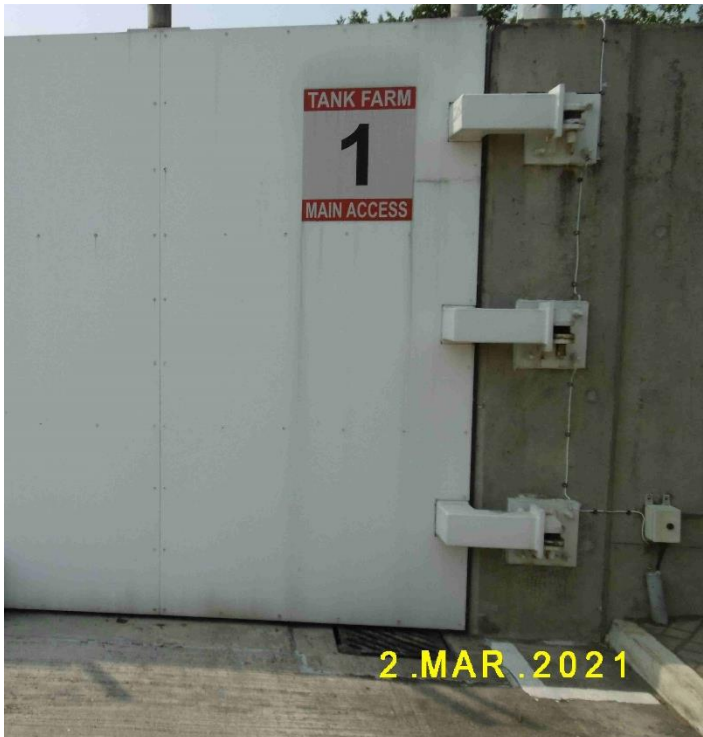
(14) Gates at security walls with sealant are maintained in good condition

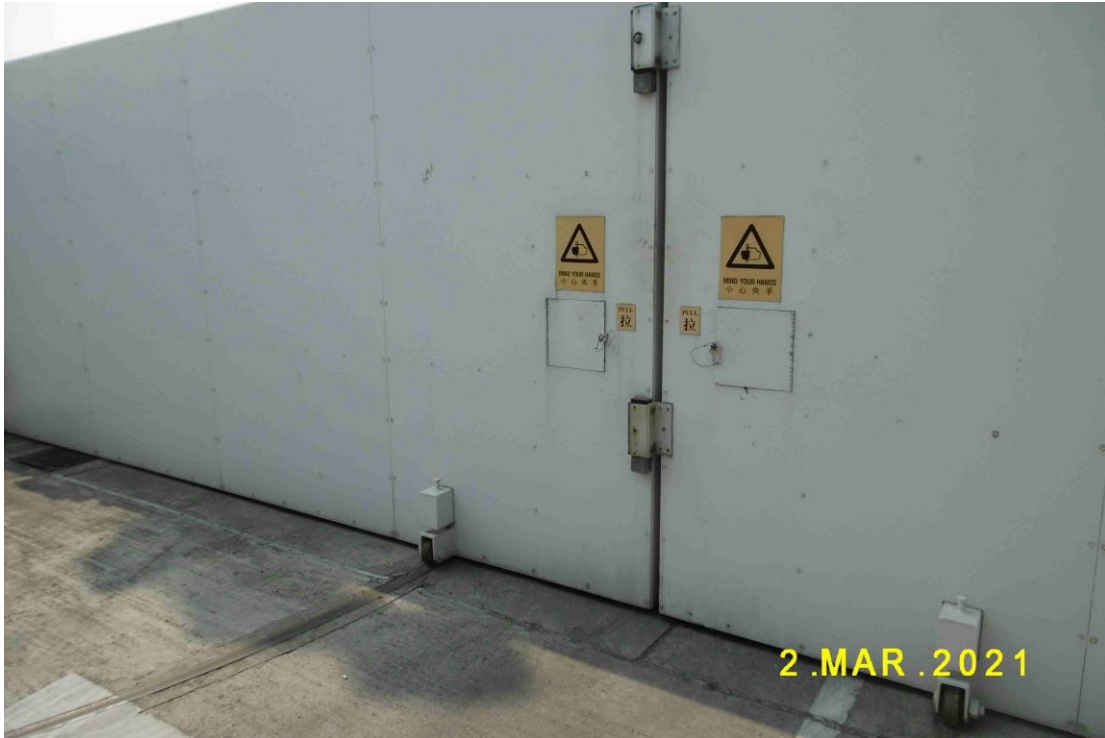
(15) Gates at security walls with sealant are maintained in good condition

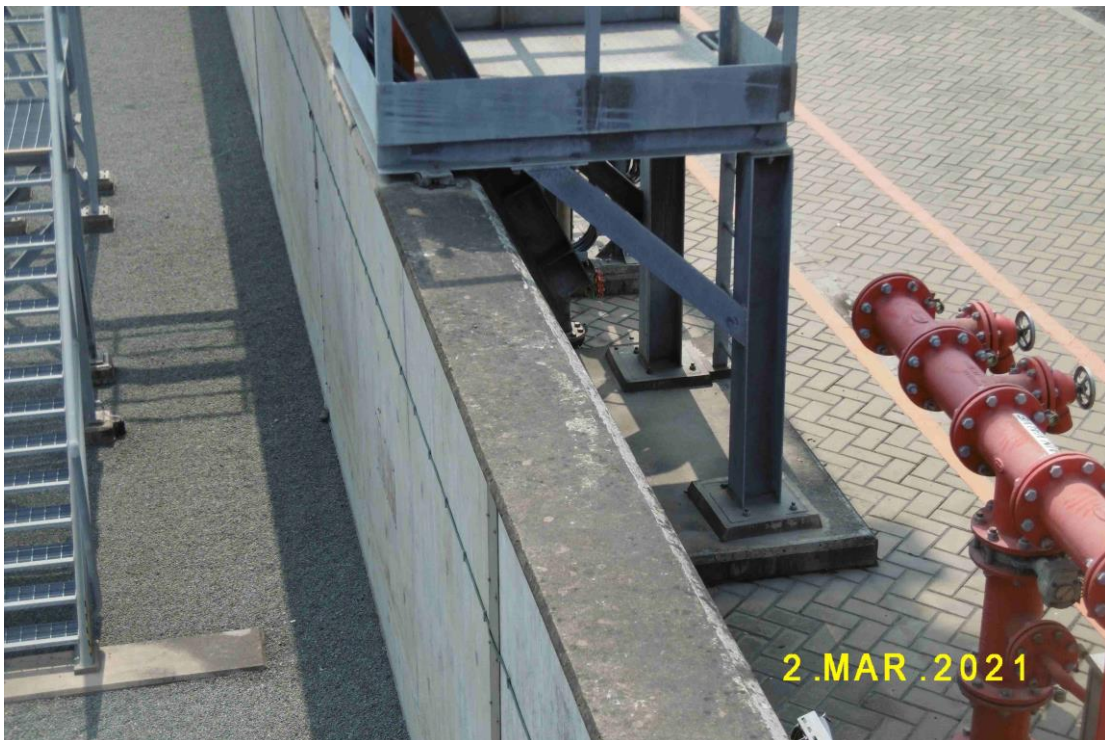
(16) This shows the thickness of the bund wall provided

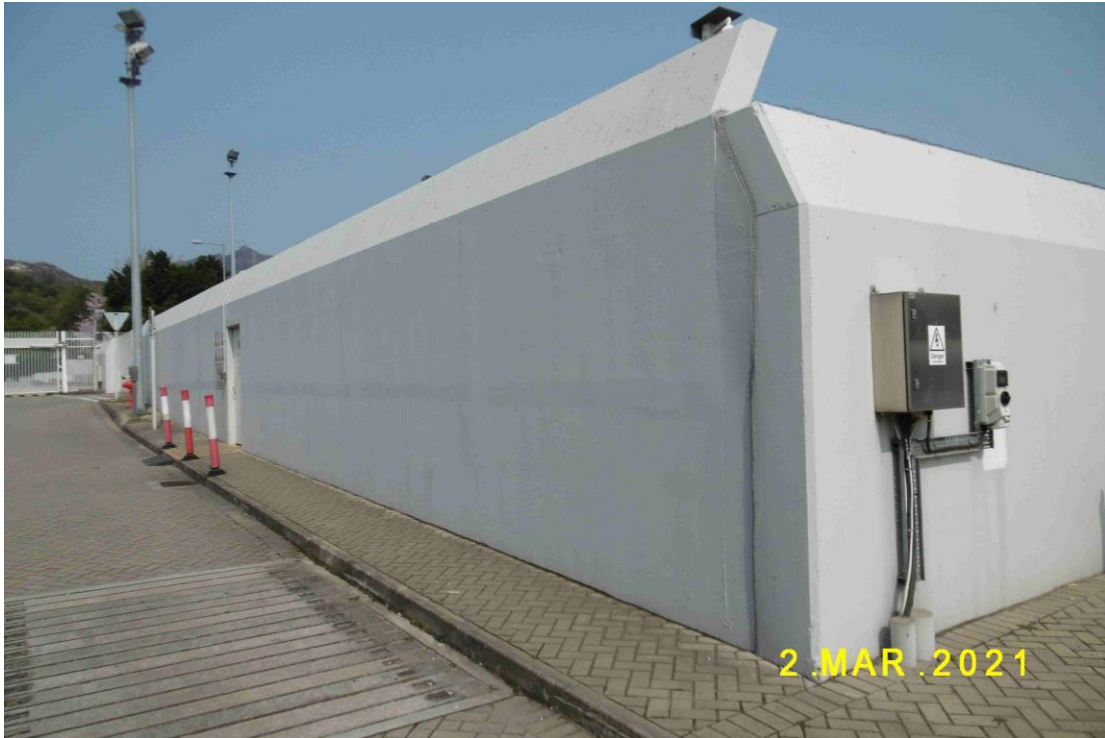
(17) This shows the thickness of the security wall provided

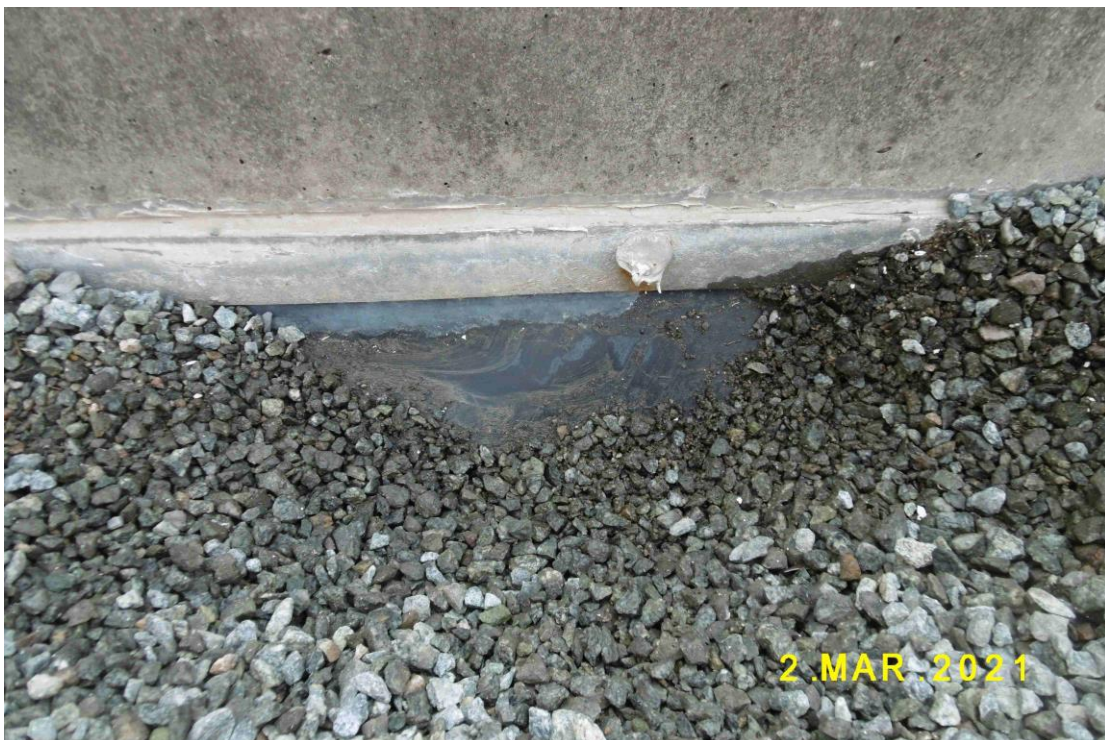
(18) Impervious lining are maintained in good condition

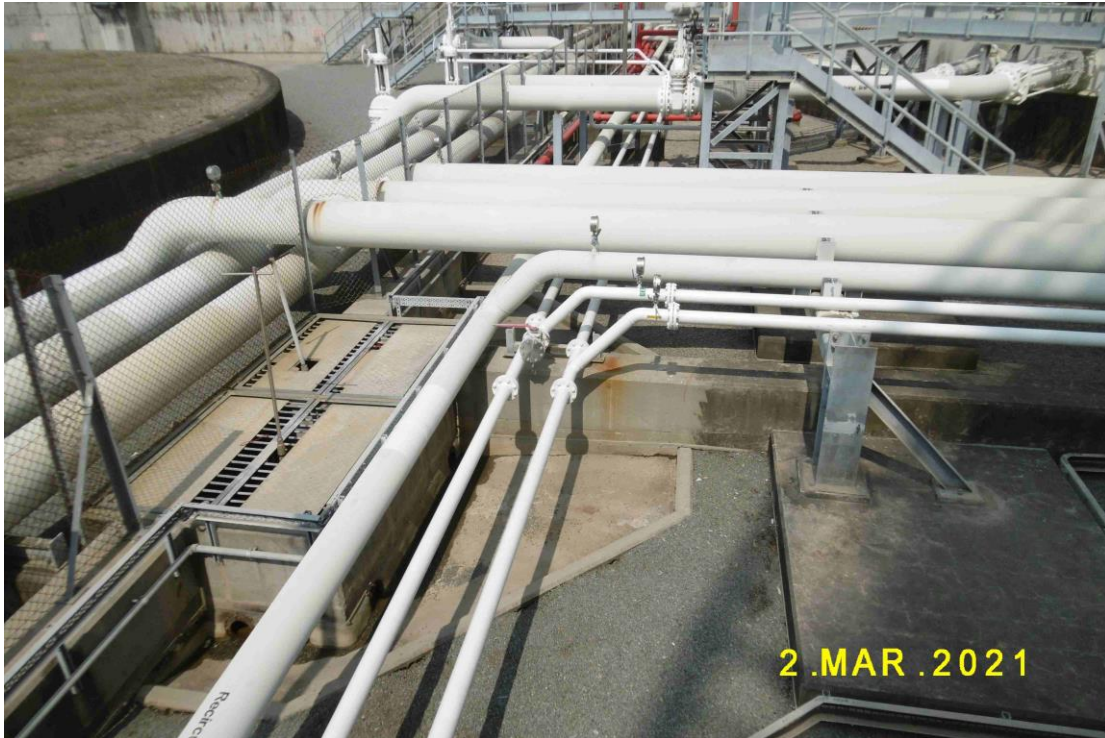
- (19) Tank farm is with appropriate gradient and the drainage falls to interceptor for collection

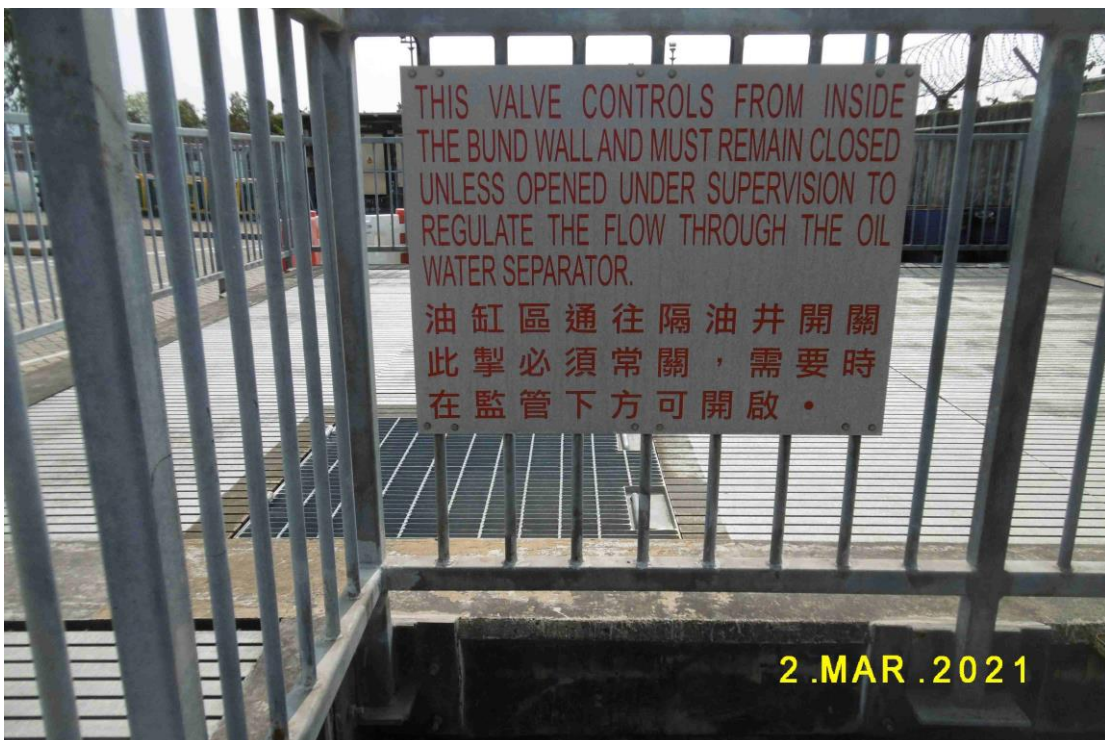
- (20) Outlet valve provided for Phase 1a Interceptor with instruction sign to keep “normally closed”

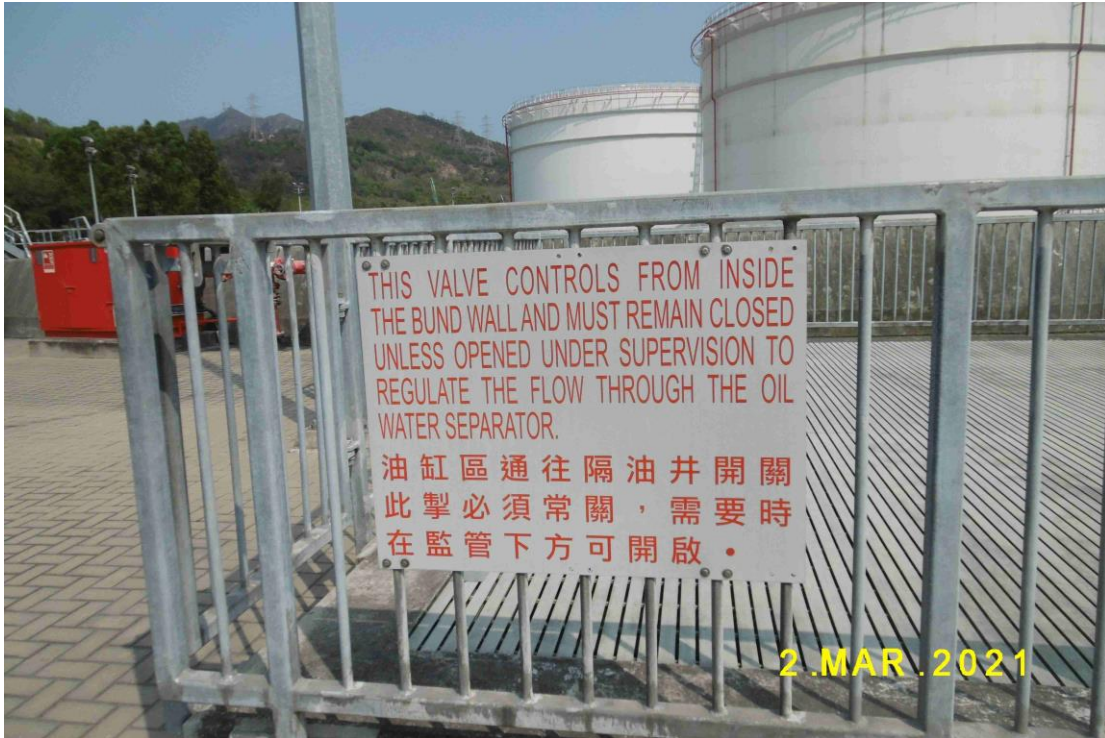
(21) Outlet valve provided for Phase 1b Interceptor with instruction sign to keep “normally closed”

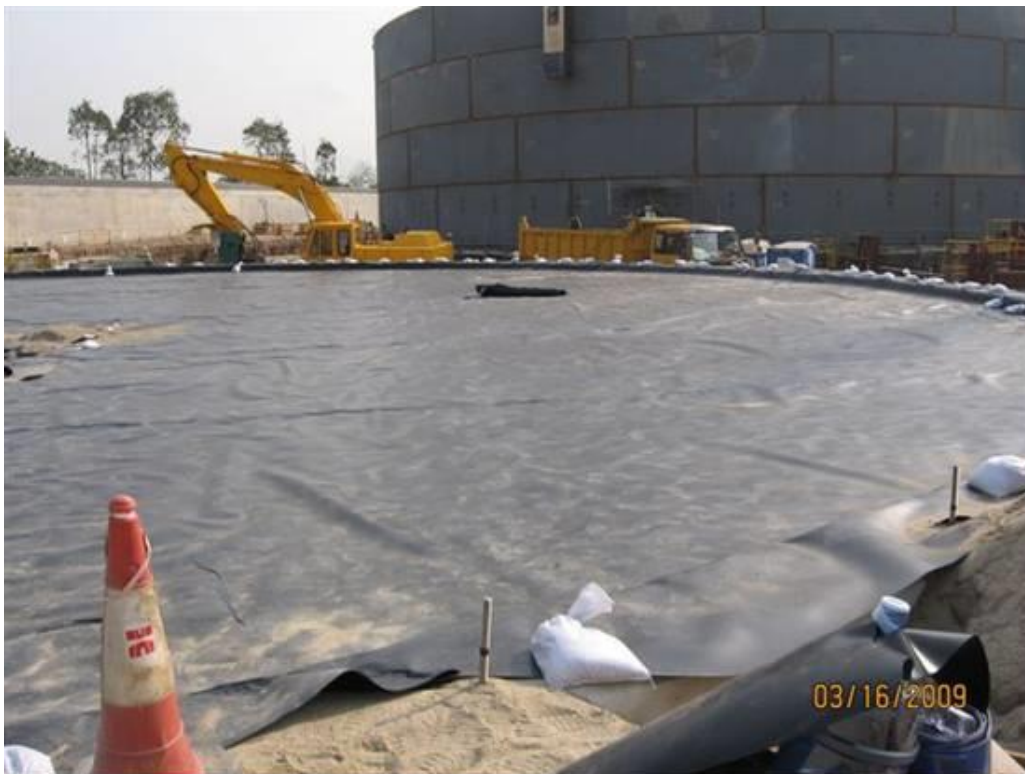
(22) Record photo shows impervious membrane being installed on top of tank foundation

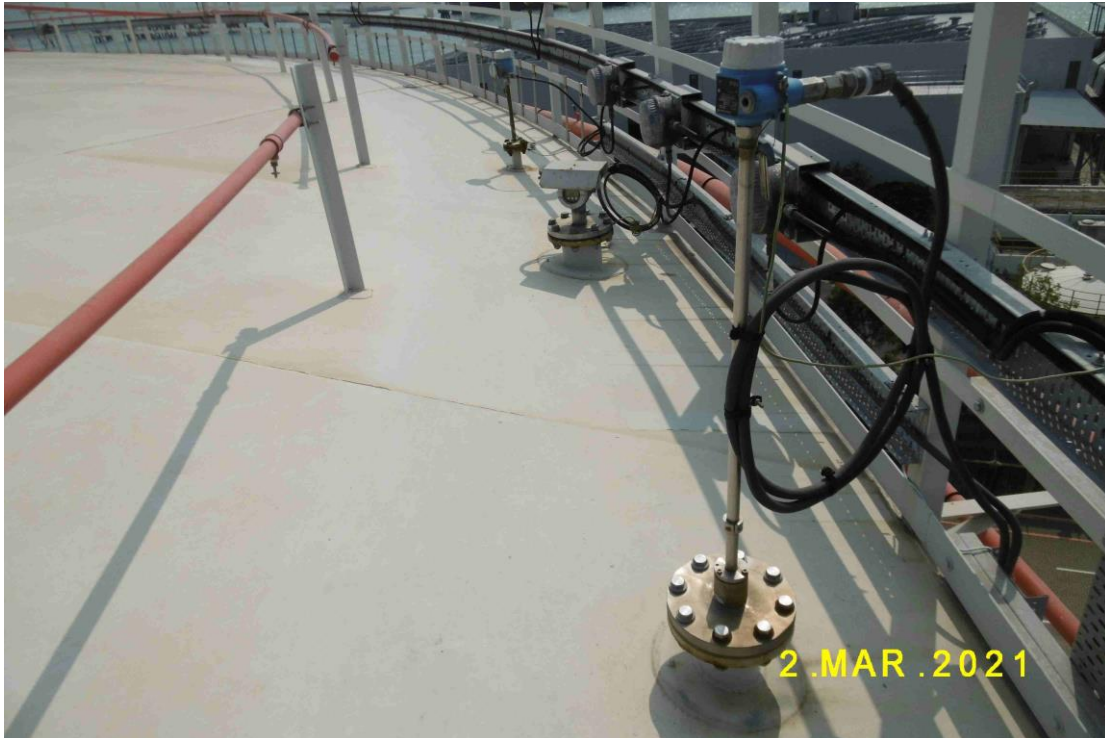
(25) Regular inspection performed on overfilling monitoring device (High-High Level Alarm)

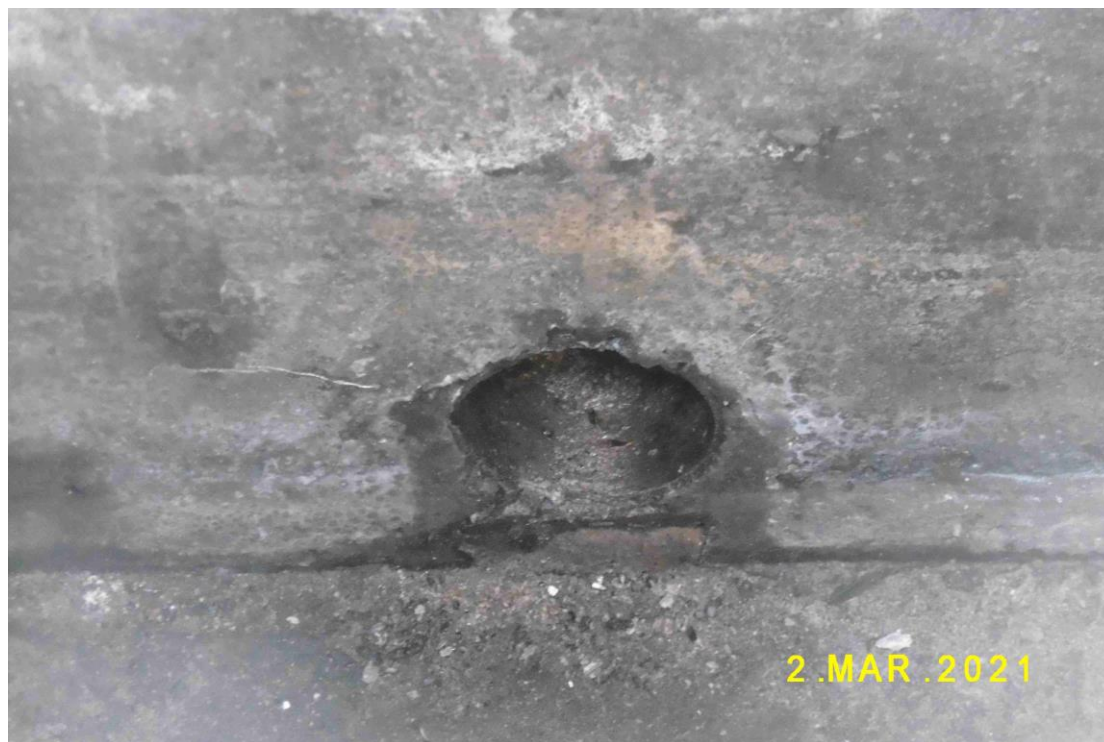
(28) Leak detection tell-tale pipe underneath the storage tank opens out to a collection chamber

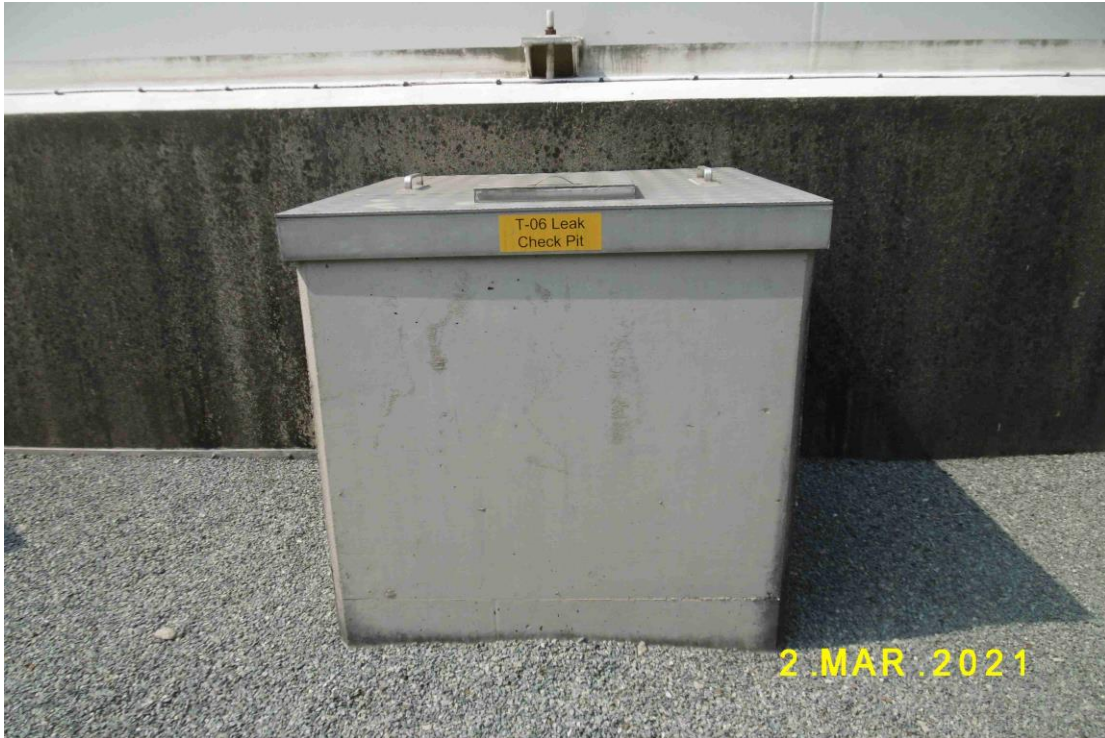
(29) Collection chamber located adjacent to tank foundation is maintained in good condition with periodic inspection

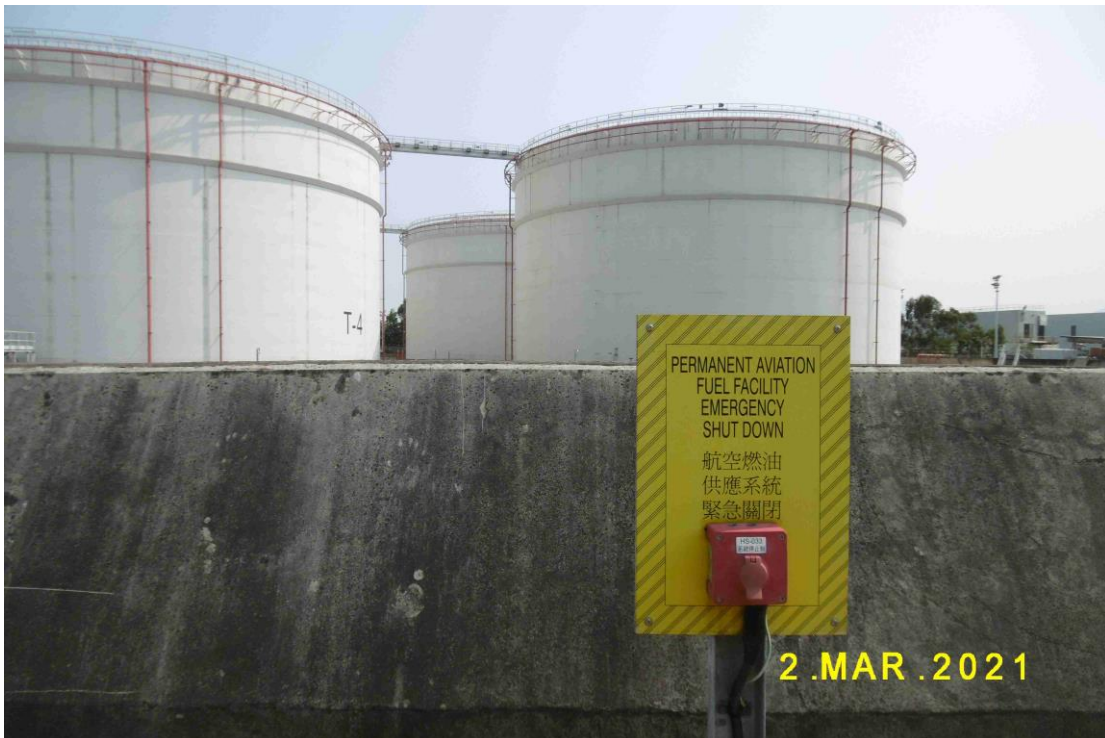
(30) ESD device is maintained in good condition and being tested periodically

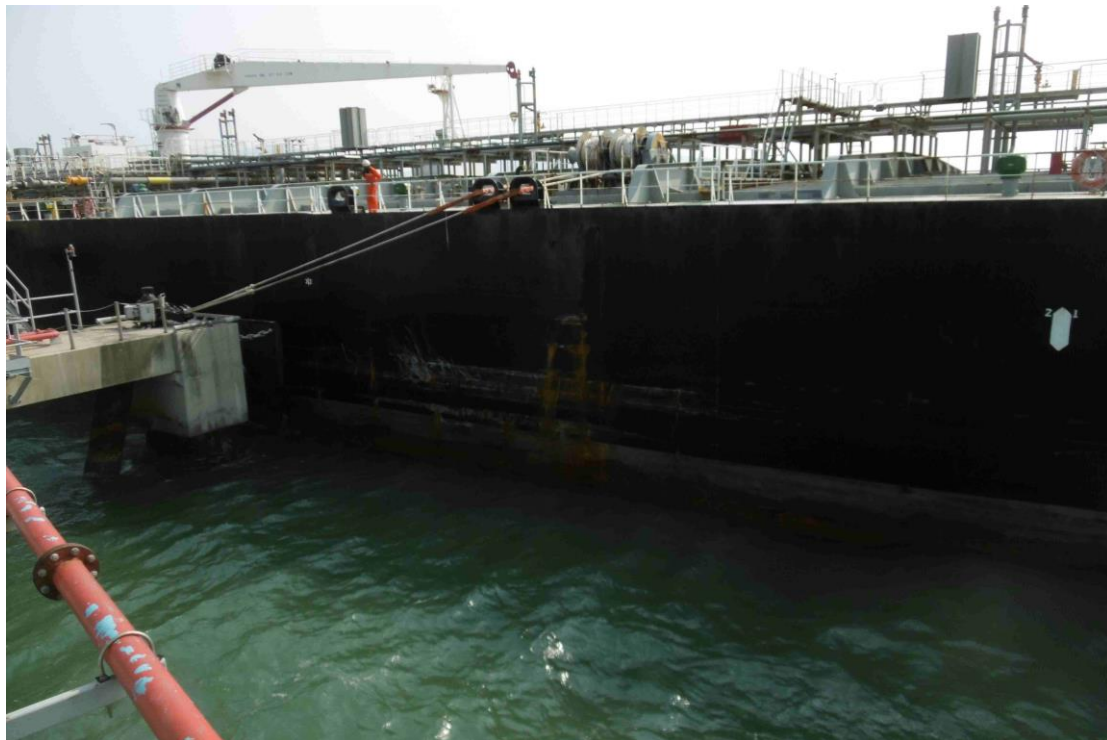
(36) Fenders are installed at sea side of the jetty

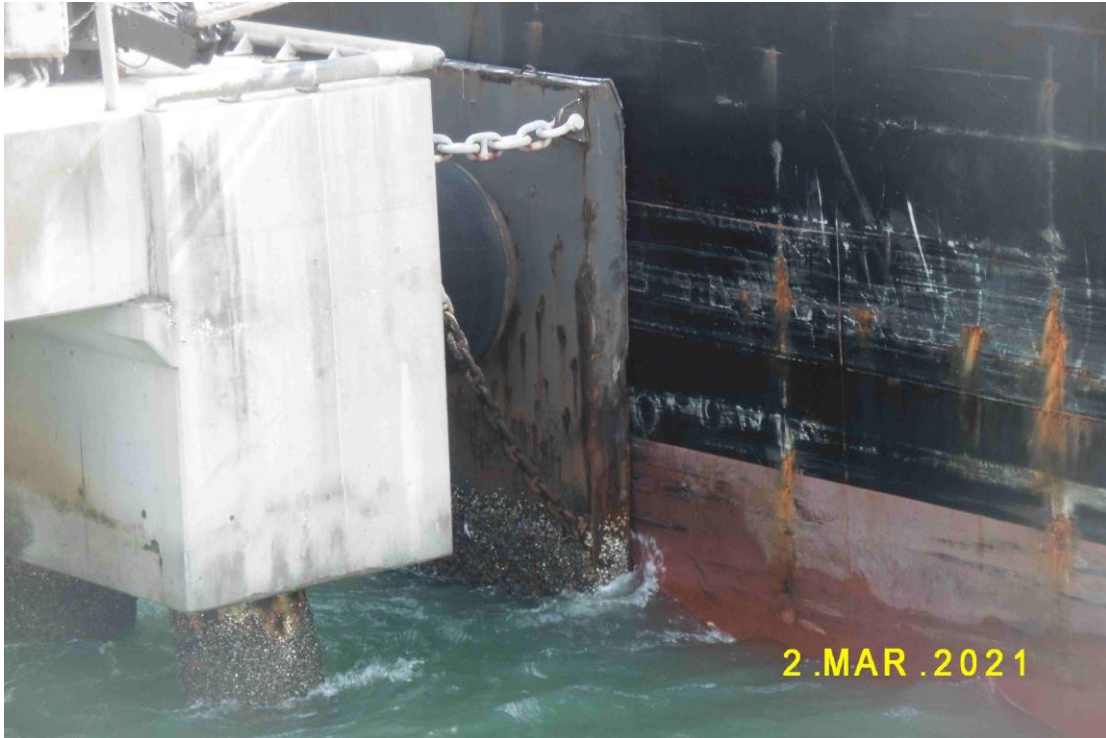
(37) Fenders are installed at sea side of the jetty
