ECO Aviation Fuel Services Limited

**ANNUAL AUDIT REPORT**  
**For**  
**PERMANENT AVIATION FUEL FACILITY**  
**Environmental Permit**  
**EP-262/2007/B**

Date of Audit :		27 February to 19 March 2021
Prepared By :	Michael Chung, Technical Manager	19 March 2021
Reviewed By :	Sylvia Har, Facility Manager	23 March 2021
Approved By :	Tommy Siu, General Manager	26 March 2021

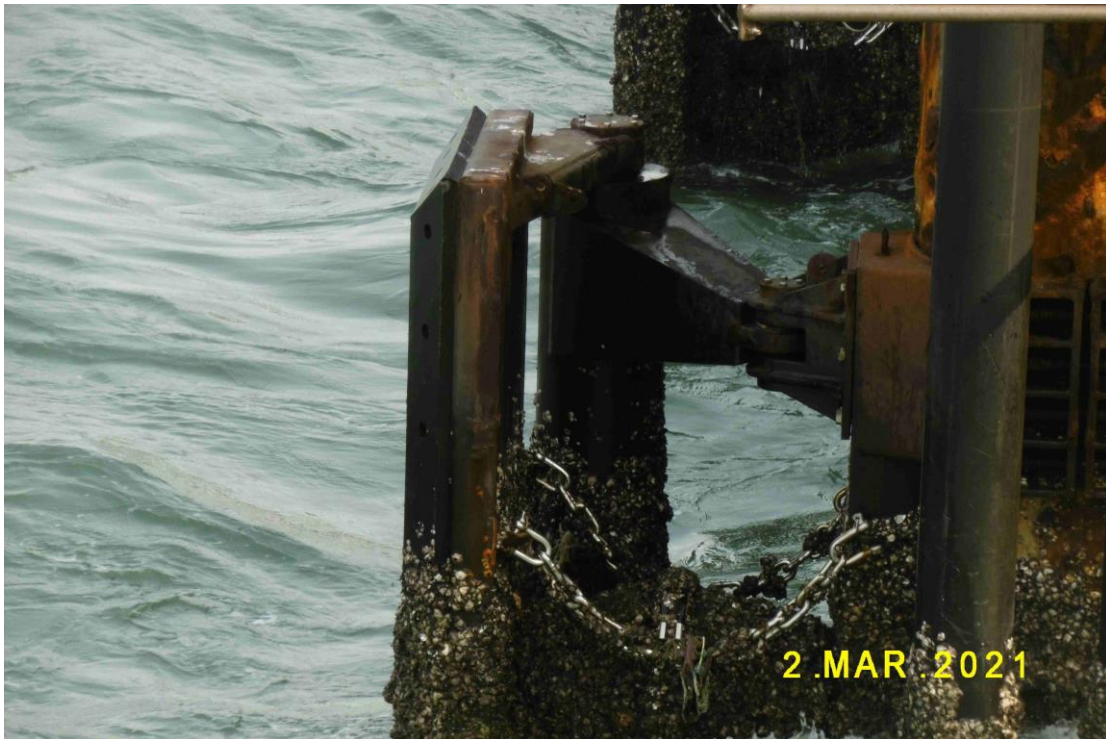
(38) Fenders are installed at shore side of the jetty

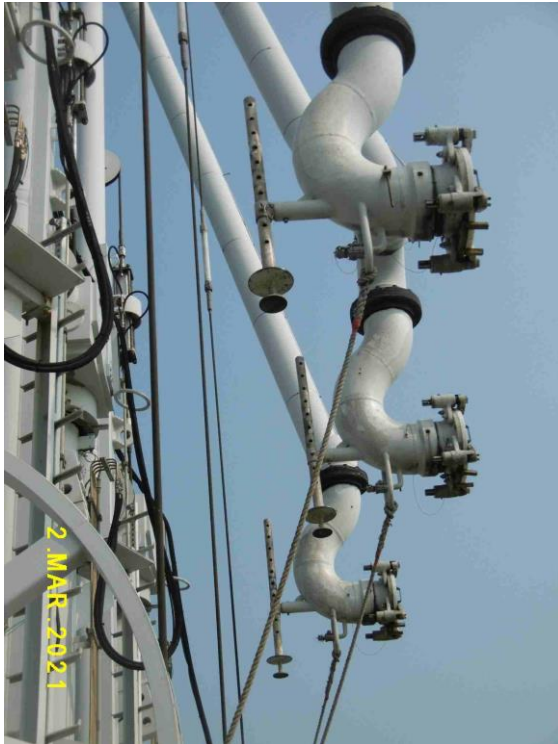
- (39) Slope collection utilities are used for coupling and de-coupling of the loading arms

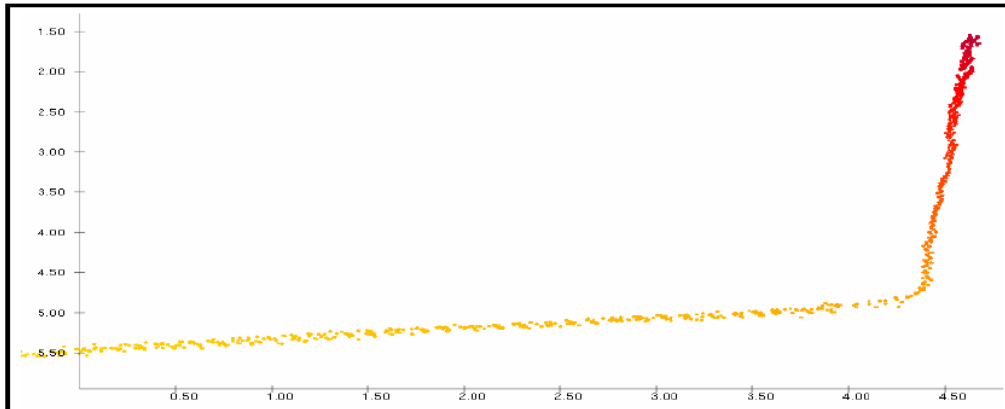
**Figure 5: Cross section image at intake location showing no sediment accumulation**
