ANNUAL AUDIT REPORT
For
PERMANENT AVIATION FUEL FACILITY
Environmental Permit
EP-262/2007/B

Date of Audit :		27 February to 25 March 2022
Prepared By :	Michael Chung, Technical Manager

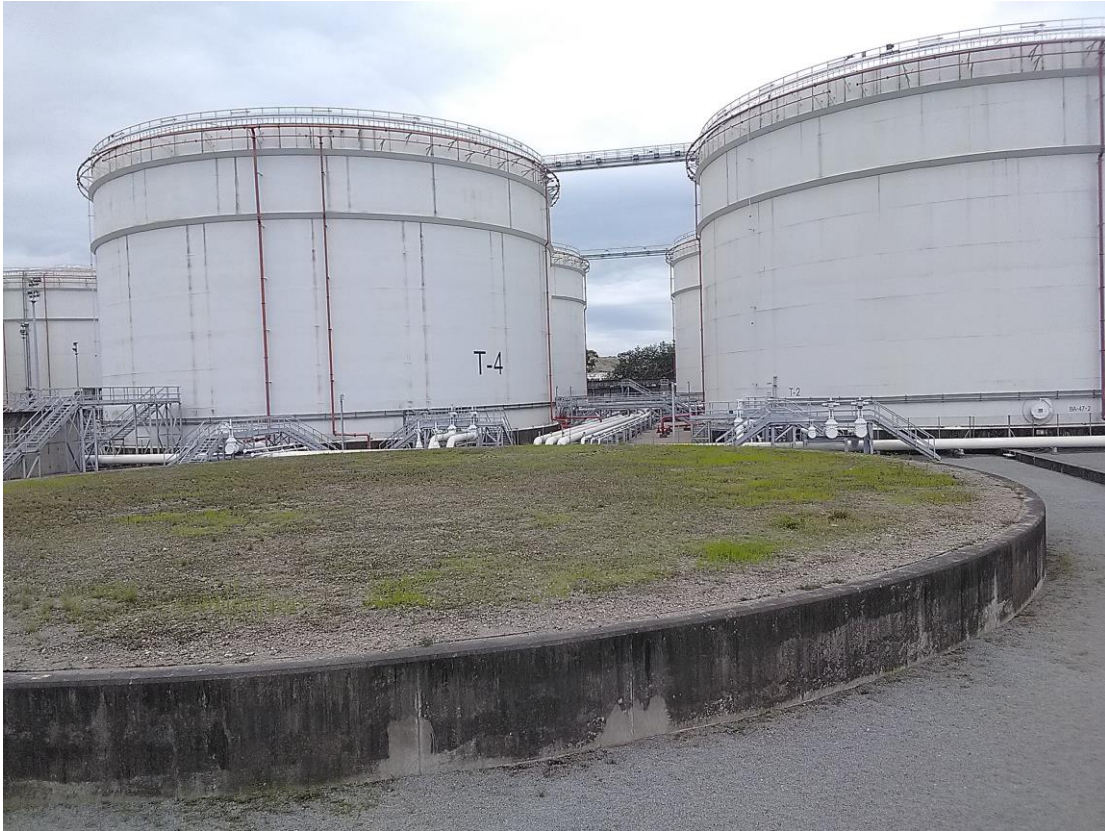
(1) Four tanks are located within bunded compound – Phase 1a

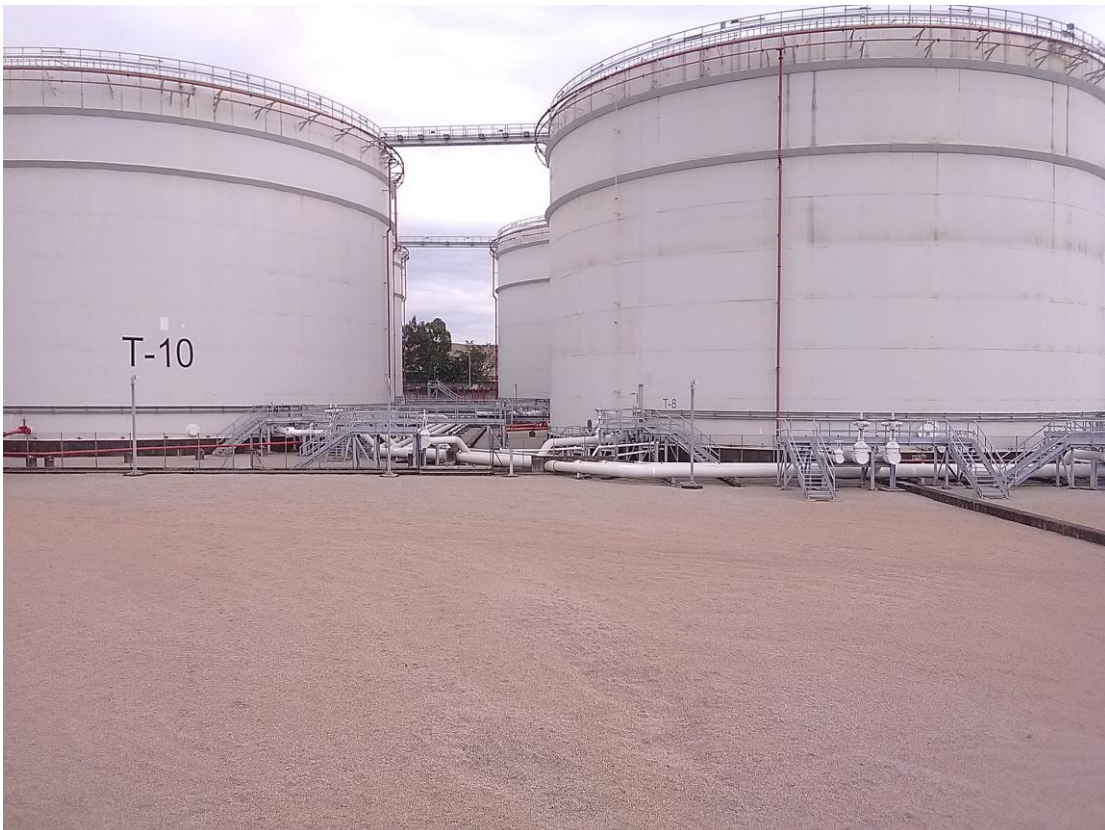
(2) Four tanks are located within bunded compound – Phase 1b

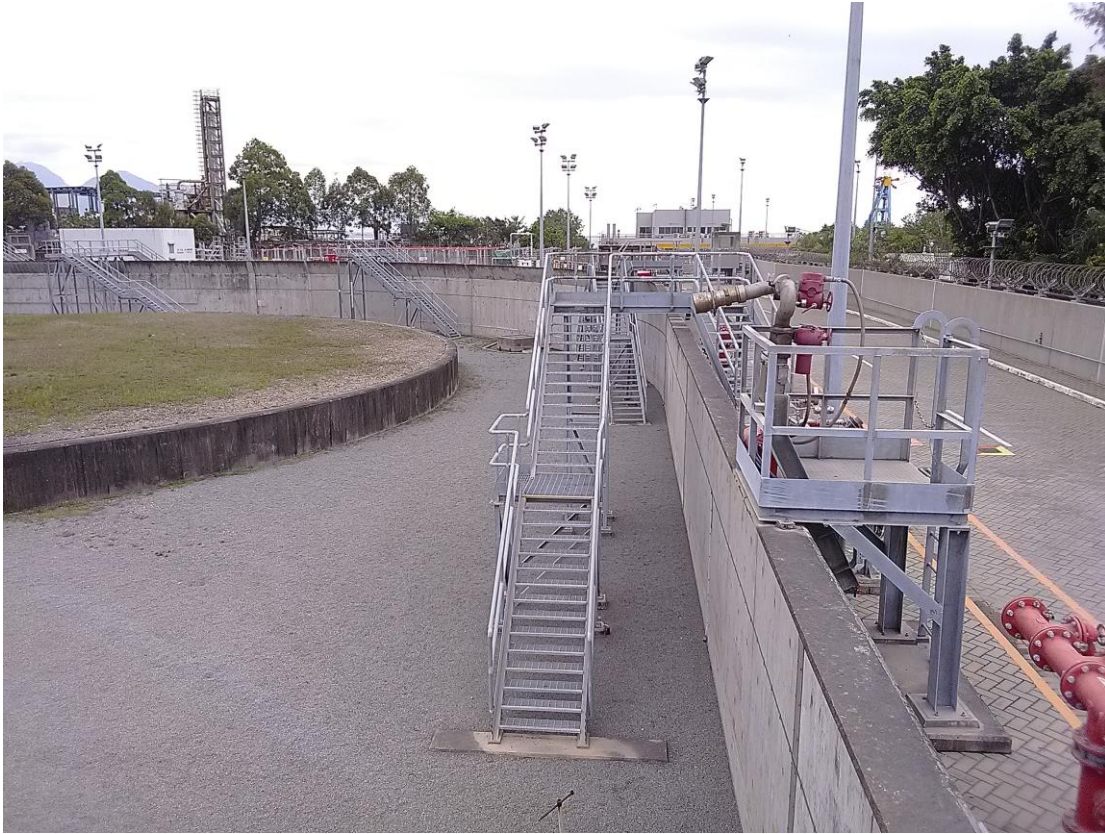
(3) Phase 1a bunded compound is lower than the ground level outside the bunds

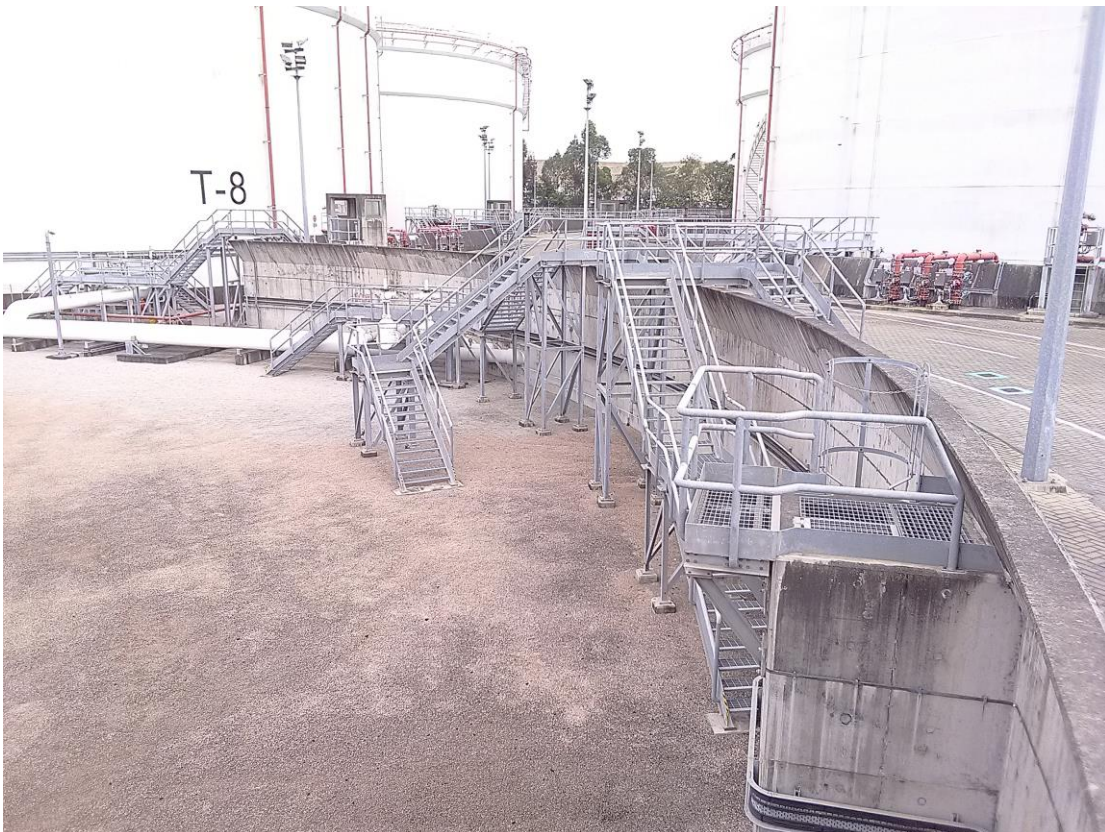
(4) Phase 1b bunded compound is lower than the ground level outside the bunds

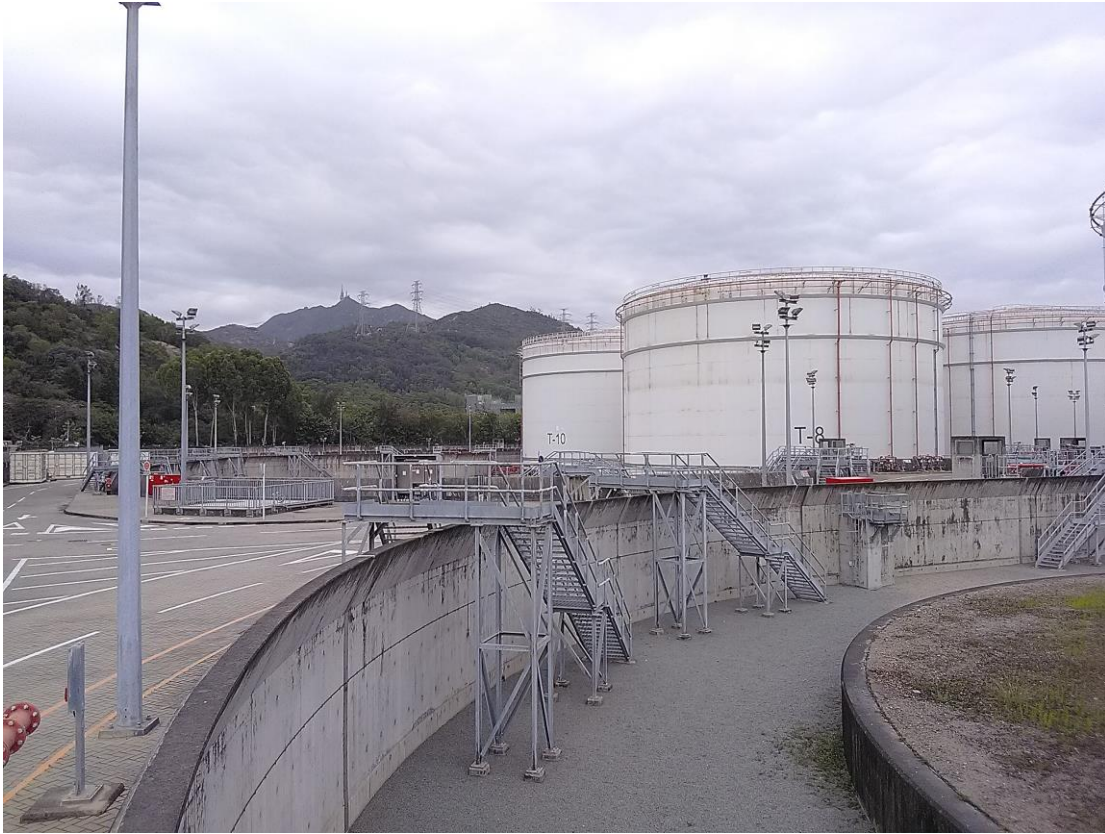
(5) Wave deflector is located at top of the bund

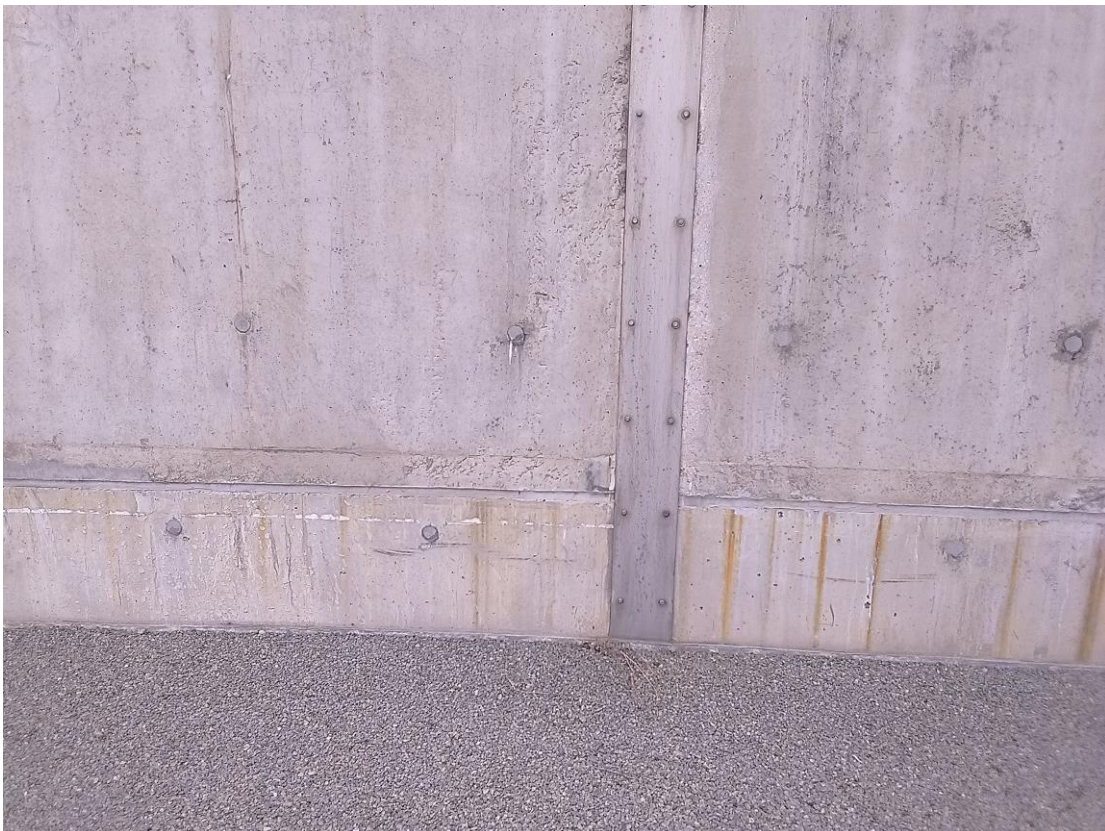
(6) Visible parts of the joints are covered by stainless steel plates on the inside at phase 1a bund

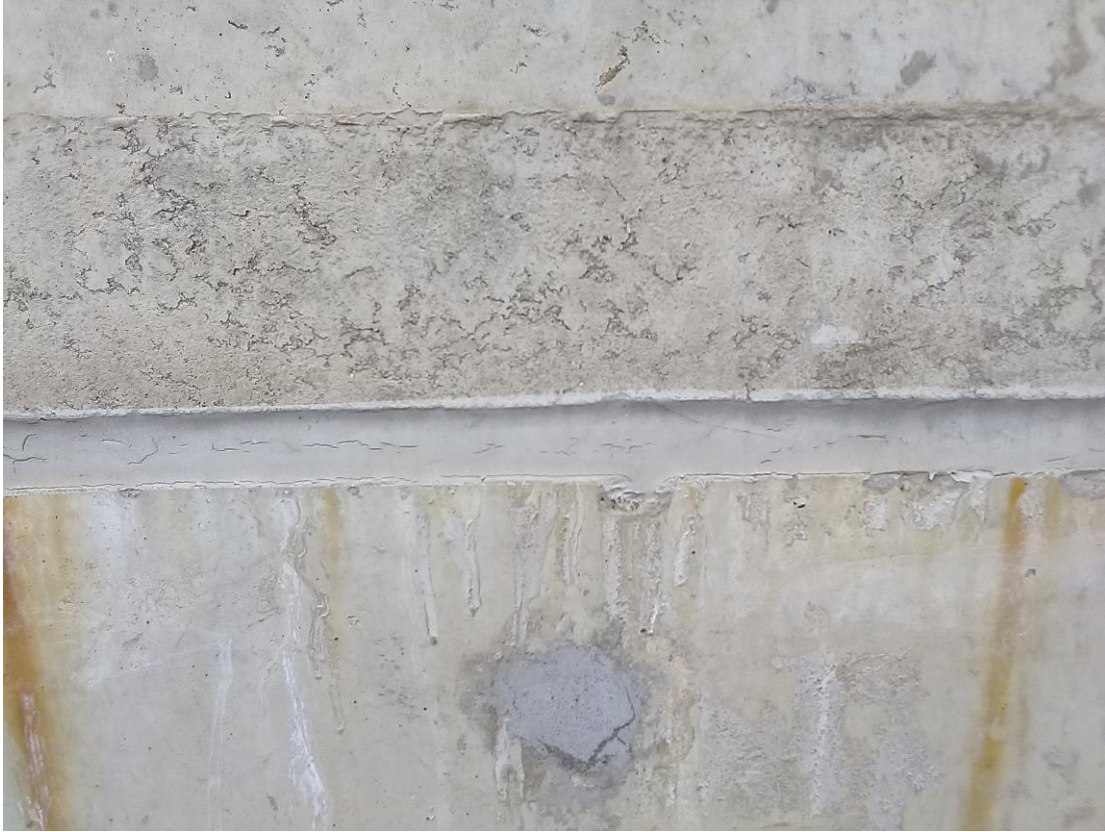
(7) Maintenance works have been performed on sealant at joints

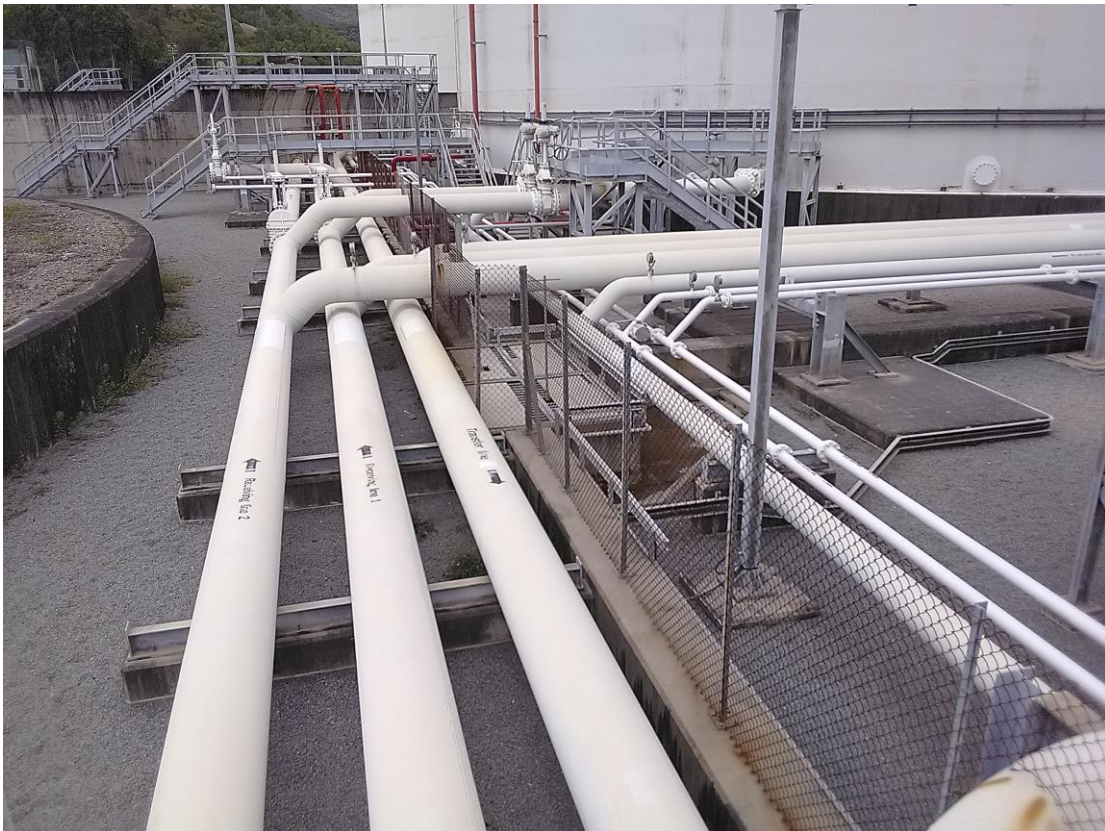
(8) Intermediate bund walls are provided in place near T-01-004

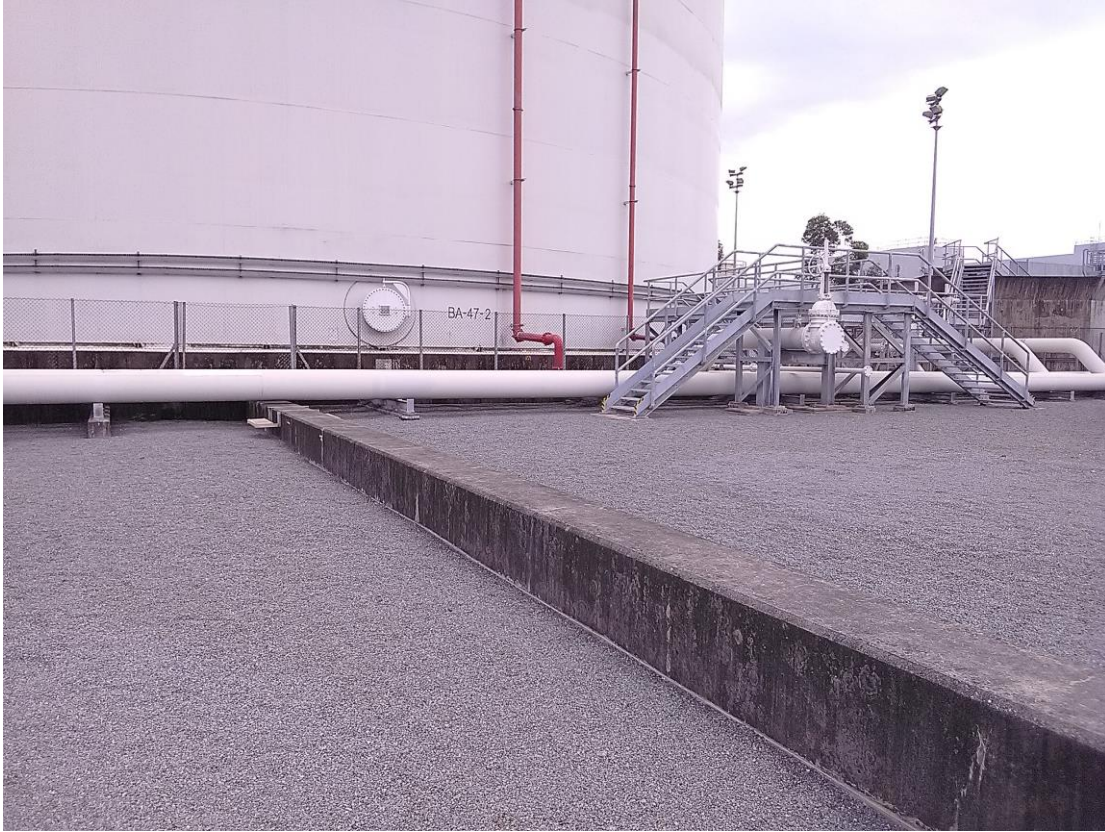
(9) Intermediate bund walls are provided in place near T-01-002

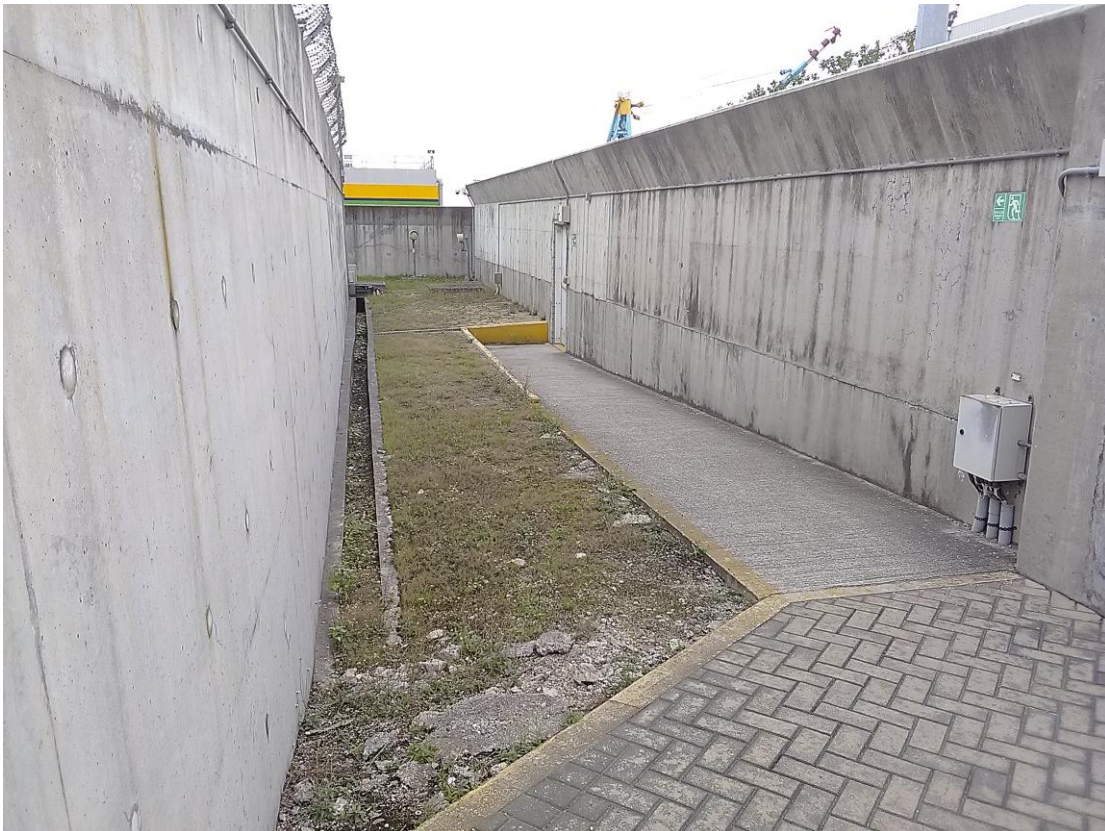
(10) Two impervious security walls are provided outside the bunded compounds

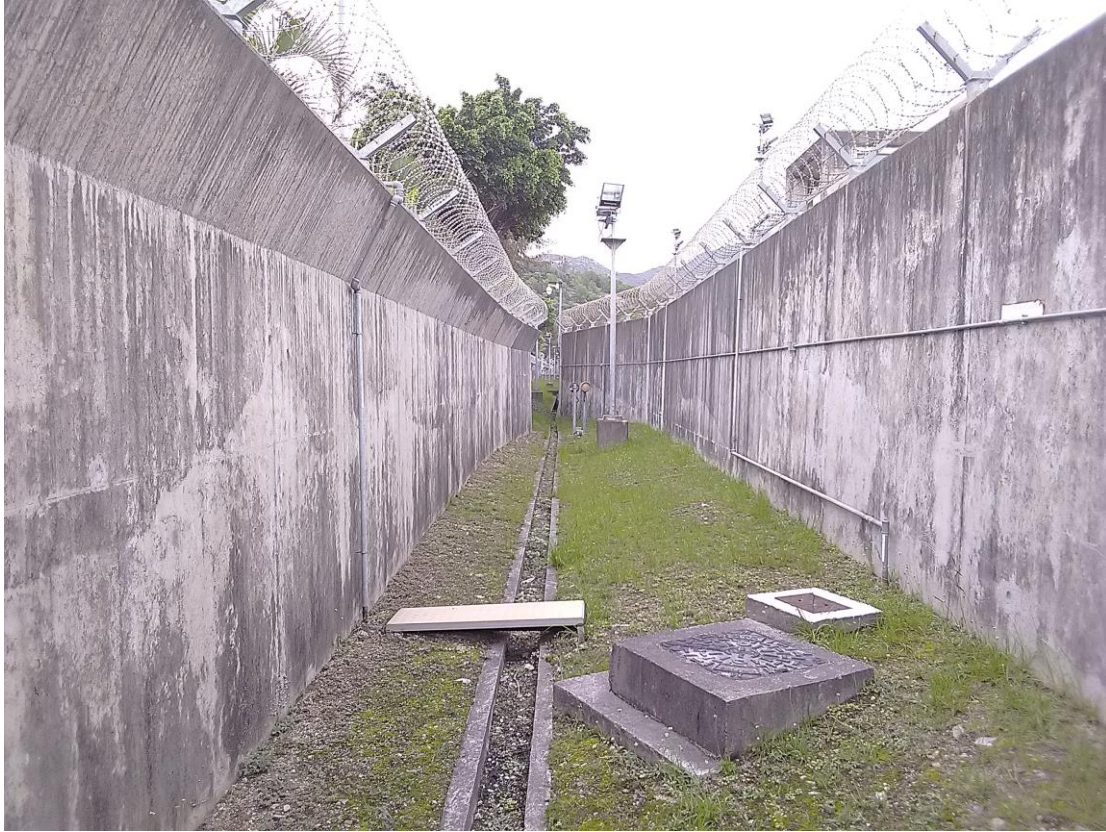
(11) Two impervious security walls are provided outside the bunded compounds

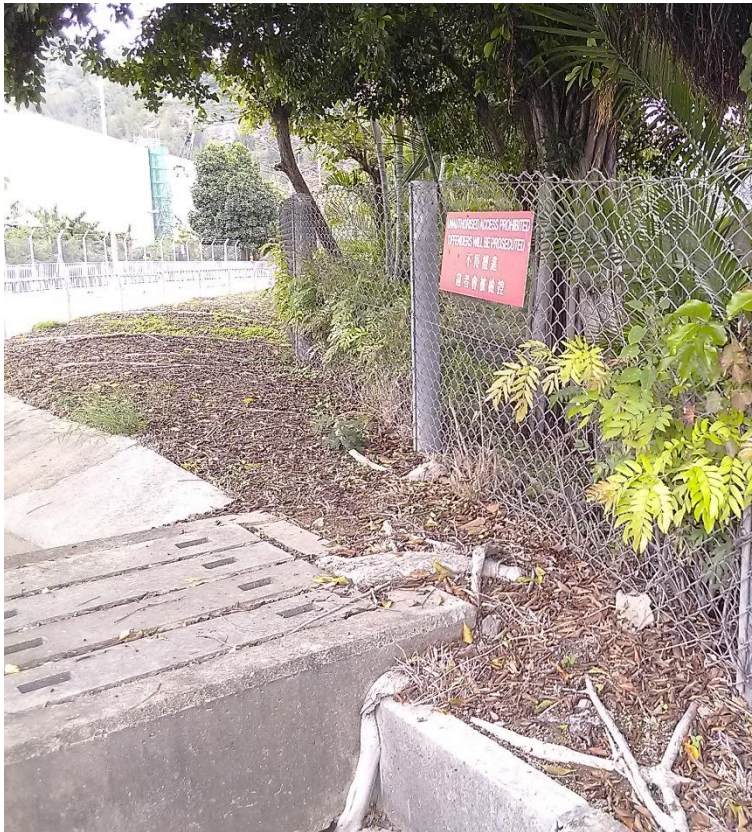
(12) Landscaped berm is maintained at least 1.5m high

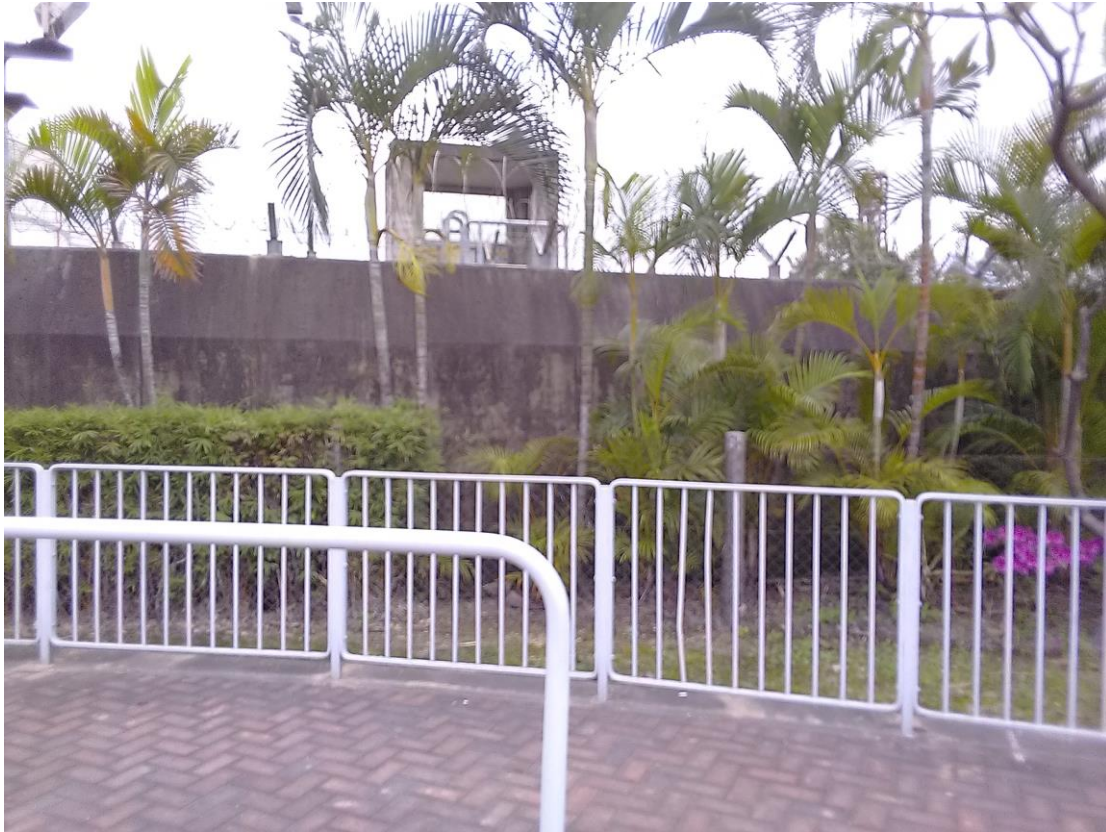
(13) Landscaped berm is maintained at least 1.5m high

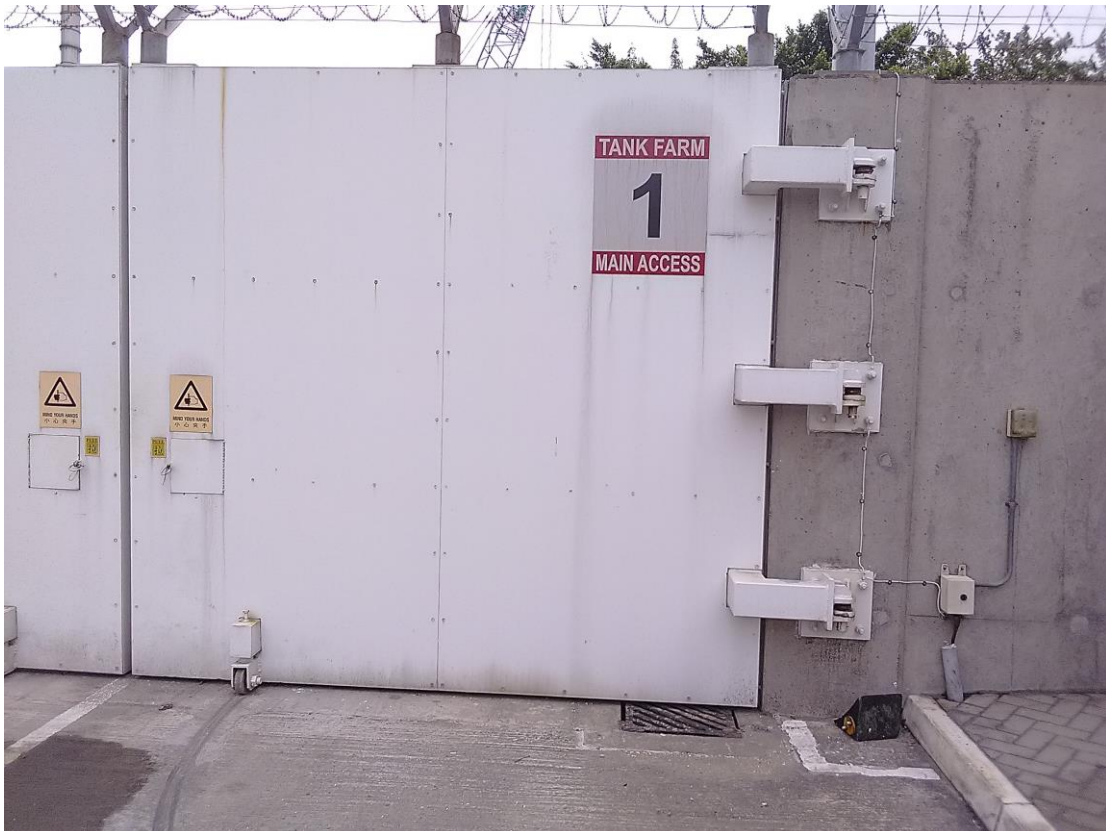
(14) Gates at security walls with sealant are maintained in good condition

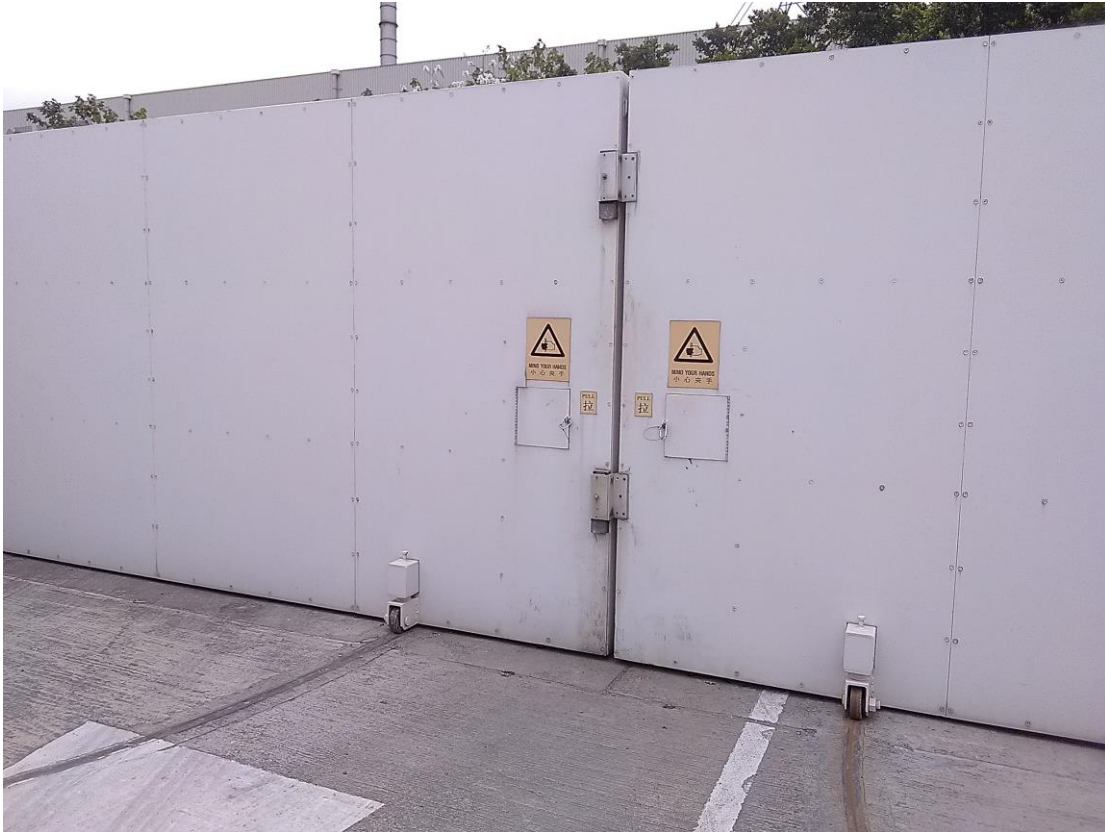
(15) Gates at security walls with sealant are maintained in good condition

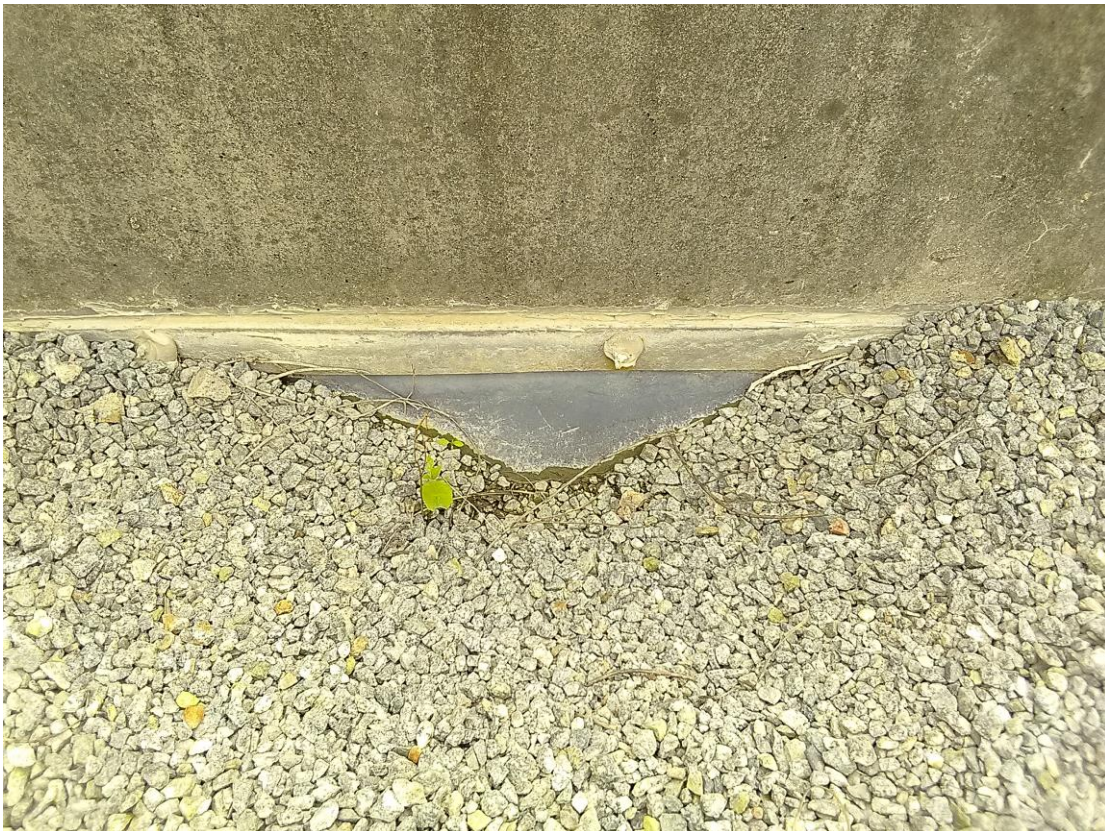
(18) Impervious lining are maintained in good condition

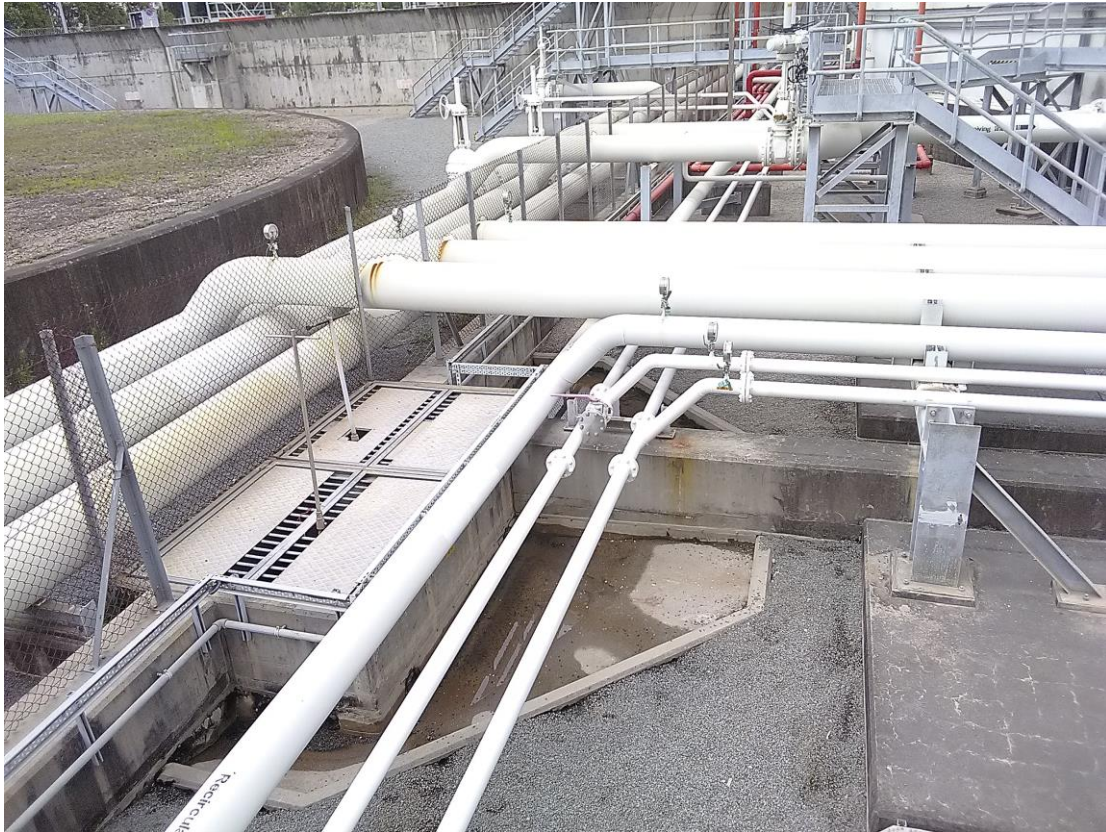
(19) Tank farm is with appropriate gradient and the drainage falls to interceptor for collection

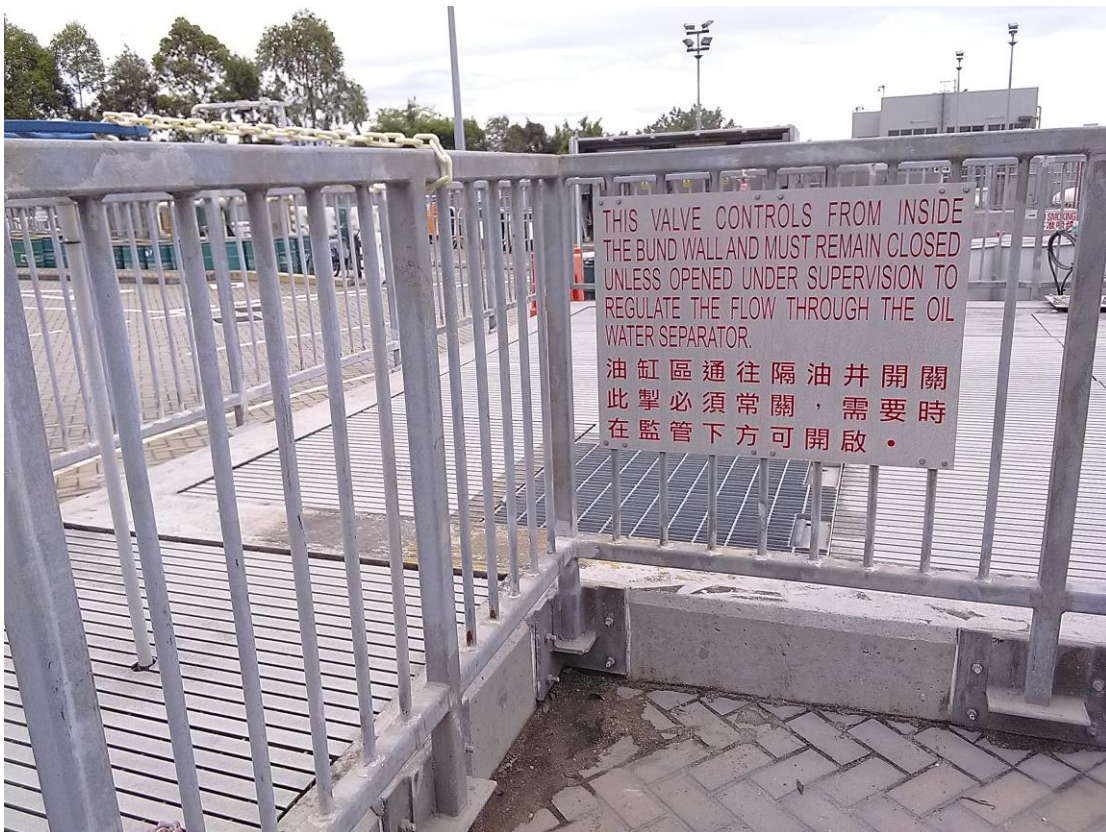
(20) Outlet valve provided for Phase 1a Interceptor with instruction sign to keep “normally closed”

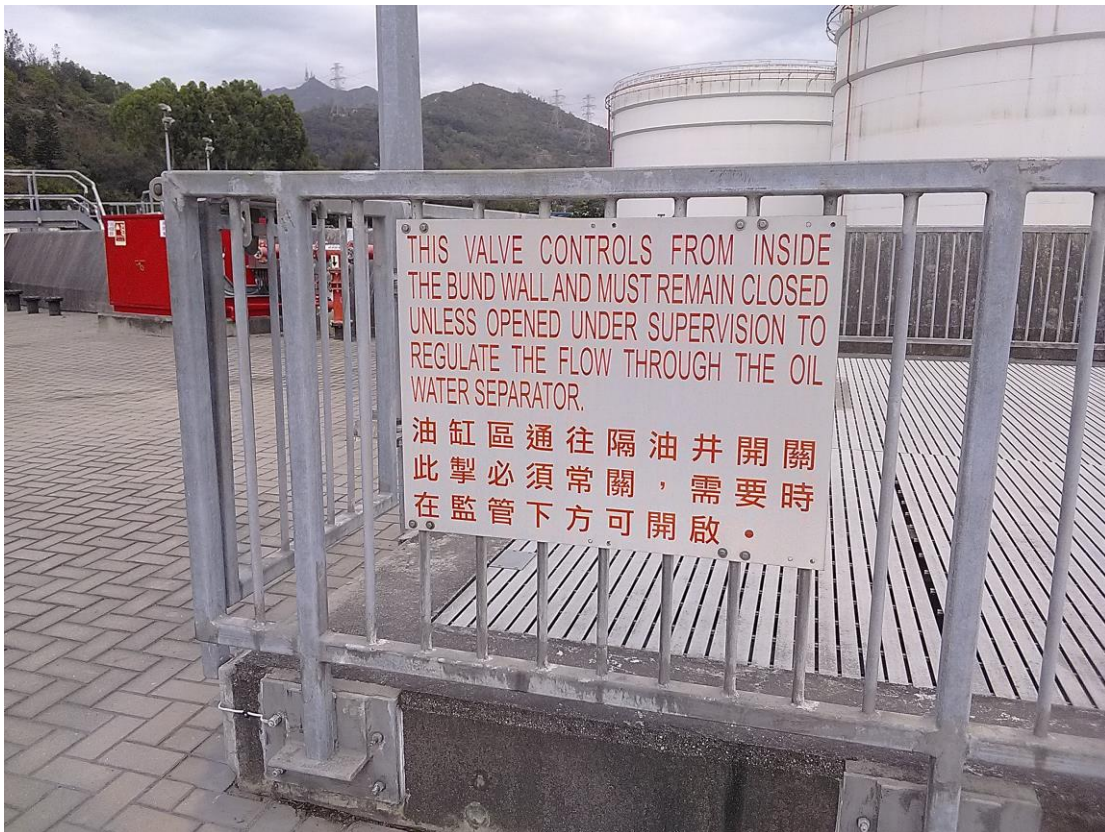
(21) Outlet valve provided for Phase 1b Interceptor with instruction sign to keep “normally closed”

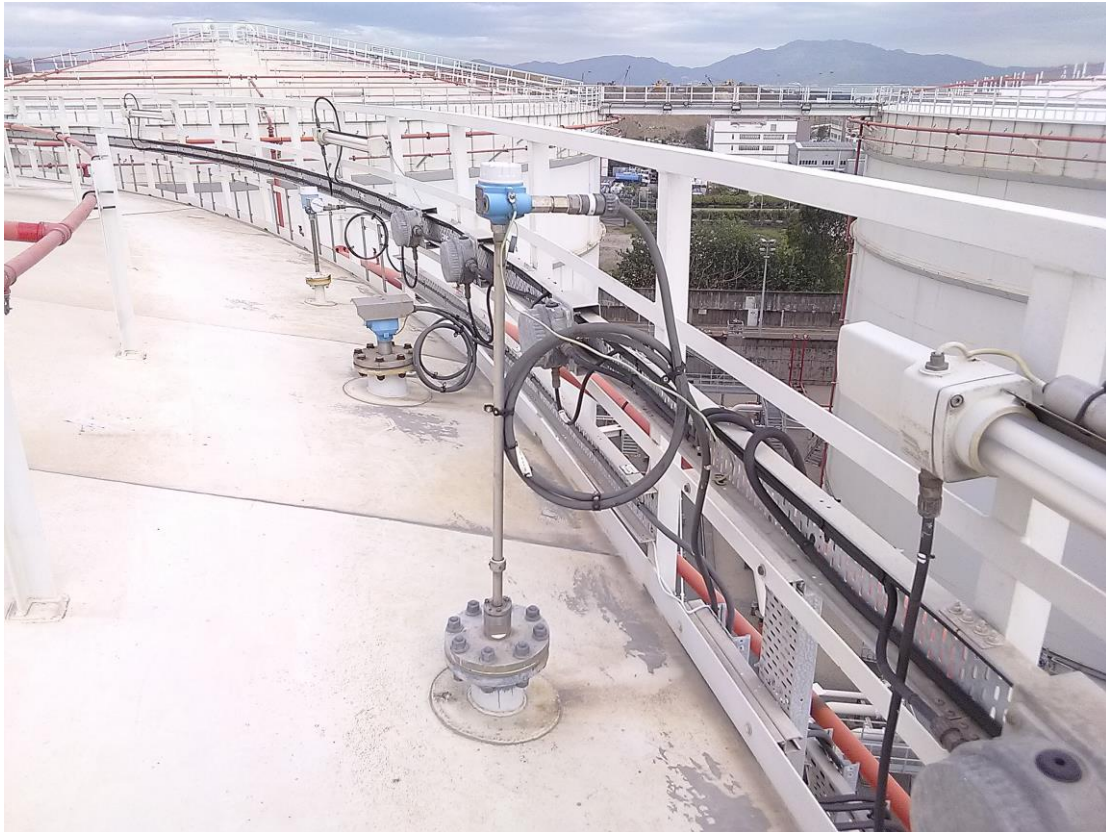
(25) Regular inspection performed on overfilling monitoring device (High-High Level Alarm)

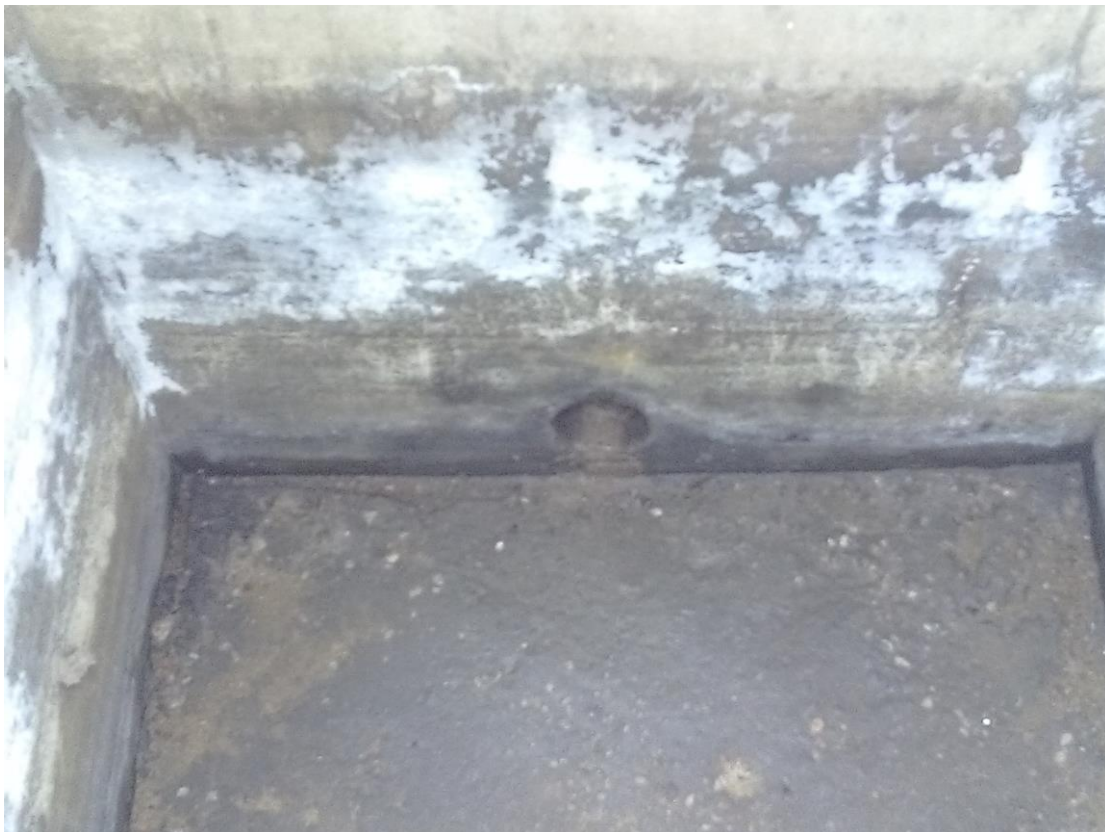
(28) Leak detection tell-tale pipe underneath the storage tank opens out to a collection chamber

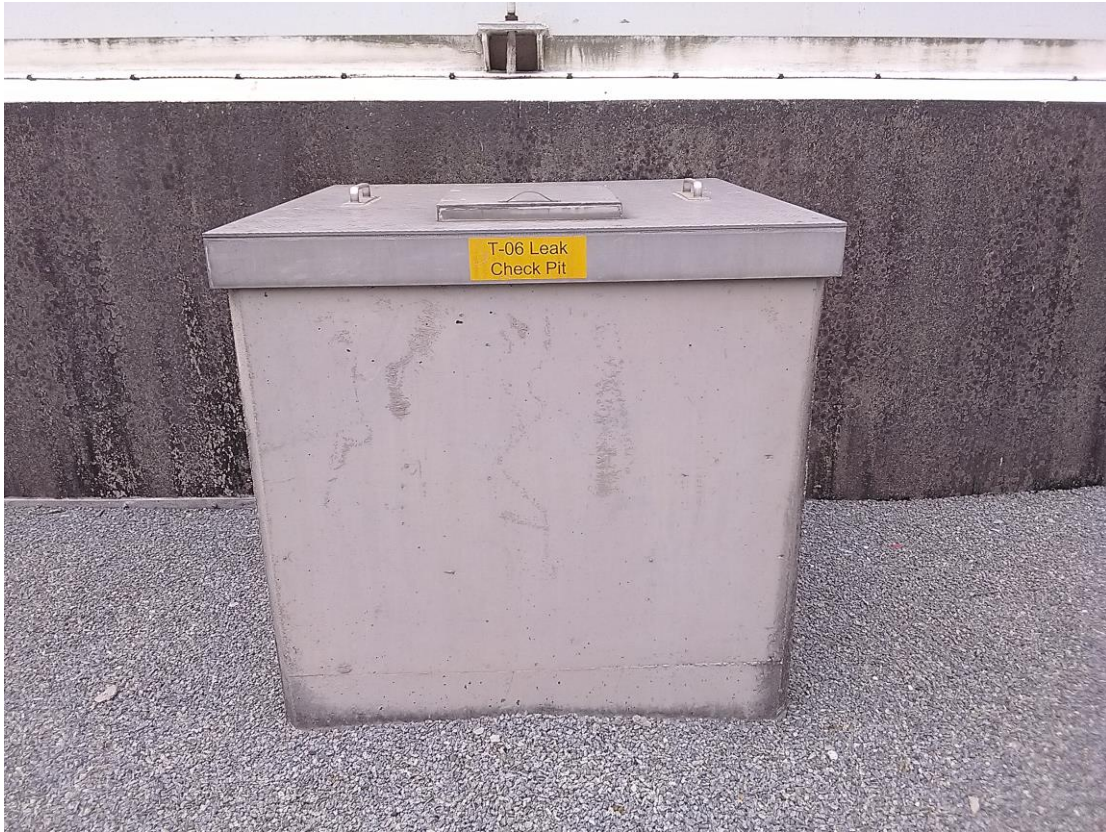
(29) Collection chamber located adjacent to tank foundation is maintained in good condition with periodic inspection

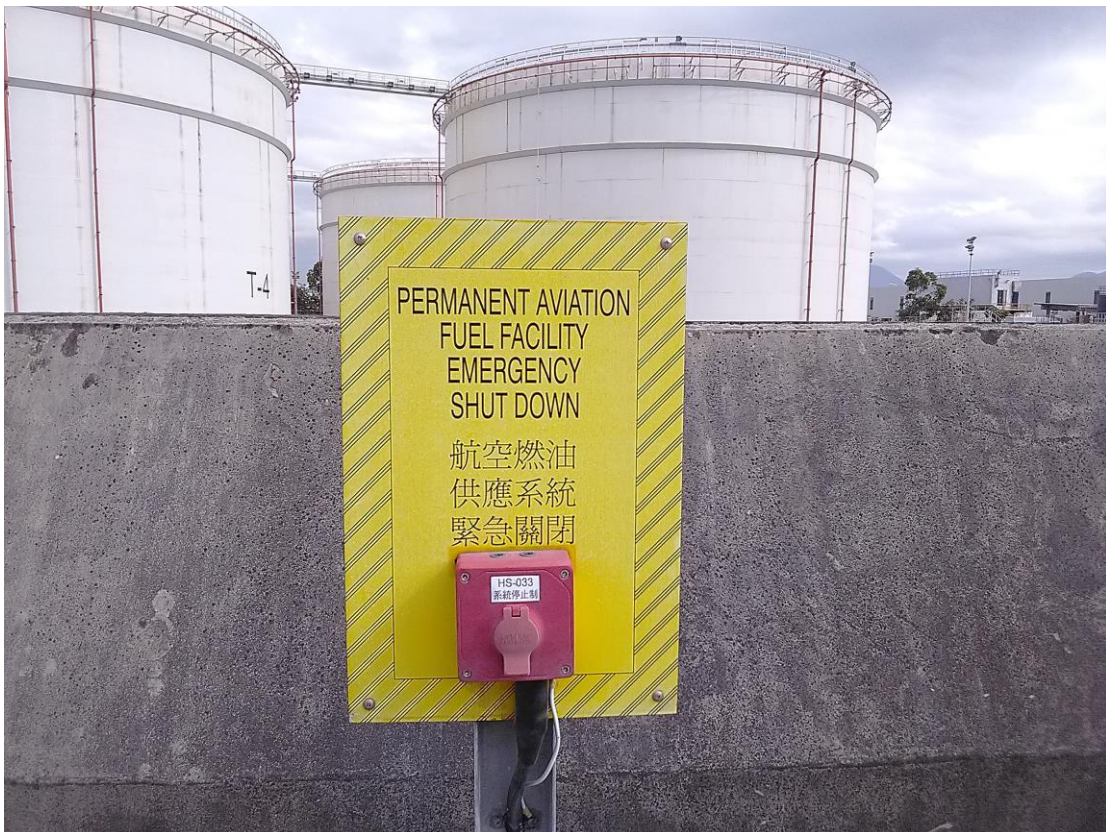
(30) ESD device is maintained in good condition and being tested periodically

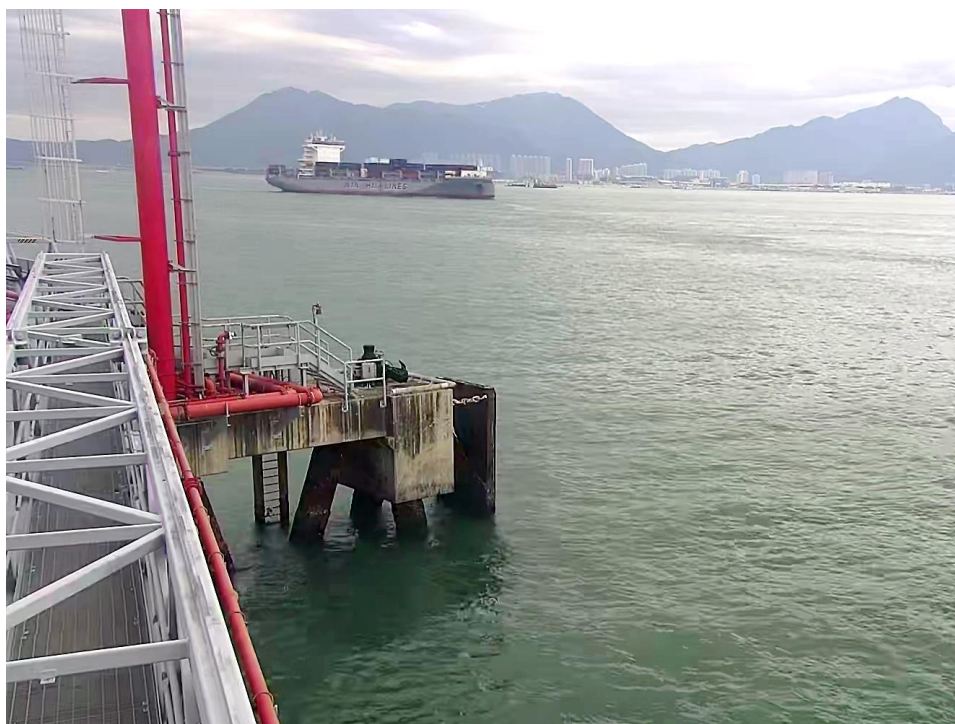
(36) Fenders are installed at sea side of the jetty

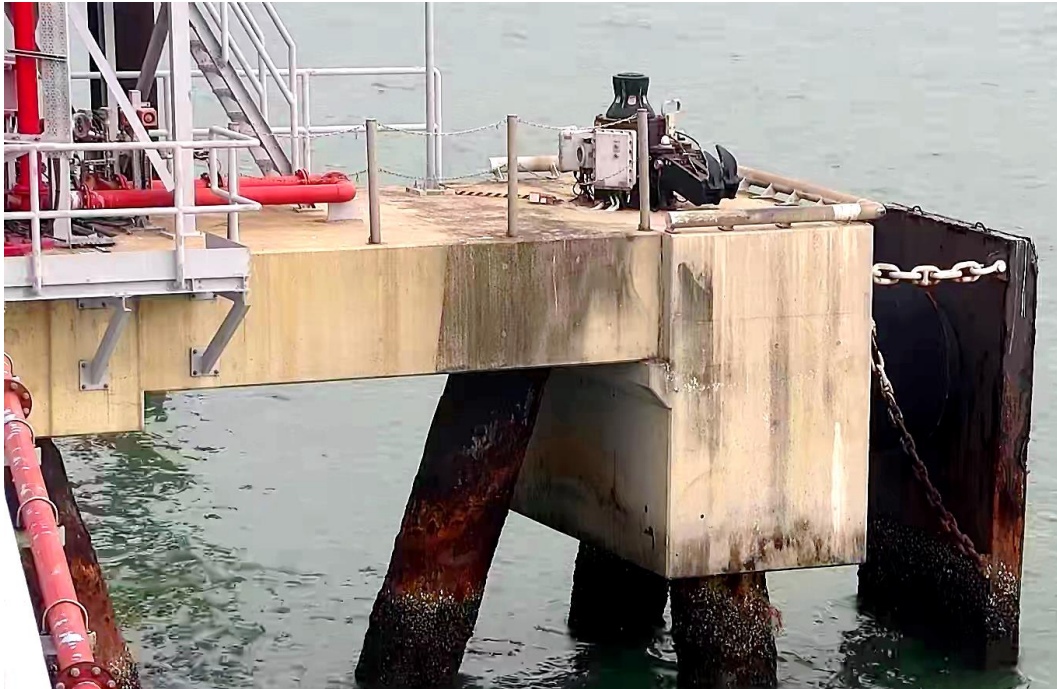
(37) Fenders are installed at sea side of the jetty
