ANNUAL AUDIT REPORT
For
PERMANENT AVIATION FUEL FACILITY
Environmental Permit
EP-262/2007/B

Date of Audit :		27 February to 25 March 2022
Prepared By :	Michael Chung, Technical Manager

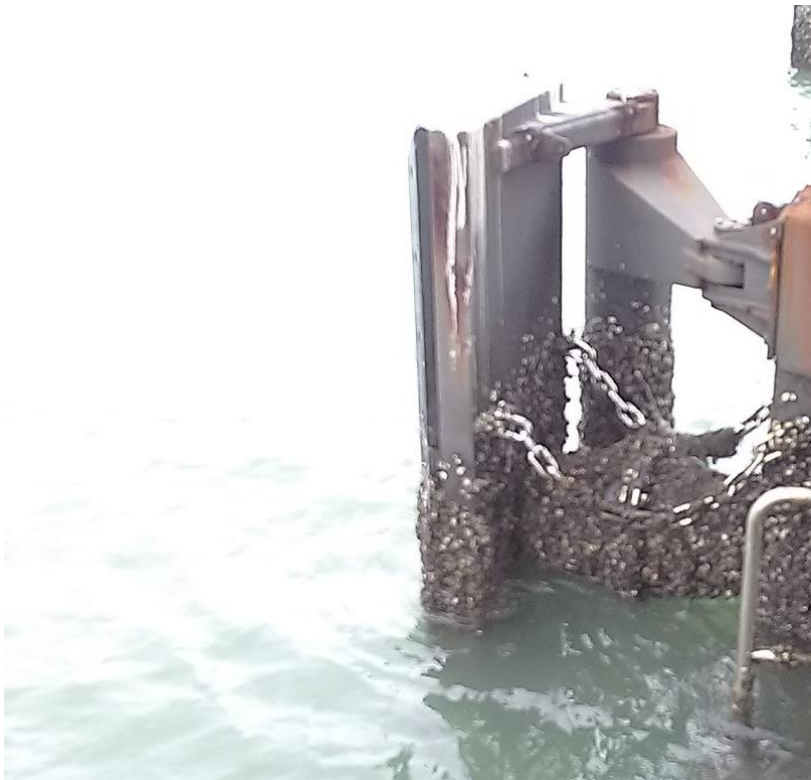
(38) Fenders are installed at shore side of the jetty

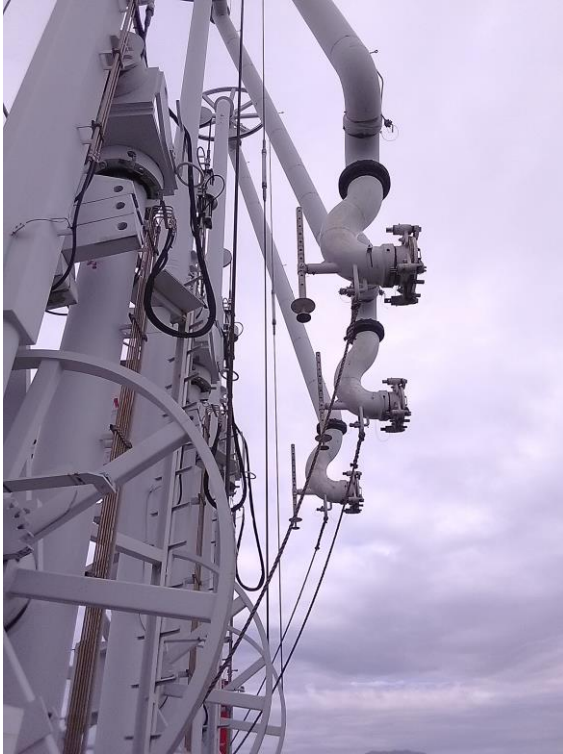
- (39) Slop collection utilities are used for coupling and de-coupling of the loading arms

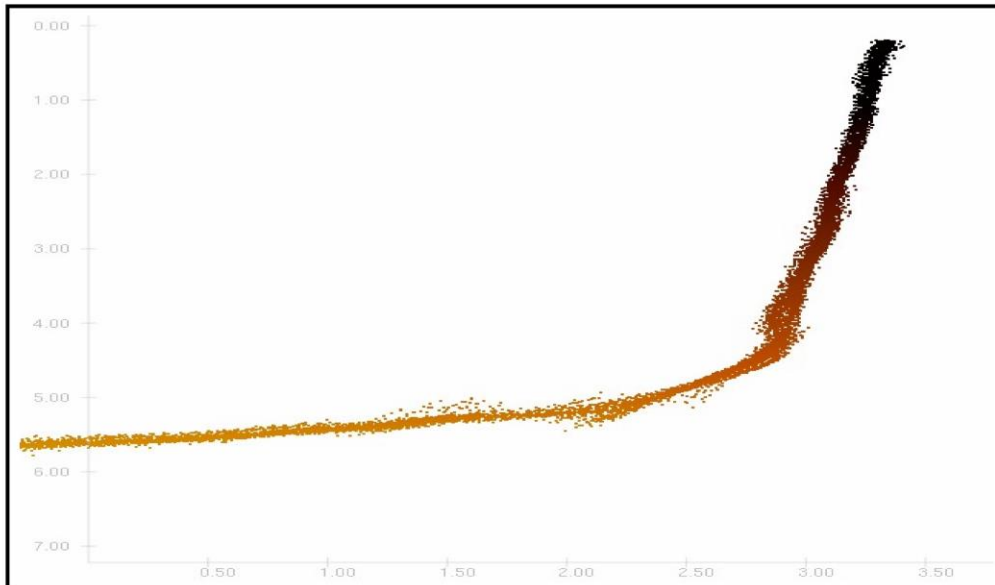
The seabed levels are generally -5mPD to -6mPD within 10m from the seawall of PAFF. The seabed descends gently from the seawall towards southwest to about -10mPD at 50m from shore. The seabed is flat and smooth in general without distinct object. A couple of 3D perspective view images and a cross section image at intake and outfall location of raw MBES soundings are presented below. From these images in which the fire services intakes and storm-water outfall are clearly measured by the system and it has no evidence showing sediment accumulation around these locations.

Figure 5: Cross section image around the intake location showing no sediment accumulation
