ANNUAL AUDIT REPORT

PERMANENT AVIATION FUEL FACILITY

Environmental Permit EP-262/2007/B

Date of Audit:		1-17 March 2023
Prepared By :	Michael Chung, Technical Manager	20 March 2023
Approved By :	Sylvia Har, General Manager	23 March 2023

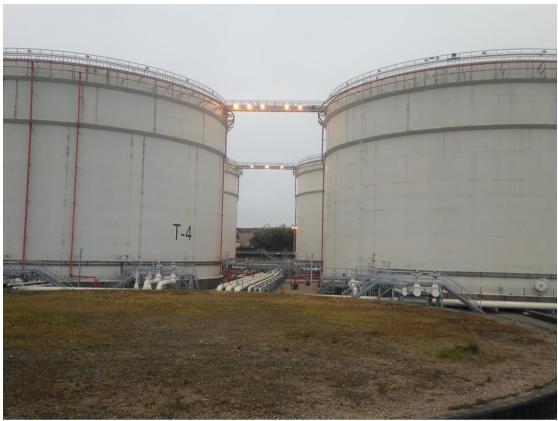
(1) Four tanks are located within bunded compound – Phase 1a

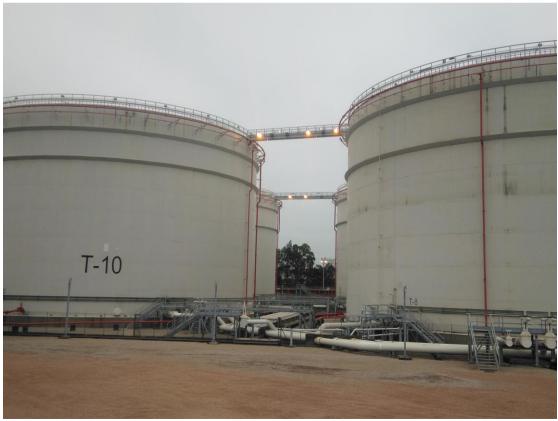
(2) Four tanks are located within bunded compound – Phase 1b

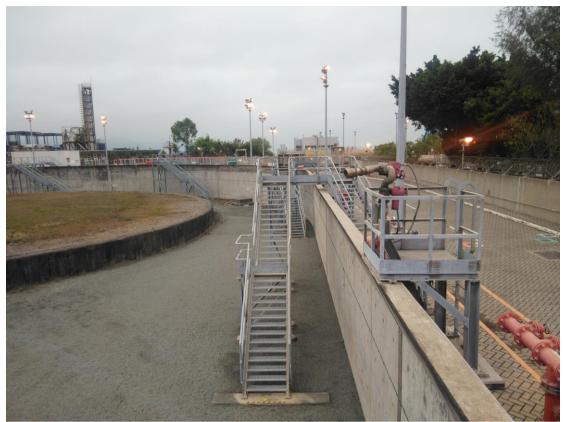
(3) Phase 1a bunded compound is lower than the ground level outside the bunds

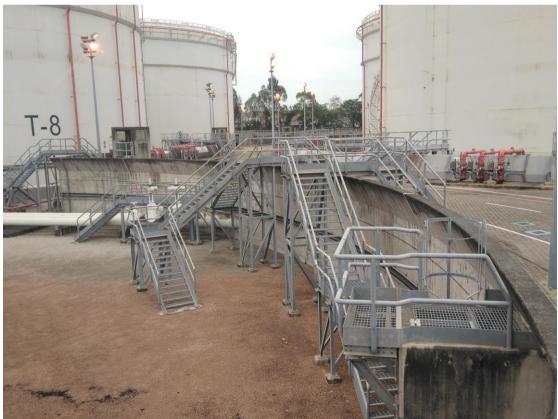
(4) Phase 1b bunded compound is lower than the ground level outside the bunds

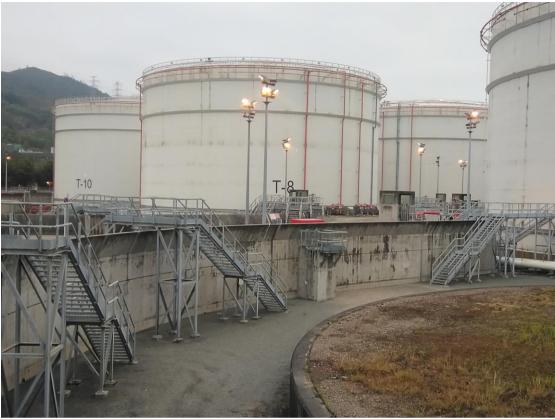
(5) Wave deflector is located at top of the bund

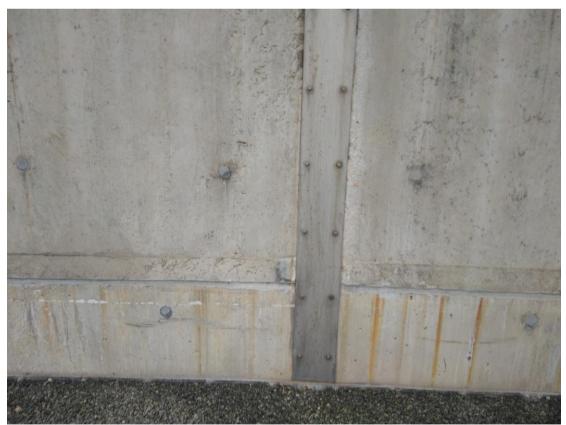
(6) Visible parts of the joints are covered by stainless steel plates on the inside at phase 1a bund

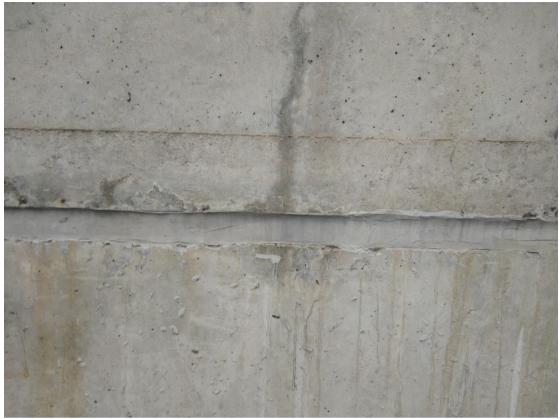
(7) Maintenance works have been performed on sealant at joints

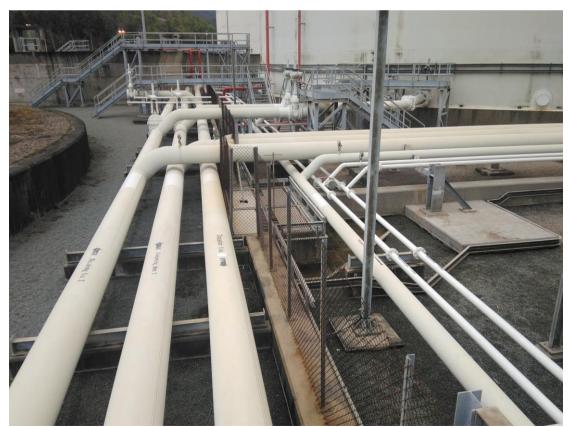
(8) Intermediate bund walls are provided in place near T-01-004

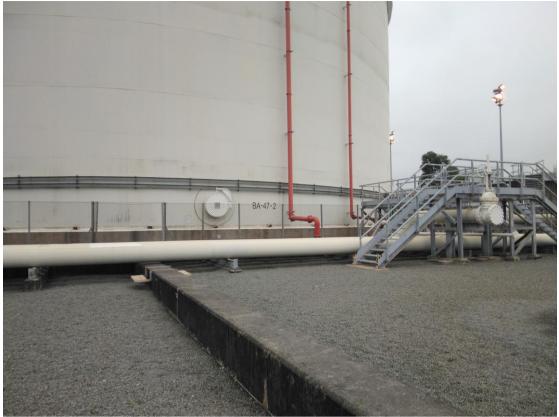
(9) Intermediate bund walls are provided in place near T-01-002

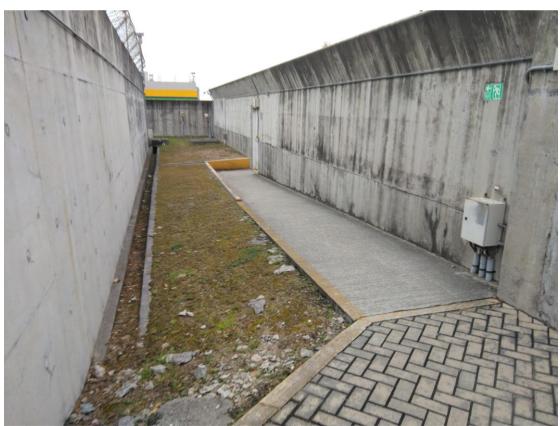
(10) Two impervious security walls are provided outside the bunded compounds

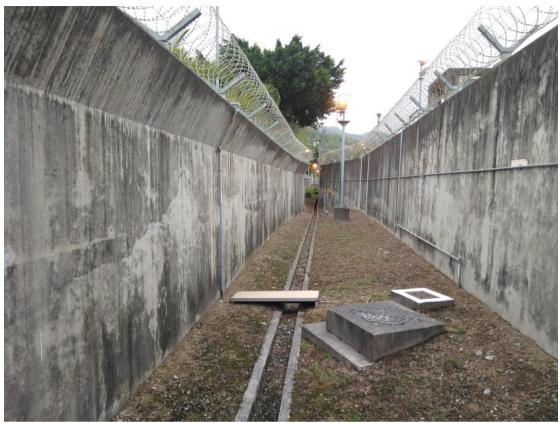
(11) Two impervious security walls are provided outside the bunded compounds

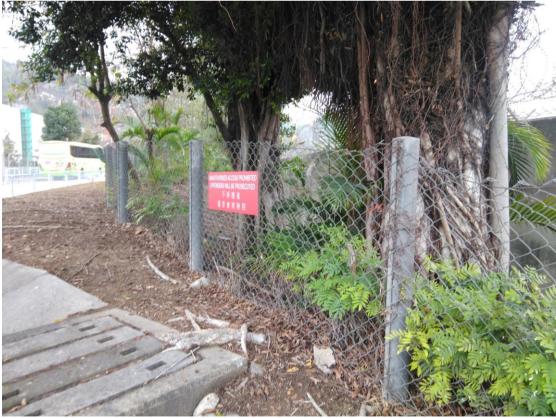
Observation	Result
It was confirmed in the Design Audit Report dated October 2010 that :-	O
Drawing PAFF/BA/02/DWG/C/1481 illustrates a landscaped berm of at least 1.5m high outside the outer security wall."	
There had been no change made after the completion of construction since October 2010. Photographs No. 12 & 13 show that a landscaped berm of at least 1.5m high outside the outer security wall is in place and properly maintained.

(12) Landscaped berm is maintained at least 1.5m high

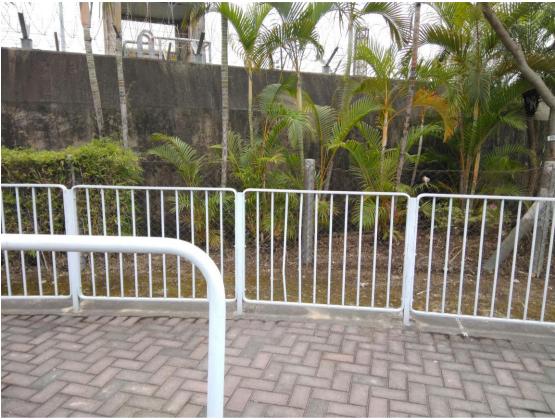
(13) Landscaped berm is maintained at least 1.5m high

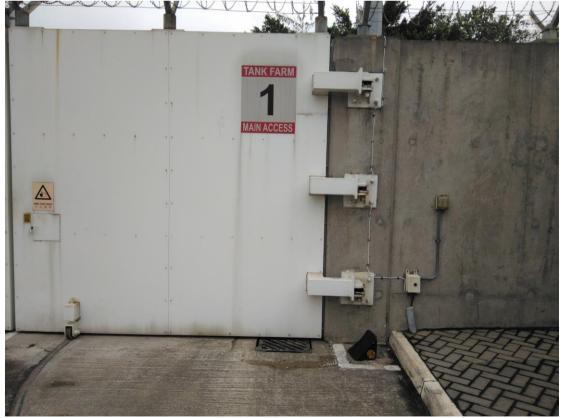
(14) Gates at security walls with sealant are maintained in good condition

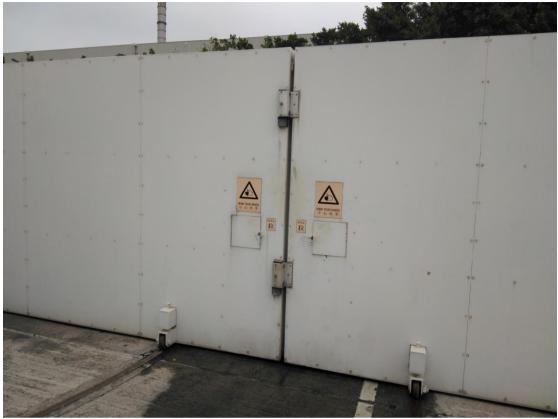
(15) Gates at security walls with sealant are maintained in good condition

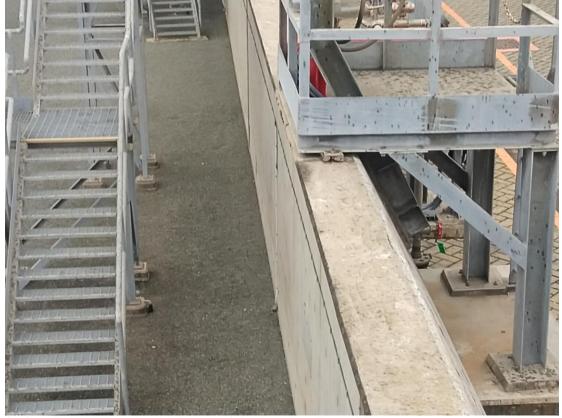
(16) This shows the thickness of the bund wall provided

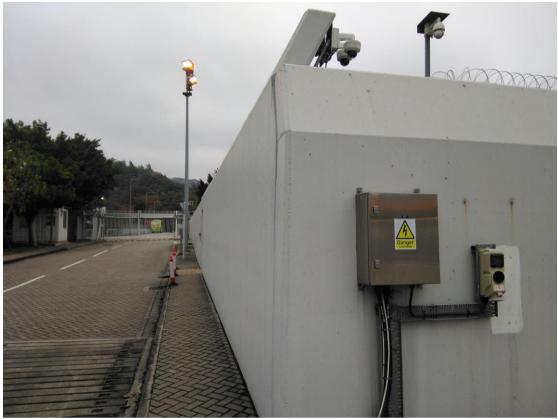
(17) This shows the thickness of the security wall provided

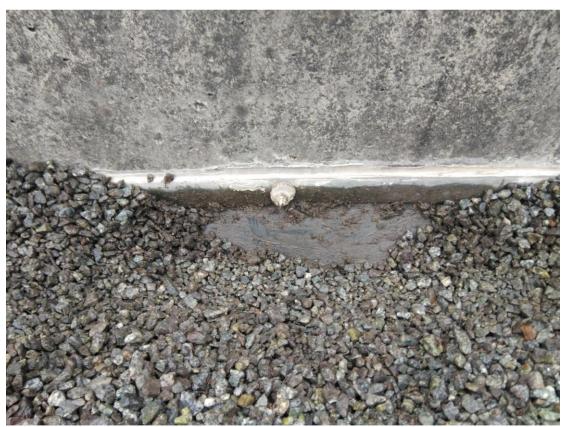
(18) Impervious lining are maintained in good condition

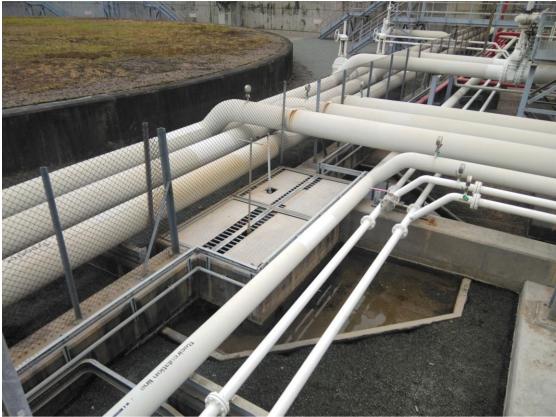
(19) Tank farm is with appropriate gradient and the drainage falls to interceptor for collection

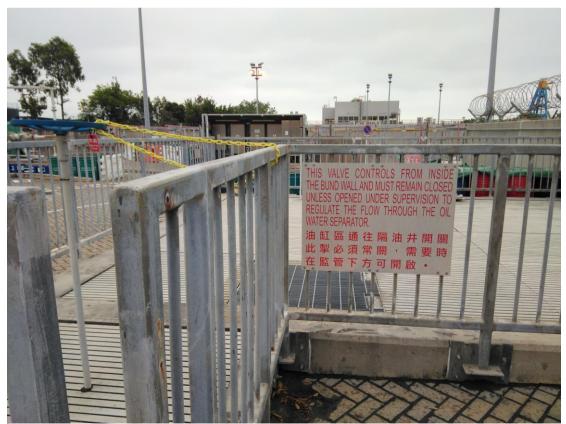
(20) Outlet valve provided for Phase 1a Interceptor with instruction sign to keep "normally closed"

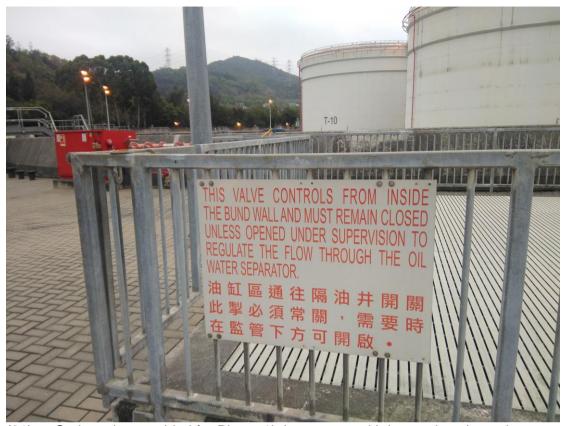
(21) Outlet valve provided for Phase 1b Interceptor with instruction sign to keep "normally closed"

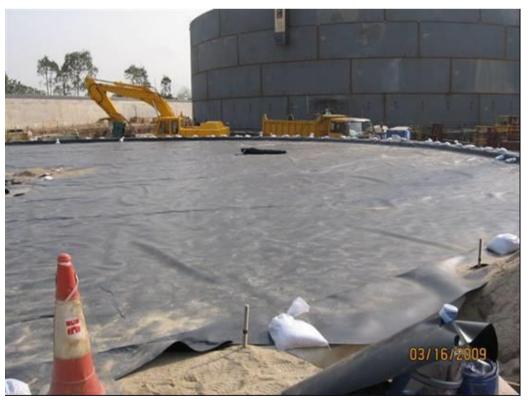
(22) Record photo shows impervious membrane being installed on top of tank foundation

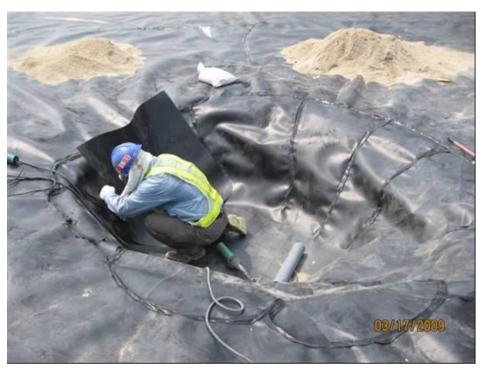
(23) Record photo shows imperious membrane laid at tank center sump with tell-tale pipe embedded for leak detection

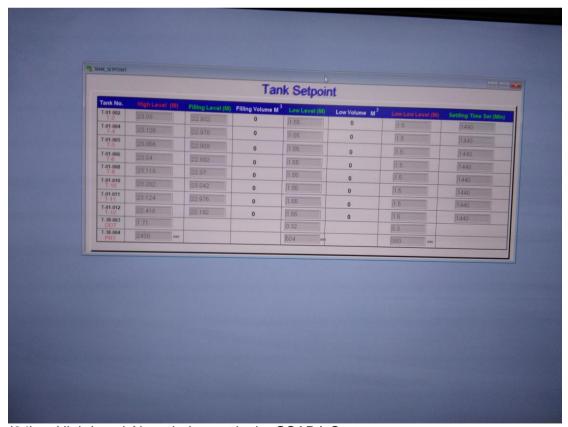
(24) High Level Alarm being set in the SCADA System

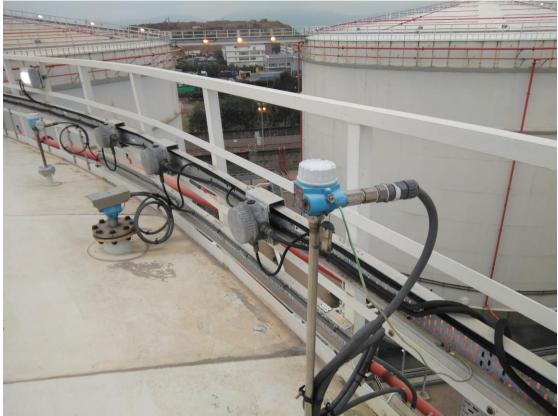
(25) Regular inspection performed on overfilling monitoring device (High-High Level Alarm)

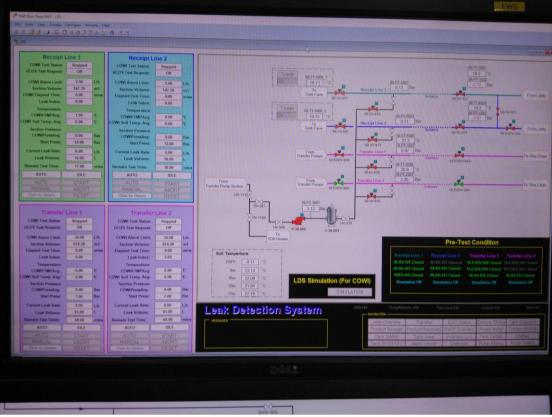
(27) Leak detection "COWI Stat Leak System" installed into computer

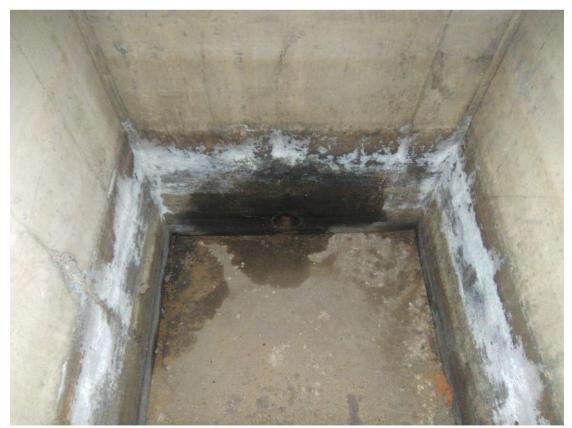
(28) Leak detection tell-tale pipe underneath the storage tank opens out to a collection chamber

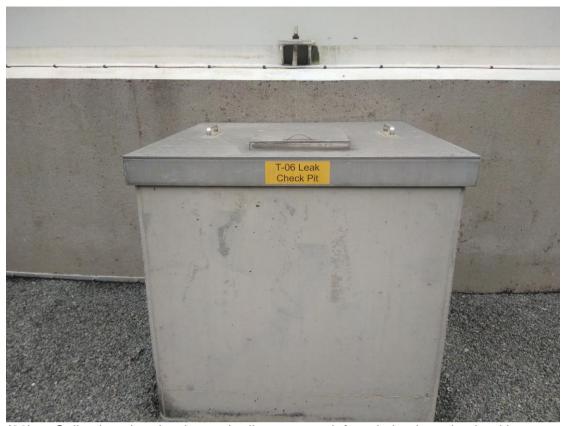
(29) Collection chamber located adjacent to tank foundation is maintained in good condition with periodic inspection

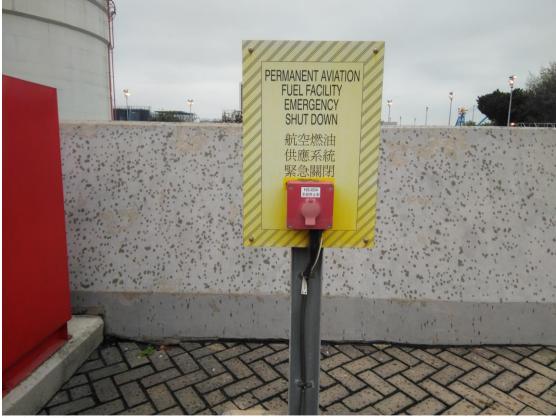
(30) ESD device is maintained in good condition and being tested periodically

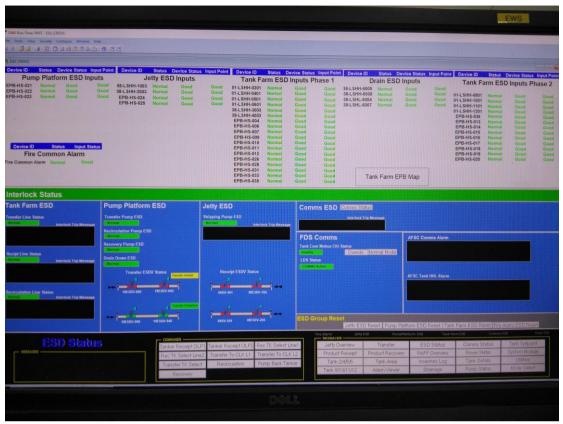
(31) The ESD regular testing as shown in SCADA System

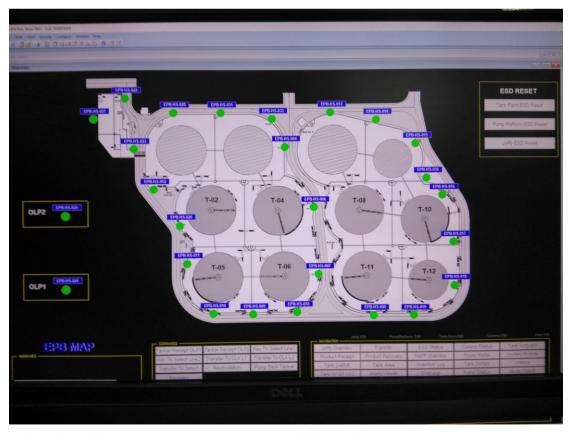
(32) The ESD regular testing as shown in SCADA System

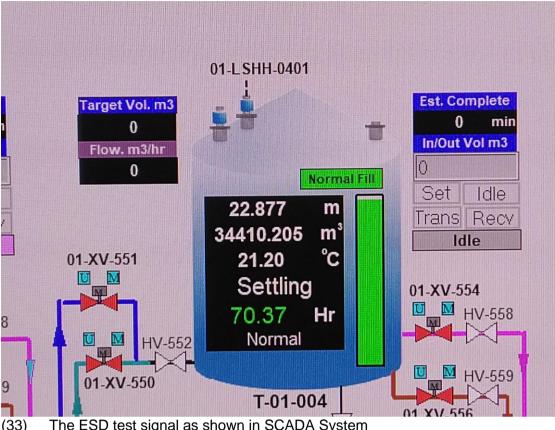
The ESD test signal as shown in SCADA System (33)

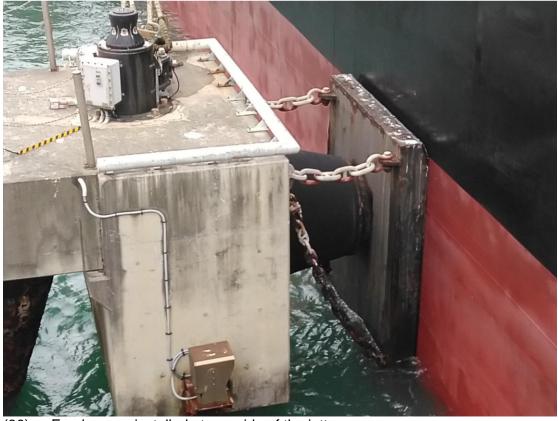
(36) Fenders are installed at sea side of the jetty

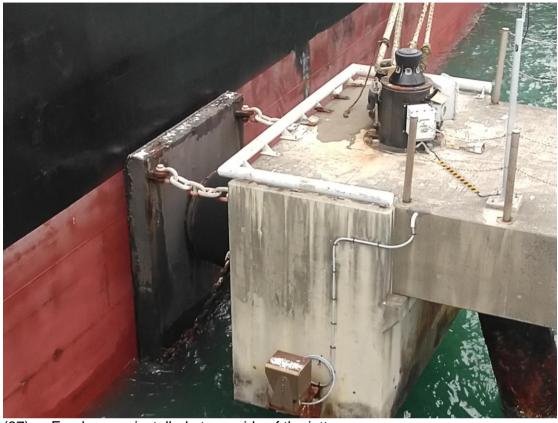
(37) Fenders are installed at sea side of the jetty

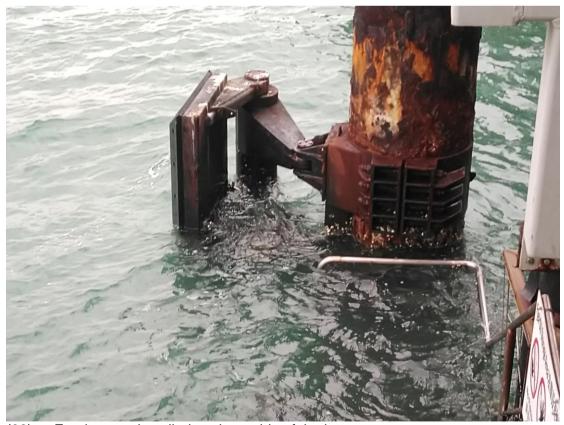
(38) Fenders are installed at shore side of the jetty

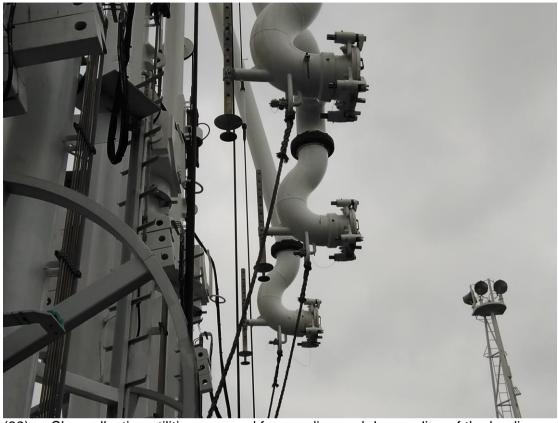
(39) Slop collection utilities are used for coupling and de-coupling of the loading arms
