ANNUAL AUDIT REPORT
For
PERMANENT AVIATION FUEL FACILITY
Environmental Permit
EP-262/2007/B

Date of Audit :		1-7 March 2024
Prepared By :	Ip Siu On, HSE Officer	8 March 2024
Approved By :	Sylvia Har, General Manager	18 March 2024

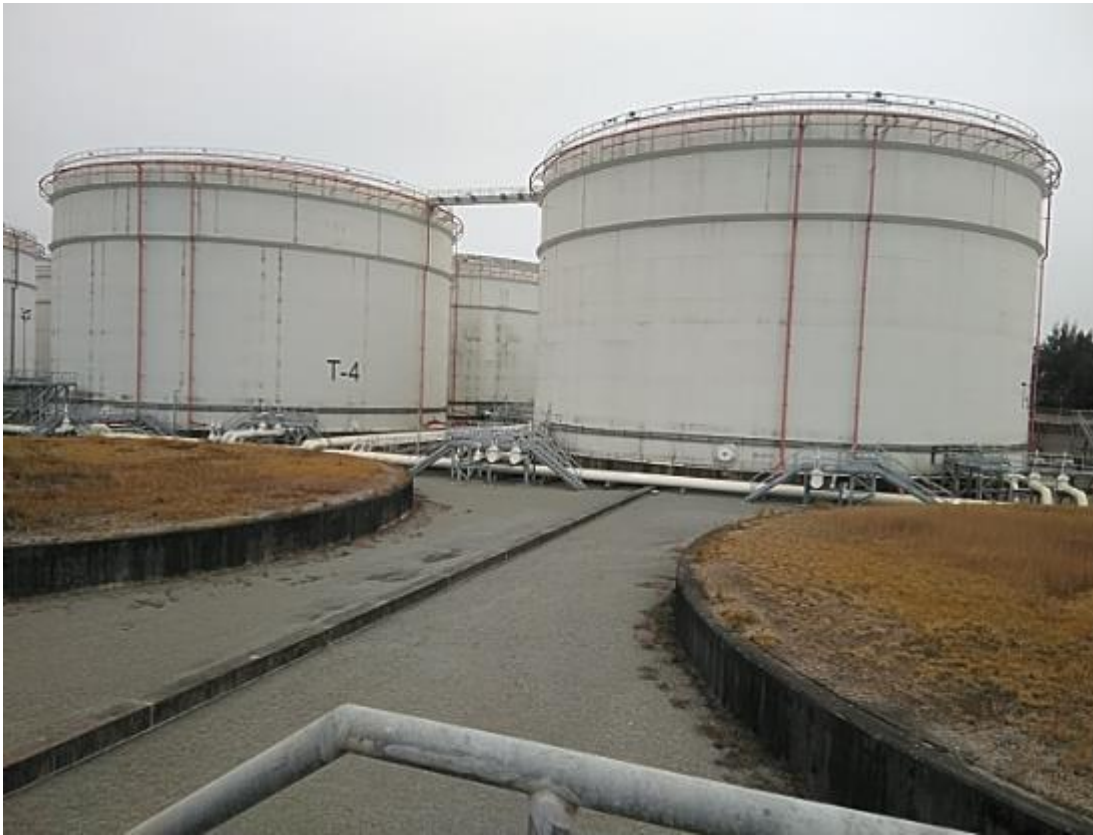
(1) Four tanks are located within bunded compound – Phase 1a

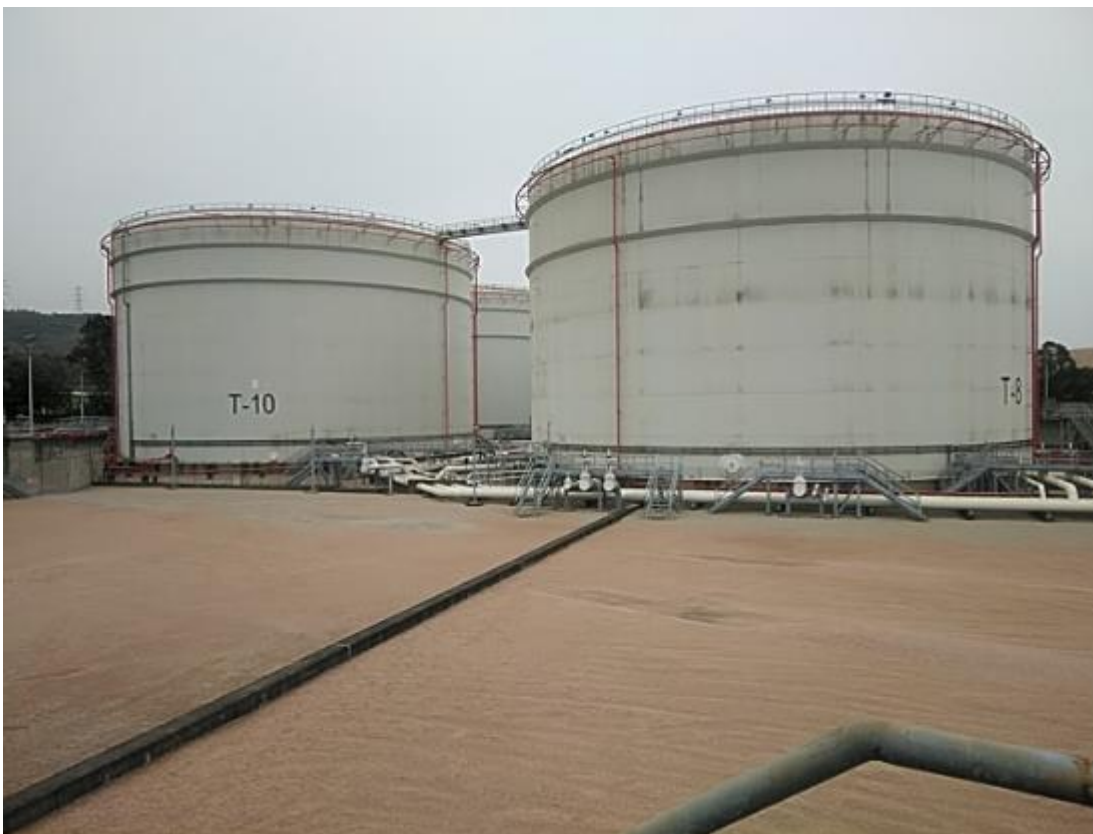
(2) Four tanks are located within bunded compound – Phase 1b

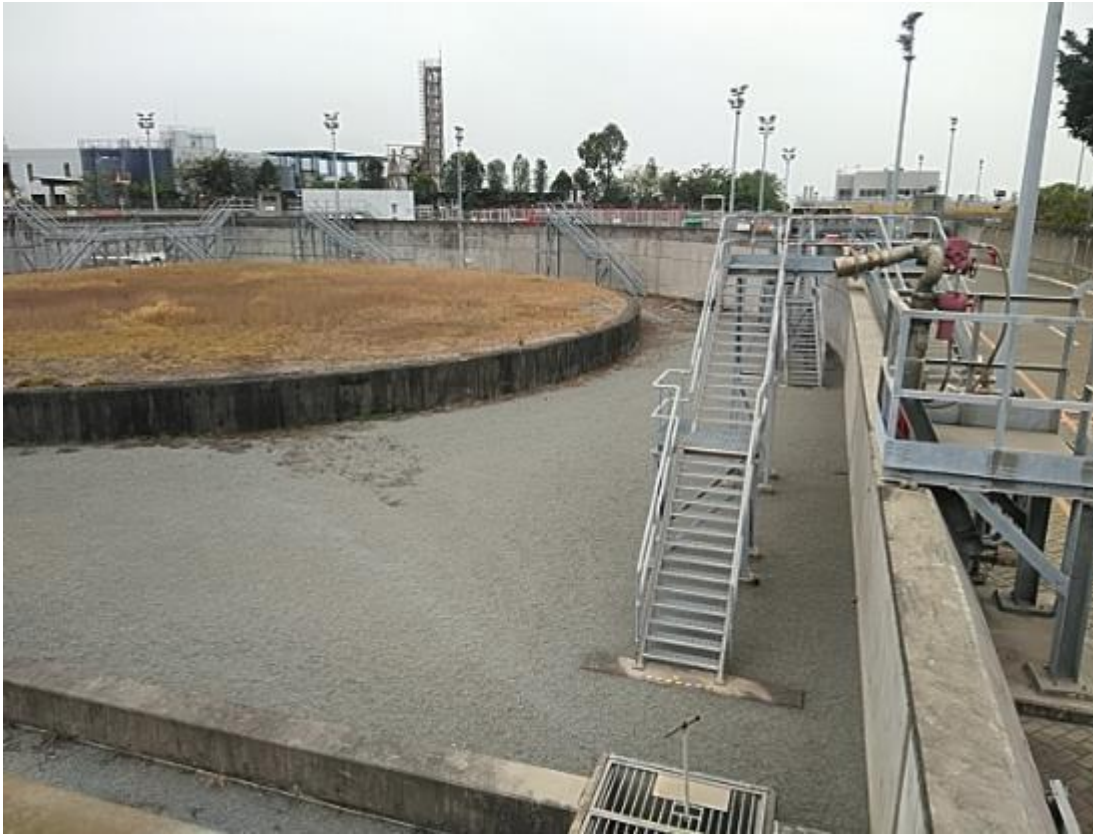
(3) Phase 1a bunded compound is lower than the ground level outside the bunds

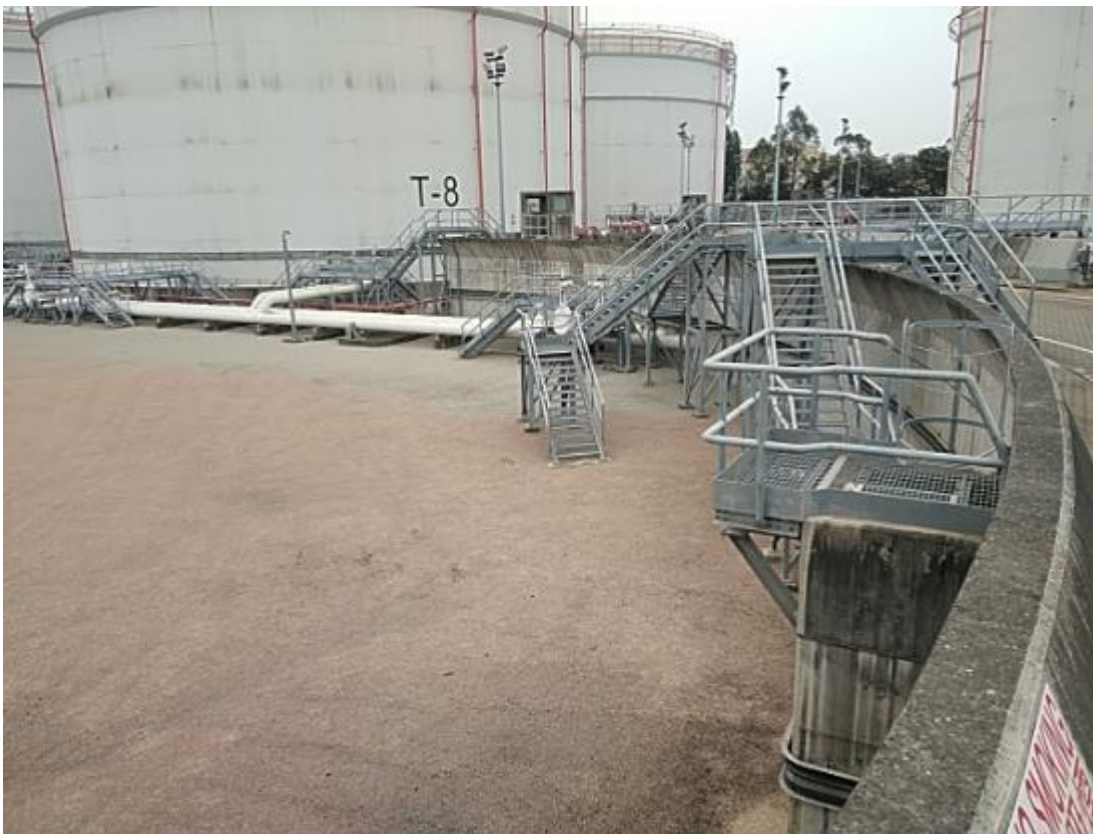
(4) Phase 1b bunded compound is lower than the ground level outside the bunds

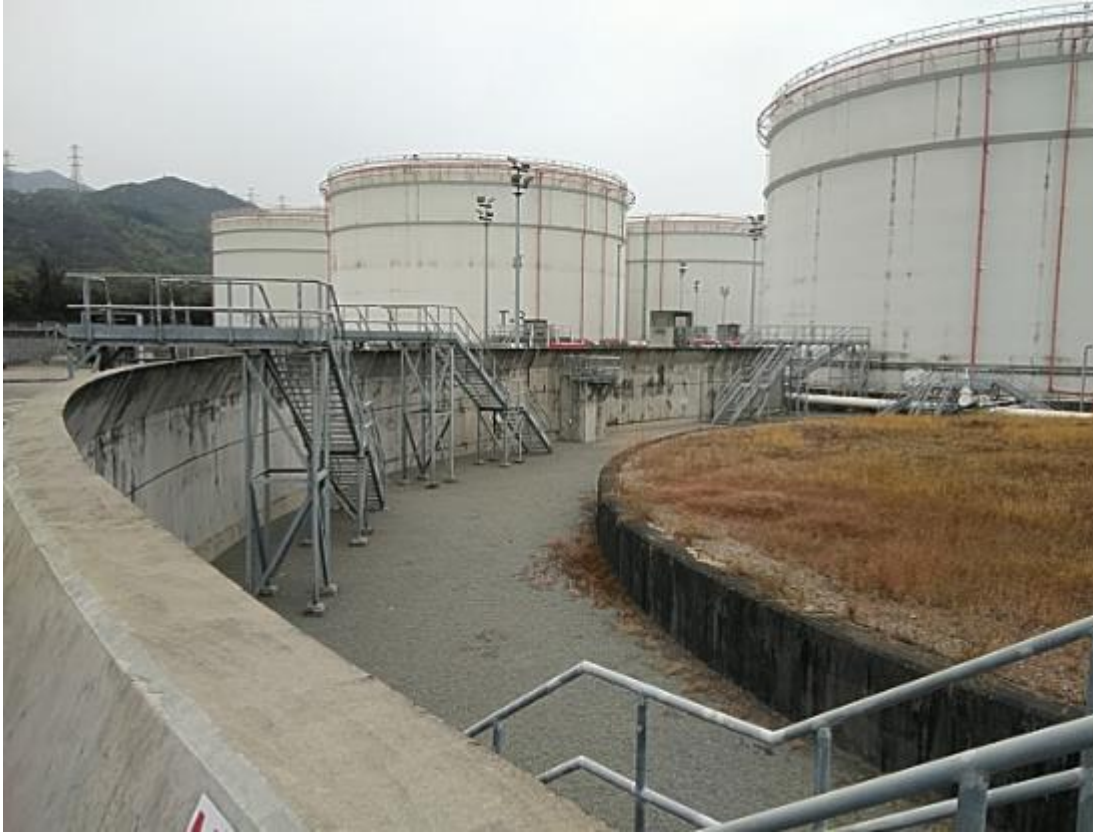
(5) Wave deflector is located at top of the bund

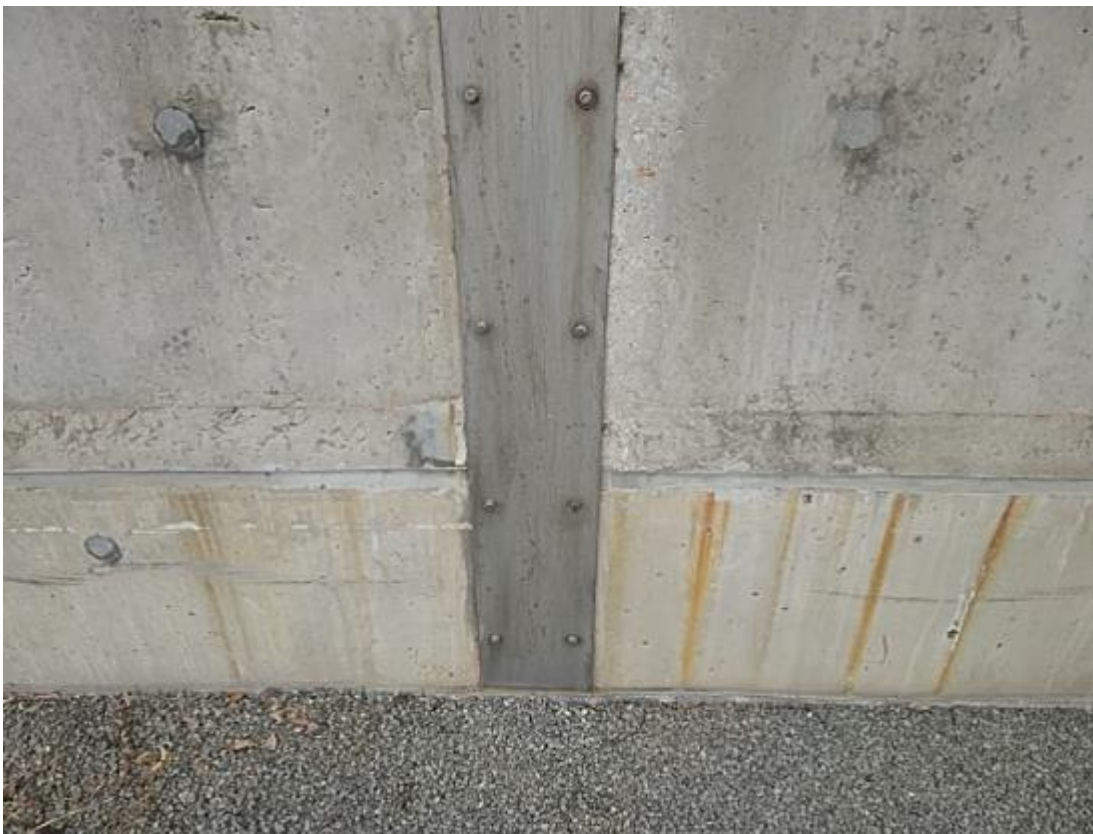
(6) Visible parts of the joints are covered by stainless steel plates on the inside at phase 1a bund

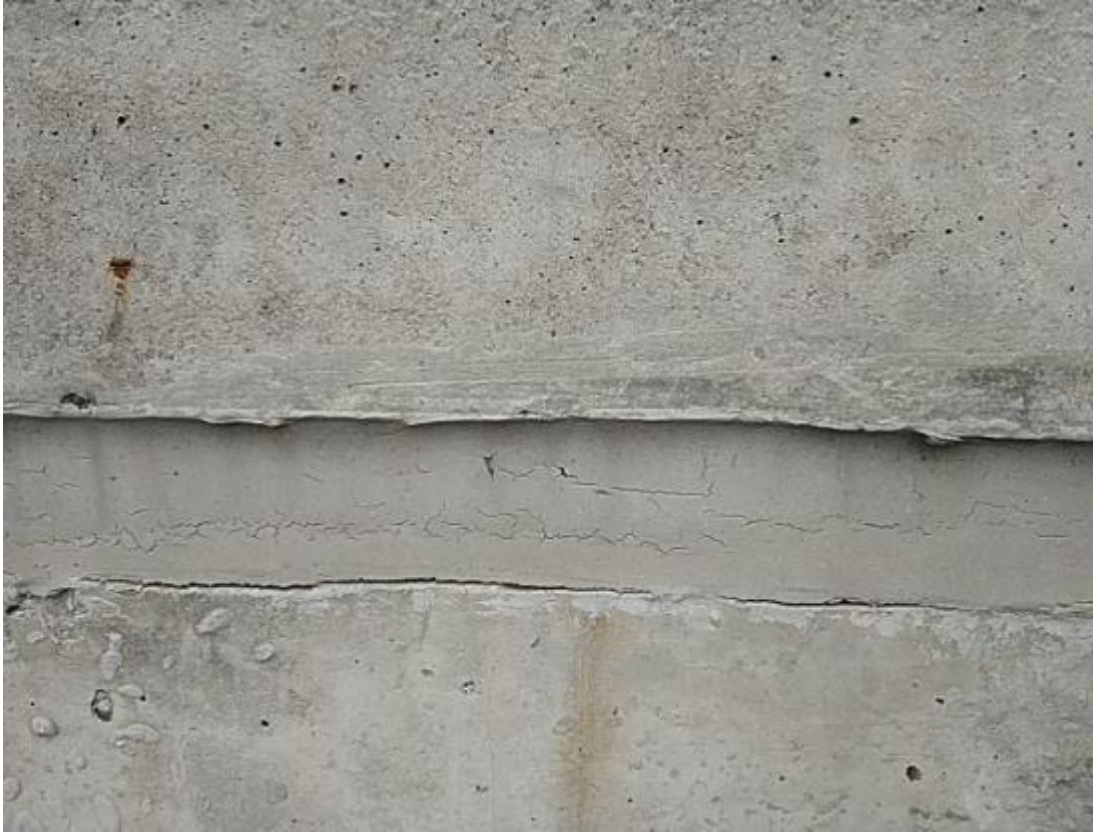
(7) Maintenance works have been performed on sealant at joints

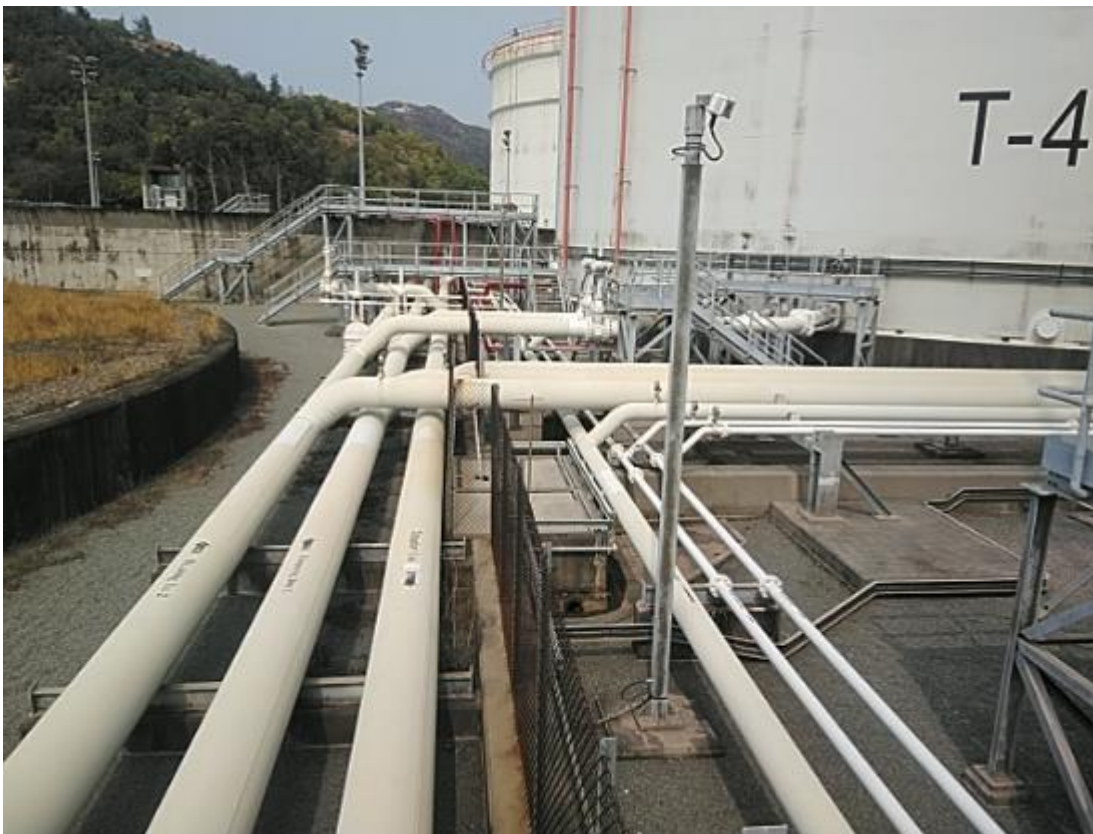
(8) Intermediate bund walls are provided in place near T-01-004

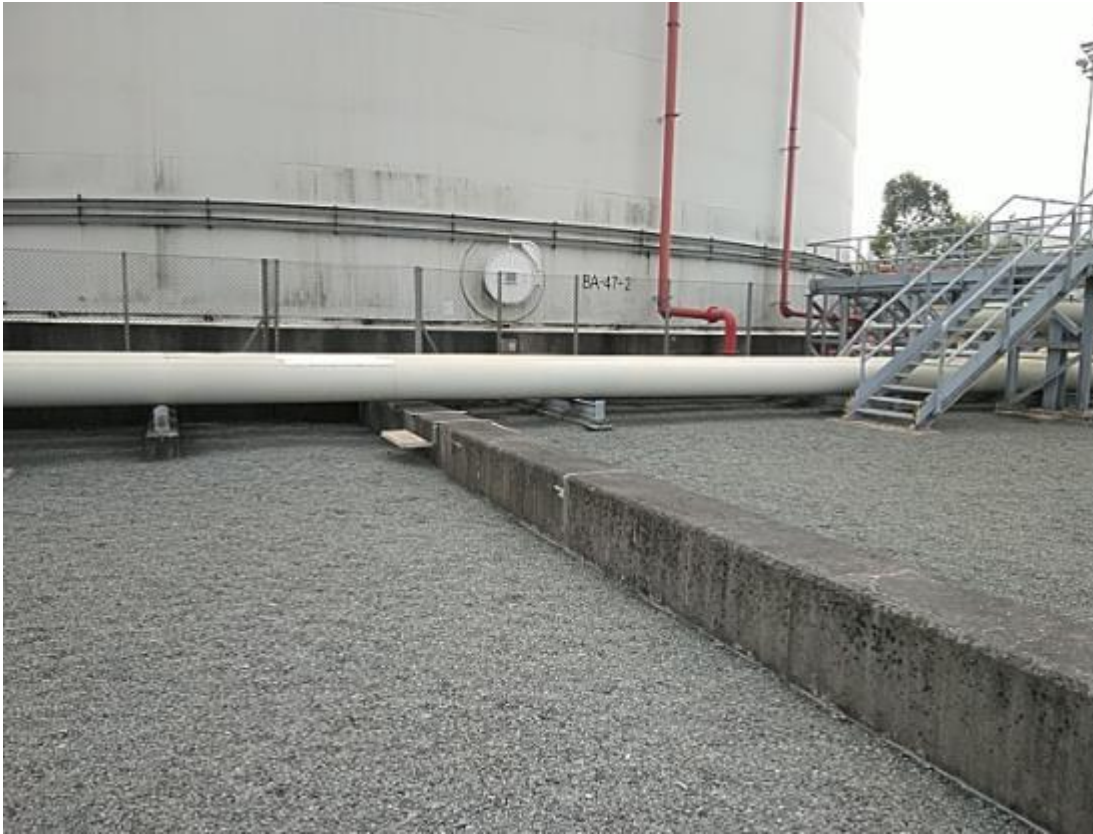
(9) Intermediate bund walls are provided in place near T-01-002

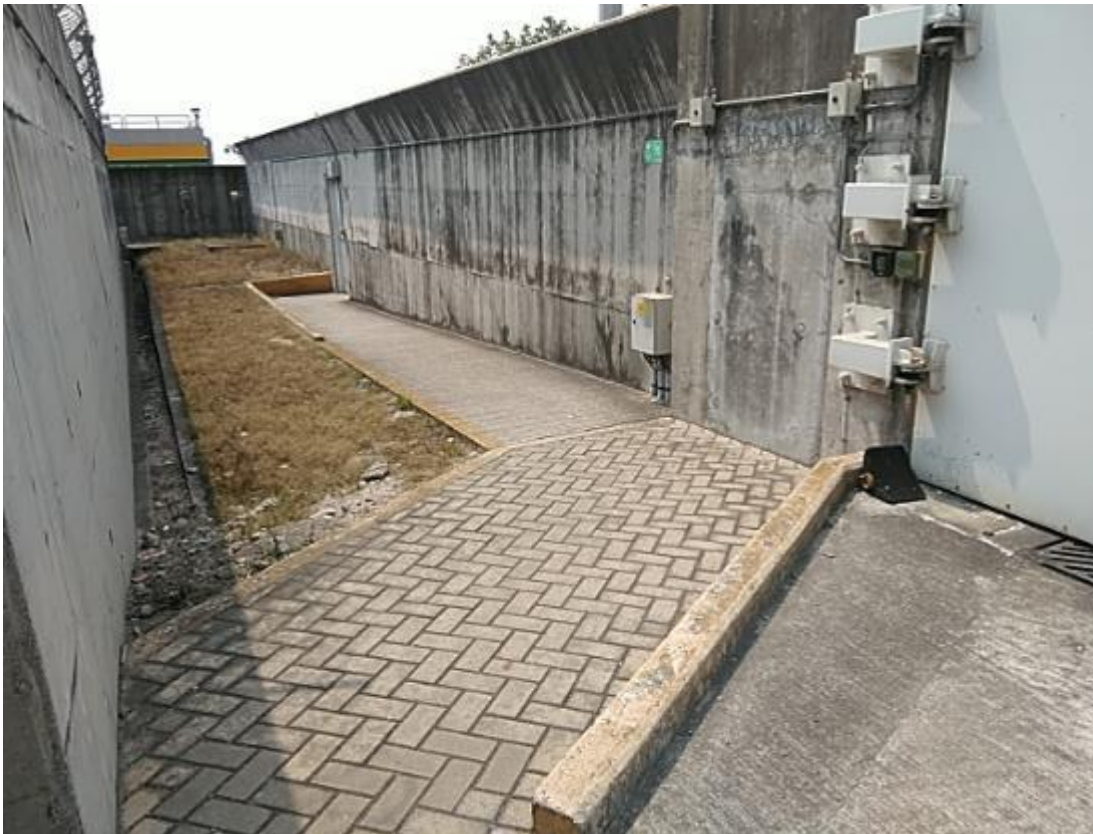
(10) Two impervious security walls are provided outside the bunded compounds

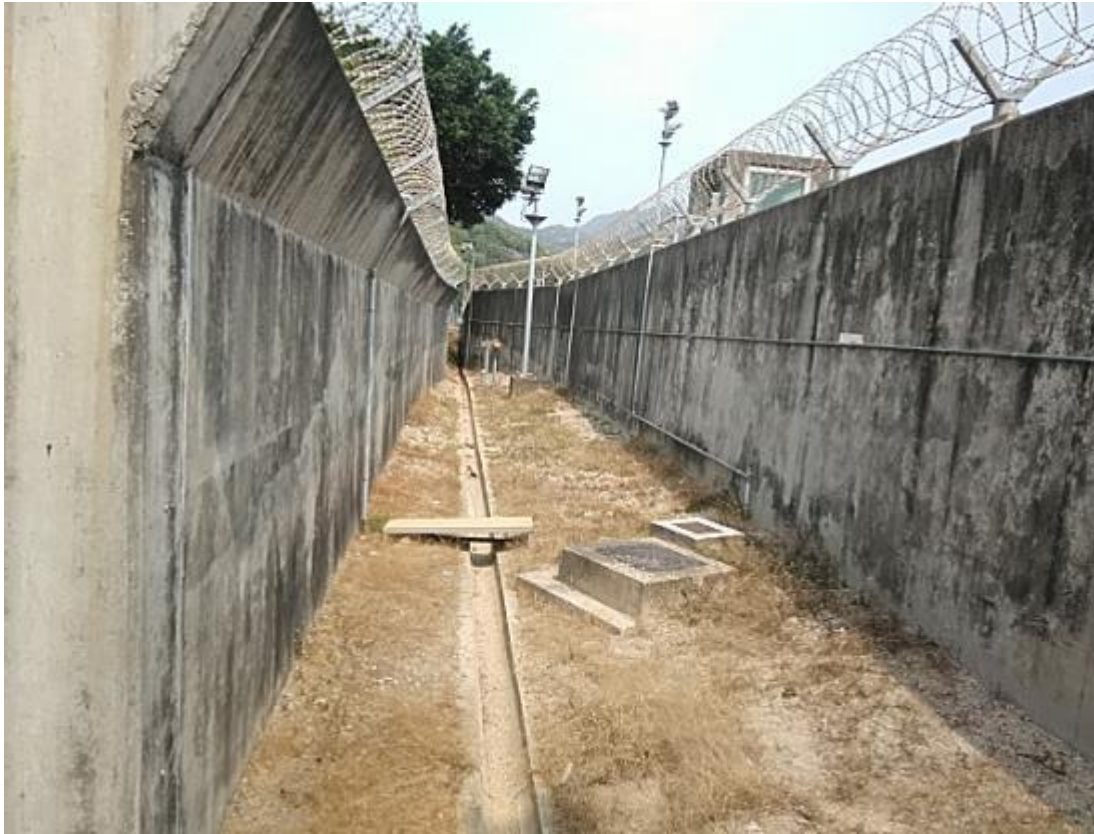
(11) Two impervious security walls are provided outside the bunded compounds

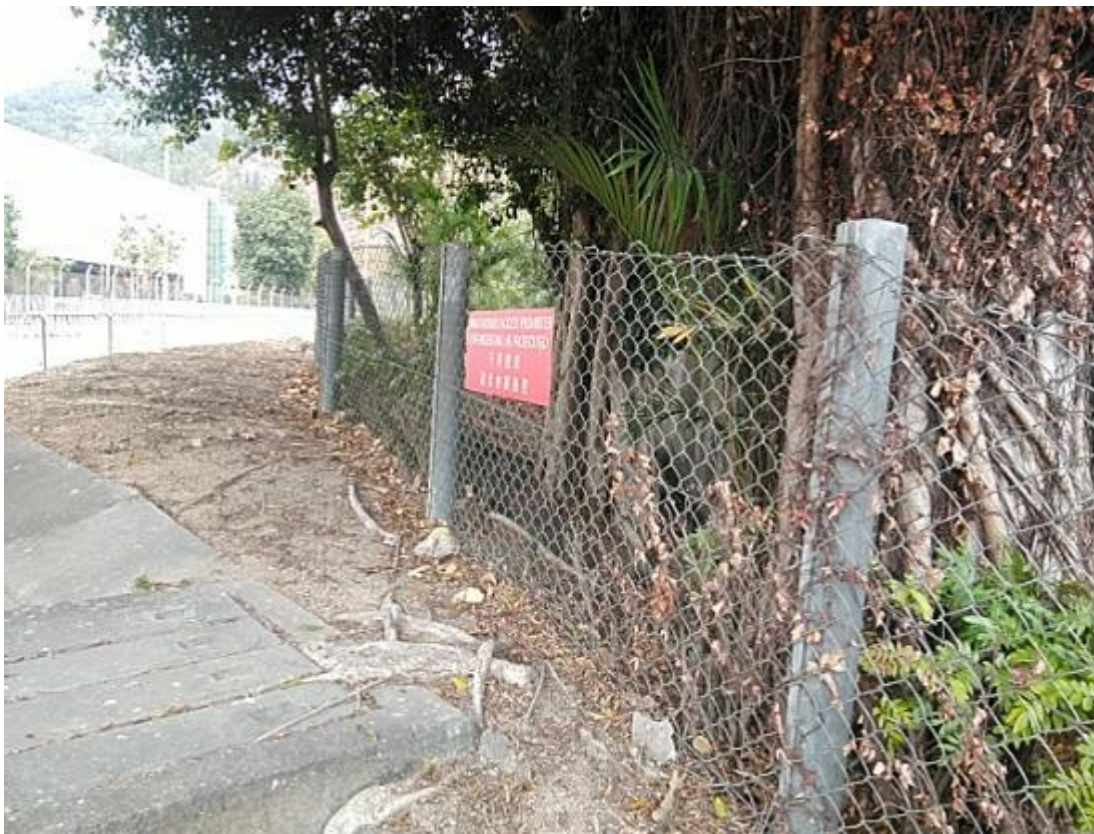
(12) Landscaped berm is maintained at least 1.5m high

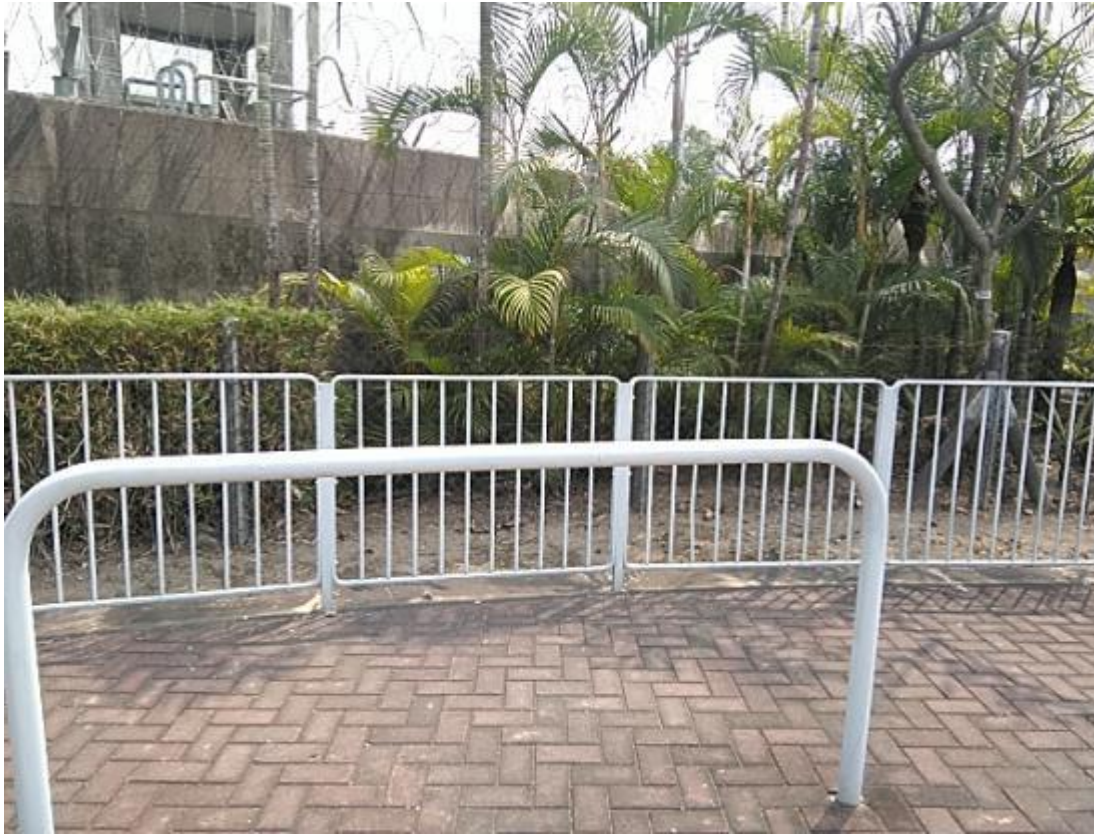
(13) Landscaped berm is maintained at least 1.5m high

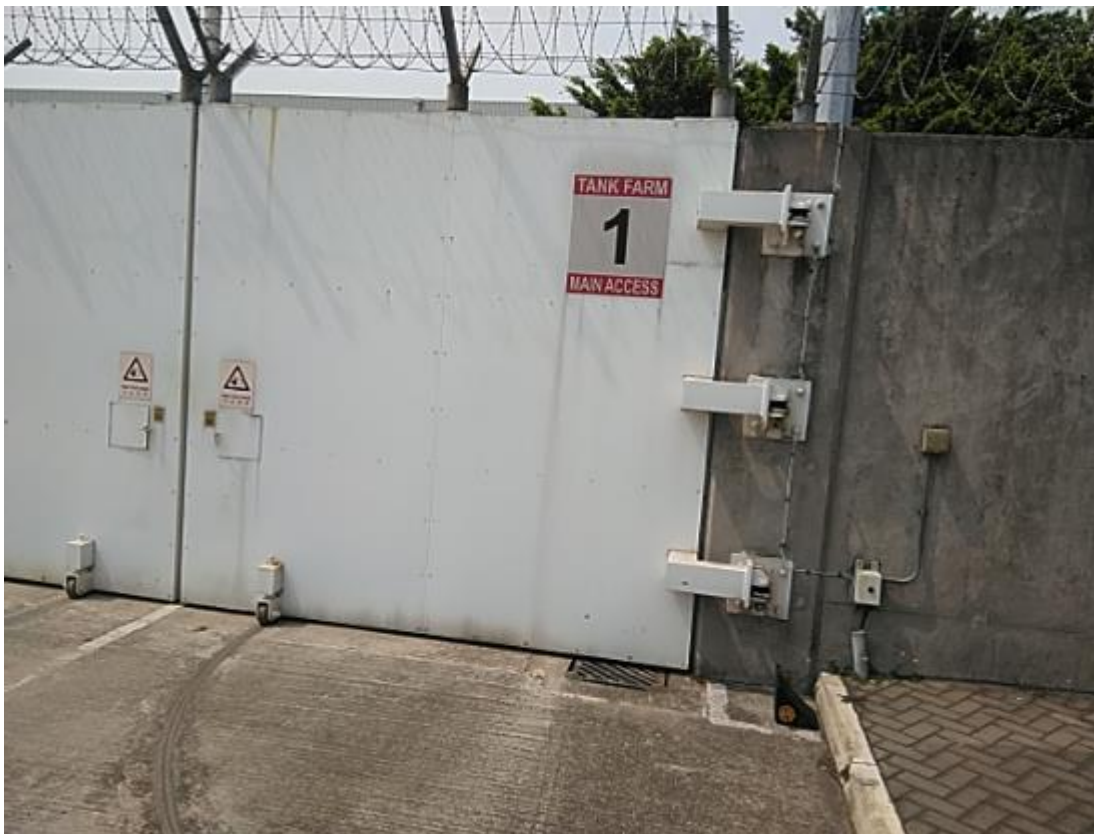
(14) Gates at security walls with sealant are maintained in good condition

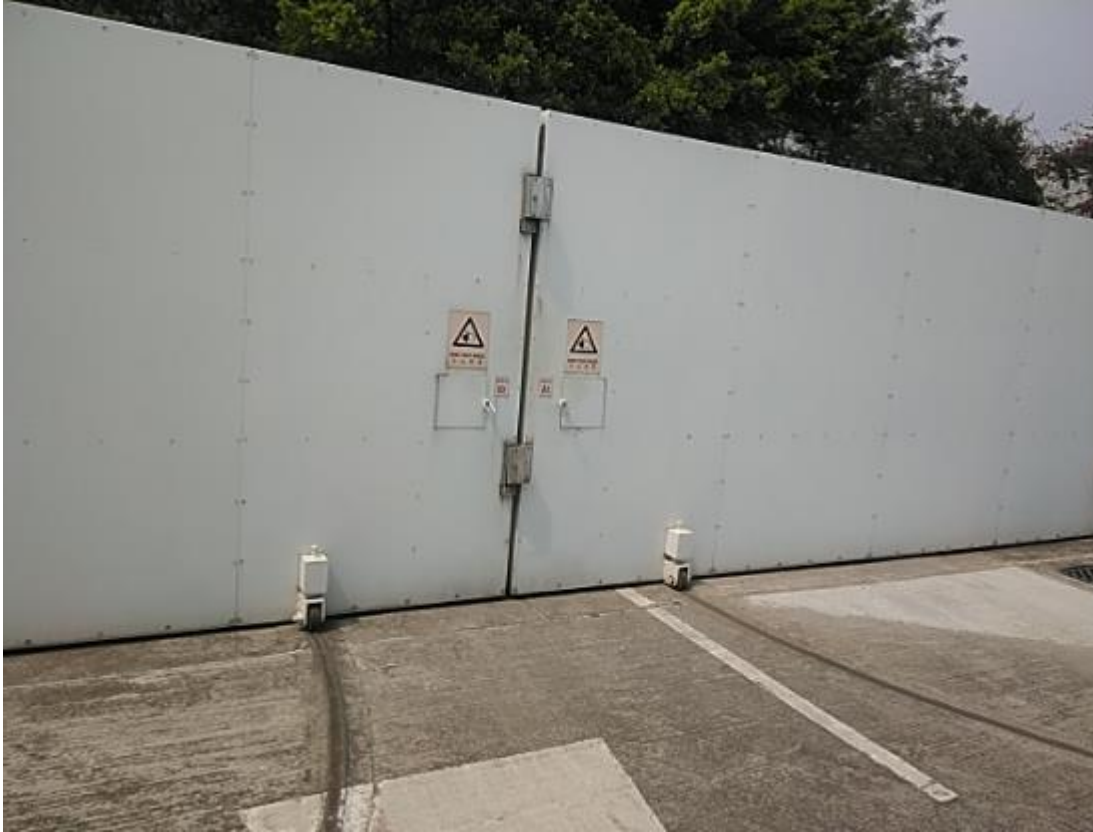
(15) Gates at security walls with sealant are maintained in good condition

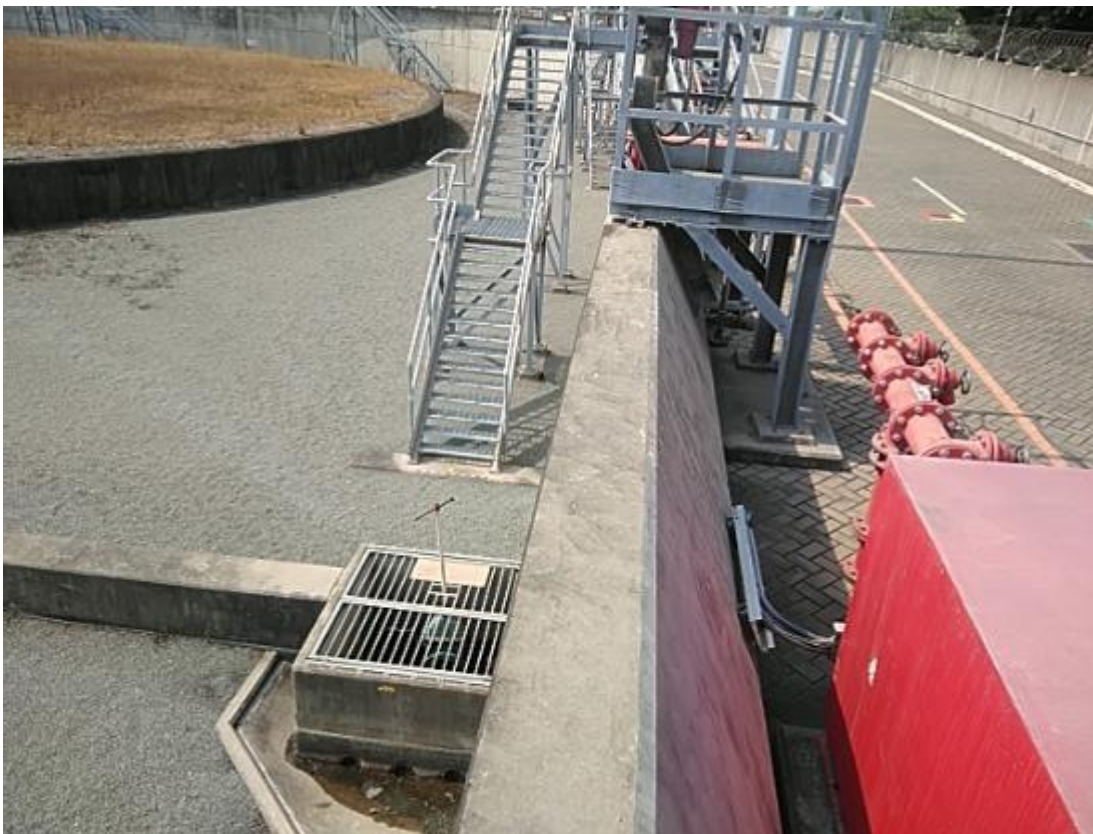
(16) This shows the thickness of the bund wall provided

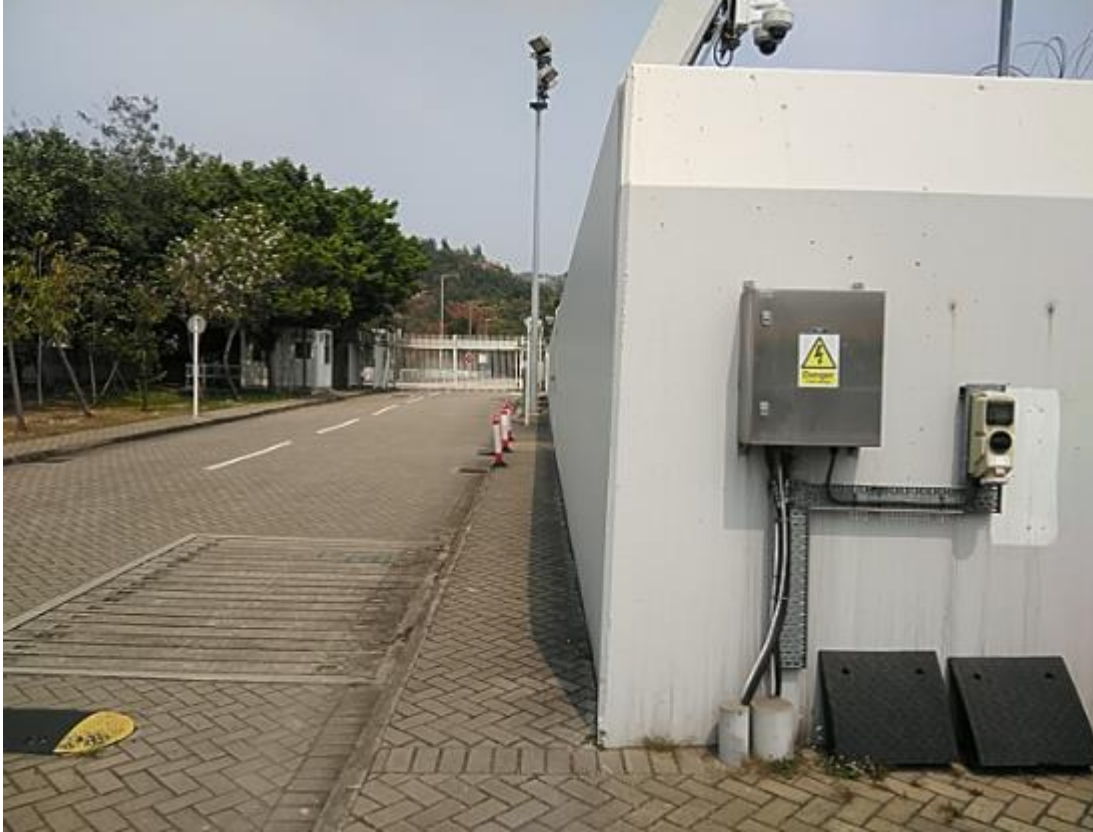
(17) This shows the thickness of the security wall provided

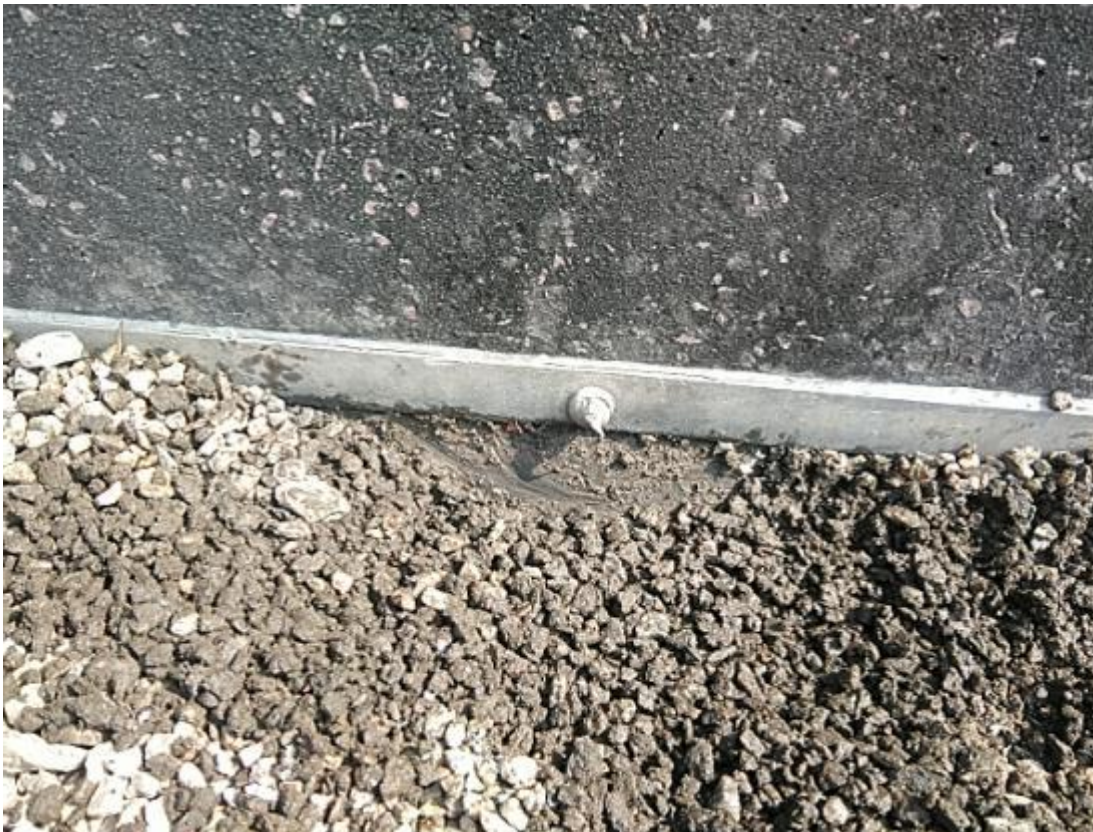
(18) Impervious lining are maintained in good condition

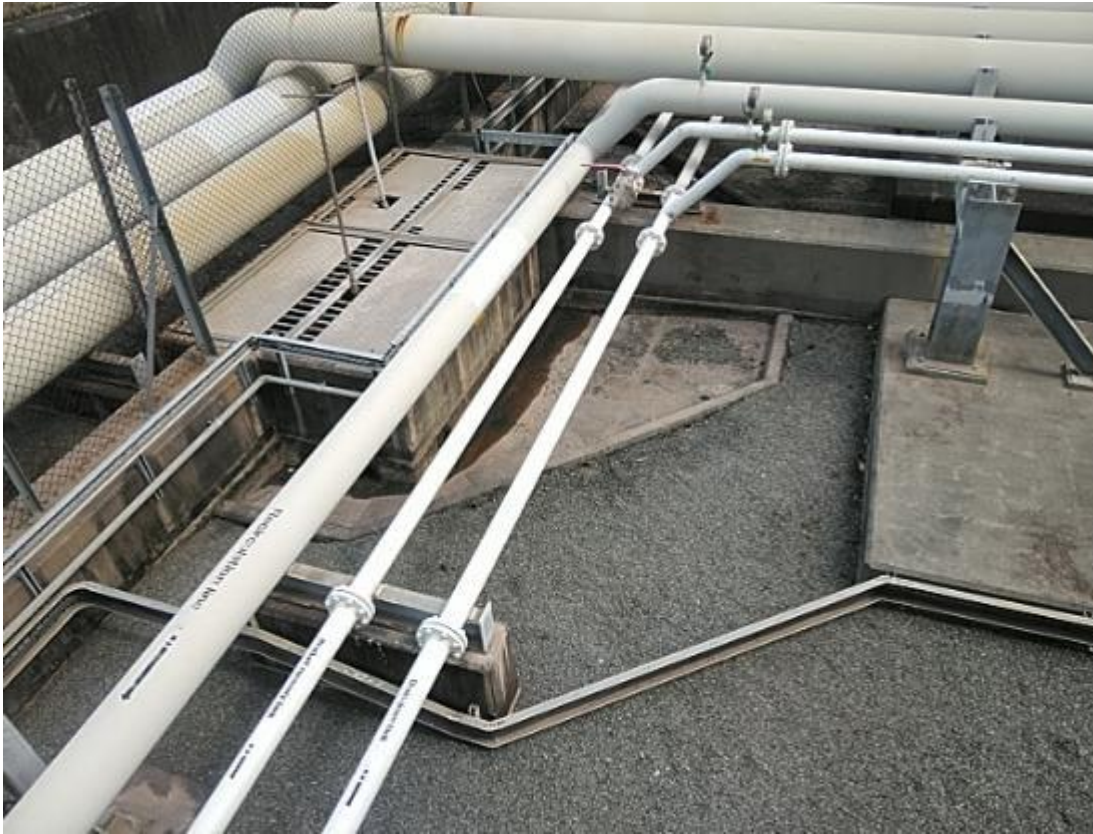
(19) Tank farm is with appropriate gradient and the drainage falls to interceptor for collection

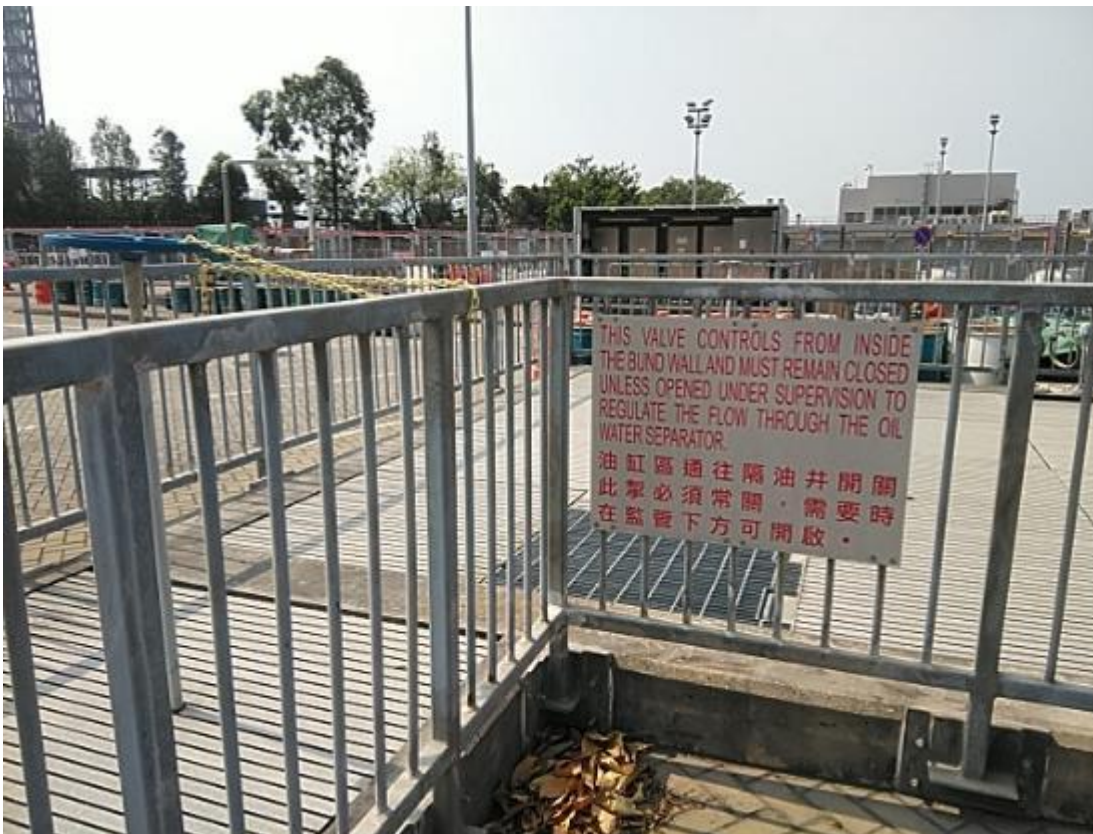
(20) Outlet valve provided for Phase 1a Interceptor with instruction sign to keep “normally closed”

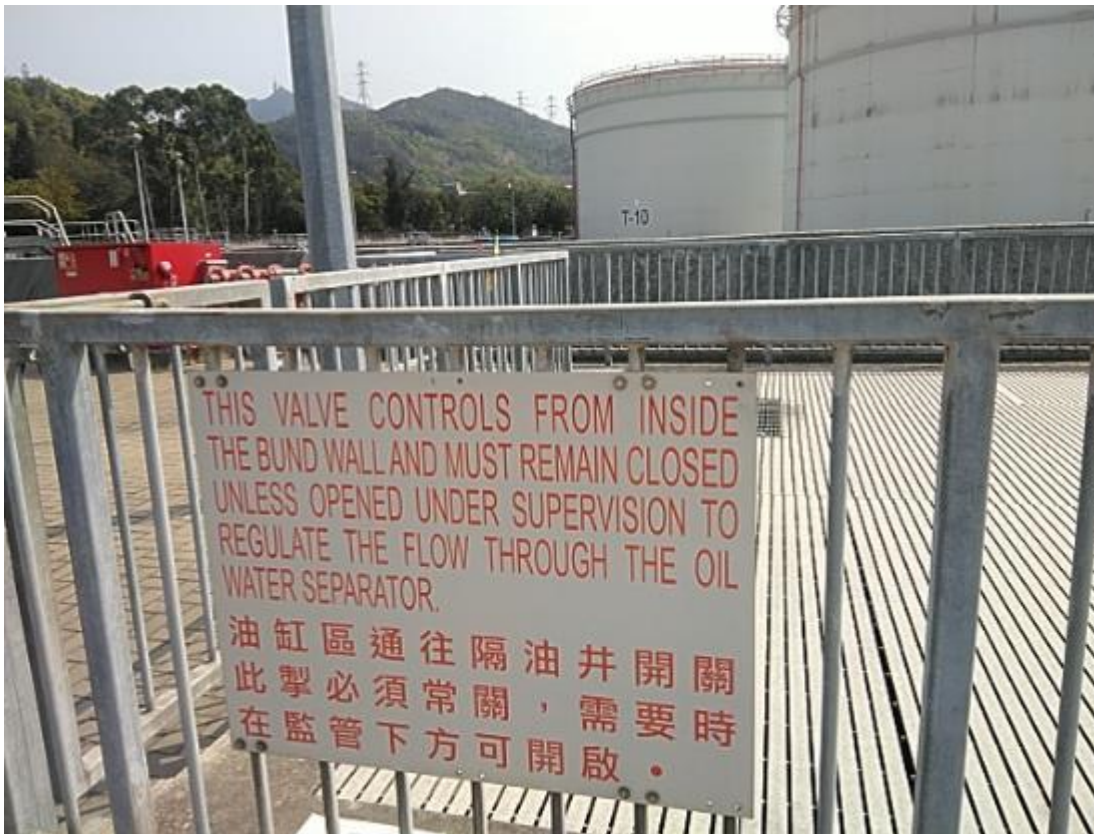
(21) Outlet valve provided for Phase 1b Interceptor with instruction sign to keep “normally closed”

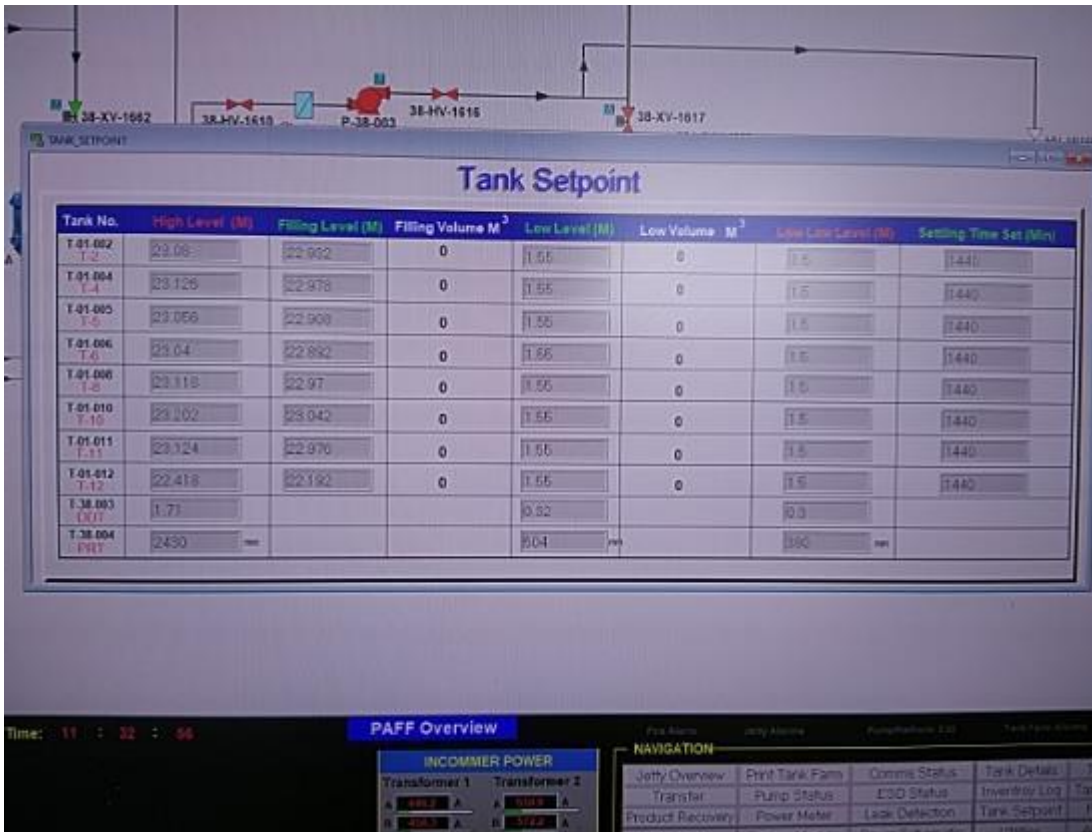
(24) High Level Alarm being set in the SCADA System

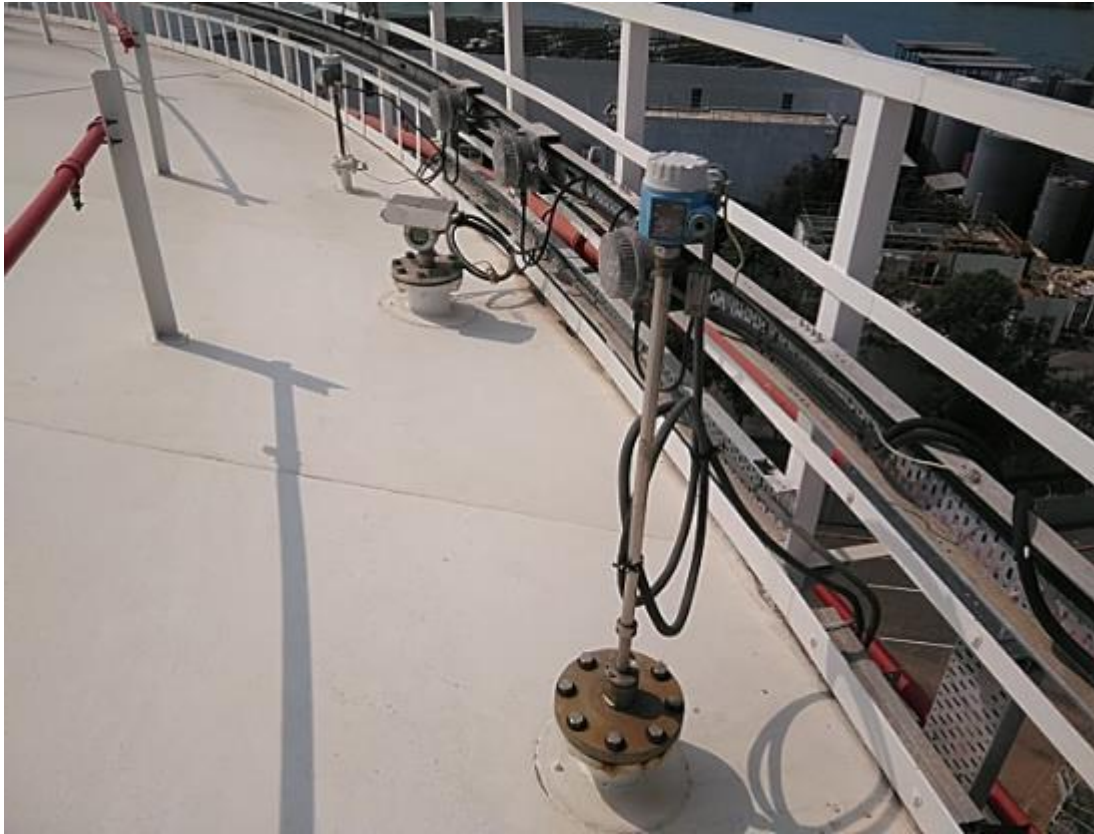
(25) Regular inspection performed on overfilling monitoring device (High-High Level Alarm)

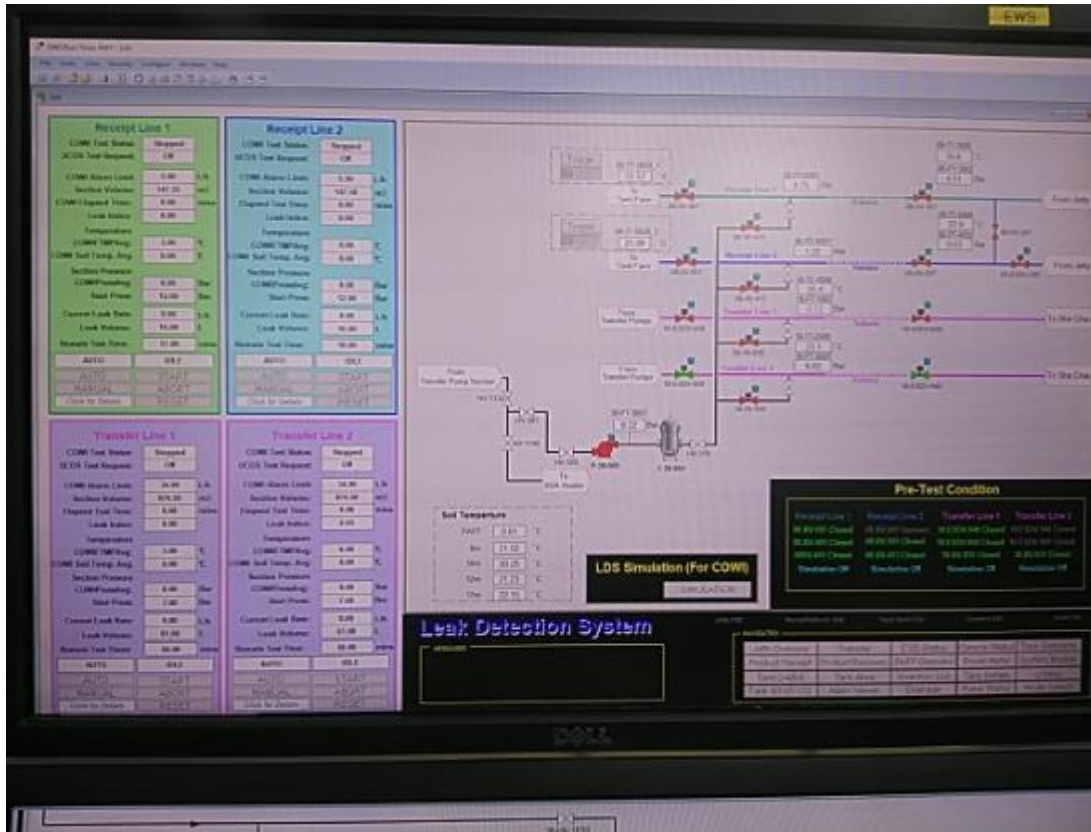
(27) Leak detection “COWI Stat Leak System” installed into computer

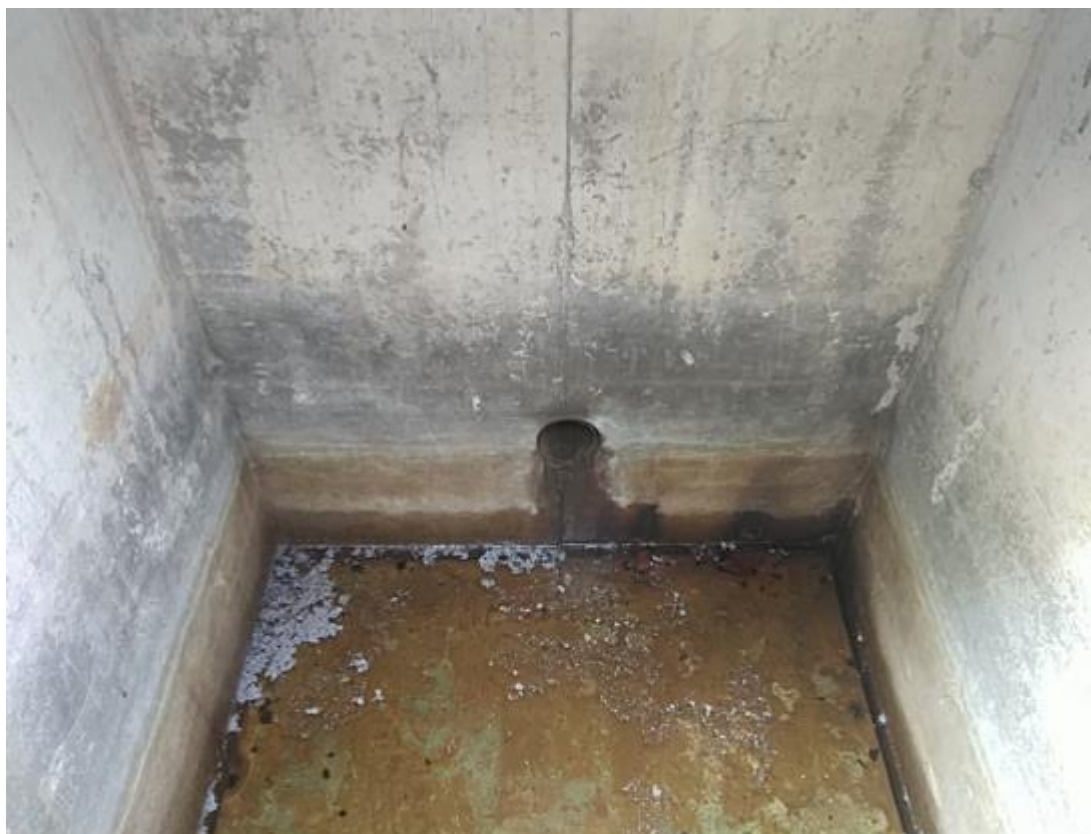
(28) Leak detection tell-tale pipe underneath the storage tank opens out to a collection chamber
