ANNUAL AUDIT REPORT
For
PERMANENT AVIATION FUEL FACILITY
Environmental Permit
EP-262/2007/B

Date of Audit :		1-7 March 2024
Prepared By :	Ip Siu On, HSE Officer	8 March 2024
Approved By :	Sylvia Har, General Manager	18 March 2024

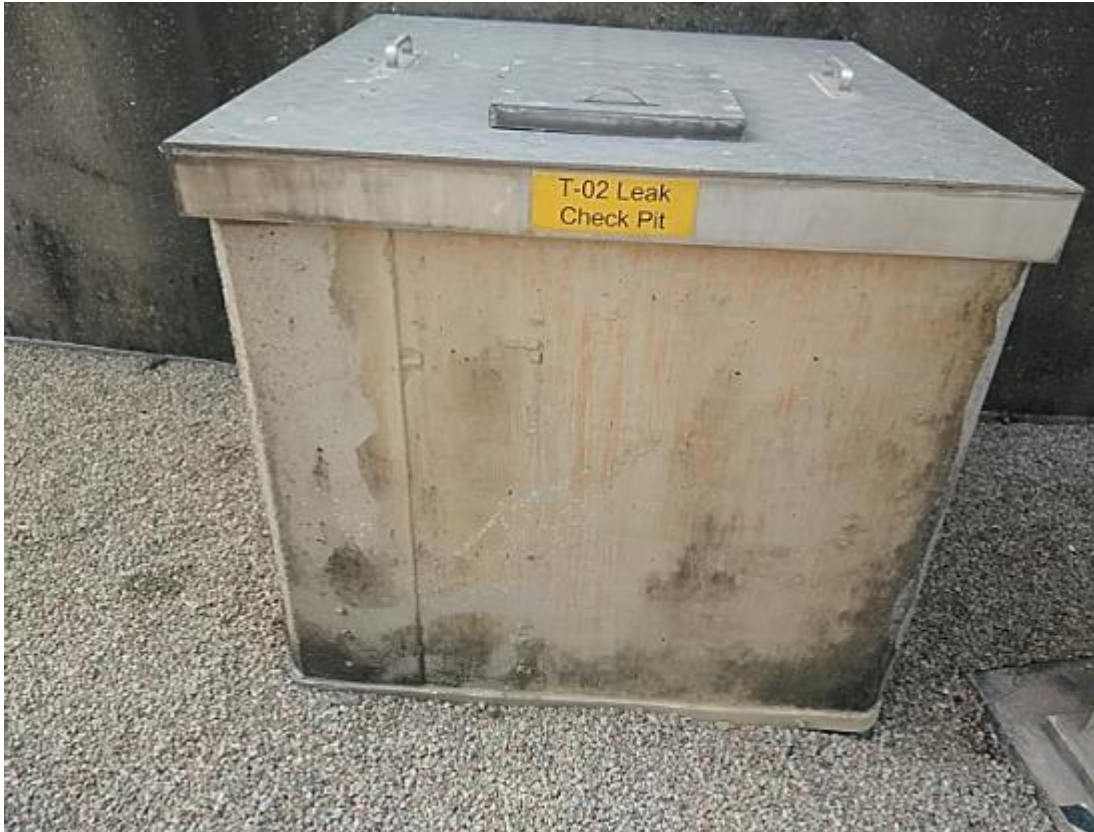
(29) Collection chamber located adjacent to tank foundation is maintained in good condition with periodic inspection

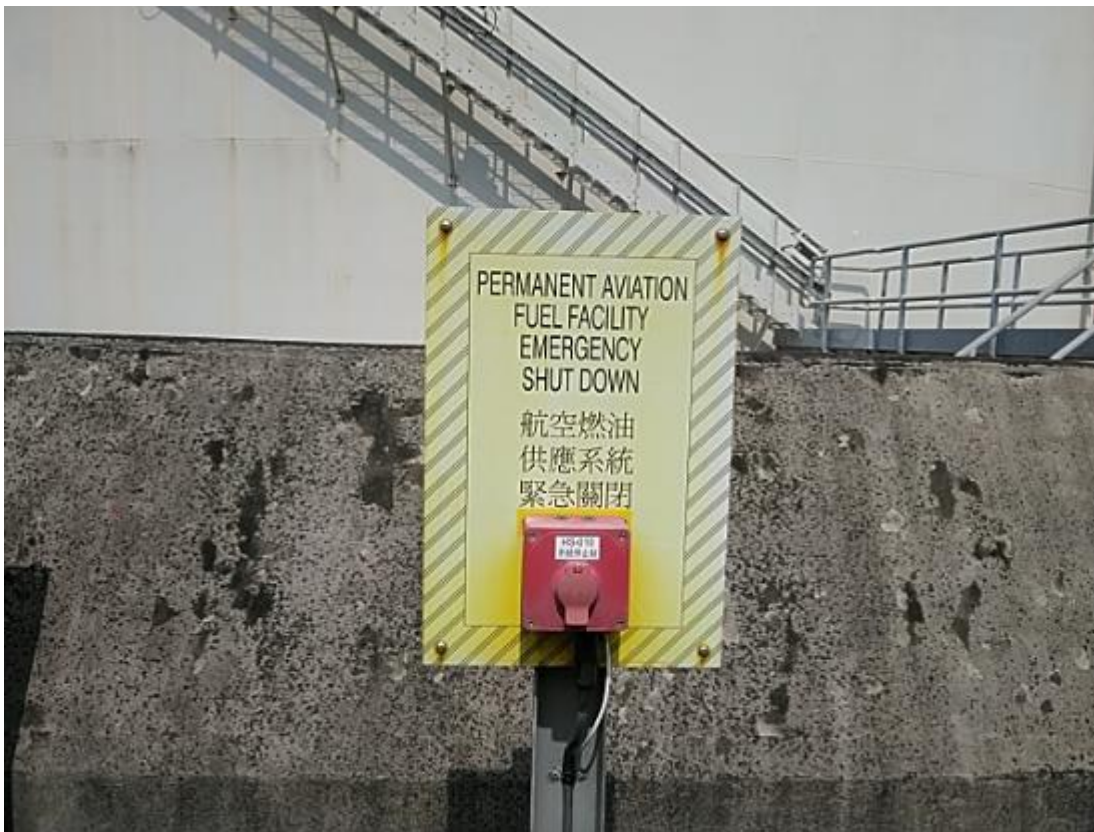
(30) ESD device is maintained in good condition and being tested periodically

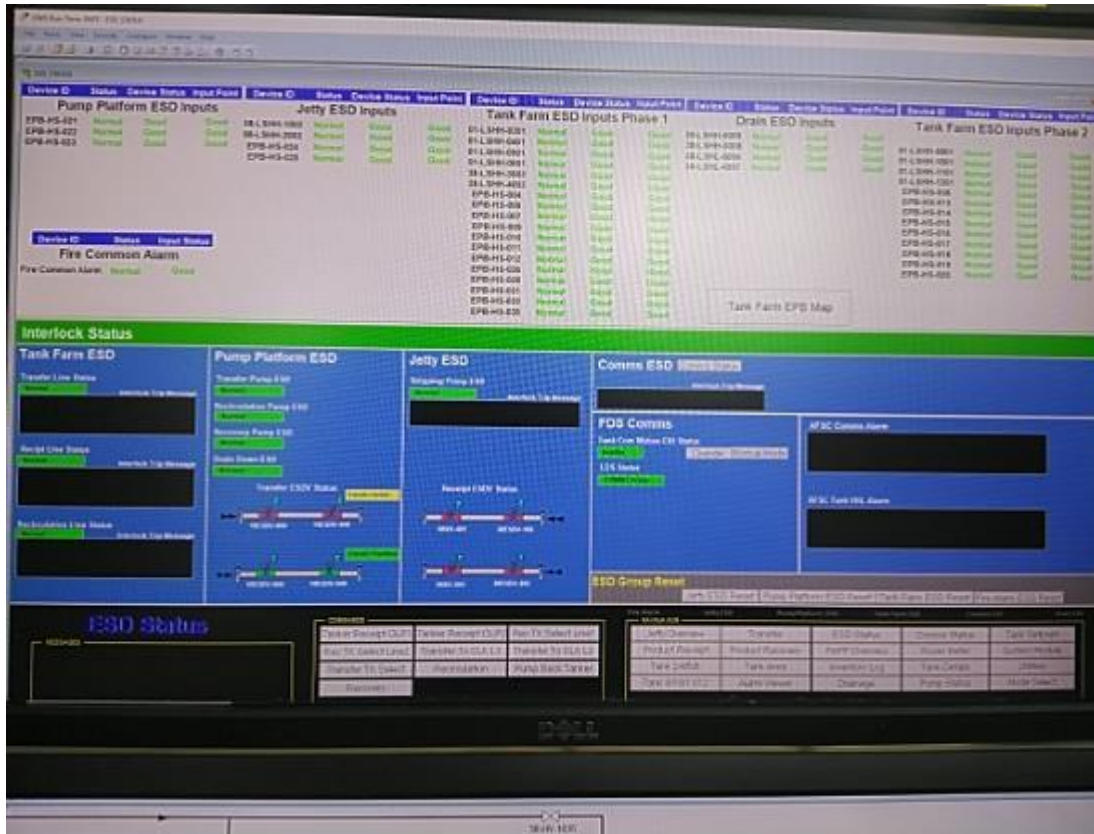
(31) The ESD regular testing as shown in SCADA System

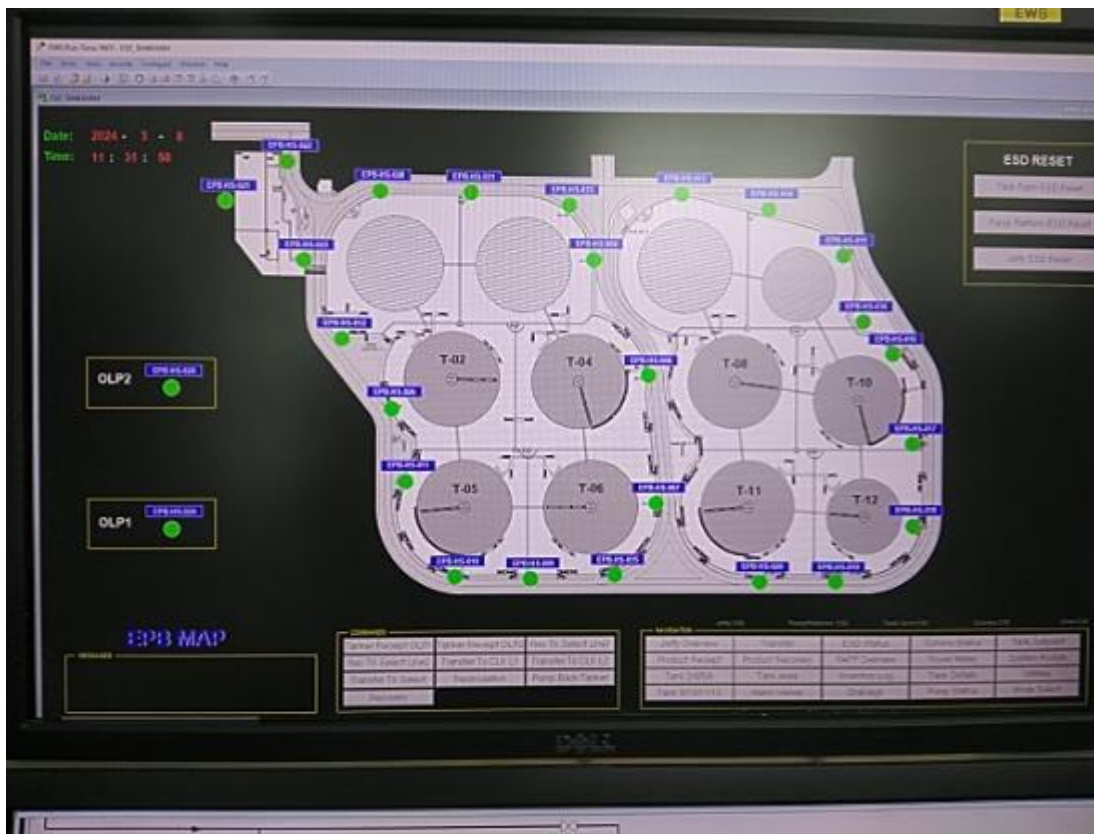
(32) The ESD regular testing as shown in SCADA System

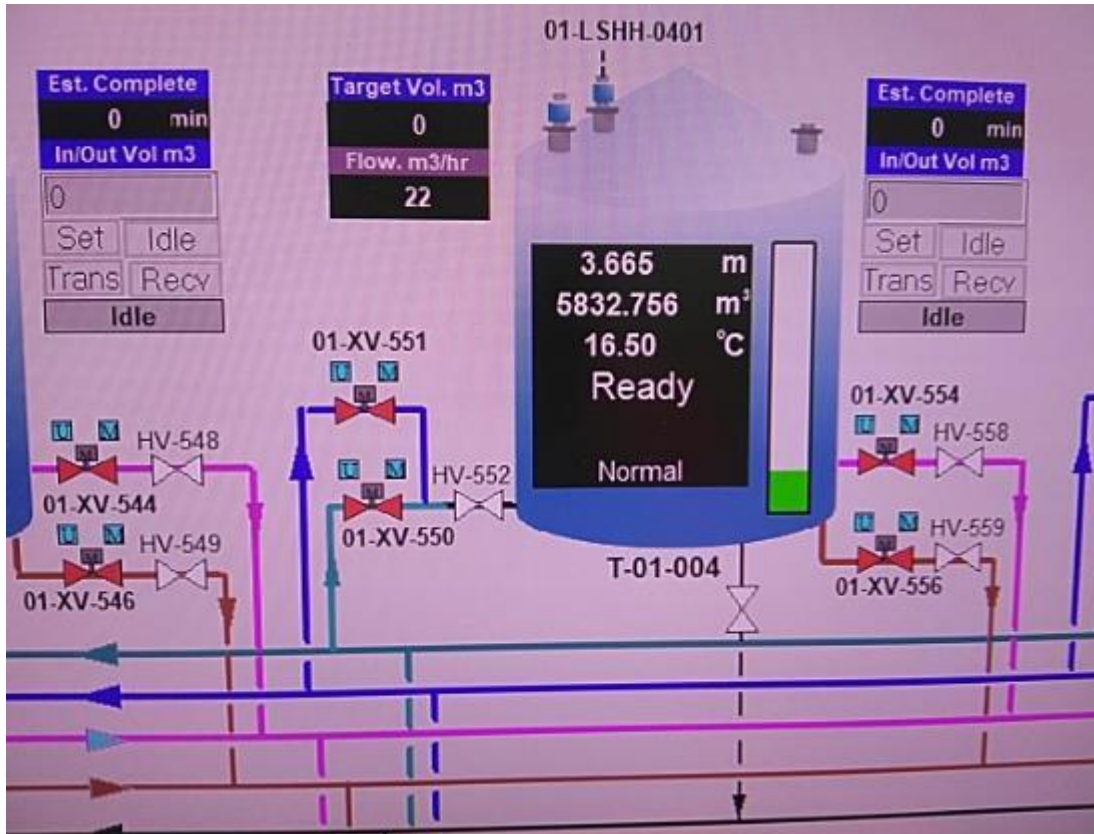
(33) The ESD test signal as shown in SCADA System

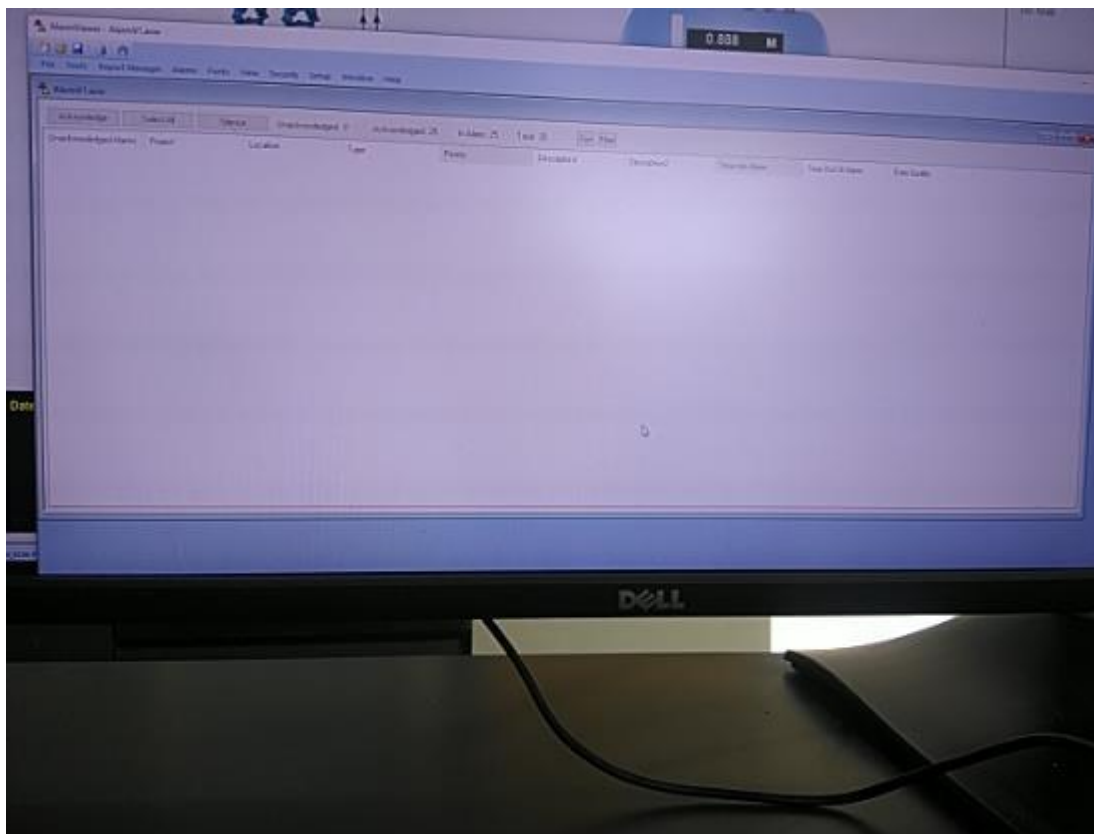
(34) Once the system received ESD test signal, the valves will be closed automatically and shut down the operation as shown in SCADA System

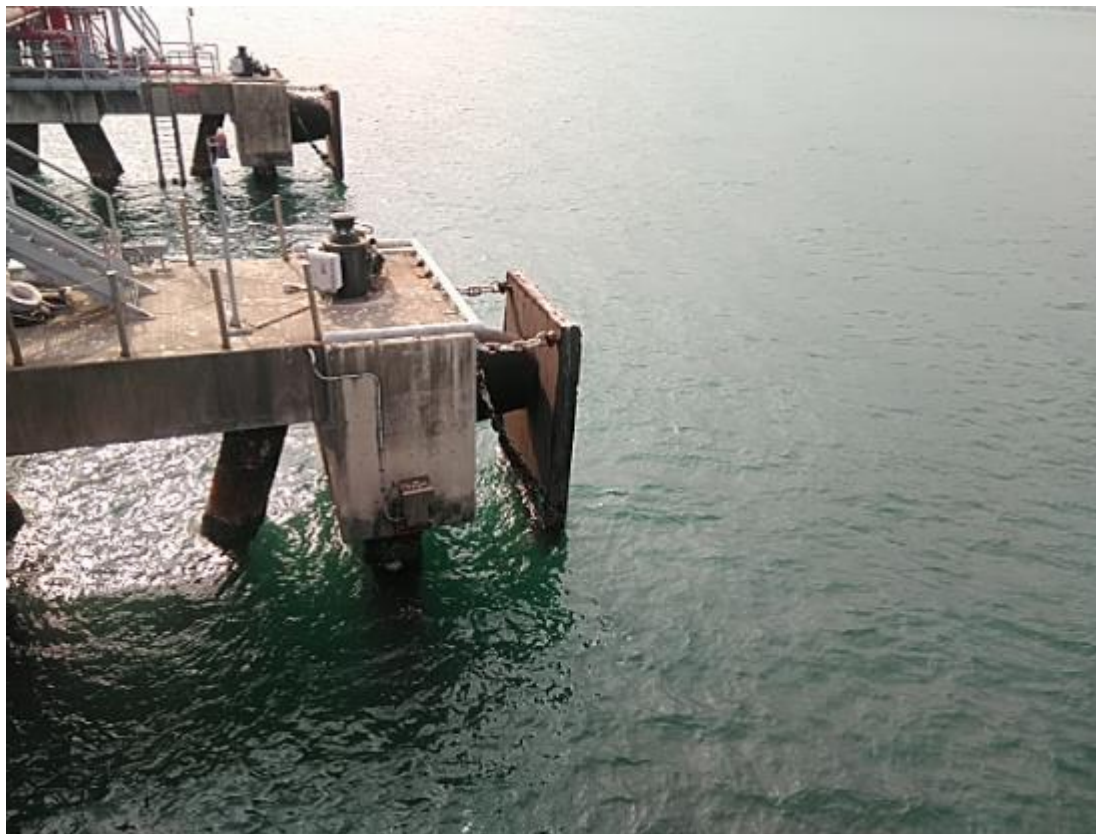
(36) Fenders are installed at sea side of the jetty

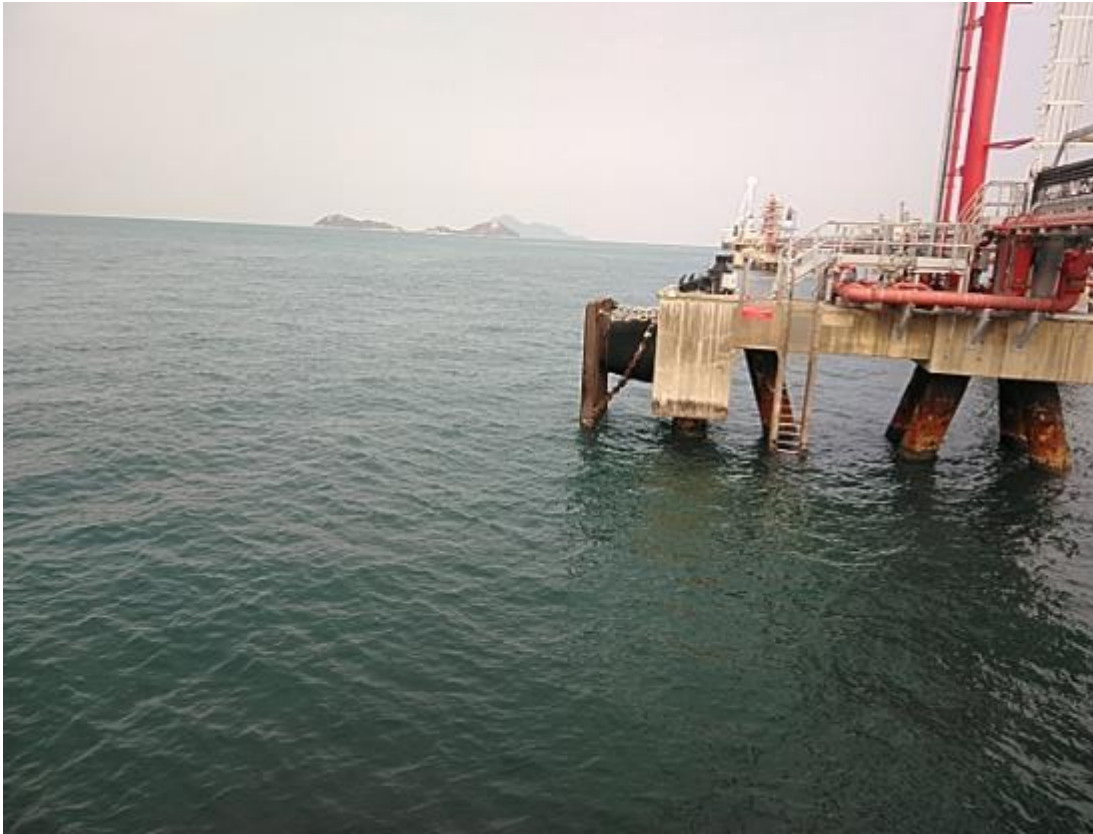
(37) Fenders are installed at sea side of the jetty

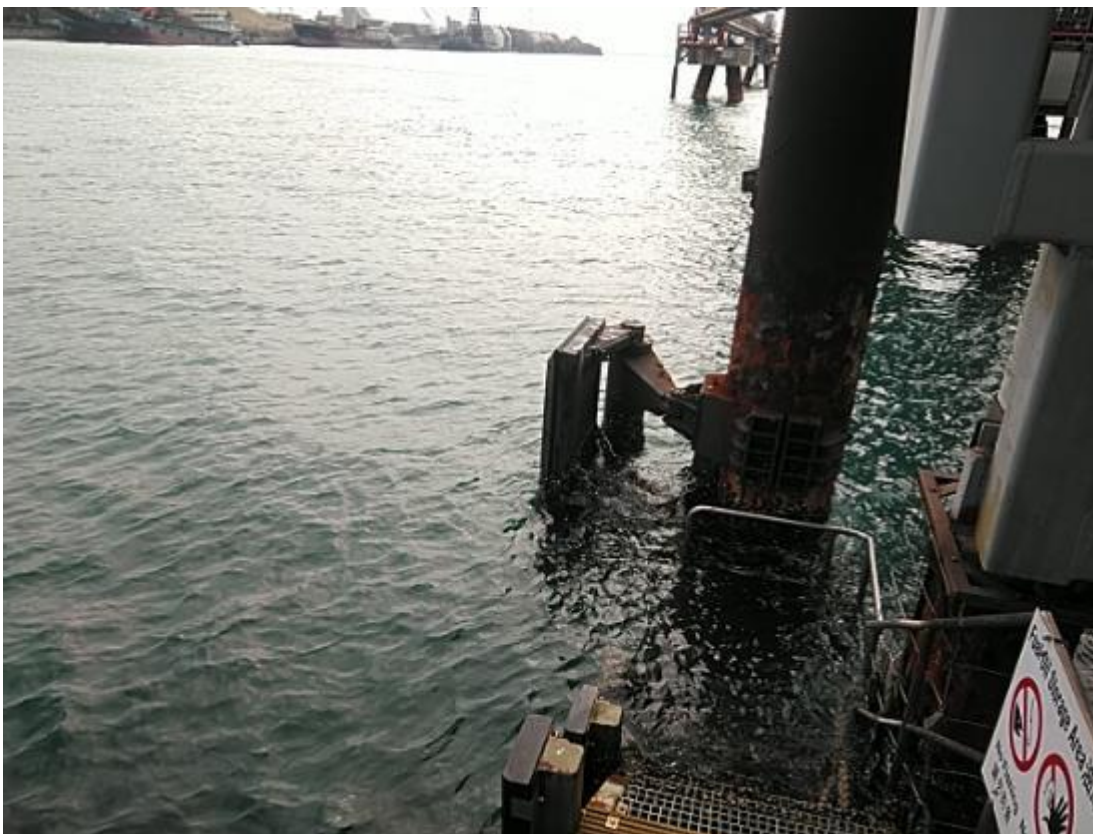
(38) Fenders are installed at shore side of the jetty

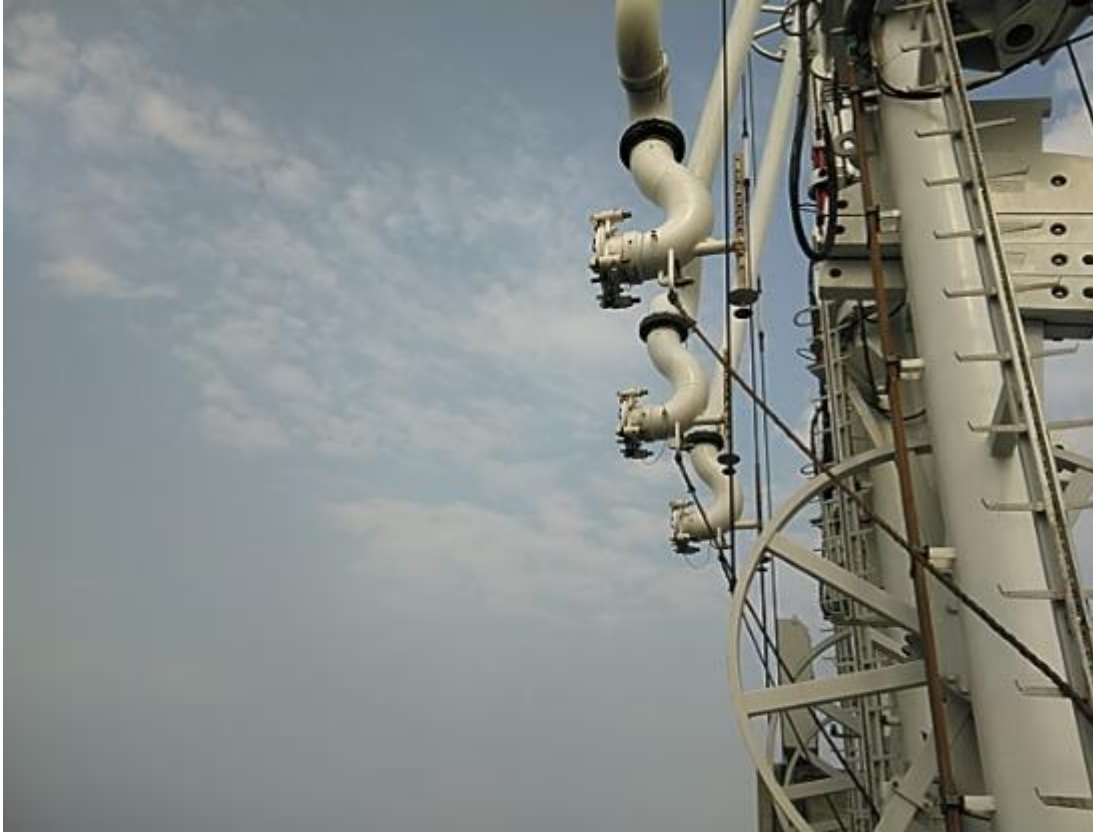
(39) Slop collection utilities are used for coupling and de-coupling of the loading arms

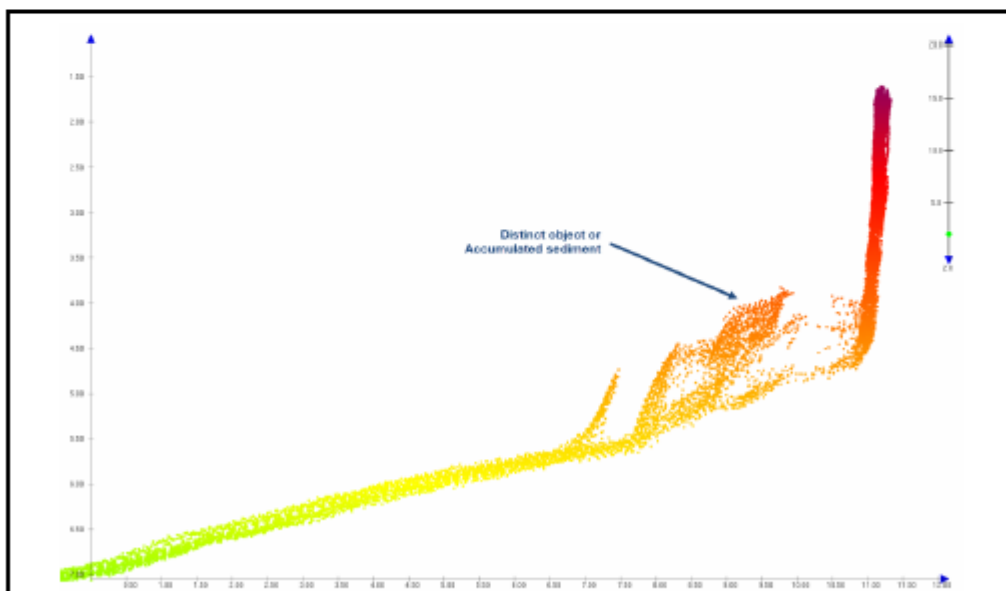
accumulated sediments are observed below the storm-water outfall position with the highest spot at about -4.0mPD while there is not accumulation of sediment or object observed around the intakes position. Refers to the design drawing, the invert level of the storm-water outfall is +0.154mPD therefore there is about 4m distance from the outfall to the top of the accumulated sediment.

Figure 6: Cross section image at the outfall location showing object or accumulated sediment

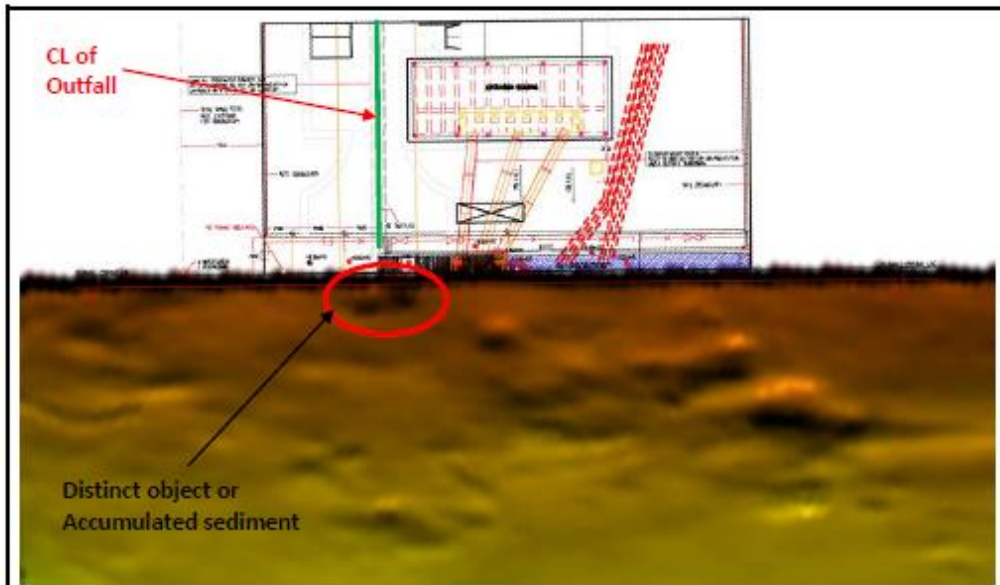
Figure 8: Sun-illuminated bathymetry image at the seafront showing object or accumulated sediment at outfall location
