Permanent Aviation Fuel Facility (EP-262/2007/B)

Sixth Landscape & Visual Bi-Monthly Audit Report – Mar 2011

28 March 2011

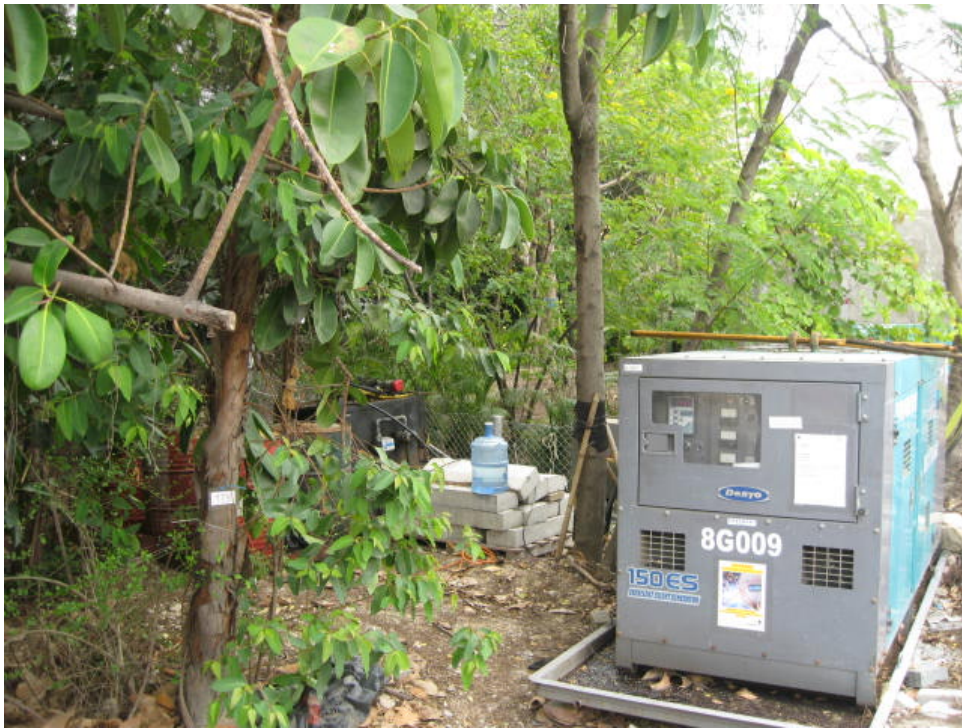
- A generator, construction materials and several drums in drip trays were still observed near retained tree (T1) (refer to *Annex A*).

Area of Works	Items to be Monitored	Phase 1a & 1b (Operational)	
		Observation	Recommendation
Advance planting	Monitoring of implementation and maintenance of planting, and against possible incursion, physical damage, fire, pollution, surface erosion, etc.	New tree planting has been maintained. Stakes are present to provide adequate support. No incursion, physical damage, fire, pollution or surface erosion was observed.	Not required.
Protection of all trees to be retained	Identification and demarcation of trees / vegetation to be retained, erection of physical protection (e.g. fencing), monitoring against possible incursion, physical damage, fire, pollution, surface erosion, etc.	<p>Construction materials and debris observed close to the trunks of the retained trees T68 and T69 in the last site audit were cleared and trees are properly protected (Photo 2).</p> <p>Material debris was cleared and trees were properly trimmed and maintained at the north corner of phase 1b. (Photo 1)The generator and several drums in drip trays were still observed, as per the previous inspection in January 2011.</p>	Location of the retained trees at the north corner of phase 1b are all updated (as indicated on <i>Figure 1</i>) according to the revised Landscape Plan . Contractor was advised to ensure generator and drums do negatively impact on the nearby retained trees, or remove them as soon as possible as advised from the last audit.

Photo 1- Generator, construction materials and drums in drip trays were still observed near retained tree T1.

The Contractor was advised to ensure generator, construction materials and oil drums will not affect the nearby retained trees, or relocate them if found harmful to the trees. Contractor was also advised to keep tree root zones clear to prevent tree damage.

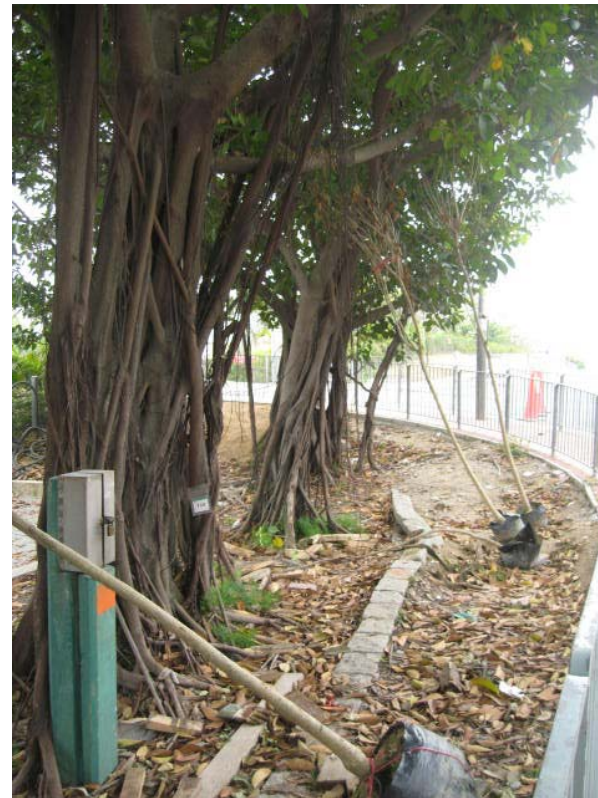
Photo 2 - Construction materials and debris stored near retained trees T68 and T69 are all cleared and retained trees are protected.

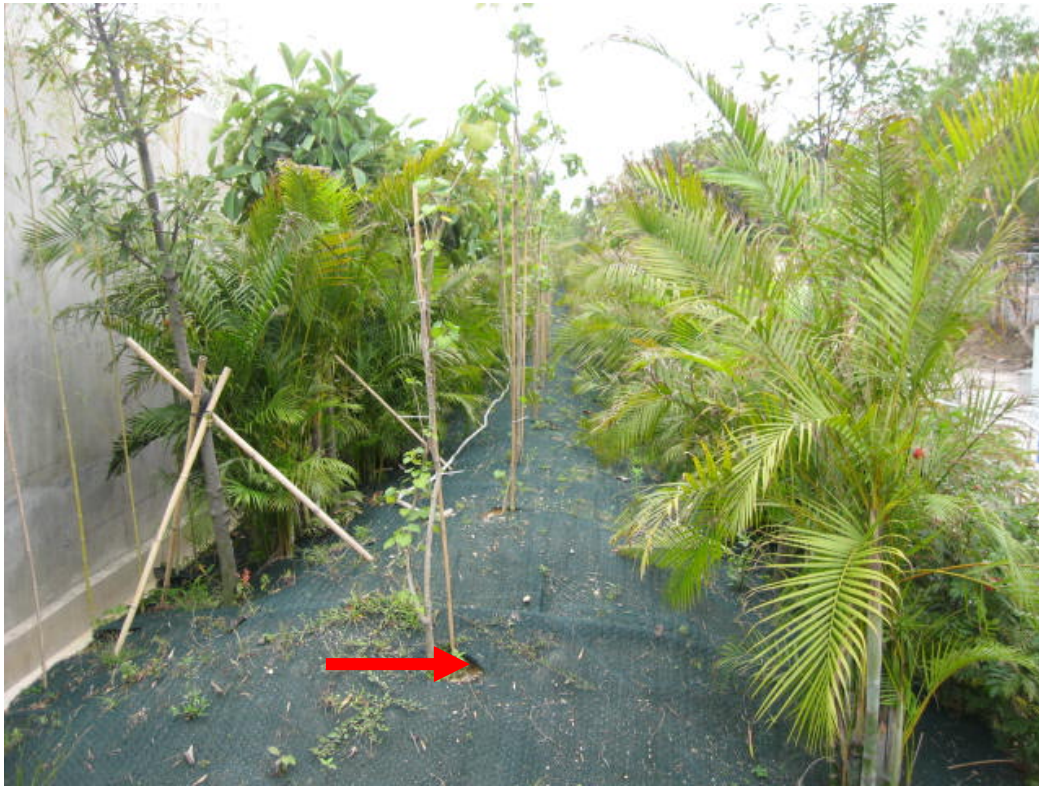
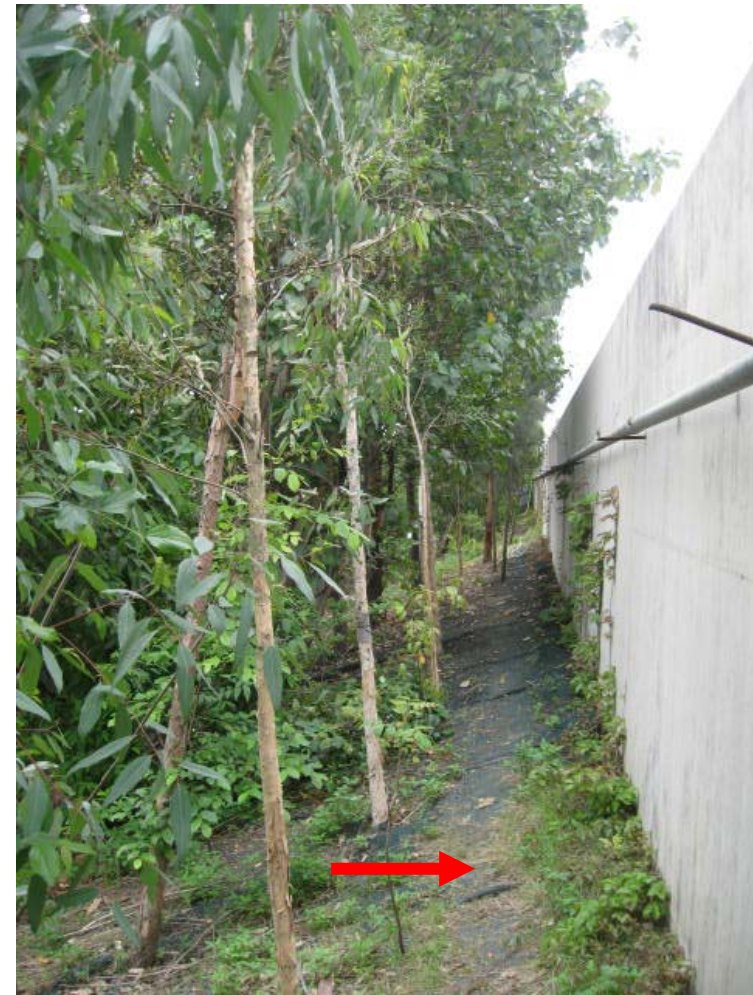
Photos 3 & 4- Example of soil erosion control matt outside boundary wall.

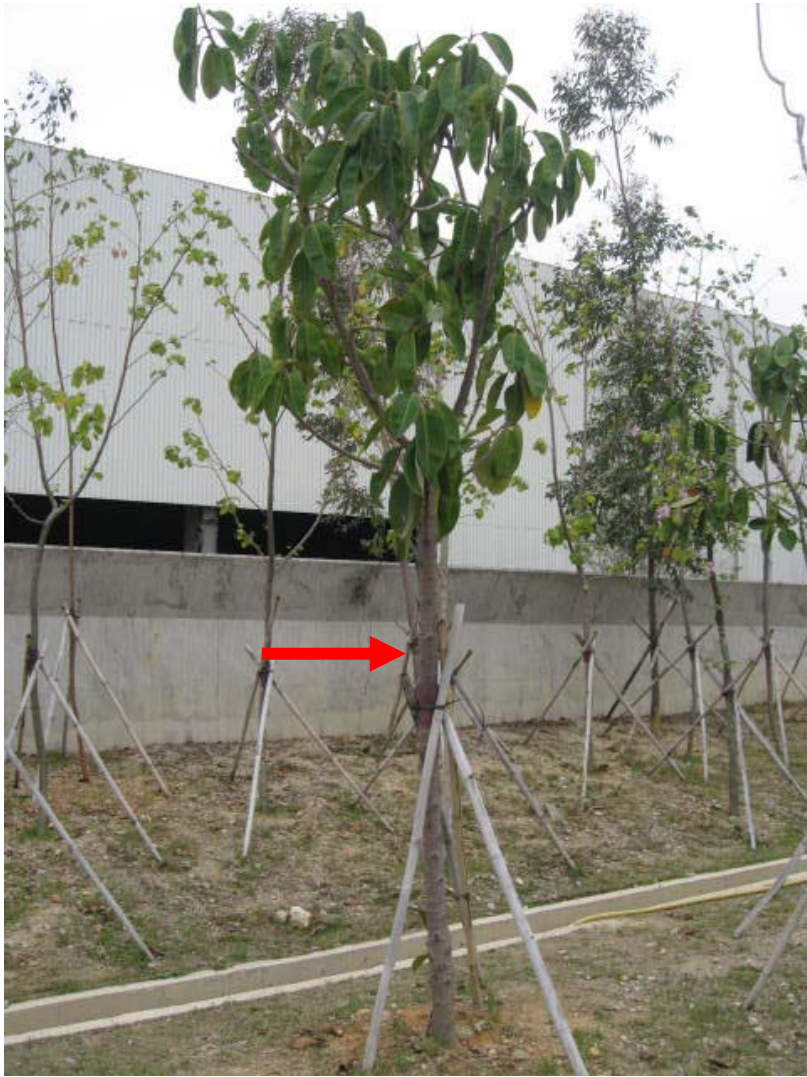
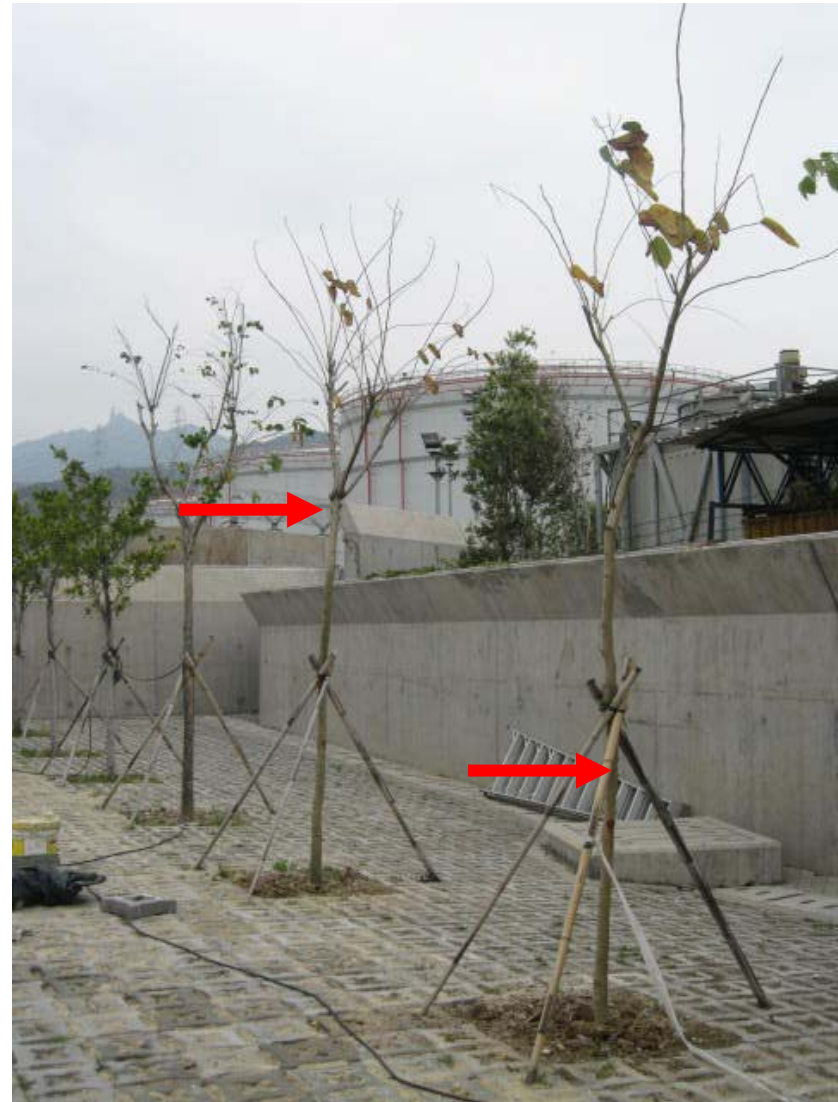
Establishment Works	Monitoring of implementation of maintenance operations during Establishment Period	Trees observed to be in poor health in the Operation Building area of phase 1a were all replaced with new trees. Some of these new trees were observed to be in poor health (Photos 5 & 6). Trees outside the boundary were in good health in general with trees previously recorded as dead or in bad health having been replaced with new trees. Some other trees were in poor health(Photos 7 & 8), (Figure 1).	Contractor is recommended to review health of all newly planted trees and others in poor health or damaged, and take appropriate action to restore the condition of the damaged trees before the hand over period.

Photos 5 & 6 – Examples of new trees in the Operations Buildings area of Phase 1a, some of them in poor health.

The Contractor was recommended to review the health of all compensatory and retained including newly planted trees, and take appropriate action to improve their condition if confirmed as being in poor health. This should be carried out before the hand over period.

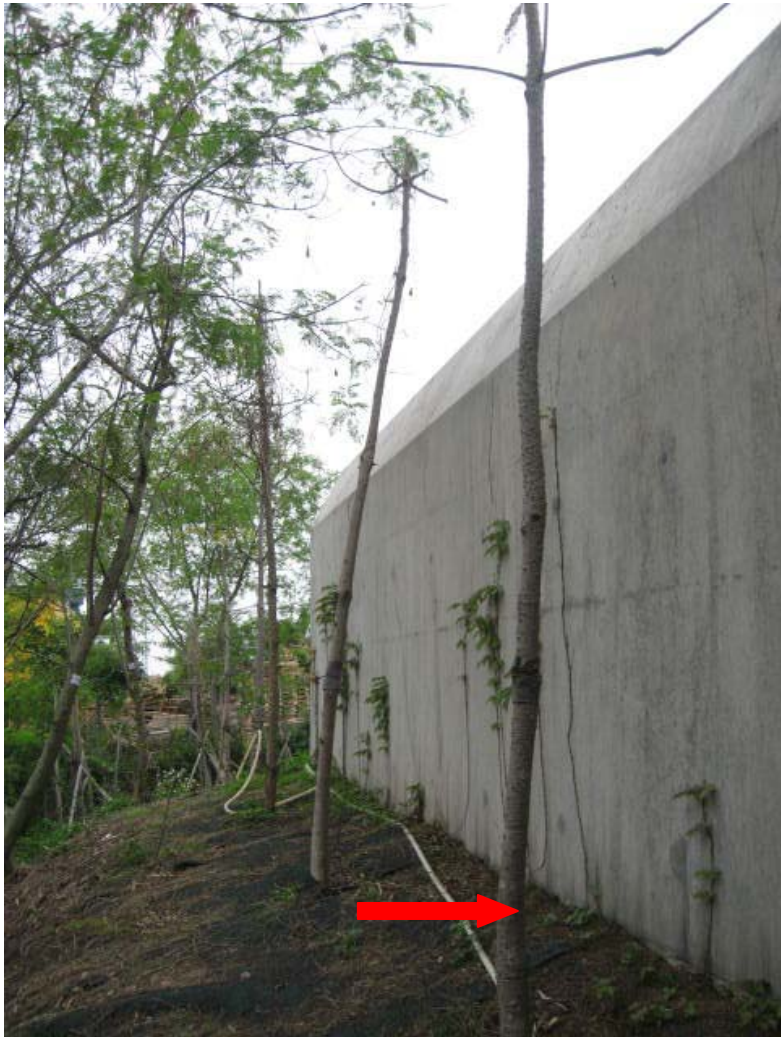
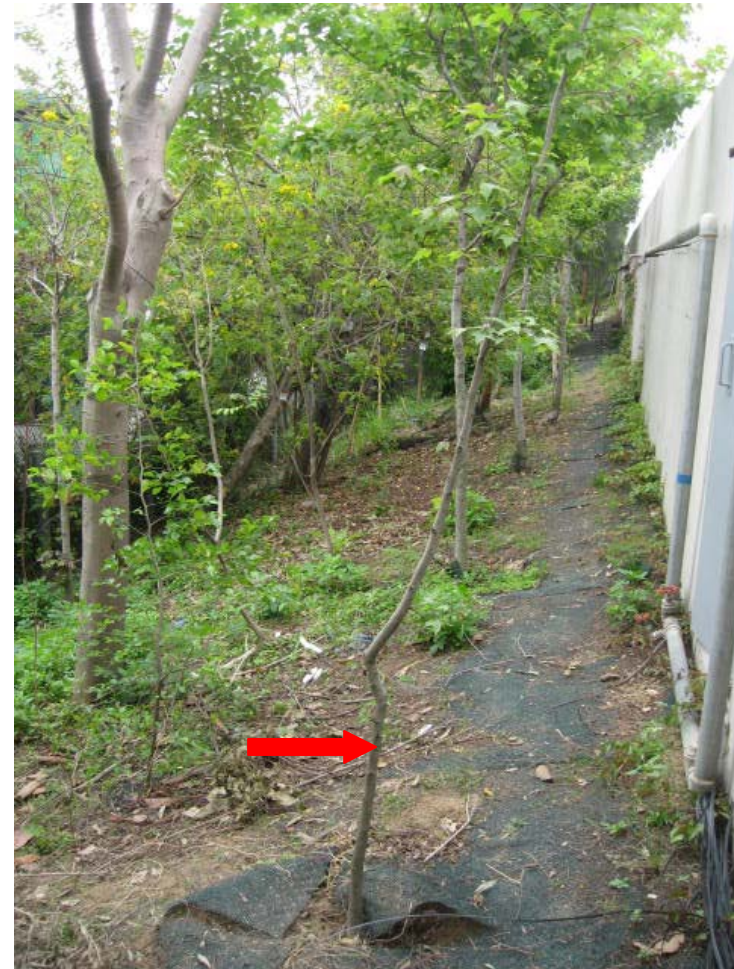
Photos 7 & 8 – Examples of trees outside boundary wall of Phase 1a and 1b, observed to be in poor health (7) and newly planted trees replacing dead trees observed in the last audits (8).

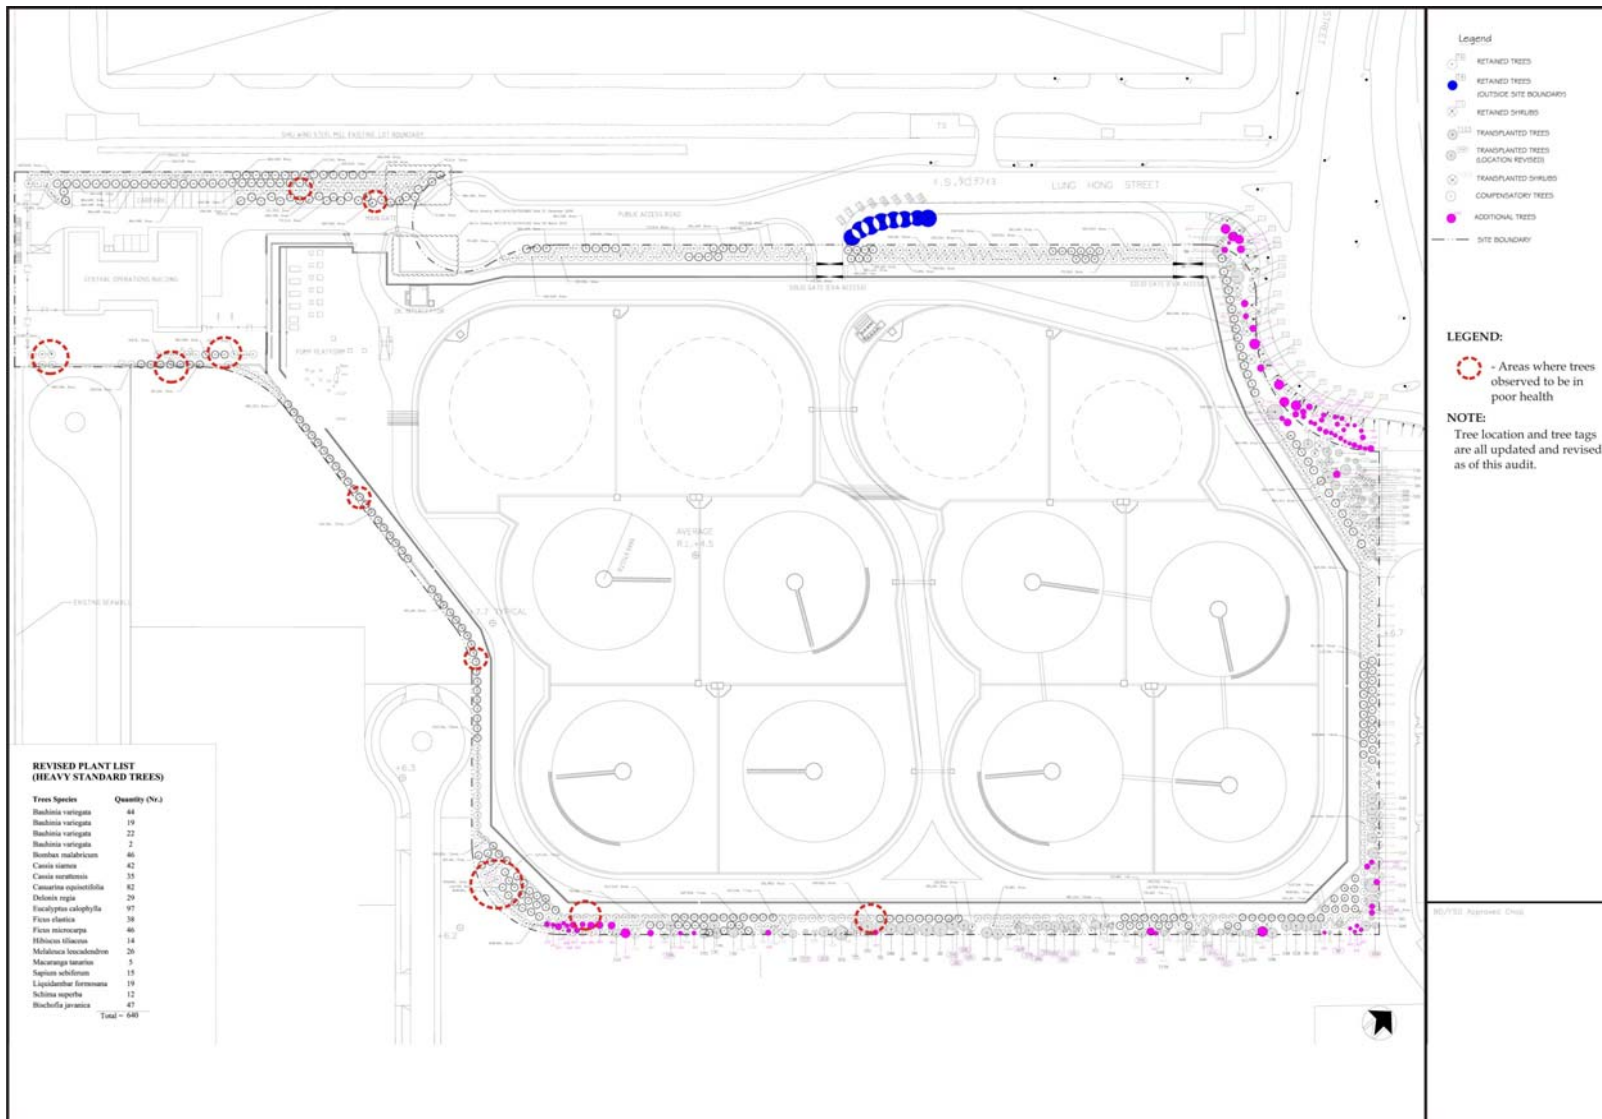
- Some new trees planted around the site to replace dead trees or trees in poor health, were still in poor health and/or slightly damaged (refer to *Annex A, Figure 1*).

Figure 1 - Updated Planting Plan showing Areas where trees observed to be in poor health.
