**Contract No. : DC/2007/06**  
**River Improvement Works in Upper Lam Tsuen, She  
Shan River and Upper Tai Po River**

**MONTHLY EM&A REPORT of**

**UPPER TAI PO RIVER**

**for March 2010**

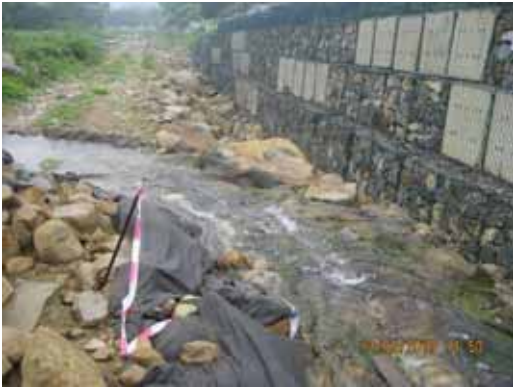
3. During the investigation, generation of muddy water was ceased and source was not observed. Generally, river water was observed to be clear (Fig.3.1 to 3.4).

Fig.3.1 – River water at ch.50, at the afternoon on 12 March

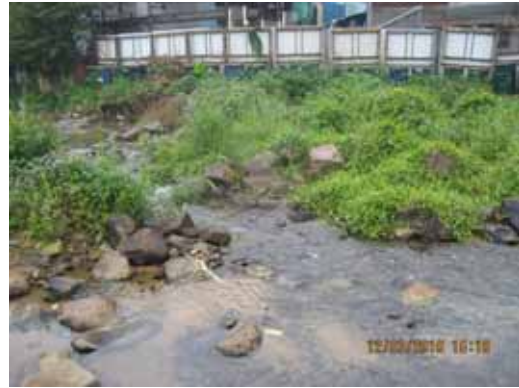
Fig.3.2 – River water at ch.500, at the afternoon on 12 March

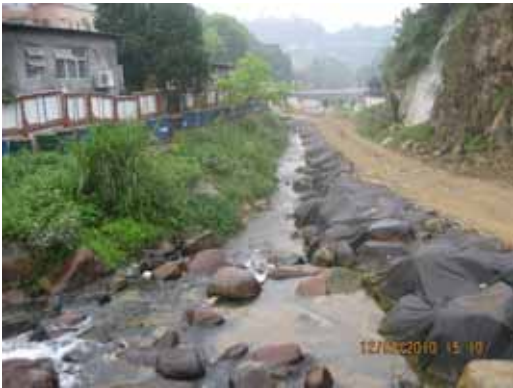
Fig.3.3 – River water at ch.600, at the afternoon on 12 March

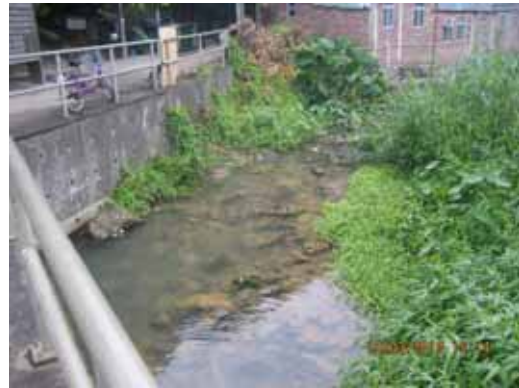
Fig.3.4 – Branch of UTPR, at the afternoon on 12 March

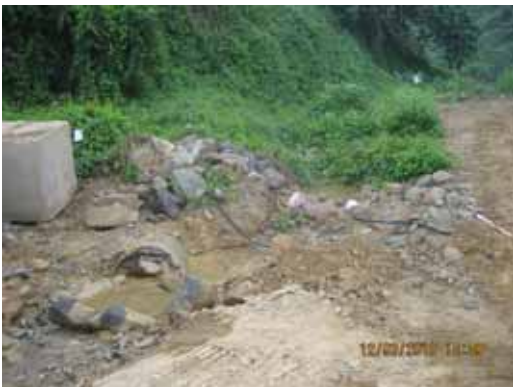
4. Geo-textile coverings for the earth/rock bunds were found drifted, and some of the riverbanks were exposed without geo-textile coverings during the investigation (Fig.4.1 & 4.2). As such, contractor was advised to rectify such discrepancies immediately to minimize soil erosion and surface run-off from the project site.

Fig.4.1 – Site water diversion channel at ch.50 was exposed without geo-textile coverings

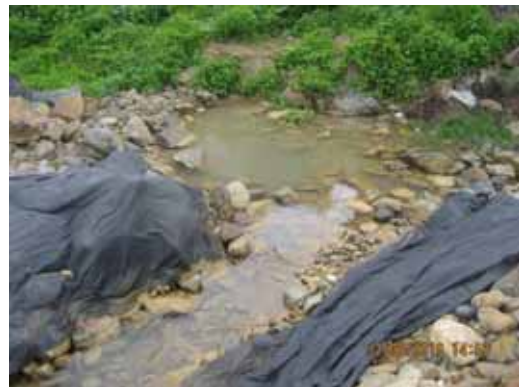
Fig.4.2 – Some of the haul access was not completely protected with proper earth bund and/or barriers

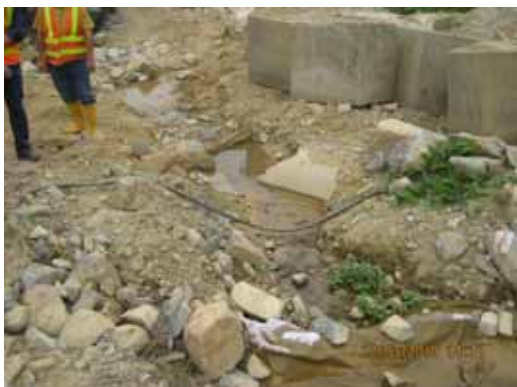
Fig.6.1 – Barriers with geo-textile coverings were provided along the site diversion channel at ch.50

6. Defective site practices, causing direct site water discharge and runoff, were not found during investigation on 17 March 2010. As follow up actions, improvements were made for the site water diversion channel at ch.0 to 50 (Fig.6.1), also application of de-silting tank was observed for the construction activities at the boulder trap site (Fig.6.2).

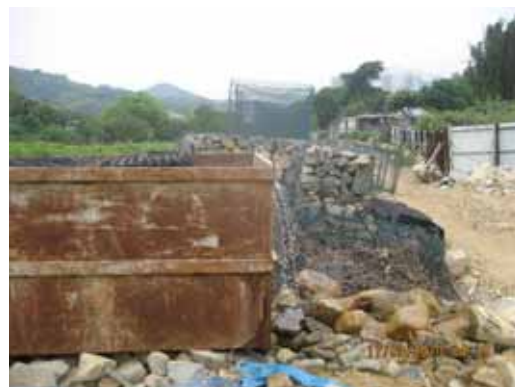
Fig.6.2 – De-silting tank was provided for site water treatment
